DOCUMENT DESCRIPTION: Journal Article - Examination of Asbestos Floor Tile by White Light Interference Microscopy and Scanning Electron Microscopy

## Examination of Asbestos Floor Tile by White Light Interference Microscopy and Scanning Electron Microscopy

James R. Millette\*, Richard S. Brown\*, William M. Ewing\*\* and Tod A. Dawson\*\*

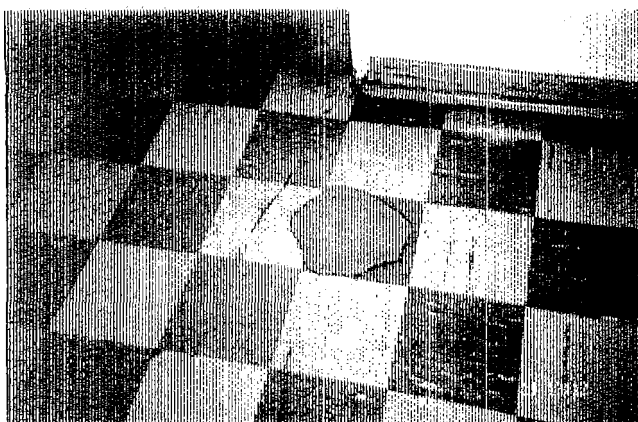
weight) when new, it is evident that they wear with use (Figure 1).

Figure 1. An example of an area of asbestos-containing floor tile that had worn away completely.

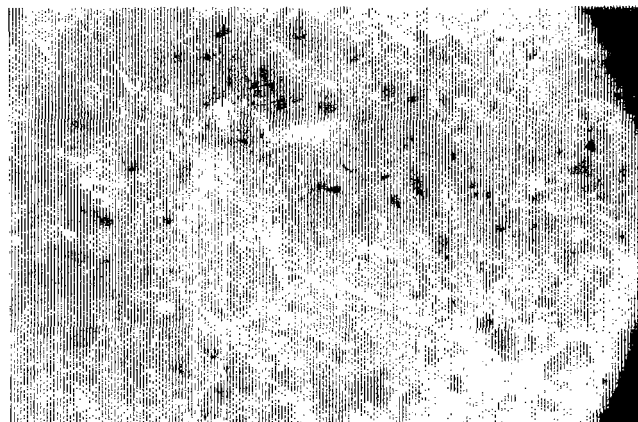
Figure 3. View of scratches on a floor tile surface caused by a dirty shoe under approximately 100 pounds weight. Magnification = approximately 30x.

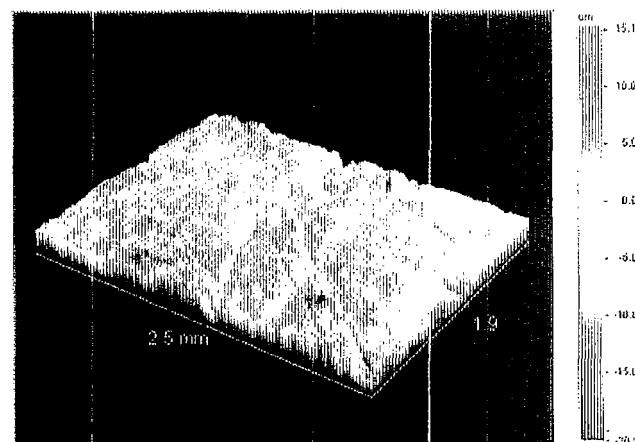
Figure 4. Scanning white light interference microscope view of scratches on a floor tile surface caused by a dirty shoe under approximately 100 pounds weight.

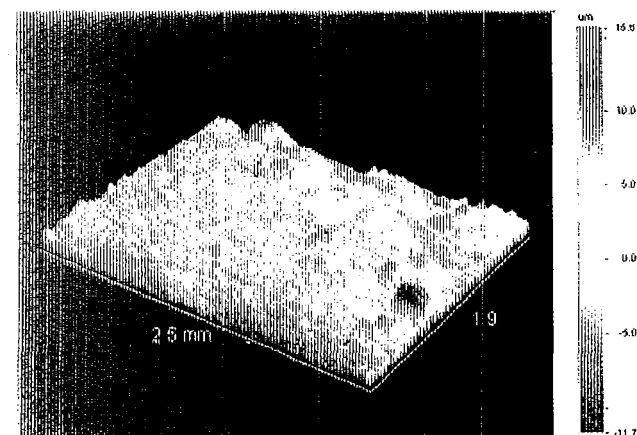
Figure 5. Scanning white light interference microscope view of scratches on a floor tile surface caused by a dirty shoe under approximately 100 pounds weight.

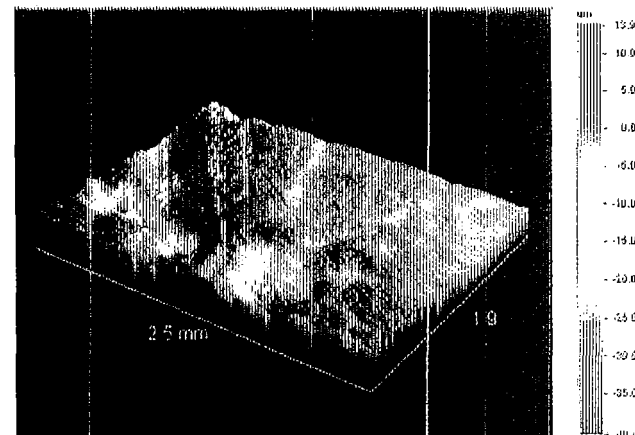
Figure 6. Scanning white light interference microscope view of a pit and scratches on a floor tile surface from a tile taken from a building after years of normal use.

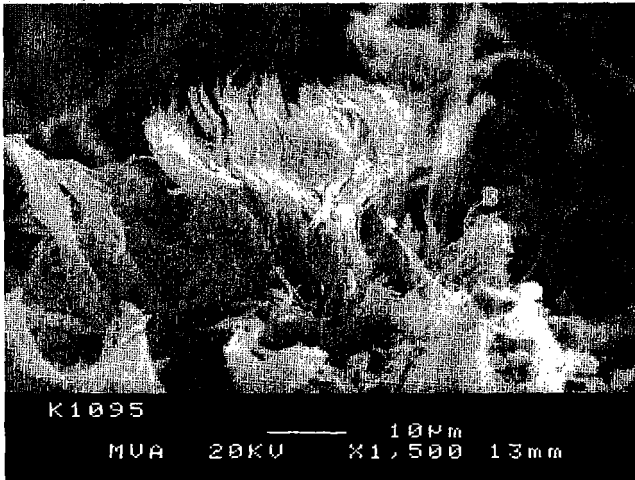
Figure 7. Scanning Electron Microscope view of uncoated asbestos fibers in scratches on a floor tile surface caused by a dirty shoe under approximately 100 pounds weight.

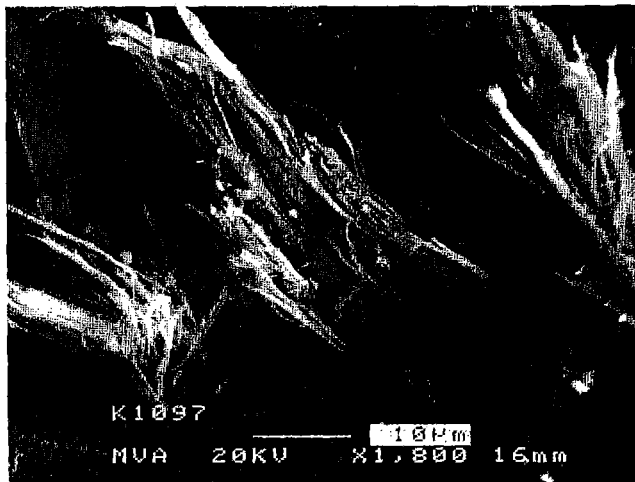
Figure 8. Scanning Electron Microscope View of uncoated asbestos fibers in scratches on a floor tile surface caused by a dirty shoe under approximately 100 pounds weight.
