## **HAZARDOUS MATERIALS/ RAILROAD ACCIDENT REPORT**

**BUTADIENE RELEASE AND FIRE  
FROM GATX 55996 AT THE  
CSX TERMINAL JUNCTION INTERCHANGE  
NEW ORLEANS, LOUISIANA,  
SEPTEMBER 8, 1987**

NTSB/HZM-88/01

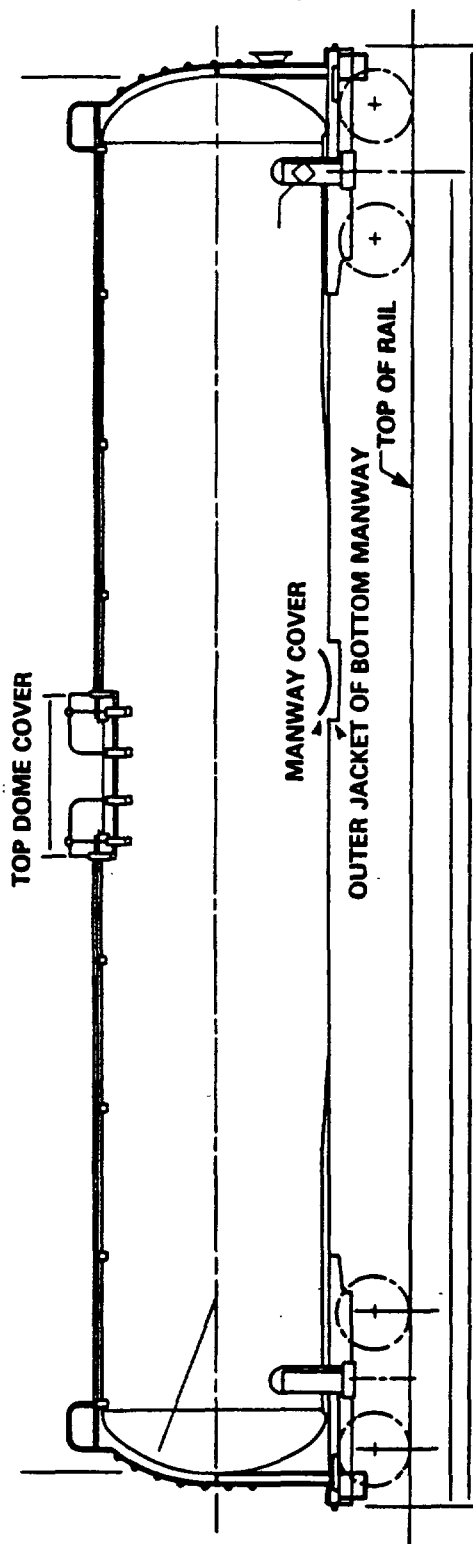
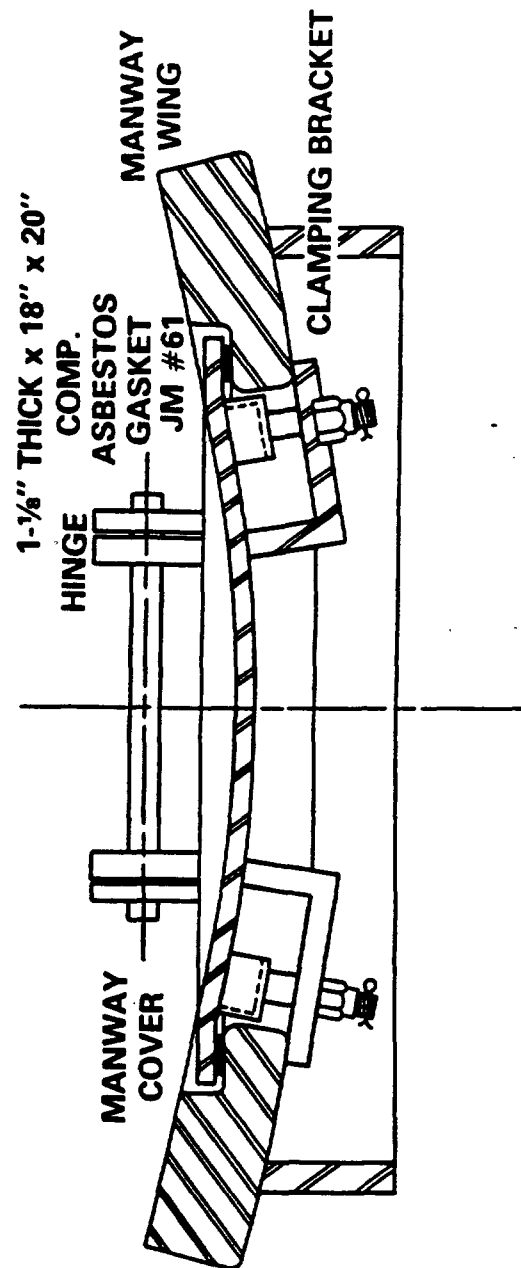
Figure 7.--Tank car with an 18-inch bottom manway.

Unlike most tank cars whose manways are colocated on the top center of the tank with the valve housing, the manway was located near the center of the tank bottom. (See figure 7.) The manway

opening was 18 inches in diameter and had an internally-hinged cover which opened to the inside of the tank. The manway cover was secured in the closed position by six L-shaped brackets that were bolted to the manway cover and designed to maintain pressure to seal the manway seat until liquid was added to the tank. When liquid was loaded into the tank, the weight of the liquid above the manway cover and the vapor pressure of that liquid resulted in additional pressure being applied to the manway and the manway seat. Thus, this manway design became known as an internal, self-energizing manway. The AAR-approved tank car design drawing specified the use of an asbestos type gasket (1/8-inch-thick by 18-inch inside diameter by 20-inch outside diameter asbestos gasket - JM #61) between the manway cover and the manway flange.

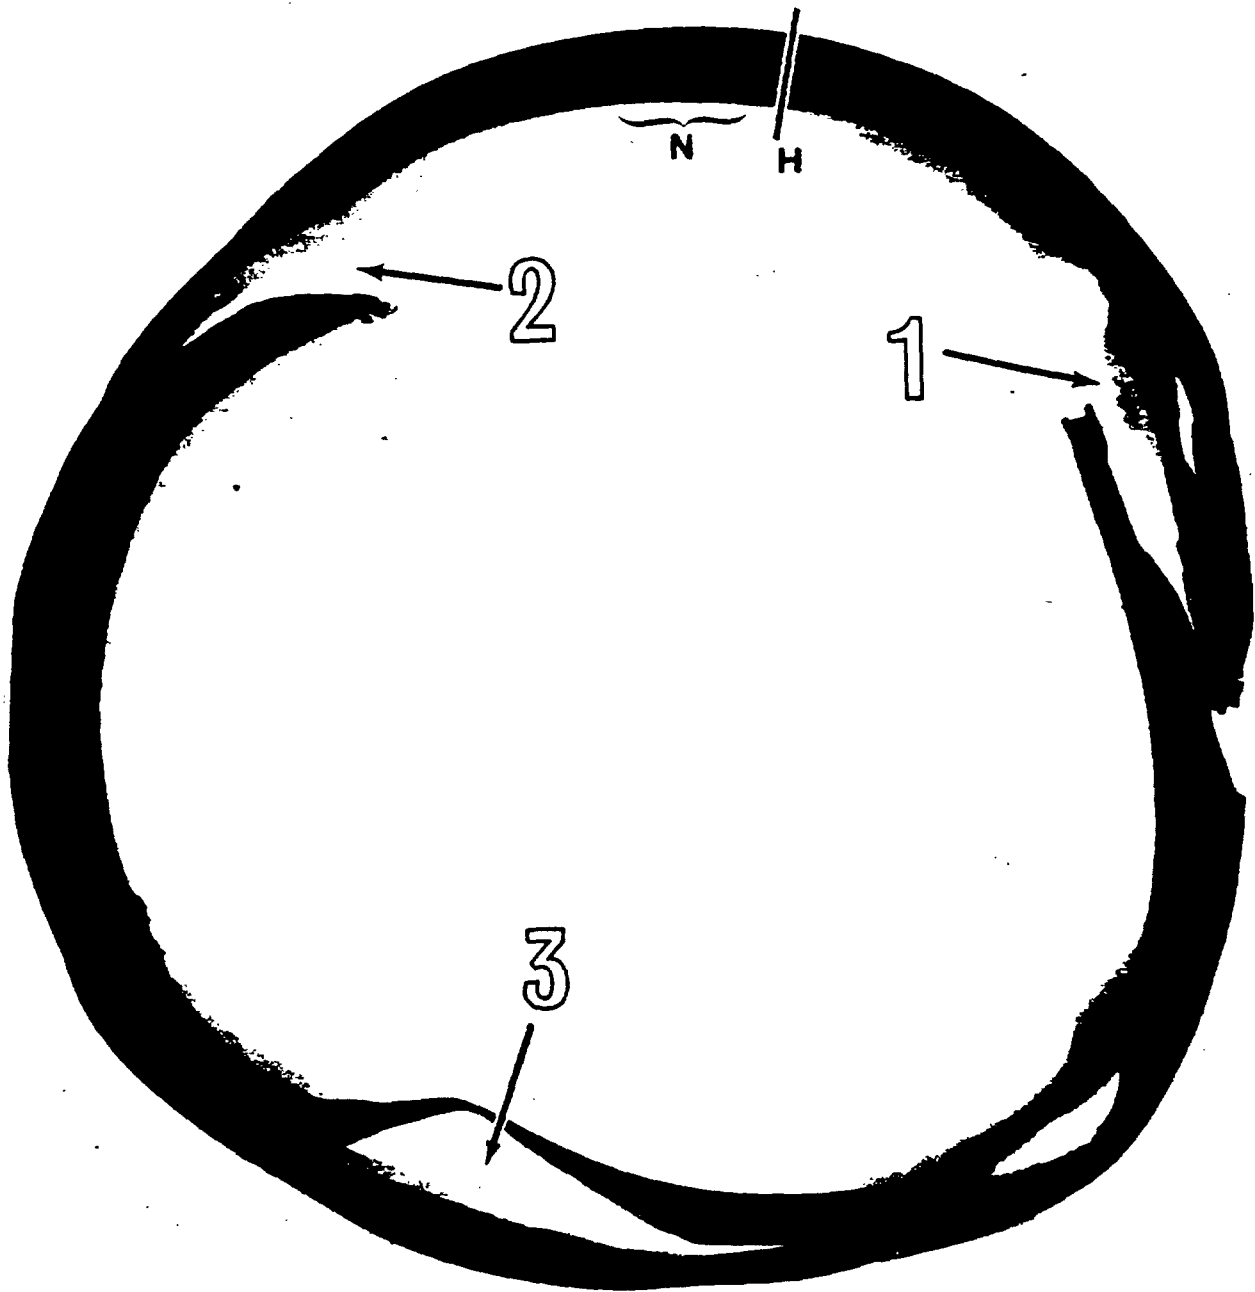
The investigation also revealed that the release of butadiene from the bottom of the tank car occurred because the gasket in the bottom manway had been severely damaged at the time it was reinstalled and that large amounts of sealant had been used when installing the gasket. The Safety Board determined that the butadiene leaked from the bottom manway of tank car GATX 55996 which was being used for the first time since it was inspected and tested in a tank car repair facility in November 1986 before being sold. The gasket used in the manway and the closure attachments for the manway were not of the types specified on the design drawings for GATX 55996. As a part of this investigation, the Safety Board reviewed the adequacy of procedures used by the Association of American Railroads, by tank car manufacturers, and by tank car repair facilities for ensuring that tank cars comply with Federal requirements and that they are safely maintained. The safety issues discussed in this report are:

The National Transportation Safety Board determines that the probable cause of the uncontrolled release of butadiene from the bottom manway of tank car GATX 55996 was the misalignment and subsequent tearing of the the gasket when the manway cover was improperly closed. Contributing to the improper closing of the manyway cover were the lack of established procedures by both the North American Tank Car Corporation and Phillips 66 for correctly using the uniquely designed cover hinge and the insufficient training of the carman who performed the work. Contributing to the length of the emergency and the increased risk to life and property were the lack of any means to stop the flow of butadiene from the bottom manway of the tank car and the failure of personnel responding to comprehend the extent of the danger posed by the burning tank car and to promptly evacuate the threatened area.

Figure 1. A reduced size (50 percent) photograph showing the lower surface of the as-received gasket with corresponding manway handle location marked at line "H."
