UNION CARBIDE CORPORATION  
ENGINEERING AND HYDROCARBONS DIVISION  
CENTRAL ENGINEERING  
SOUTH CHARLESTON, WEST VIRGINIA

MEMORANDUM

SUBJECT: INSPECTION OF TRANSITE PIPING SECTION OF WASTEWATER  
COLLECTION SYSTEM, SOUTH CHARLESTON PLANT

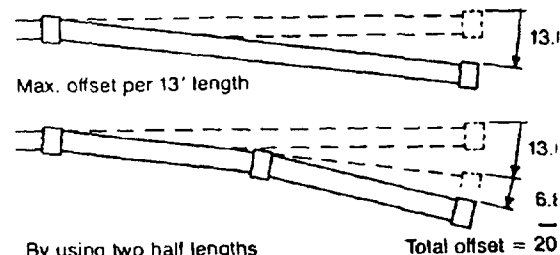
Fig. 12 Short lengths allow sharper curves.

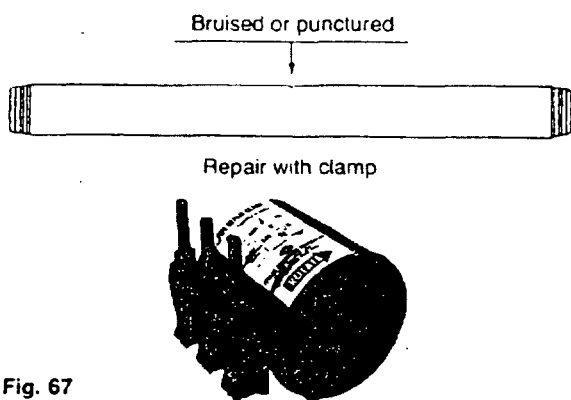
Fig. 67

2. Whether the blow results in a bruise or in a hole through the pipe-wall, some or all of the pipe will still be useable. As shown in Fig. 67, bruises and punctures can be repaired with repair clamps.

If a repair clamp is to be used the full circle type with opposed bolt-line flanges is recommended and should be installed in accordance with the manufacturer's instructions. When using a repair clamp the area on the pipe barrel around which clamp will be placed should first be cleaned with a wire brush. Apply Ring-Tite lubricant to the cleaned area — (to help seat

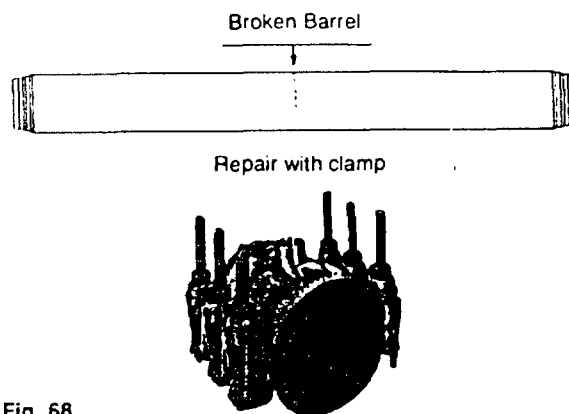
Fig. 68

3. If the pipe has been broken cleanly into two pieces the ends can be joined together with a repair clamp.

the rubber lining smoothly during final adjustments). The clamp is then put around the pipe with the nut position on top for easy access. After the nuts have been tightened lightly the clamp should be rotated slightly in the same direction as the overlap of the rubber lining to assure its smoothness. The nuts are then tightened so as to distribute the pull evenly on all the bolts and the repair is completed. Either clamp shown in Fig. 67 or 68 is suitable for either repair.

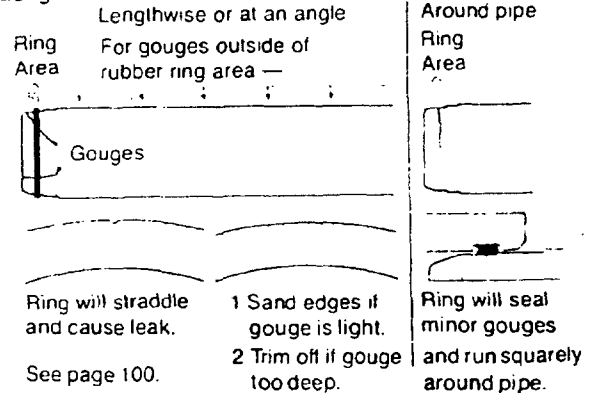
Fig. 70

6. On the machined end of the pipe (where water-tightness is attained by sealing with rubber rings) grooves and scratches that run lengthwise, and would be in the rubber ring area, will have to be repaired or trimmed off and re-machined. Refer to Fig. 70. Slight scratches (not over 1/16" deep and no wider than 1/4") can be repaired by sanding the sharp edges so that the rubber rings will seat properly on the pipe. Wider or deeper scratches will prevent the ring from sealing properly and should be trimmed off.

7. Scratches that run around the pipe will not cause trouble if the rubber ring will fully cover the scratch (see Fig. 70) —but, if the ring will cross it at an angle, it would cause leakage and should be repaired or trimmed off as described above.

Ring will straddle  
and cause leak.

Ring will seal  
minor gouges  
and run squarely  
around pipe.

1 Sand edges if  
gouge is light.  
2 Trim off if gouge  
too deep.
