**REPORT OF INDUSTRIAL STORMWATER  
COMPLIANCE EVALUATION INSPECTION**

**AT  
Vance Brothers – Brighton Location,  
5201 Brighton Ave  
Kansas City, MO 64130  
NPDES NO: MOG490576**

**September 19, 2023**

**by U. S. ENVIRONMENTAL PROTECTION AGENCY  
Region 7: Enforcement and Compliance Assurance Division**

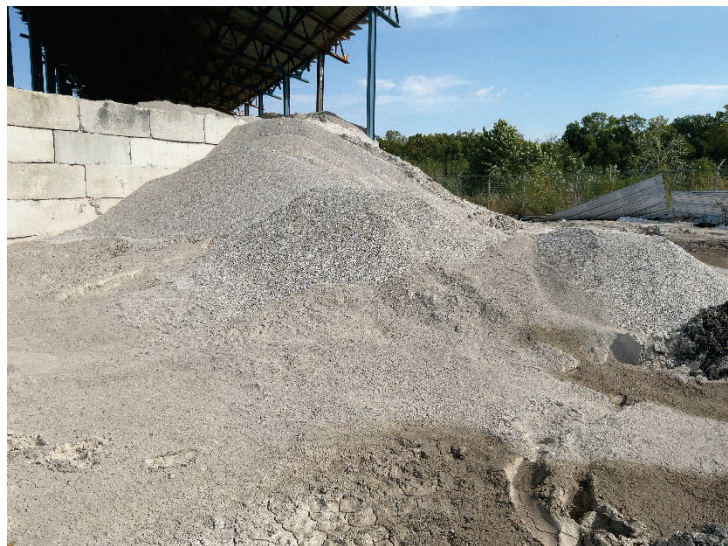
*Image #12 from the digital image log.*

permanent structures are open sided with metal roofs. The facility uses concrete bin blocks to surround the aggregate materials on three sides. The facility stores some materials, like recycled asphalt and materials collected from dust collection equipment or baghouses, in piles outside the barns (Image #12). I saw piles of powdery grey material stored to the south of the east aggregate barn (Image #12). Mr. Kerans said that the fine grey material was baghouse

material. These baghouse materials are not covered with an awning, tarp, or roof. The baghouse materials are not surrounded with dikes or berms to contain materials. Mr. Kerans said they allow the baghouse material to "get a little water on it" to make handling easier and sometimes stir the material back into process mixtures. Mr. Kerans said they were just a little overrun this year and they try to keep a balance of incoming to outgoing material. Waste

materials from dust collection systems are not promptly disposed. Materials collected through dust collection systems are fine and easily mobilized in stormwater and by wind. The facility does not store collected dusts in a way that prevents contact with precipitation or losses due to wind.

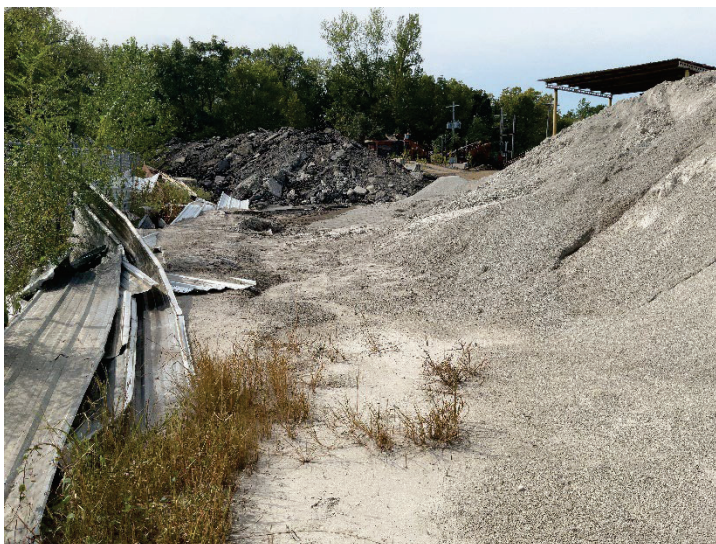
*Image #13 from the digital image log.*

The permit requires that facilities manage materials to prevent materials from being transported off-site (permit section VI.1.(e)). Loose materials on the east side of the stockpiles were not well contained and potentially being discharged to the Blue River in stormwater (Image #13). To the east of the uncovered stockpiles and barn is the property line and a chain link fence. Along the fence there are piles of old sheet metal roofing and deposited fines are built up around the scrap sheet metal; some of the pieces of sheet metal are

embedded in the fines (Image #13). Flow patterns and the location of deposited materials show the materials are migrating east and north. Facility must minimize erosion from stockpiles caused by stormwater and wind through temporary cover when possible and minimize sediment in stormwater from stockpiles using sediment controls (permit section VI.1.(e)).
