INSPECTION REPORT

| Type of Inspection | CEI - Compliance Evaluation Inspection | | |
| Permittee Name | Ohio Coatings Co. | | |

**APPENDIX 1: PHOTO LOG**

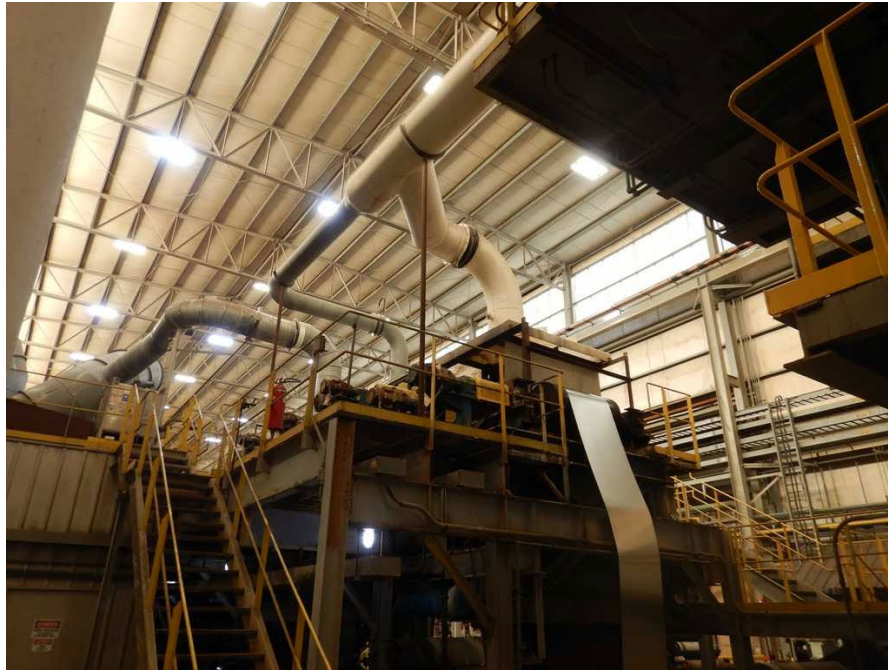
| Cleaning process | DSCN0457.JPG | |

| Cleaning process. Fume collection is through white pipe or duct, above process | | |

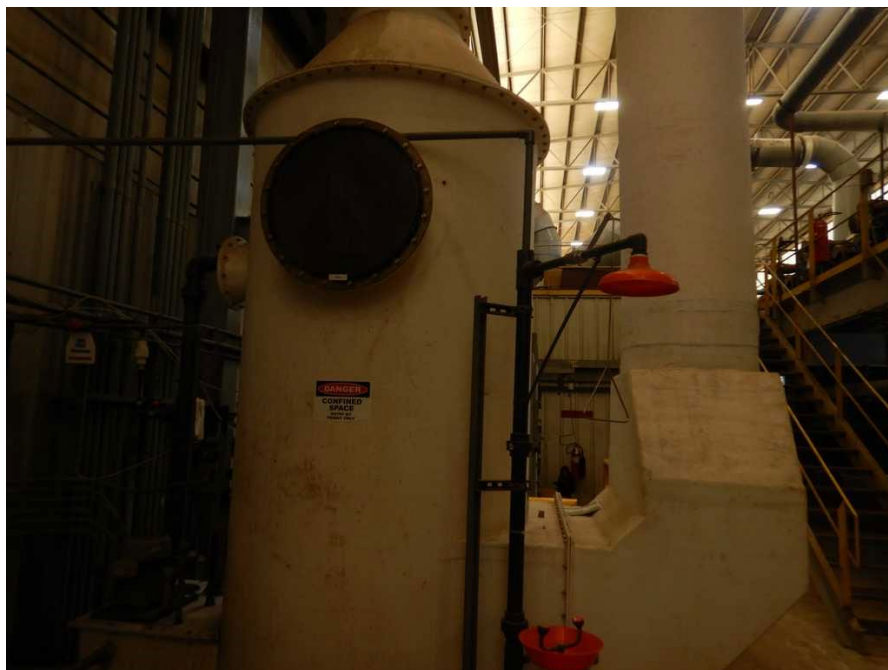
| Cleaning process fume water | DSCN0458.JPG | |

| Cleaning process fume water flows here and is then pumped to wastewater treatment | | |

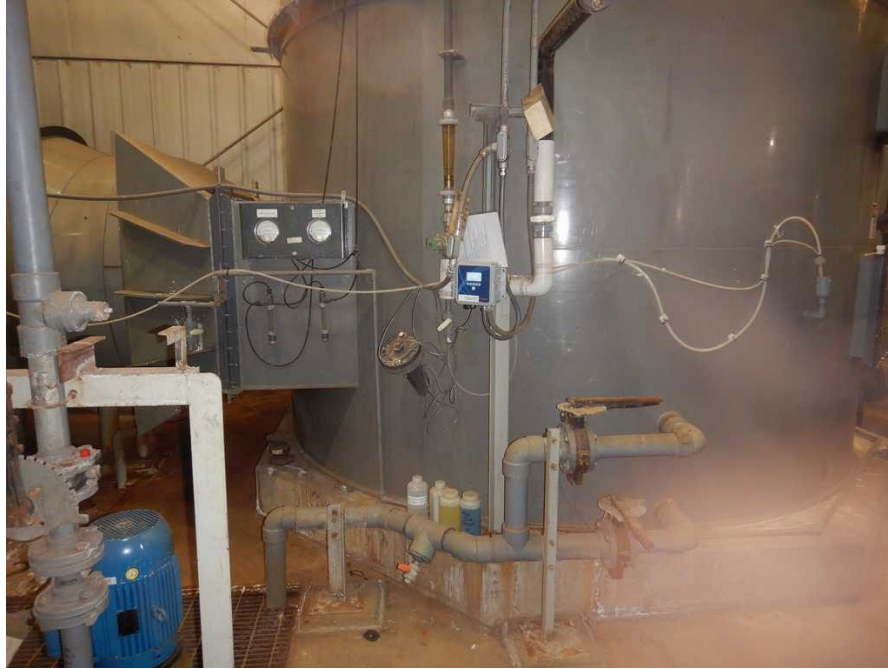
| Main fume exhaust | DSCN0459.JPG | |

| Main fume exhaust - reverse osmosis treatment occurs where screen is. Wastewater flows out through pipe in bottom left of photo via sump pump (blue) to equalization tank. | | |

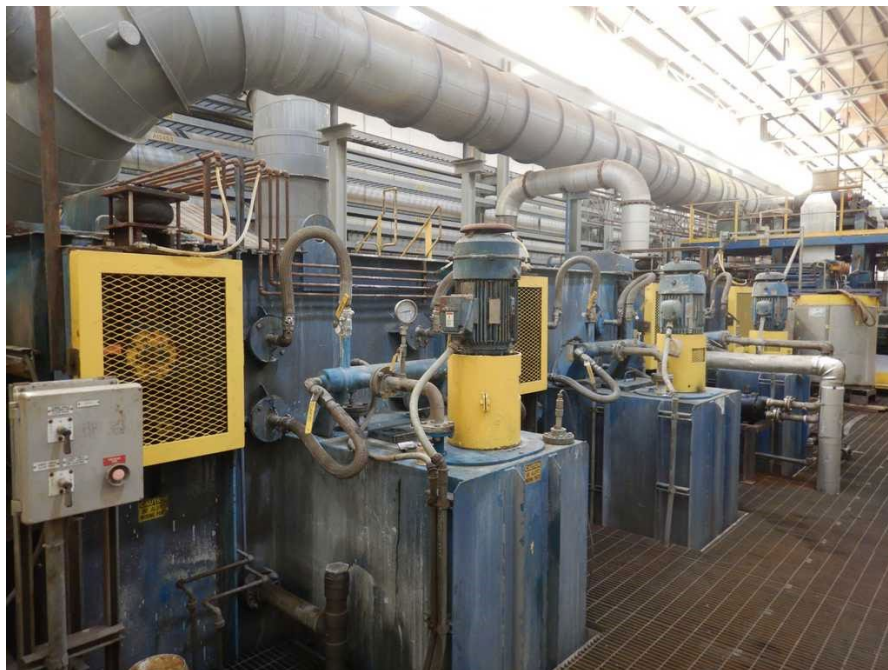
| Pumps that spray reverse osmosis water for cleaning | DSCN0461.JPG | |

| Pumps that spray reverse osmosis water for cleaning. Drains to sump 1 | | |

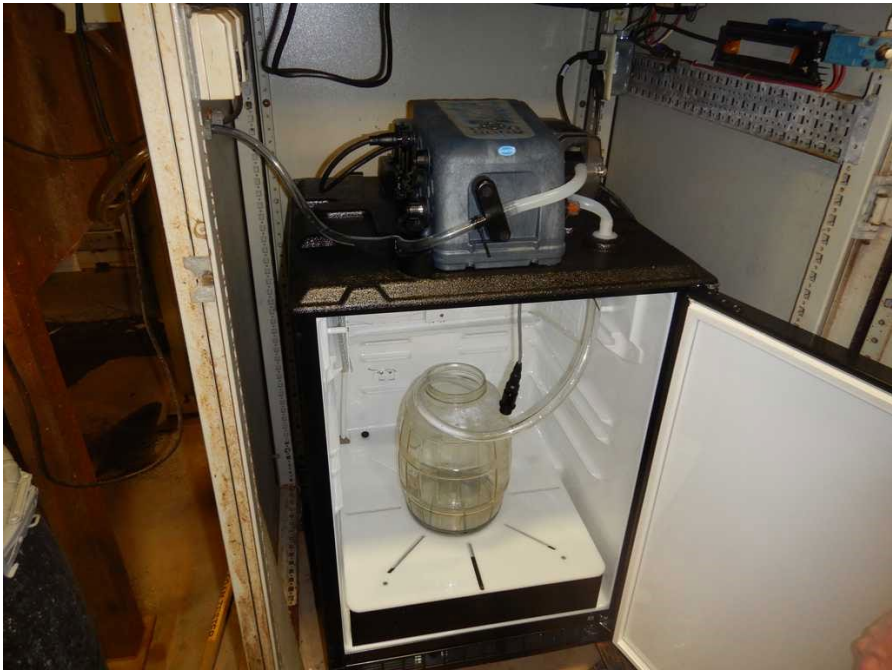
| Effluent sampler refrigerator | DSCN0471.JPG | |

| OHIO COATINGS CO. | | |
|---|---|---|
| <p>There was no wet thermometer in the effluent automatic sampler refrigerator.</p> | | |

| Effluent sampler refrigerator | | |

EPA conducted the closing conference on 3/22/2023 at 10:30 AM. Dave Emerich joined via phone call. EPA stated that there should be a wet thermometer in the automatic sampler fridge where the effluent leaves the plant. EPA also mentioned that the pH buffers for the outfall sampling that were stored near the effluent automatic sampler looked dirty. EPA asked for information about the blue liquid in the floor drain next to the effluent location in the facility and Dave Emerich responded that it was precipitation from chemical testing in lab and that the chemicals from the laboratory go through the drain and to treatment. EPA asked if a pH calibration versus a pH verification is done at the effluent location regularly. Dave Emerich answered that pH is calibrated weekly. EPA asked if drawings were available for the effluent piping to the outfall diffuser system and asked about the apparent effluent flow in the stormwater pipe outside of the black effluent pipe. Dave Emerich verified that the black pipe should be effluent. He said it begins inside the facility. He confirmed that the 3-foot diameter pipe is the stormwater pipe. He said drawings were with the PTI for the installation of the outfall diffuser. He also said both the diffuser and the black stormwater pipe were installed in June 2014. He also said he does not know where the current flow in the stormwater pipe is coming from. He said there is normally no flow in the stormwater pipe on dry days like the day of the inspection.

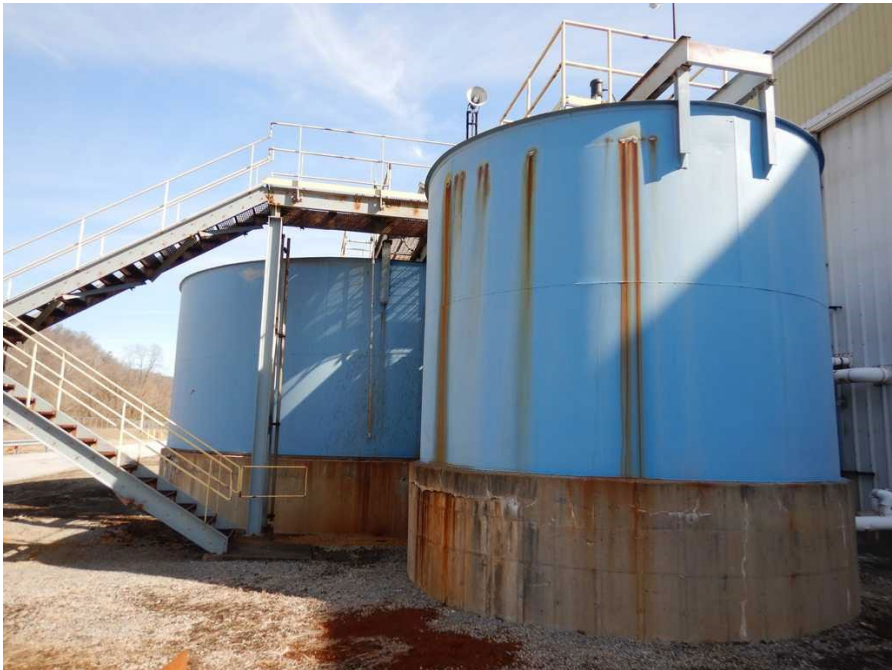
| Thickener (foreground) and clarifier (background) | DSCN0472.JPG | |

Some of the wastewater treatment components were located outside. These components were the sludge thickener, clarifier, equalization tank, and cooling towers.

| Thickener (foreground) and clarifier (background) | | |

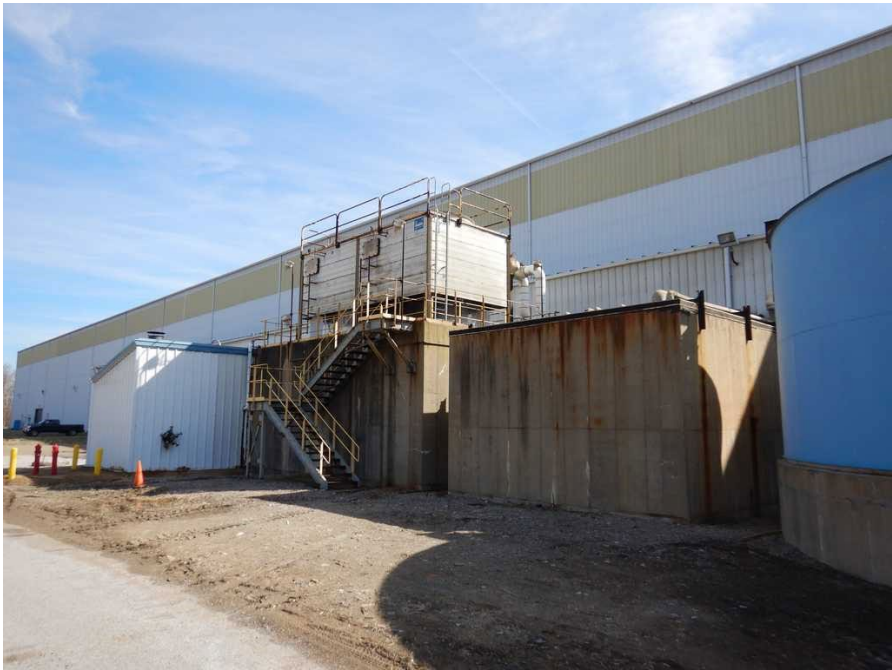
| EQ tank on right, cooling towers on left | DSCN0473.JPG | |

| Equalization tank on right, cooling towers on left | | |

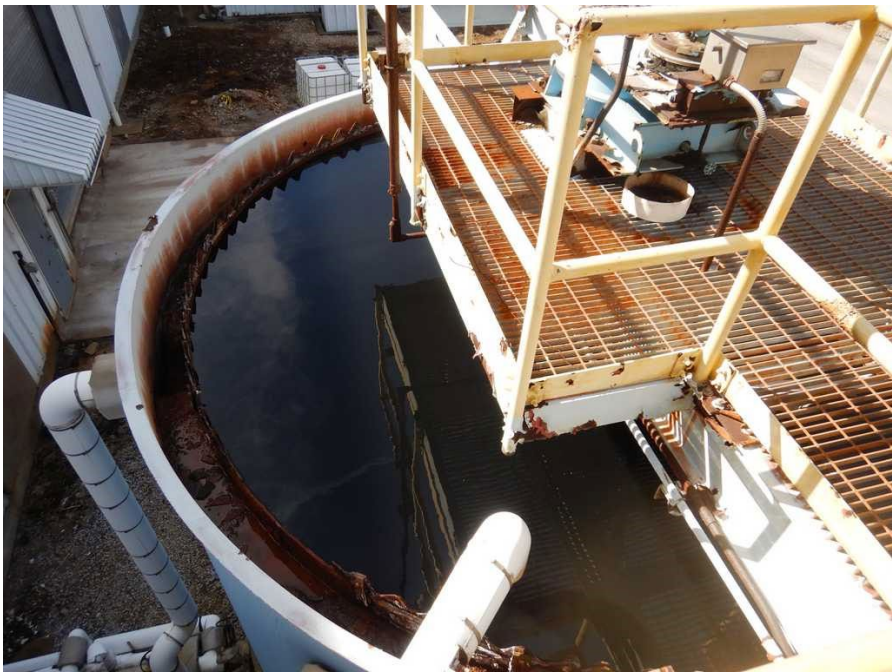
| Thickener | DSCN0475.JPG | |

| Thickener (sludge from bottom of clarifier is pumped here) | | |

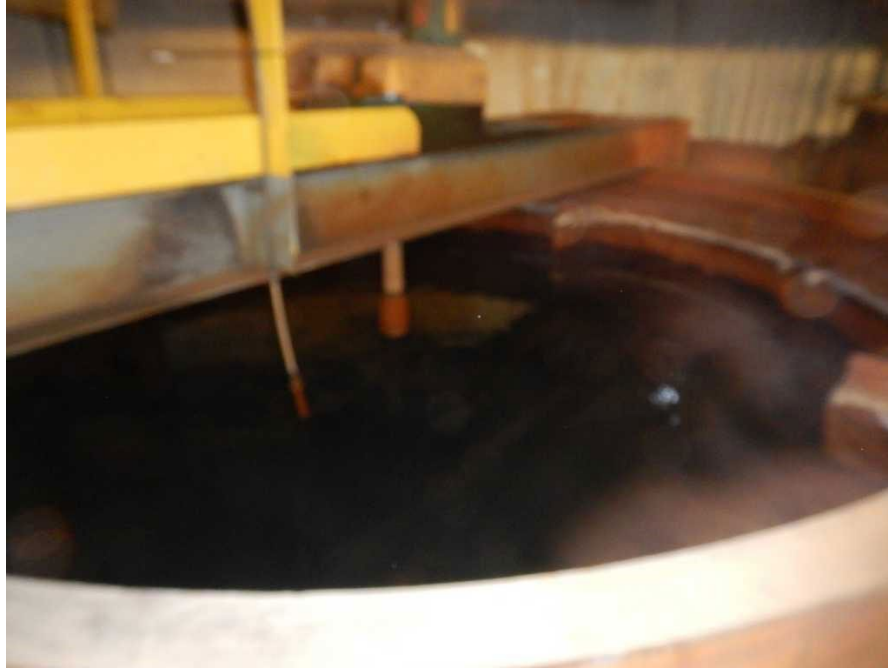
| Neutralization tank | DSCN0478.JPG | |

| Neutralization tank (NaOH or dilute sulfuric acid added here) | | |

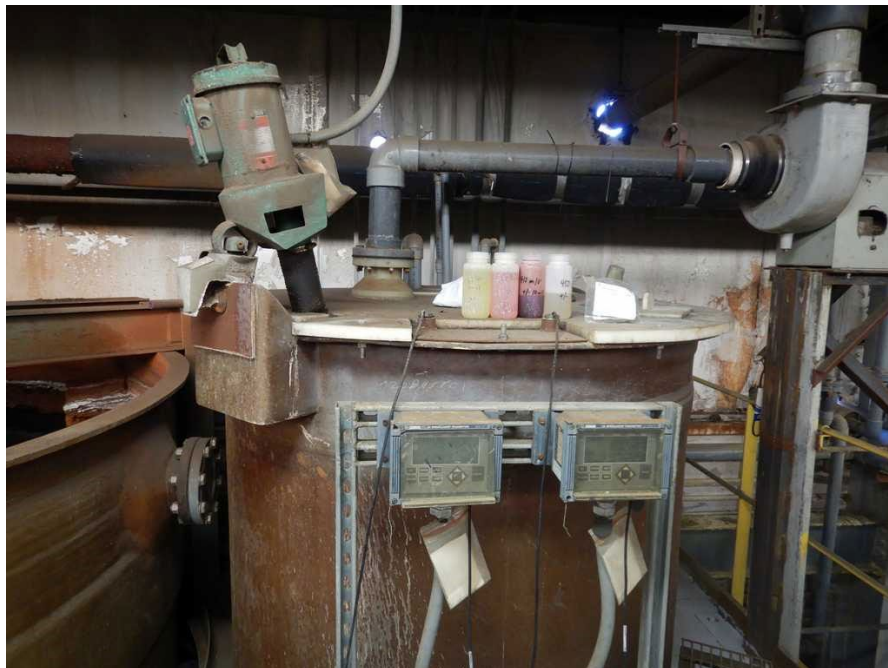
| Chrome reduction tank | DSCN0479.JPG | |

| Chrome reduction tank (sodium bisulfite used to reduce hexavalent chromium to trivalent chromium) | | |

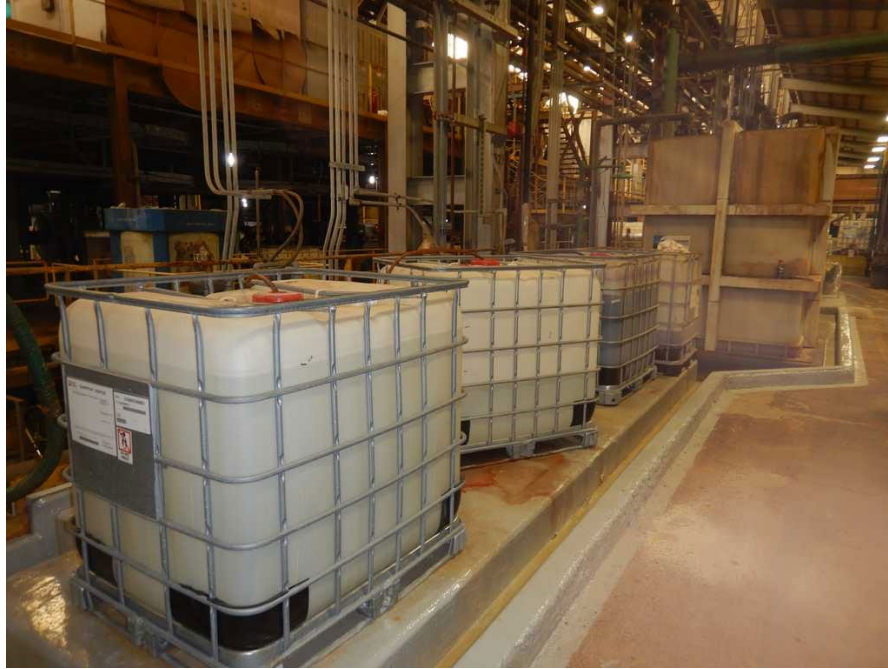
| Additives | DSCN0481.JPG | |

| Additives. Contained spill would go to equalization tank. | | |

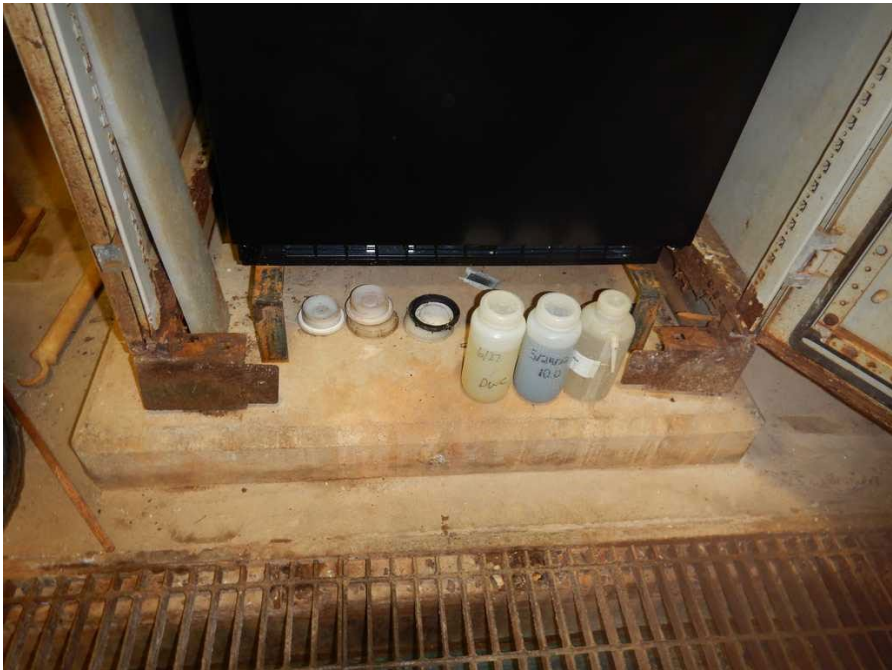
| Buffers for pH probe calibration at effluent sampler | DSCN0485.JPG | |

| OHIO COATINGS CO. | | |
|---|---|---|
| <p>The pH buffers for the effluent sampling probe appeared dirty.</p> | | |

| Buffers for pH probe calibration at effluent sampler | | |

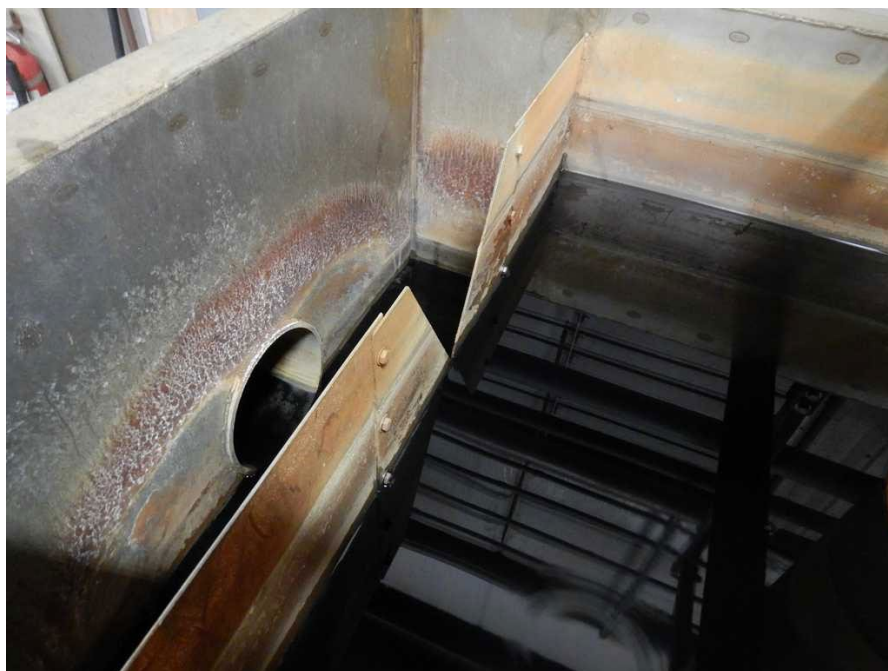
| Weir for effluent flow monitor | DSCN0488.JPG | |

| Time | Description | Lat | Long | Temp (F) | Sp. Cond. (uS/cm) | pH | ORP (mV) |
|---|---|---|---|---|---|---|---|
| 9:27 AM | Discharge effluent box inside facility, shown in photo DSCN0488.JPG and DSCN0489.JPG. | 40.1469617 | -80.7103217 | 79.5 | 6,359 | 7.90 | -108 |

| Weir for effluent flow monitor | | |

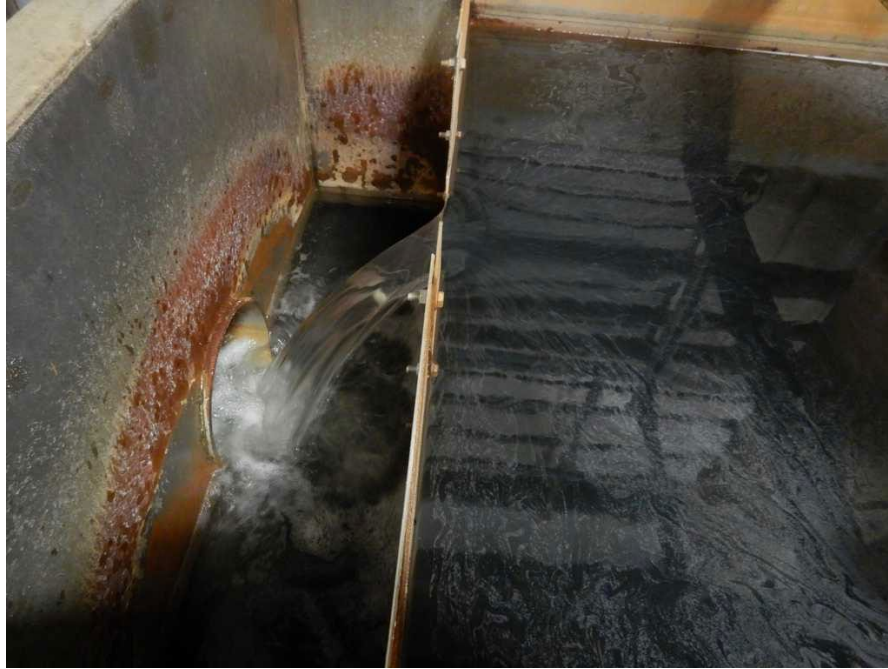
| Effluent during plant operation | DSCN0489.JPG | |

| Effluent during plant operation | | |

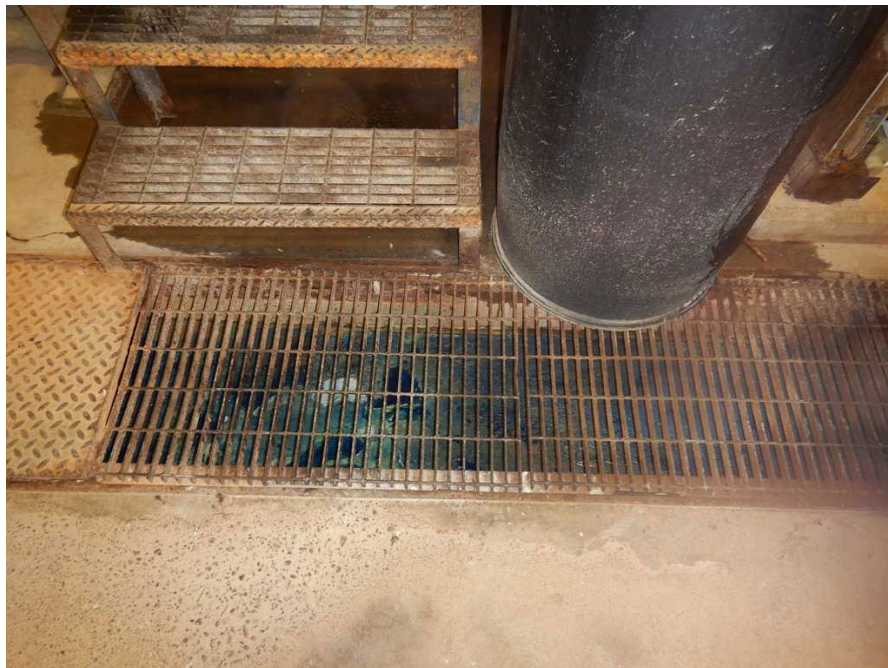
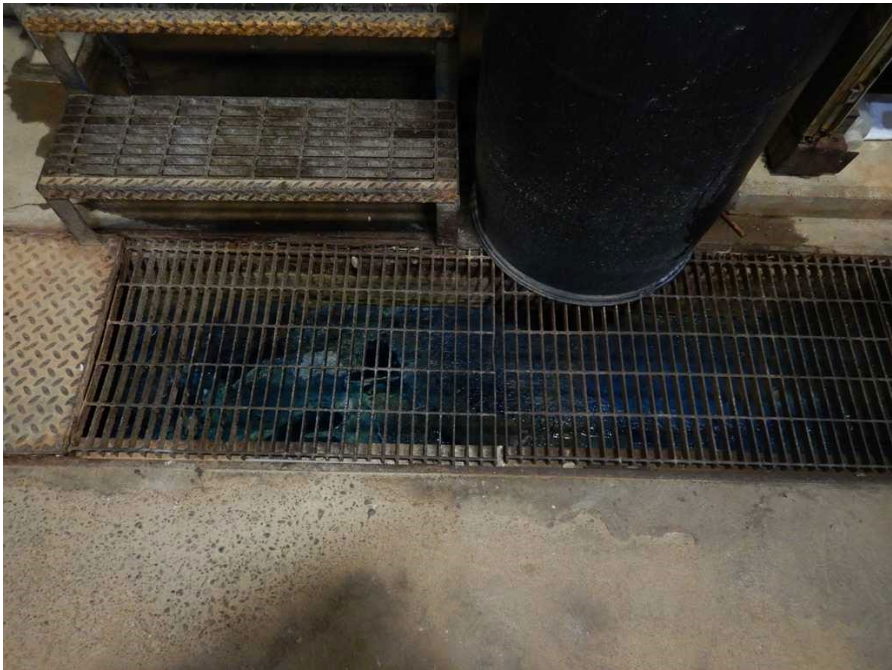
| Blue liquid in floor drain system near effluent | DSCN0490.JPG | |

| Blue liquid in floor drain system near effluent | | |

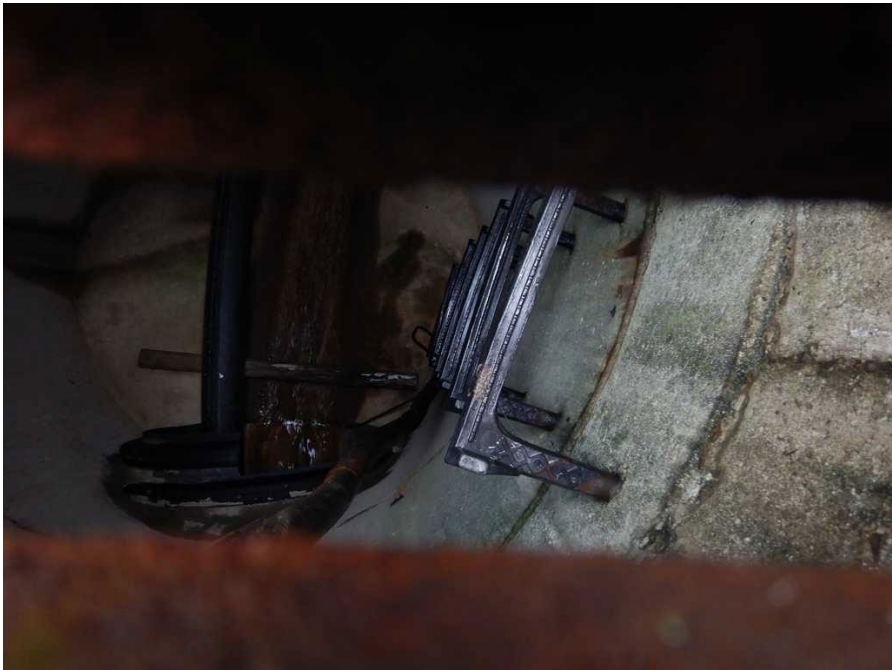
| Flowing liquid in stormwater pipe | DSCN0493.JPG | |

| OHIO COATINGS CO. | | |
|---|---|---|
| <p>The designated stormwater effluent pipe outside of the facility had a significant amount of flow on the day of the inspection. Steam could be seen coming from the pipe, which indicated that the flow did not consist entirely of stormwater. It appeared to exit the outfall prior to the diffuser (Photos # 492 through 505). A schematic received from facility representatives showed that a PVC pipe for the facility's wastewater effluent was located within the stormwater pipe and connected to the diffuser.</p> | | |

| Flowing liquid in stormwater pipe | | |

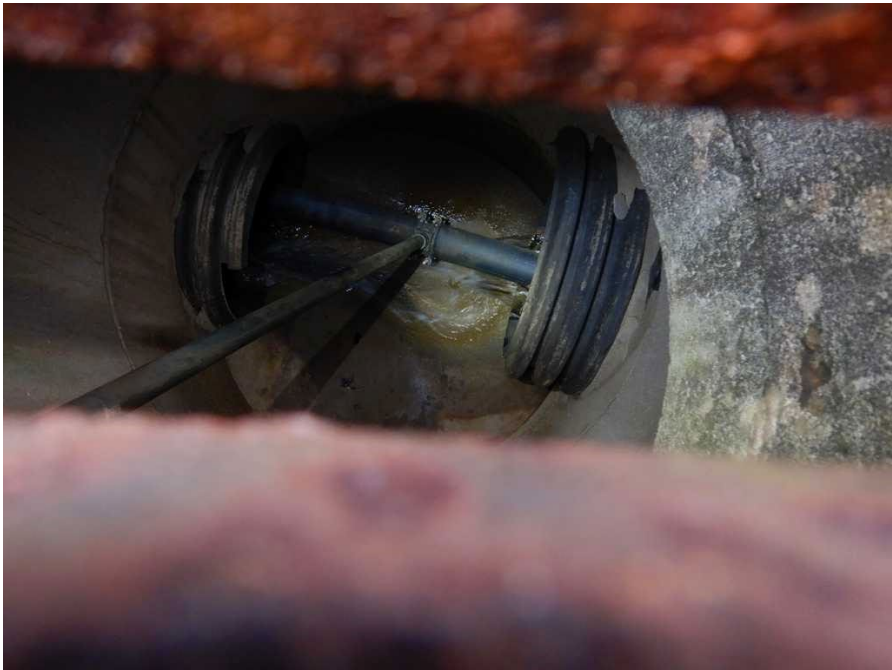
| Manhole downstream of first stormwater outfall | | |

| Manhole downstream of first stormwater outfall.<br>Per Dave Bechtel, the black pipe is the water from outfall 001 and goes to the diffuser. | DSCN0495.JPG | |

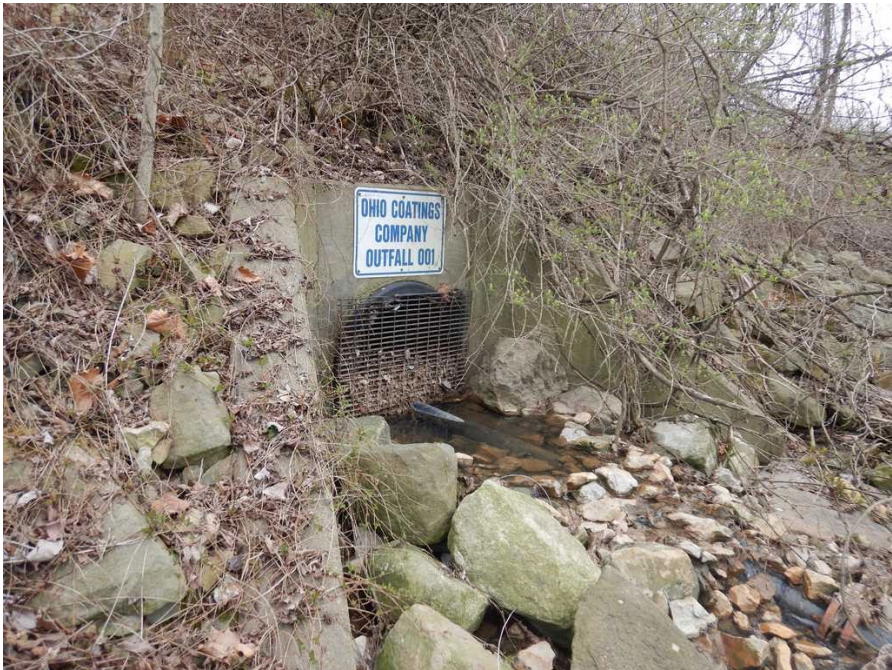
| Time | Description | Lat | Long | Temp (F) | Sp. Cond. (uS/cm) | pH | ORP (mV) |
|---|---|---|---|---|---|---|---|
| 9:52 AM | Stormwater outfall (002) shown in photo DSCN0497.JPG | 40.1465900 | -80.707335 | 67.5 | 4,610 | 8.00 | 114 |

**AOC:** At the time of the inspection, there was a significant quantity of flow coming from outfall 002 which is supposed to be the stormwater only outfall. It was not raining at the time of the inspection. Based on field monitoring conducted during the inspection, the temperature and specific conductivity of the water at outfall 002 was similar to the field monitoring parameters at outfall 001. The temperature at 001 was 79.5 fahrenheit and the temperature at 002 was 67.5 fahrenheit which was warmer than the ambient air temperature and the temperature of the river which was approximately 46 degrees fahrenheit. The specific conductivity at outfall 001 was 6,359 uS/cm, the specific conductivity at 002 was 4,610 uS/cm, the specific conductivity in the Ohio River upstream of the confluence was 300 uS/cm.

The designated stormwater effluent pipe outside of the facility had a significant amount of flow on the day of the inspection. Steam could be seen coming from the pipe. It appeared to exit the outfall prior to the diffuser. A schematic received from facility representatives showed that a PVC pipe for the facility's wastewater effluent was located within the stormwater pipe and connected to the diffuser.

| Significant flow from stormwater outfall pipe. Per Dave Bechtel, the black pipe is wastewater from facility effluent and goes to the diffuser in the Ohio River. | DSCN0497.JPG | |

EPA received an email from Dave Emerich on May 9<sup>th</sup>, 2023 containing a schematic showing that a PVC pipe for the facility's wastewater effluent was located within the stormwater pipe and connected to the diffuser. The email also stated that the PVC pipe was found dislodged from its position and allowing water to bypass, and that repairs were planned for May 13<sup>th</sup>, 2023.

EPA received an additional email from Dave Emerich on May 26<sup>th</sup>, 2023 which contained photos showing repairs made to the diffuser line.

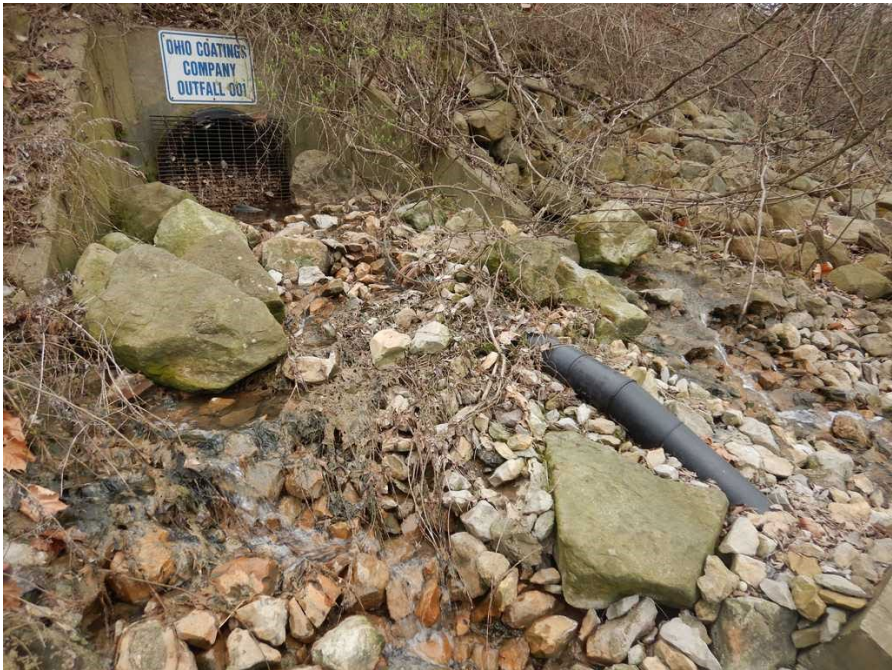
| Significant flow from stormwater outfall (002). Per Dave Bechtel, the black pipe is the wastewater from facility effluent and goes to the diffuser in the Ohio River. | | DSCN0498.JPG | |

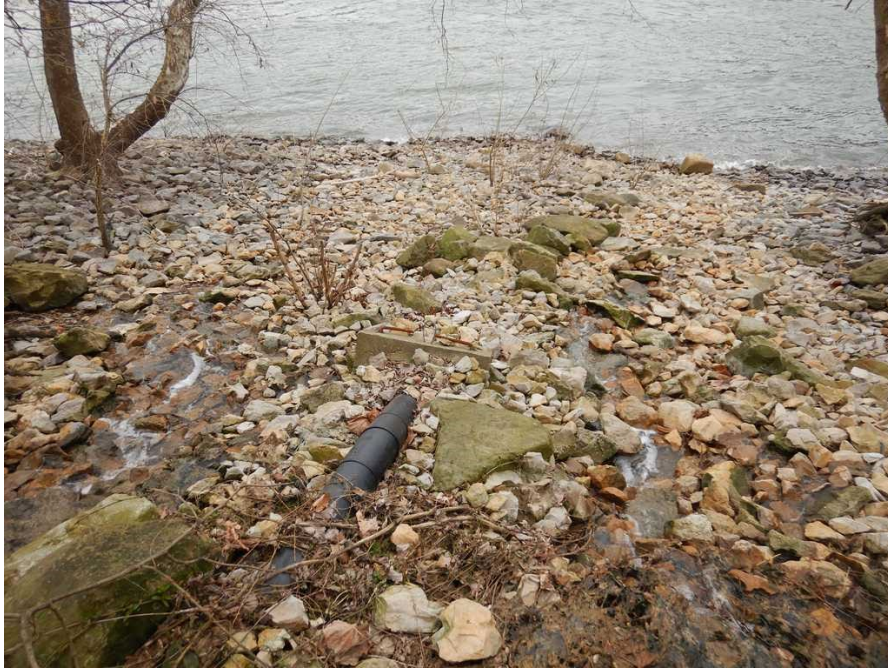
| Effluent from stormwater outfall flowing toward river. Per Dave Bechtel, the black pipe is the water from facility effluent and goes to the diffuser in the Ohio River. | | DSCN0500.JPG |

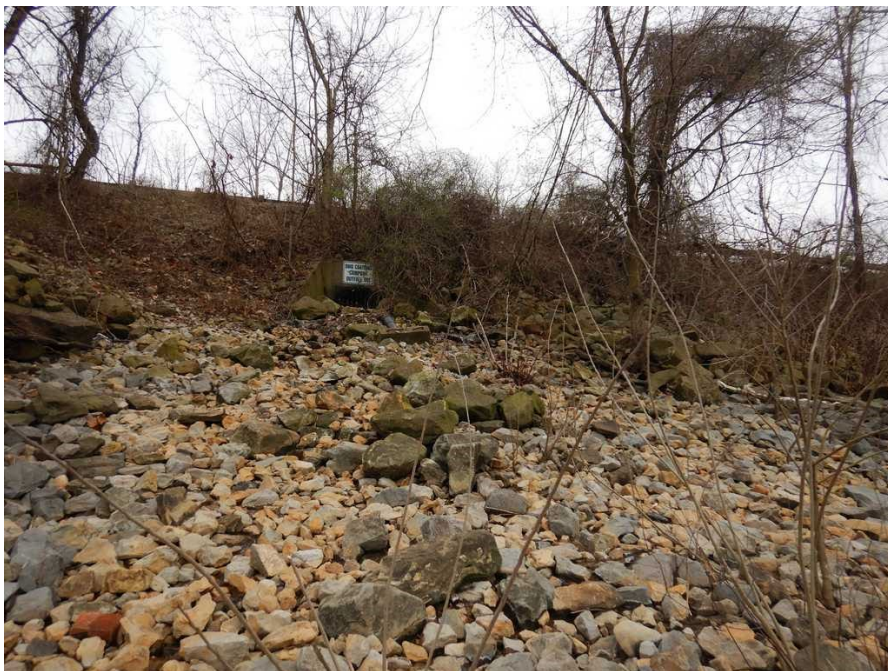
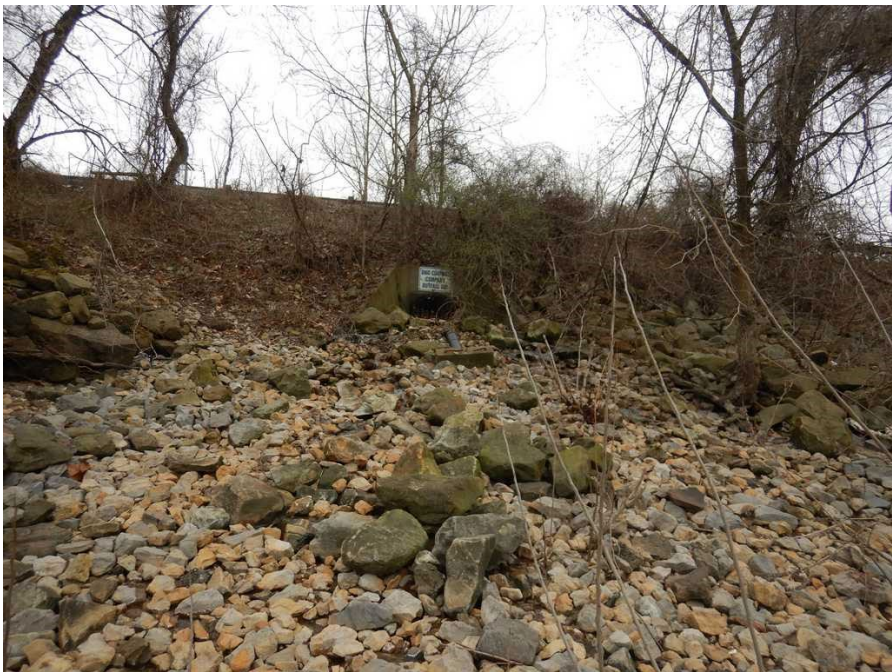
| Facing stormwater outfall from river. Outfall 002. | | DSCN0501.JPG |
