# Manufacturing Chemists' Association, Inc.

August 1965 Issue

SUBJECT: Case Histories of Accidents (including Fires and Explosions)

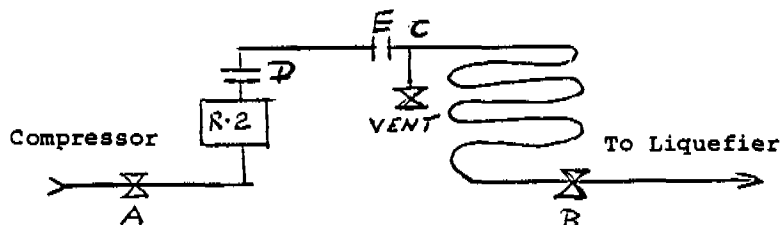
Description: A rugged converter had been shut down, block valved from the system, and depressurized in order that the catalyst could be replaced. As the operator loosened one bolt on flanged spool "E", a small flow of gas was heard. He then tightened valve "B" further and the gas flow stopped. Two operators then removed all bolts and disconnected flanged spool "E". They then began disconnecting flanged spool "D". When all but one bolt had been removed, one operator walked away. At that time gas suddenly surged and ignited, severely burning the other operator on arms and legs.

Cause: Failure of valve seat due to thread on seat being tapered.

1. Entire plant to be shut down and system depressurized before start of maintenance work.
2. Installation of double block valves, with bleeder valve between.
