## Region 6 - Enforcement & Compliance Assurance Division

### INSPECTION REPORT

| Company Name: | Northstar Builders Group, LLC | |
| Facility Name: | Royse City ISD Middle School 3 | |

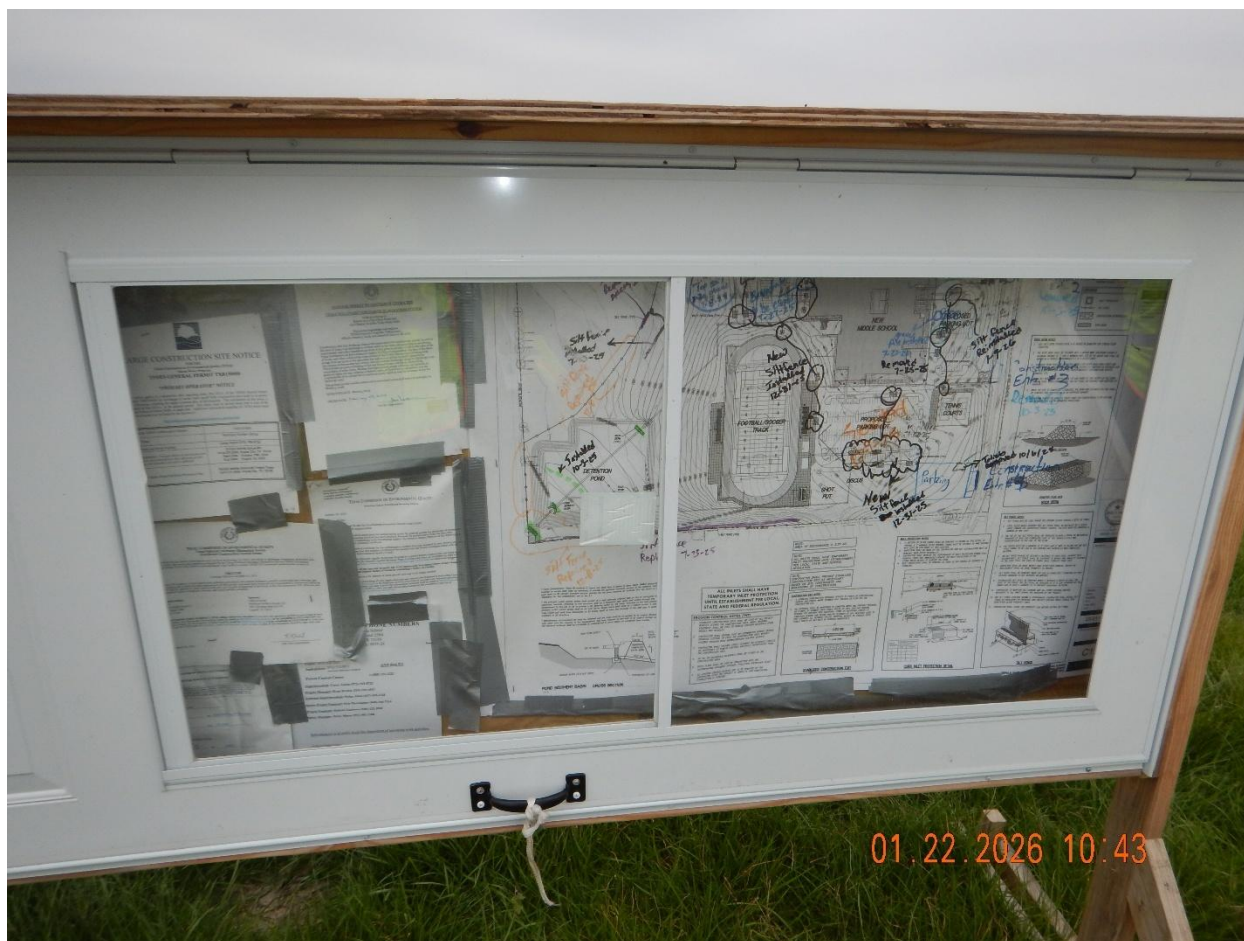
Photo no. 1

- The Construction Site Notice (CSN), site map, and Stormwater Pollution Prevention Plan (SWPPP) were posted/stored in a large, enclosed bulletin board at the construction entrance off Co Rd 2584 (**Appendix 1, Photos 1-2**). I observed that the posted CSN permit number was listed as TXR1514SK instead of TXR1515SK and the SWPPP did not contain all the required documentation as discussed in Section III of this report.

Description: The Construction Site Notice (CSN), site map, and other TCEQ Construction General Permit (CGP) documentation in the large, enclosed bulletin board at the construction entrance off Co Rd 2584. The SWPPP was also stored in the bulletin board (only visible when open).

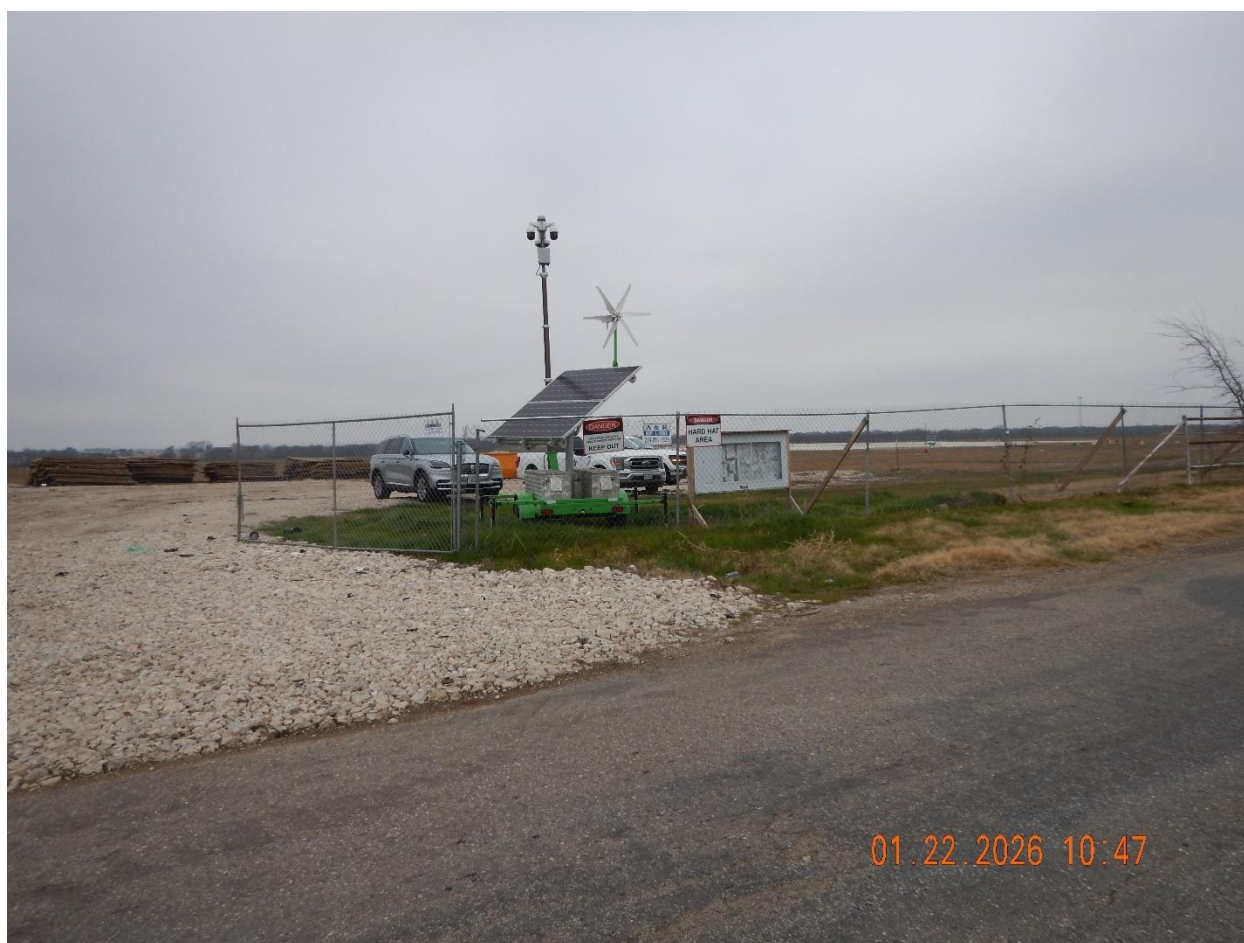
Photo no. 2

- During the inspection Mr. Rouse and Mr. Knight informed us that Mr. Knight conducts the site's weekly stormwater inspections as required by the CGP.
- We observed the construction entrance stabilized with rock/gravel (**Appendix 1, Photo 2**).

Description: The construction entrance off Co Rd 2584 stabilized with rock/gravel. Also pictured is the enclosed bulletin board storing site information including the CSN, site map, CGP documentation, and the SWPPP.

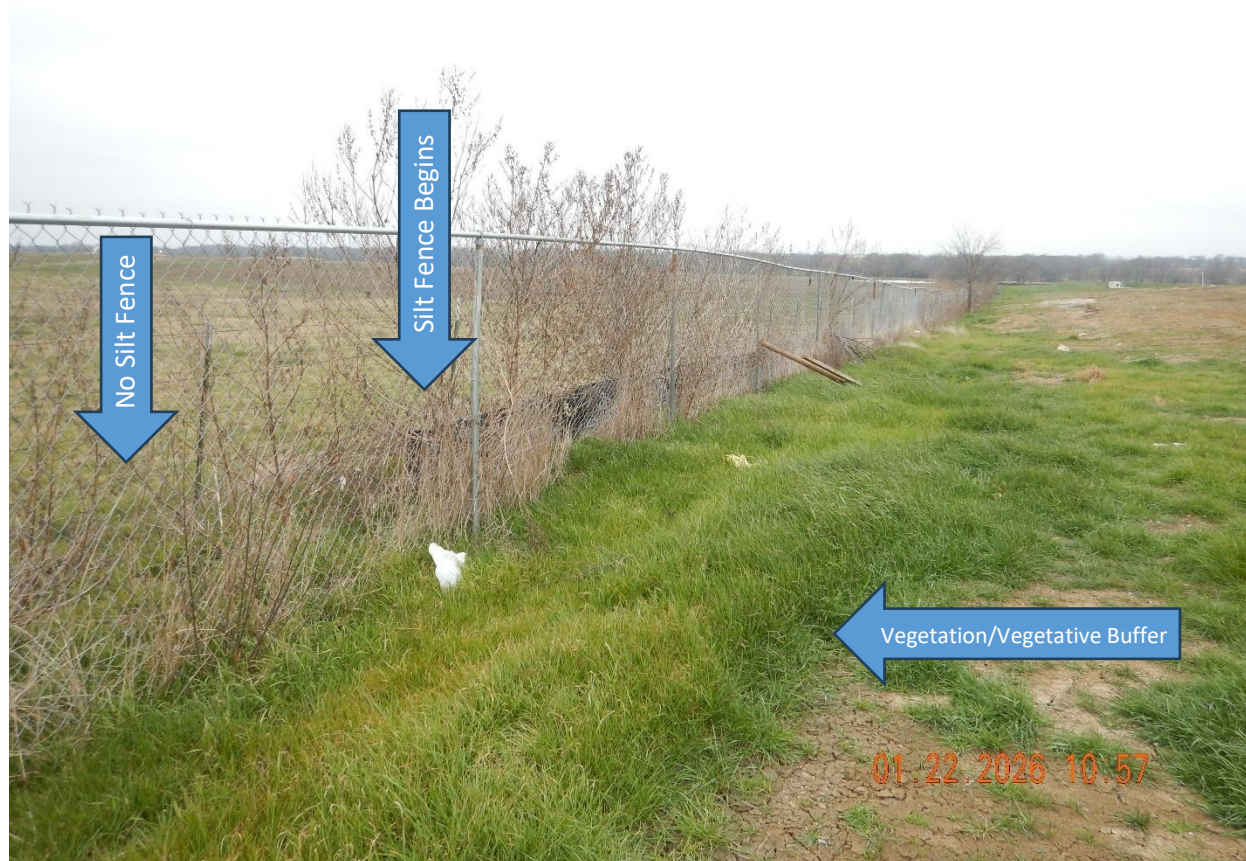
Photo no. 3

- We observed silt fence installed in sections along the perimeter of the construction site (**Appendix 1, Photo 4**). The silt fence along the perimeter was not continuous (**Appendix 1, Photo 3**) but did have a natural vegetative buffer in some areas with no BMPs.

Description: Silt fence installed along the southern perimeter of the site. Also note the vegetative buffer of grass.

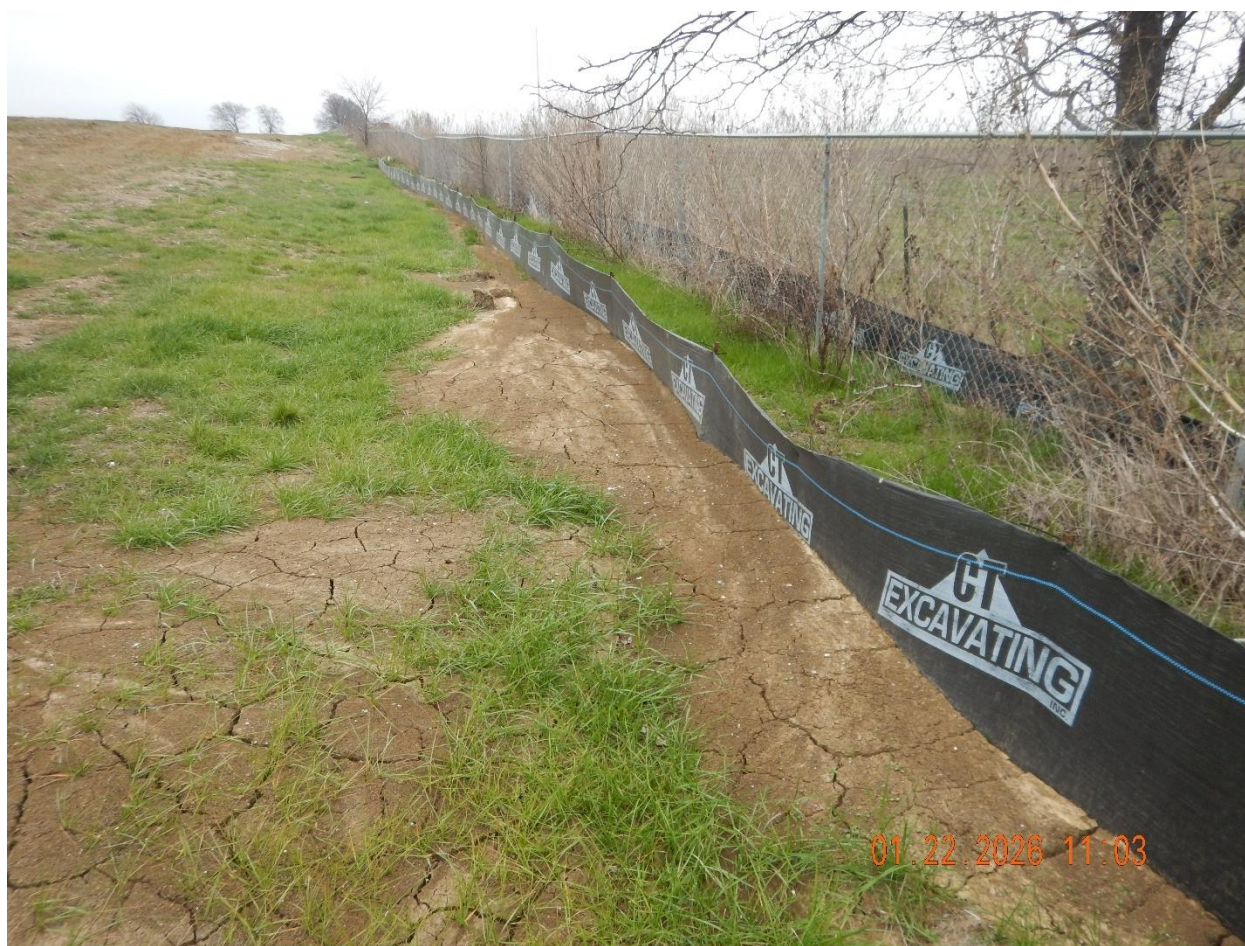
Photo no. 4

Description: Silt fence installed along the southern perimeter of the site. Also note the patches of vegetation.

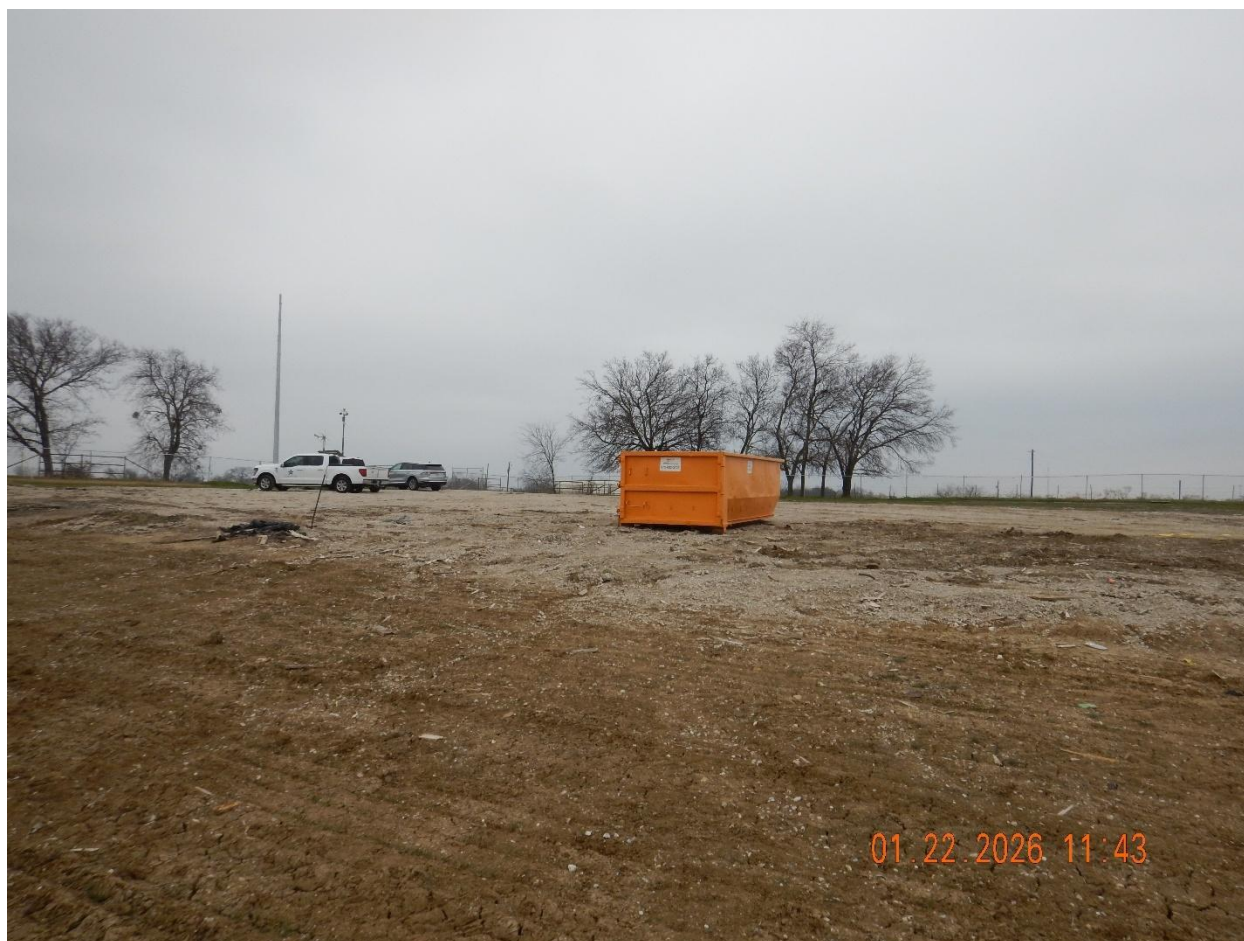
Photo no. 5

- We observed a roll-off dumpster in the southeastern area of the construction site (**Appendix 1, Photo 5**). Mr. Knight advised that the dumpster is serviced once a week. Minimal blowable trash was observed at the time of the inspection.

Description: The roll off dumpster located in the southeastern area of the site, near the construction entrance. Minimal blowable trash was observed throughout the site at the time of inspection. Also note the exposed sediment throughout this area with a patch of vegetation (grass) visible near the southern property line.

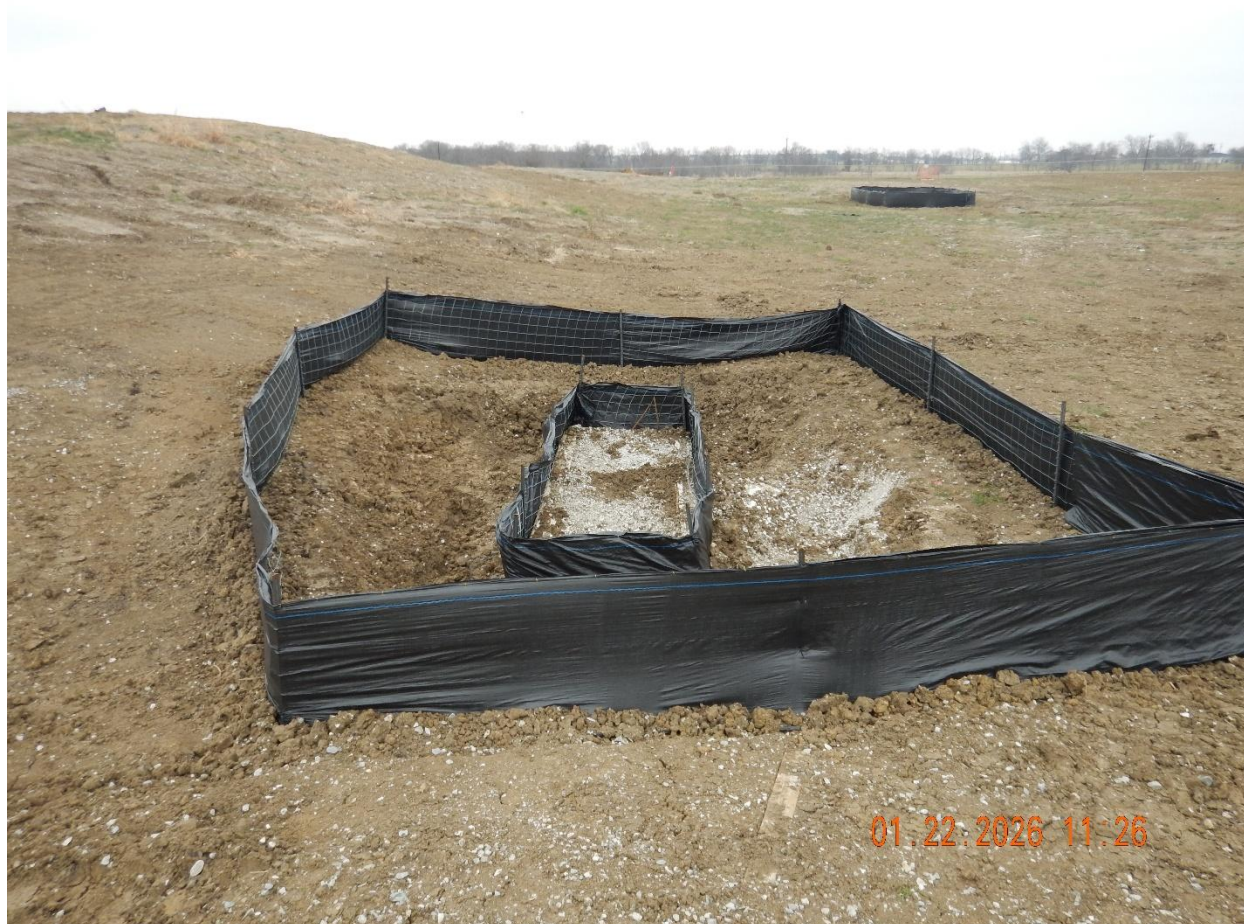
Photo no. 6

- Drop inlets and curb inlets were observed throughout the interior of the site. Silt fence and plywood were utilized to minimize sediment from entering the inlets (**Appendix 1, Photo 6**).

Description: A curb inlet with silt fence installed. The silt fence was shallowly buried instead of trenched into the ground, providing opportunity for stormwater and sediment to flow into the inlet.

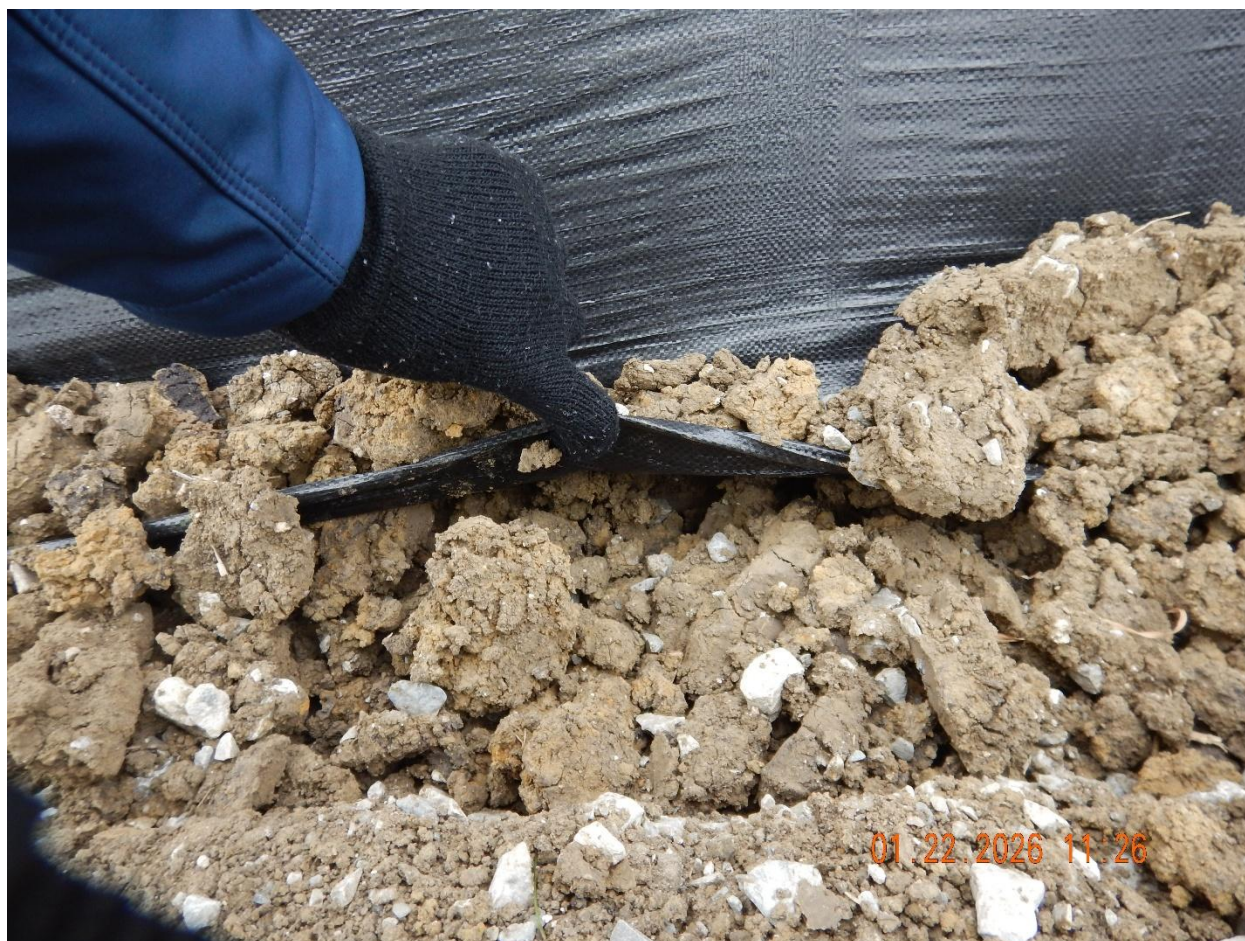
Photo no. 7

1. We observed visible signs of a sediment discharge from the outfall at the southwest corner of the construction site onto the neighboring property (**Appendix 1, Photos 8-9**). The silt fence around the outfall was not properly installed in multiple areas (**Appendix 1, Photos 10**) and silt fence (or another effective BMP) was missing along the southern property line (**Appendix 1, Photos 8-9**).
2. Silt fence along the west perimeter of the site was not properly installed (**Appendix 1, Photo 11**).
3. Silt fence around multiple inlets were not properly installed (**Appendix 1, Photo 7**).

Description: Closer view of the improperly installed silt fence around an inlet. The silt fence was observed shallowly buried along multiple inlets throughout the site.

**Note: AOCs 1-3 were addressed by Northstar Builders on or around January 29, 2026, with photo evidence provided by Mr. Rouse as illustrated in Appendix 2 of this report.**

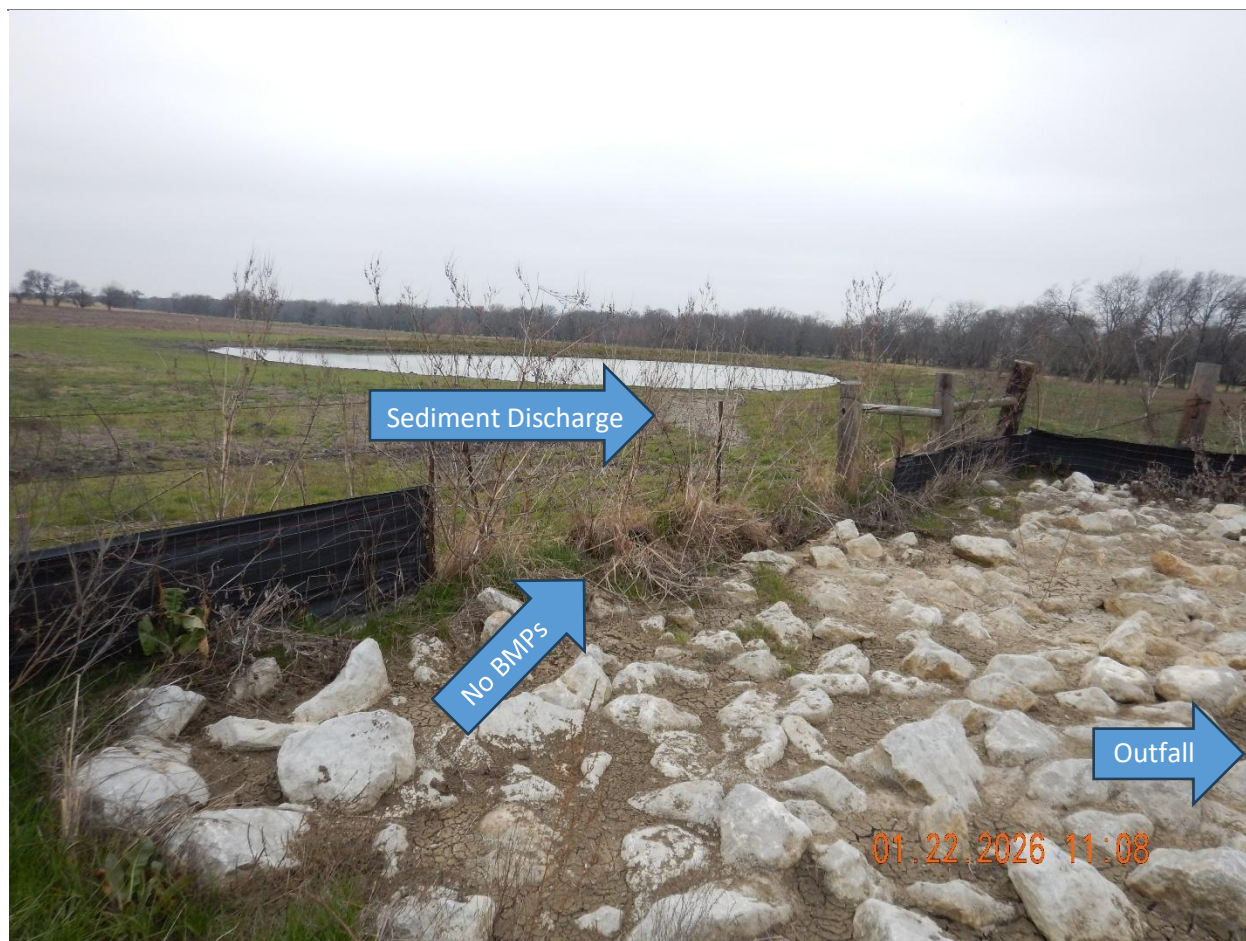
Photo no. 8

Description: Outfall (not pictured) is immediately to the right. Sediment from the site visible on the rocks. The silt fence along the outfall was improperly installed or missing, allowing for a visible sediment discharge onto the neighboring property.

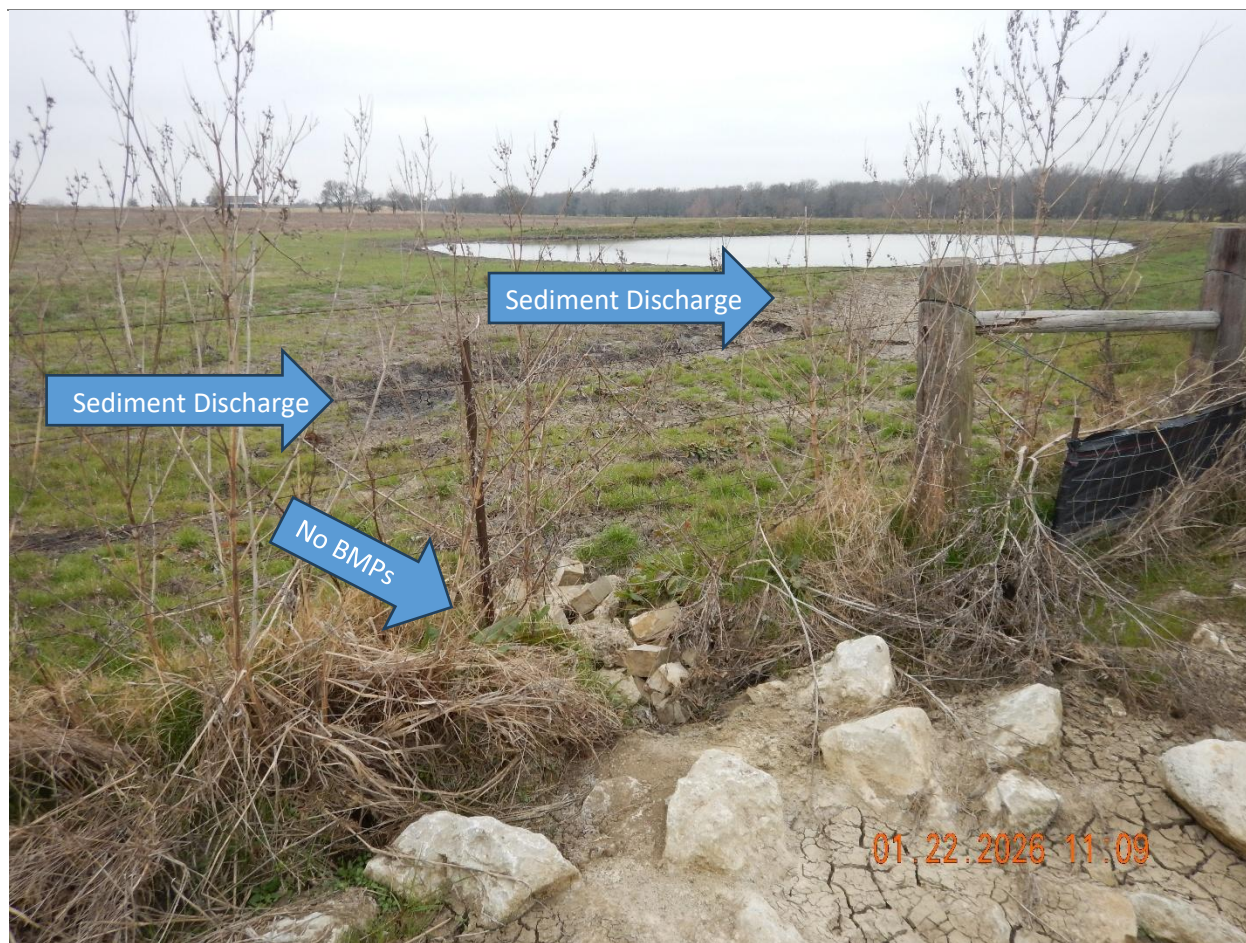
Photo no. 9

Description: Closer view of missing BMPs and sediment discharge from the outfall on the southwest corner of the construction site onto the neighboring property.

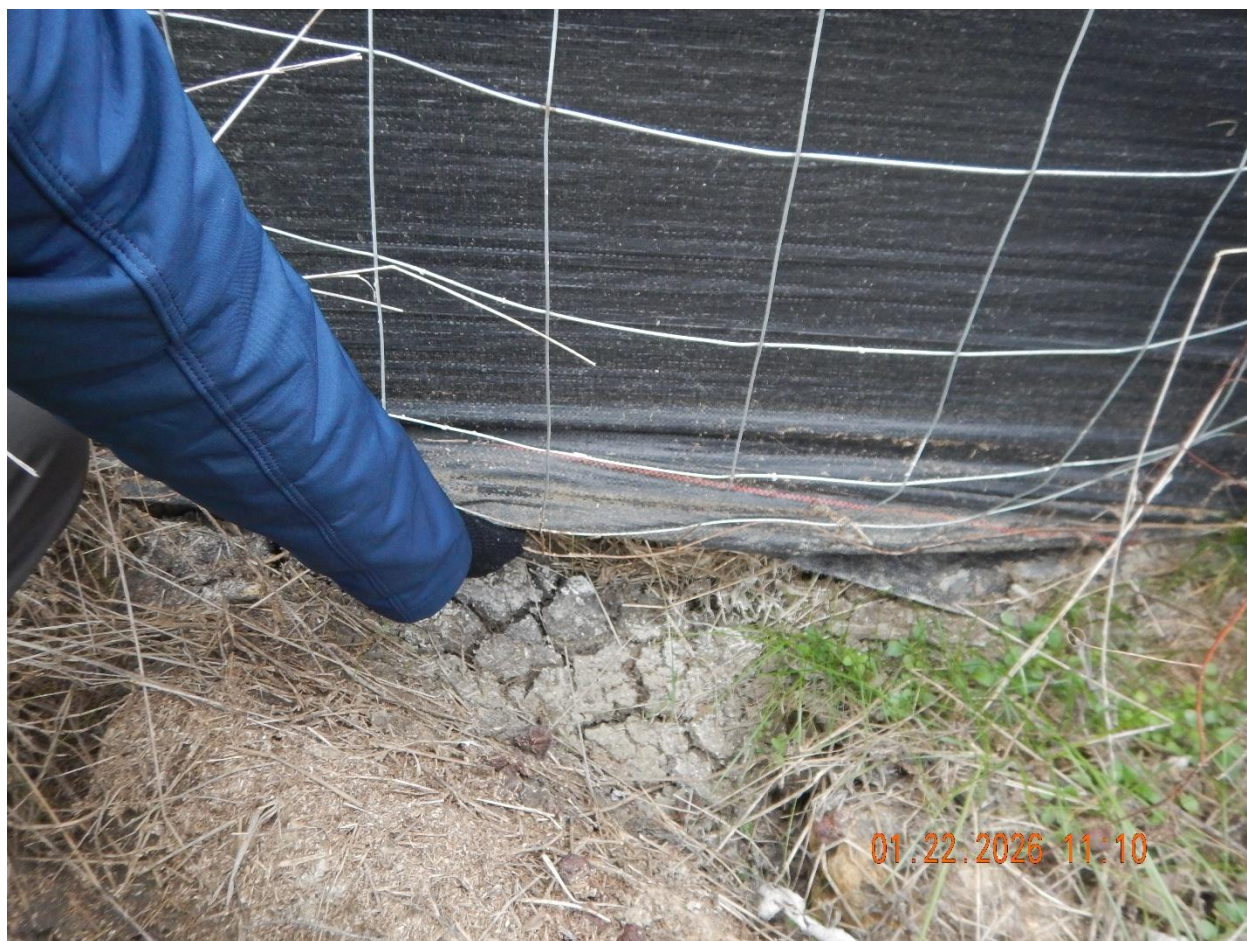
Photo no. 10

**Description:** Improperly installed silt fence along the outfall at the southwest corner of the site.

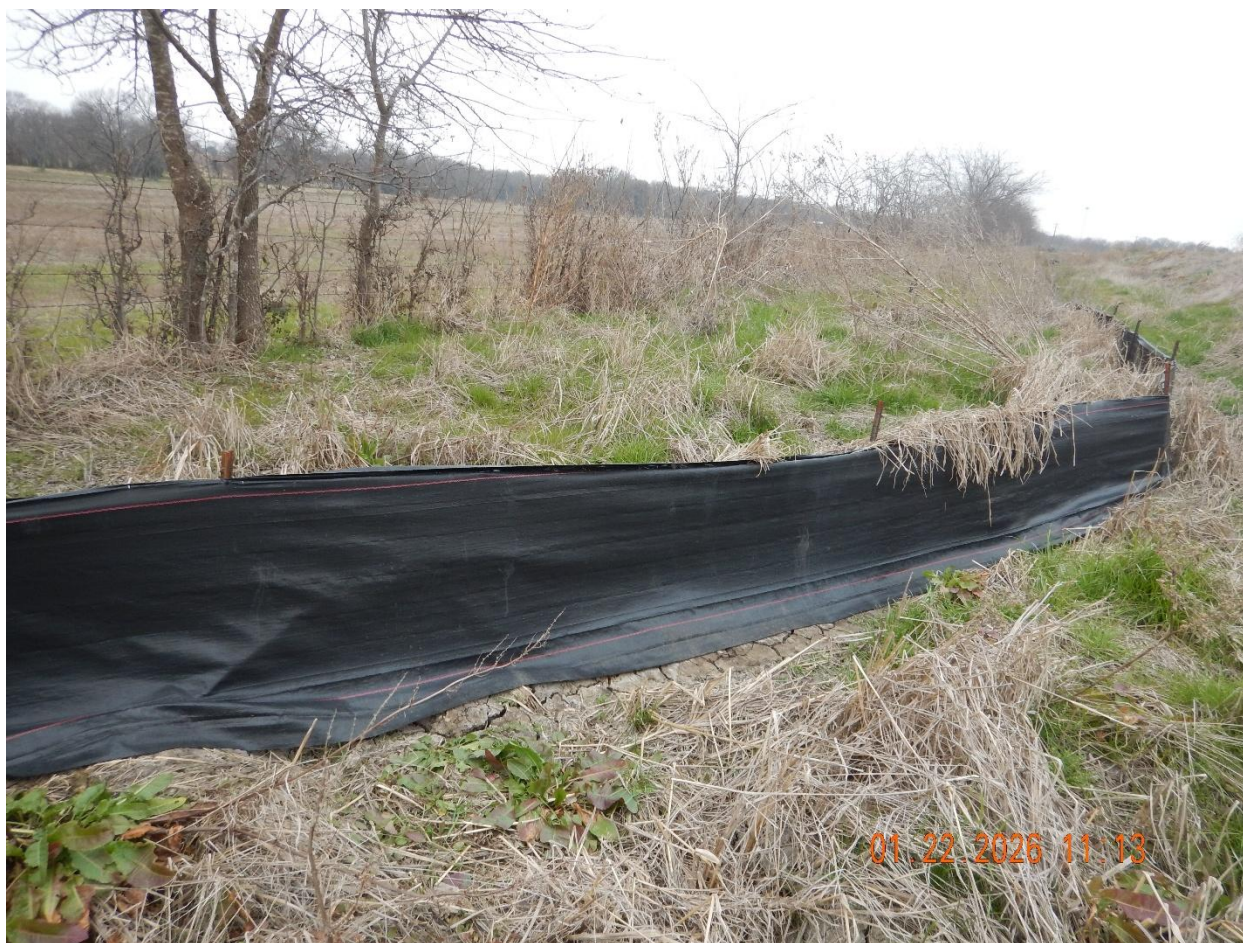
Photo no. 11

Description: Improperly installed silt fence along the west perimeter of the site.
