**Region 6 - Enforcement & Compliance Assurance Division**  
**INSPECTION REPORT**

| Inspection Date(s): | 06/08/2022 | |
| Company Name: | McCann Resources, Inc | |
| Facility Name: | Bowring Lease | |

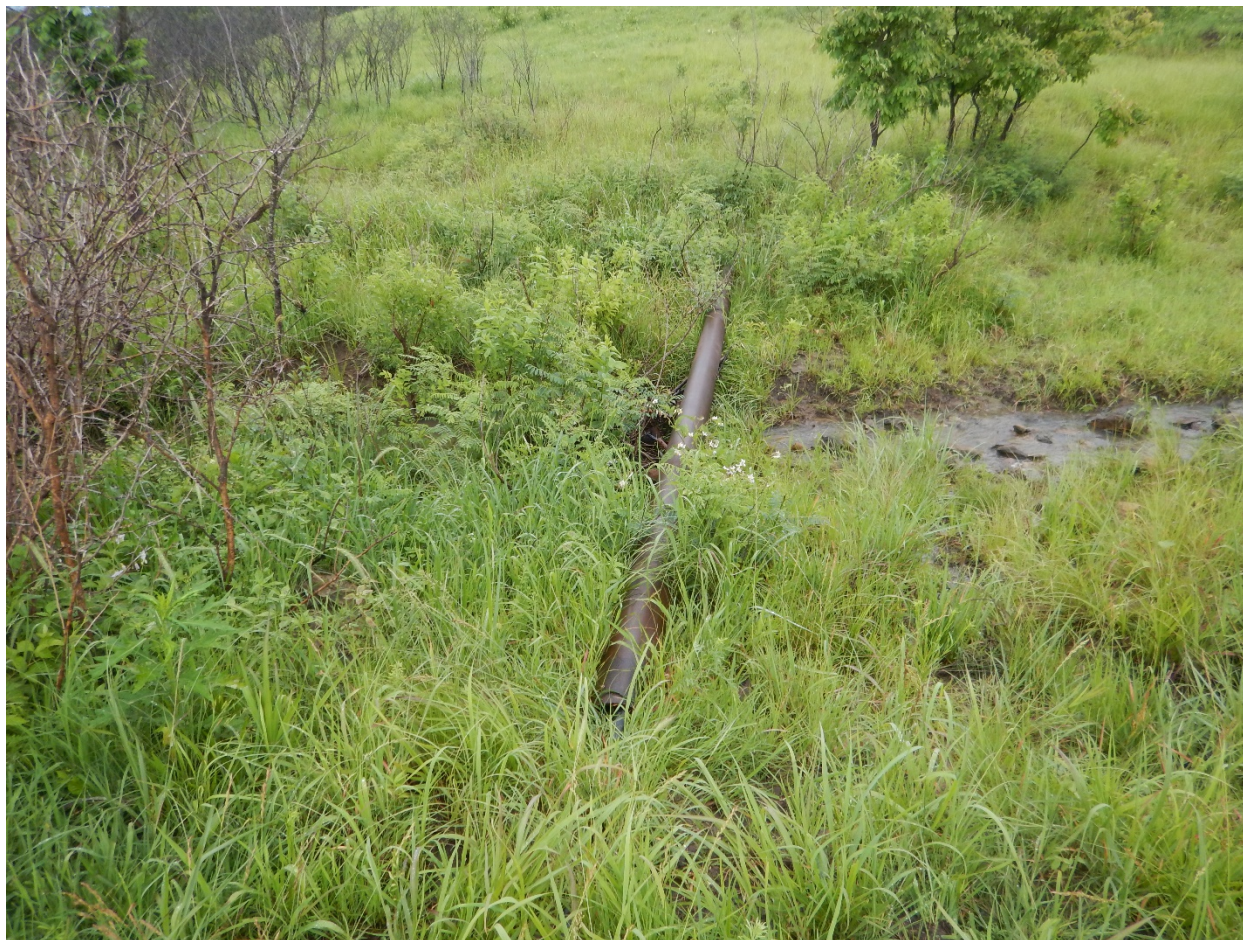
Photo No. 1

I observed the Release Point and the Point of Entry (POE) (36.889034, -96.122796) into the unnamed tributary, according to Charles Randall (landowner). The POE can be seen in Appendix 1/Photo Log, photo No. 1. I did not observe any signs of spill impacts in the area around the POE. A Total Dissolved Solids (TDS) field reading of 85.1 mg/L (photo No. 3) was taken immediately upstream from the POE in the main channel of the unnamed tributary. An additional TDS field reading of 101.3 mg/L (photo No. 5) was taken in a deep pool approximately 30 feet downstream from the POE into the tributary. TDS field readings were taken with a properly calibrated YSI Pro 30 conductivity meter. Both field readings observed at the time of the inspection were well within the normal “background” TDS levels for the area. I observed normal vegetation in and around the tributary and could see no evidence of spill impacts along flowpath. At the time of the inspection, the impacted area had recovered to pre-spill condition.

**Description:** This was the location where the flowline crossed the impacted tributary. The poly flowline was inside the steel pipe as it crossed over the tributary. This was the Release Point and Point of Entry (POE).

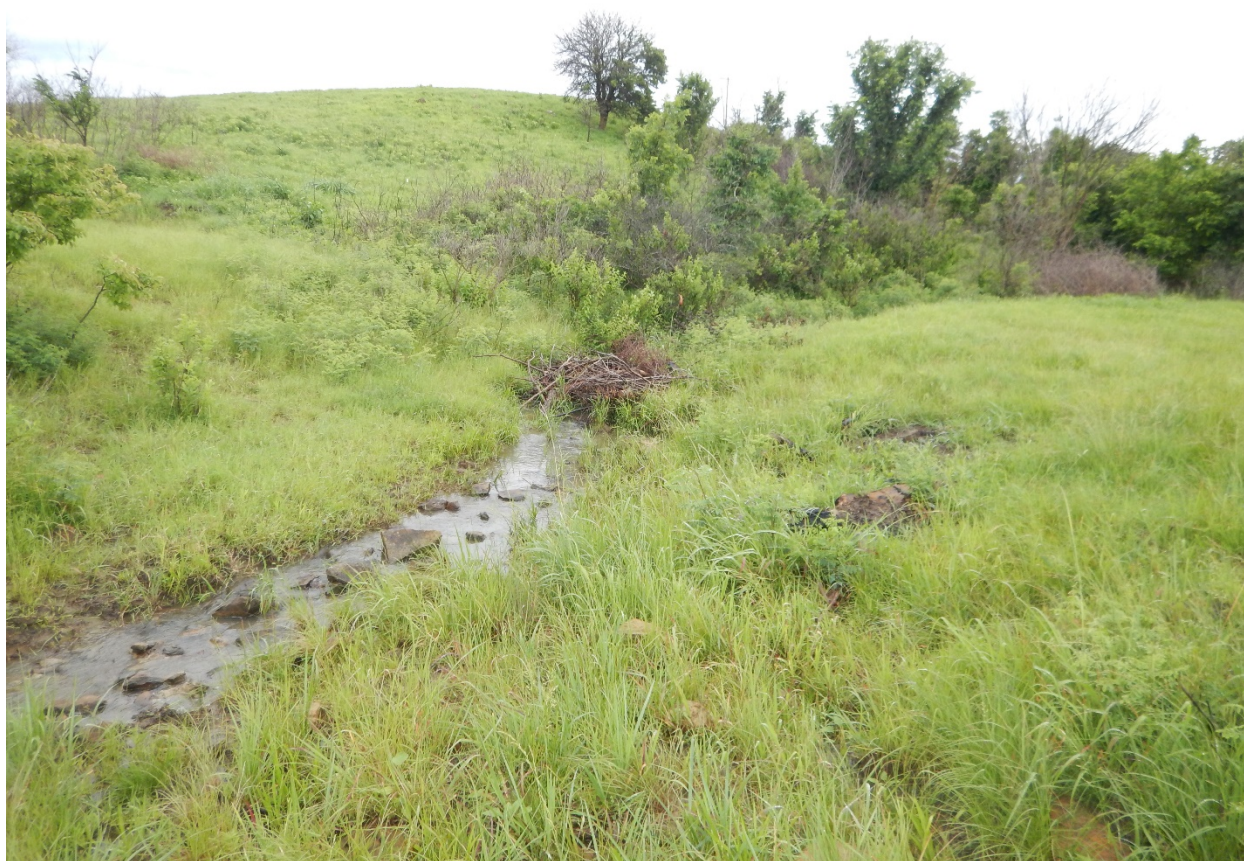
Photo No. 2

**Description:** This was a view looking upstream or southwest from the POE.

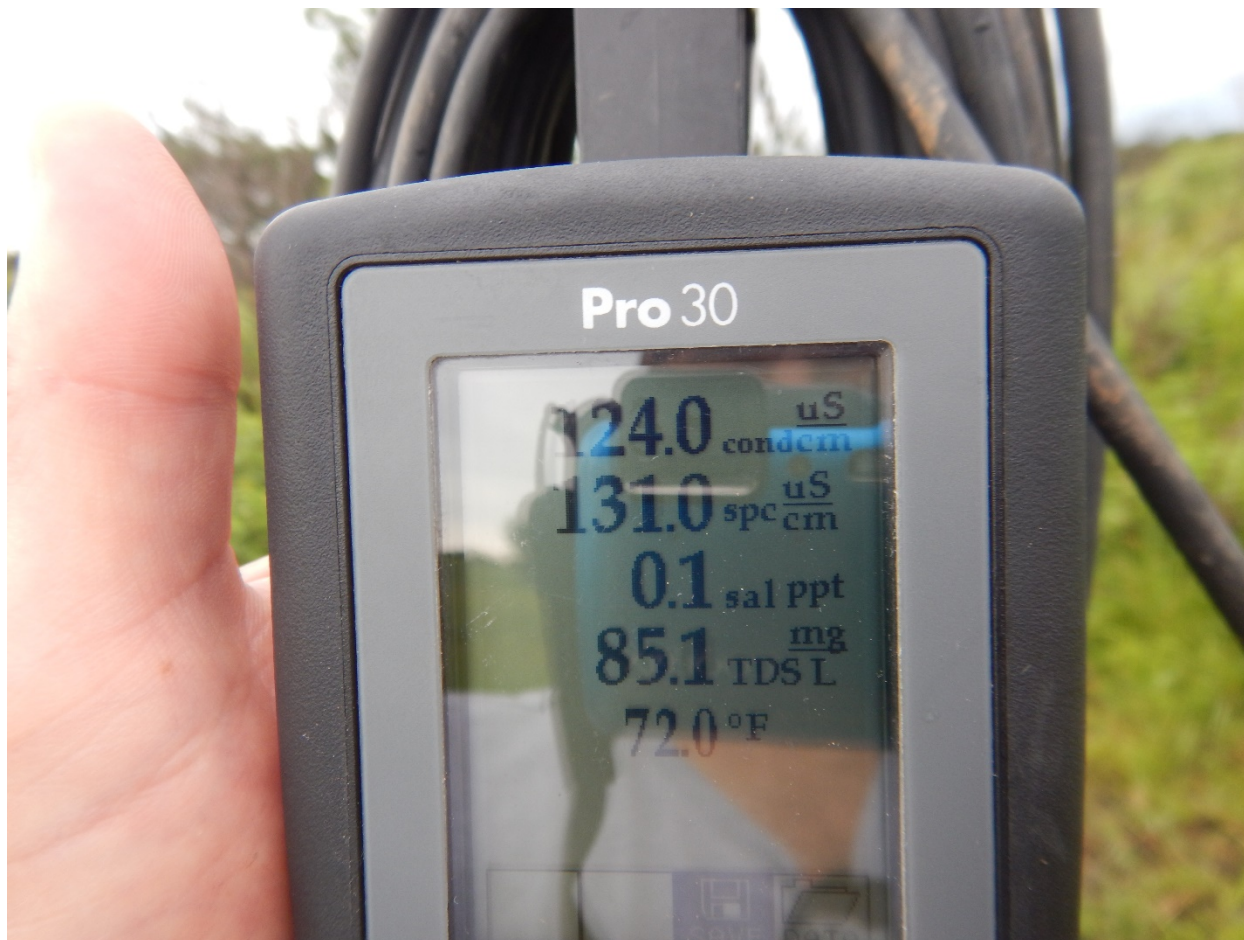
Photo No. 3

**Description:** This was a Total Dissolved Solids (TDS) field reading of 85.1 mg/L taken immediately upstream from the Release Point/Point of Entry (POE).

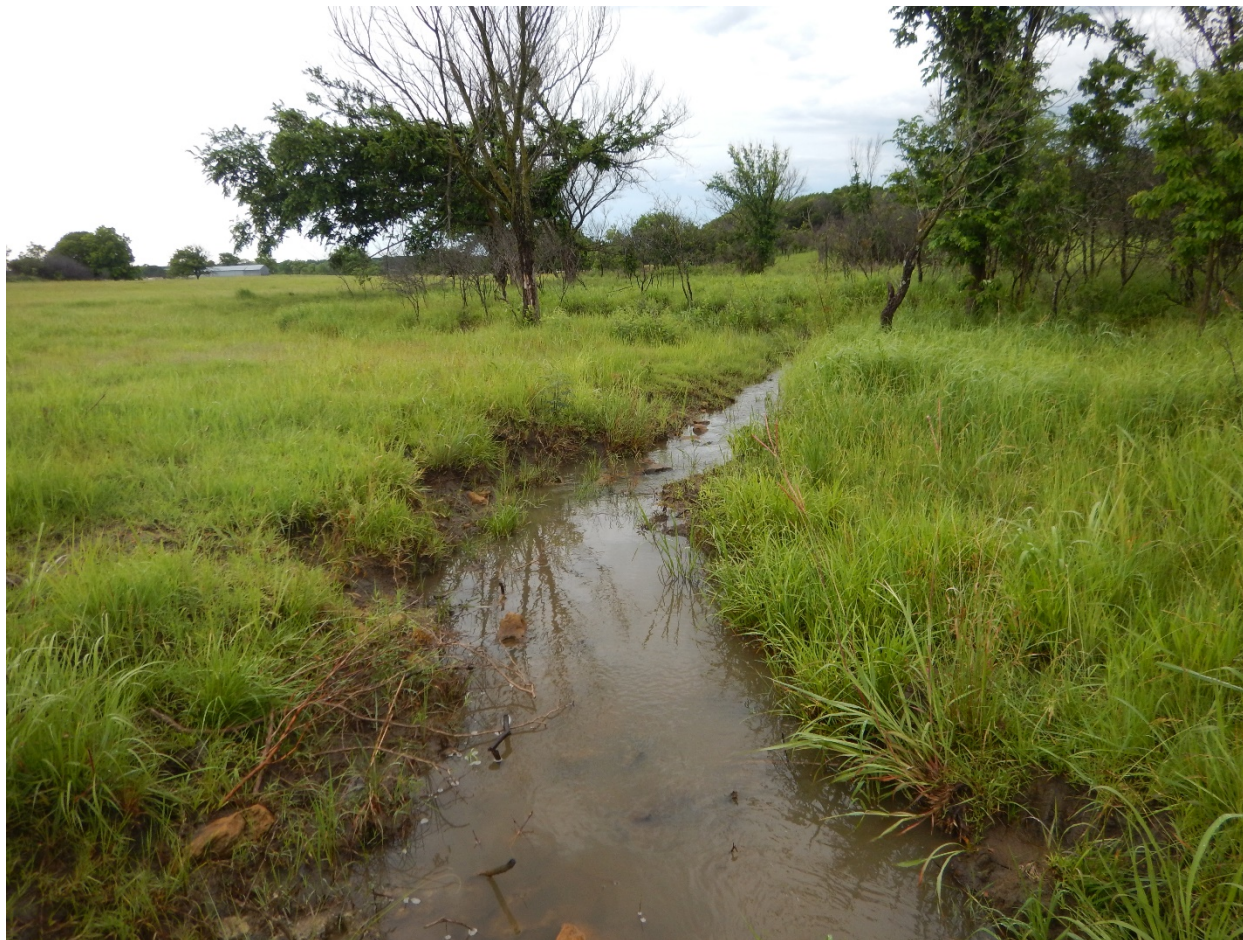
Photo No. 4

**Description:** This was a photo taken immediately downstream from the POE, with a view downstream. We did not observe any remaining spill impacts during the inspection.

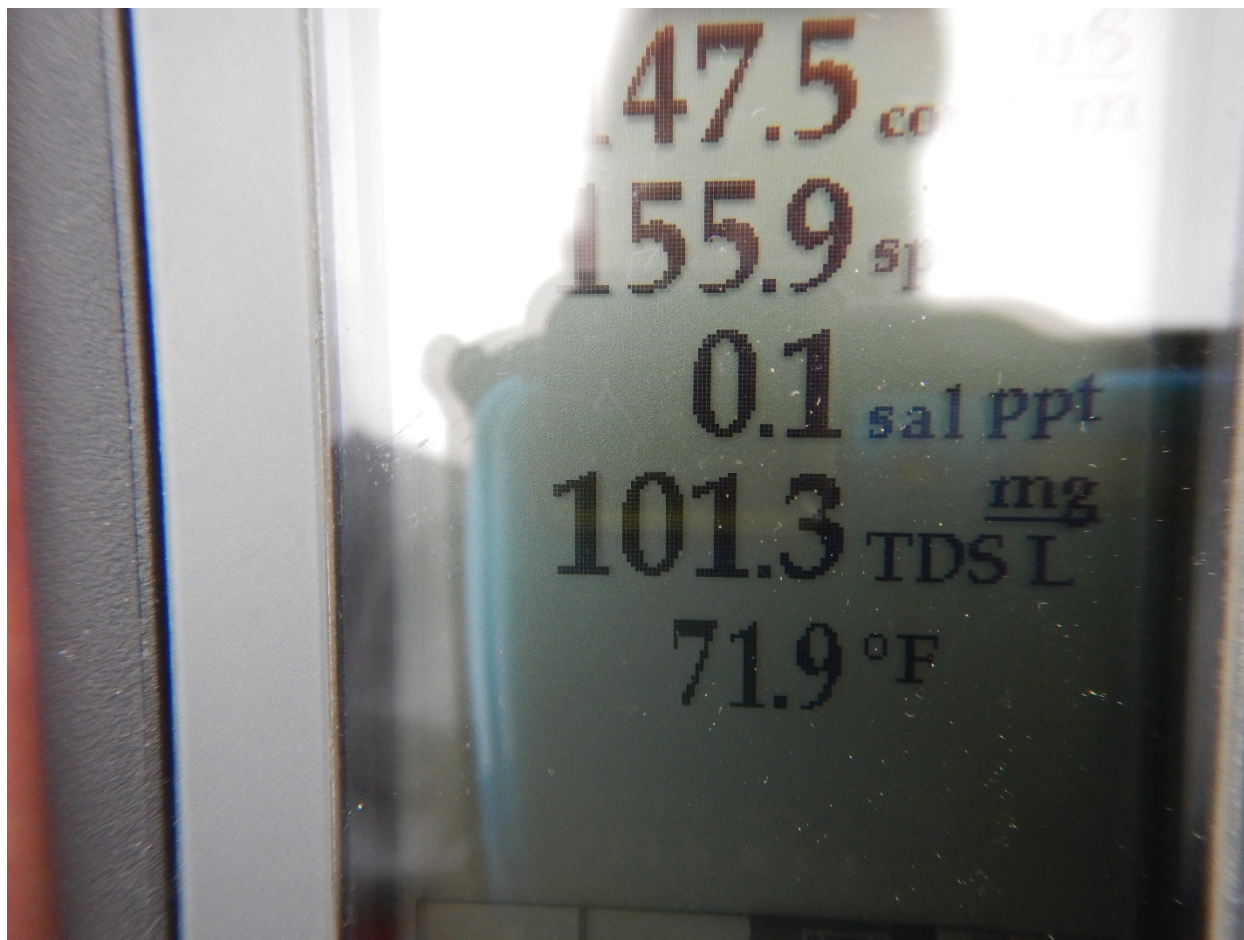
Photo No. 5

**Description:** This was a TDS field reading of 101.3 mg/L taken in a deep pool approximately 30 feet downstream from the POE, this reading was well within the "background" range for the area.
