**Well Inspection**  
**Osage DNR / Environmental Protection Agency**  
**1201 Elm Street, Suite 500**  
**Dallas, Texas 75270**

| <b>Operator Info</b> | CapturePoint, LLC | <b>Inventory ID</b> OS3865000 | | | | |
| | Allen, TX 75013 | <b>Well ID</b> 102 W6 | | | | |

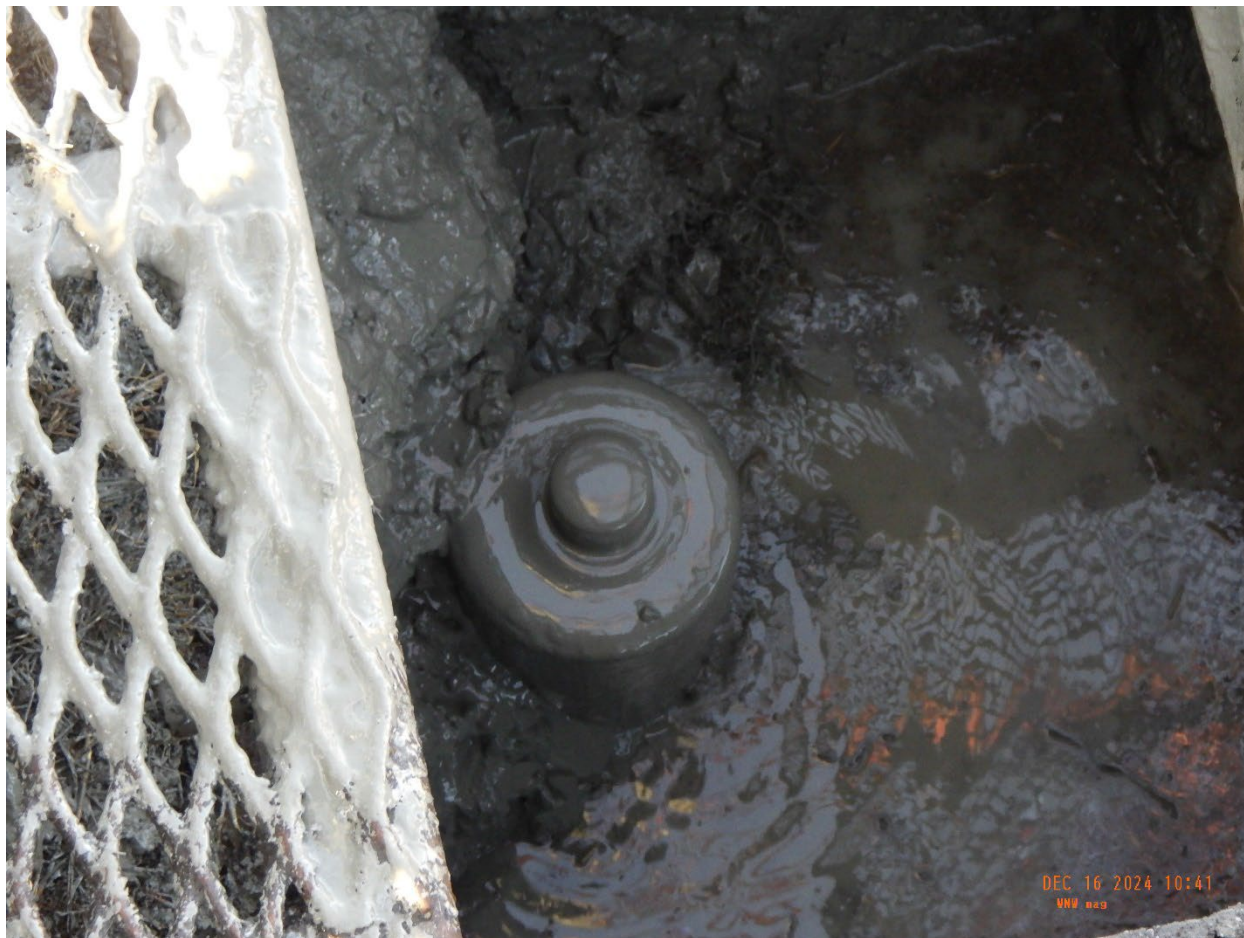
Photo No. 1

| <b>Inspection Comments</b> | | CapturePoint, LLC cut the well tubing at 275 feet below the surface. Inspector observed Hurricane Services Inc (HSI) run in well OS3865000 and tag the top of the middle plug at 275 feet. HSI pumped 50 sacks of cement from 275 to surface. Inspector observed cement standing full at the surface. | | | | |

**Description:** This was well OS3865000 with cement standing at the surface.
