**U.S. ENVIRONMENTAL PROTECTION AGENCY  
REGION III WATER BRANCH, ENFORCEMENT  
AND COMPLIANCE ASSURANCE DIVISION  
CLEAN WATER ACT  
COMPLIANCE INSPECTION REPORT**

**Name of Facility:** AdvanSix Resins & Chemicals, LLC – Hopewell Plant

| <b>Type of Inspection:</b> | Industrial Stormwater |
| <b>NPDES Permit No:</b> | VAR052505 (General Permit) and VA0005291 (Individual Permit) |

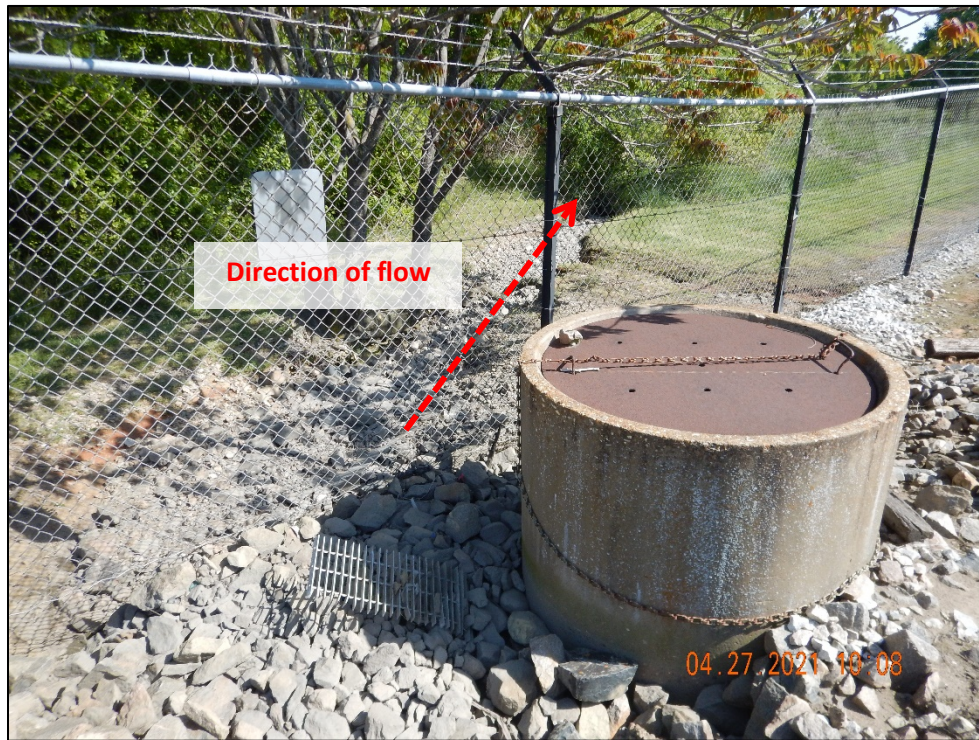
- Soil erosion from stormwater sheet flow was observed at the north perimeter of the Facility, near the manhole where the Facility samples for Outfall 912 (refer to Appendix A, DSCN 2311 and DSCN 2313).

**DSCN2311.** View, facing northeast, of the manhole where Facility representatives collect samples for Outfall 912. Note the signs of sheet flow beyond the north perimeter fence.

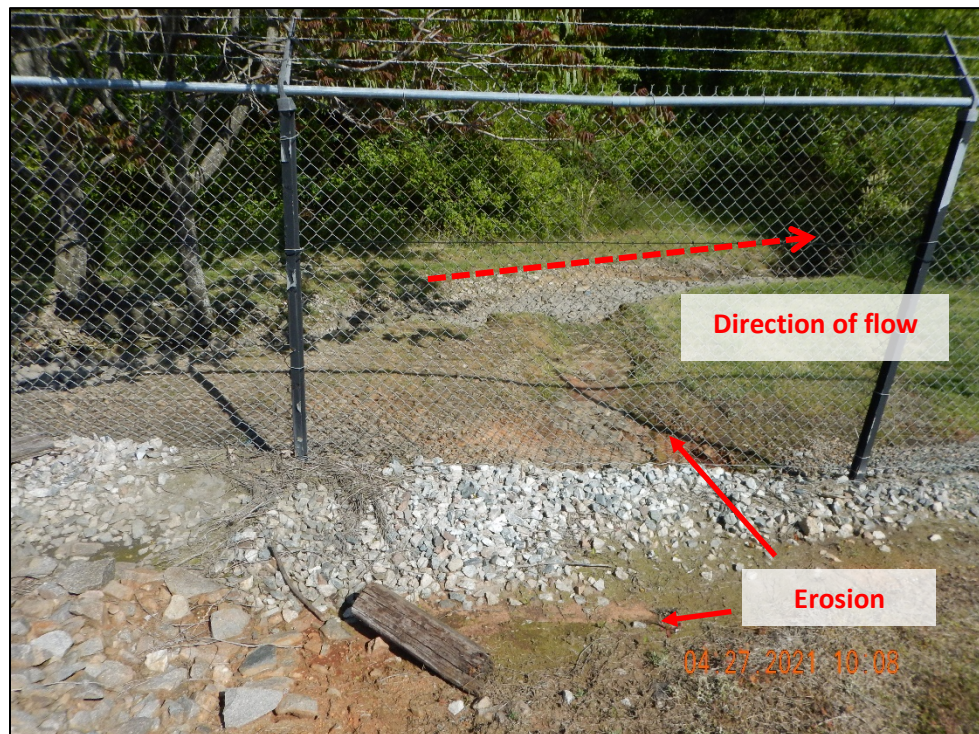
**DSCN2313.** View, facing north, of soil erosion to the east of the manhole where Facility representatives collect samples for Outfall 912.

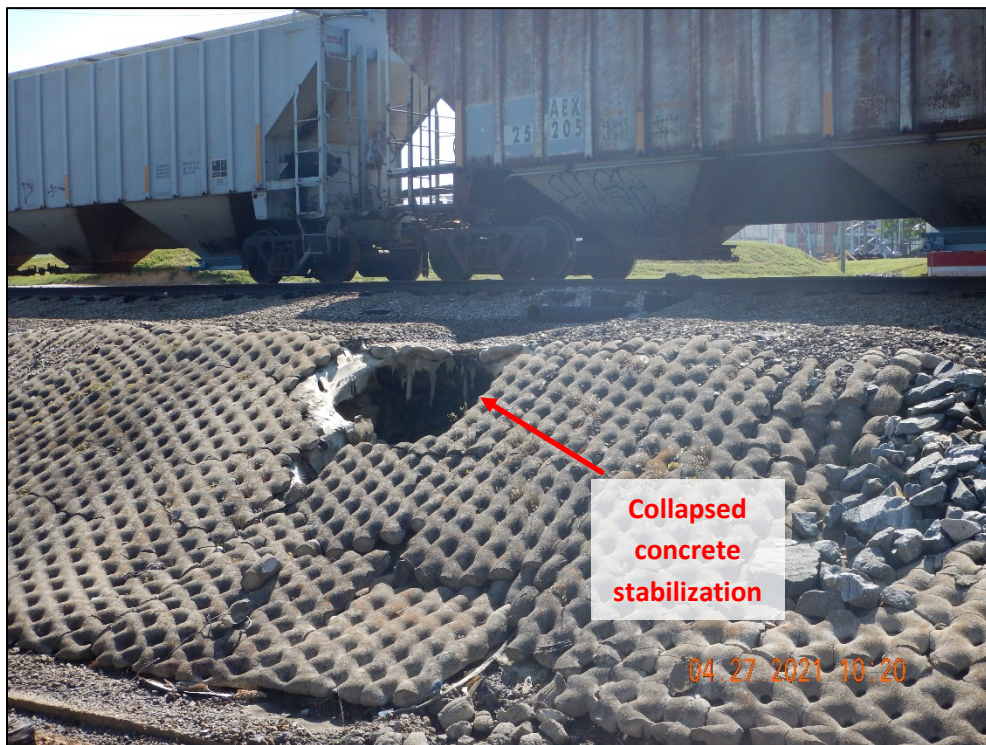
- A portion of the concrete stabilization of the slope in the northeast corner of the Facility had collapsed (refer to Appendix A, DSCN 2318).
- An unknown white substance was observed in multiple areas at the Facility, including the north drainage ditch in the Outfall 906 drainage area (refer to Appendix A, DSCN 2323), in the ditch directly upgradient of the inlet to Outfall 906 (refer to Appendix A, DSCN 2335 and DSCN 2333), and in the ditch flowing to Outfall 905 (refer to Appendix A, DSCN 2351 and DSCN 2350). All of these areas were directly adjacent to a hillside in the northeast corner of the Facility. Facility representatives stated that they did not know what the substance was, but they did not believe it was ammonium sulfate fertilizer. They stated that the substance “comes out of the hillside” and that they tested it a few years ago and determined it was not ammonium sulfate fertilizer.

**DSCN2318.** View, facing southeast, of a collapsed portion of the concrete stabilization on the slope between the rail tracks and the north perimeter fence.

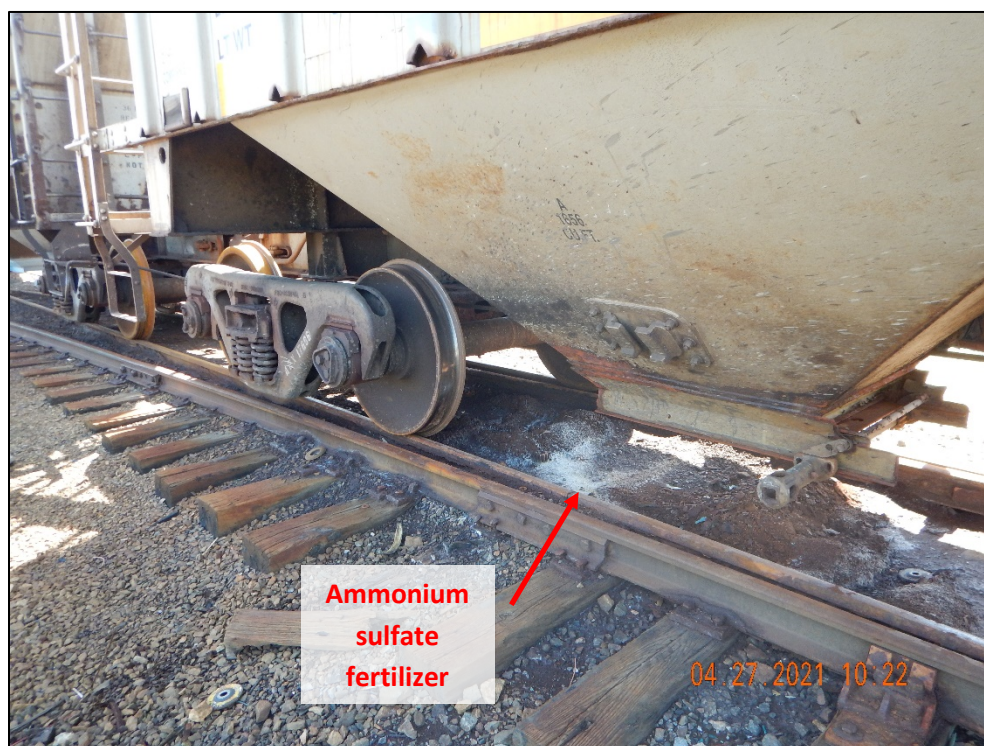
stabilization and install new stabilization by 2024. The EPA Inspection Team also observed a white powder on the ground underneath a rail car hopper (refer to [Appendix A, DSCN 2319](#)). Facility representatives stated that the white powder was ammonium sulfate fertilizer that had spilled from the rail car. The EPA Inspection Team also observed an accumulation of water containing a white substance in the ditch at the base of the concrete slope (refer to [Appendix A, DSCN 2323](#)). Facility representatives stated that they do not know what the substance is, but they do not believe it is ammonium sulfate fertilizer. They stated that the substance “comes out of the hillside” and that they tested it a few years ago and determined it was not ammonium sulfate fertilizer. The EPA Inspection Team observed this white substance in multiple locations throughout the Facility.

- Ammonium sulfate fertilizer was observed in multiple areas at the Facility that were subject to stormwater runoff, including beneath a railcar in the Outfall 906 drainage area (refer to Appendix A, DSCN 2319), adjacent to the north fertilizer storage warehouse in the Outfall 906 drainage area (refer to Appendix A, DSCN 2325), in and around a stormwater inlet in the entryway to the north fertilizer storage warehouse in the Outfall 906 drainage area (refer to Appendix A, DSCN 2329 and DSCN 2332), in track-out south of the fertilizer storage warehouse in the Outfall 904 drainage area (refer to Appendix A, DSCN 2364 and DSCN 2365), in and around the fertilizer conveyor pit and near unprotected stormwater inlets in the Outfall 907 drainage area (refer to Appendix A, DSCN 2373 through DSCN 2376), and in track-out south of the southern fertilizer storage warehouse in the Outfall 001 drainage area (refer to Appendix A, DSCN 2382, DSCN 2385, and DSCN 2386). Page 2 of the October 10, 2019 DEQ Warning Letter (refer to Appendix B, Exhibit 3) states that similar issues were noted in the 2019, 2017 and 2015 DEQ inspections of the Facility.

**DSCN2319.** View, facing southeast, of ammonium sulfate fertilizer on the ground beneath a rail car hopper.

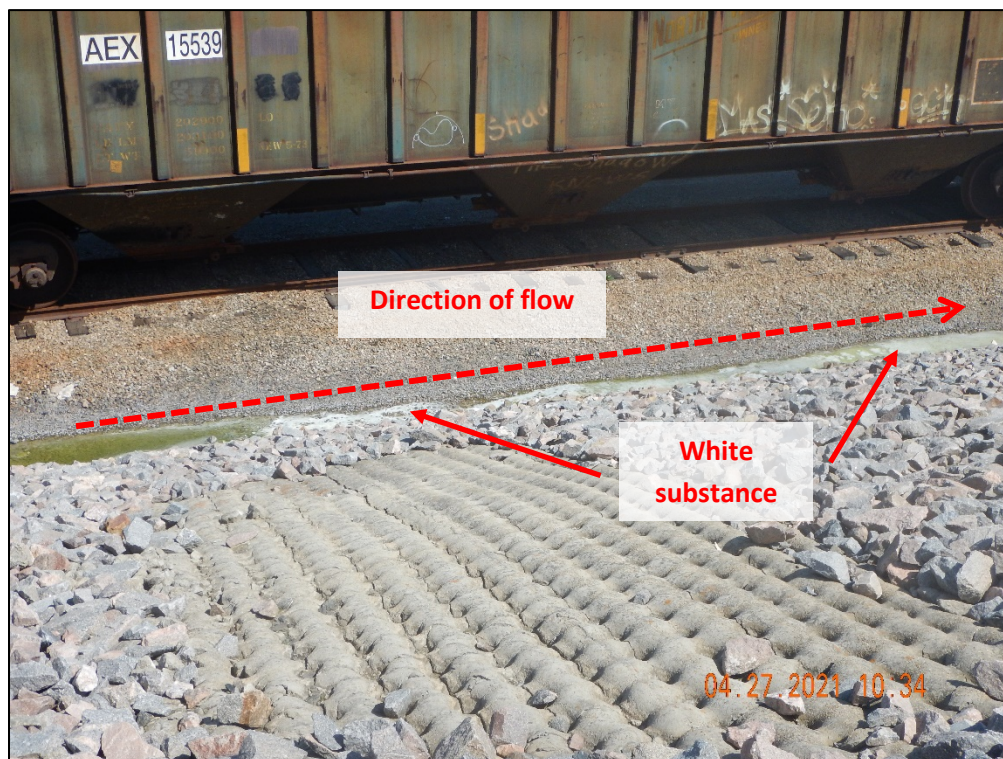
**DSCN2323.** View, facing north, of a white substance in the ditch at the base of the concrete slope. Facility representatives stated that they did not know what it was.

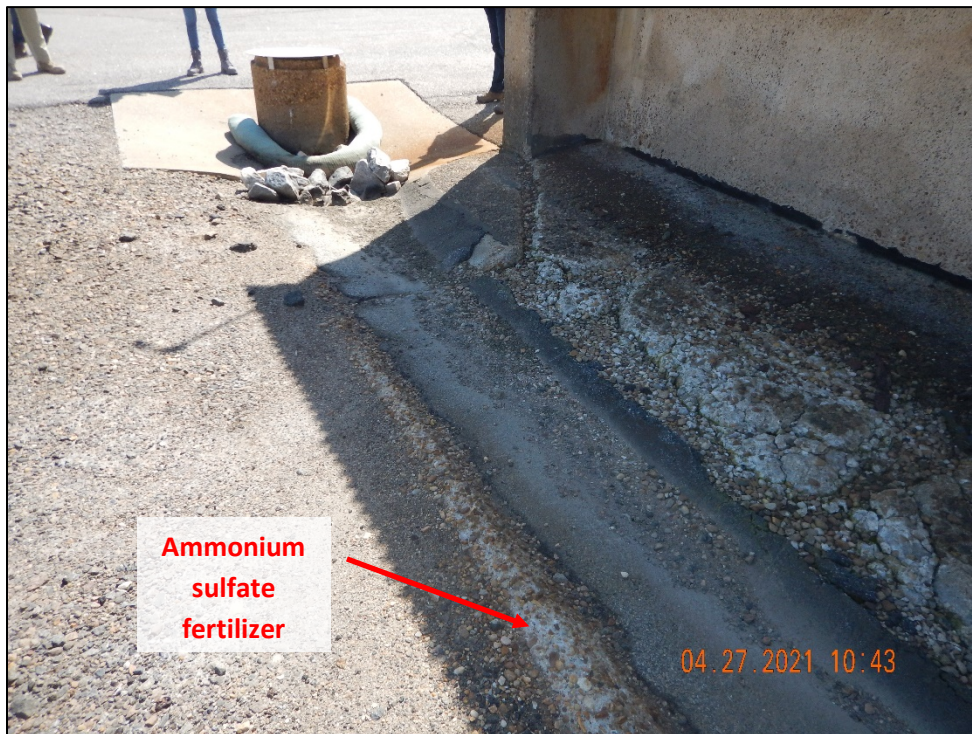
**DSCN2325.** View, facing east, of the ditch and stormwater inlet at the northeast corner of the northernmost fertilizer warehouse. Note the white fertilizer staining in the ditch.

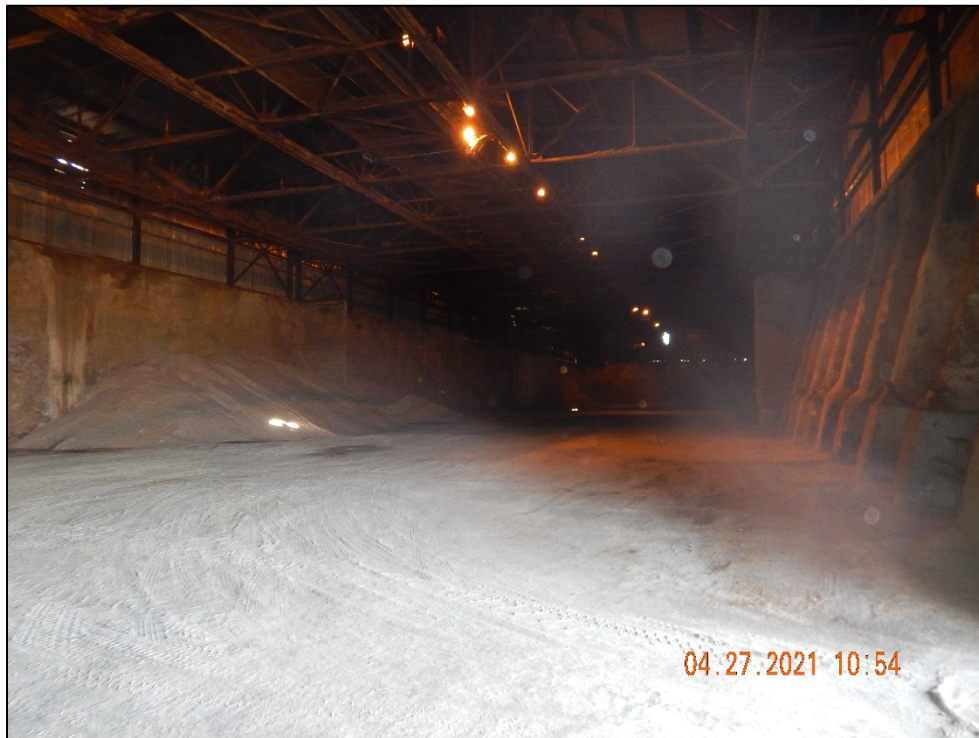
**DSCN2330.** View, facing west, of the inside of the ammonium sulfate fertilizer warehouse. Note the piles of fertilizer and heavy tracking throughout the warehouse.

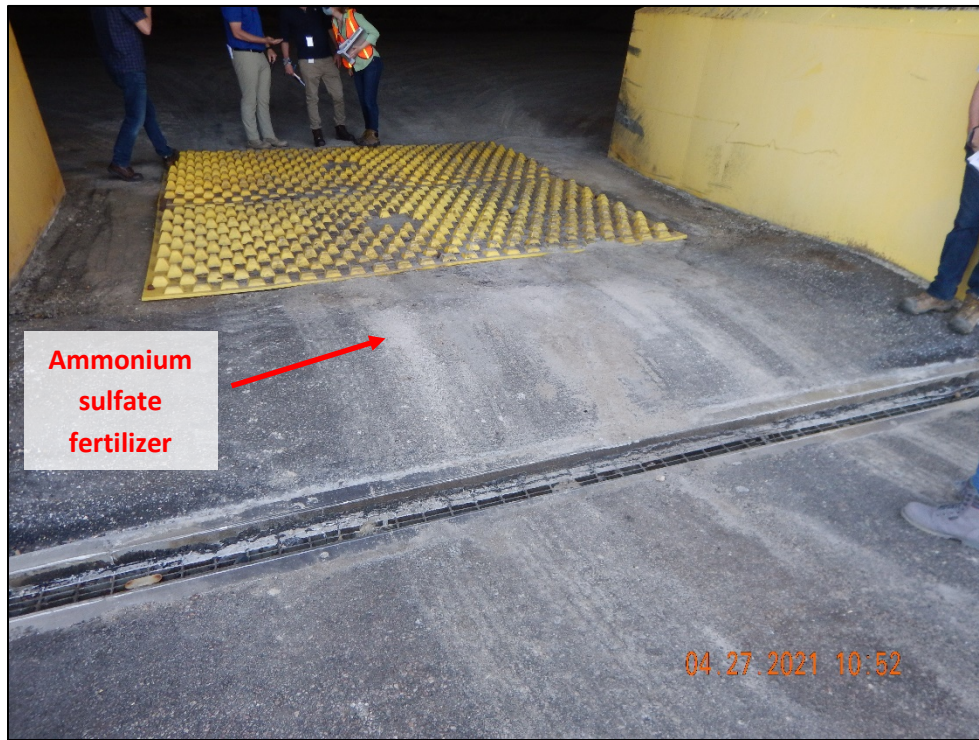
**DSCN2329.** View, facing south, of the entryway to the fertilizer storage warehouse. Note the heavy fertilizer tracking over and inside the storm drain in the entryway.

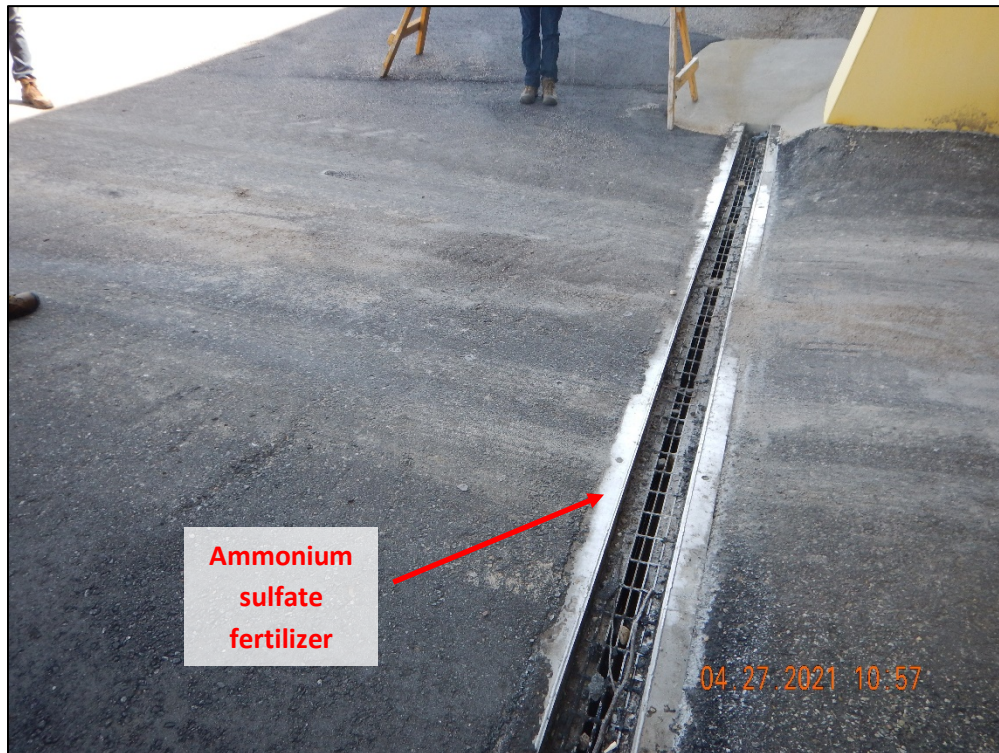
**DSCN2332.** Alternate view, facing east, of the entryway to the fertilizer storage warehouse. Note the fertilizer in and around the storm drain to Outfall 906.

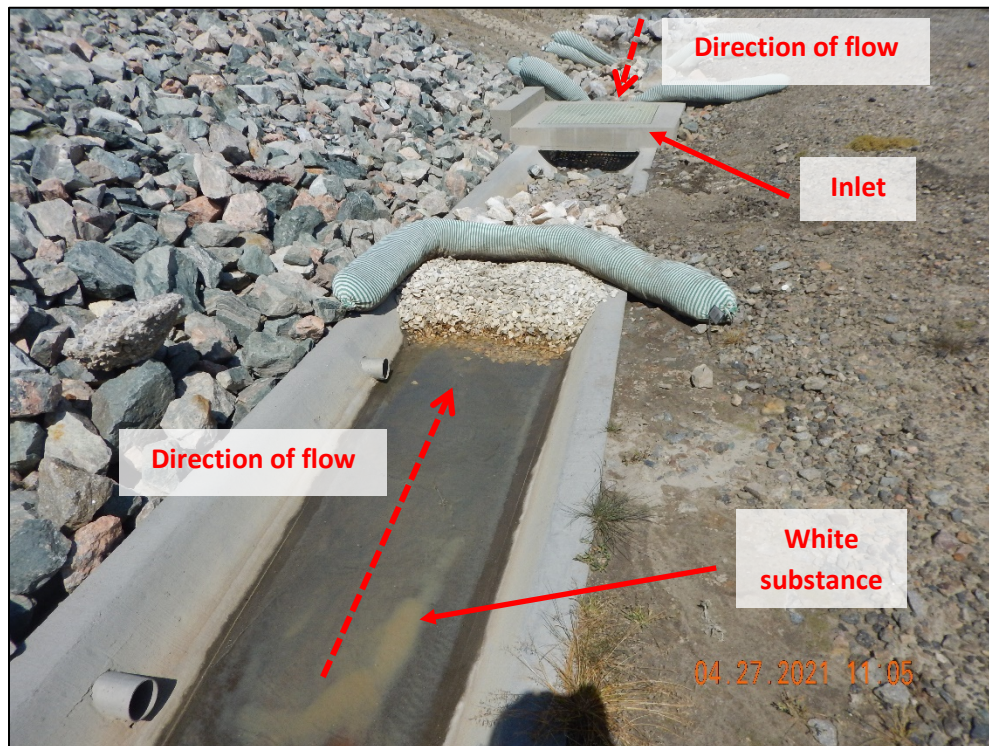
**DSCN2335.** View, facing north, of the stormwater inlet from DSCN2336. Note the presence of the same unknown white substance in the water upgradient of the inlet.

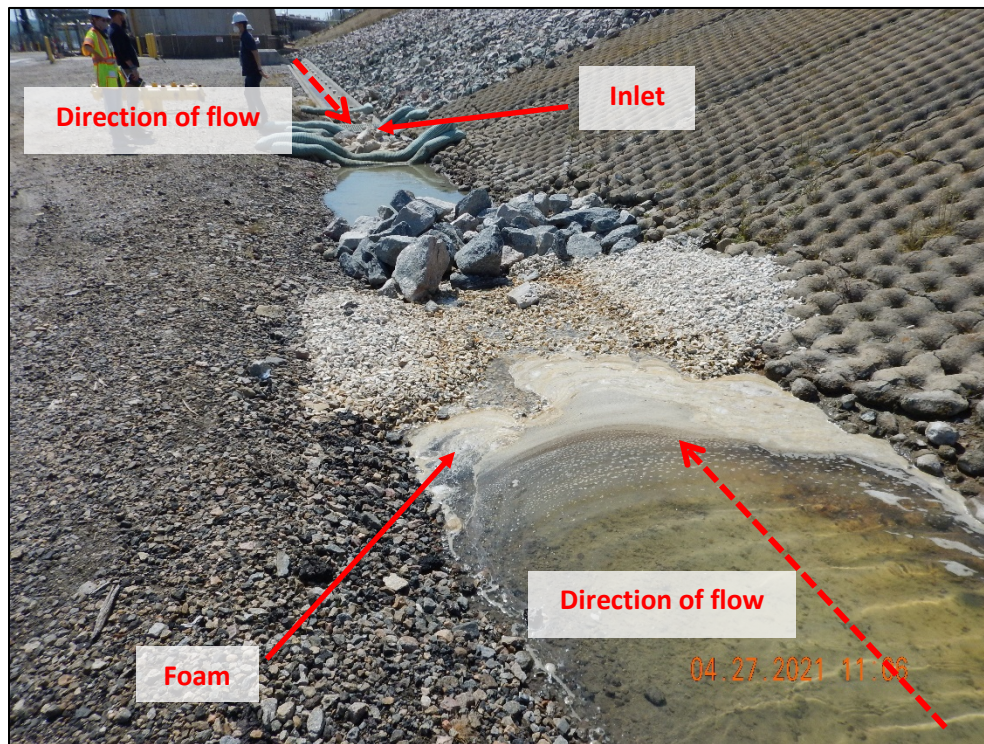
**DSCN2336.** View, facing south, of the end of the ditch in the northeast corner of the Facility. Note the surface foam buildup, inlet protection, and inlet in the background of the photograph.

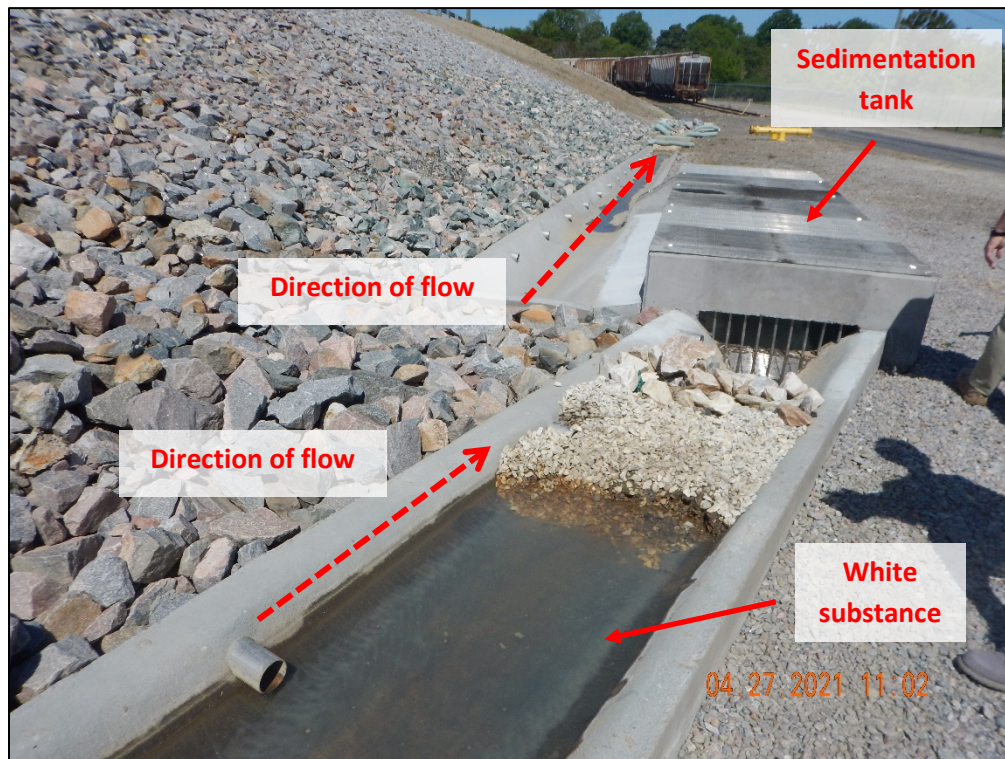
**DSCN2333.** View, facing north, of a sedimentation tank to the south of the stormwater inlet used for Outfall 906 sampling. Note the presence of an unknown white substance in the water.

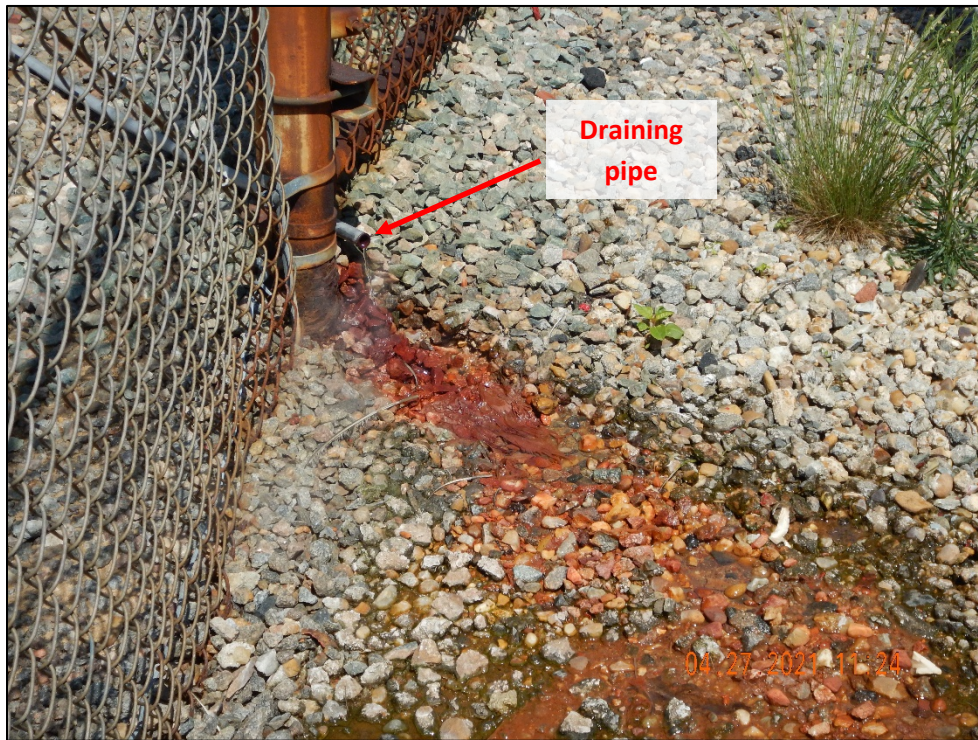
- A small, unlabeled pipe was observed to be draining a steaming liquid directly onto the shoreline of the James River, under the marine dock (refer to Appendix A, DSCN 2342). The liquid had stained the surrounding gravel red. Facility representatives stated that the flow was from air-conditioning condensate.

**DSCN2342.** View of a small pipe draining a steaming liquid onto the shoreline of the James River. Facility representatives stated it was a low-pressure steam drain.

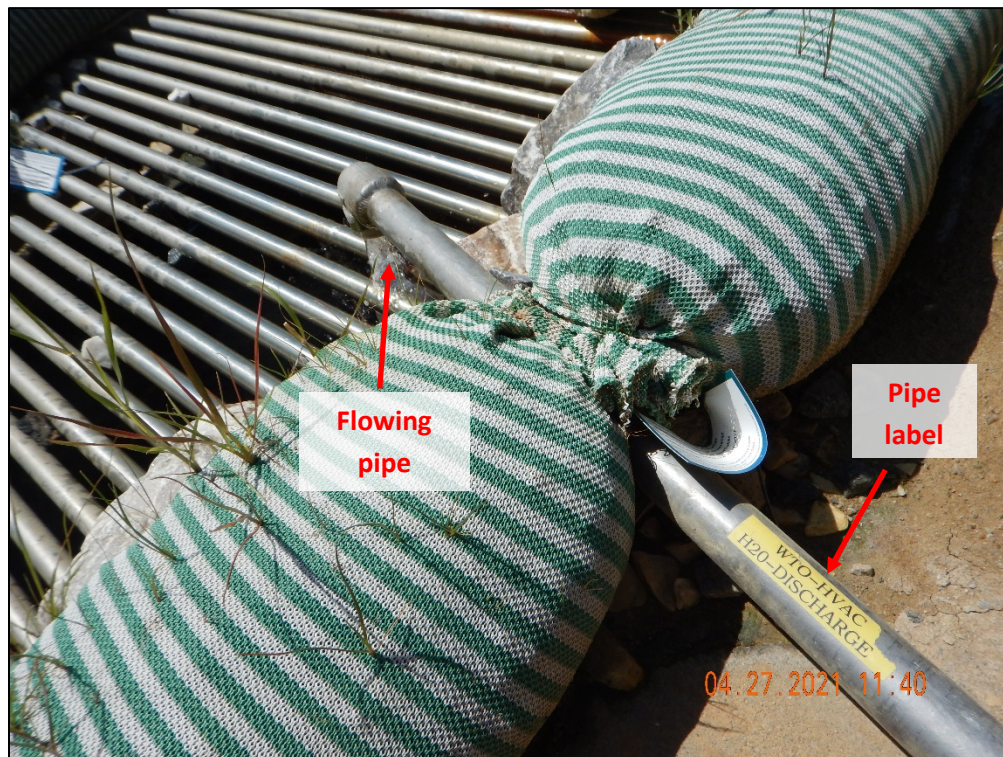
- Locations and descriptions of all non-stormwater discharges were not present on the site maps. For example, the EPA Inspection Team observed an HVAC pipe discharge into an inlet upgradient of Outfall 905 (refer to Appendix A, DSCN 2349); however, this was not marked on the site map. Additionally, the large non-stormwater discharge into Outfall 911 (refer to Appendix A, DSCN 2358 through DSCN 2363) was not marked on the site map.

**DSCN2349.** View of the small pipe labelled “WTO-HVAC H2O-DISCHARGE” flowing into the inlet upgradient of Outfall 905.

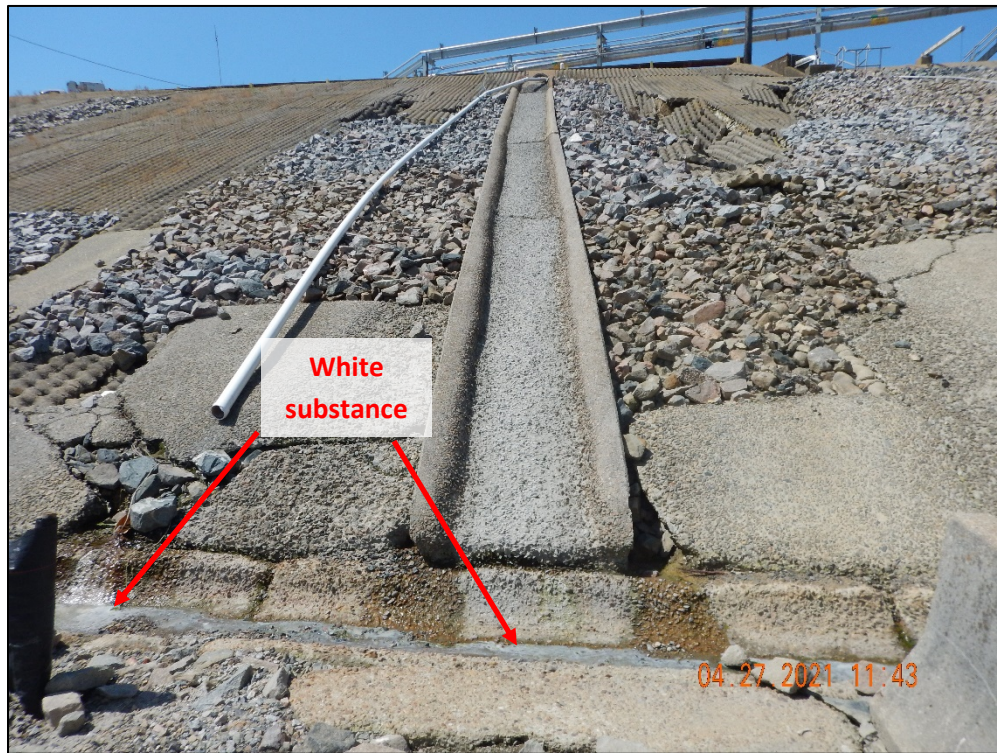
**DSCN2351.** View, facing west, of a concrete drainage ditch running down the steep slope. Note the presence of an unknown white substance in the ditch.

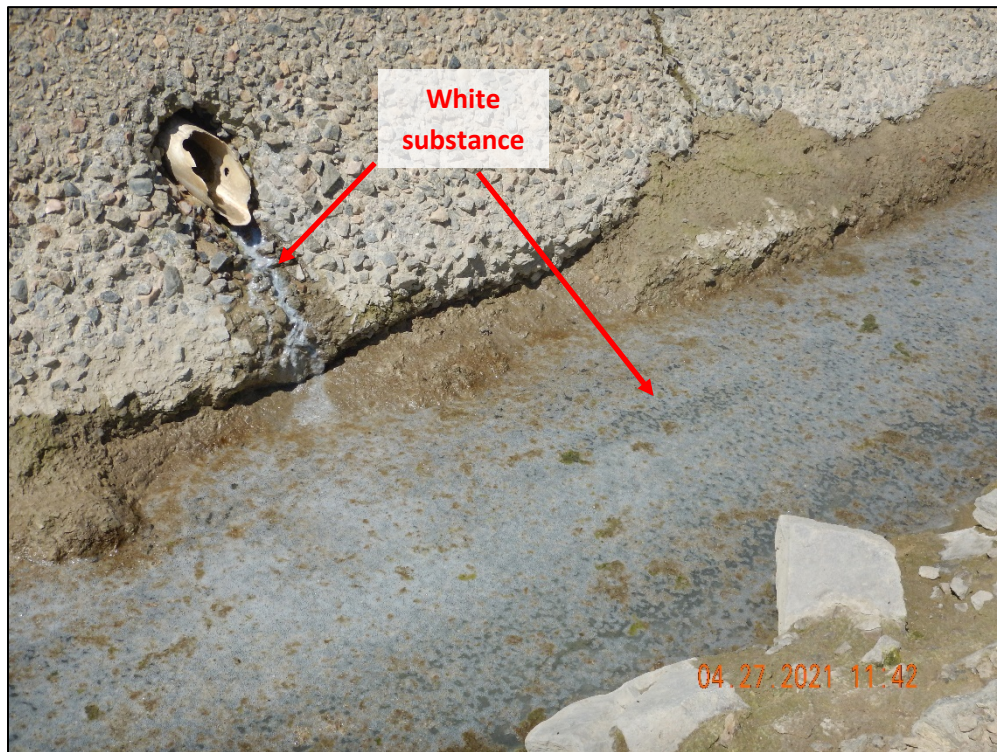
**DSCN2350.** View, facing northwest, of a small pipe in the side of the steep slope draining an unknown white liquid into the ditch to Outfall 905.

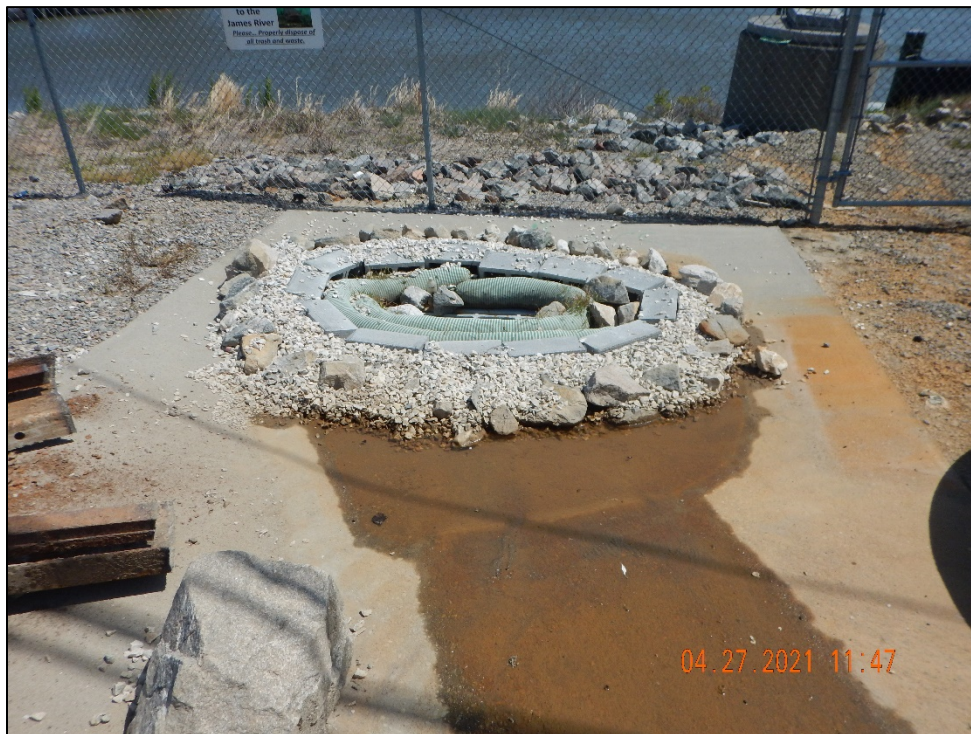
**DSCN2355.** View, facing east, of the third sampling point upgradient of Outfall 904. The EPA Inspection Team observed dry-weather flow to this inlet.

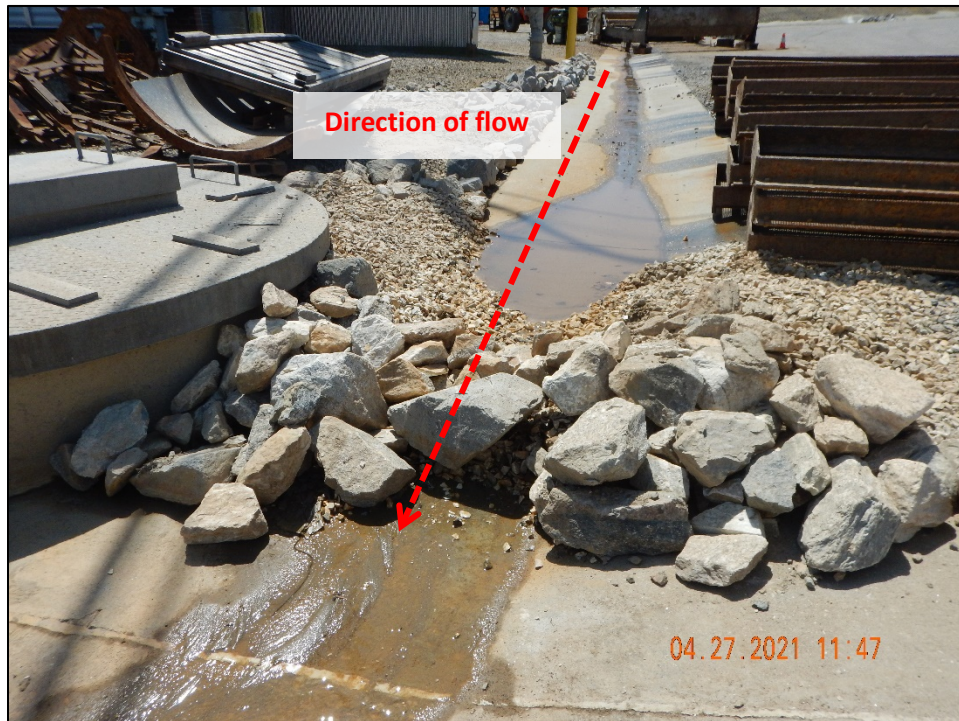
**DSCN2356.** View, facing southwest, of a ditch with dry-weather flow running to the inlet from DSCN 2355.

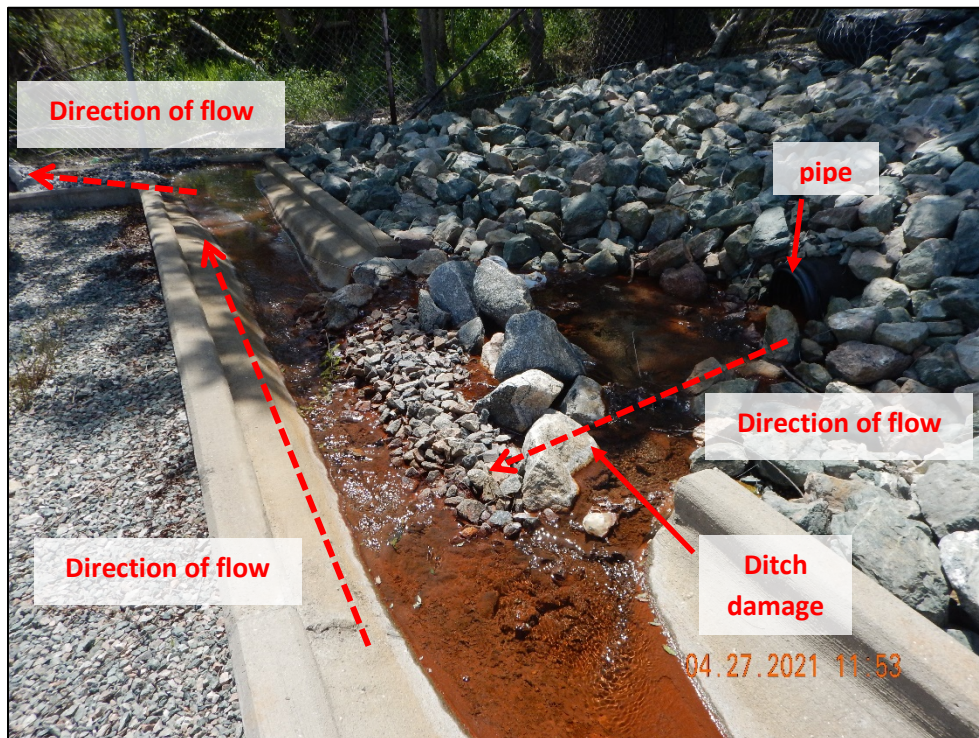
- Heavy dry-weather flow was observed emanating from a slope in the Outfall 911 drainage area (refer to Appendix A, DSCN 2358 through DSCN 2363). The flow was red in color. Facility representatives stated the flow is constant and attributed it to a possible leak in a subsurface river water intake pipe in the slope. Facility representatives stated that there is a 66-inch river water intake pipe located approximately 20 feet under the slope. Additionally, Facility representatives stated that they think the red color is from metals in the soil. Facility representatives stated they sampled the flow in 2020 and noted the water was not chlorinated, so they do not believe it to be drinking water. In addition to the red flow, the EPA Inspection Team observed that the concrete ditch had been damaged in two places and that gravel and rip rap had spilled into the ditch (refer to Appendix A, DSCN 2359). The EPA Inspection Team also observed surface sheen in areas of standing water, and observed plastic debris on the ground between the concrete ditch and the James River (refer to Appendix A, DSCN 2360 through DSCN 2363).

**DSCN2358.** View, facing south, of heavy dry-weather flow with a red color flowing into the concrete ditch upgradient of Outfall 911. Note the damage to the concrete ditch.

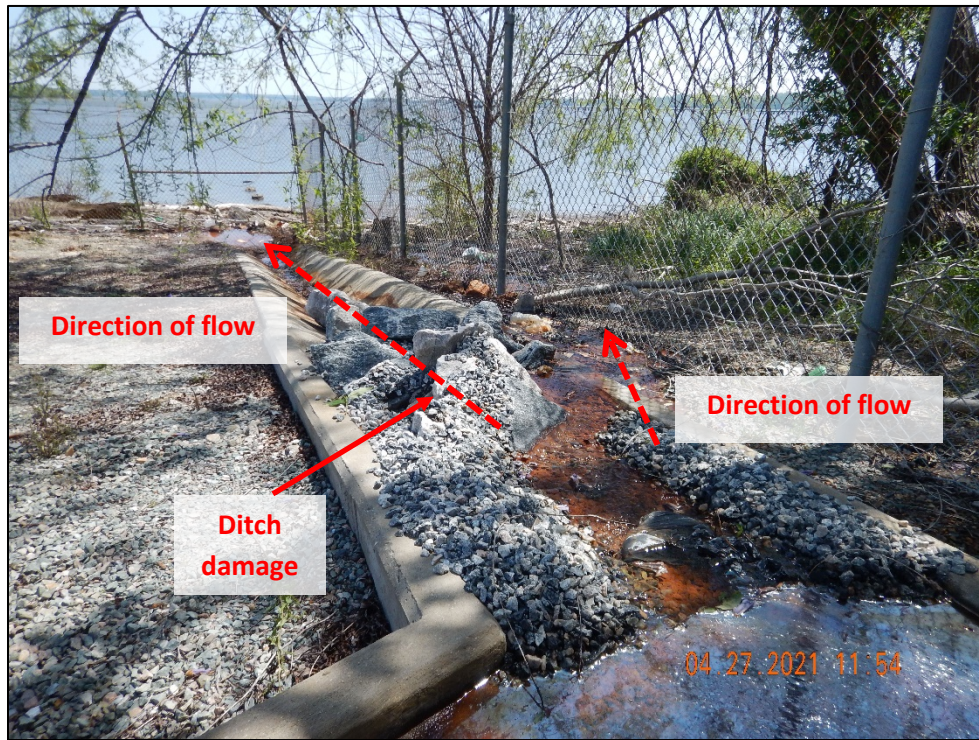
**DSCN2359.** View, facing east, of the red dry-weather flow running into the James River. Note the damage to the concrete ditch and flow spilling over the side of the ditch.

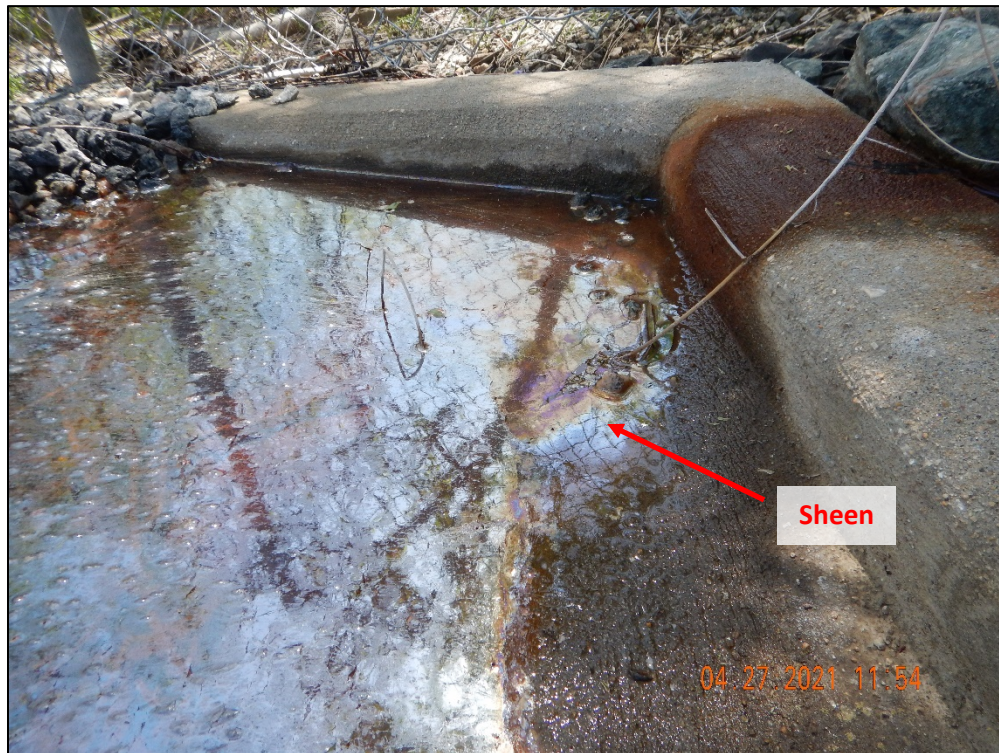
**DSCN2360.** View of surface sheen at the end of the concrete ditch from DSCN 2358 and DSCN 2359.

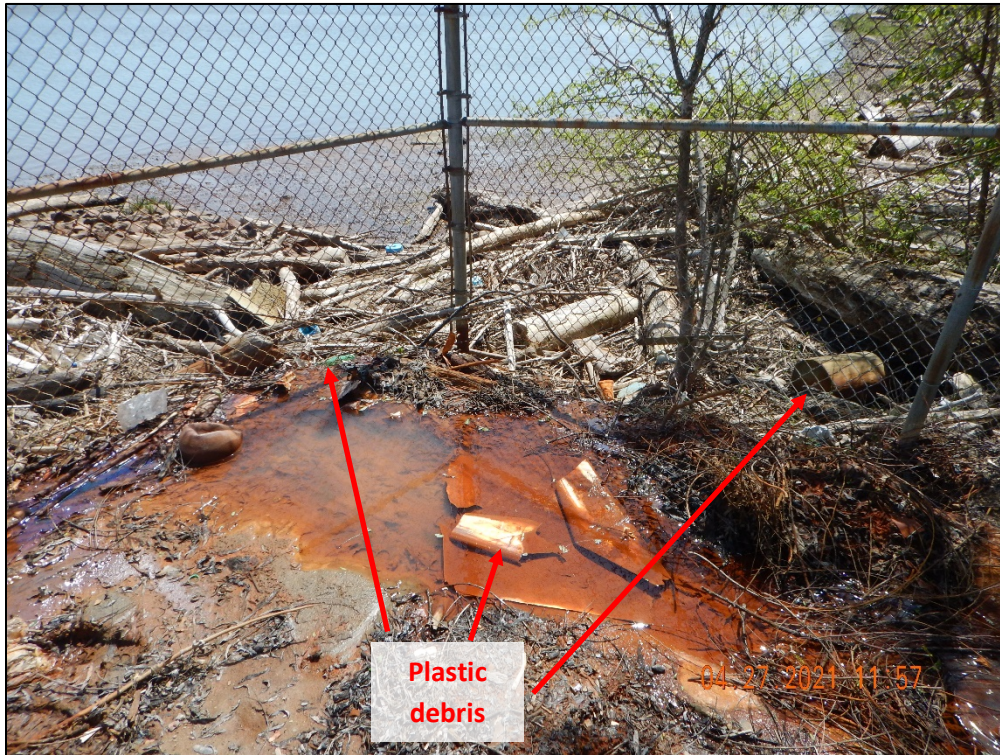
**DSCN2361.** View, facing southeast, of the area between the end of the concrete ditch and the James River. Note the presence of plastic debris on the ground.

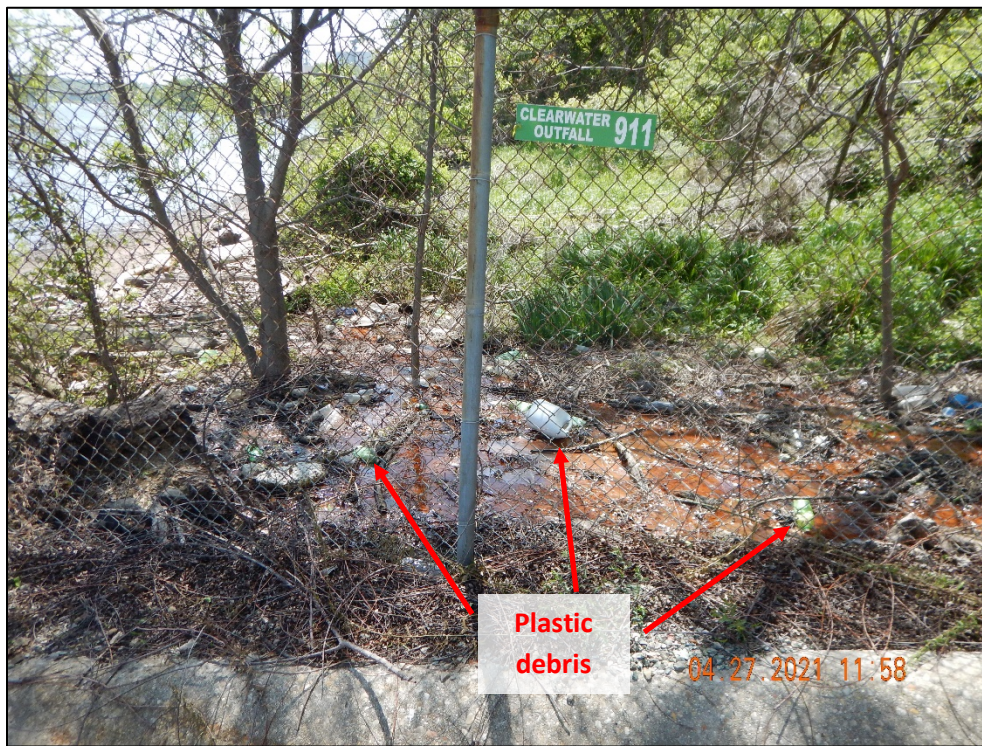
**DSCN2362.** View, facing south, of the area between the concrete ditch and the James River. Note the presence of plastic debris on the ground.

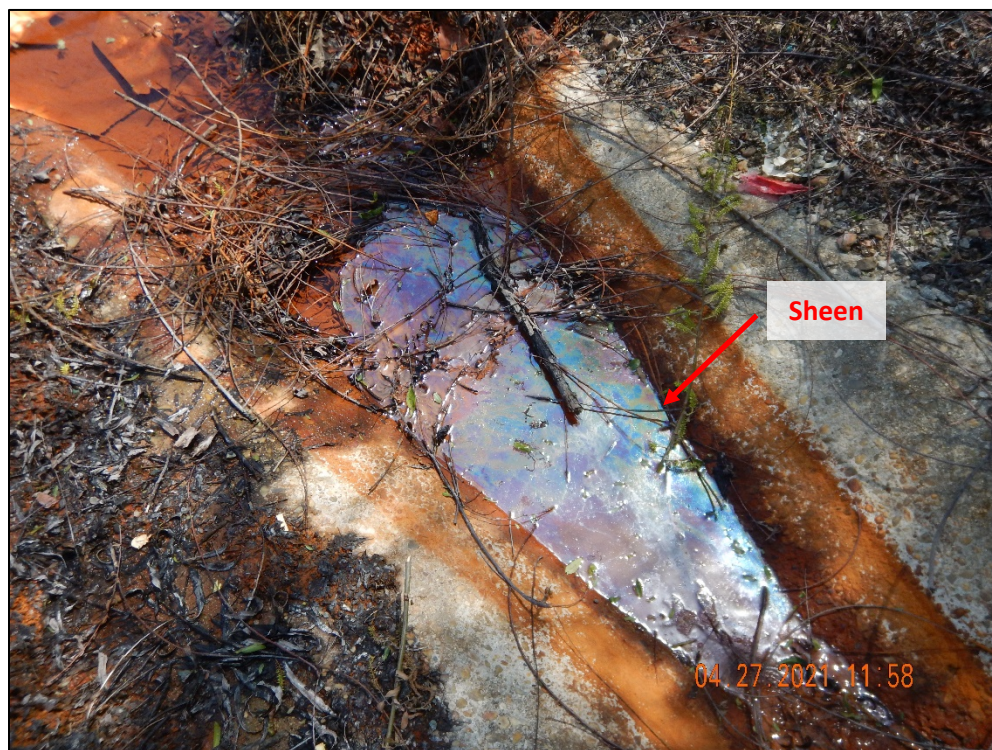
**DSCN2363.** Another view of surface sheen in the dry-weather flow to Outfall 911.

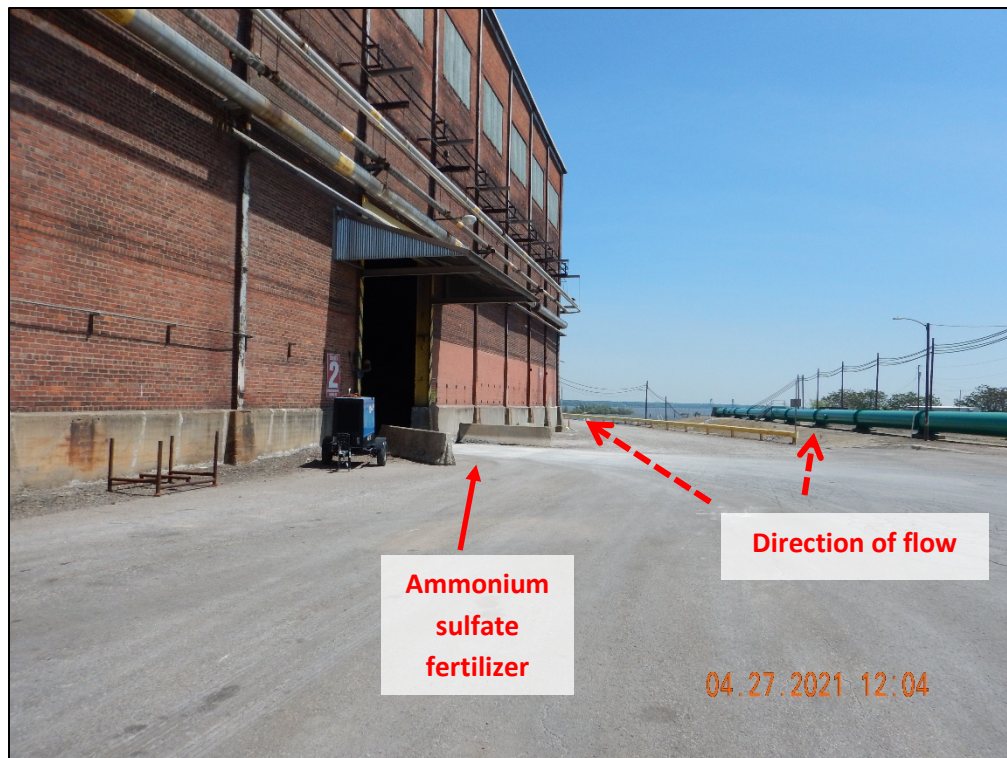
**DSCN2364.** View, facing east, of ammonium sulfate fertilizer track-out in front of a storage warehouse in the Outfall 904 drainage area.

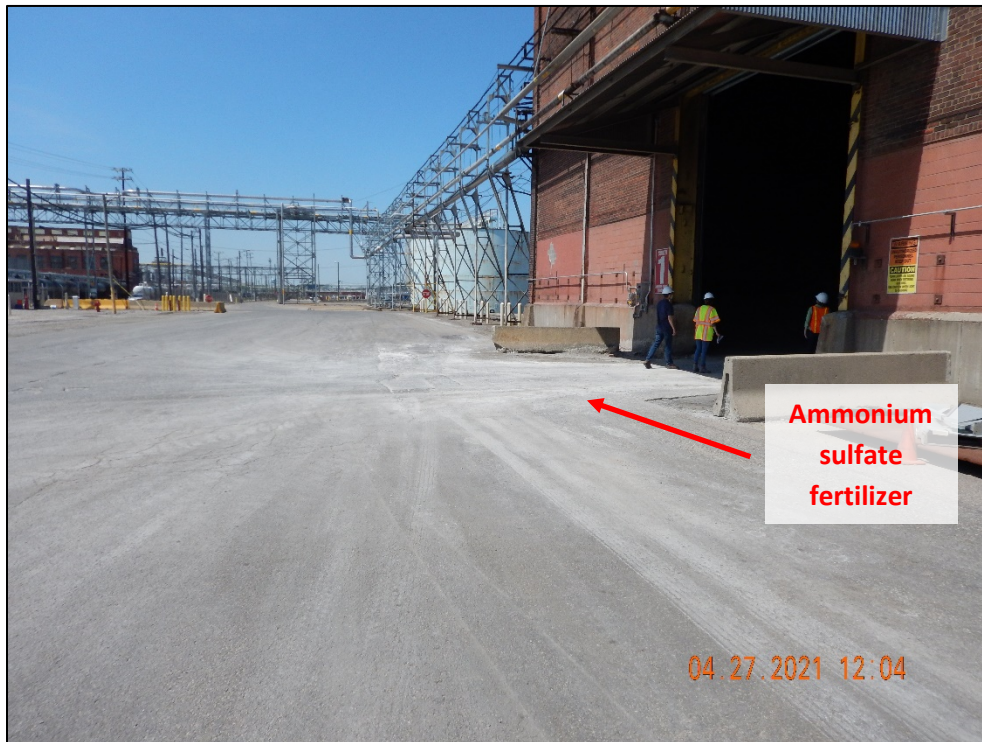
**DSCN2365.** View, facing west, of ammonium sulfate fertilizer track-out in front of a storage warehouse in the Outfall 904 drainage area.

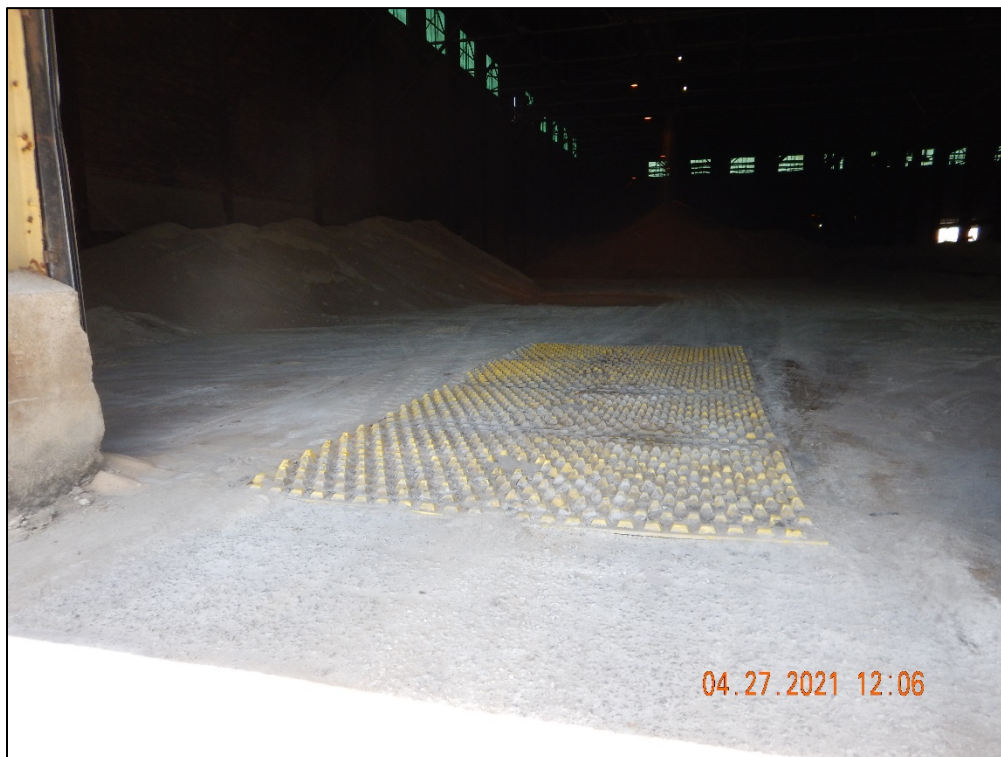
**DSCN2366.** View of the foreign object debris system in the entryway to the warehouse from DSCN 2364 and DSCN 2365. The debris system was heavily laden with fertilizer.
