**U.S. ENVIRONMENTAL PROTECTION AGENCY  
REGION III WATER BRANCH, ENFORCEMENT  
AND COMPLIANCE ASSURANCE DIVISION  
CLEAN WATER ACT  
COMPLIANCE INSPECTION REPORT**

**Name of Facility:** AdvanSix Resins & Chemicals, LLC – Hopewell Plant

| <b>Type of Inspection:</b> | Industrial Stormwater |
| <b>NPDES Permit No:</b> | VAR052505 (General Permit) and VA0005291 (Individual Permit) |

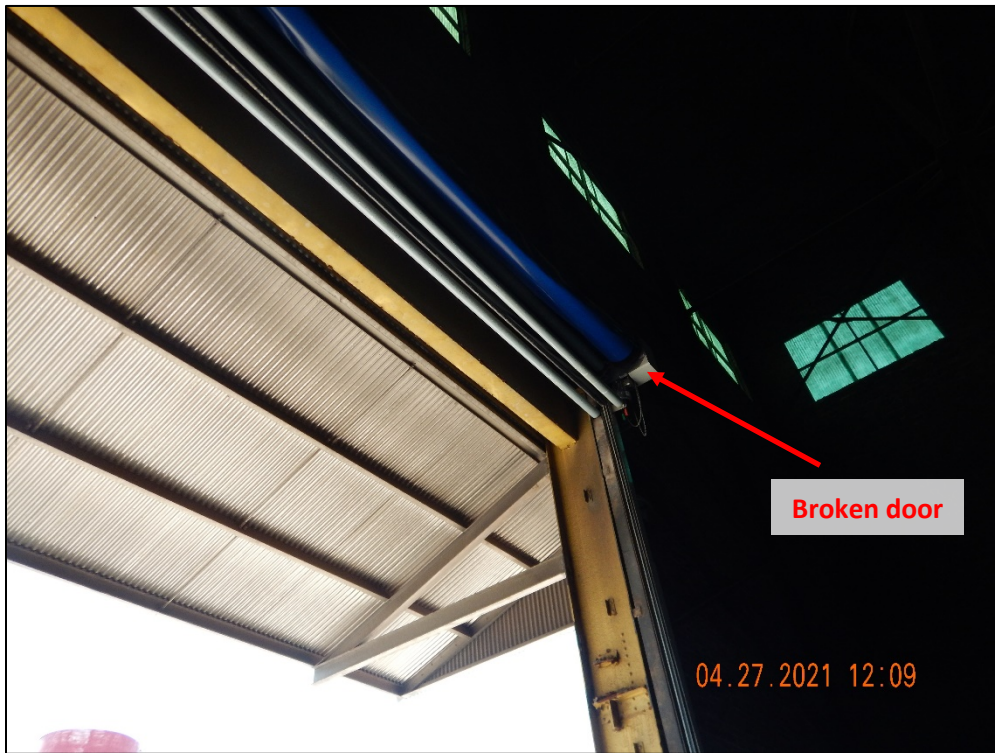
The EPA Inspection Team moved west from Outfall 911 to the south entrance of a third, actively used, ammonium sulfate fertilizer warehouse in the Outfall 904 drainage area. The warehouse did not have stormwater drains in the entryways similar to the aforementioned warehouse; however, the EPA Inspection Team observed a significant amount of ammonium sulfate fertilizer track-out on the pavement in front of the warehouse (refer to [Appendix A, DSCN 2364 and DSCN 2365](#)). This track-out is in an area that would sheet flow east toward a stormwater inlet outside the east corner of the warehouse and directly into Outfall 904. The EPA Inspection Team observed the foreign object debris system in the entryway of the warehouse to be heavily laden with fertilizer (refer to [Appendix A, DSCN 2366](#)). The EPA Inspection Team also observed a fast-closing door had been installed in the entryway to the warehouse; however, it was not functioning (refer to [Appendix A, DSCN 2368](#)). Facility representatives stated that they were piloting the door in this single entryway to prevent ammonium sulfate fertilizer from blowing out of the warehouse; however, Facility representatives stated that a dump truck had recently struck the door and that it was no longer working.

**DSCN2368.** View of a fast-closing door in the entryway to the fertilizer warehouse. Note that it was not functioning at the time of the EPA inspection.

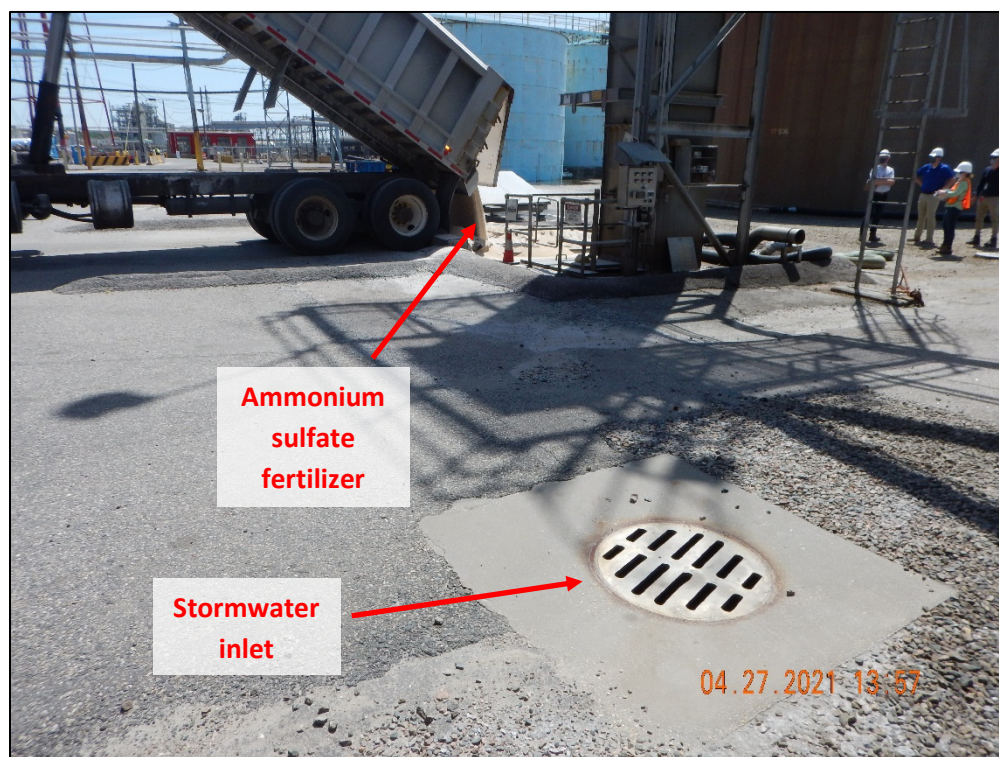
**DSCN2375.** View, facing southwest, of a dump truck unloading fertilizer into a subsurface pit. Note the presence of a nearby unprotected stormwater inlet that was not on the site map.

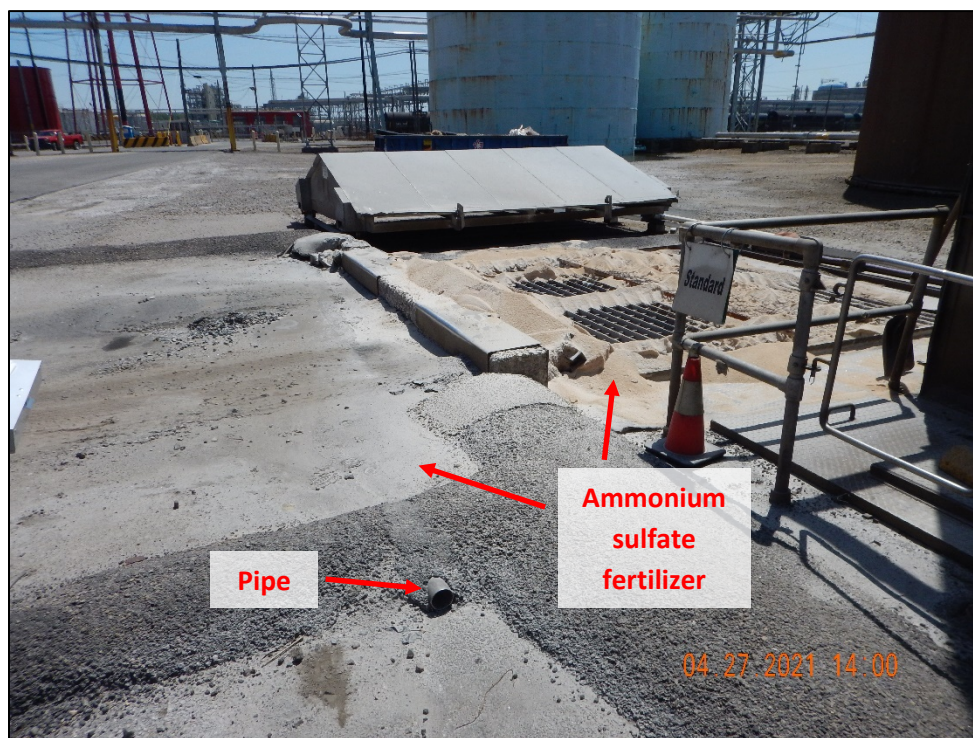
**DSCN2376.** View, facing south, of ammonium sulfate fertilizer pit with a small pipe through the bermed unloading area. Note the presence of fertilizer on the ground in the area.

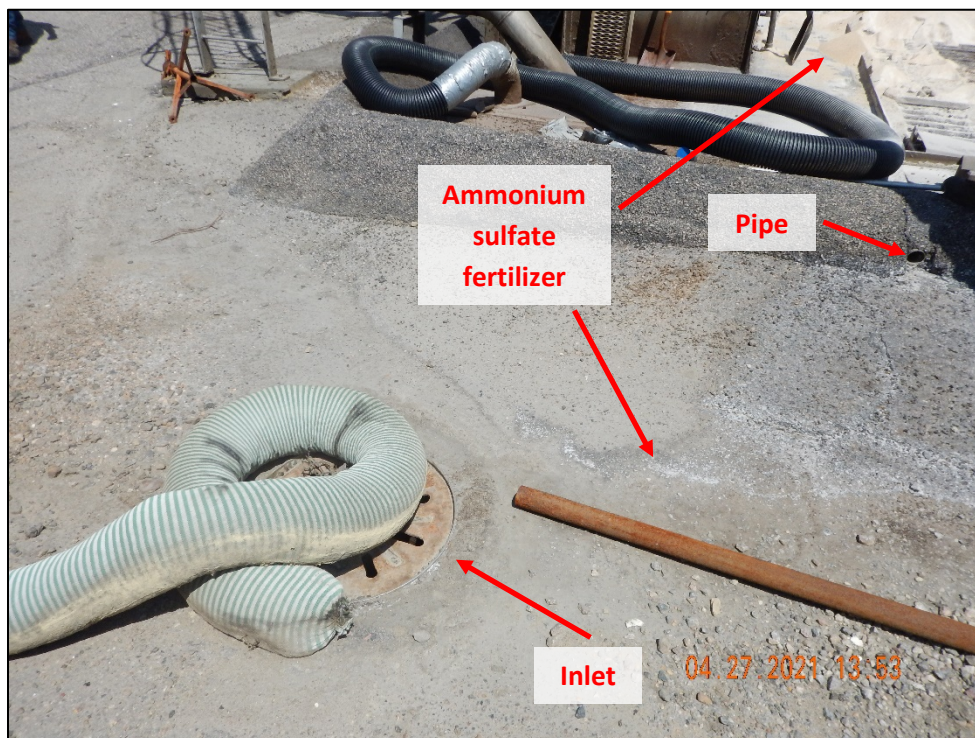
**DSCN2374.** View, facing east, of improperly placed rolled inlet protection at the inlet located 10 feet from the fertilizer pit. Note the small pipe through the fertilizer pit berm.

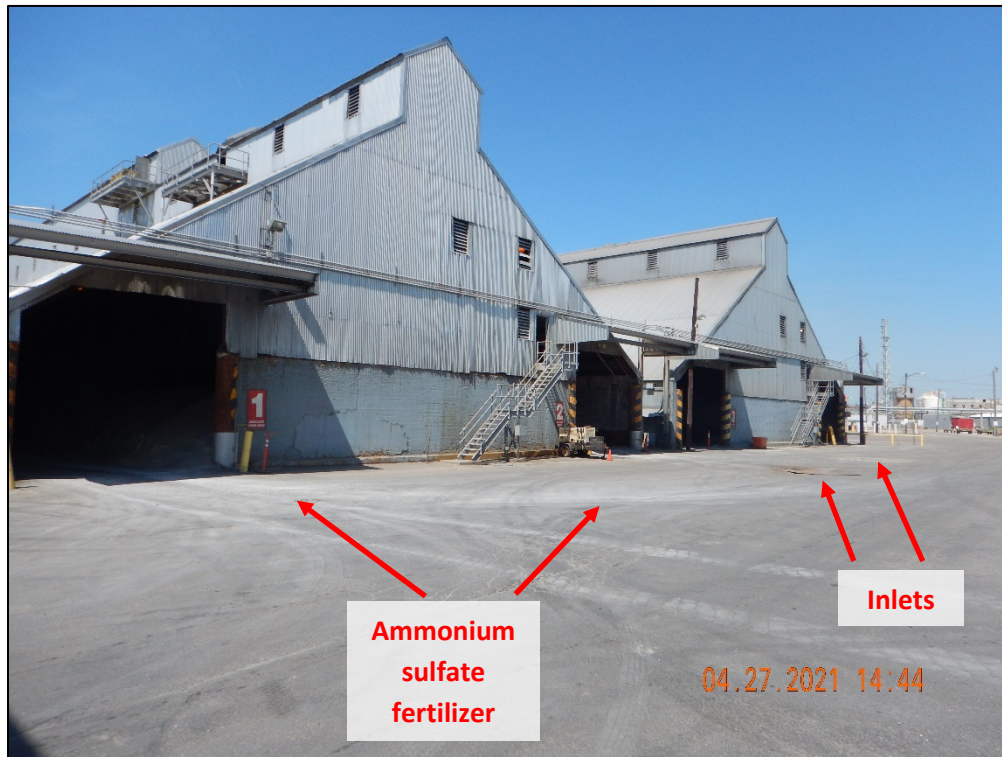
The EPA Inspection Team moved to the south end of the Outfall 001 clear water sewer system area and observed two additional ammonium sulfate fertilizer warehouses (refer to [Appendix A, DSCN 2382](#)). The EPA Inspection Team observed fertilizer track-out on the pavement in front of the warehouses. The area in front of the warehouse contains two inlets that drain to Outfall 001 (refer to [Appendix A, DSCN 2385](#)), as well as an inlet that drains to the process waste sewer system Outfall 004 (refer to [Appendix A, DSCN 2386](#)).

**DSCN2382.** View, facing northeast, of two additional ammonium sulfate fertilizer warehouses located in the Outfall 001 clear water sewer system area. Note the fertilizer track-out.

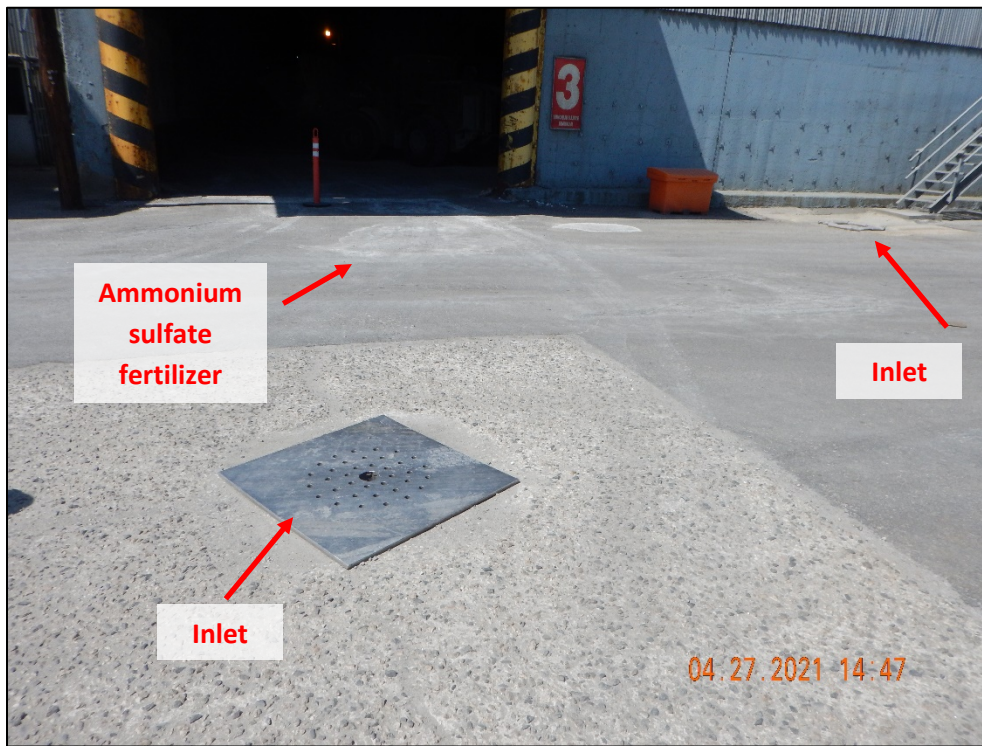
**DSCN2385.** View, facing north, of an inlet flowing to Outfall 001. Note the presence of ammonium sulfate fertilizer on the ground surrounding the inlet.

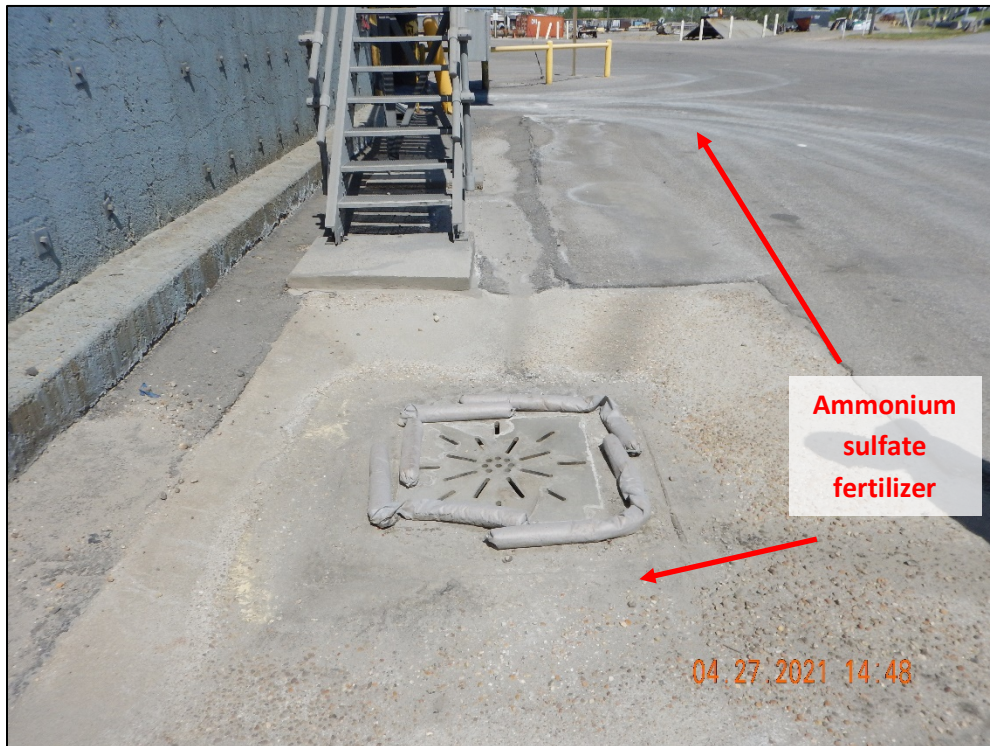
**DSCN2386.** View, facing east, of an inlet flowing to Outfall 004. Note the presence of ammonium sulfate fertilizer on the ground surrounding the inlet.

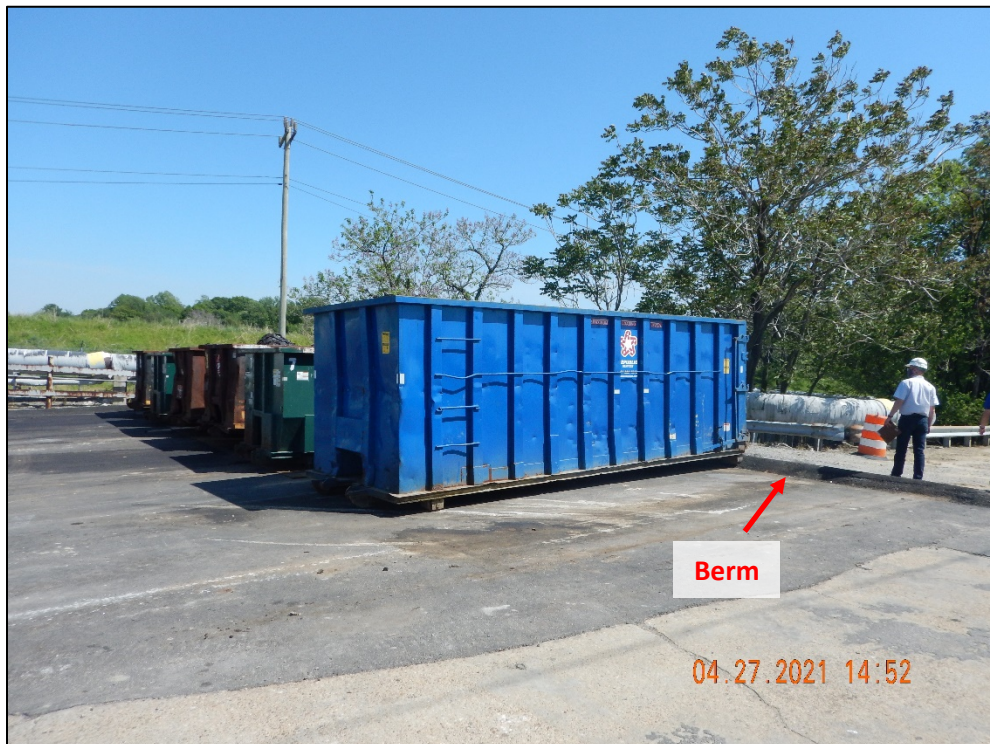
The EPA Inspection Team moved towards the southeast corner of the Facility and observed six dumpsters holding solid waste residue from the Facility's chemical processes (refer to [Appendix A, DSCN 2387](#)). The dumpsters were uncovered, but were located in an area that would drain to the process waste sewer system outfall. The DEQ representative stated that an earlier DEQ inspection found the dumpsters to be located in a position which could drain south into the stormwater Outfall 910 drainage area; however, the Facility had since installed a berm behind the dumpsters to prevent this. The EPA Inspection Team moved to the southeast corner of the facility and observed Outfall 910, which discharges to Gravelly Run (refer to [Appendix A, DSCN 2388](#)). Facility representatives stated that Outfall 910 receives stormwater drainage from a small area located south of the wastewater treatment lagoons. Outfall 910 consists of a wide ditch and contains no stormwater piping. The EPA Inspection Team moved northwest and observed the large clear water sewer system Outfall 001, which discharges to Gravelly Run (refer to [Appendix A, DSCN 2391](#)). Outfall 001 discharges contact and non-contact cooling river water at an average of 65 million gallons per day. Outfall 001 also drains stormwater from a majority of the Facility's process areas; however, Facility representatives stated that stormwater contributes a small fraction of the total flow. The EPA Inspection Team also observed stormwater Outfall 909 located approximately 25 feet downstream of Outfall 001 (refer to [Appendix A, DSCN 2393](#)). Outfall 909 discharges to Gravelly Run and receives stormwater flow from a single stormwater inlet in a small parking lot (refer to [Appendix A, DSCN 2394](#)). The EPA Inspection Team moved to the southwest and observed another small parking lot that drains to stormwater Outfall 908 (refer to [Appendix A, DSCN 2397](#) and [DSCN 2396](#)).

**DSCN2386.** View, facing southeast, of six uncovered dumpsters holding solid process waste. A berm had been installed behind the dumpsters to prevent runoff from reaching Outfall 910.
