**Subj:** Inspection Report  
Clean Water Act - National Pollutant Discharge Elimination  
System ("NPDES")  
New Bedford Regional Airport

- A. *Facility Name:* New Bedford Regional Airport
- B. *Facility Location:* 1569 Airport Rd.  
New Bedford, MA 02746
- C. *Facility Contacts:* Scot Servis, Airport Manager  
508-991-6161  
Scot.servis@newbedford-ma.gov
- D. *NPDES ID No(s):* MAR053159

- A. *Date(s) of inspection:* October 30, 2023
- B. *Weather Conditions:* 55 °F, Rain the morning of the inspection.
- C. *US EPA Representative(s):*  
Alex Rosenberg, Nafisah Ali, Damian Bednarz, and Anna Hatke
- D. *Federally Enforceable Requirements Covered During the Inspection:*  
National Pollutant Discharge Elimination System Multi-Sector General Permit  
(40 C.F.R. § 122.26), Oil Pollution Prevention regulations (40 CFR Part 112).

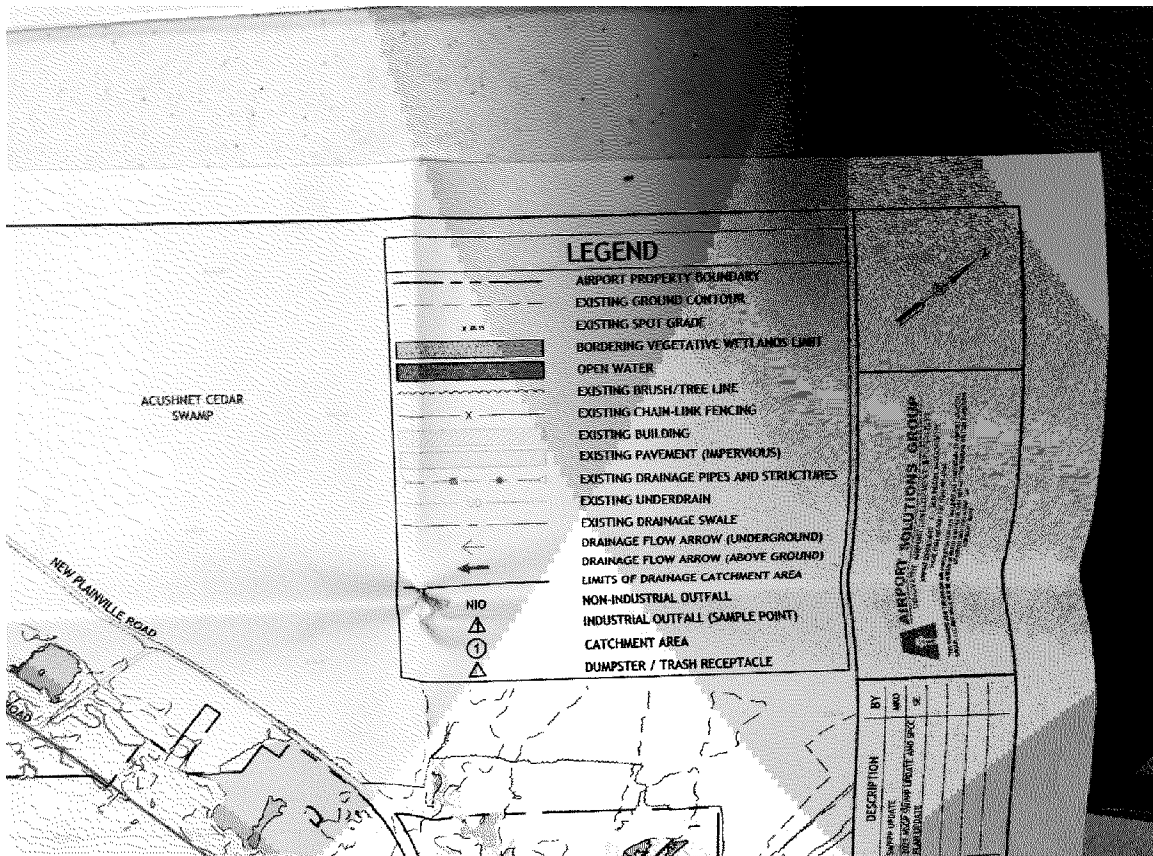
Photo 2 – SWPPP Diagram Legend

Inspectors reviewed the SWPPP which included taking photos of portions of the site diagram (see below). Inspectors noted that the SWPPP was updated for the 2021 MSGP permit reissuance. However, the site map needs updating.
