## Region 6 - Enforcement & Compliance Assurance Division

### INSPECTION REPORT

| Company Name: | CapturePoint, LLC | |
| Facility Name: | North Burbank Unit (NBU) 31 Battery | |

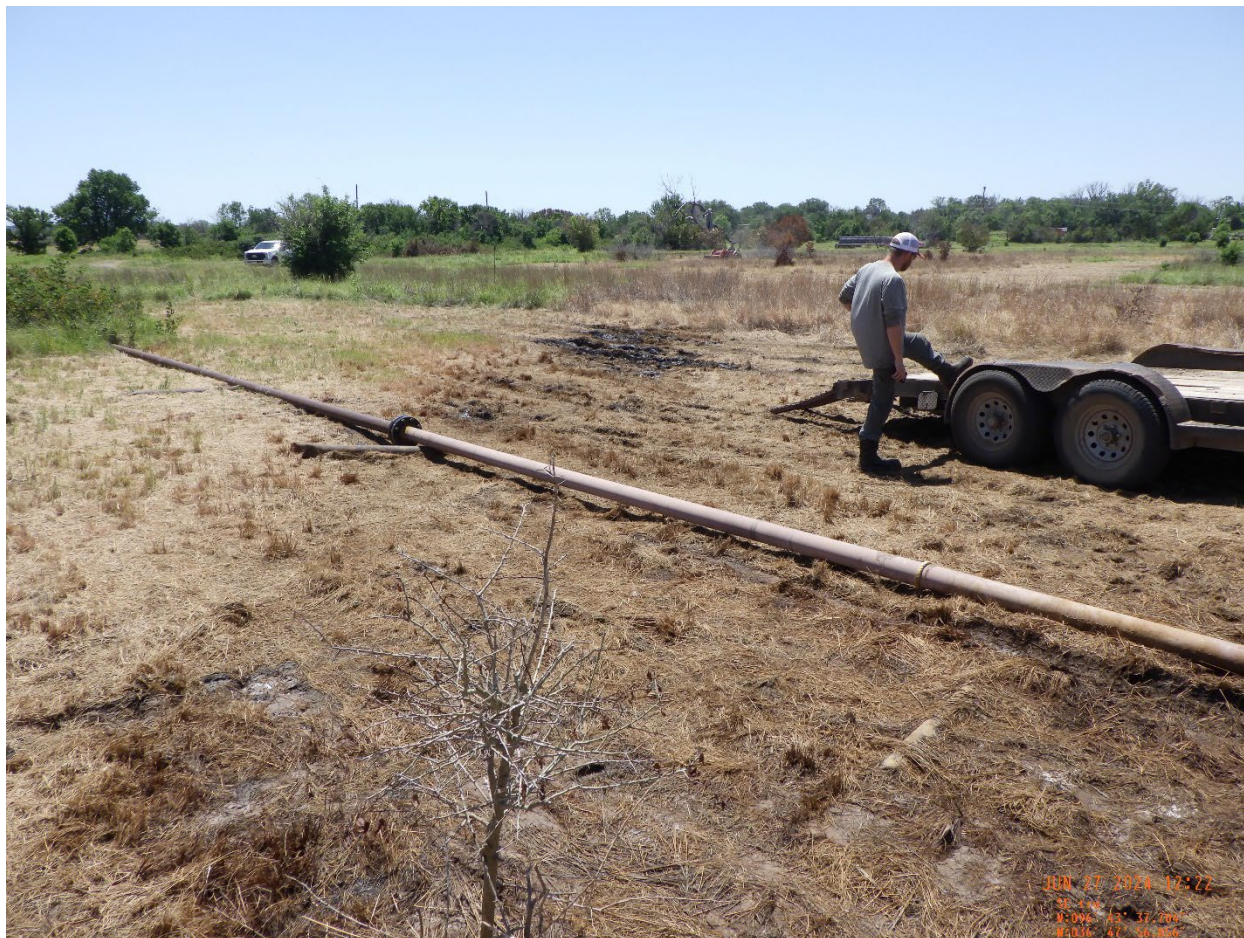
Photo No. 1

I observed the release point of the spill. At the same location, I observed brine impacted soil and vegetation. Spill impacts migrated southeast from the release point, across pastureland. I observed men and equipment performing cleanup and remediation efforts near the release point of the spill. See photo No. 1 in Appendix 1 (photo log). For additional location information and photo metadata, see Appendix 1.

**Description:** This was the release point of the spill. At the time of the inspection, the equipment failure that caused the leak had been repaired. Dead grass and brine impacted soil were observed at the location. Spill impacts migrated SE and E across pastureland.

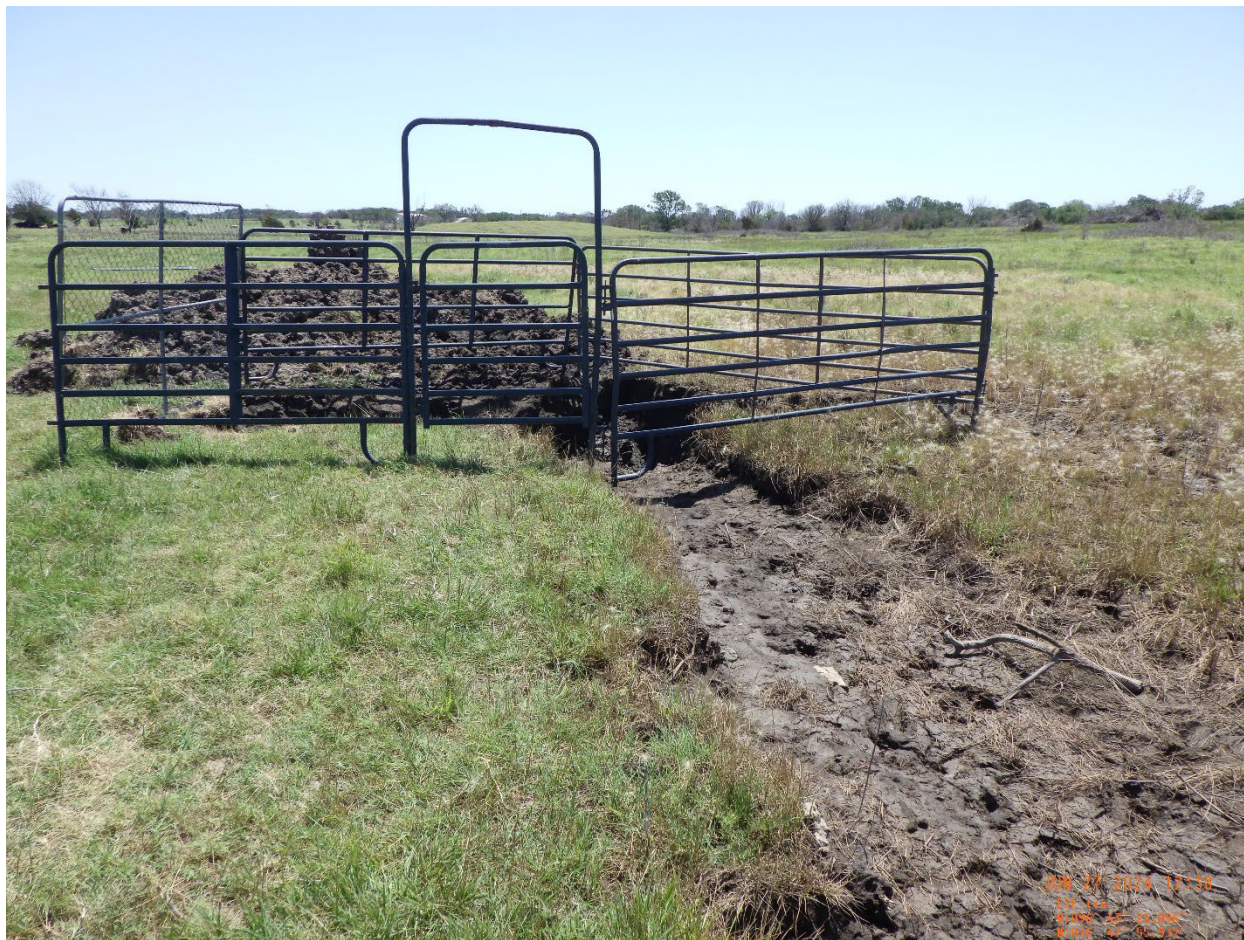
Photo No. 2

I observed the end point of the spill, which was a low point in the pastureland approximately ¼ mile southeast from the release point. At the same location, the operator had dug a catch pit to collect impacted waters for removal. At the time of the inspection, all pooled water along the flowpath had been removed. See photo No. 2.

**Description:** This was the end point of the spill. The spill migrated across pastureland from the point of origin to a low point in the pasture. The operator had dug a catch pit to capture contaminated waters for removal.
