# Granite State Concrete Co. Inc

January 25, 2023

Inspector: Solanch Pastrana-Del Valle

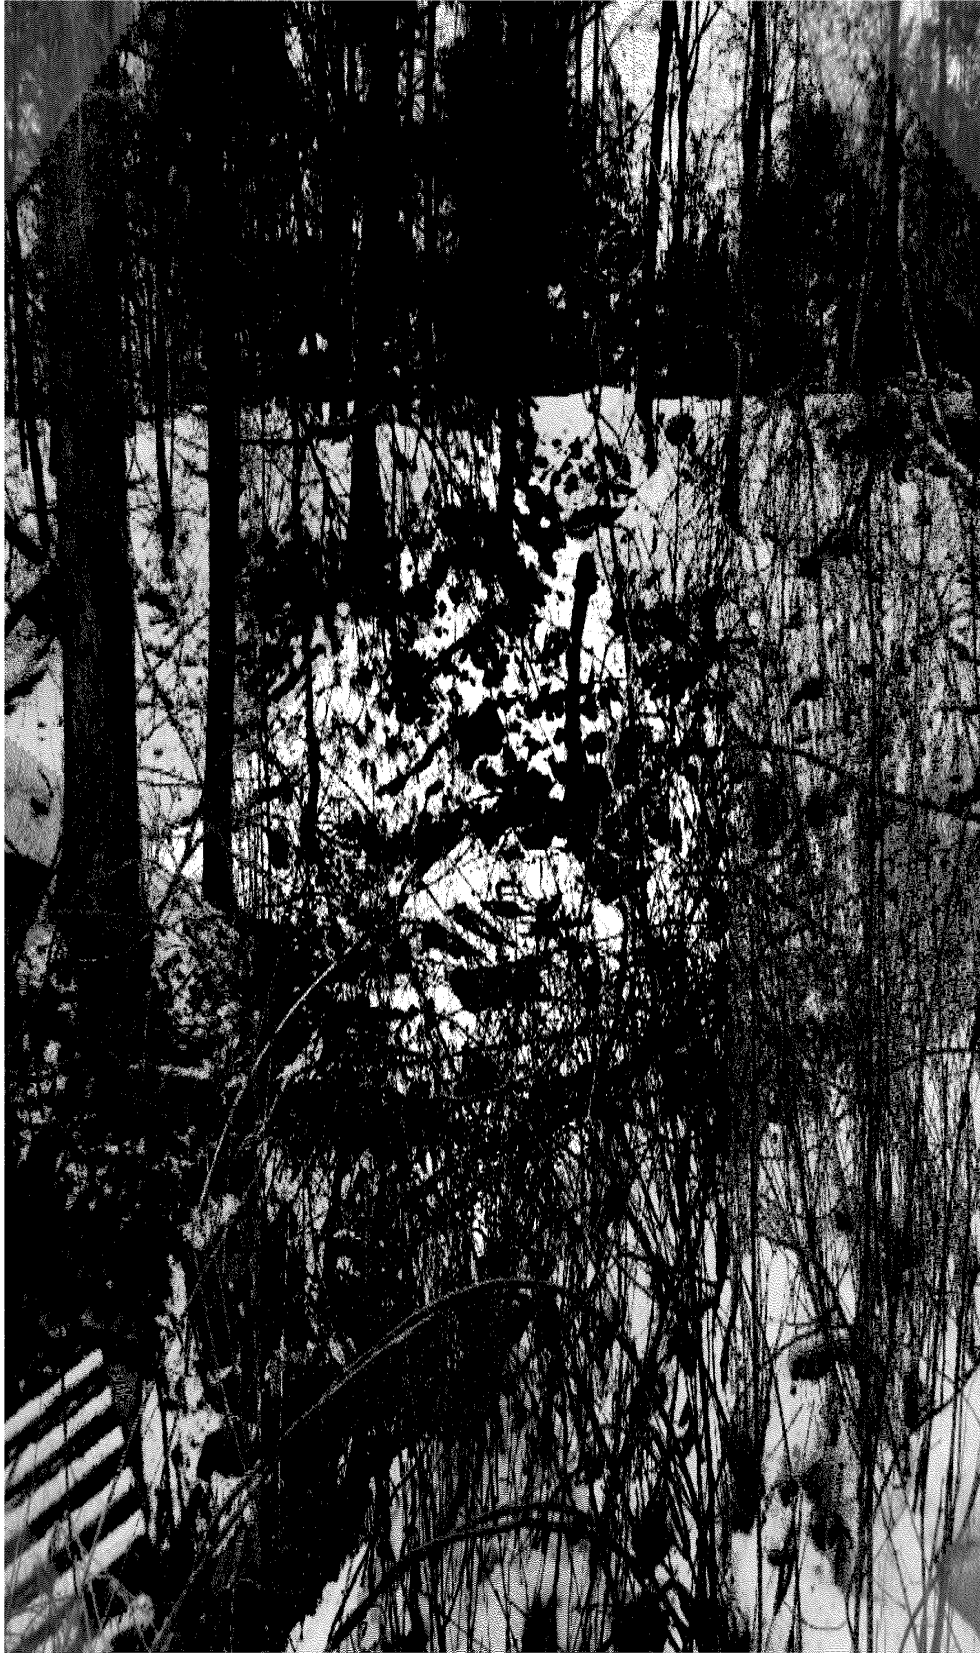
*Quarry water flows through here to Gilson Brook Pond*

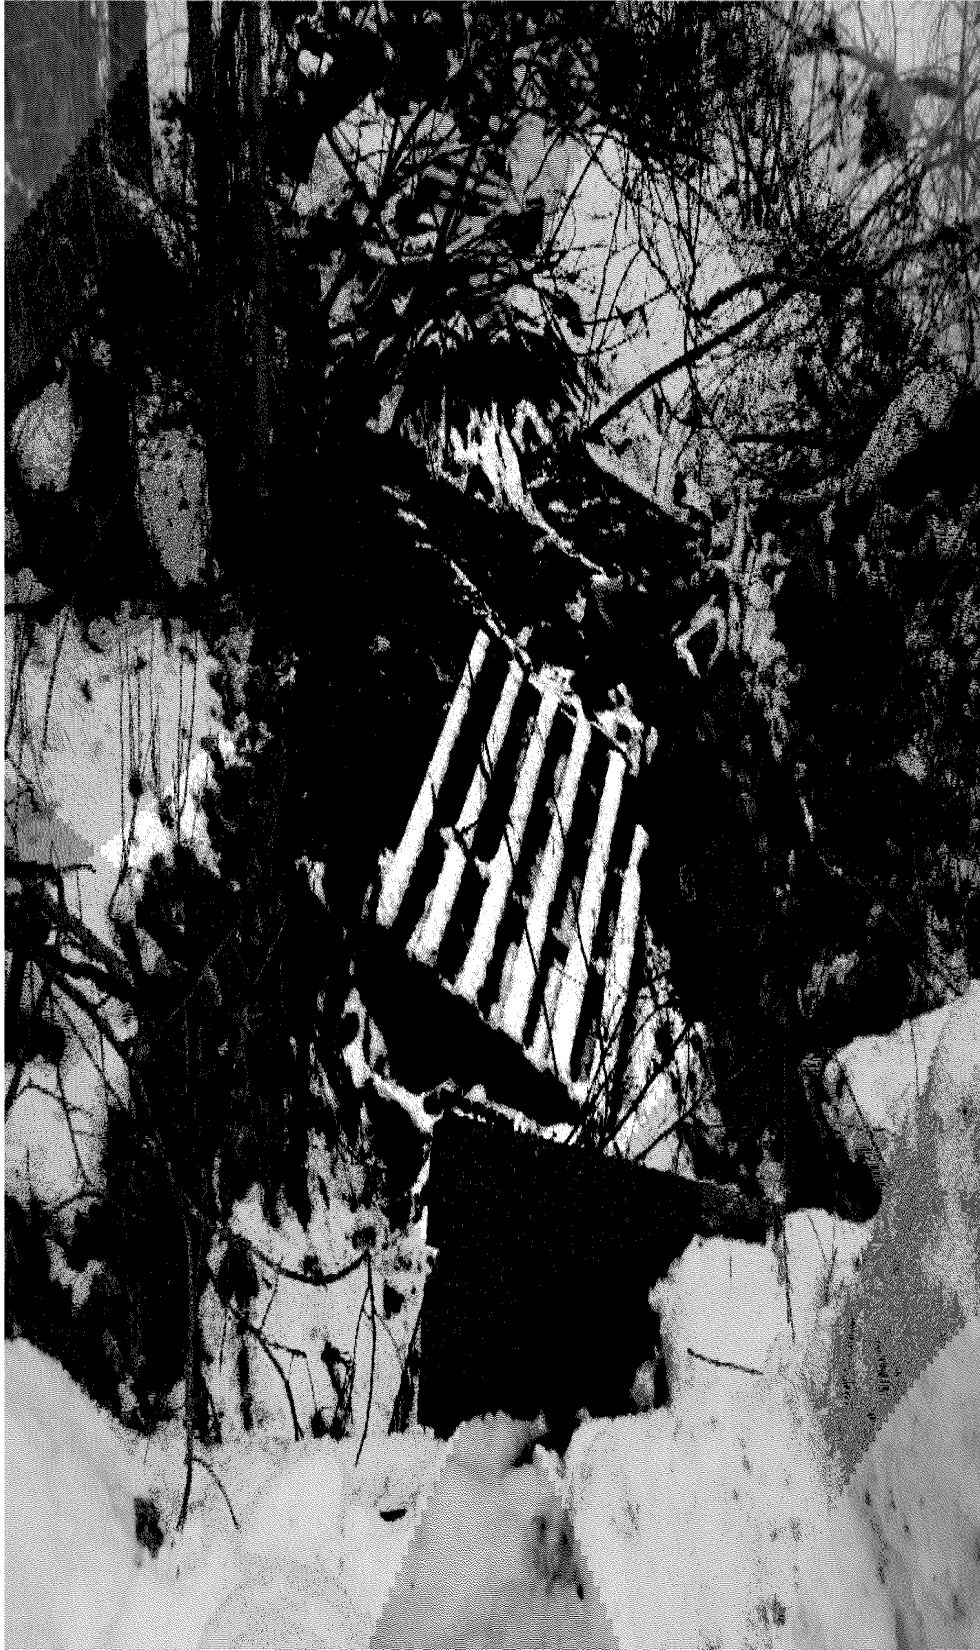
*Quarry water flows through here to Gilson Brook Pond*

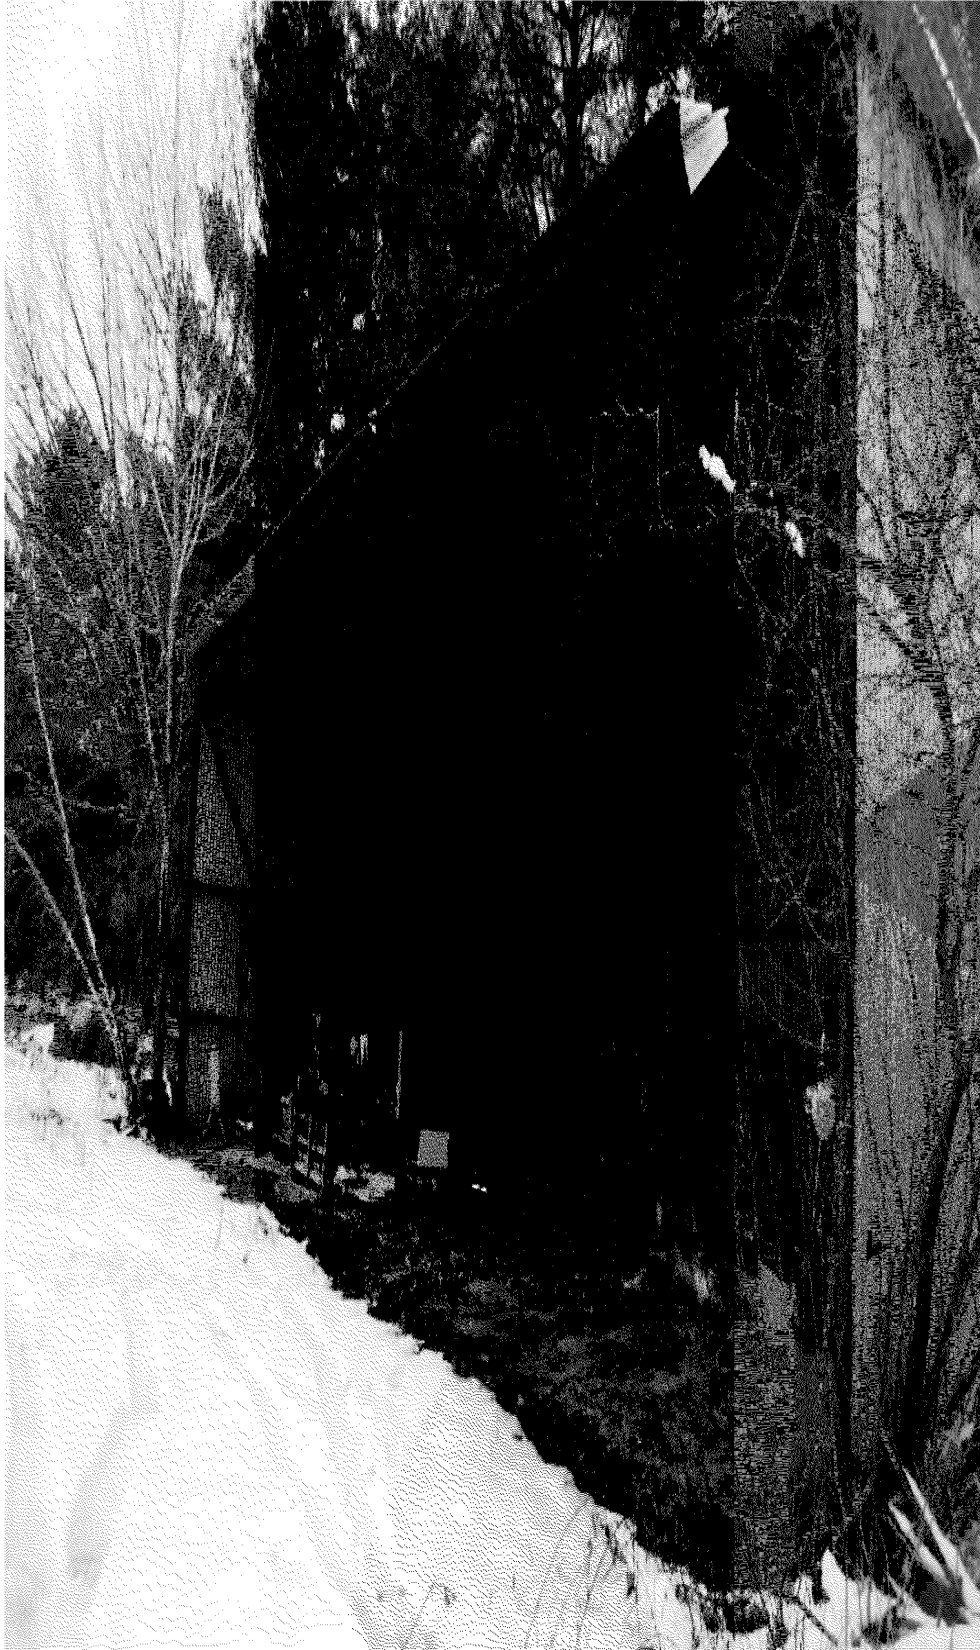
*Shed on open area next to Gilson Brook Pond*

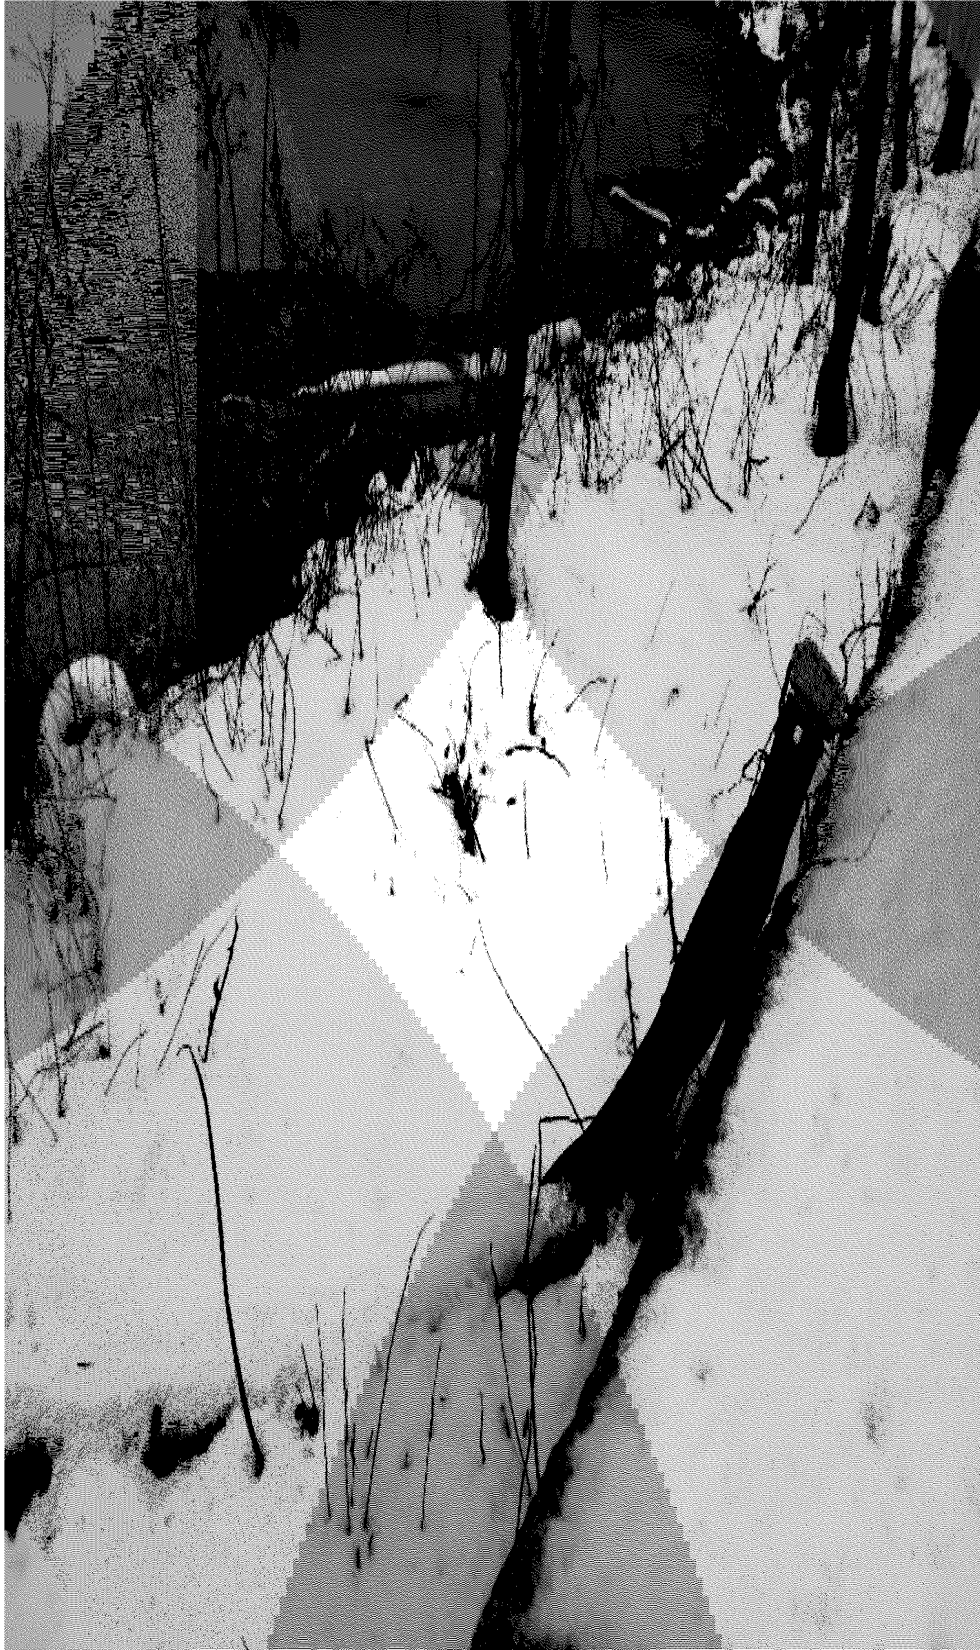
*Water intake from Gilson Brook Pond for Truck Water*

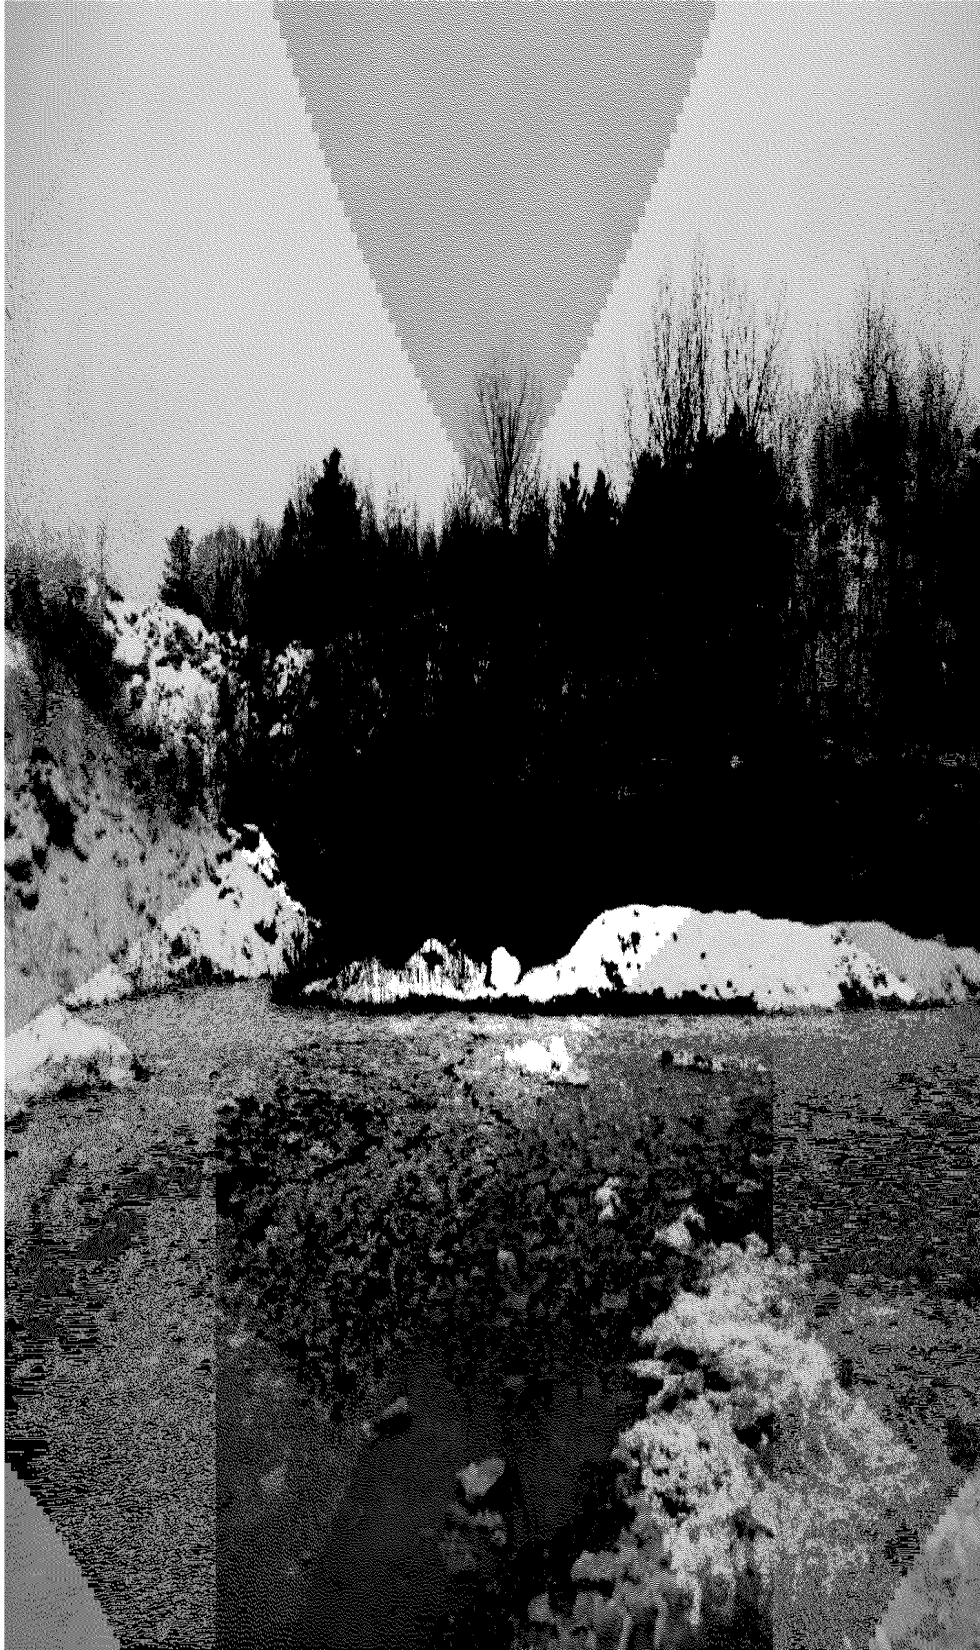
*Standing water near stone crushing operations*

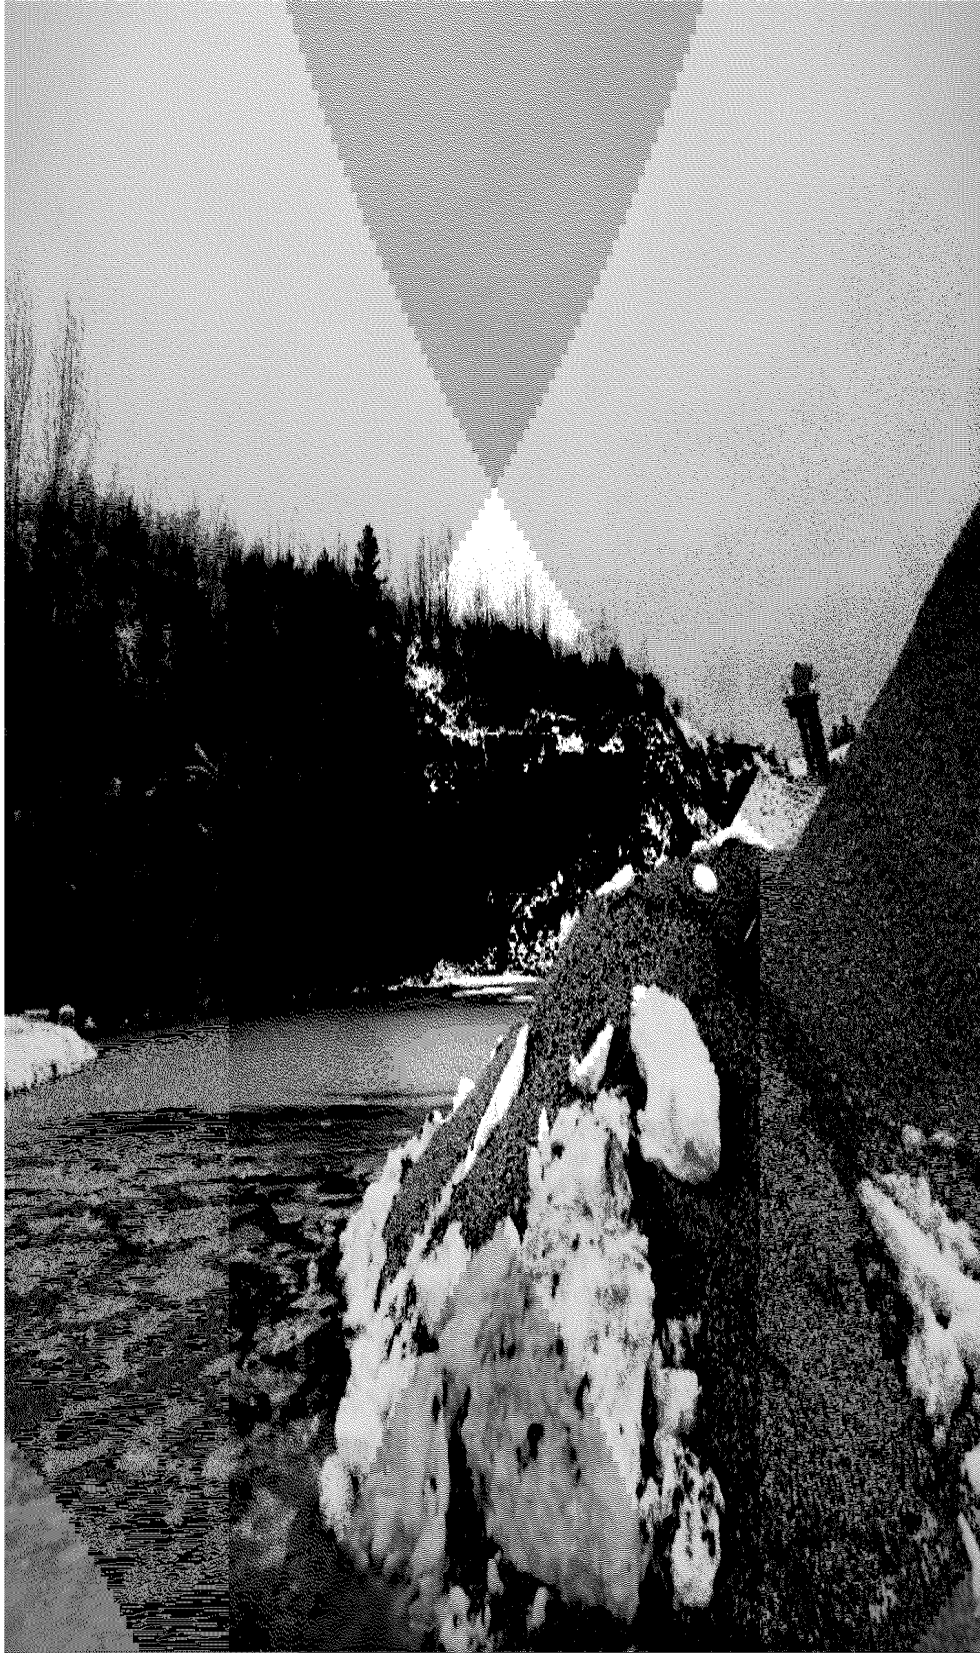
*Standing water near stone crushing operations*

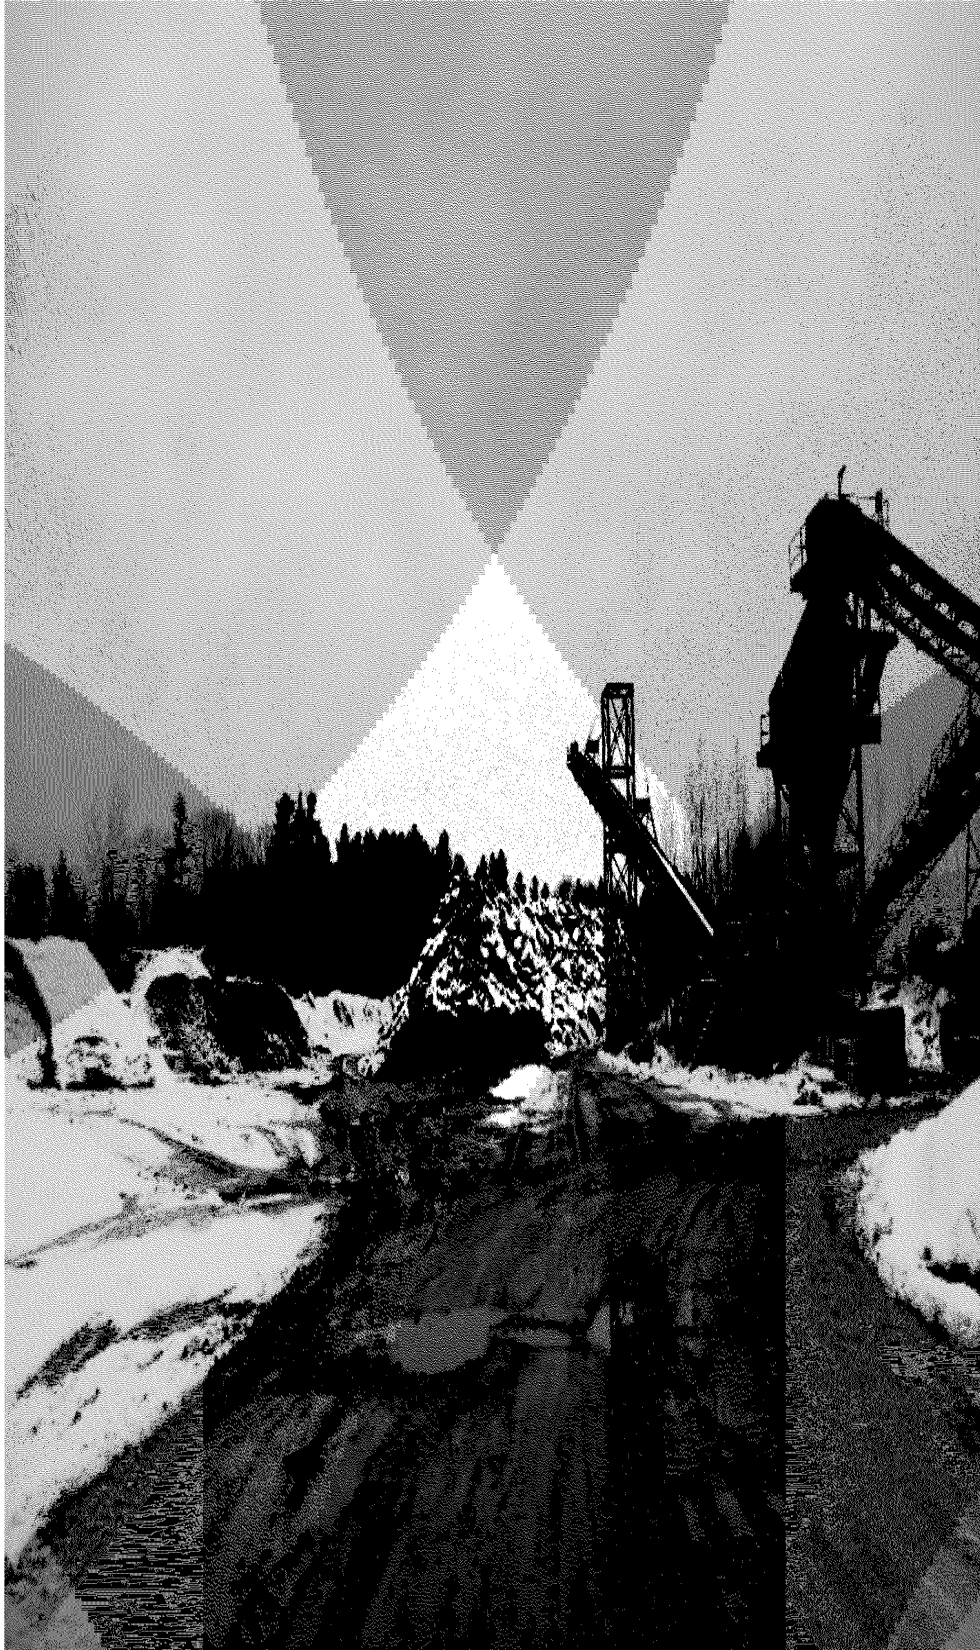
*Water flows to stormwater outfall 001 thru wetland (see next slide)*

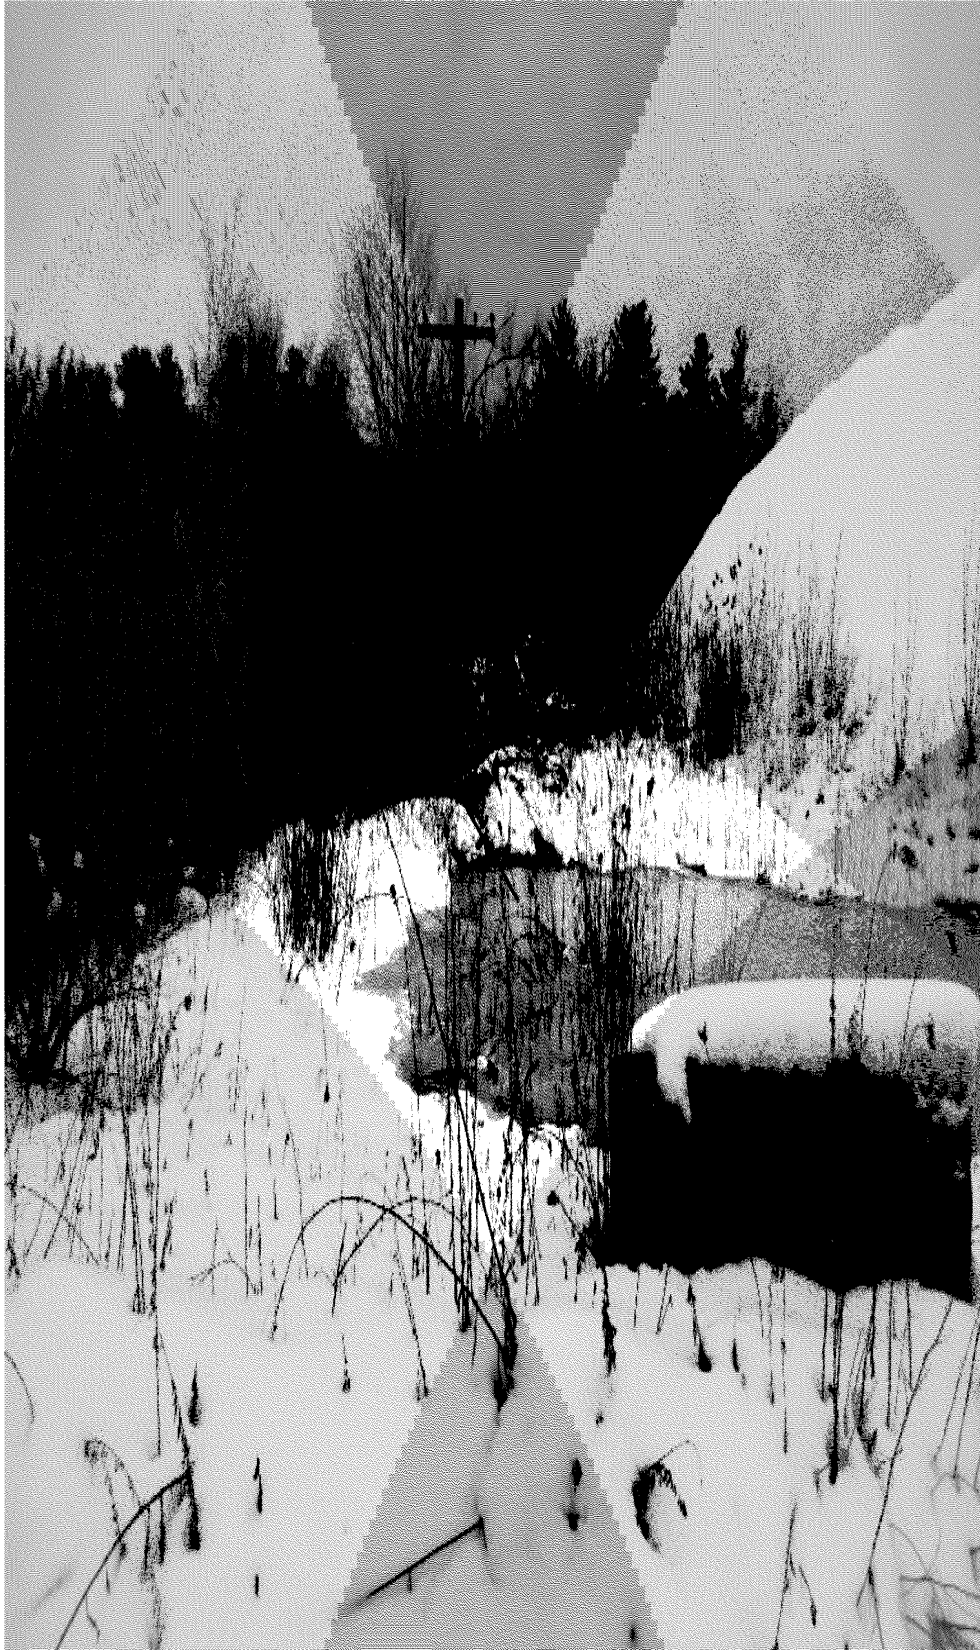
*Water flows to stormwater outfall 001*

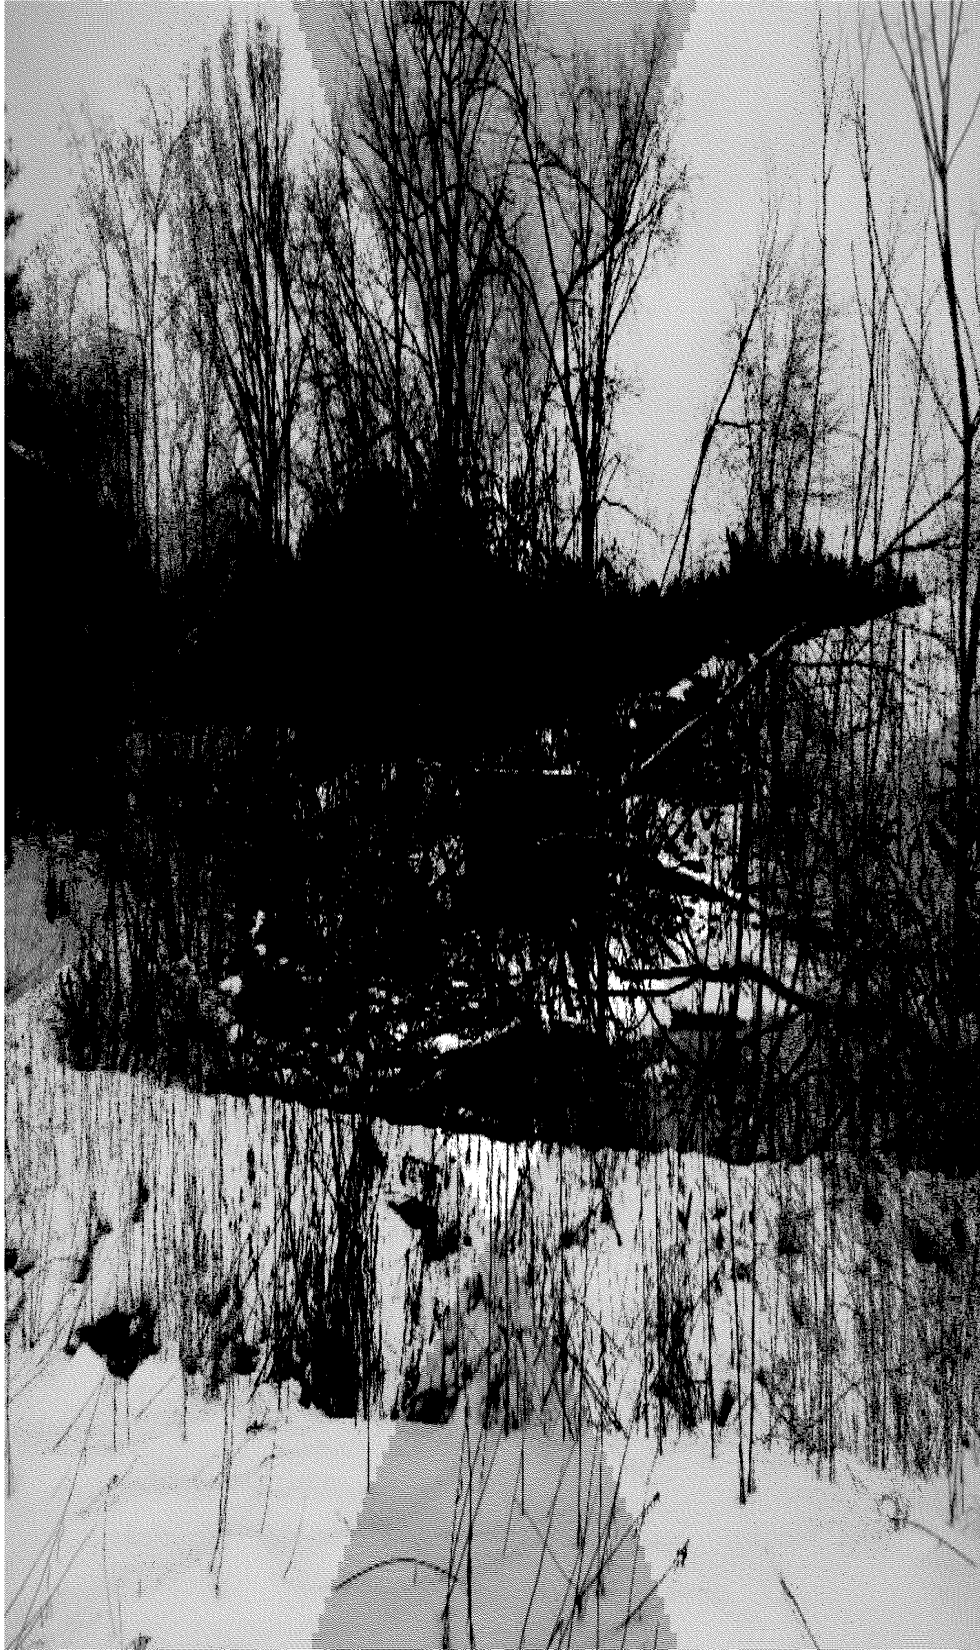
*Stormwater outfall 001 to Gilson Brook Pond*

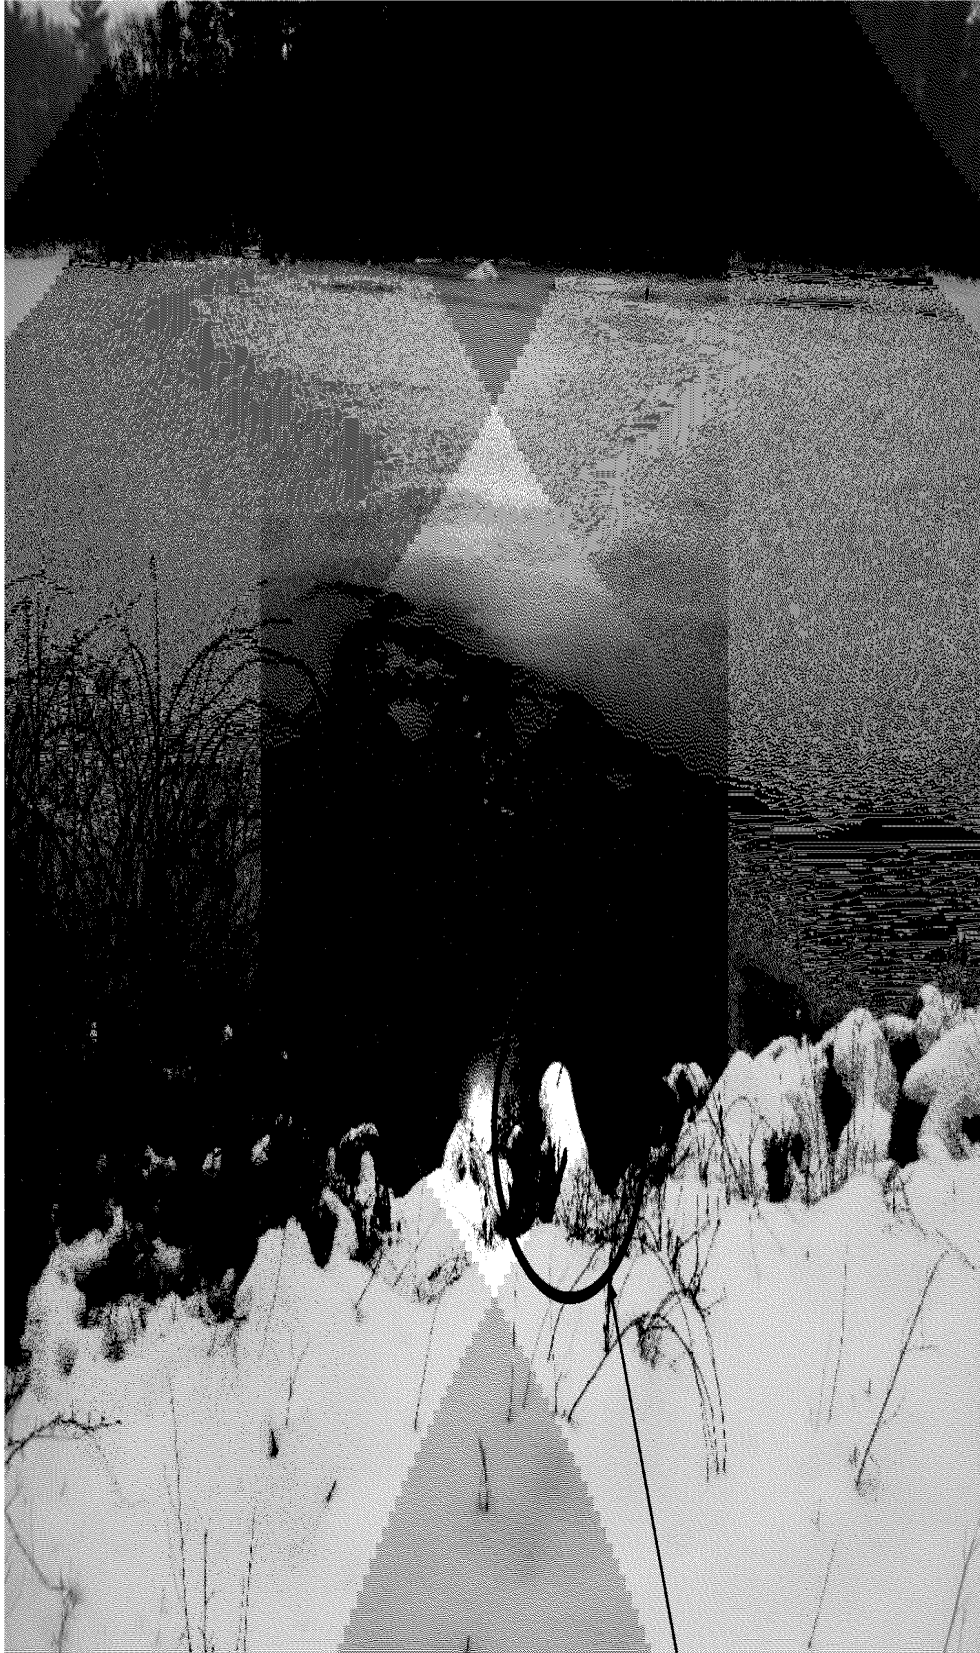
*Culvert with running water from unknown source*
