**Region 6 Compliance Assurance and Enforcement Division  
INSPECTION REPORT**

| Inspection Date(s): | 07/18/2017 | | |
| Company Name: | Farrell Cooper Mining Company | | |
| Facility Name: | Brazil Creek Minerals - Shady Point Mine | | |

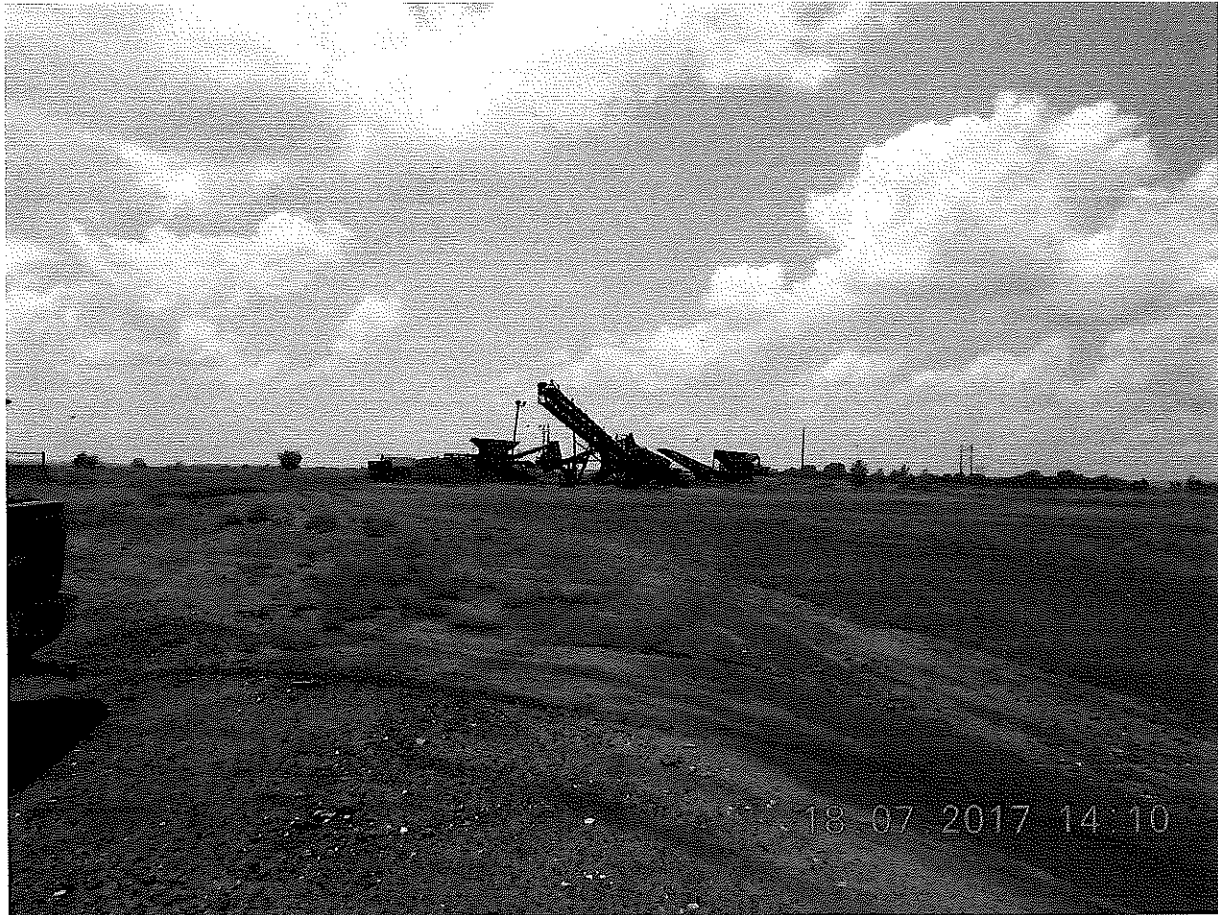
Photo File Name: DSCN0019

Description: Coal loading area for the Shady Point Mine

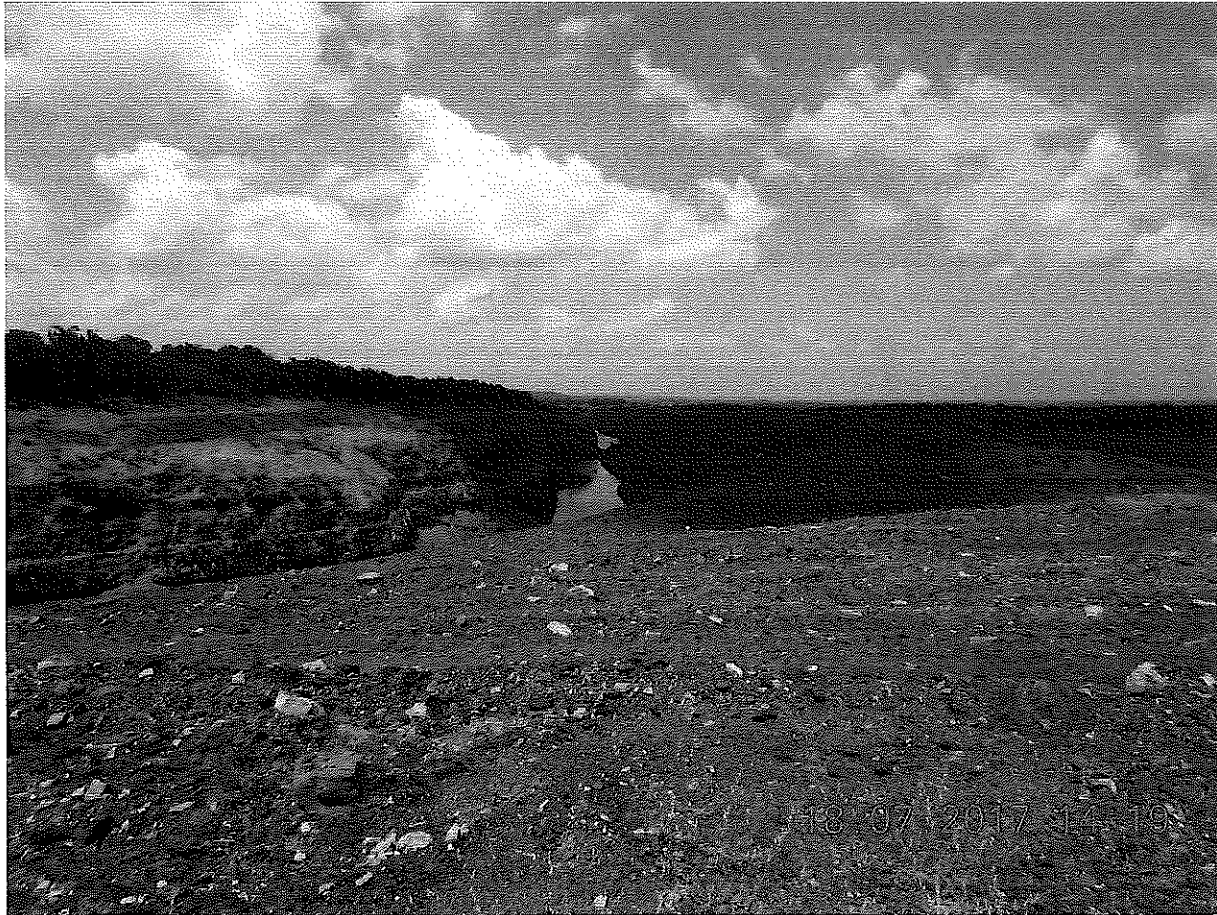
Photo File Name: DSCN0022

Description: Coal excavation area for the Shady Point Mine
