**Report Title:** Clean Water Act, Section 404 Inspection Report for Paul Goodwin Site  
**Inspection Date(s):** 07/17/2024  
**Start Time:** 09:10 **End Time:** 11:05  
**Regulatory Program(s):** Inspections authorized pursuant to Clean Water Act, Sections 308 and 404 (33 U.S.C. §§ 1318 and 1344)  
**Site Name:** Paul Goodwin  
**Site Location:** Near Dixie Winds Lane  
Bremo Bluff, VA 23022  
**Latitude:** 37.739458 **Longitude:** -78.2234262  
**County/Parish:** Fluvanna County  
**Site Owner(s):** Christopher Lacy  
**Mailing Address:** 115 Carriage Hill Road  
Palmyra, Virginia 22974

**DSB-ID #:** ECAD-5512

On July 17, 2024, the U.S. Environmental Protection Agency (“EPA”) conducted an inspection for compliance with Section 404 of the Clean Water Act pertaining to an Administrative Order on Consent (“Order”, EPA Docket # CWA-03-2022-0039DW). The inspection was conducted as part of injunctive relief monitoring of the aquatic resource restoration activities required by paragraph 17 of the Order. On January 11, 2023, EPA issued a letter approving the Restoration and Mitigation Plan (“RMP”), prepared for Mr. Paul Goodwin by Wetland Studies and Solutions, Inc (“WSSI”).

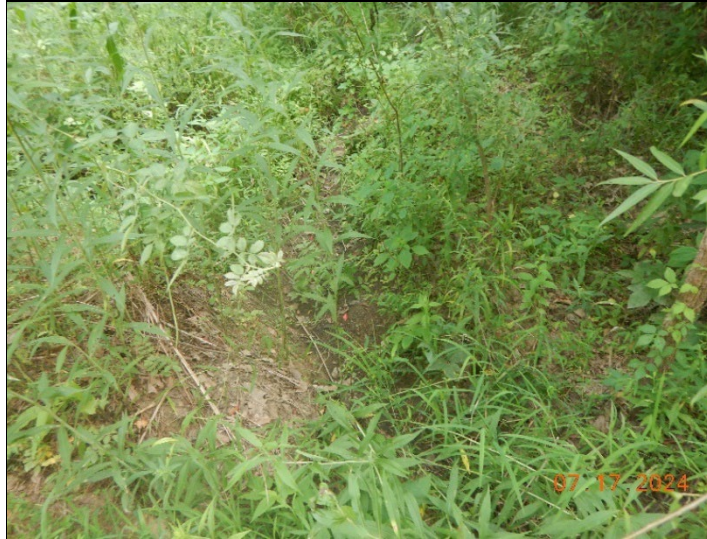
Paul Goodwin  
Date: 17 July 2024  
Photo ID: DSCN5483.JPG  
Photo taken by: Laura Mathew

Following opening conference, the inspection began at culvert 1A near the northeastern portion of the restoration area. The inspectors did not observe any flow through culvert 1A (**Attachment 2** – Photographic Log; DSCN5483 to DSCN5485). The inspectors then moved to the west to culvert 1B. Water was present in UNT1 upstream of the culvert (DSCN5486 and DSCN5487). Mr. Lacy stated that the culvert was recently replaced with a 36-inch pipe and the outfall area was recently regraded. Water and vegetation were not present in the outfall of the culvert at the time of the inspection (DSCN5488 to DSCN5490). Additionally, there was not any evidence of stabilization measures such as matting or seeding of the denuded areas. The inspection team followed UNT1 to the southwest and documented its condition, which exhibited strong geomorphic characteristics including Ordinary High-Water Mark, deeply incised bed and banks with exposed roots of woody vegetation (DSCN5492-DSCN5494). Water was not flowing in UNT1 at the time of the inspection. The inspection team observed the confluence of UNT1 with South Creek (DSCN5495) and continued westward in the South Creek channel. At the time of inspection, South Creek possessed strong geomorphic characteristics including Ordinary High-Water Mark, bed and banks, and was flowing from west to east.

Notes: Inlet of existing culvert 1A.

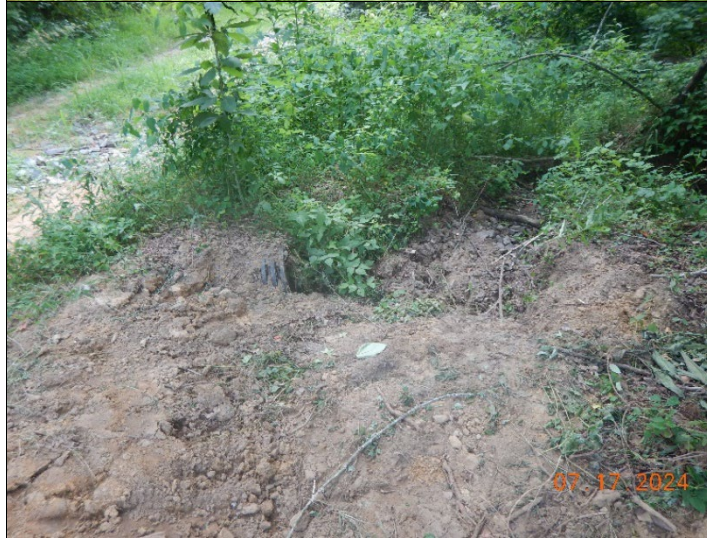
Paul Goodwin  
Date: 17 July 2024  
Photo ID: DSCN5484.JPG  
Photo taken by: Laura Mathew

Notes: Outlet of existing culvert 1A.

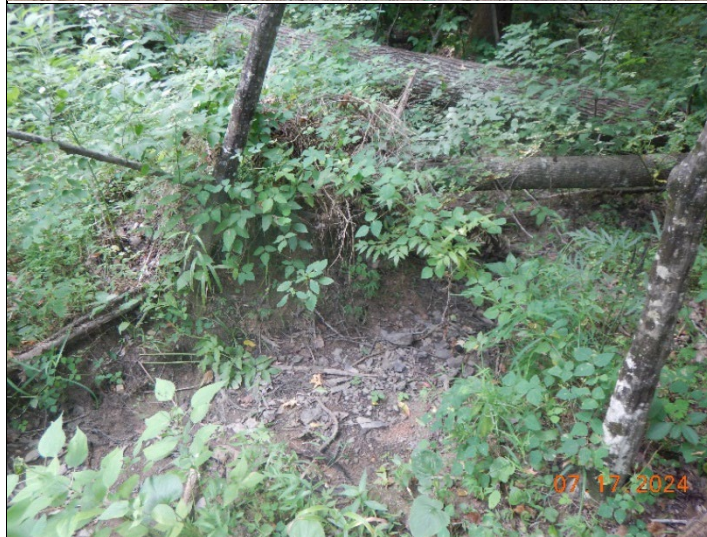
Paul Goodwin  
Date: 17 July 2024  
Photo ID: DSCN5485.JPG  
Photo taken by: Laura Mathew

Notes: Downstream view of culvert 1A.

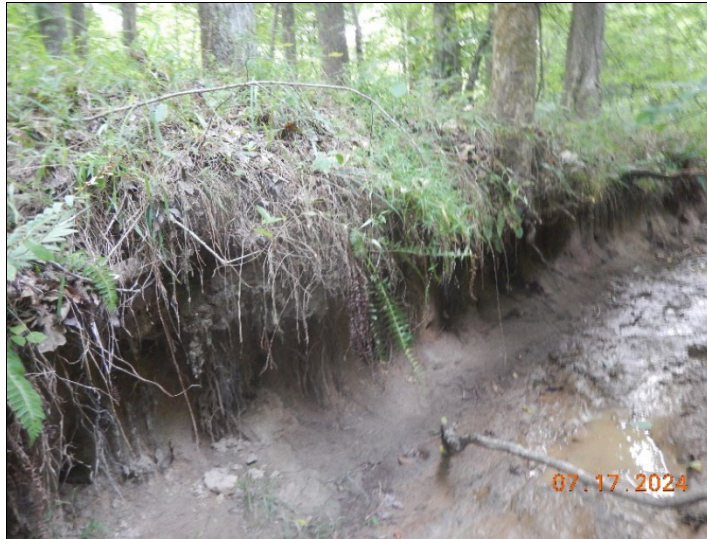
Paul Goodwin  
Date: 17 July 2024  
Photo ID: DSCN5493.JPG  
Photo taken by: Laura Mathew

Notes: View of the left bank of UNT1.  
Note the deeply incised bed and banks with exposed roots of woody vegetation.

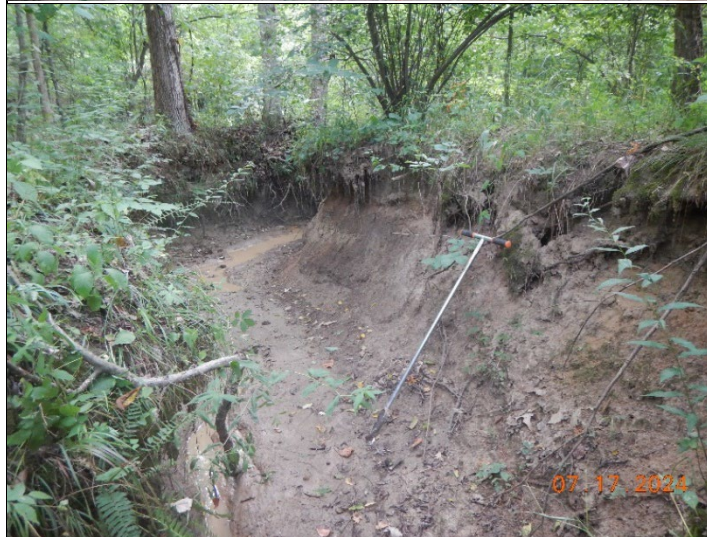
Paul Goodwin  
Date: 17 July 2024  
Photo ID: DSCN5494.JPG  
Photo taken by: Laura Mathew

Notes: Farther downstream in UNT1.  
Note the deeply incised bed and banks with exposed roots of woody vegetation.  
Dutch auger for scale.

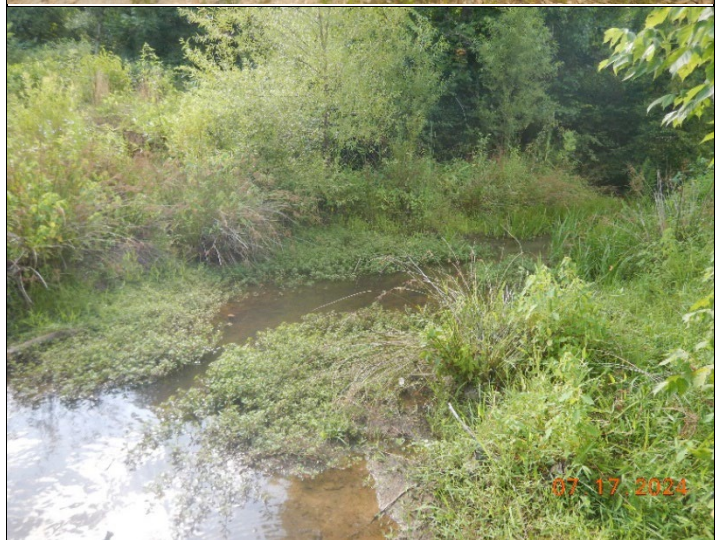
Paul Goodwin  
Date: 17 July 2024  
Photo ID: DSCN5505.JPG  
Photo taken by: Laura Mathew

and bed and banks that were generally stable and well vegetated (DSCN5505 and DSCN5506). Water was flowing in the stream at the time of the inspection at an approximate depth of 14 inches (DSCN5507 and DSCN5508). The inspection team continued to document South Creek. A proposed restoration condition of the Overall Restoration Plan (**Attachment 1**) included the placement of a log vane on the outer bank of South Creek for the purpose of stabilization. A log vane was not present at the time of inspection. The inspection team then proceeded upstream to the western confluence of South Creek with the ditch. The Planting Plan, provided as Sheet 9 of 13 in the RMP (**Attachment 3**), proposed the installation of sedge plugs and live stakes along the disturbed banks of South Creek. The inspection team did not observe any plugs or stakes along the banks.

Notes: Upstream view of South Creek.

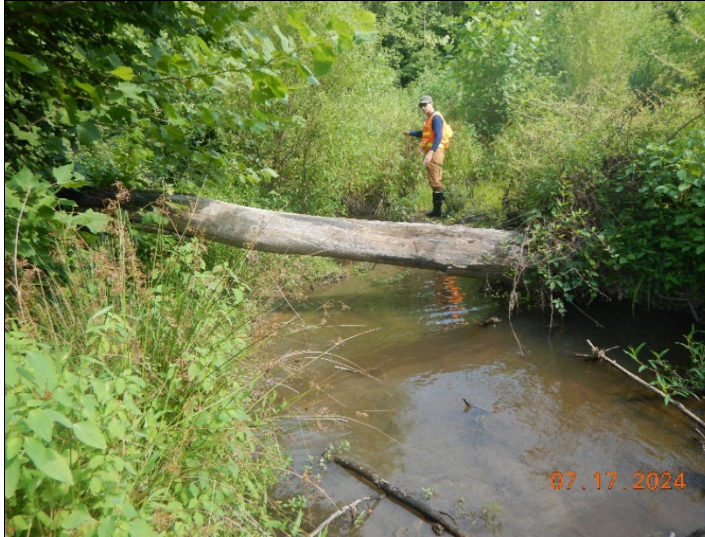
Paul Goodwin  
Date: 17 July 2024  
Photo ID: DSCN5506.JPG  
Photo taken by: Laura Mathew

Notes: Upstream view of South Creek with downed tree.

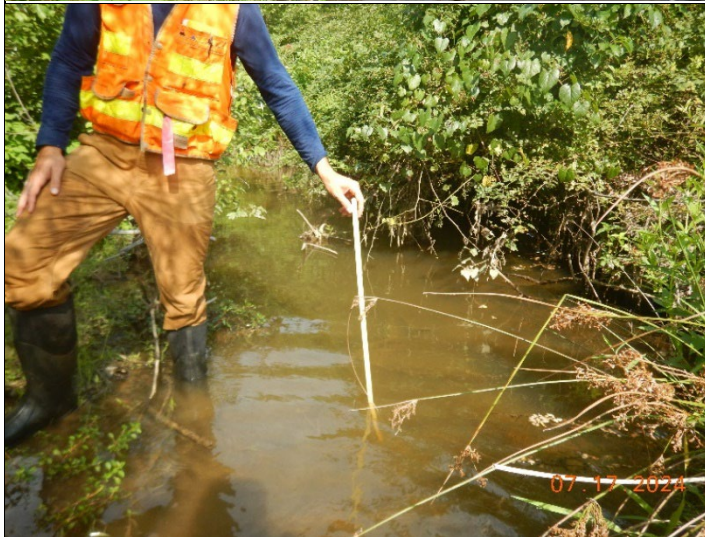
Paul Goodwin  
Date: 17 July 2024  
Photo ID: DSCN5507.JPG  
Photo taken by: Laura Mathew

Notes: Depth of South Creek at approximately 14 inches.

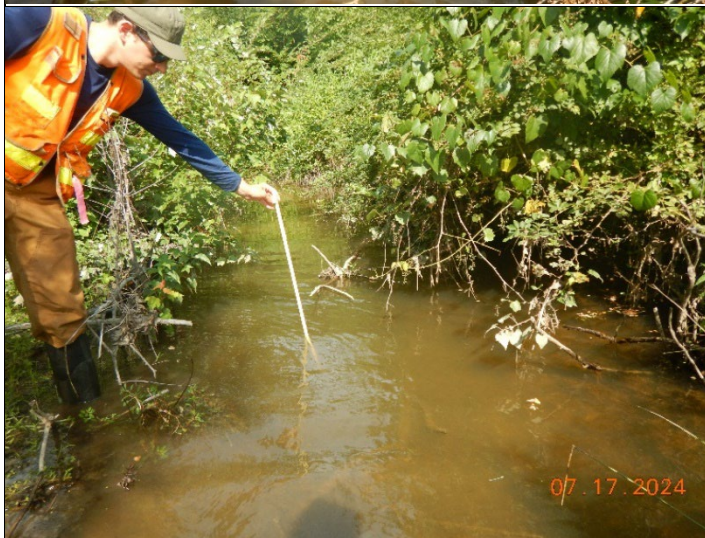
Paul Goodwin  
Date: 17 July 2024  
Photo ID: DSCN5508.JPG  
Photo taken by: Laura Mathew

Notes: Another view showing the depth of South Creek.

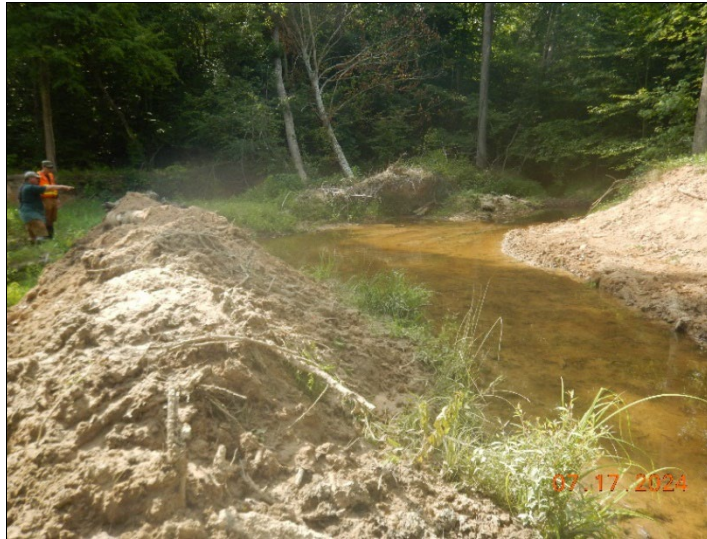
Paul Goodwin  
Date: 17 July 2024  
Photo ID: DSCN5509.JPG  
Photo taken by: Laura Mathew

Notes: Southward view of the western terminus of the ditch. In the foreground is a berm constructed of unconsolidated material which appeared to be excavated from the opposite bank.

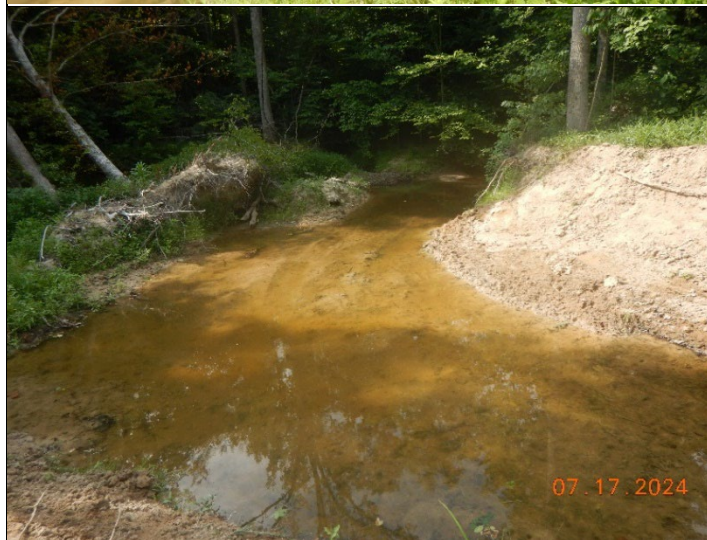
Paul Goodwin  
Date: 17 July 2024  
Photo ID: DSCN5511.JPG  
Photo taken by: Laura Mathew

The inspection team continued in the South Creek channel to the west and encountered the western terminus of the ditch (DSCN5512). A proposed restoration condition of the Overall Restoration Plan (**Attachment 1**) included the placement of root wads at the western terminus of the ditch. The root wads were not present at the time of the inspection. Rather, a berm comprised of unconsolidated fill material was observed blocking the flow from South Creek to the ditch (DSCN5509). The fill material that comprised the berm exhibited redoximorphic features and appeared to be sourced from the opposite bank (DSCN5511, DSCN5513 to DSCN5516, and DSCN5522). Stabilization measures, such as matting or seeding were not present on the newly constructed berm or the on the opposite bank which was denuded. Upended trees with exposed roots were also observed to the south (DSCN5511 and DSCN5521).

Notes: Southward view of South Creek to the west of the ditch. Note the uprooted trees in the background.

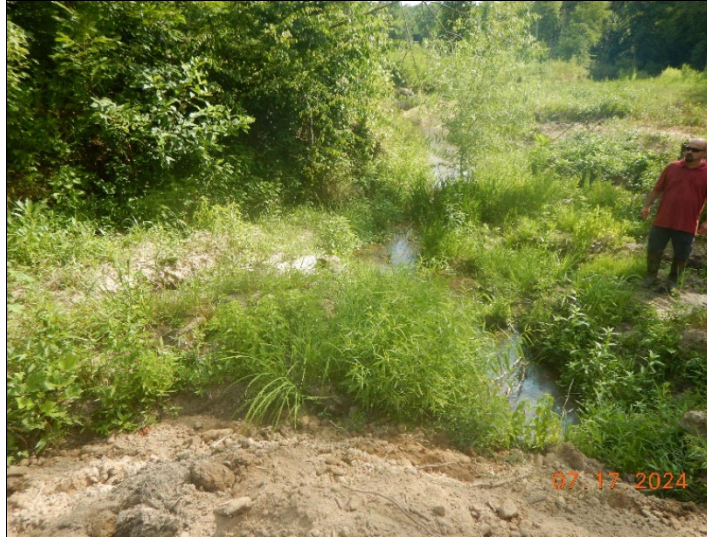
Paul Goodwin  
Date: 17 July 2024  
Photo ID: DSCN5512.JPG  
Photo taken by: Laura Mathew

Notes: Eastward view of the ditch behind the berm.

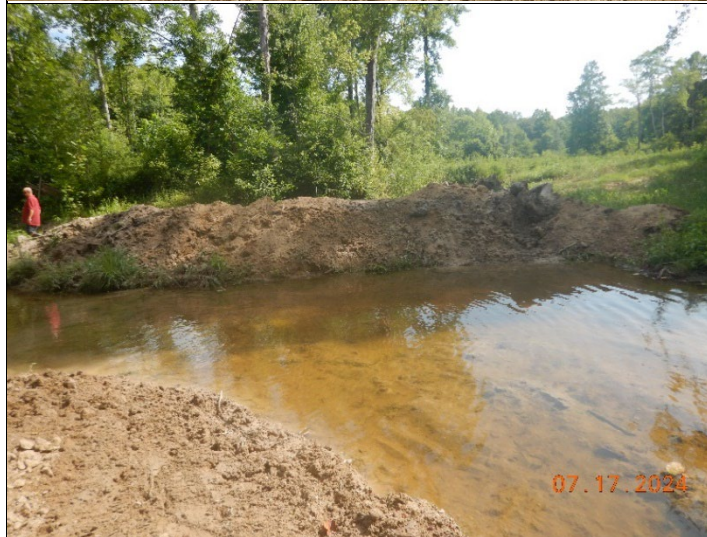
Paul Goodwin  
Date: 17 July 2024  
Photo ID: DSCN5514.JPG  
Photo taken by: Laura Mathew

Notes: Eastward view of the newly constructed berm.

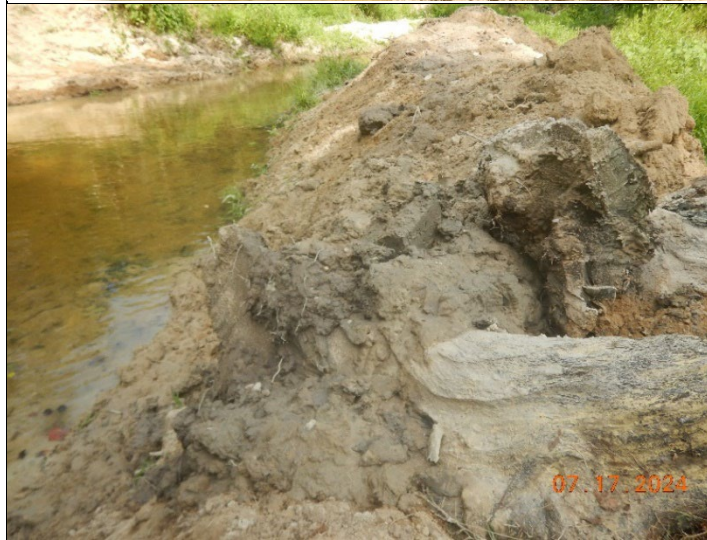
Paul Goodwin  
Date: 17 July 2024  
Photo ID: DSCN5516.JPG  
Photo taken by: Laura Mathew

Notes: Closeup view of the newly constructed berm.

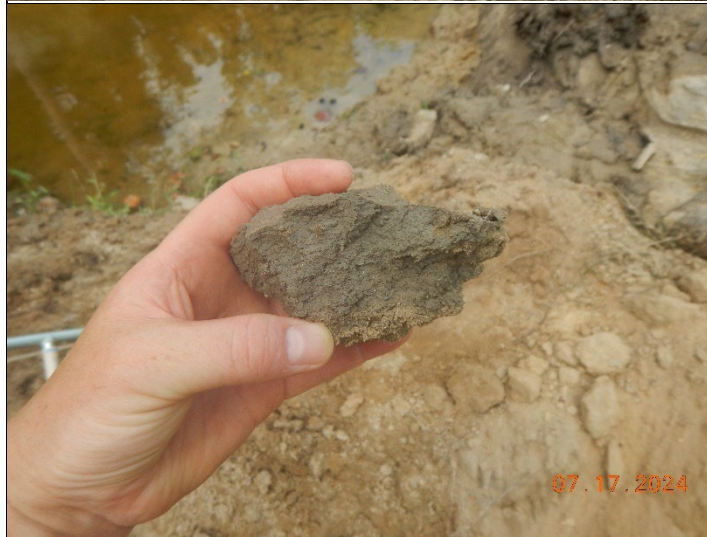
Paul Goodwin  
Date: 17 July 2024  
Photo ID: DSCN5518.JPG  
Photo taken by: Laura Mathew

Notes: Close up view of fill material comprising the berm. Note the reduced matrix and redoximorphic features.

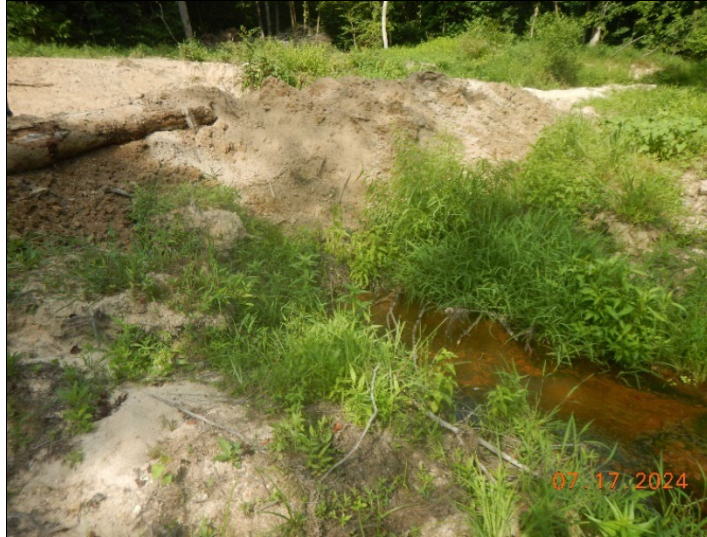
Paul Goodwin  
Date: 17 July 2024  
Photo ID: DSCN5519.JPG  
Photo taken by: Laura Mathew

The inspection team then moved to the east and documented the condition of the ditch immediately behind the berm. Water was present in the ditch at the time of the inspection (DSCN5519 and DSCN5520). Consistent with the observations made above regarding the eastern terminus of the ditch, the presence of water in the channel indicates active diversion of flow from South Creek through the ditch. A sheen of oxidized iron deposits was observed on the surface of the water (DSCN5526 and DSCN5527). Adjacent to the ditch were unstabilized slopes that were denuded and exhibited evidence of erosion (DSCN5523 and DSCN5524). The channel that had formed in the ditch was measured to be 9 inches deep by 77 inches wide (DSCN5525 and DSCN5526).

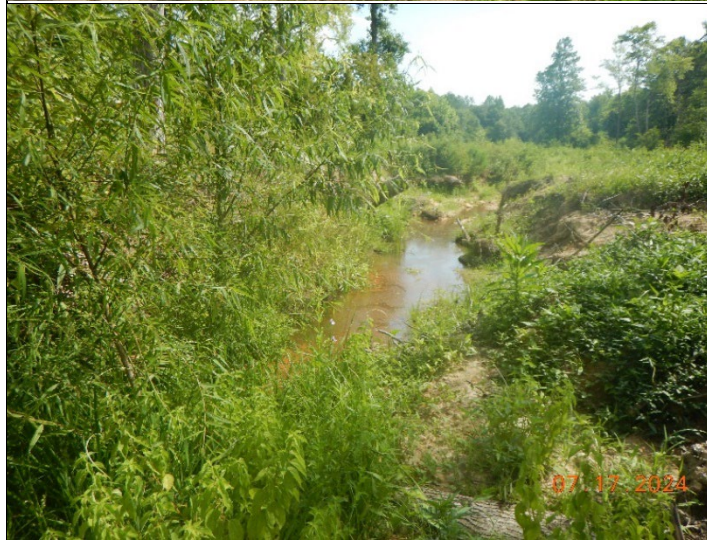
Paul Goodwin  
Date: 17 July 2024  
Photo ID: DSCN5520.JPG  
Photo taken by: Laura Mathew

Notes: Eastward view of the ditch behind the berm. Note the water in the background.

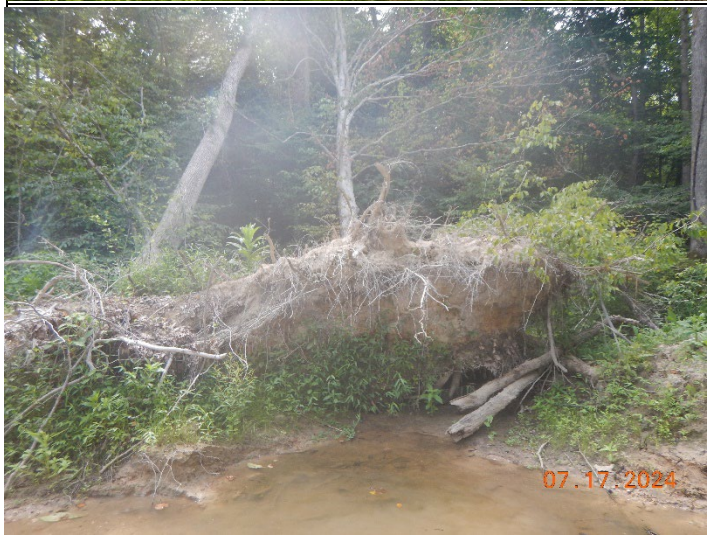
Paul Goodwin  
Date: 17 July 2024  
Photo ID: DSCN5521.JPG  
Photo taken by: Laura Mathew

Notes: View of the right bank of South Creek with upended trees and other vegetation.

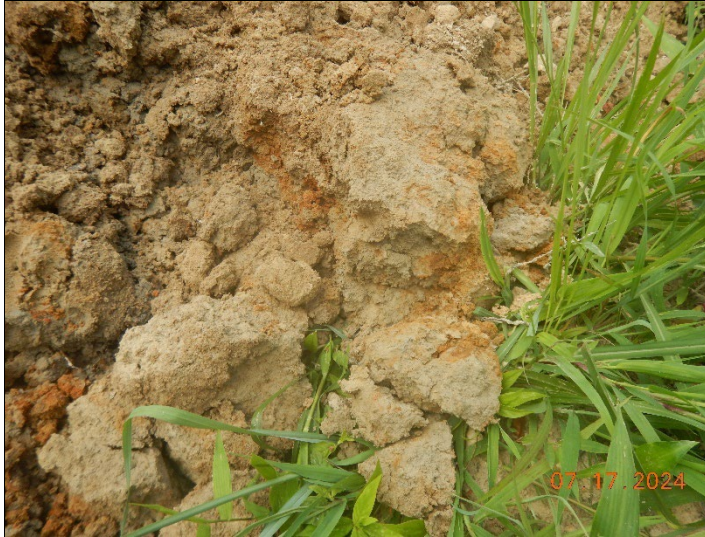
Paul Goodwin  
Date: 17 July 2024  
Photo ID: DSCN5522.JPG  
Photo taken by: Laura Mathew

Notes: View of depleted matrix and redoximorphic features in the unconsolidated material comprising the berm.

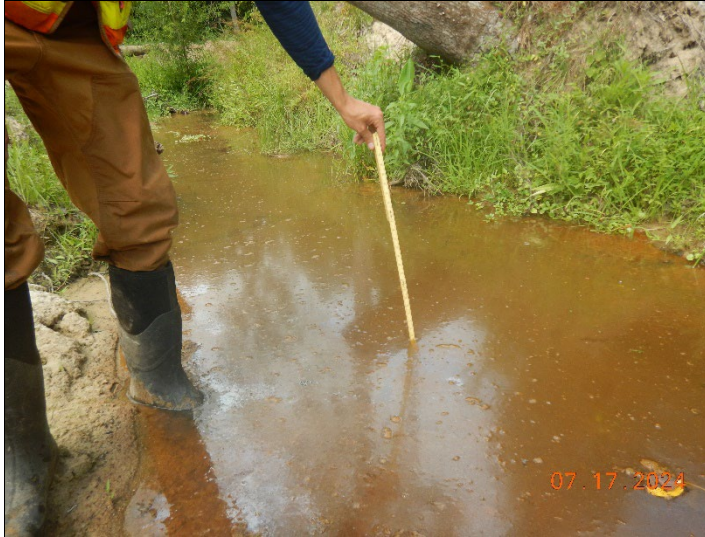
Photo ID: DSCN5525.JPG

Notes: Depth of the water measured at 9 inches.

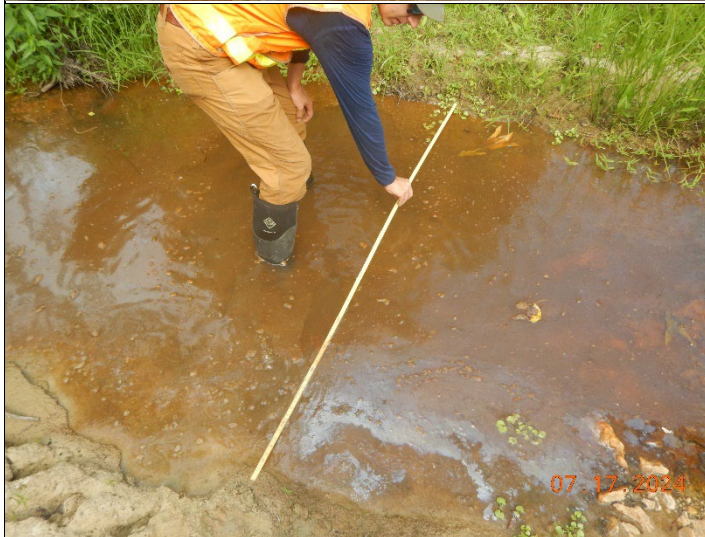
Photo ID: DSCN5526.JPG

Notes: Width of the ditch channel measured at 77 inches. Note the sheen of oxidized iron on the water surface in the foreground.

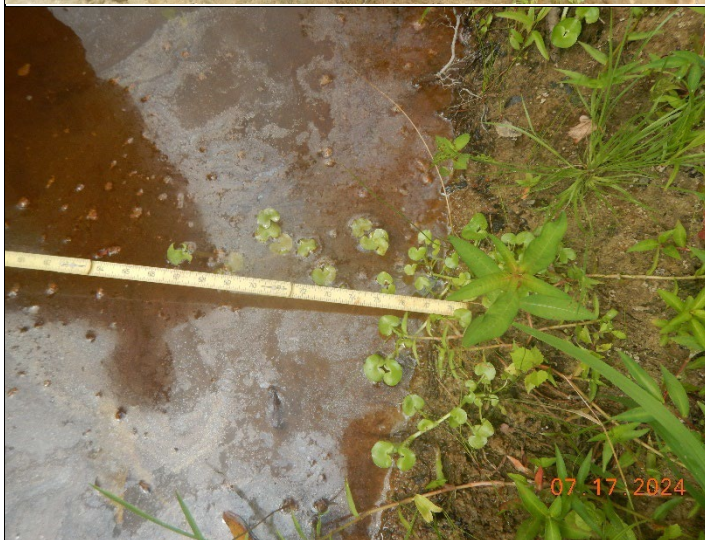
Photo ID: DSCN5527.JPG

Notes: Close up of the measurement of the width of the ditch channel. Sheen of oxidized iron on the water surface also visible.

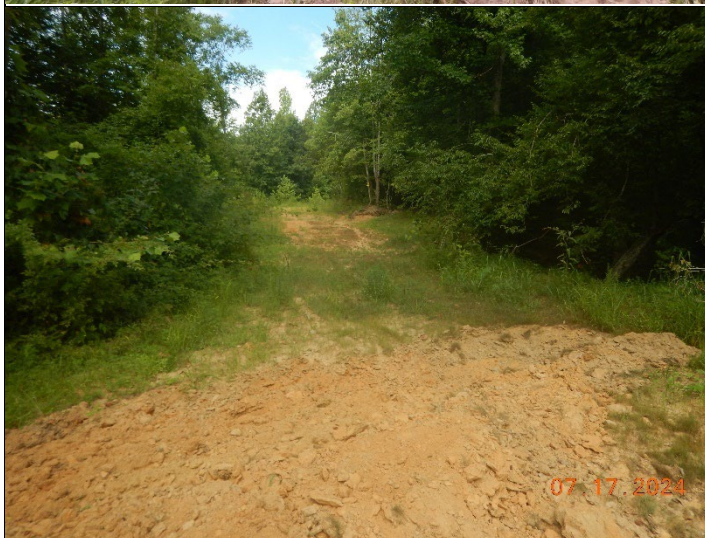
Paul Goodwin  
Date: 17 July 2024  
Photo ID: DSCN5530.JPG  
Photo taken by: Laura Mathew

The inspection then moved to the northwest along an access path and encountered UNT3. The access path leading to the west of UNT3 was sparsely vegetated at the time of the inspection and evidence of erosion was observed (DSCN5530 and DSCN5531). The inspection team documented that the culvert for UNT3 had been removed. Depressions left by a vehicle with an 8"-wide track were documented within the access road and through the reconstructed stream bed of UNT3 (DSCN5531 and DSCN5532). Water was flowing within the reconstructed channel of UNT3 at the time of the inspection (DSCN5533 to DSCN5535). In the upstream reach, evidence of erosion and sediment deposition was documented within UNT3, and the bed and banks of the channel were not clearly defined or stable. Further downstream, the stream banks appeared stable and were well vegetated (DSCN5536). A proposed restoration condition of the Sediment and Erosion Control Plan, provided as Sheet 6 of 13 of the RMP (**Attachment 4**), included the installation of sediment and erosion control measures including temporary stream crossings, stabilization matting, compost filter socks, mulching and seeding. Sediment and erosion control measures were not observed in this area. Evidence of stream crossings were documented without the requisite erosion controls (DSCN5531 and DSCN5532).

Notes: West facing view upgradient of where Dixie Winds Lane was extended beyond UNT3.

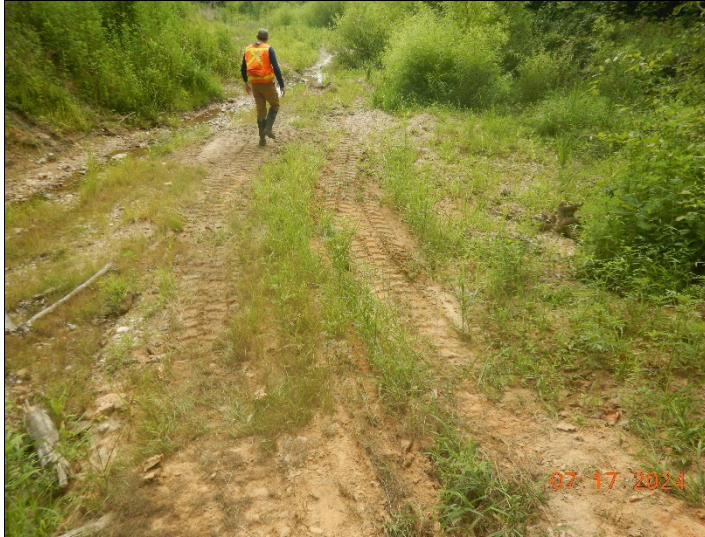
Paul Goodwin  
Date: 17 July 2024  
Photo ID: DSCN5531.JPG  
Photo taken by: Laura Mathew

Notes: East facing view of the former access road approaching UNT3.

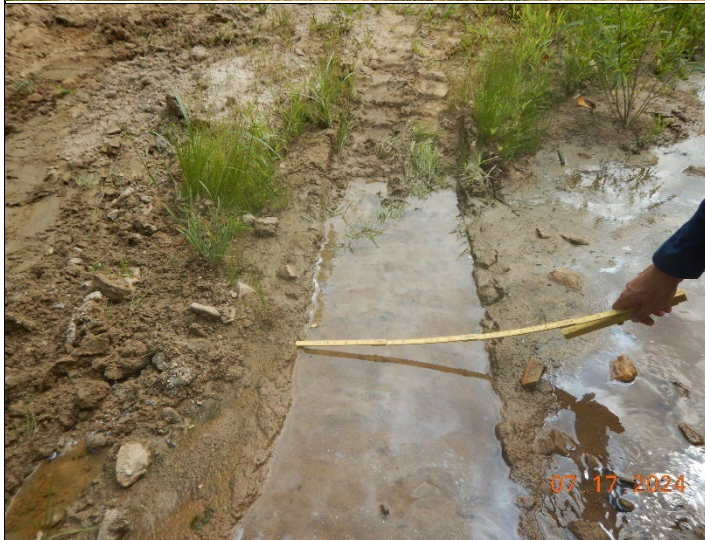
Paul Goodwin  
Date: 17 July 2024  
Photo ID: DSCN5532.JPG  
Photo taken by: Laura Mathew

Notes: View of an 8-inch depression from a tracked vehicle through UNT3.

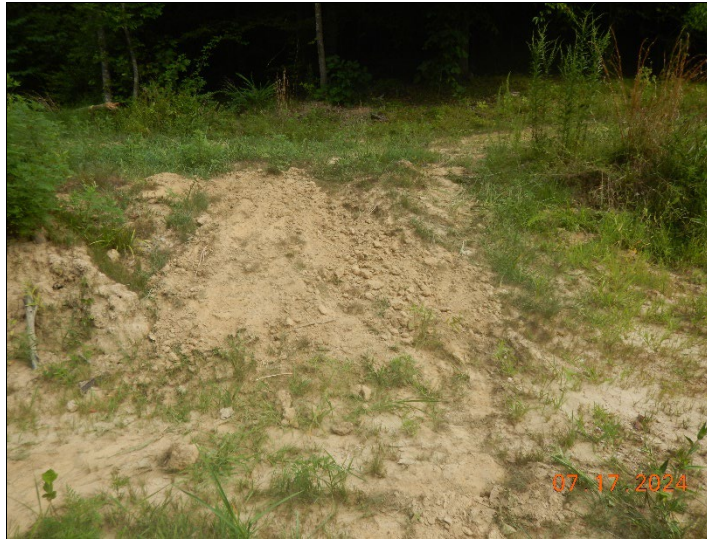
Paul Goodwin  
Date: 17 July 2024  
Photo ID: DSCN5534.JPG  
Photo taken by: Laura Mathew

Notes: View of bare soil proximate to UNT3.

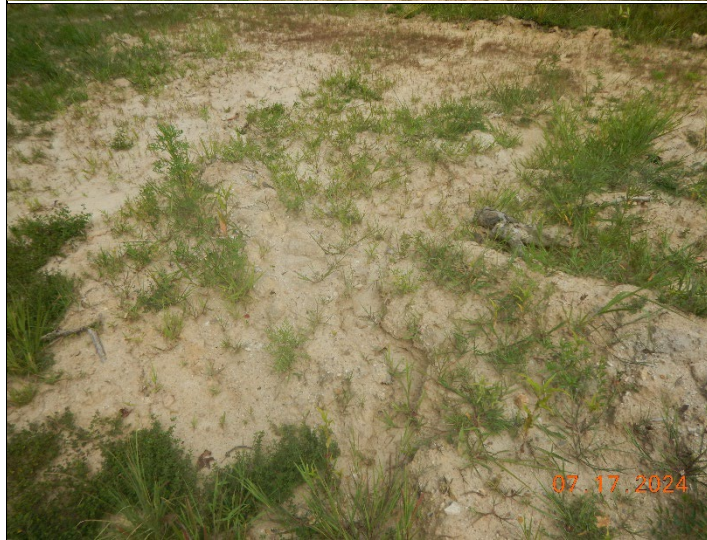
Paul Goodwin  
Date: 17 July 2024  
Photo ID: DSCN5535.JPG  
Photo taken by: Laura Mathew

Notes: Another view of bare soil along bank of UNT3.

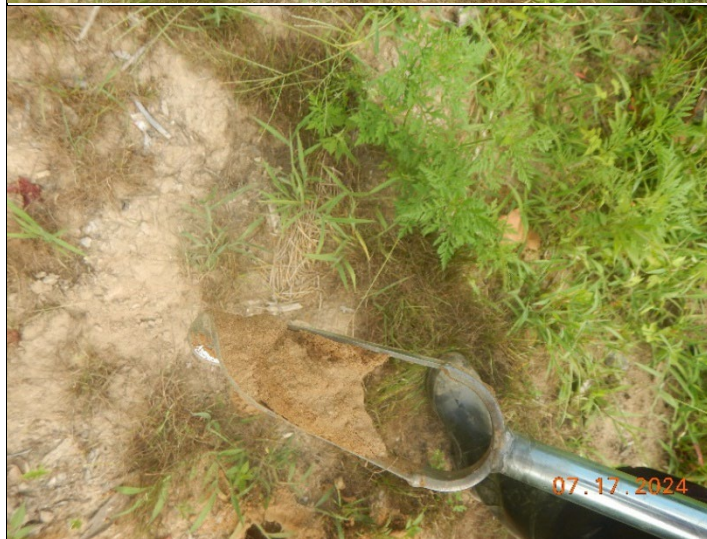
Paul Goodwin  
Date: 17 July 2024  
Photo ID: DSCN5538.JPG  
Photo taken by: Laura Mathew

The inspectors then moved to the east to document the floodplain wetlands that occurred immediately to the north of South Creek. A soil boring was conducted at 38.738848, -78.23546 within an area where wetland areas were proposed to be seeded with a wetland mix, per the Planting Plan (**Attachment 3**). The soil boring was characterized as: [0-15 inches] 10YR 4/4 sandy fill; [15-21 inches] 10YR 4/3 sandy fill with 40% 10YR 6/4 redoximorphic features; [21-27 inches] 5YR 5/1 sandy loam matrix with 15% 5YR 4/6 redoximorphic features. No hydrology was observed, and the area was sparsely vegetated with approximately 40% Oriental lady's thumb (*Polygonum cespitosum*), 10% crabgrass (*Digitaria sp.*), 5% soft rush (*Juncus effusus*), 5% yellow nutsedge (*Cyperus esculentus*), and trace amount of Chinese bushclover (*Lespedeza cuneata*). Overall, approximately 21 inches of non-native fill was observed over the native hydric soil layer; evidence of wetland hydrology were not present; and the area did not possess a hydrophytic community. The soils, vegetation and hydrology were altered by the discharge of fill. At the time of the inspection, this area was disturbed, did not meet the definition of a wetland, and evidence of seeding with wetland plants was not observed. As noted, wetland hydrology was not observed in this area, likely due to two observations: (i) the presence of a 21" fill layer and (ii) the absence of root wads, which would restore the flow to South Creek. As outlined in a paragraph above, the ditch possessed water and was diverting flow from South Creek. The RMP proposes to restore the hydrology to South Creek, which would also restore the hydrology to the adjacent wetlands. Under the observed condition, the hydrology of the Site was impaired and was not in compliance with the RMP.

Notes: Sandy fill material at the surface of the soil boring.

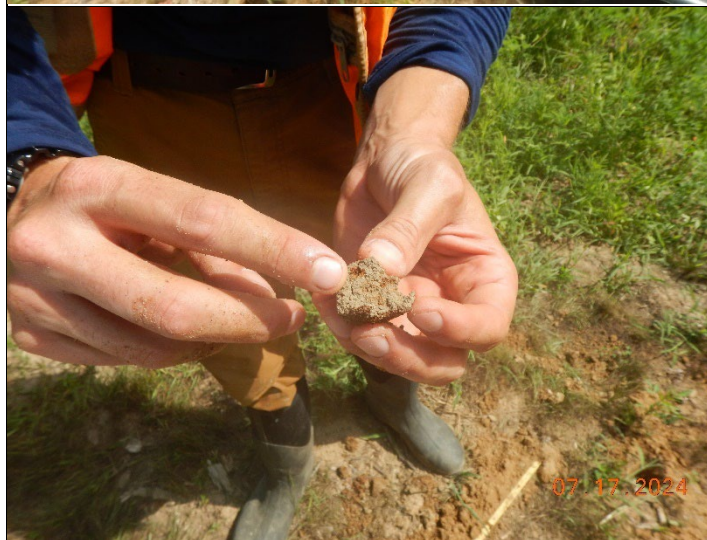
Paul Goodwin  
Date: 17 July 2024  
Photo ID: DSCN5539.JPG  
Photo taken by: Laura Mathew

Notes: Close up view redoximorphic features present in the native hydric soil located at >21" below ground surface.

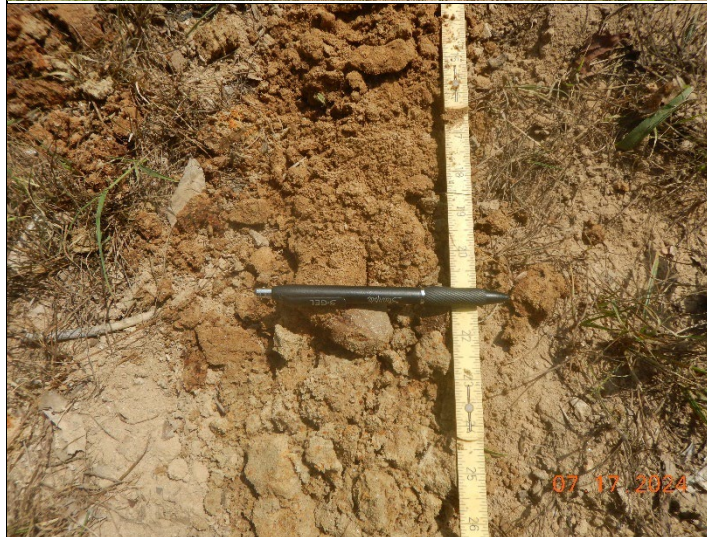
Paul Goodwin  
Date: 17 July 2024  
Photo ID: DSCN5541.JPG  
Photo taken by: Laura Mathew

Notes: Close up of layer change at 21 inches.

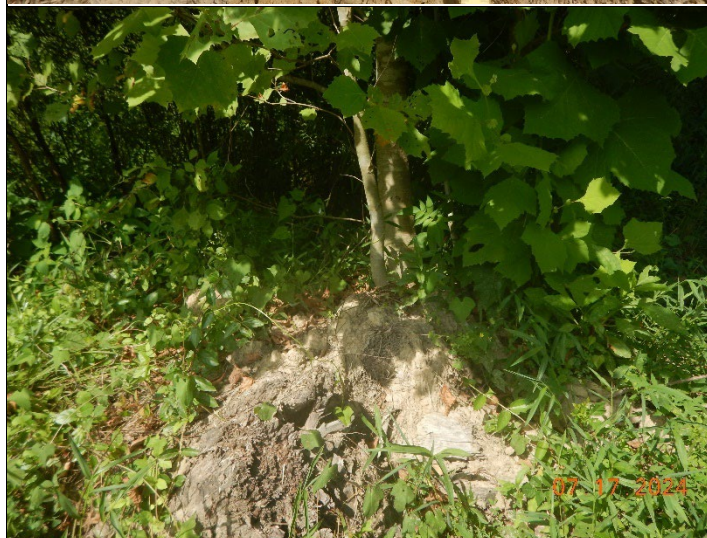
Paul Goodwin  
Date: 17 July 2024  
Photo ID: DSCN5542.JPG  
Photo taken by: Laura Mathew

Notes: Fill material pushed up on trunk of an American sycamore (*Platanus occidentalis*) sapling.

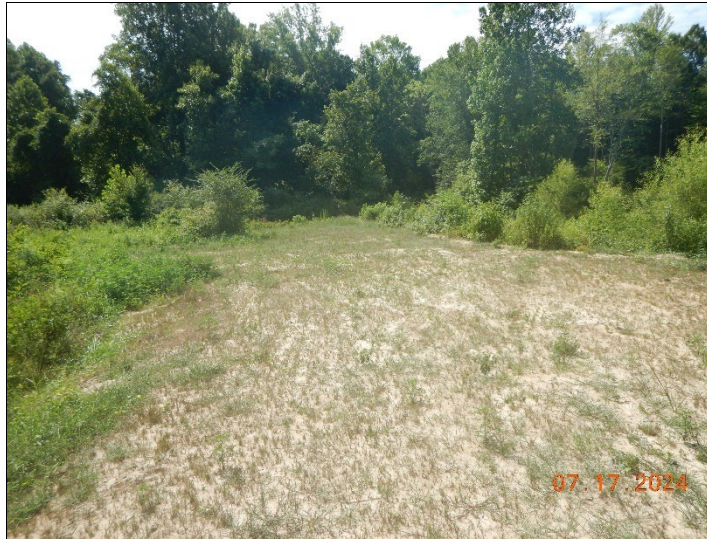
Paul Goodwin  
Date: 17 July 2024  
Photo ID: DSCN5543.JPG  
Photo taken by: Laura Mathew

Notes: View facing south of graded fill material in area designated as a wetland in the restoration plan. Note the area is elevated and sparsely vegetated.

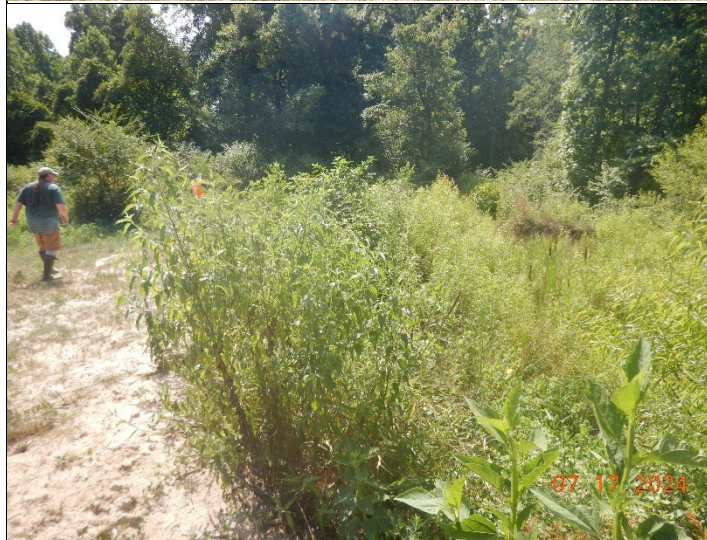
Paul Goodwin  
Date: 17 July 2024  
Photo ID: DSCN5544.JPG  
Photo taken by: Laura Mathew

Notes: Western edge of the graded area with steep drop off.

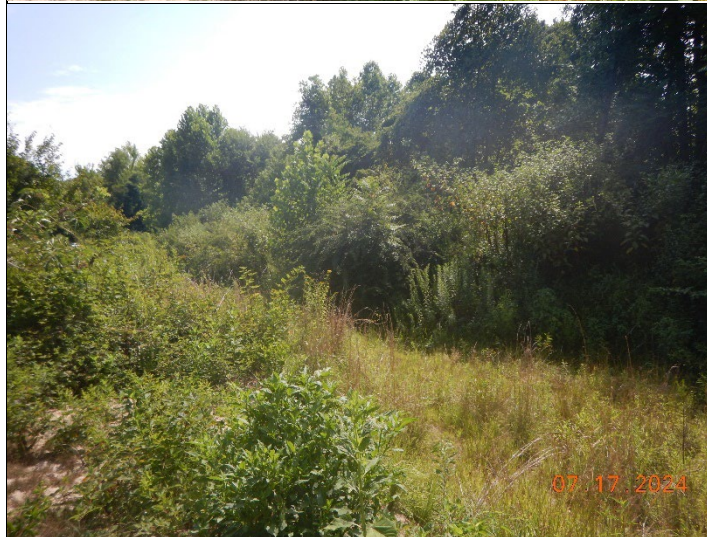
Paul Goodwin  
Date: 17 July 2024  
Photo ID: DSCN5545.JPG  
Photo taken by: Laura Mathew

Notes: Another view of the steep drop off from the graded area.

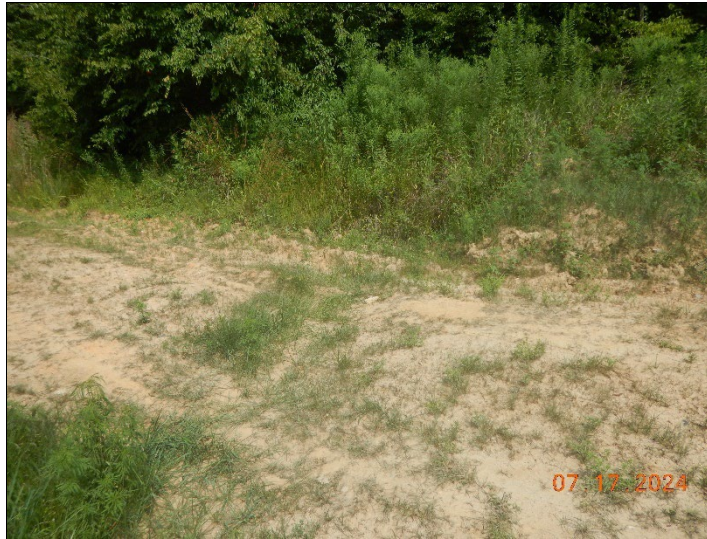
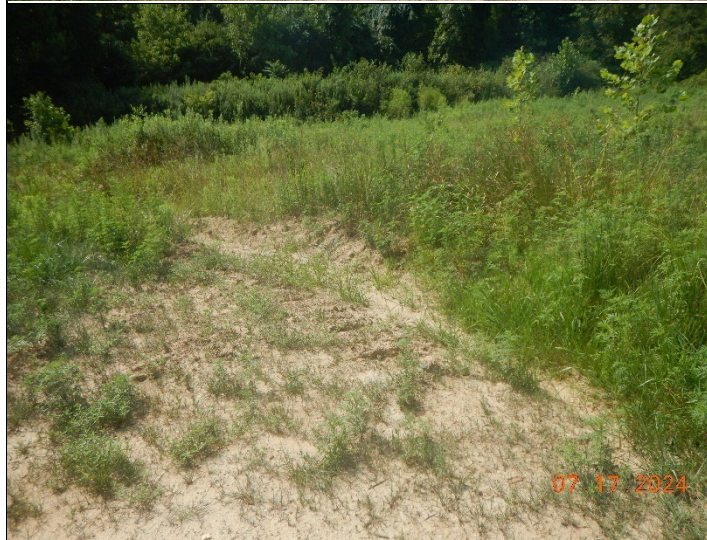
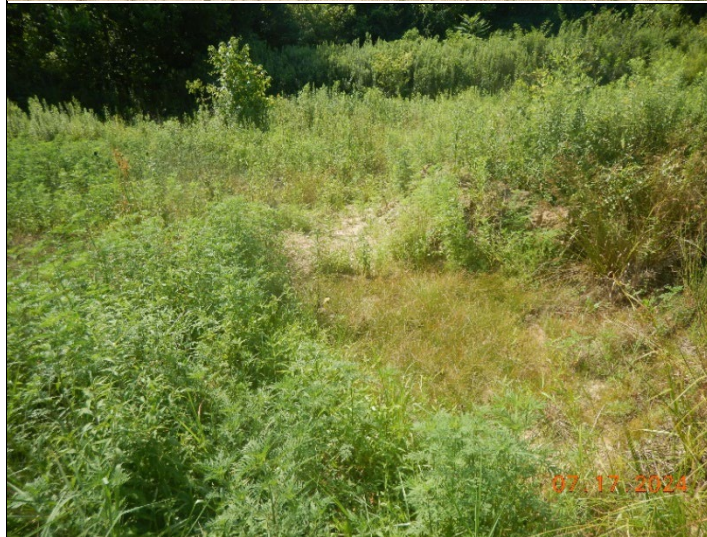
The inspection continued east along Dixie Winds Lane and UNT2 was observed. No water was flowing in UNT2 at the time of the inspection and the reconstituted channel did not have clear definable bed or banks. (DSCN5546 to DSCN5549). It did not appear that restoration work had occurred within UNT2.

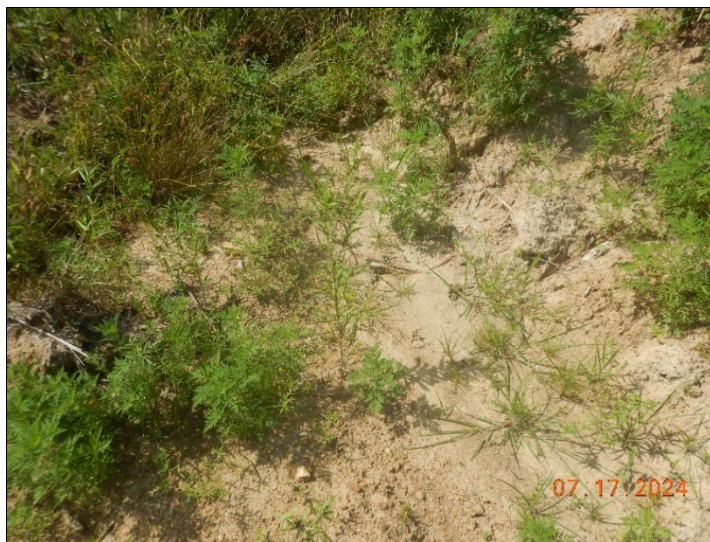
Photo ID: DSCN5549.JPG

Notes: Close up view of UNT2.
