INSPECTION REPORT

| <b>Inspection Date:</b> | 02/23/2021 | |
| <b>Regulatory Program:</b> | CWA NPDES/Construction Stormwater | |
| <b>Site Name:</b> | Rising Sun Subdivision | |

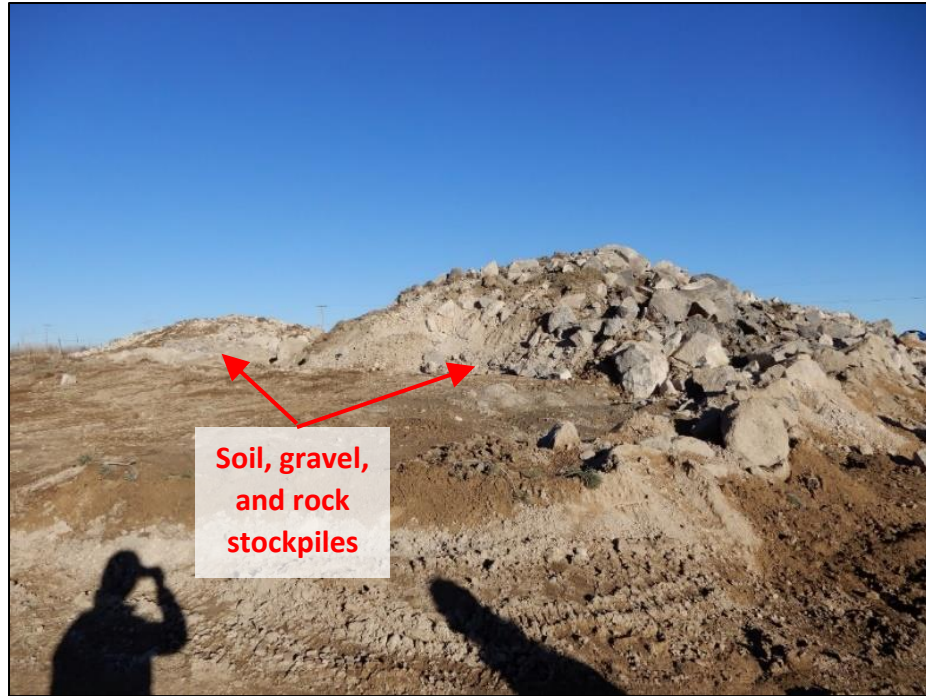
We observed eight locations of unstabilized stockpiles of soil, gravel, and rock—two locations at the north-central area of the Site, four locations at the center of the Site, one location at the south-central area of the Site, and one location at the southwestern perimeter of the Site (refer to Attachment A, Photographs 1 through 5). Downgradient of the stockpiles, sediment barriers of silt fences and fiber rolls were observed along the southern perimeter of the Site, except at the stockpile located at the southwestern perimeter of the Site that lacked sediment controls on the downgradient area (see Area of Concern 5 for further details) (refer to Attachment A, Photograph 5).

**Photograph 1.** View, facing west, of two unstabilized soil, gravel, and rock stockpiles located at the north-central location of the Site. Downgradient perimeter controls were observed.

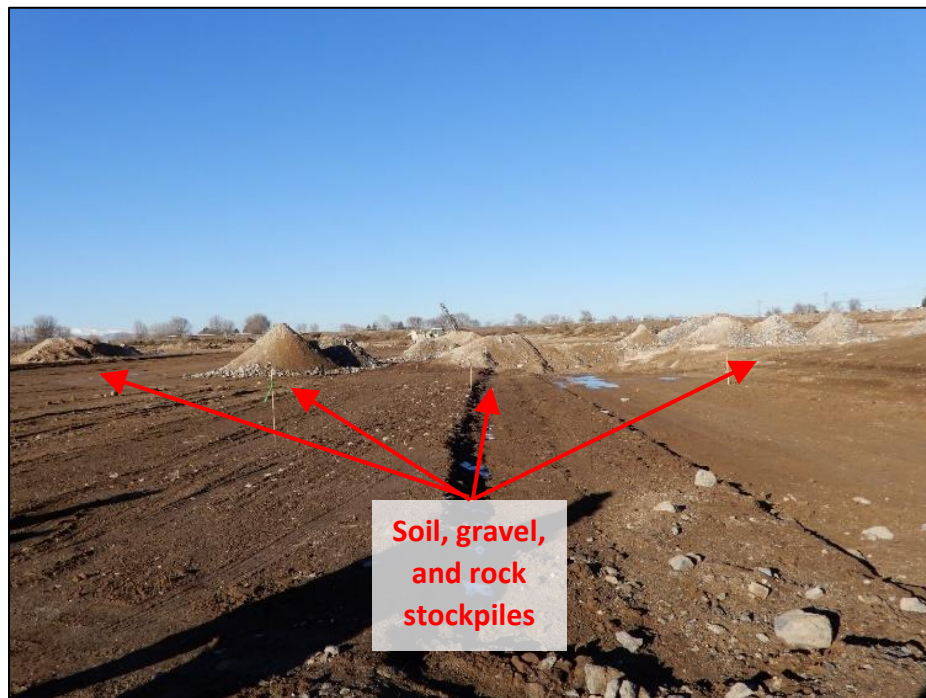
**Photograph 2.** View, facing west, of four locations of unstabilized soil, gravel, and rock stockpiles located at the center of the Site. Downgradient perimeter controls were observed at the Site's southern perimeter.

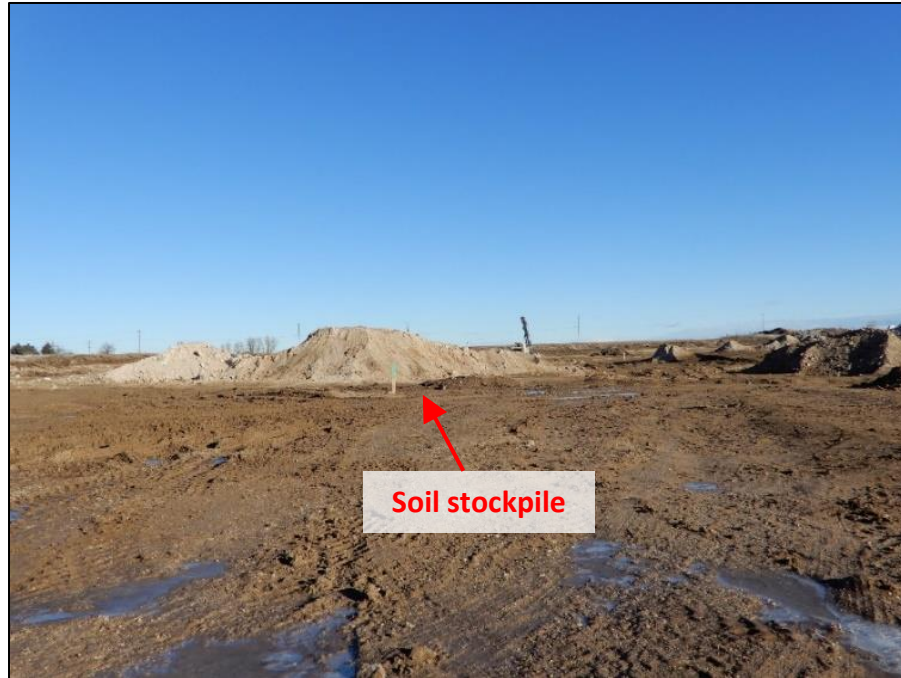
**Photograph 3.** View, facing north, of unstabilized soil stockpile located at the south-central area of the Site. Downgradient perimeter controls were observed.

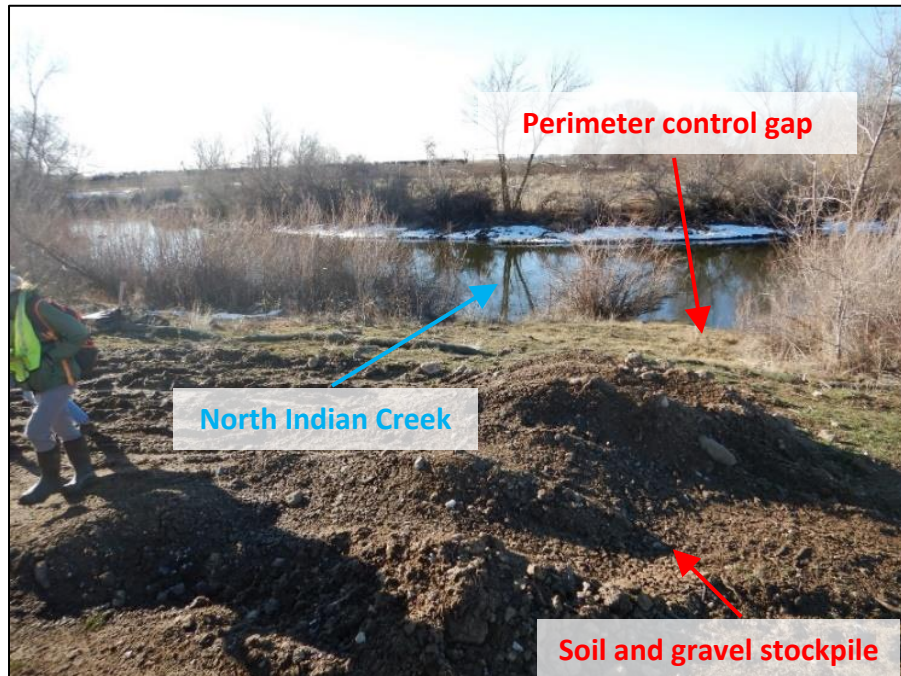
**Photograph 4.** View, facing south, of an unstabilized stockpile of soil and gravel located on the southwestern perimeter of the Site. Downgradient of the stockpile is the North Indian Creek. Note that directly downgradient the stockpile did not have sediment barriers installed and a gap in the fiber roll used for perimeter control.

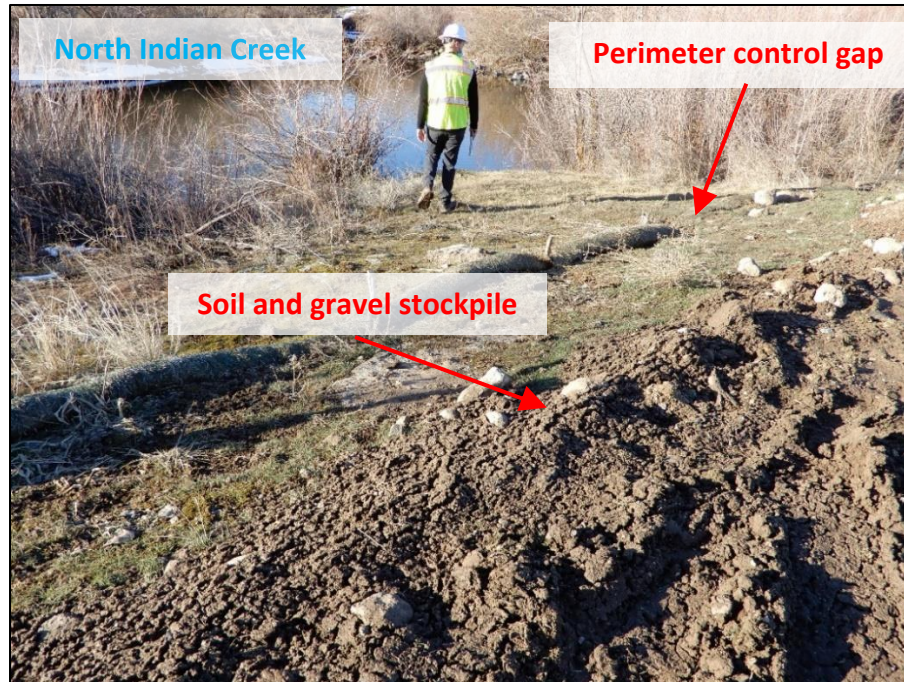
The Inspection Team was unable to determine when stockpile materials would be used, or if perimeter controls were used during precipitation due to a lack of precipitation. However, the unstabilized soil and gravel stockpile located at the southwestern perimeter of the Site was observed next to a stormwater conveyance.

We observed a location that lacked perimeter control downgradient of an unstabilized stockpile of soil and gravel on the southwestern perimeter of the Site that was adjacent to North Indian Creek (refer to Attachment A, Photograph 5). No signs of discharge were observed downgradient of the perimeter gap in North Indian Creek.

**Photograph 5.** Another view, facing southwest, of the unstabilized stockpile of soil and gravel shown in [Photograph 4](#). Note that the stockpile did not have sediment barriers installed on the downgradient perimeter area and the gap in perimeter control. No signs of discharge were observed downgradient in North Indian Creek.

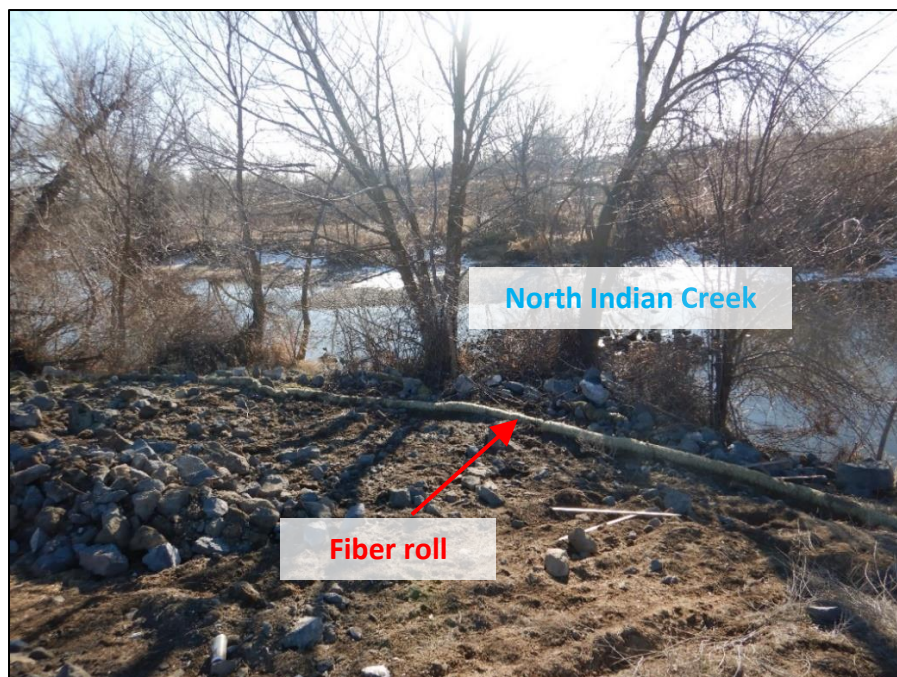
We also observed that the SWPPP map presented onsite did not identify all stormwater controls used as Site perimeter controls as required by part 7.2.4.i of the Permit. The SWPPP map labeled all southern perimeter controls as silt fences. We observed both silt fences as well as fiber rolls as the Site's southern perimeter controls (refer to Attachment A, Photographs 6 and 7 and Attachment B, Exhibit 2). Additionally, we did not observe silt fences on the western, eastern, and northern perimeters of the Site as labeled on the SWPPP map.

**Photograph 6.** View, facing south, of a fiber roll installed across the Site's southern perimeter that had not been labeled on the Site's SWPPP map. The fiber roll is located east of [Photograph 5](#).

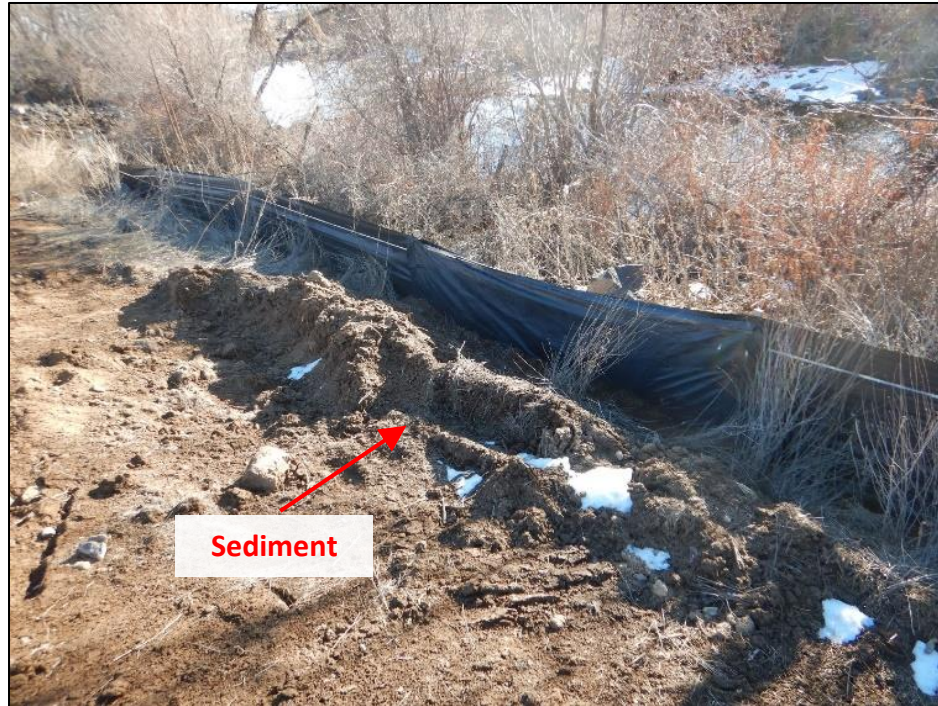
We also observed a location on the silt fence along the southern perimeter

where sediment had accumulated to approximately one-half of the above-ground height of the silt fence (refer to Attachment A, Photograph 7).

**Photograph 7.** View, facing southeast, of sediment that had accumulated to approximately one-half of the above-ground height of the silt fence. The sediment is located east of Photograph 5.

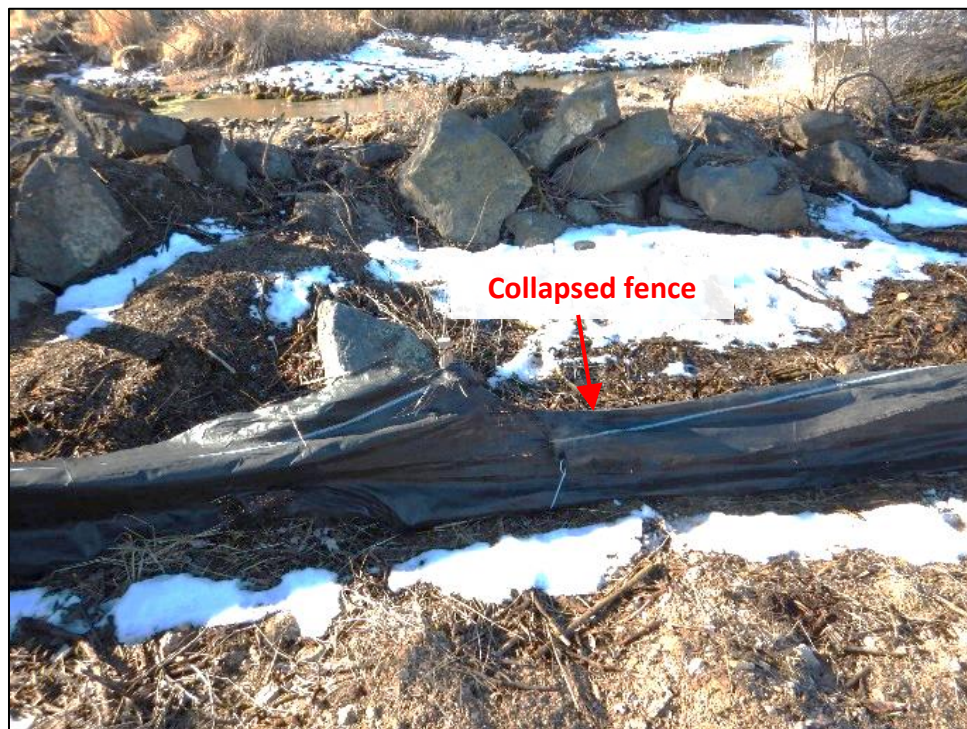
We observed three locations on the silt fence along the Site’s southern perimeter that required maintenance and/or replacement due to deterioration and collapse (refer to Attachment A, Photographs 8 through 12).

**Photograph 8.** View, facing south, of a collapsed silt fence along the Site's southern perimeter. The silt fence is located east of Photograph 7.

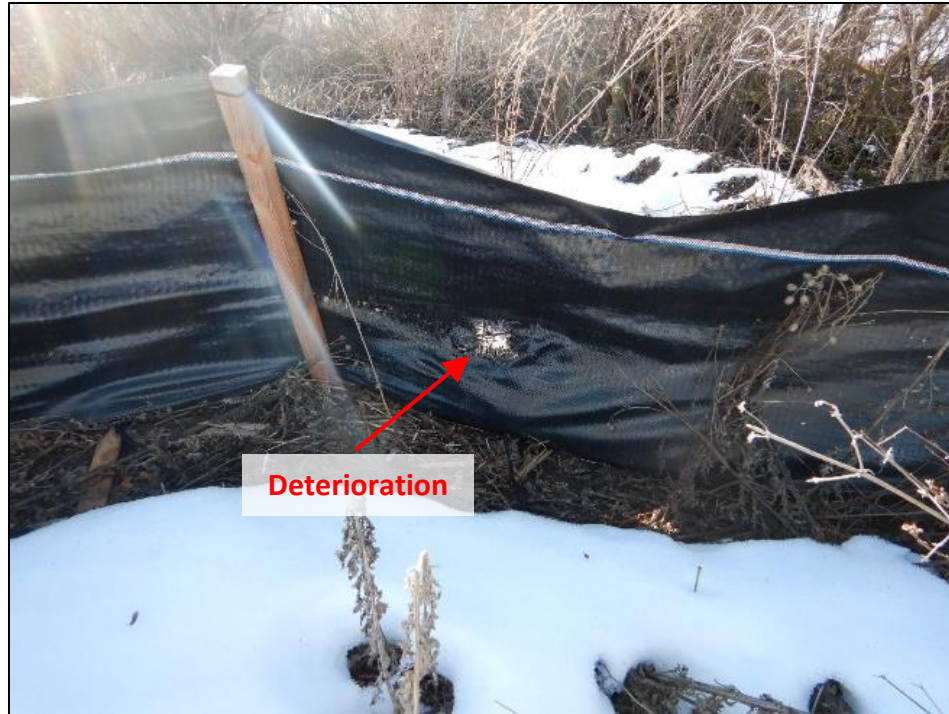
**Photograph 9.** View, facing south, of a section of the silt fence along the Site's southern perimeter. Note the deterioration. The silt fence is located east of Photograph 8.

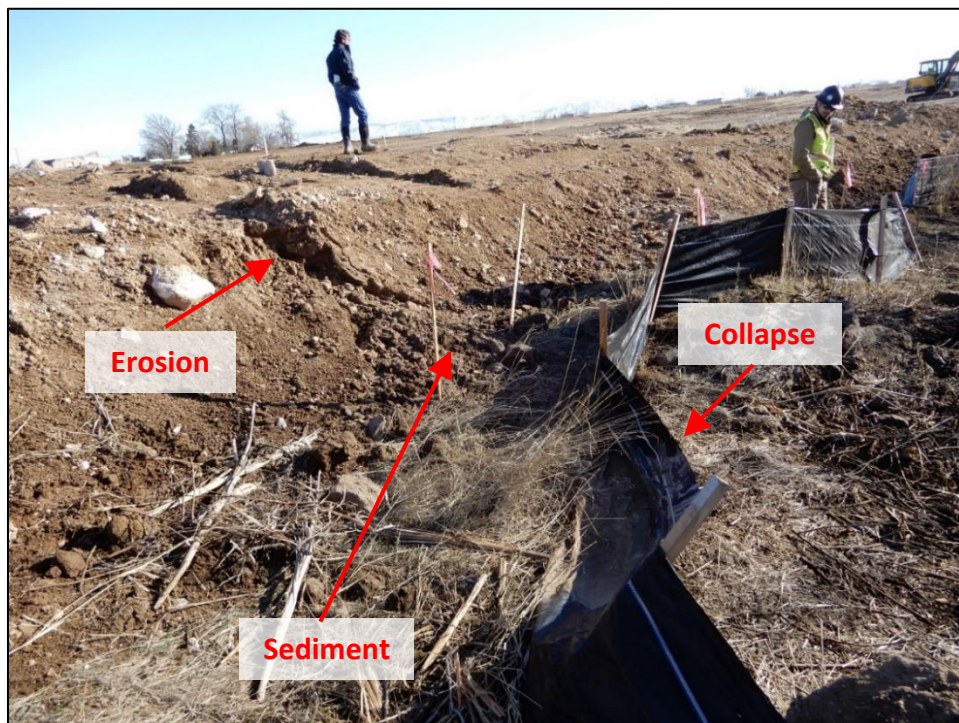
We observed a location along the silt fence located at the south-central area of the Site that had collapsed with visible signs of erosion in the surrounding soil and evidence of discharge downgradient to North Indian Creek. At the time of the inspection, no flow was observed. Sediment had accumulated adjacent to the collapsed silt fence (refer to Attachment A, Photographs 10 through 12). Site Representatives stated that they had not conducted turbidity testing on discharge at this location or at any time in the history of the Site's operation. We observed turbidity both upstream and downstream of the potential discharge location in North Indian Creek; therefore, we were unable to determine if runoff had discharged at the location and if it had contributed to the creek's turbidity (refer to Attachment A, Photographs 13 through 16). It was, however, noted that North Indian Creek seemed to be receiving turbid runoff

**Photograph 10.** View, facing east, of a collapsed silt fence along the Site's south-central perimeter. Note the erosion and sediment adjacent to the silt fence.

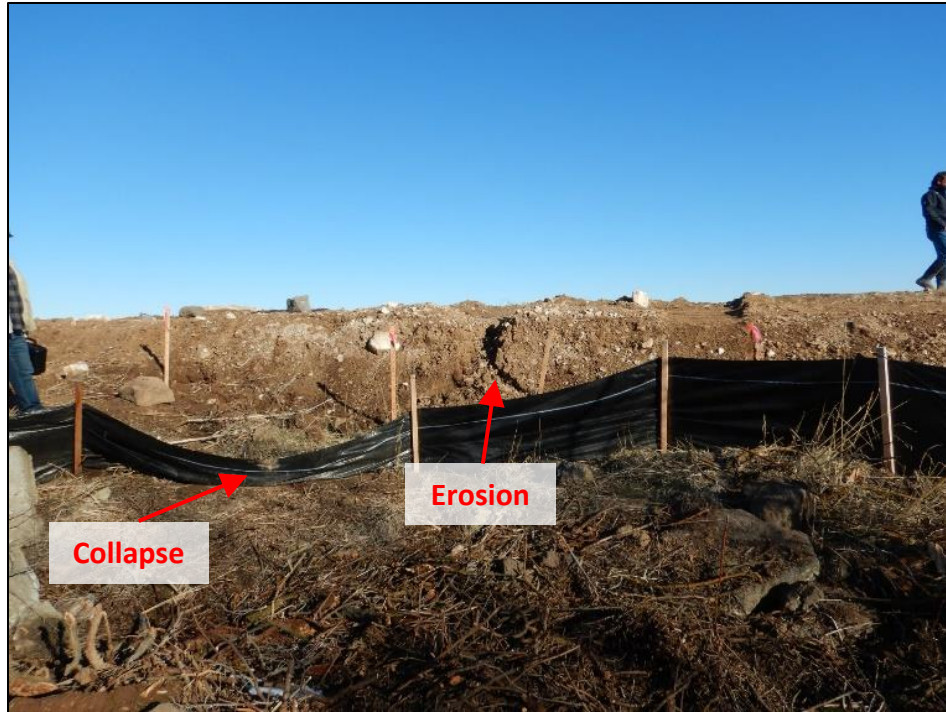
**Photograph 11.** Another view, facing north, of a collapsed silt fence along the Site's southern perimeter as shown in [Photograph 10](#). Note the erosion to the north of the collapsed silt fence.

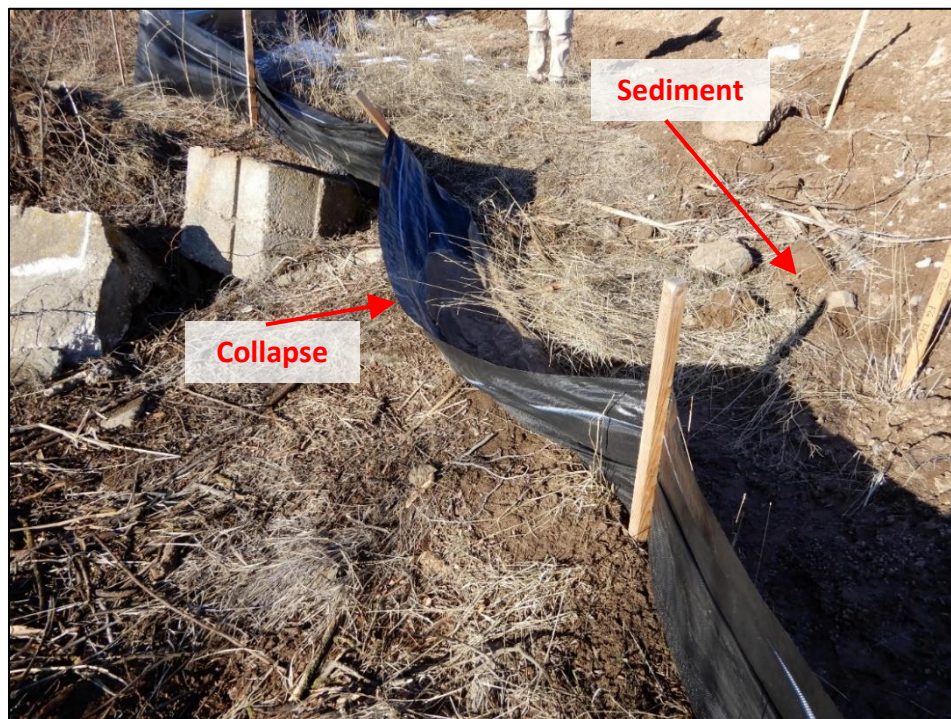
**Photograph 12.** Another view, facing southwest, of a collapsed silt along the Site's southern perimeter as shown in [Photographs 10 and 11](#). Note the sediment adjacent to the silt fence.

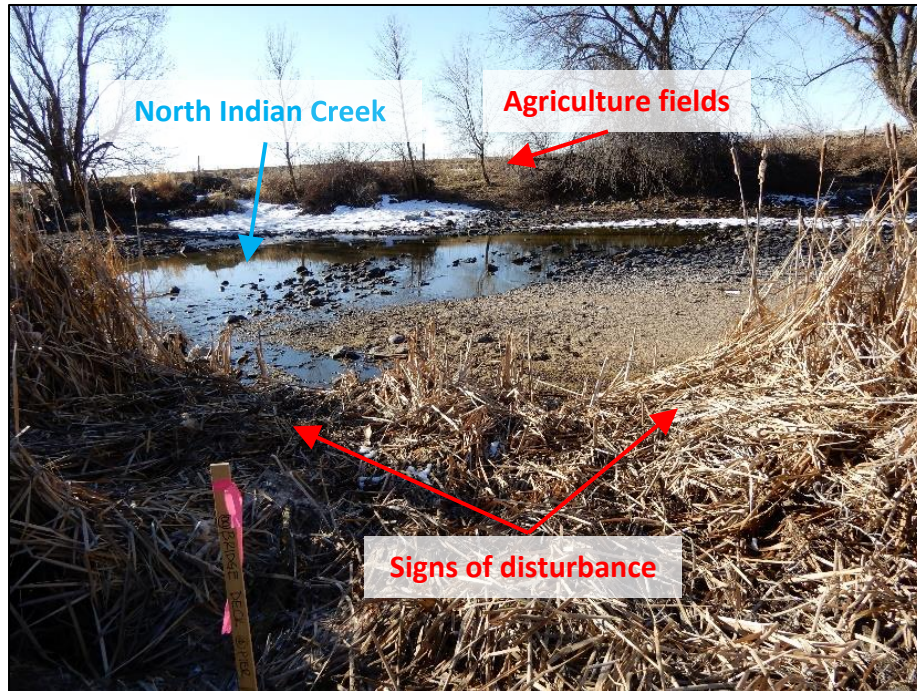
**Photograph 13.** View, facing south, of the North Indian Creek directly downgradient of a collapsed silt fence along the Site's southern perimeter as shown in Photographs 10 through 12. Note the signs of disturbance of the vegetation.

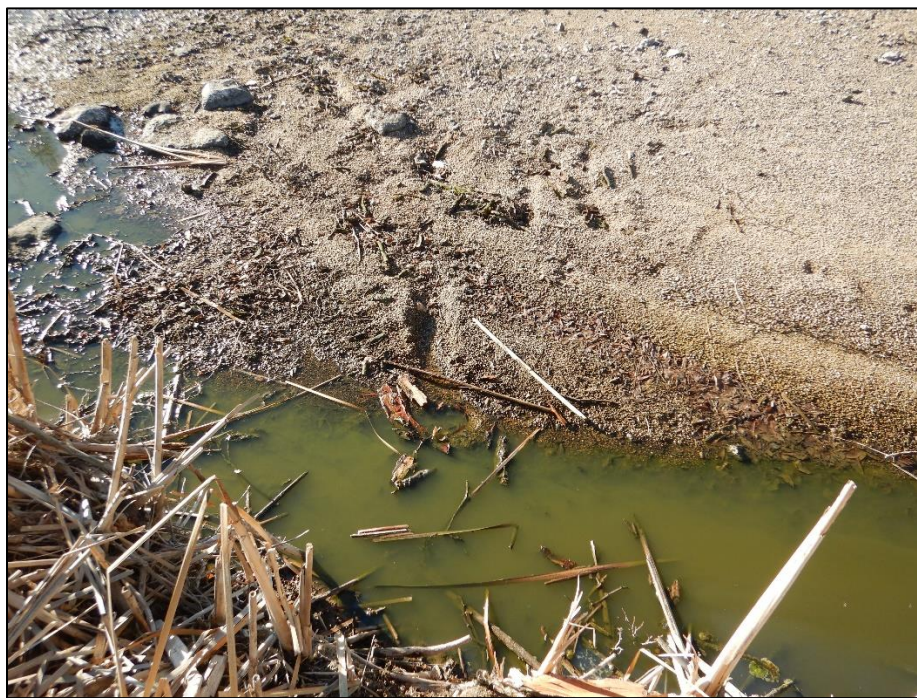
**Photograph 14.** View, facing south, of North Indian Creek directly downstream of the location shown in Photographs 10 through 13. The turbidity appeared upstream as well as downstream of the location.

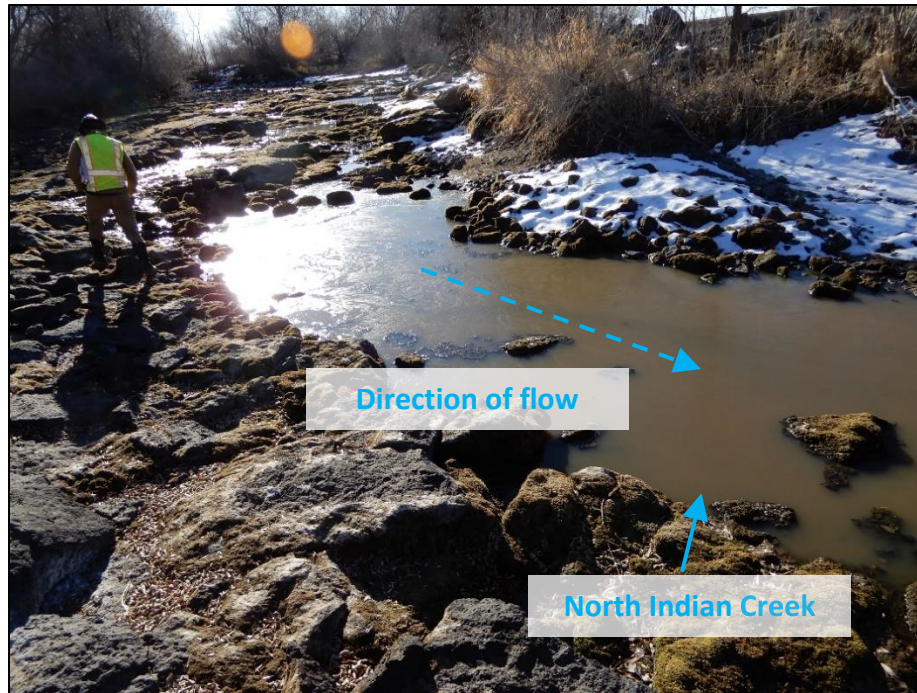
**Photograph 15.** View, facing southeast, immediately upstream of the potential discharge location in North Indian Creek shown in Photographs 13 and 14. Note the turbidity in the creek.

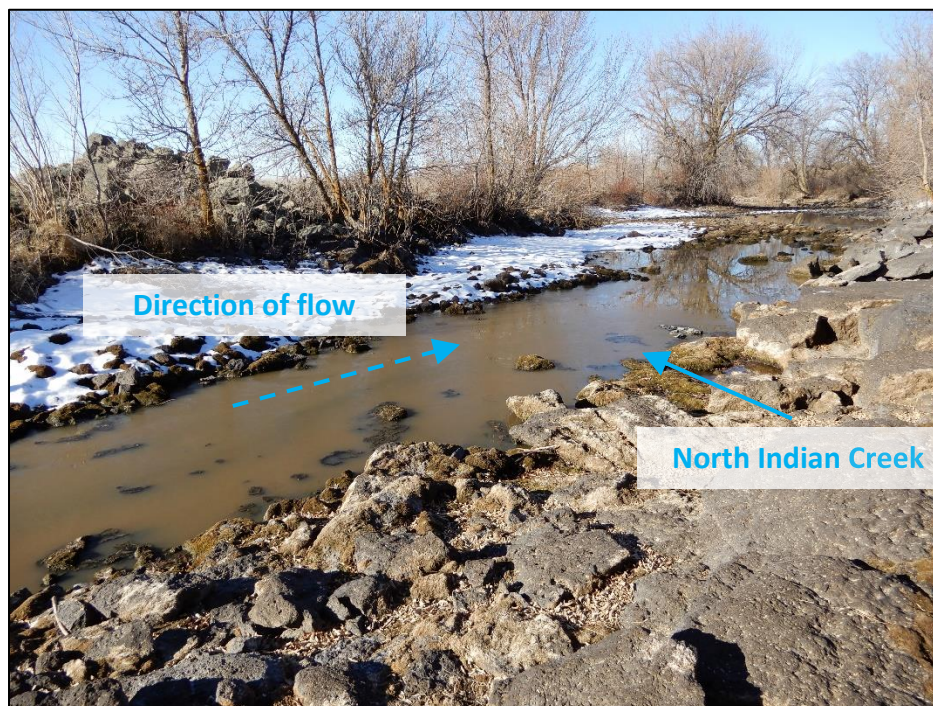
**Photograph 16.** View, facing southwest, immediately downstream of the potential discharge location shown in Photographs 13 and 14 in North Indian Creek. Location is west of the location in Photograph 15. Note the turbidity in the creek.

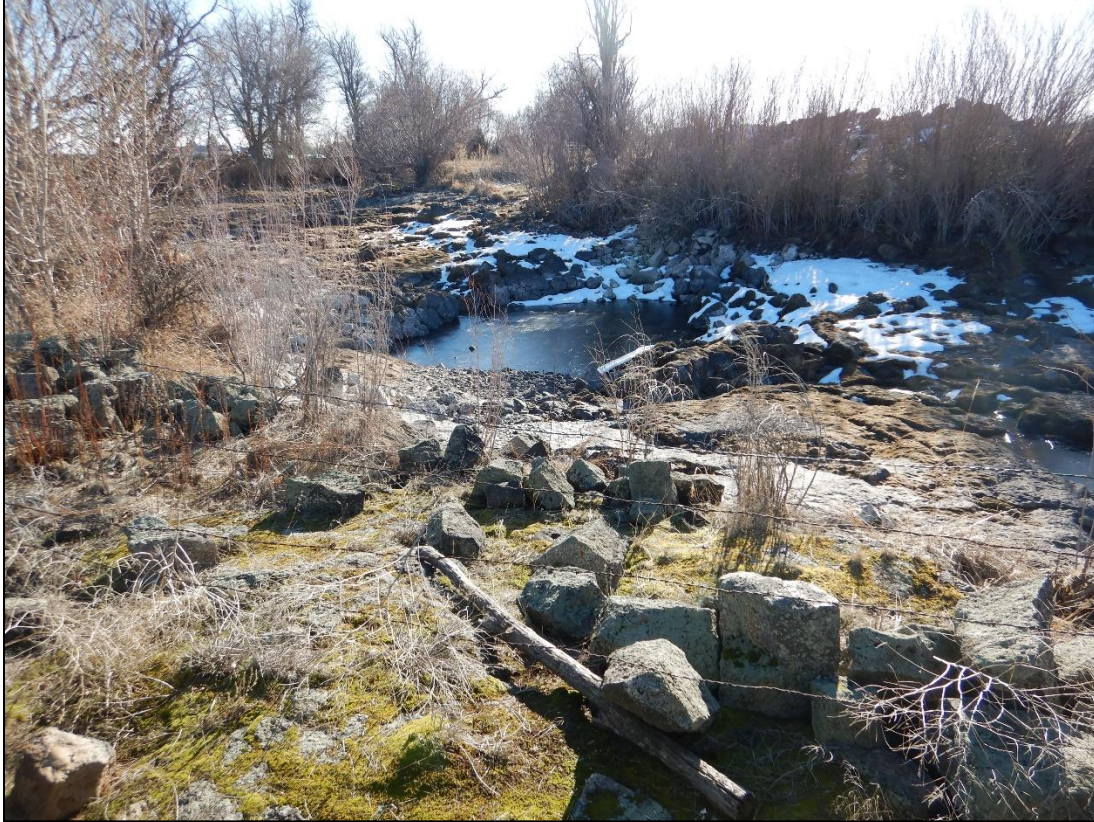
**Photograph 17.** View, facing southeast, of the southeastern perimeter of the Site. Note North Indian Creek in the background that lacks turbidity. No other discharge points were observed between this location and the location shown in Photograph 13.

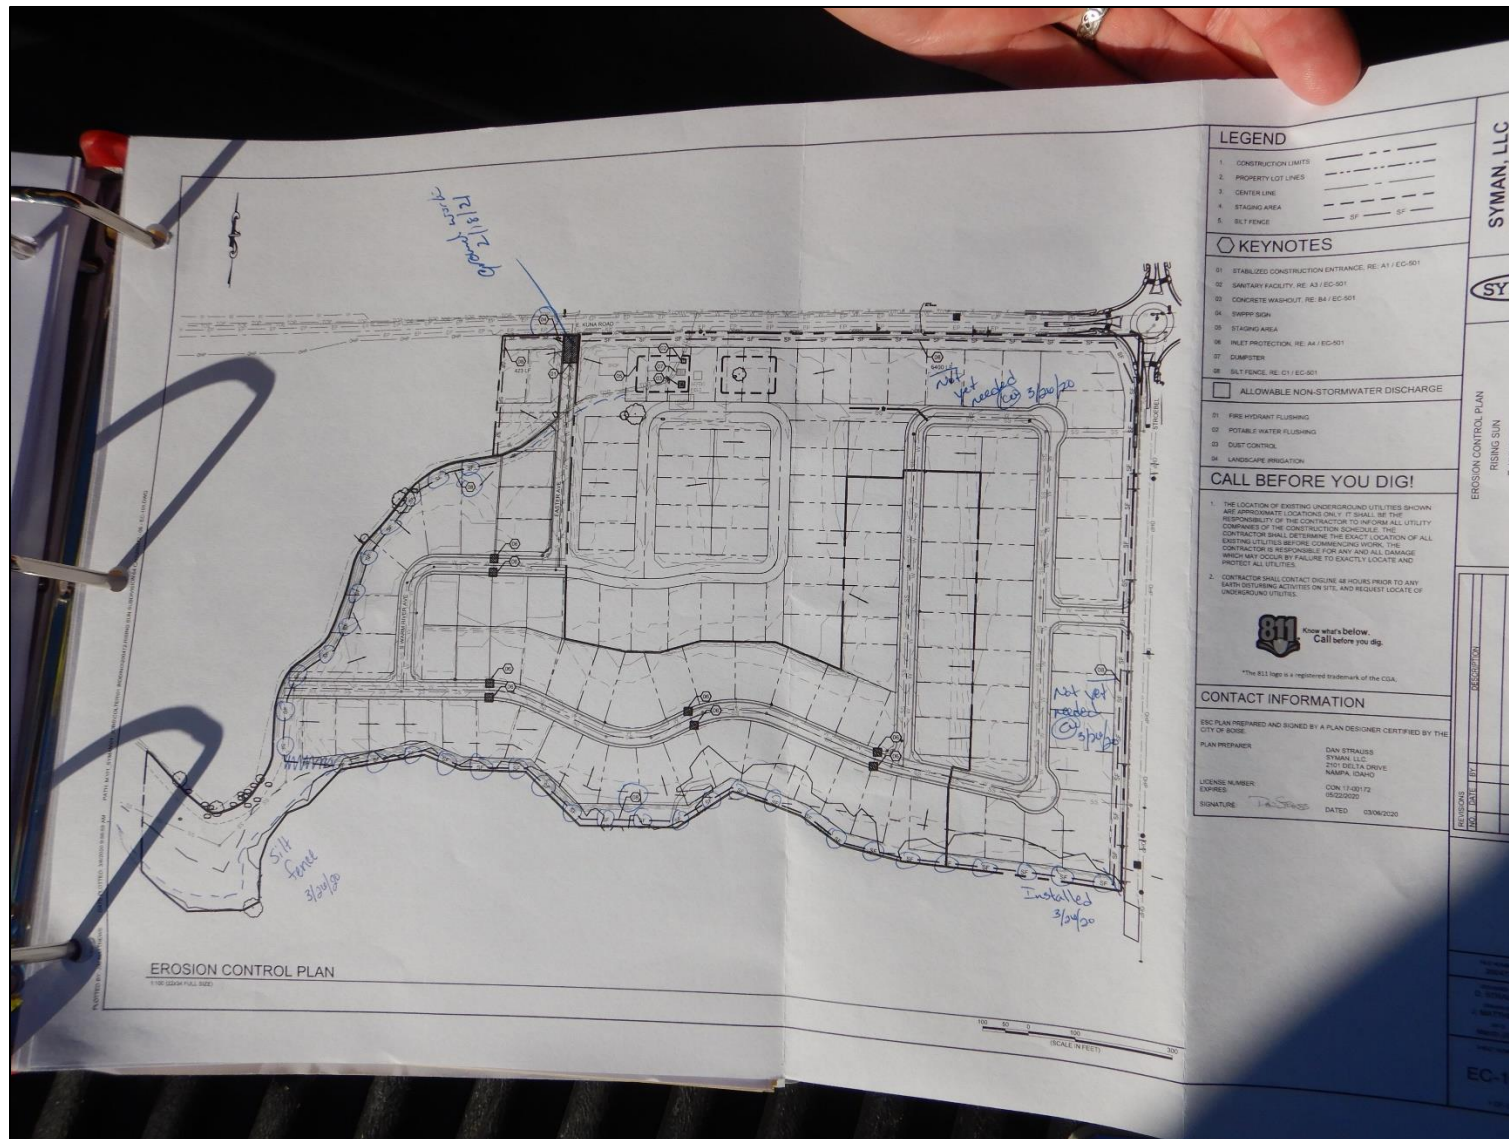
During the onsite records review, we observed that the SWPPP map presented onsite did not include locations where sediment and soil would be stockpiled as required by part 7.2.4.b.iii of the Permit. The Site had eight locations where soil, gravel, and rock were stockpiled – two locations at the north-central area of the Site, four locations at the center of the Site, one location at the south-central area of the Site, and one location at the southwestern perimeter of the Site (refer to Attachment A, Photographs 1 through 5 and Attachment B, Exhibit 2).

**Exhibit 2.** Image of the Site map provided on Site of Rising Sun Subdivision. It was noted that the Site map does not identify locations of stockpiles and that the labeled Site perimeter controls were not reflective of the Site conditions at the time of the inspection.
