**Region 6 - Enforcement & Compliance Assurance Division**  
**INSPECTION REPORT**

| Company Name: | Northcote Cleveland LLC | |
| Facility Name: | Osage B Lease | |
| Identification/Permit Number: | OKU000856 | |

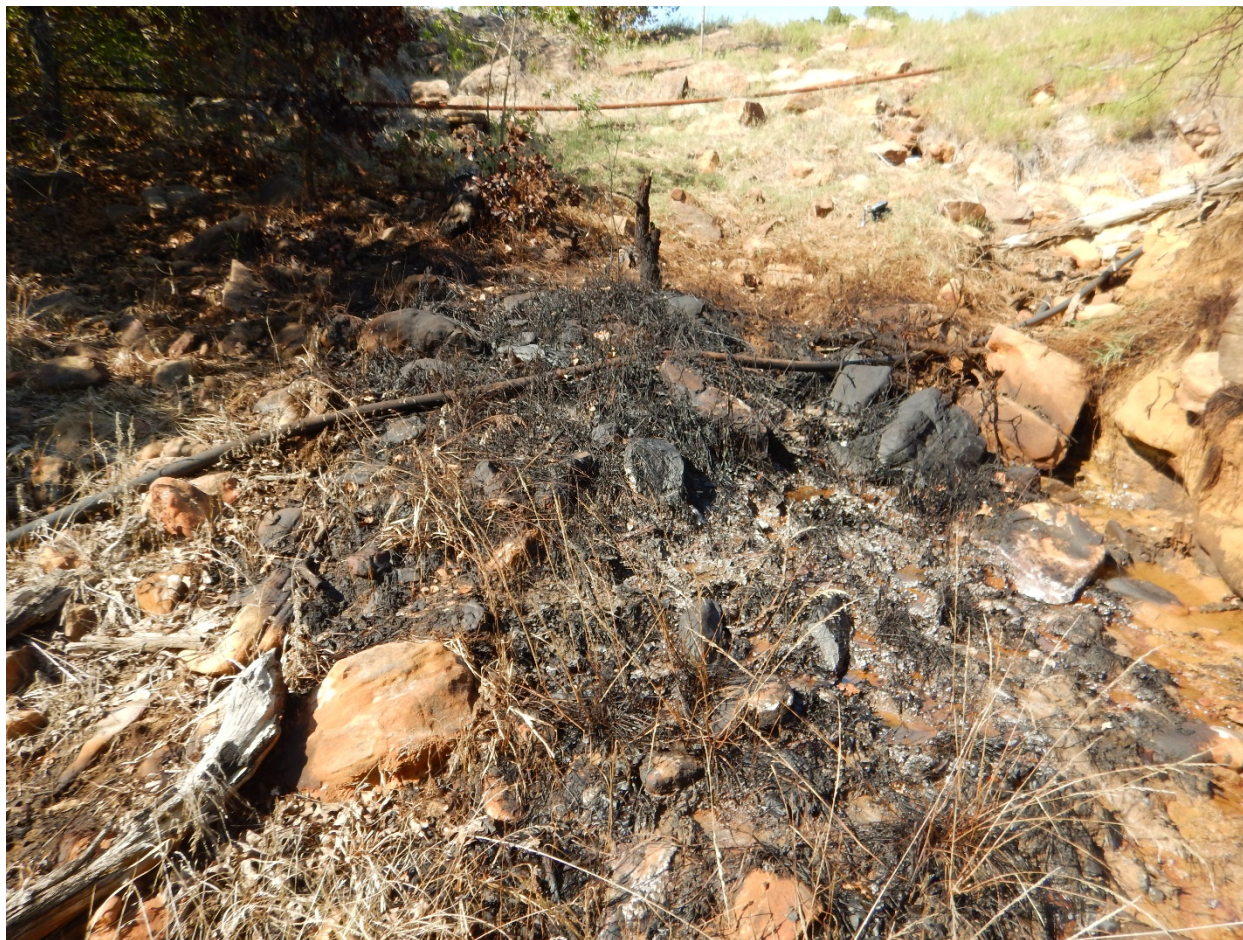
Photo No. 1

I observed the Release Point (GPS 36.259597, -96.225672) as seen in photo No. 1 of Appendix 1 (Photo Log) included with this report. At the release point, I observed oil and saltwater impacted soil, rocks, and vegetation. At the time of the inspection, the ruptured flowline had not been repaired and was no longer spilling fluid. A closeup view of the ruptured poly flowline can be seen in photo No. 2. Adjacent to the ruptured flowline, I observed an elevated TDS field reading of 42,040 mg/L in a small pool of water along the flowpath, which was documented in photos No. 4 and 5. I observed an impacted ditch/draw along the flowpath, travelling south toward an unnamed tributary, which can be seen in photo No. 6.

**Description:** This was the Release Point of the spill.

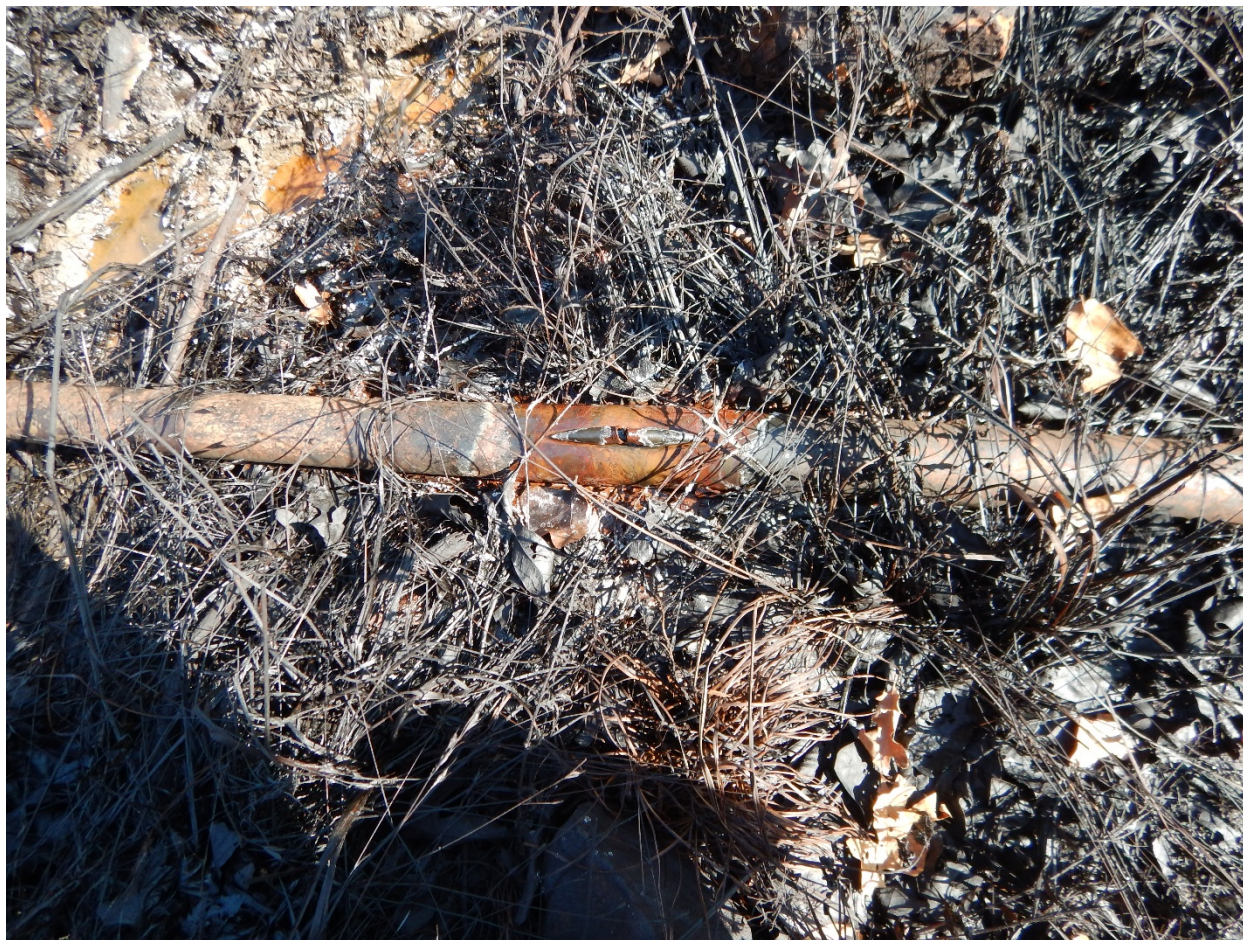
Photo No. 2

**Description:** This was the rupture in the 2" poly flowline at the release point.

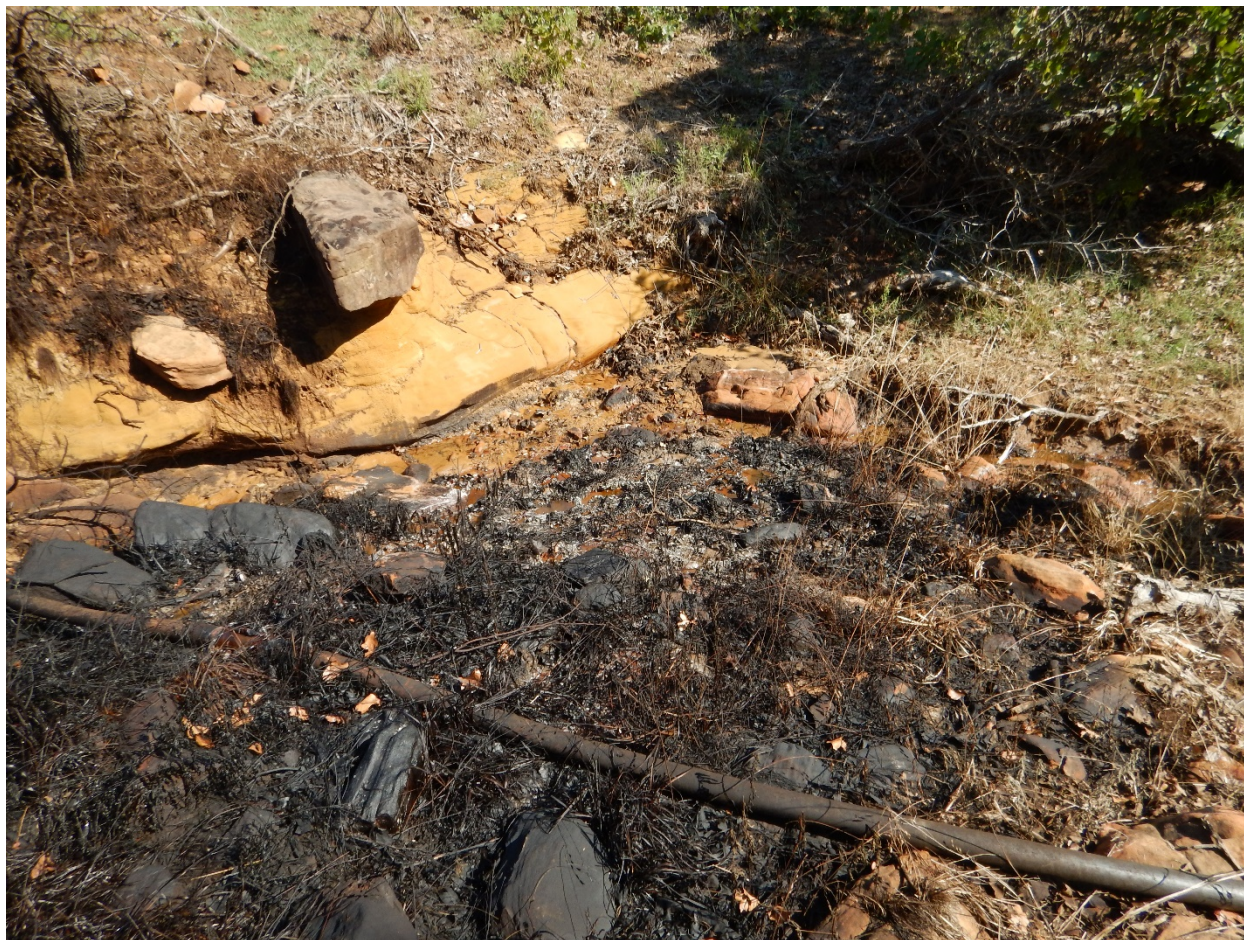
Photo No. 3

**Description:** This was a view from NW of the release point, looking SE or downgradient along the flowpath.

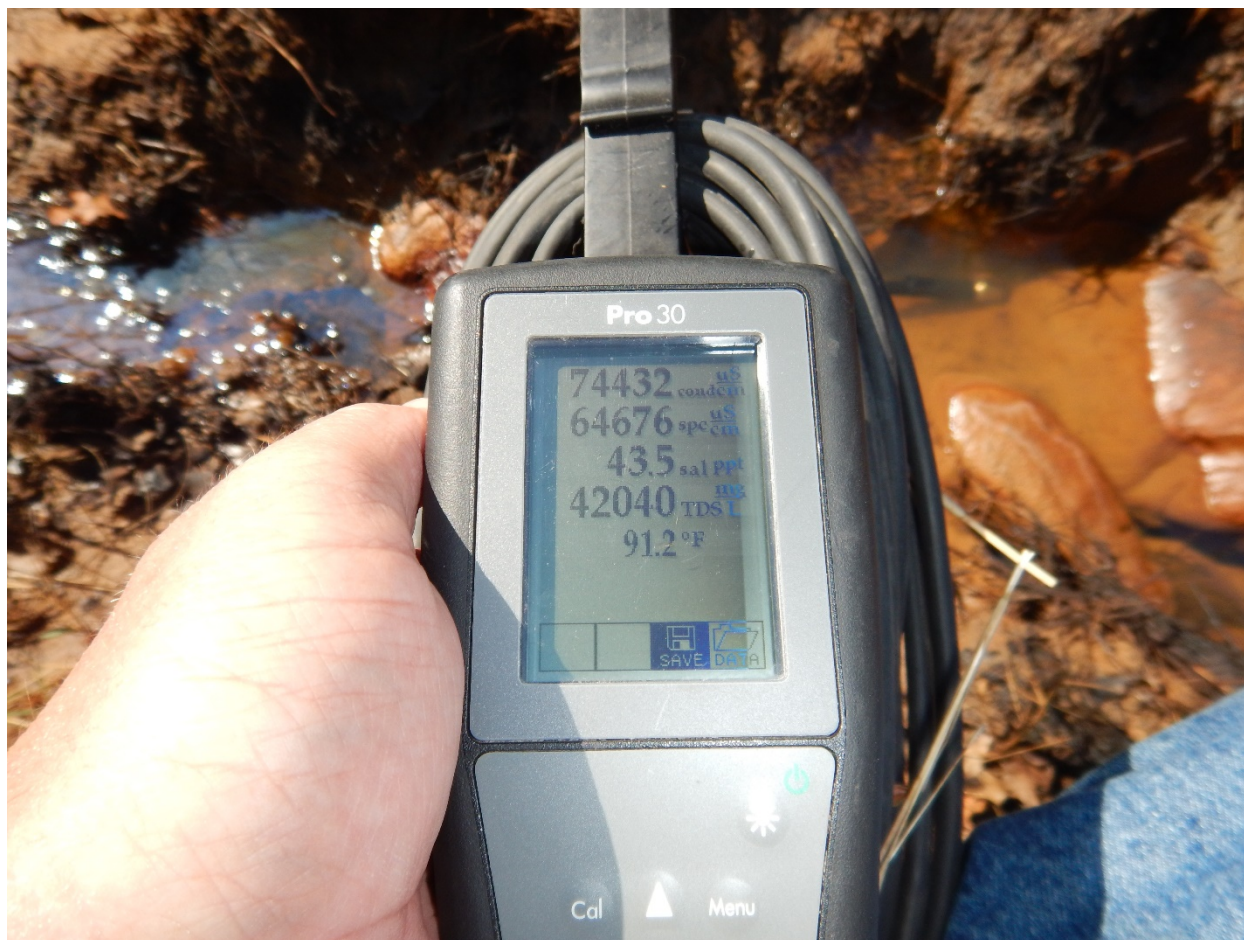
Photo No. 4

**Description:** This was an elevated TDS field reading of 42,040 mg/L. This reading was observed in the first pool of water along the flowpath of the spill immediately downgradient from the release point.

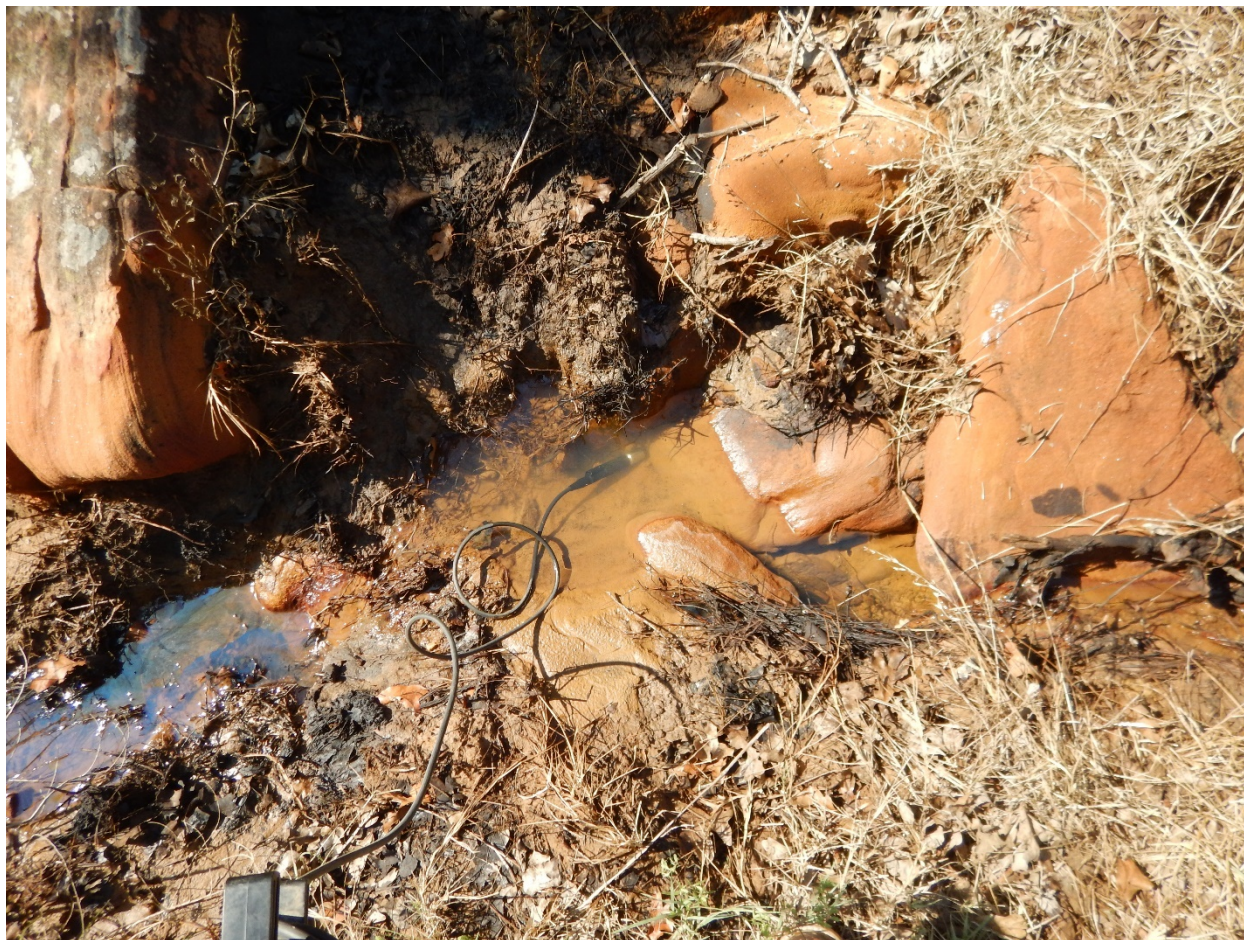
Photo No. 5

**Description:** This was the pool of water where the field reading of 42,040 mg/L TDS was taken.

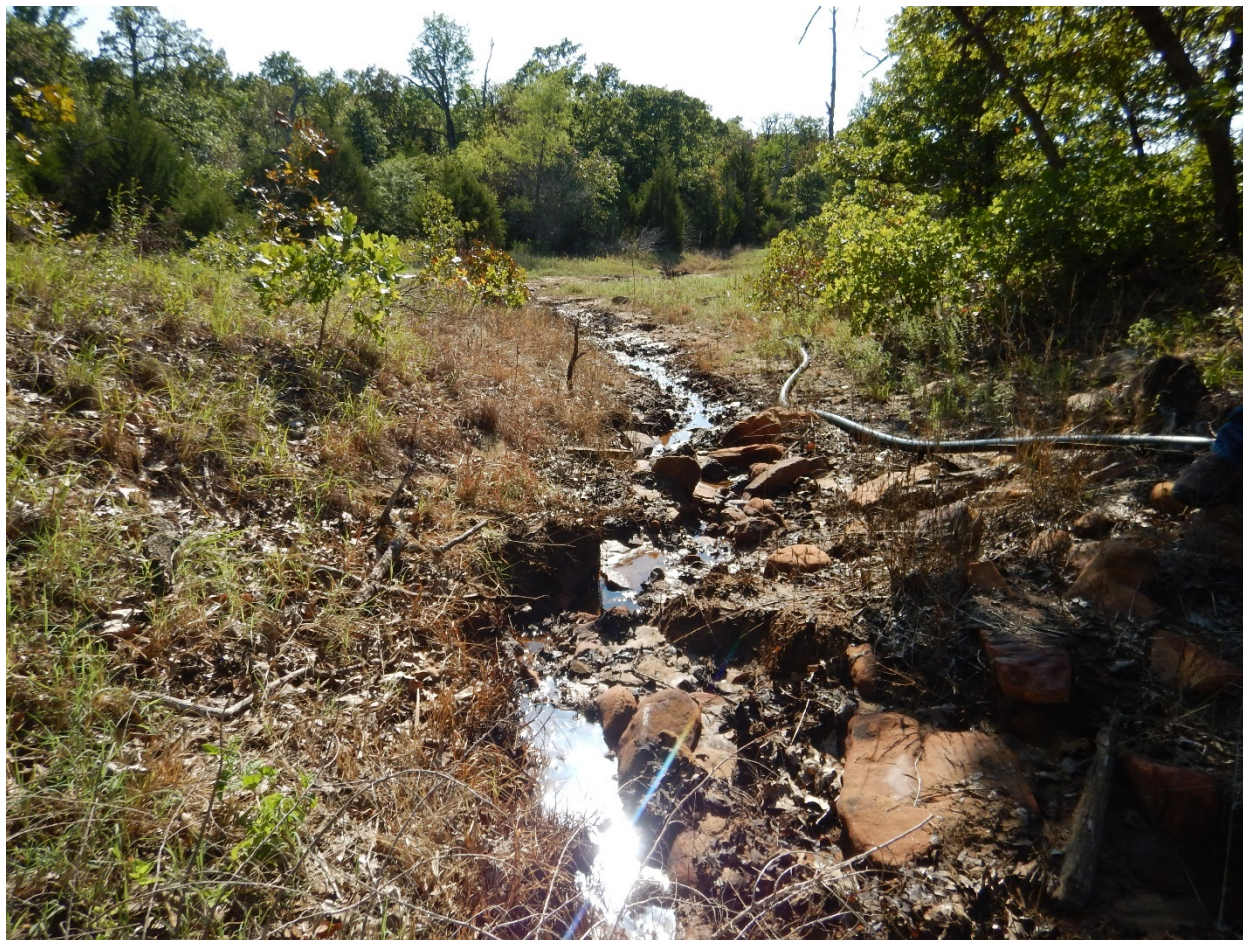
Photo No. 6

**Description:** This was a photo from the first pool of water documented in photos 4 and 5, with a view toward the south, looking toward the Point of Entry (POE) into the impacted tributary.

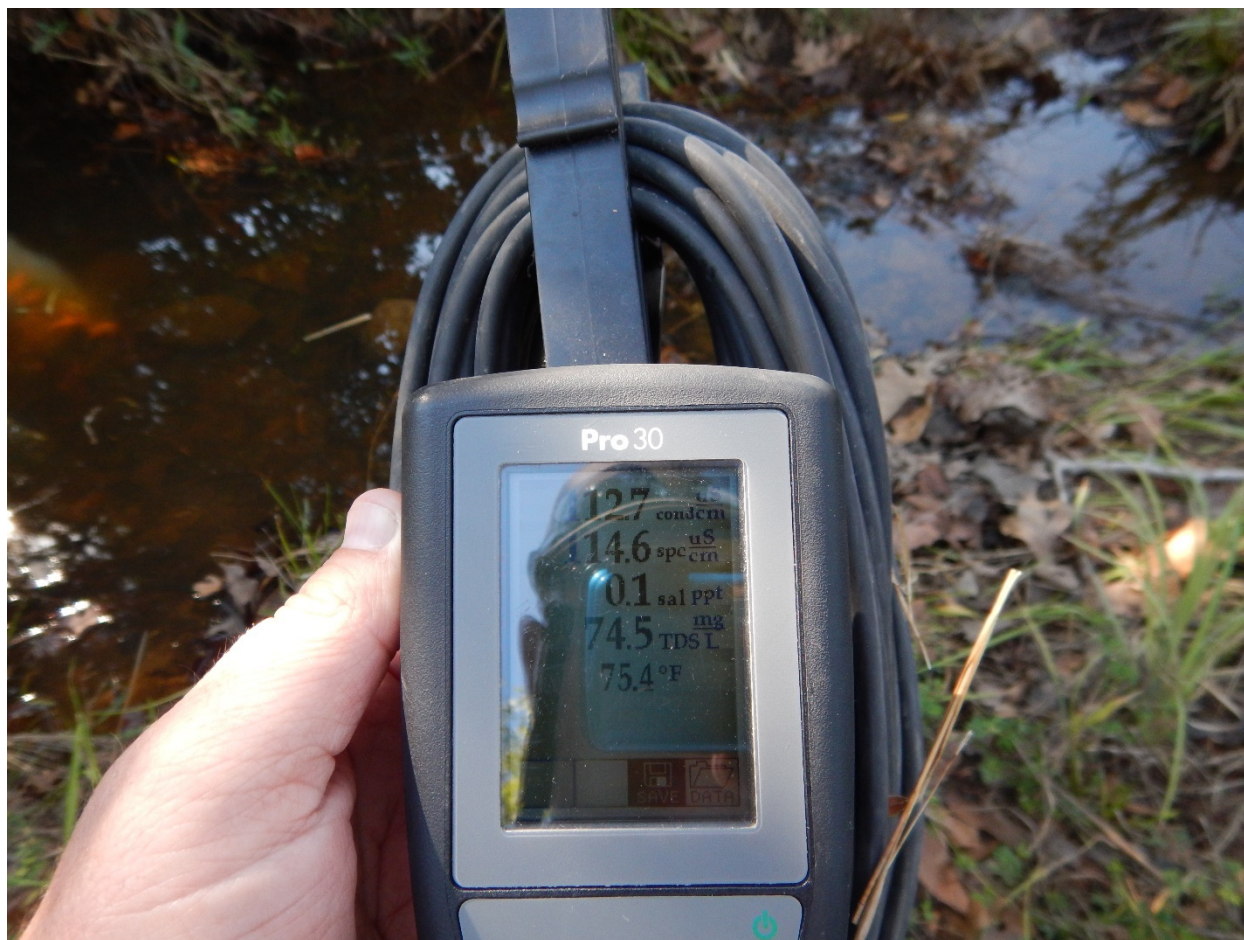
Photo No. 7

In the main channel of the impacted tributary, upstream from impacted area, I observed a TDS field reading of 74.5 mg/L (see photo No. 7), this field reading should be used when establishing “background” TDS levels for the area.

**Description:** This was a "background" TDS measurement observed upstream from the POE along the impacted tributary. This reading was taken in a pool of water which was not impacted by the spill.

**Description:** This was an elevated TDS field reading of 83,288 mg/L observed in the main channel of the impacted tributary at the POE.

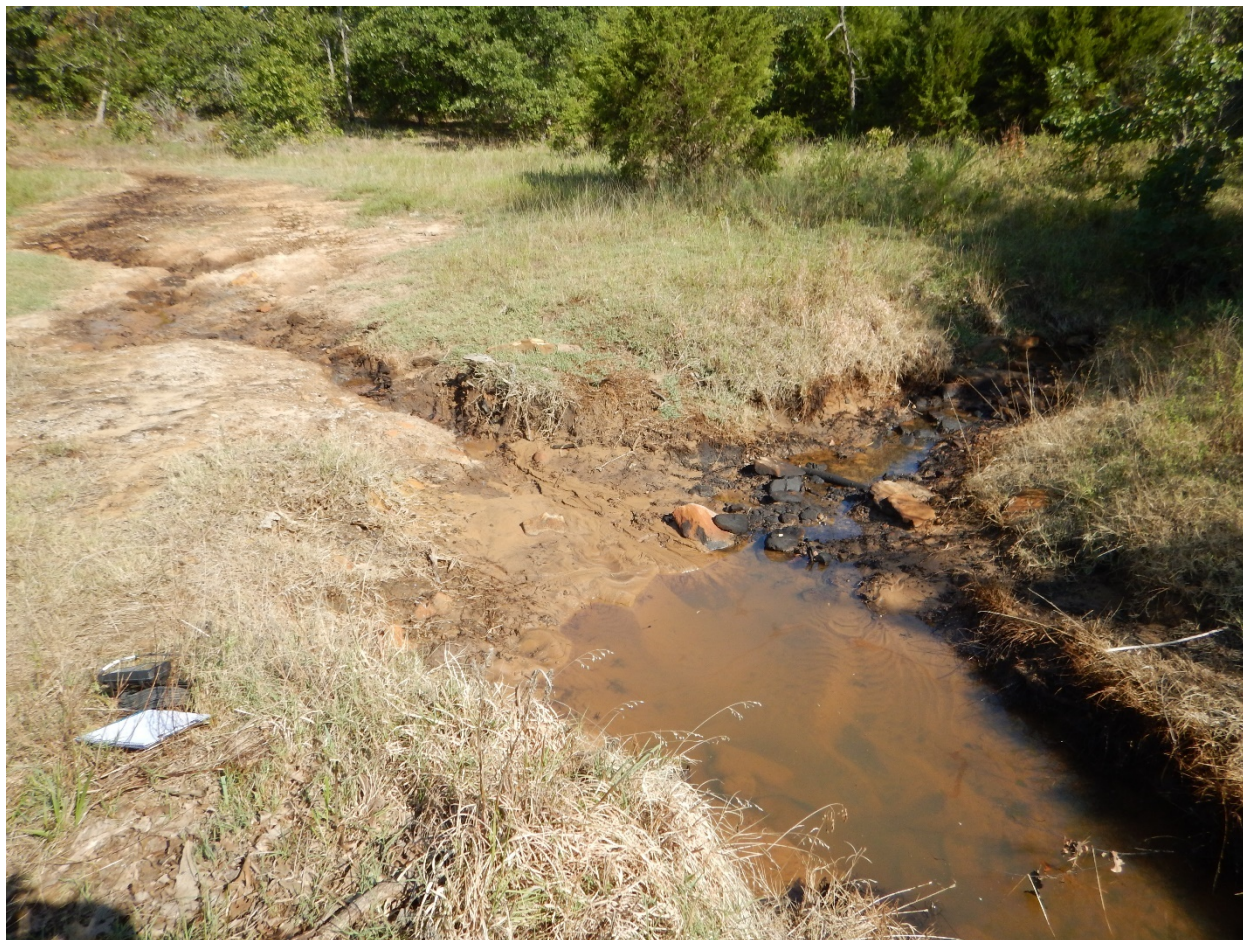
Photo No. 9

I observed the Point of Entry (POE) (GPS 36.259401, -96.226191) which was documented in photo No. 9. Oil-stained rocks and vegetation were observed at the POE. I observed an elevated TDS field reading of 83,288 mg/L at the POE (see photo No. 8) this was the highest TDS reading observed during the inspection.

**Description:** This was the POE and the pool of water where the TDS field reading of 83,288 mg/L TDS was observed. The flowpath can be seen coming into the impacted tributary. The flowpath traveled from the top left of the photo toward the bottom right and appeared light brown with a darker path of brown visible where produced fluids traveled.

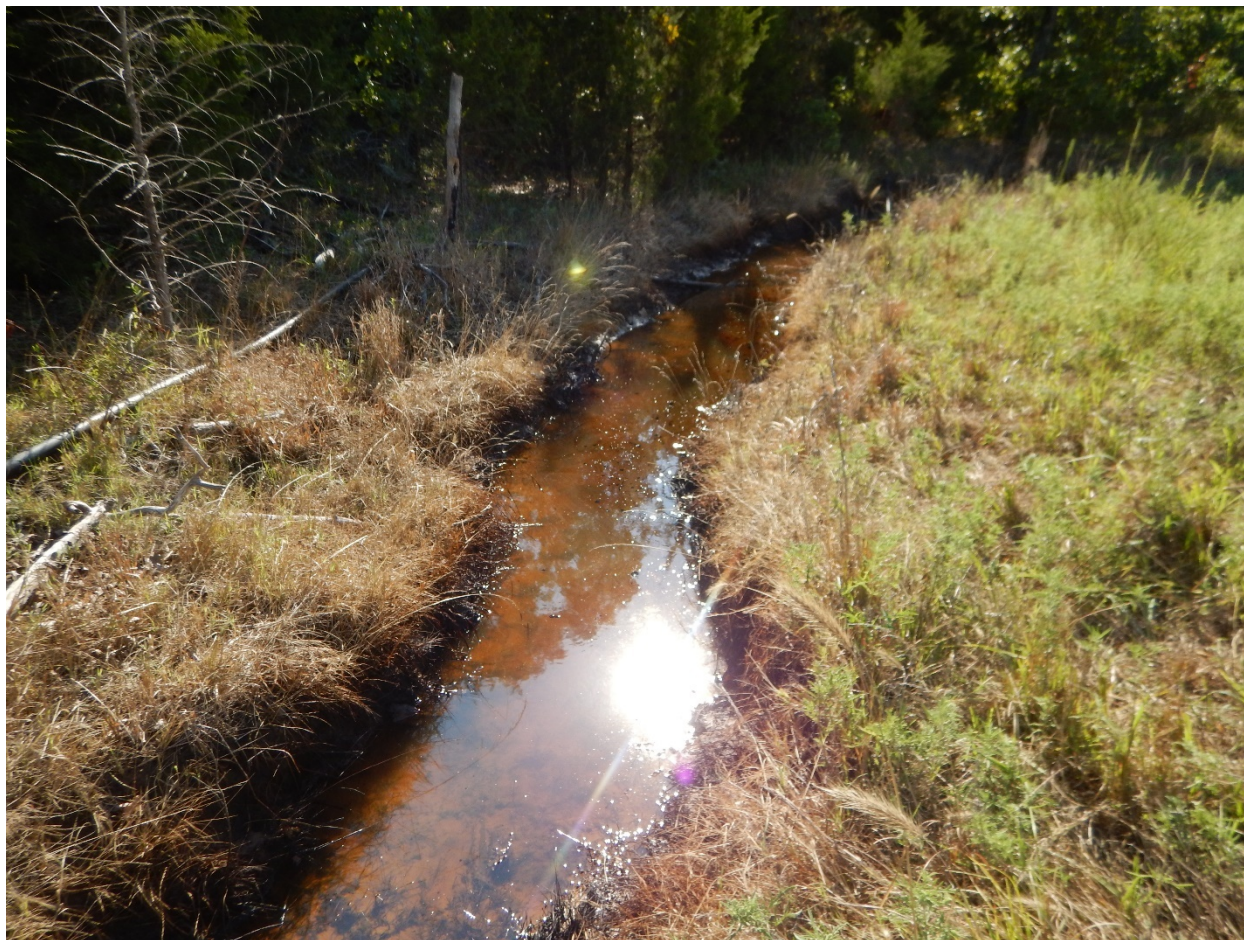
Photo No. 10

**Description:** This was a pool of water which began at the POE and flowed southwest along the main channel of the impacted tributary. Oil stains were present on the vegetation along the tributary as well as brine impacted grasses. The impacted vegetation can be seen in the photo and appears dark brown where it was impacted by oil and light brown where it was impacted by saltwater. At the time of the inspection the tributary did not have any visible instream flow. At the time of the inspection, the area of impacted vegetation along the tributary varied in width between 1 foot and 4 feet with an estimated average width of 2 feet along each bank of the tributary. As the spill impacts continued downstream, vegetation impacts decreased significantly approximately halfway to Mud Creek/Keystone Lake.

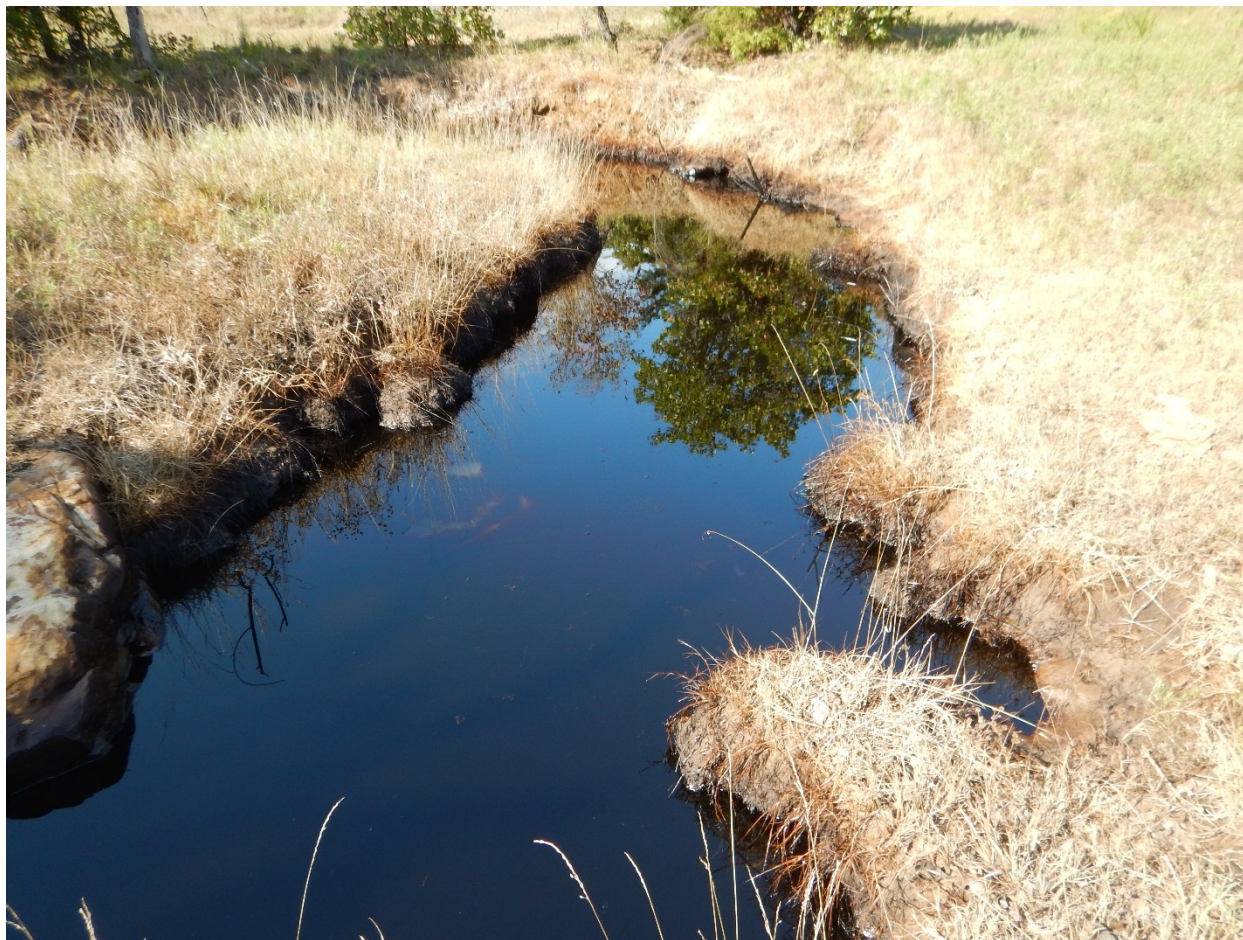
Photo No. 11

Approximately 150 feet downstream from the POE, along the main channel of the impacted tributary, I observed a pool of water covered an estimated 99% by a thin layer of crude oil. Oil-stained rocks, vegetation and banks were observed at the same location. The banks of the tributary showed a “high water mark,” evidence that recent rainfall impacted the tributary while the oil and produced water were present in the tributary (see photo No. 11). As the inspection continued downstream, I observed oil floating on small pools of water and oil-stained vegetation, banks, rocks, and streambed (see photo No. 12).

**Description:** This was a photo of oil floating in the main channel of the impacted tributary. This represented the most significant amount of oil observed during the inspection. The oil covered the pool of water to an estimated 99% but was only a thin layer with two small areas where the waters' surface was visible.

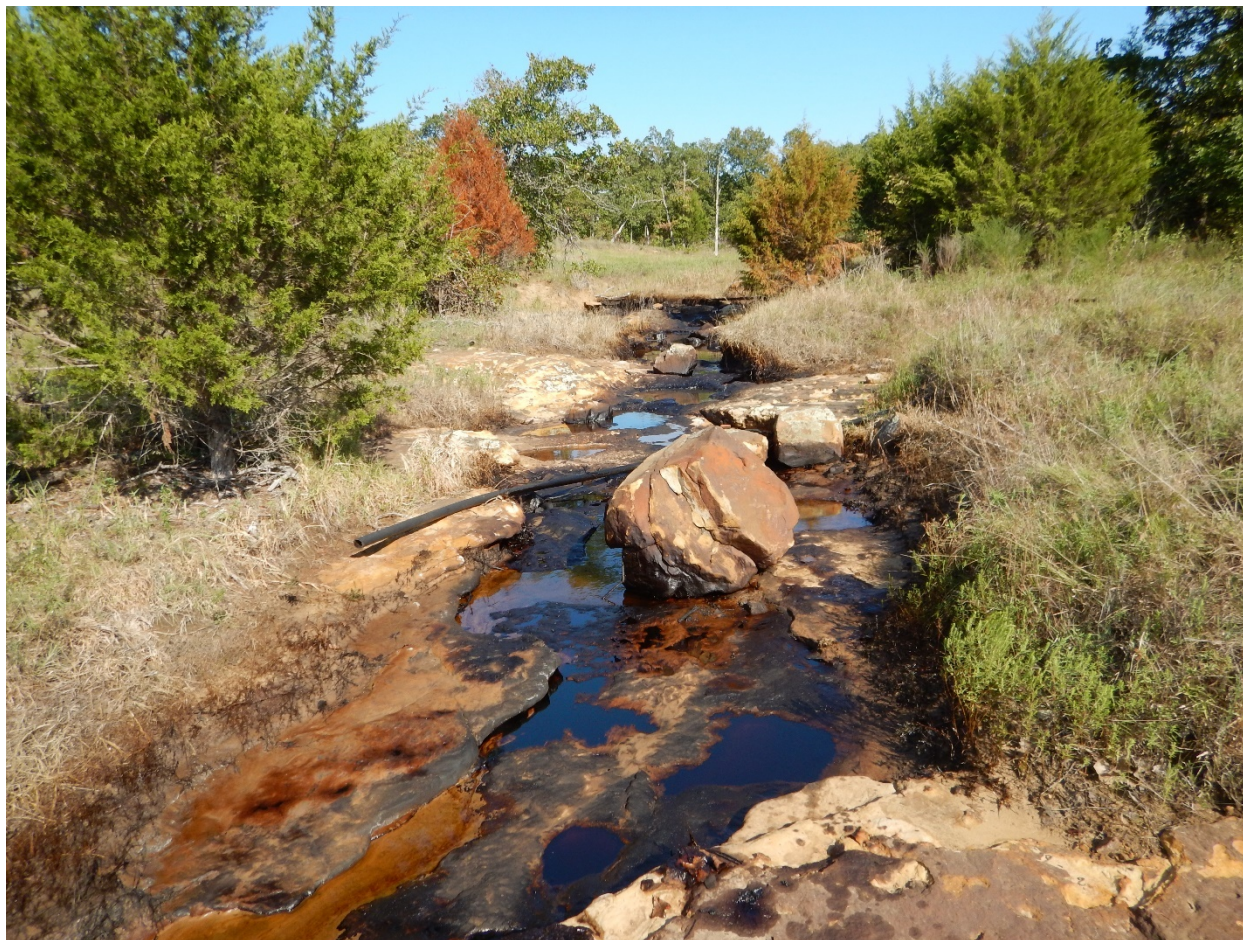
Photo No. 12

**Description:** This was a photo showing oil sitting on the bedrock channel of the impacted tributary.

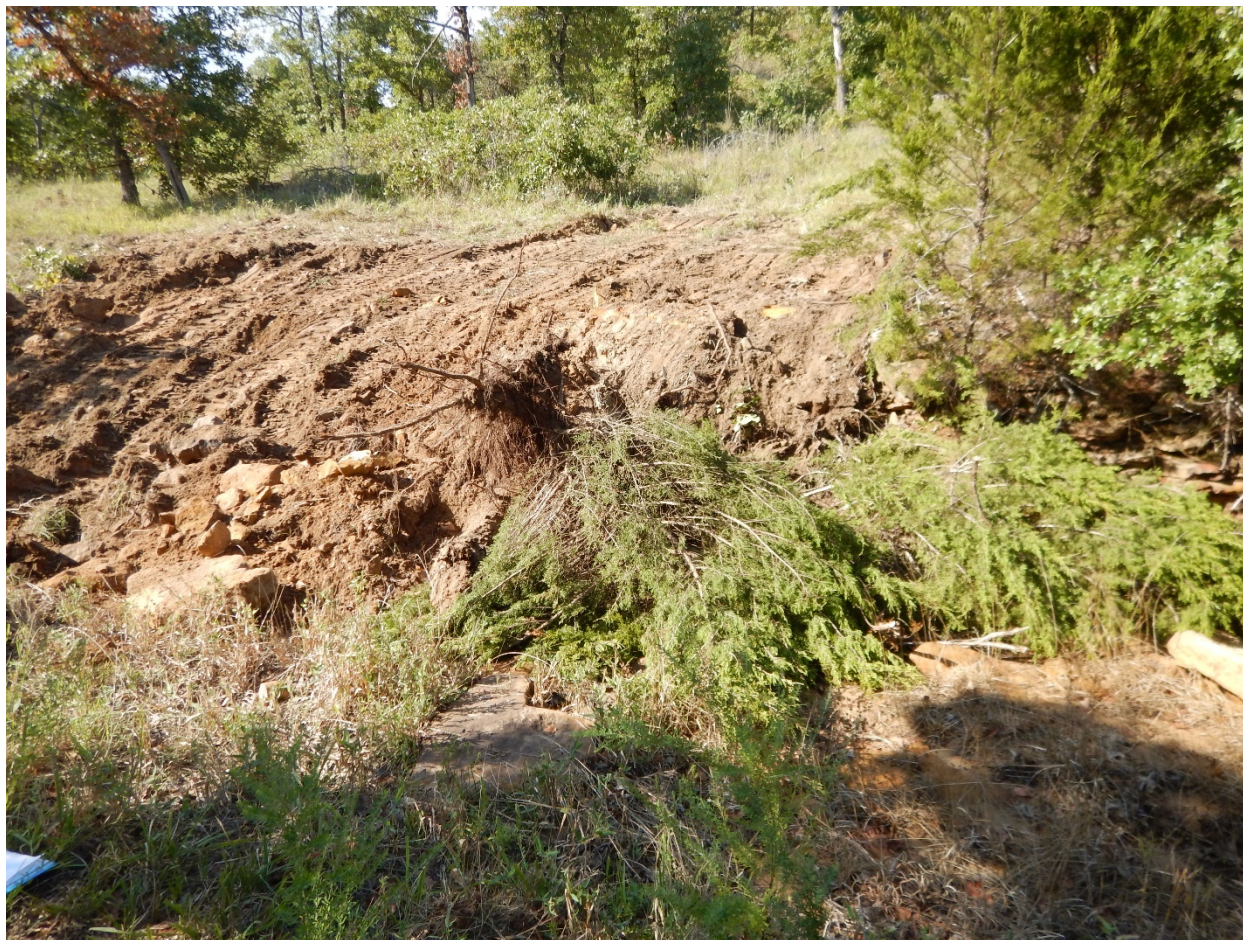
Photo No. 13

I observed a temporary containment dam placed by the operator across the impacted tributary to prevent downstream migration of impacted waters (photo No. 13) (GPS 36.260179, -96.227513).

**Description:** This was a temporary containment dam placed by the operator to ensure no additional fluids migrated downstream.

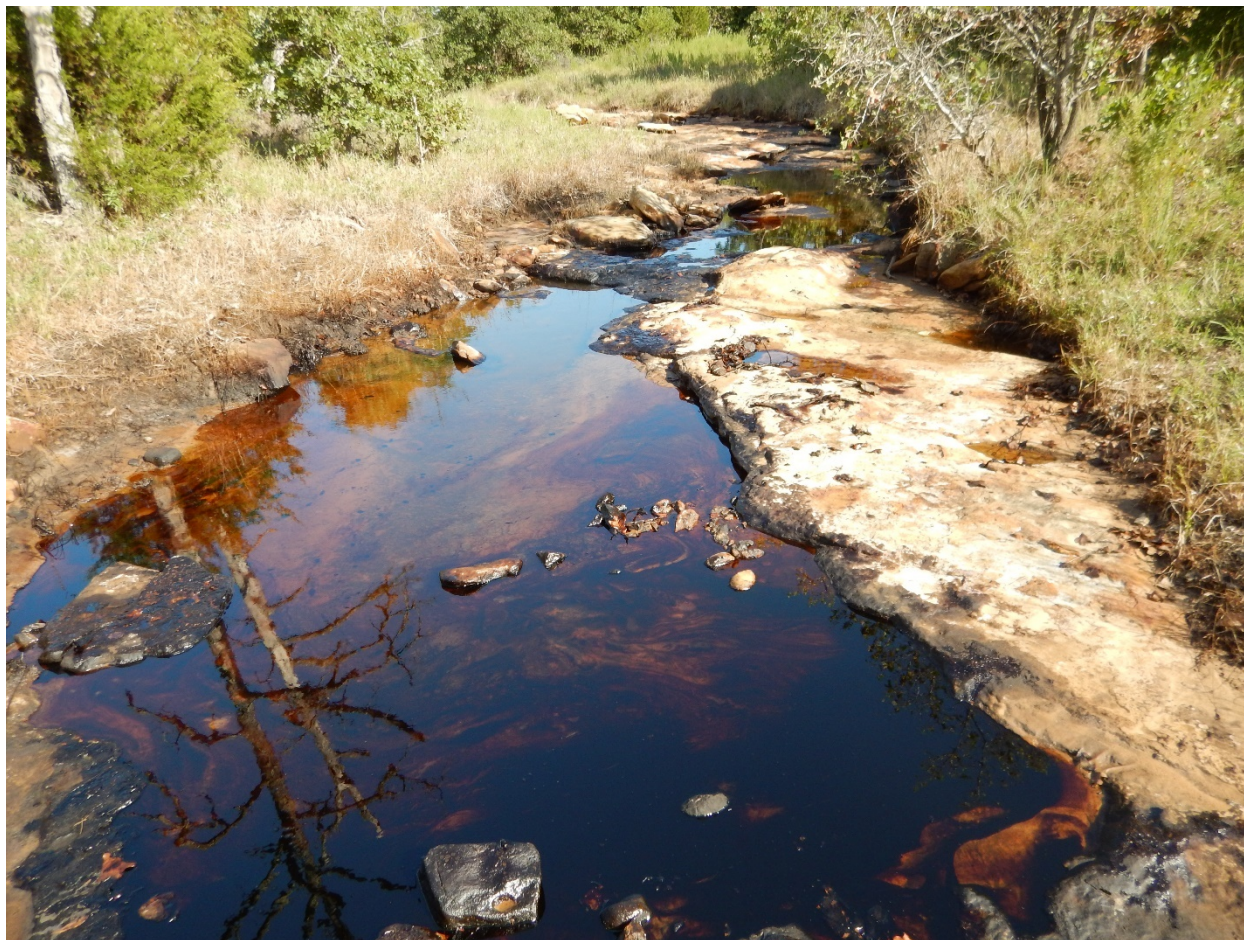
Photo No. 14

Continuing downstream beyond the first containment dam, I observed oil, oil-stained streambed, rocks, vegetation, and banks as well as an elevated TDS field reading of 25,918 mg/L (photos No. 14 and 15).

**Description:** This was a photo of oil floating on the surface of the impacted tributary. Oil-stained rocks and vegetation were also present in the photo.

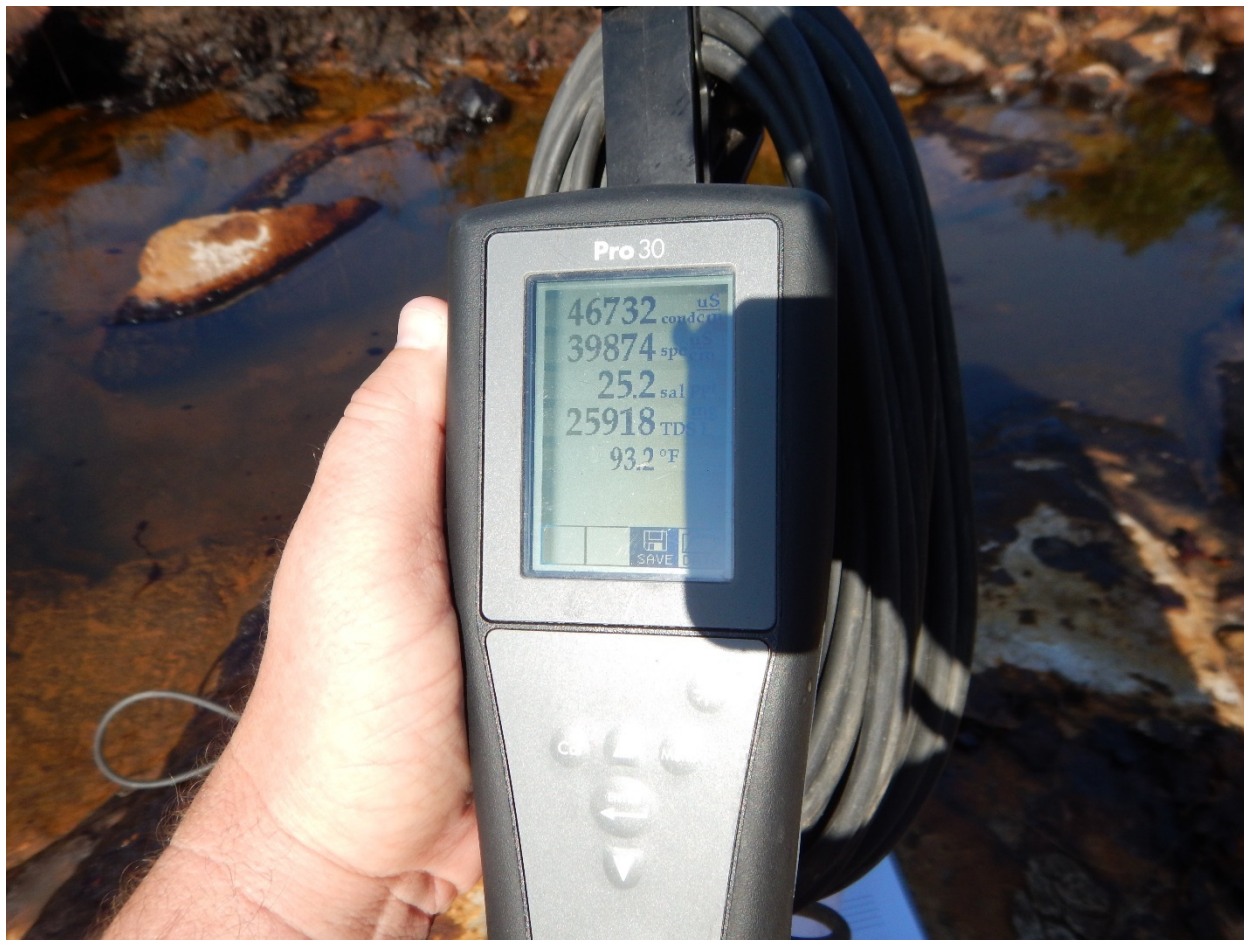
Photo No. 15

**Description:** This was an elevated TDS field reading of 25,918 mg/L taken in the same pool of water pictured in photo 15 of this photo log.

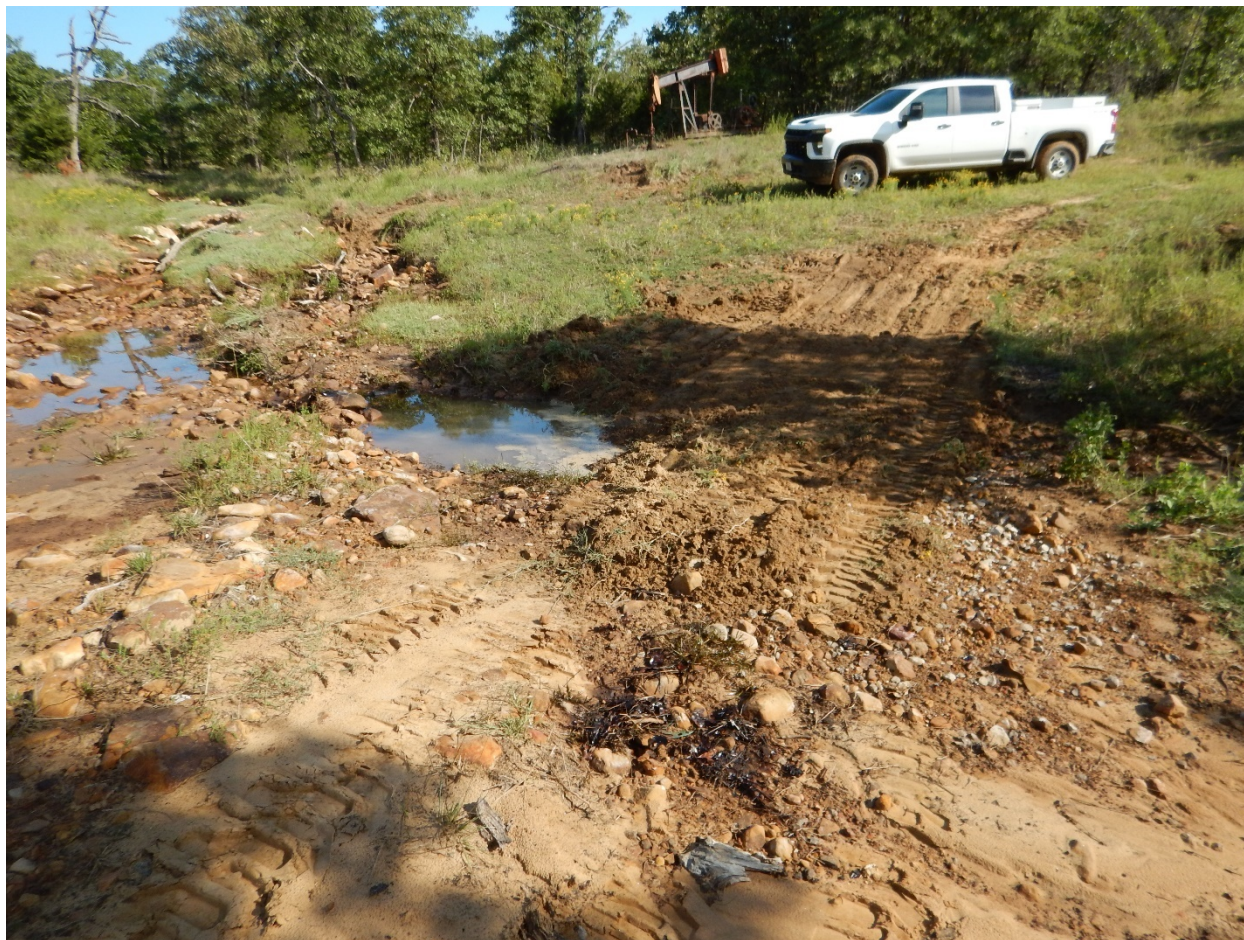
Photo No. 16

I observed a second temporary containment dam placed by the operator across the impacted tributary. (Photo No. 16) (GPS 36.261333, -96.229855).

**Description:** This was a photo of the second temporary containment dam installed by the operator to prevent fluid migration downstream.

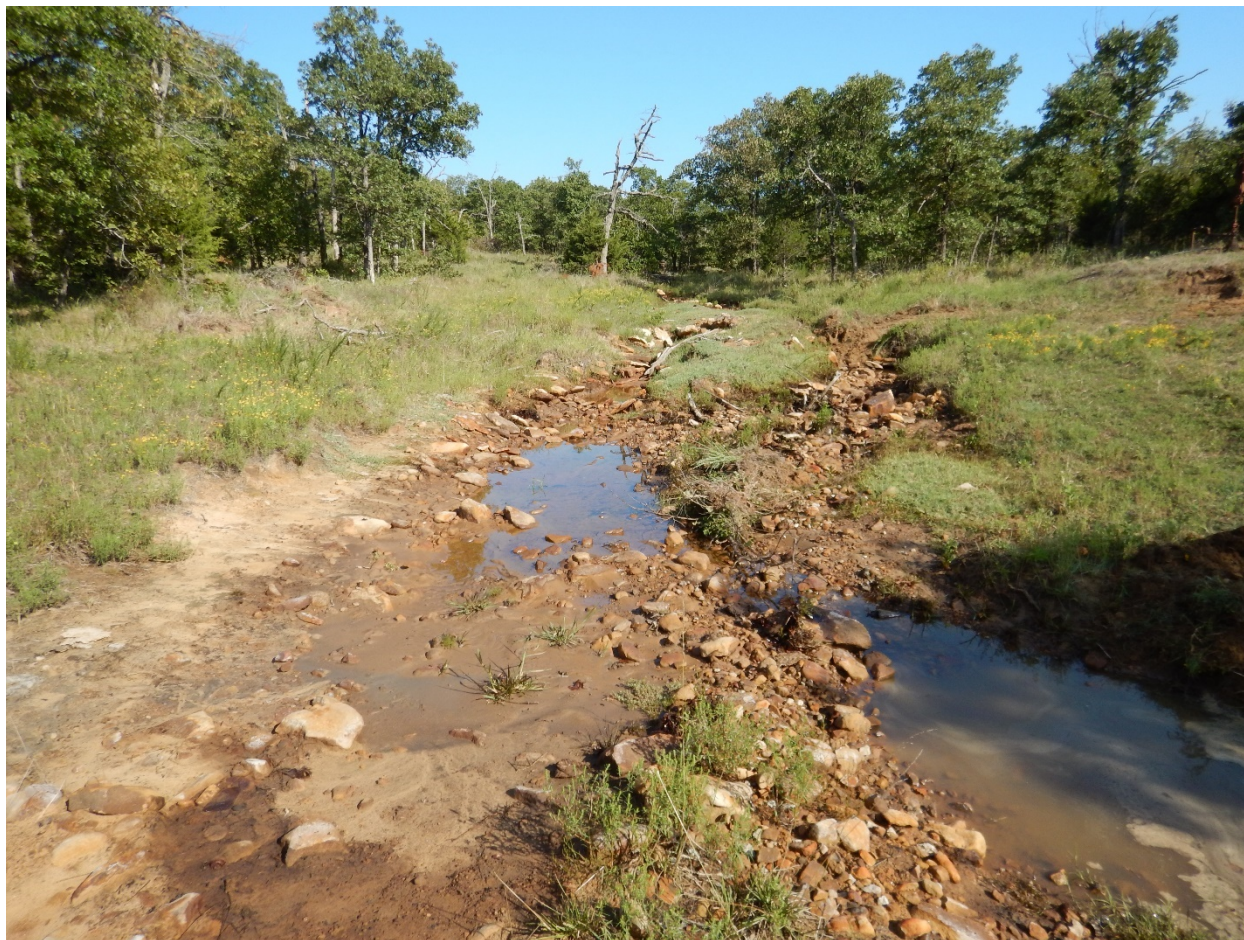
Photo No. 17

**Description:** This was a photo taken from the second temporary containment dam, looking toward the west/downstream. This photo showed the bed and bank features of the impacted tributary and was one of the few places where sediment was present in the tributary which could trap brine and require special attention during the cleanup activities.

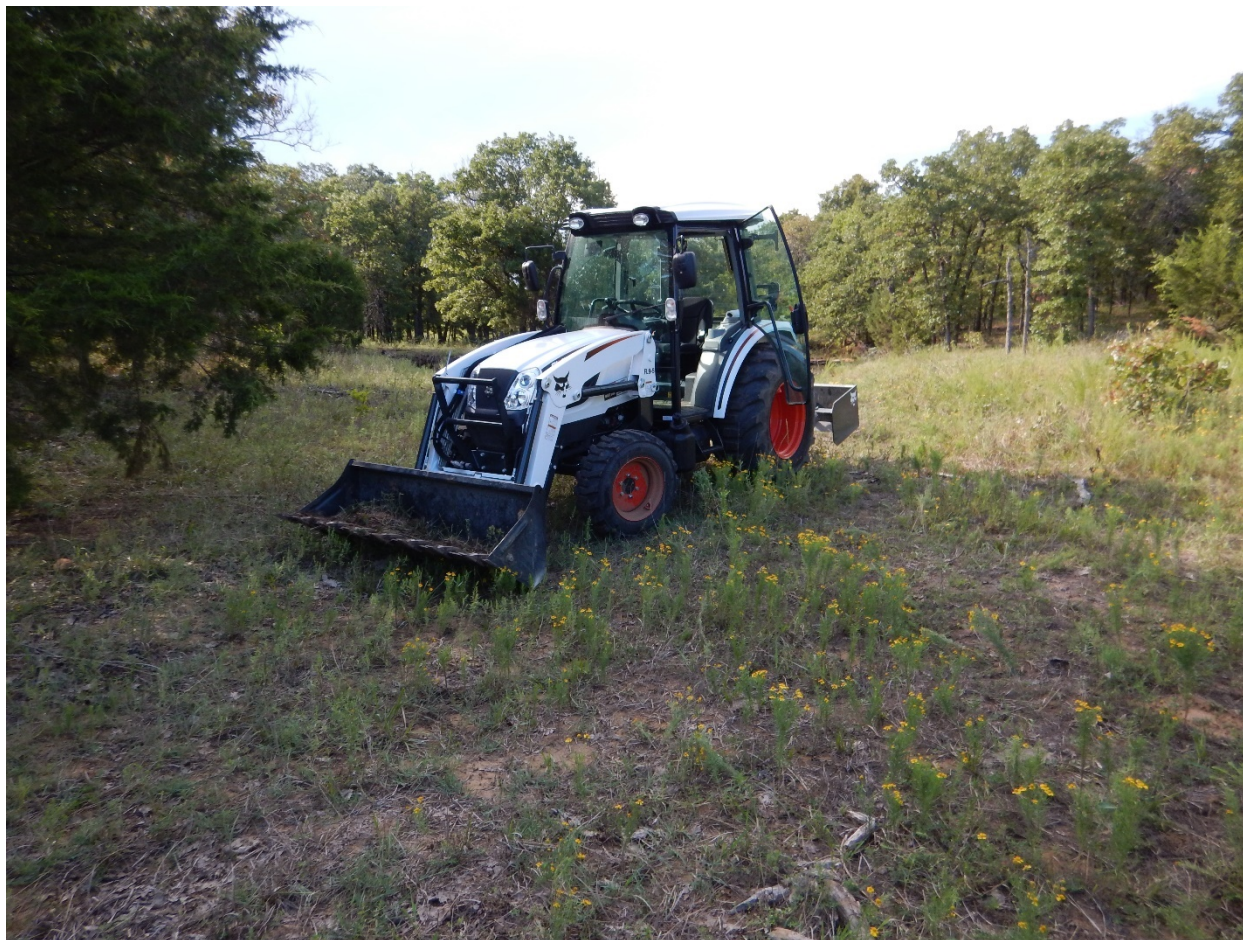
Photo No. 18

During the inspection I briefly spoke with an employee of the operator who was operating a tractor, which placed the temporary containment dams. I also observed the equipment operator working to clear a path along the impacted tributary so cleanup personnel could access the impacted areas. The tractor can be seen in photo No. 18.

**Description:** This was a tractor which I observed installing the temporary containment dams. During the inspection, I also observed the tractor and operator clearing an access path along the impacted tributary to make the area accessible to cleanup crews and equipment.

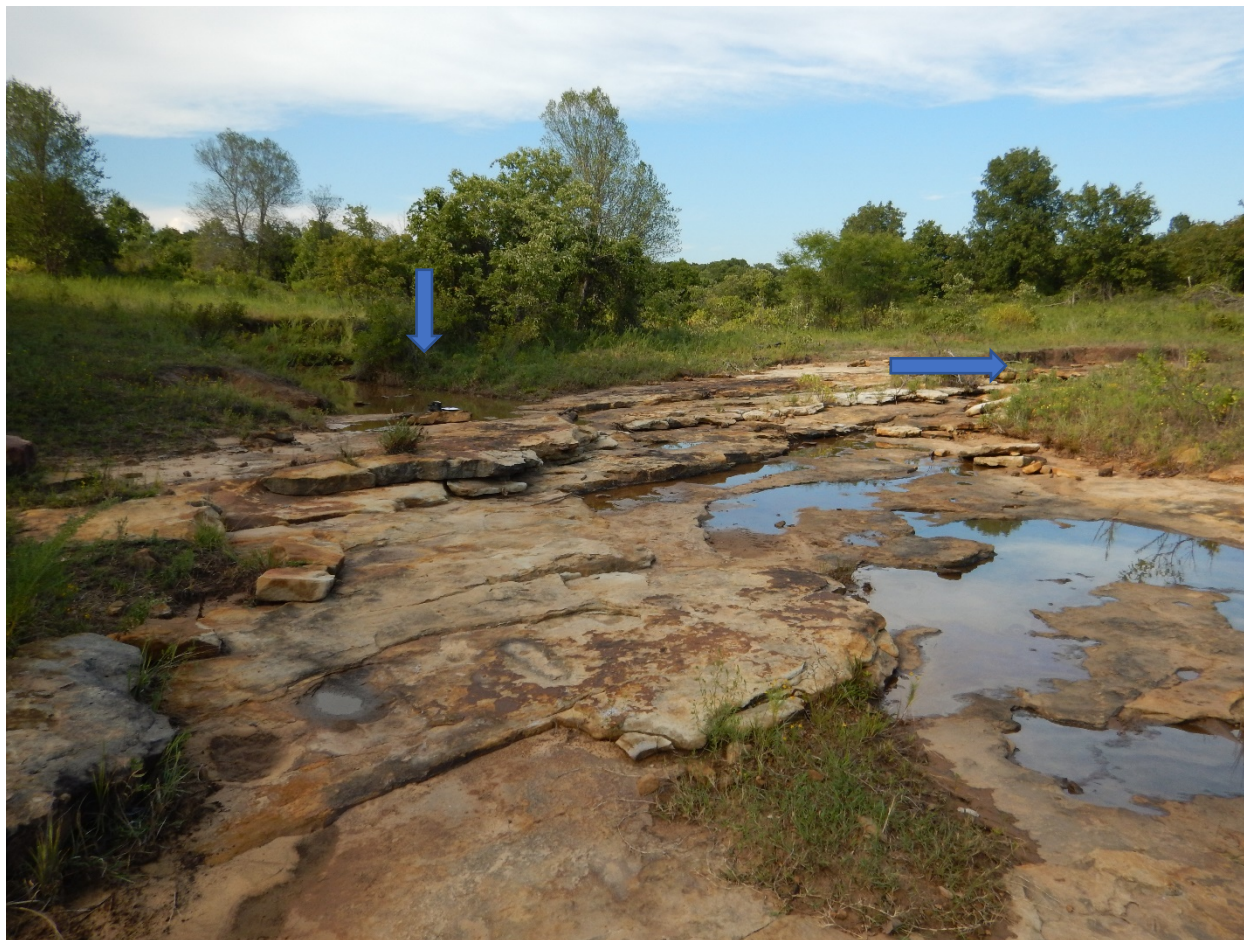
Photo No. 19

**Description:** This was the confluence of the impacted tributary and another tributary which was not impacted. The impacted tributary entered the picture from the right and is highlighted by the horizontal arrow. The adjoining tributary which was not impacted entered the photo from the top and is highlighted by the vertical arrow. I observed a "background" TDS field reading of 117.4 mg/L just below the horizontal arrow.
