**Region 6 - Enforcement & Compliance Assurance Division**  
**INSPECTION REPORT**

| Company Name: | Northcote Cleveland LLC | |
| Facility Name: | Osage B Lease | |
| Identification/Permit Number: | OKU000856 | |

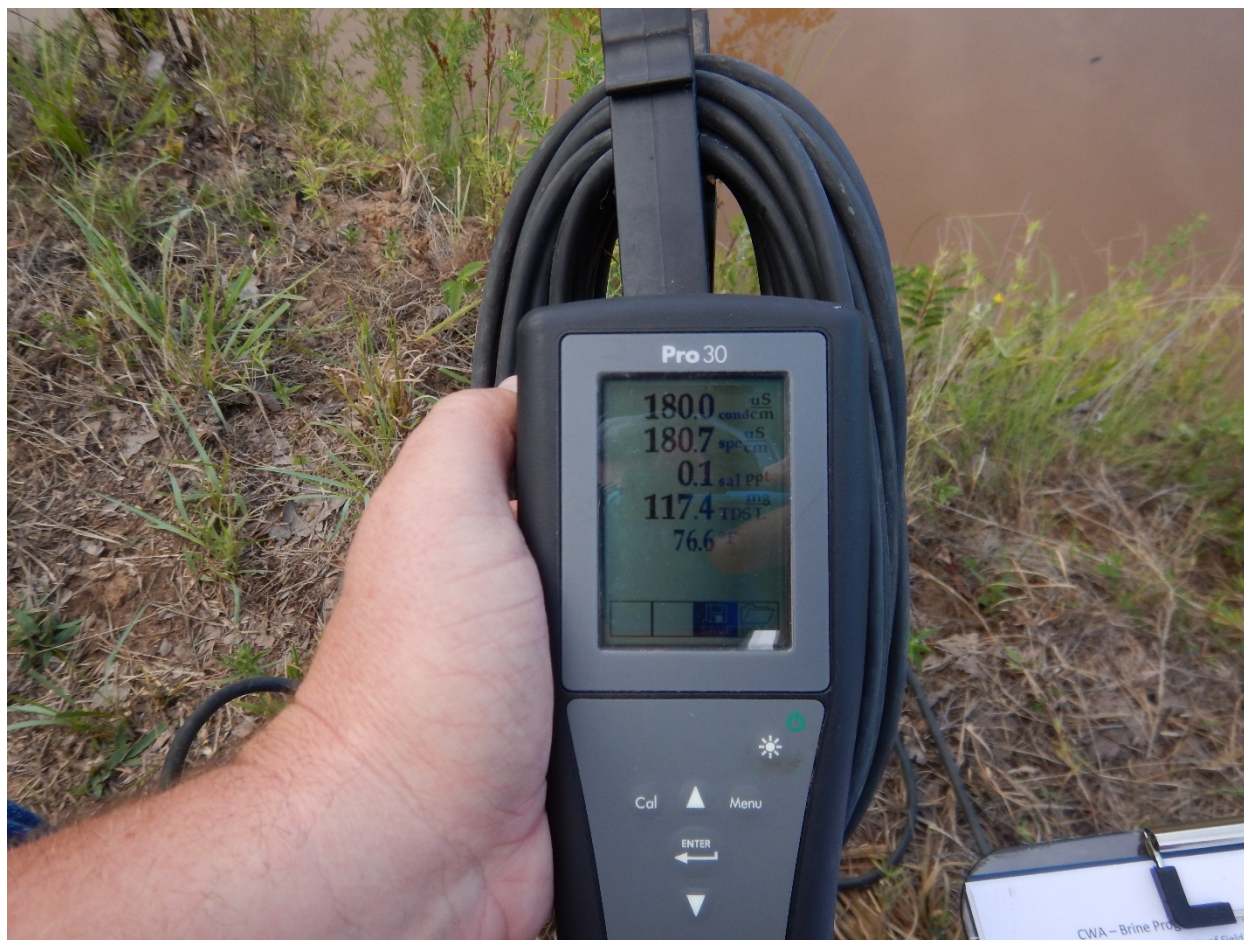
Photo No. 20

**Description:** This was a "background" TDS field reading of 117.4 mg/L observed in the adjoining tributary which was not impacted by the spill.

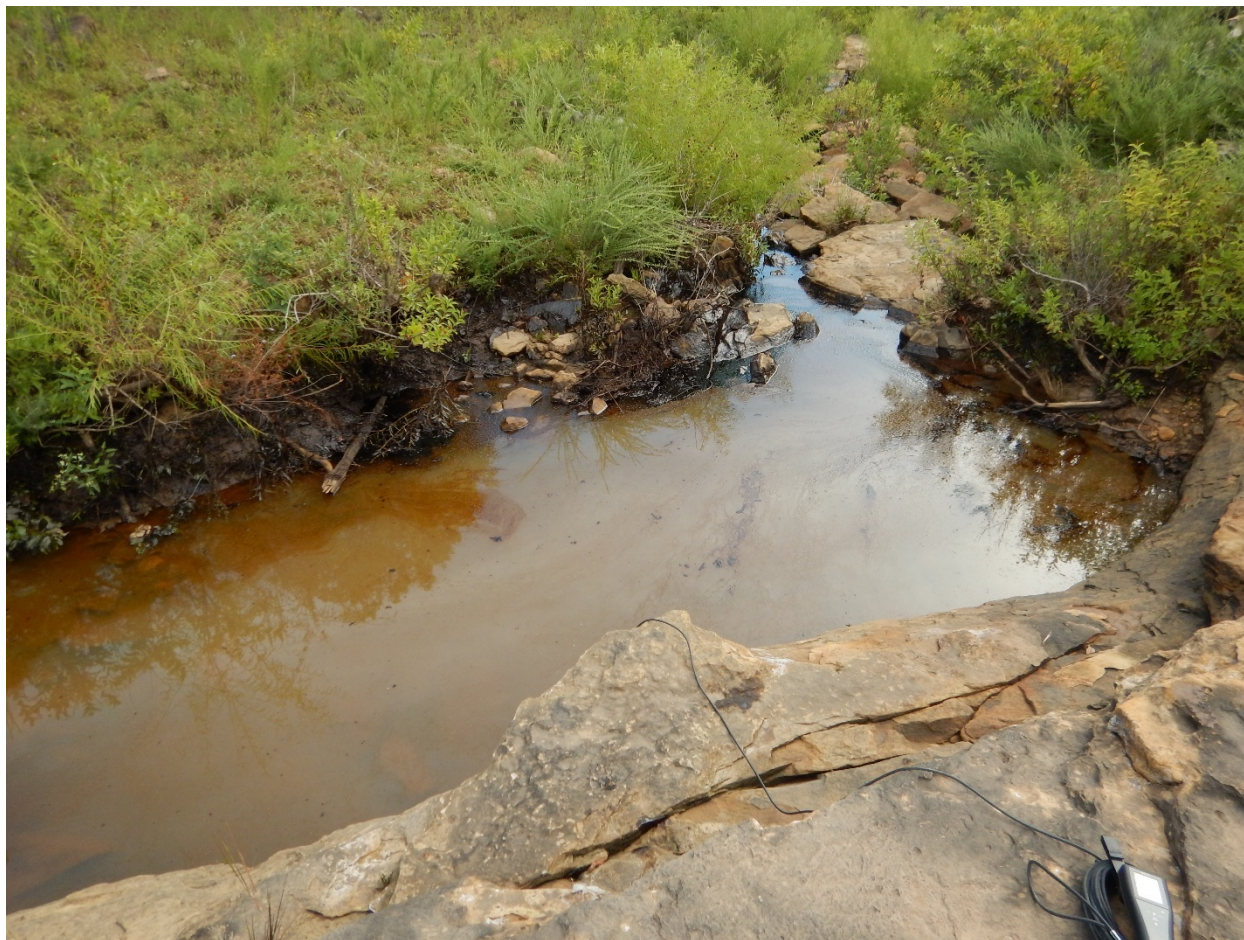
**Description:** This is the last pool of water along the impacted tributary before it spills into Mud Creek/Keystone Lake. The elevated TDS field reading from photo 23 was taken at this location. Oil was present on the water and oil-stained vegetation/rocks were present at this location.

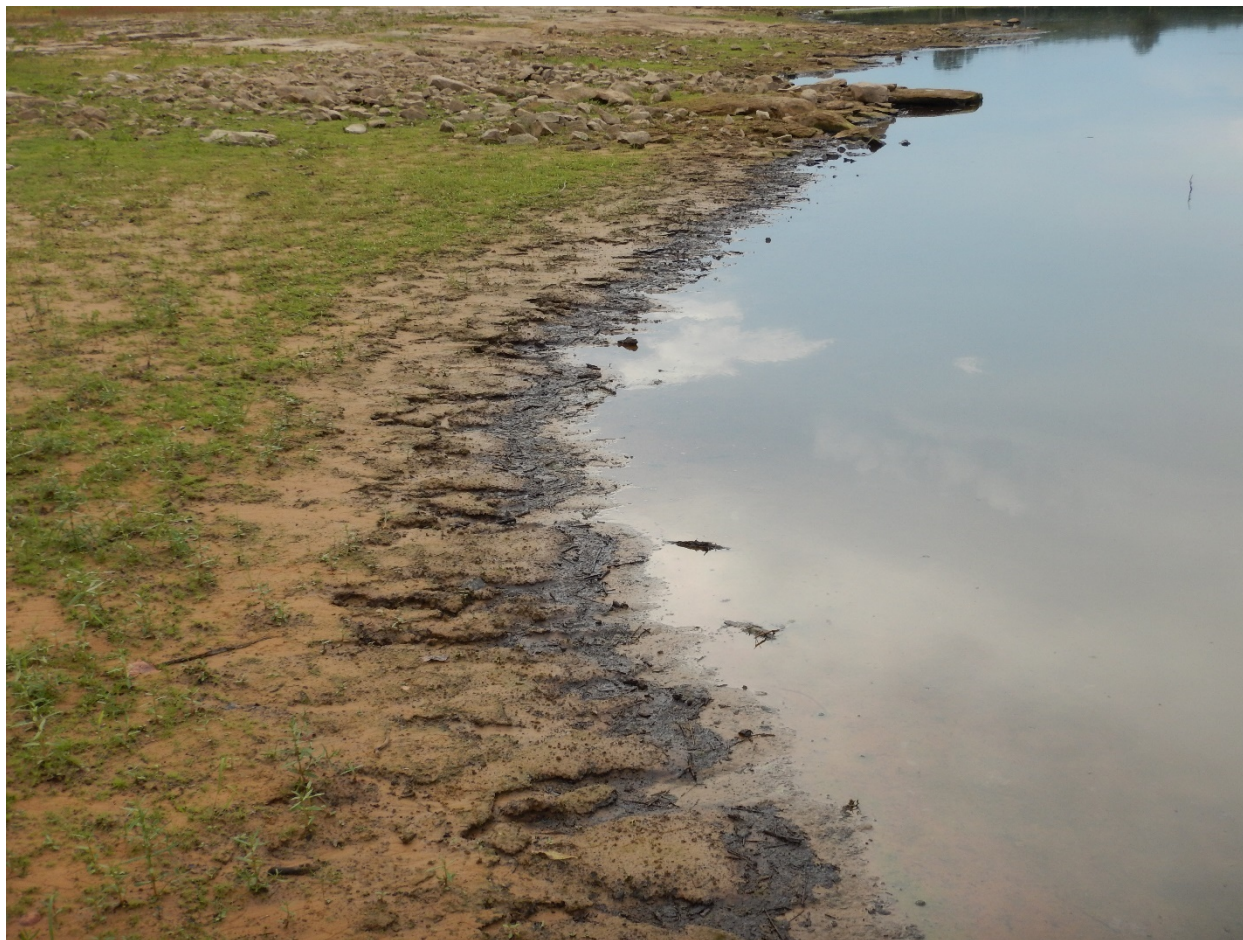
**Description:** This was a photo of oil-stained shoreline along Mud Creek/Keystone Lake.

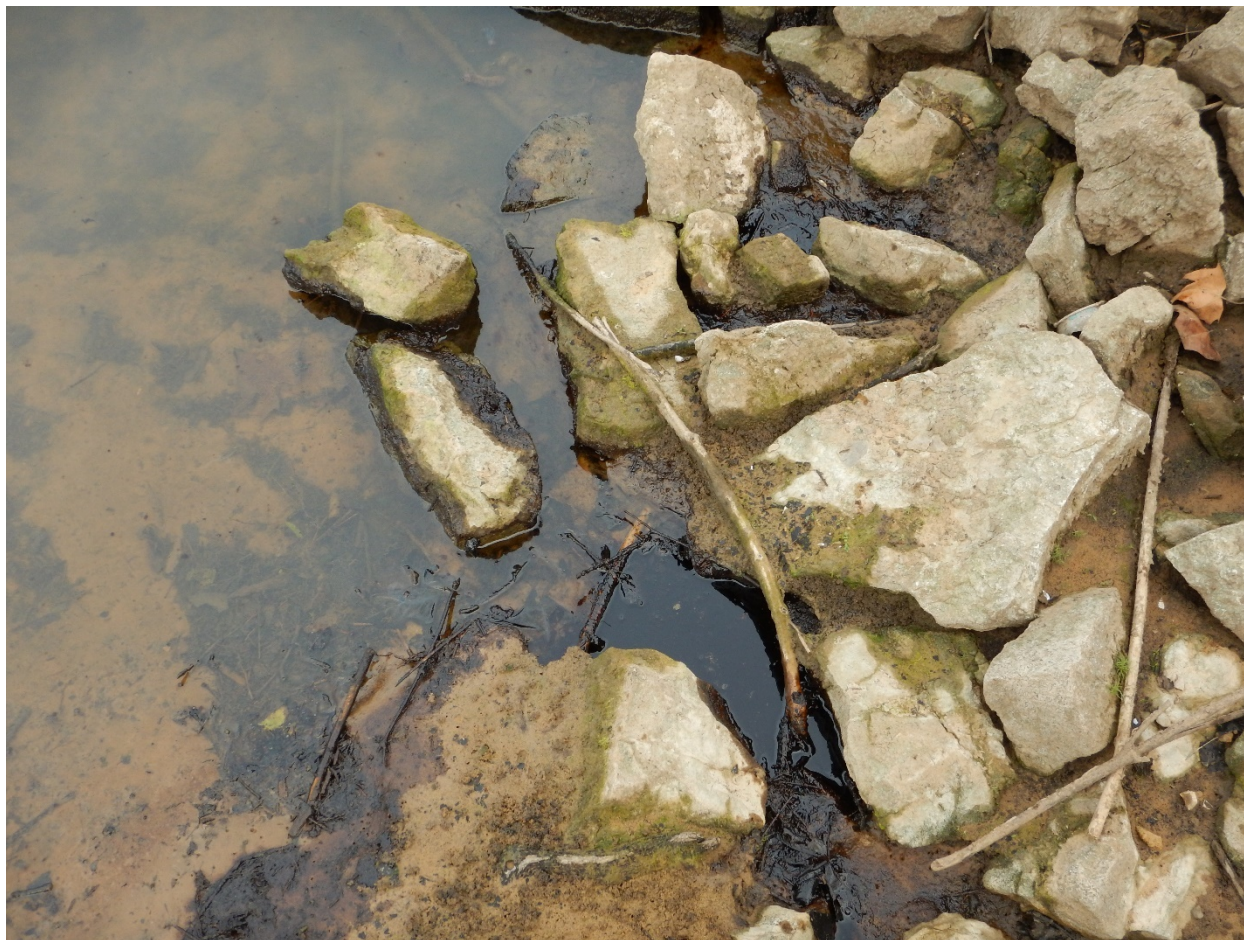
**Description:** This was a photo of oil and oil-stained rocks along the rip rap at the base of New Prue Road as it crossed Mud Creek/Keystone Lake.

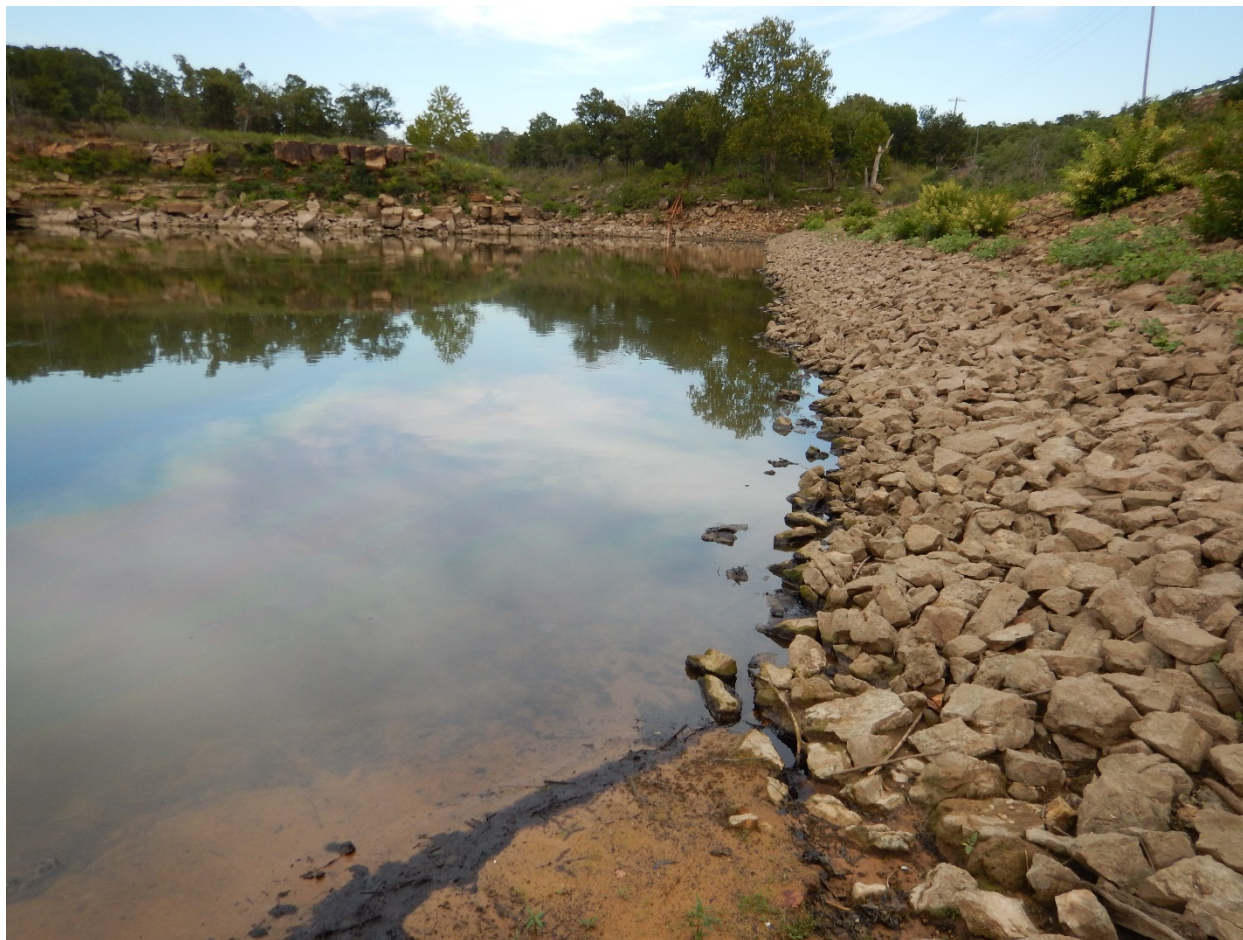
**Description:** This is a photo looking NE along the base of New Prue Road as it crossed Mud Creek/Keystone Lake. Oil and oil-stained shoreline/rip rap were present at the time of the inspection. Oil and oil sheen were floating on the water at this location.

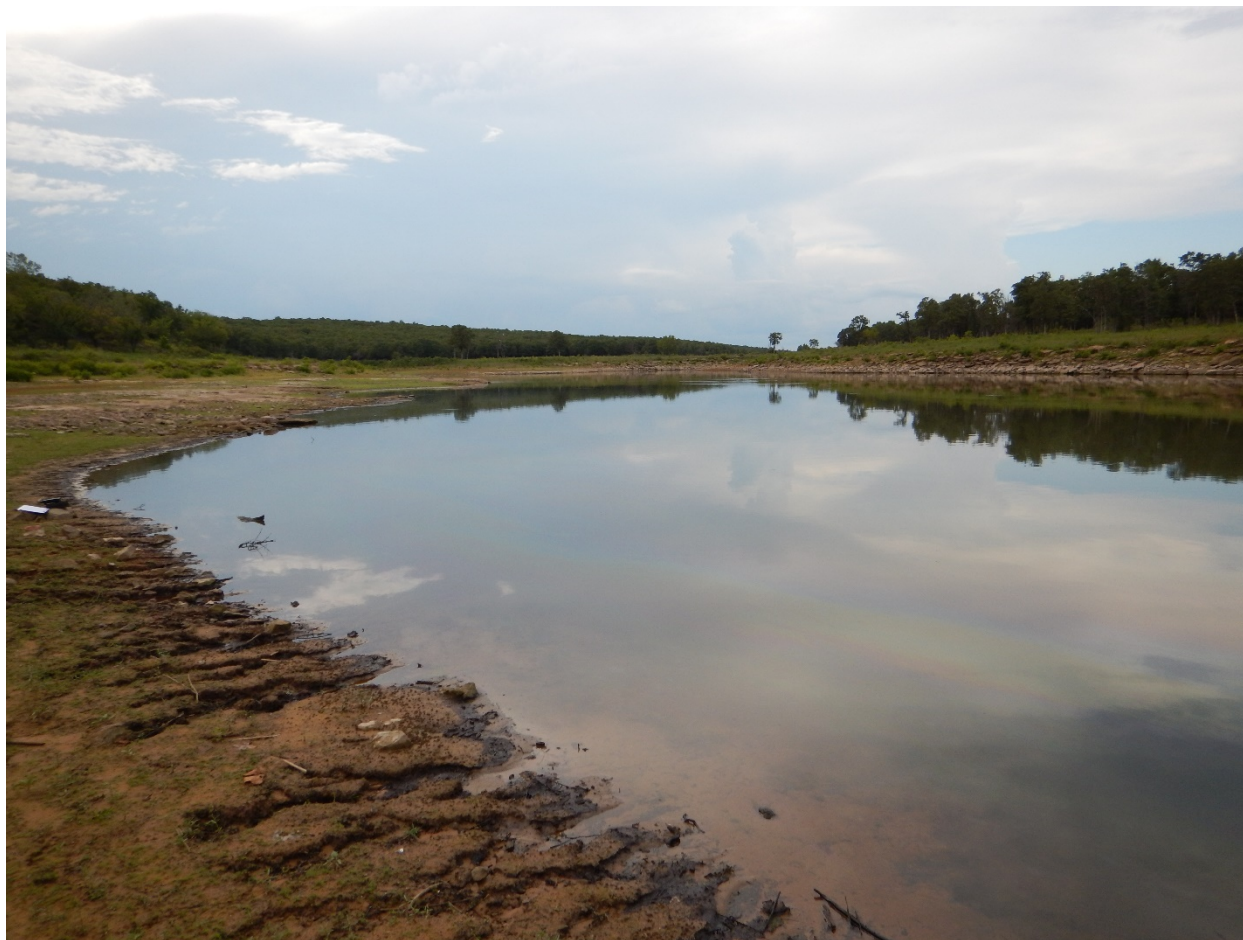
**Description:** This was a view from the base of New Prue Road looking NW up Mud Creek/Keystone Lake toward the impacted tributary. Oil, oil-stained shoreline, and a rainbow-colored oil sheen was present in the photo.
