**UNITED STATES ENVIRONMENTAL PROTECTION AGENCY**  
**OFFICE OF ENFORCEMENT AND COMPLIANCE ASSURANCE**

**SUBJECT:** CLEAN AIR ACT INSPECTION REPORT  
Waste Management Atascocita Landfill, Humble, TX

**Facility Name:** Waste Management Atascocita Landfill

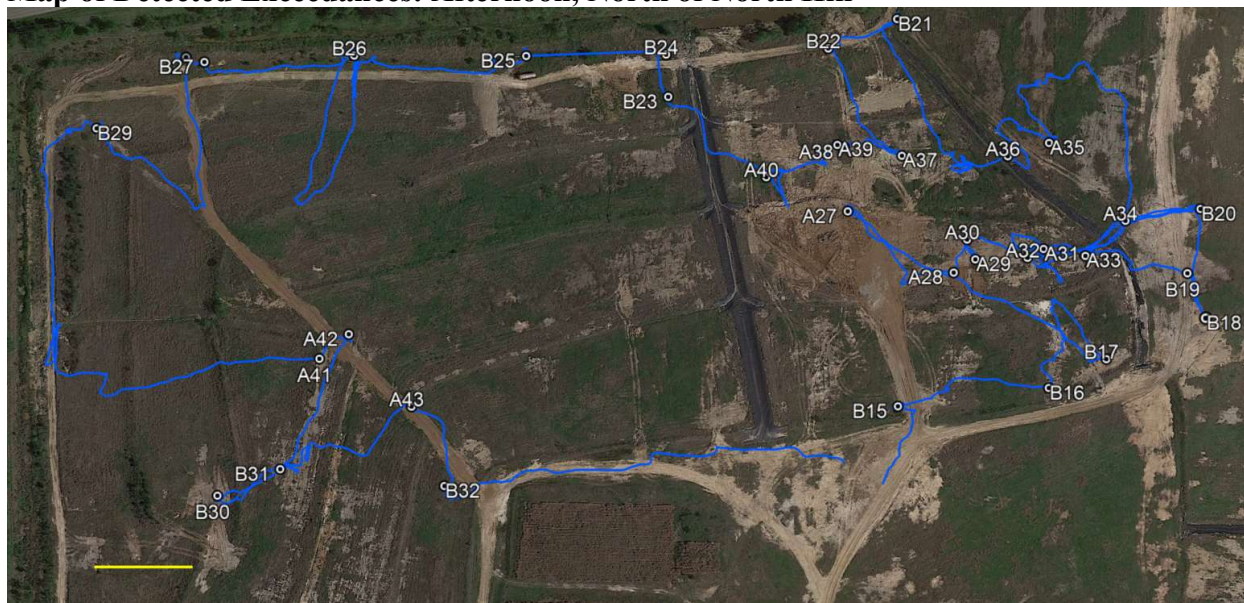
### Map of Detected Exceedances: Afternoon, North of North Hill

Blue line roughly shows EPA survey coverage, tracing the confirmation reading instrument. Exceedance locations labeled with their flag numbers. Yellow line is 50m, north is up. Satellite imagery dated to April 2022 as shown on Google Earth. Survey area covered less than 33 acres.

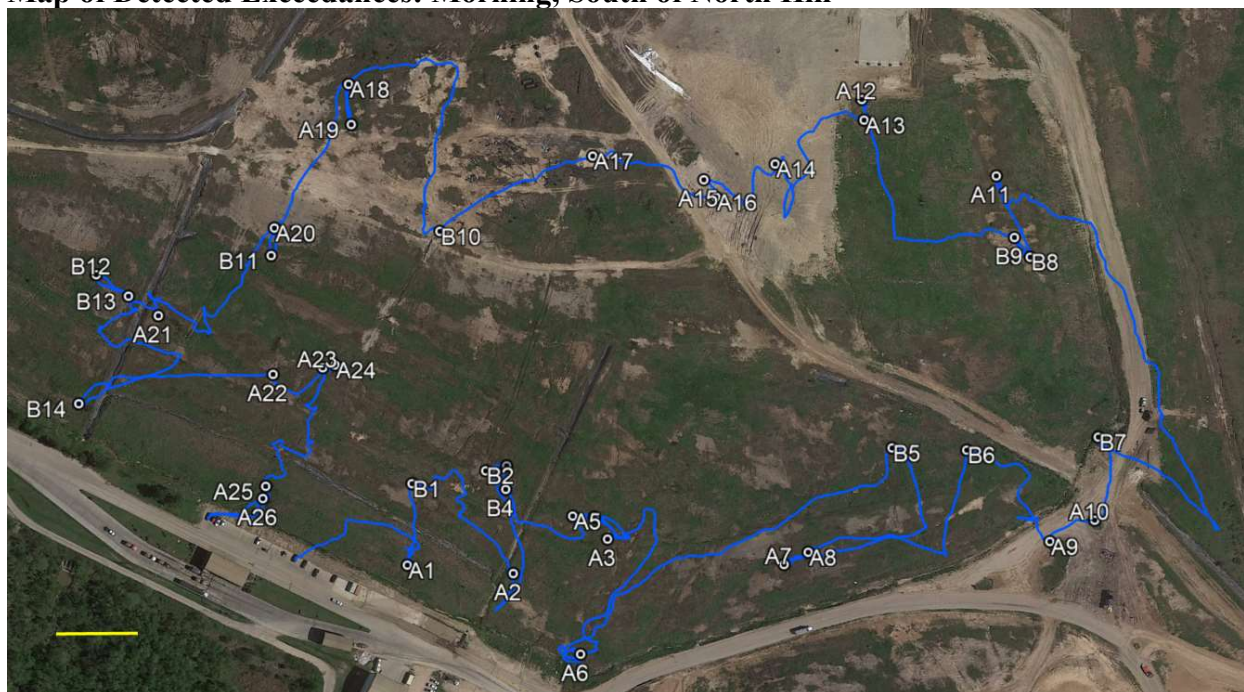
### Map of Detected Exceedances: Morning, South of North Hill

Blue line roughly shows EPA survey coverage, tracing the confirmation reading instrument. Exceedance locations labeled with their flag numbers. Yellow line is 50m, north is up. Satellite imagery dated to April 2022 as shown on Google Earth. Survey area covered less than 52 acres.
