**UNITED STATES ENVIRONMENTAL PROTECTION AGENCY  
REGION 8  
RESOURCE CONSERVATION AND RECOVERY ACT**

**Facility Name:** Estvold Oilfield Services Pipe Yard    **RCRA ID:** NDR000014183

**Date of Inspection:** September 18, 2024  
**Arrival Time:** 9:40 a.m.  
**Departure Time:** 10:30 a.m.

**Type and Purpose of Inspection:**    Compliance Evaluation Inspection  
Compliance with RCRA Subtitle C

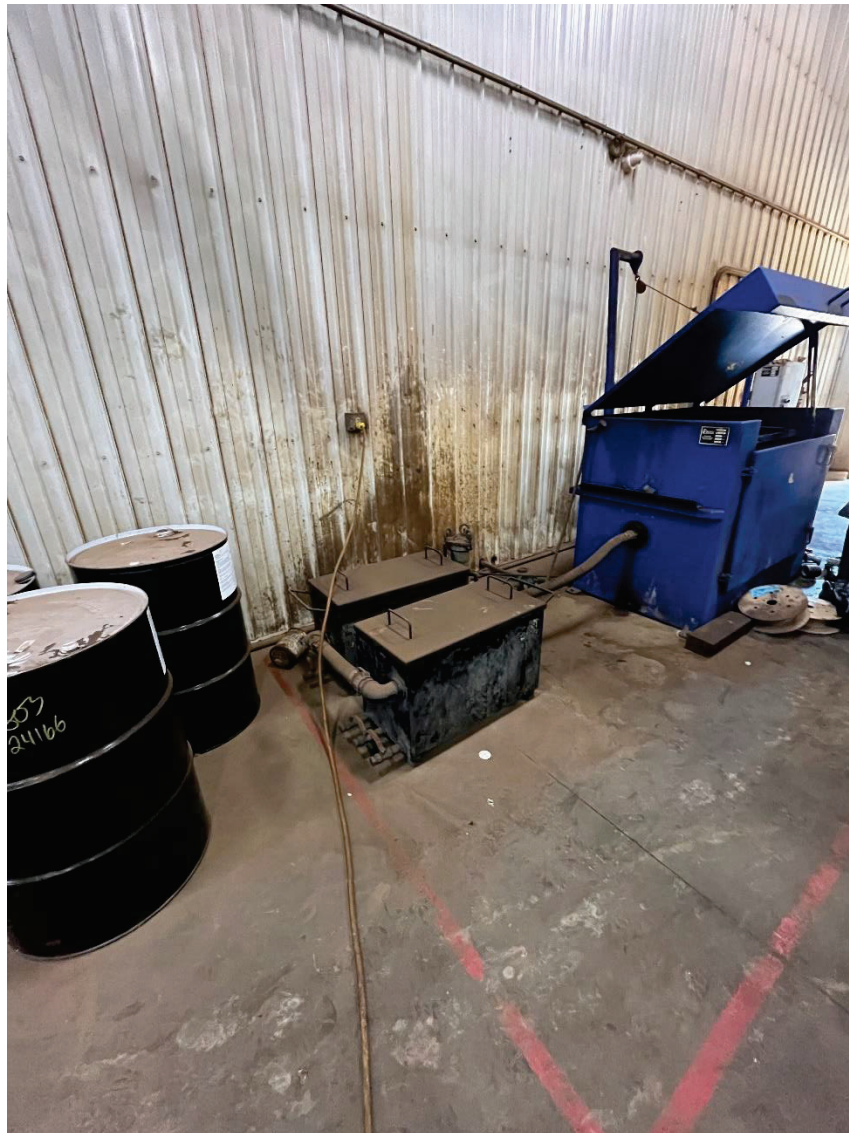
In the indoor parts washer area, I observed the washer, two filter boxes, and nearby drums that Mr. Cisneros identified as the parts washer solvent, which were labeled Sunnyside Mineral Spirits. See Attachment 3 – Photo 1.

Photo 1: IMG\_0105.jpg, 9/18/2024, 9:54 a.m. – photo of an indoor blue parts washer at right, black filters at center, and chemicals at left including Sunnyside Mineral Spirits for use in the parts washer.

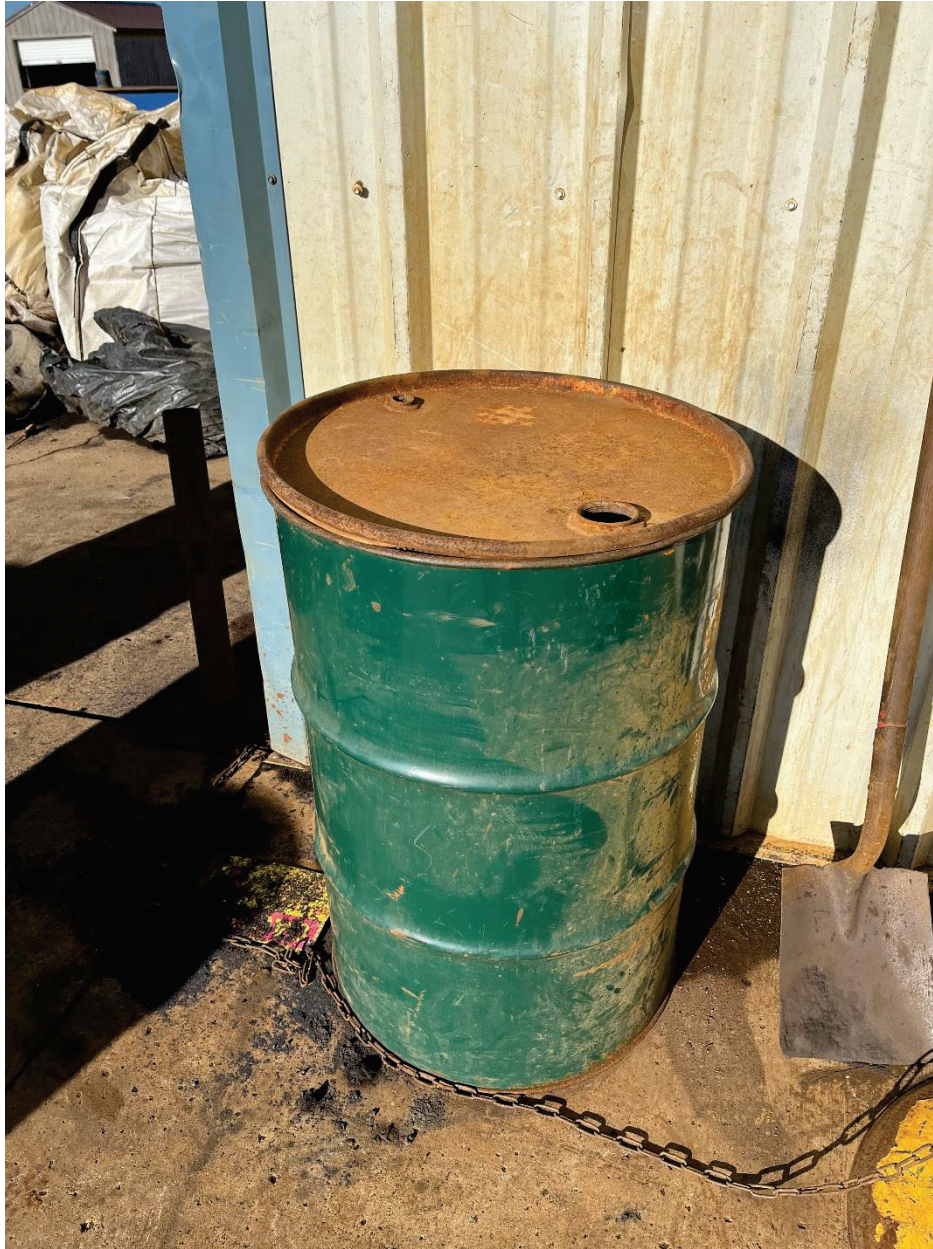
Outdoors at the southeast corner of the building, I observed a green metal 55-gallon drum containing a powdery substance that Mr. Cisneros said was pipe scale solids. See Attachment 3, photos 2-3.

Photo 2: IMG\_0106.jpg, 9/18/2024, 9:55 a.m. – photo of a drum containing powdery pipe scale solids.

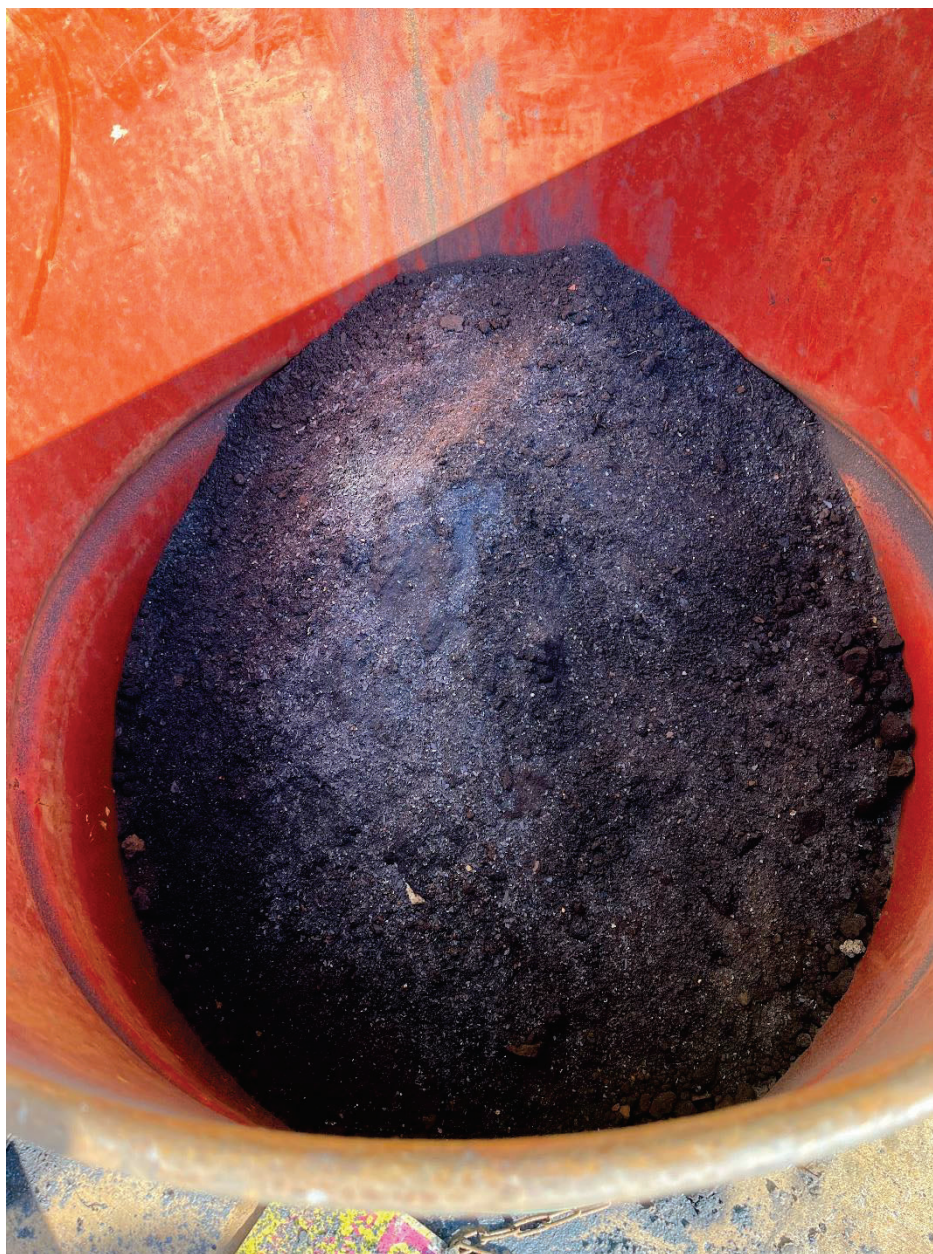
Photo 3: IMG\_0107.jpg, 9/18/2024, 9:56 a.m. – photo of the contents of the drum shown in photo 2.

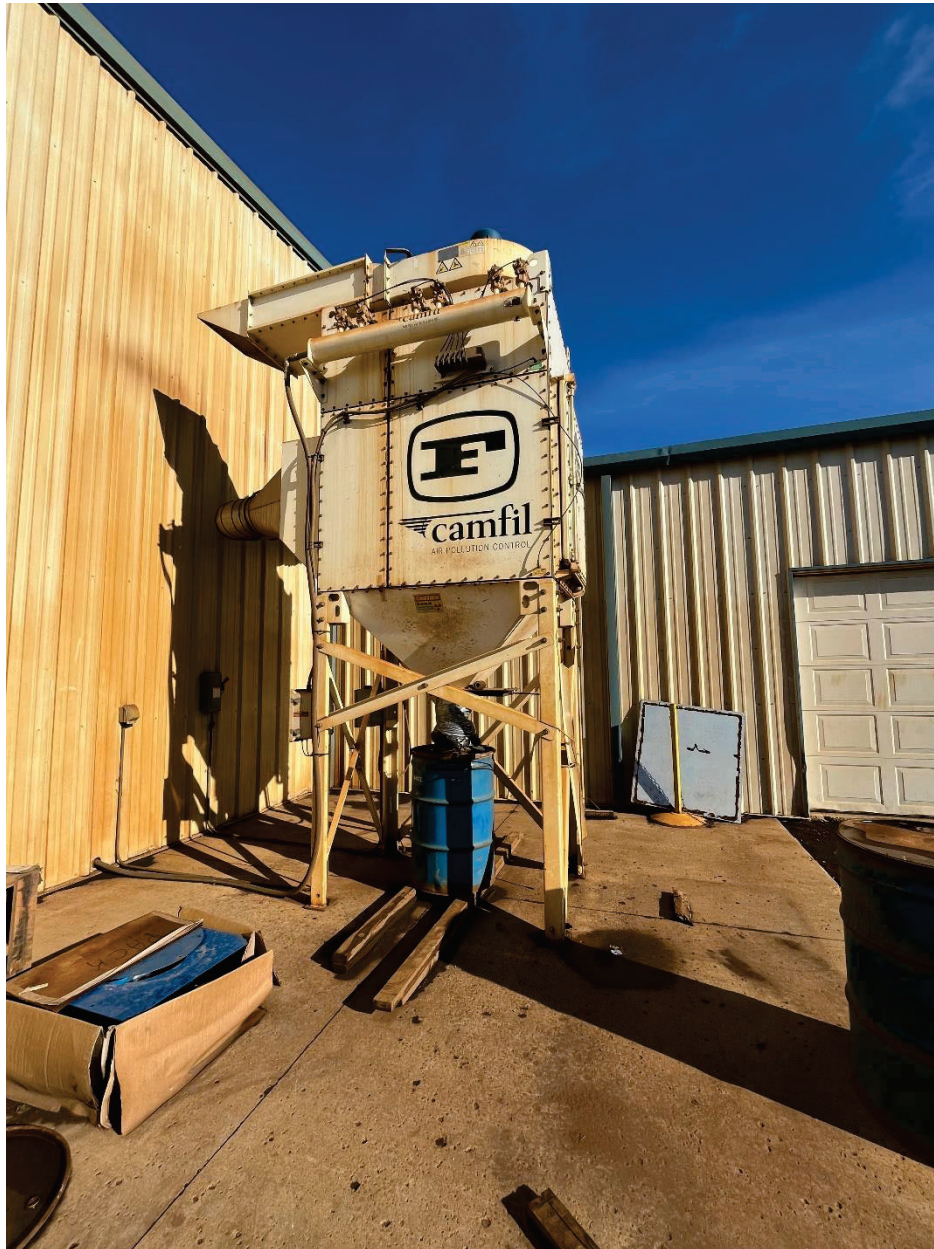
Nearby, I observed the baghouse, which was collecting solids into a blue metal 55-gallon drum. See Attachment 3, photo 4.

Photo 4: IMG\_0108.jpg, 9/18/2024, 9:58 a.m. – photo of a baghouse and collection drum.

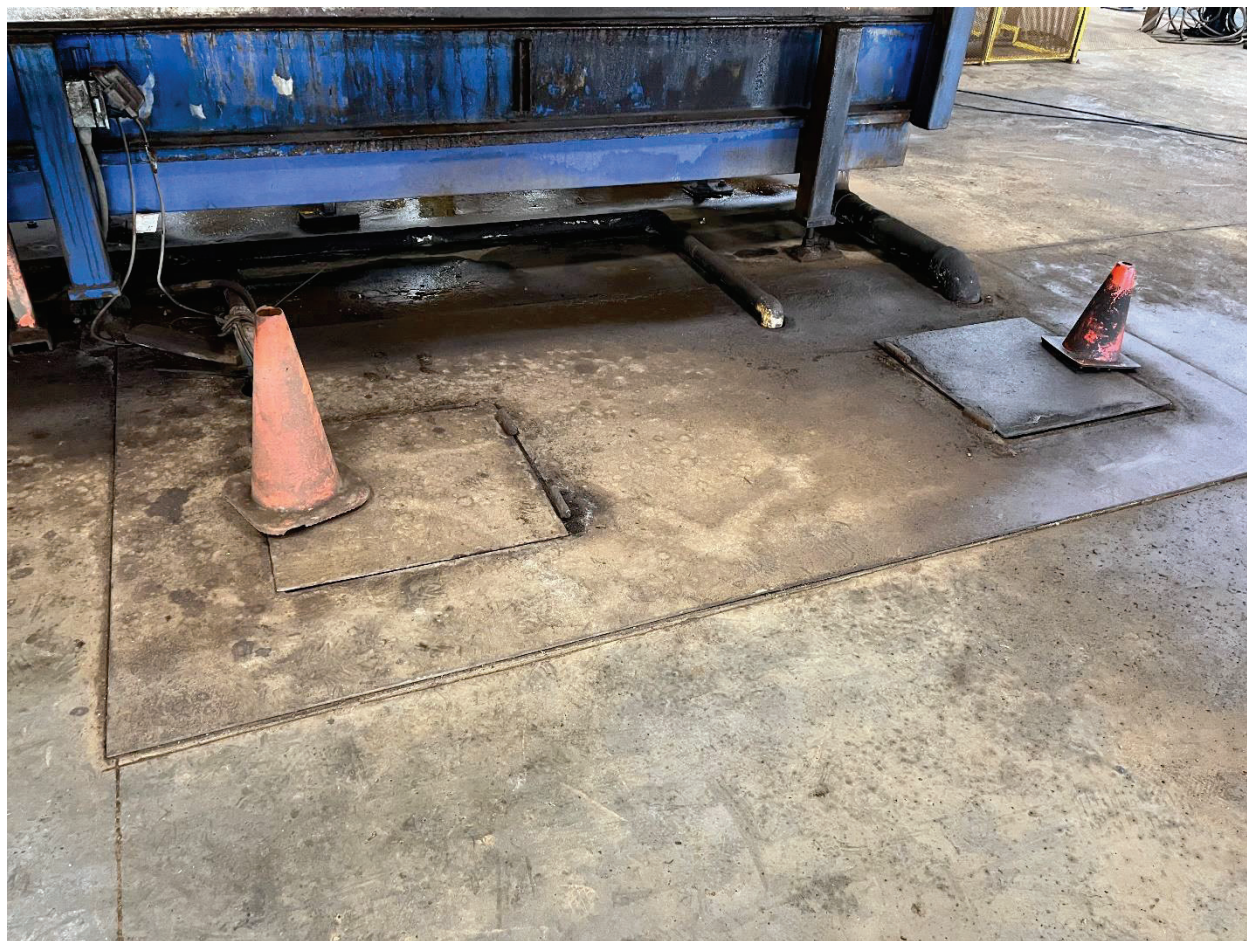
Inside the facility at a sump (Attachment 3, photo 5), Mr. Cisneros said the sump is filtered and is pumped out at least weekly using a hydrovac, which also pulls from an oil/water separator.

Photo 5: IMG\_0109.jpg, 9/18/2024, 10:03 a.m. – photo of an interior sump.

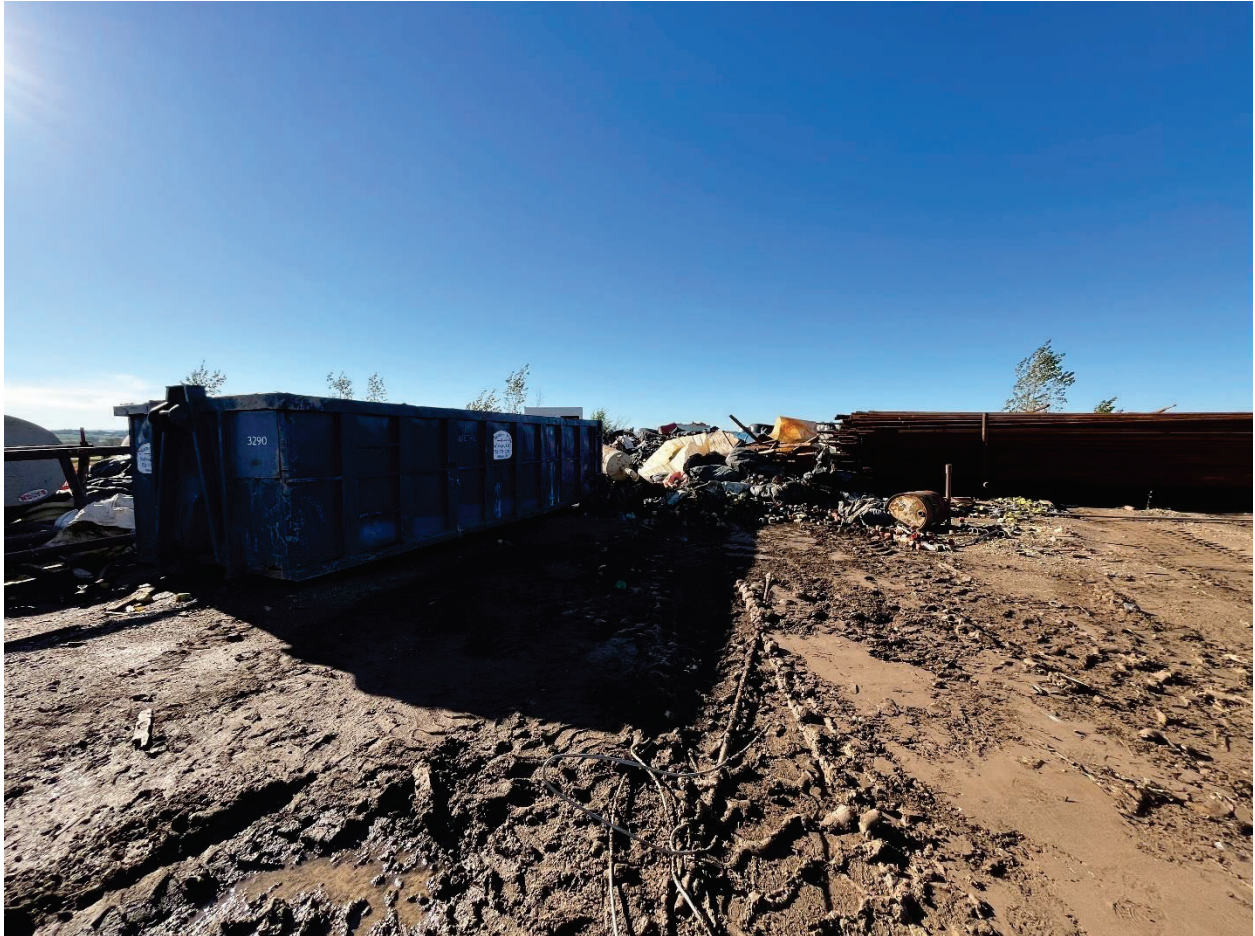
Near the southeast corner of the facility, I observed waste materials that Mr. Cisneros said was primarily trash received from well site generators. See Attachment 3, photos 6-20. He said they had been working to reduce the amount, and that it was less than had been previously stored in this area. Many of the items stored in this area were used piping caps and connectors. Drums stored in the area were primarily full of connectors visible through open bungs, but one blue metal 55-gallon drum appeared to contain liquid and was labeled “Chevron Automatic Transmission Fluid MD-3.” It was unclear whether the contents of this drum were usable raw material or waste.

Photo 6: IMG\_0110.jpg, 9/18/2024, 10:13 a.m. – photo of wastes stored near the southeast corner of the facility.

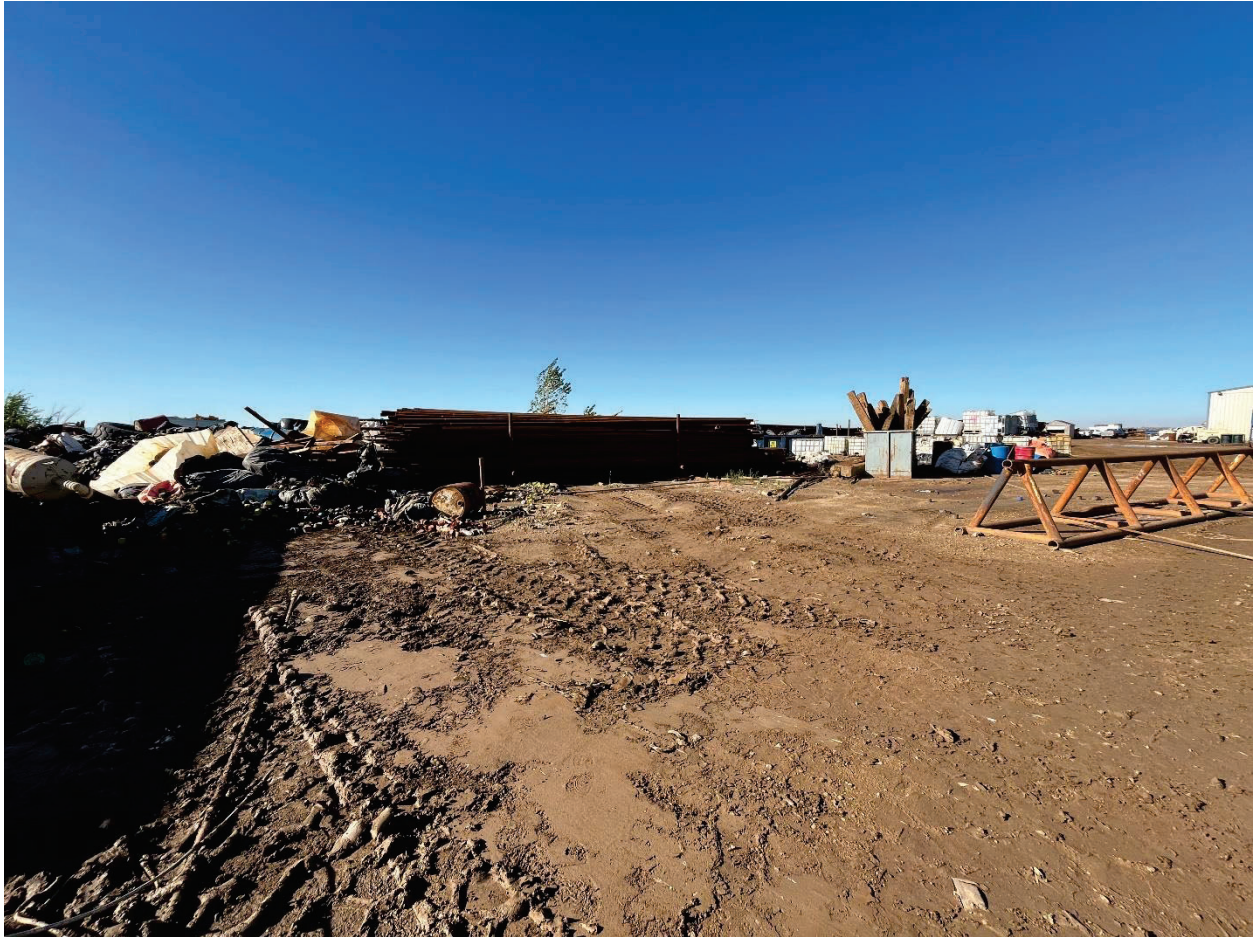
Photo 7: IMG\_0111.jpg, 9/18/2024, 10:14 a.m. – photo panned right from photo 6.

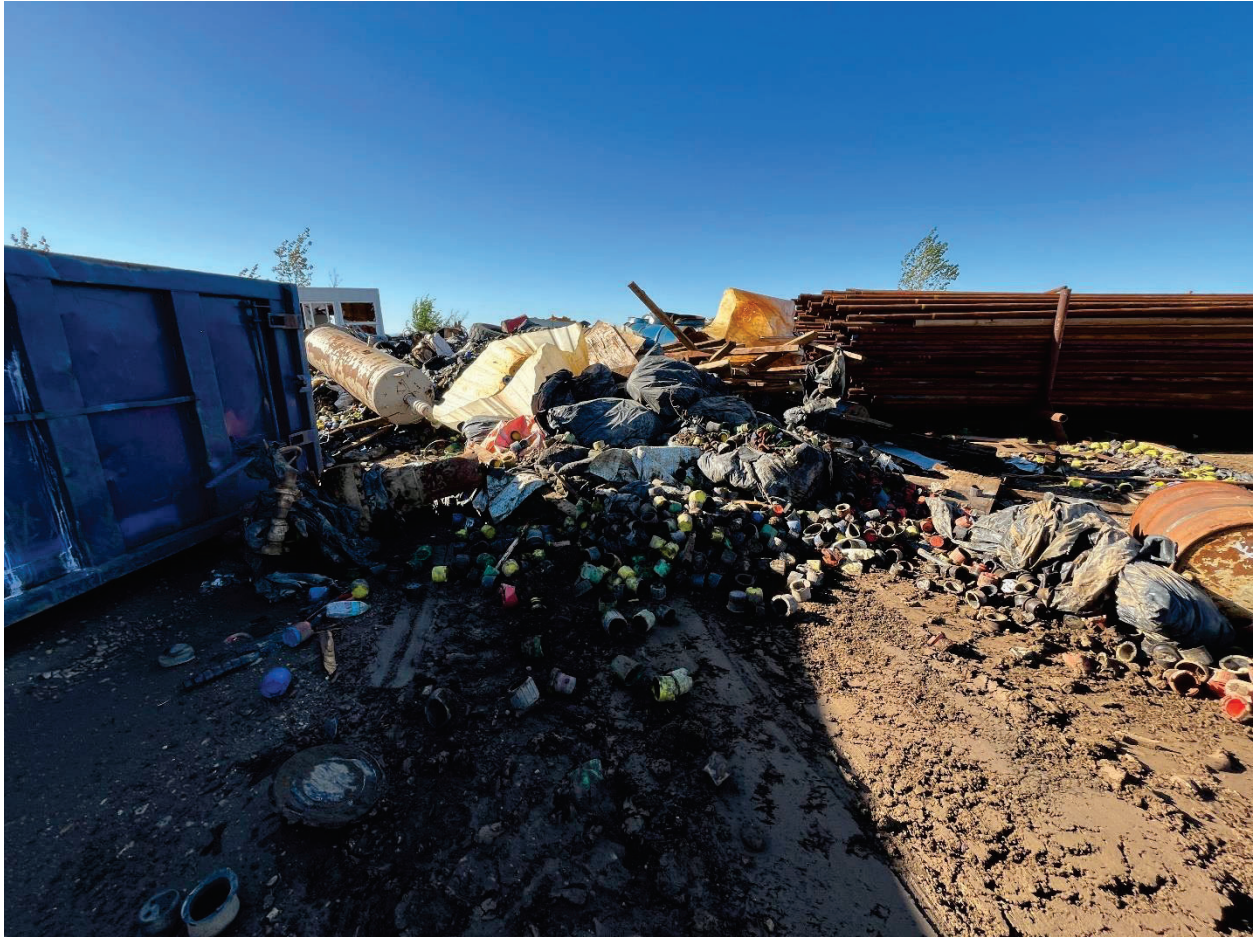
Photo 8: IMG\_0112.jpg, 9/18/2024, 10:14 a.m. – close-up of the waste shown in photo 6.

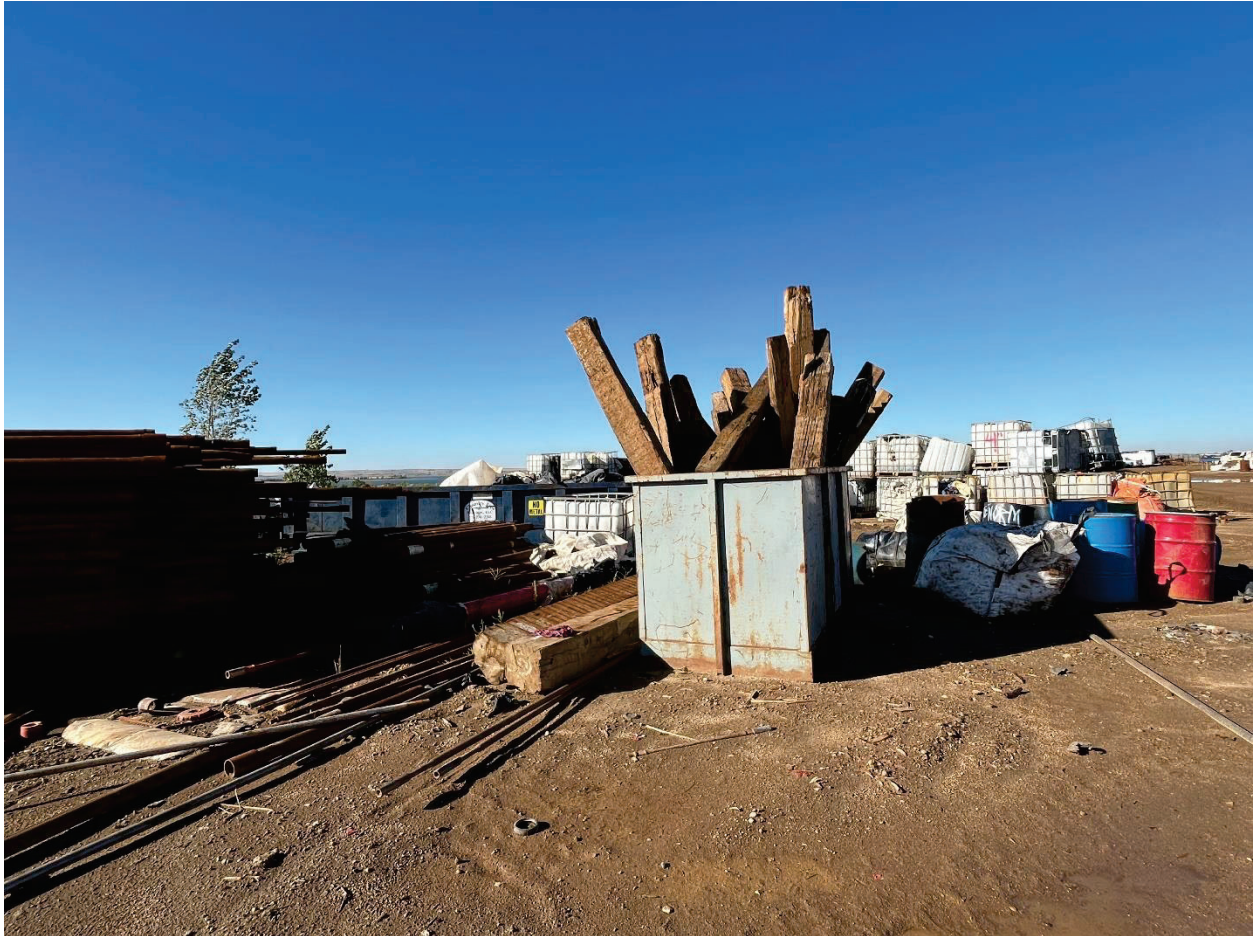
Photo 9: IMG\_0113.jpg, 9/18/2024, 10:15 a.m. – photo of wastes and piping stored near the southeast corner of the facility that were generated off-site.

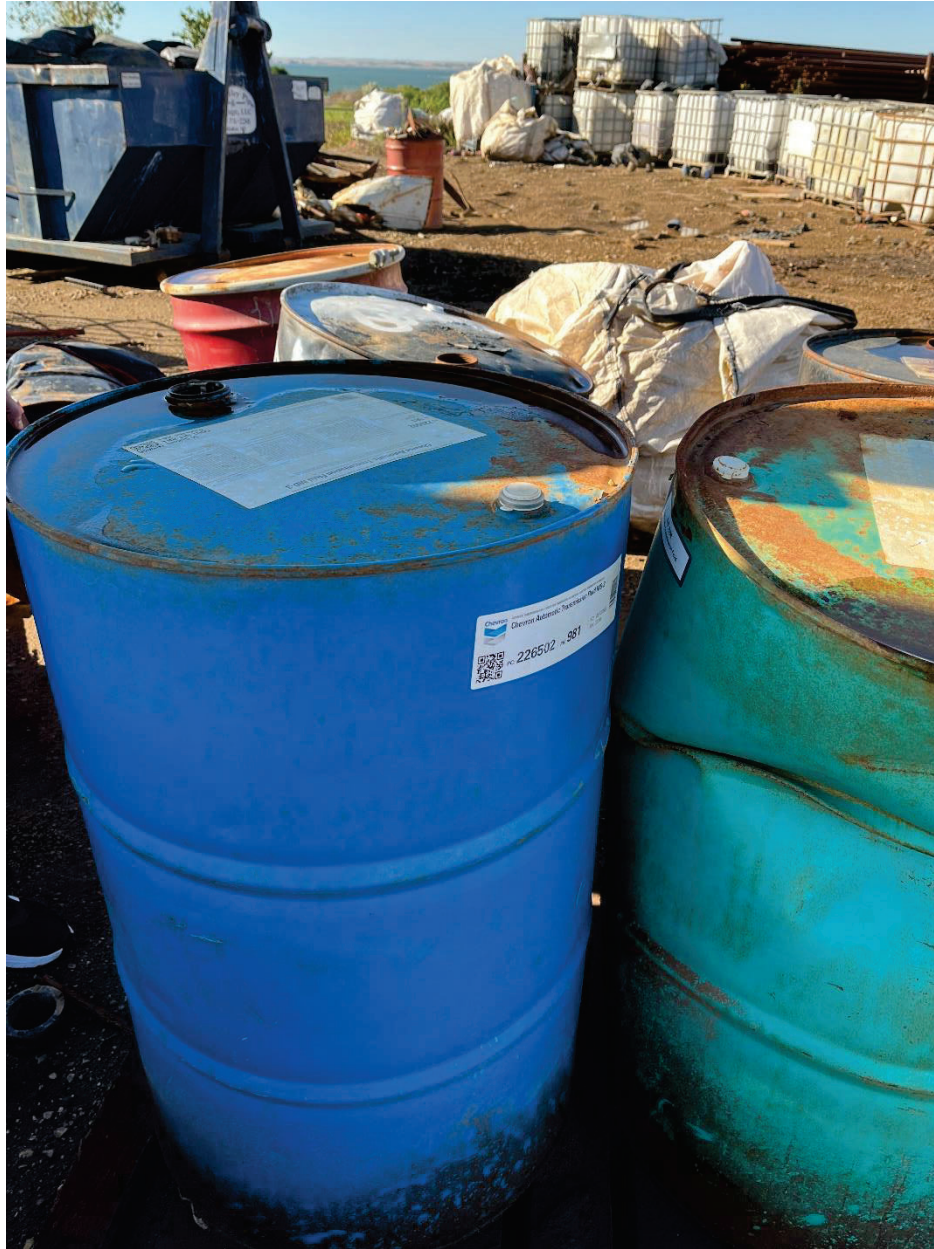
Photo 10: IMG\_0114.jpg, 9/18/2024, 10:18 a.m. – photo of wastes stored near the southeast corner of the facility.

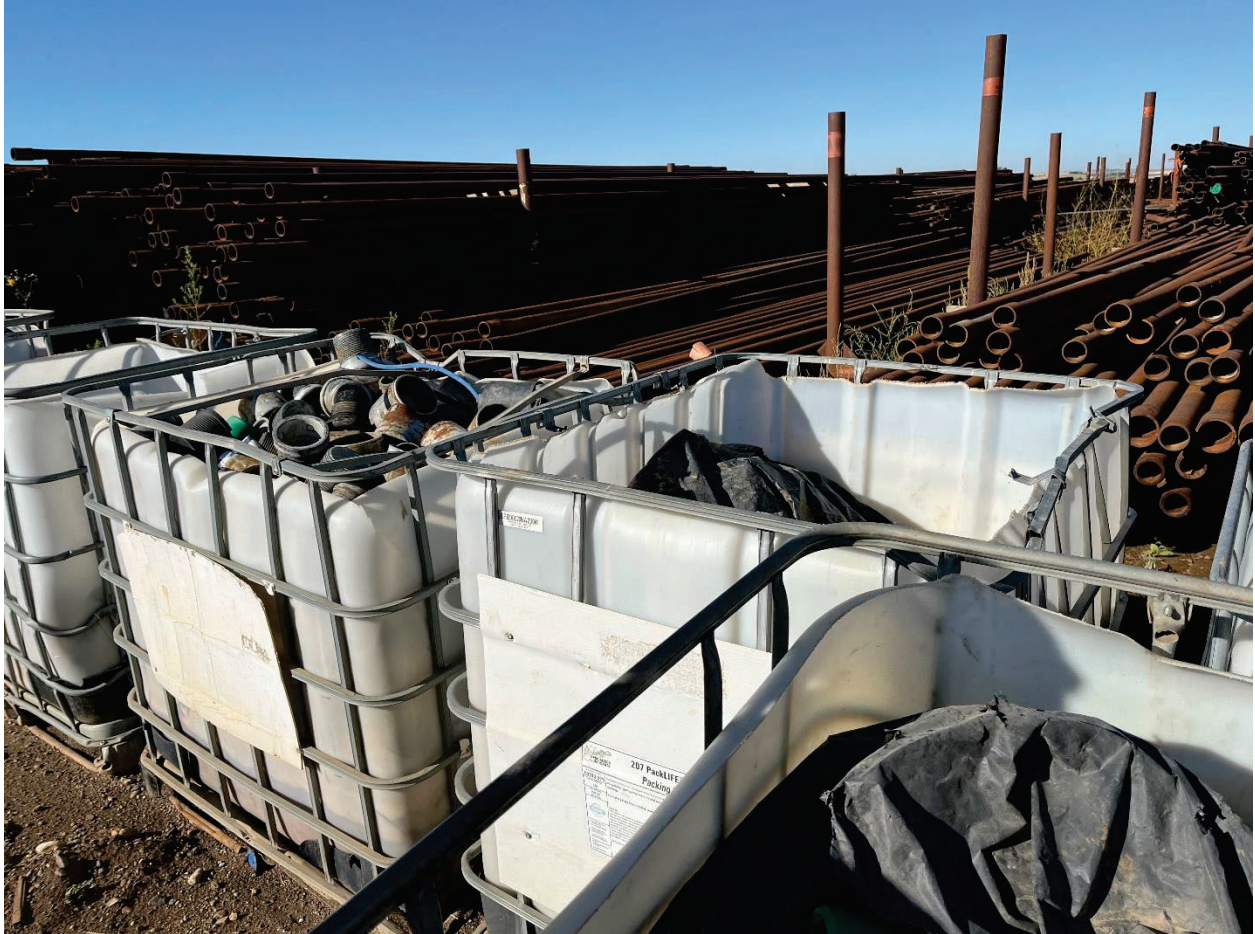
Photo 11: IMG\_0115.jpg, 9/18/2024, 10:19 a.m. – photo of connectors and other parts in open-top totes.

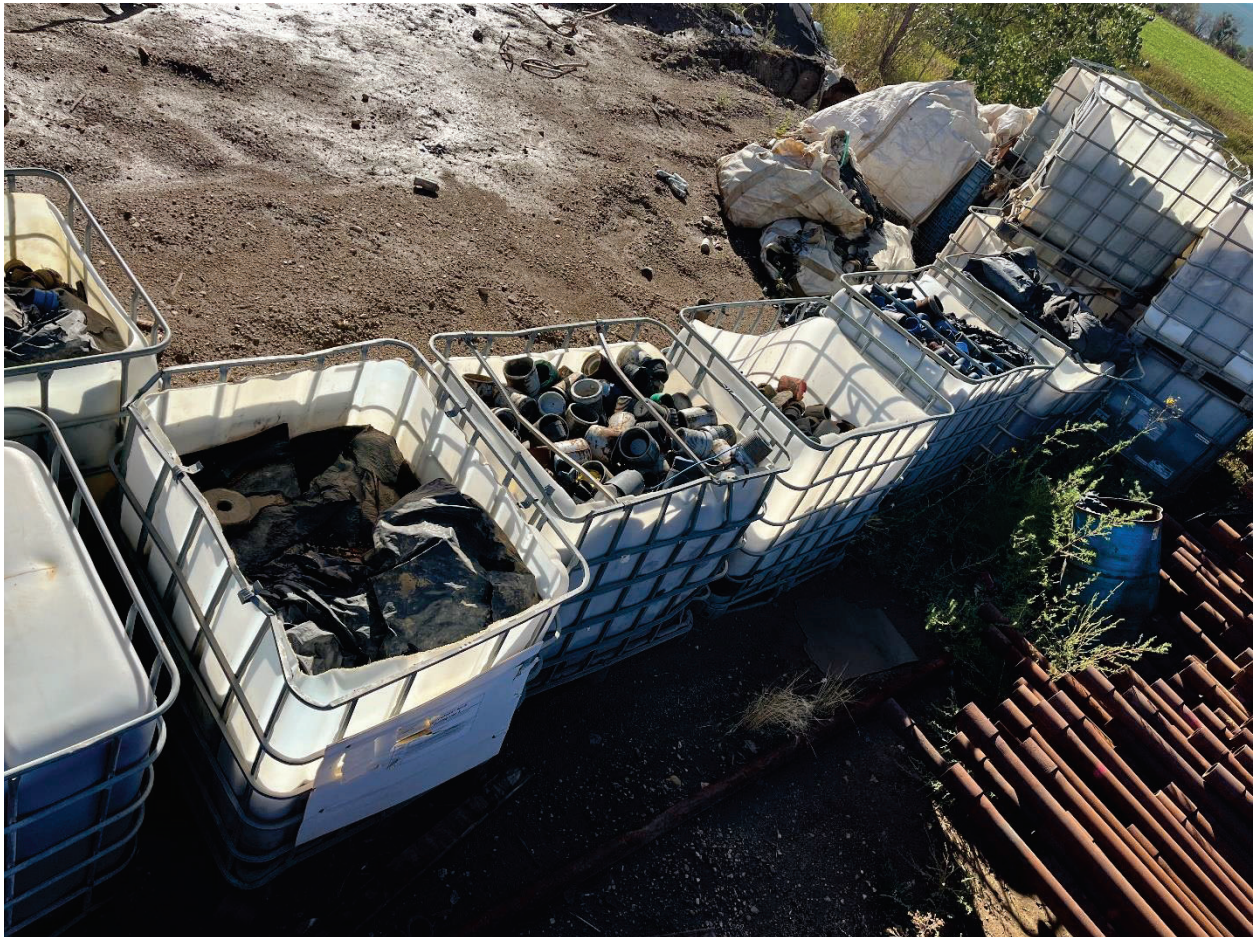
Photo 12: IMG\_0116.jpg, 9/18/2024, 10:19 a.m. – photo of the contents of open-top totes located near the southeast corner of the facility. Photo taken for Annette Maxwell by Nick Cisneros.

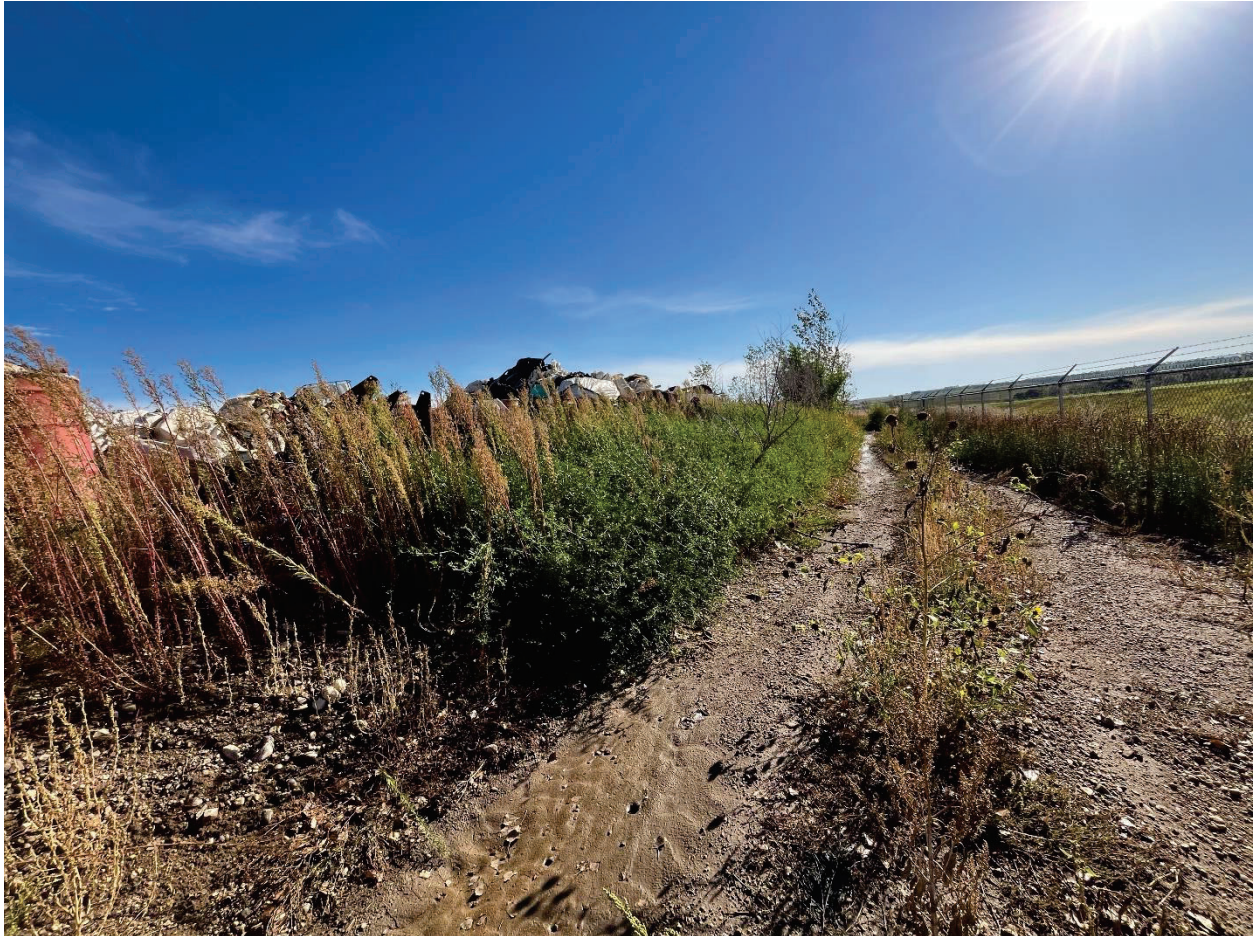
Photo 13: IMG\_0117.jpg, 9/18/2024, 10:22 a.m. – photo of the southern boundary of the facility, taken facing southeast, with waste material visible on the hill at left.

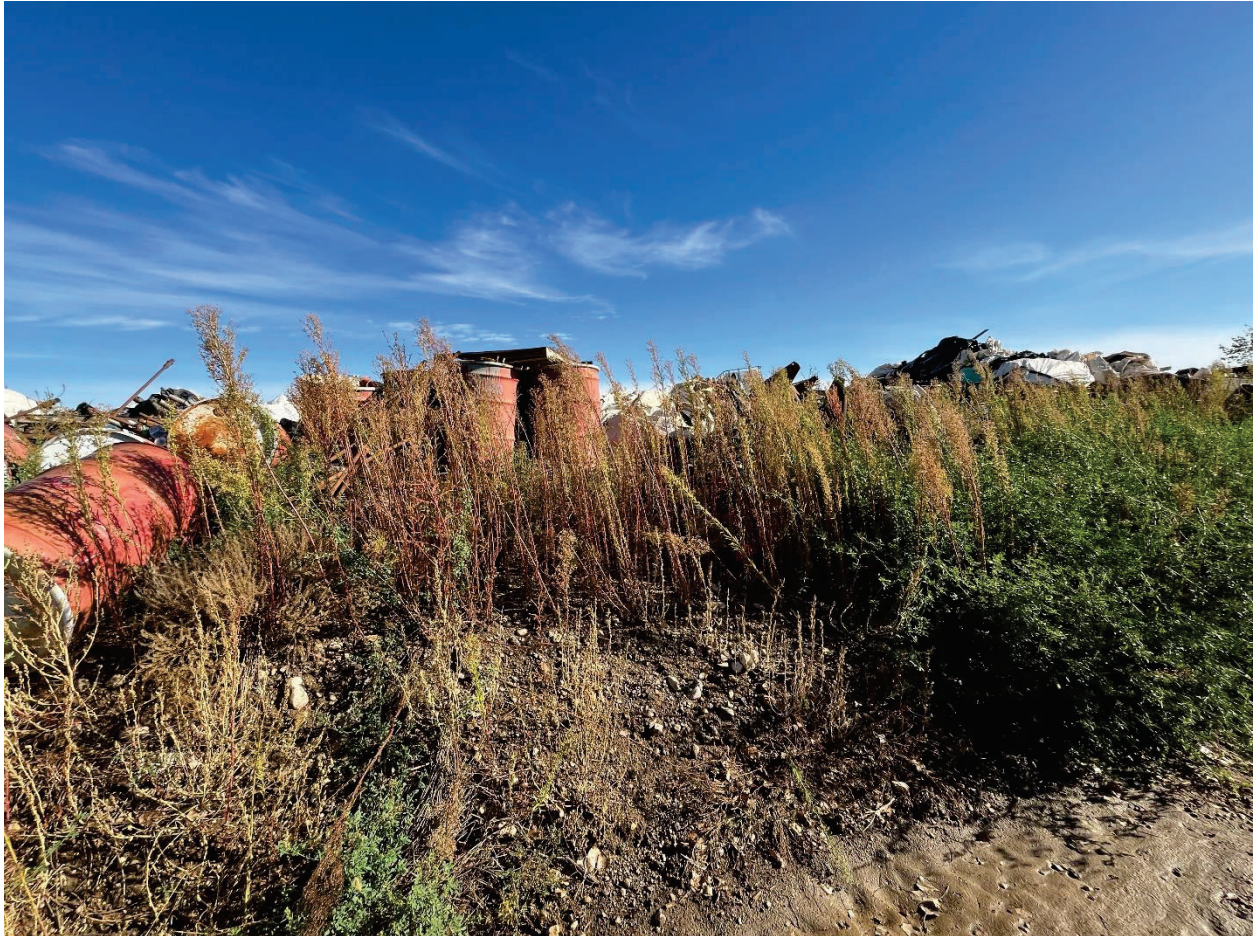
Photo 14: IMG\_0118.jpg, 9/18/2024, 10:22 a.m. – photo of the same area shown in photo 13, panned left.

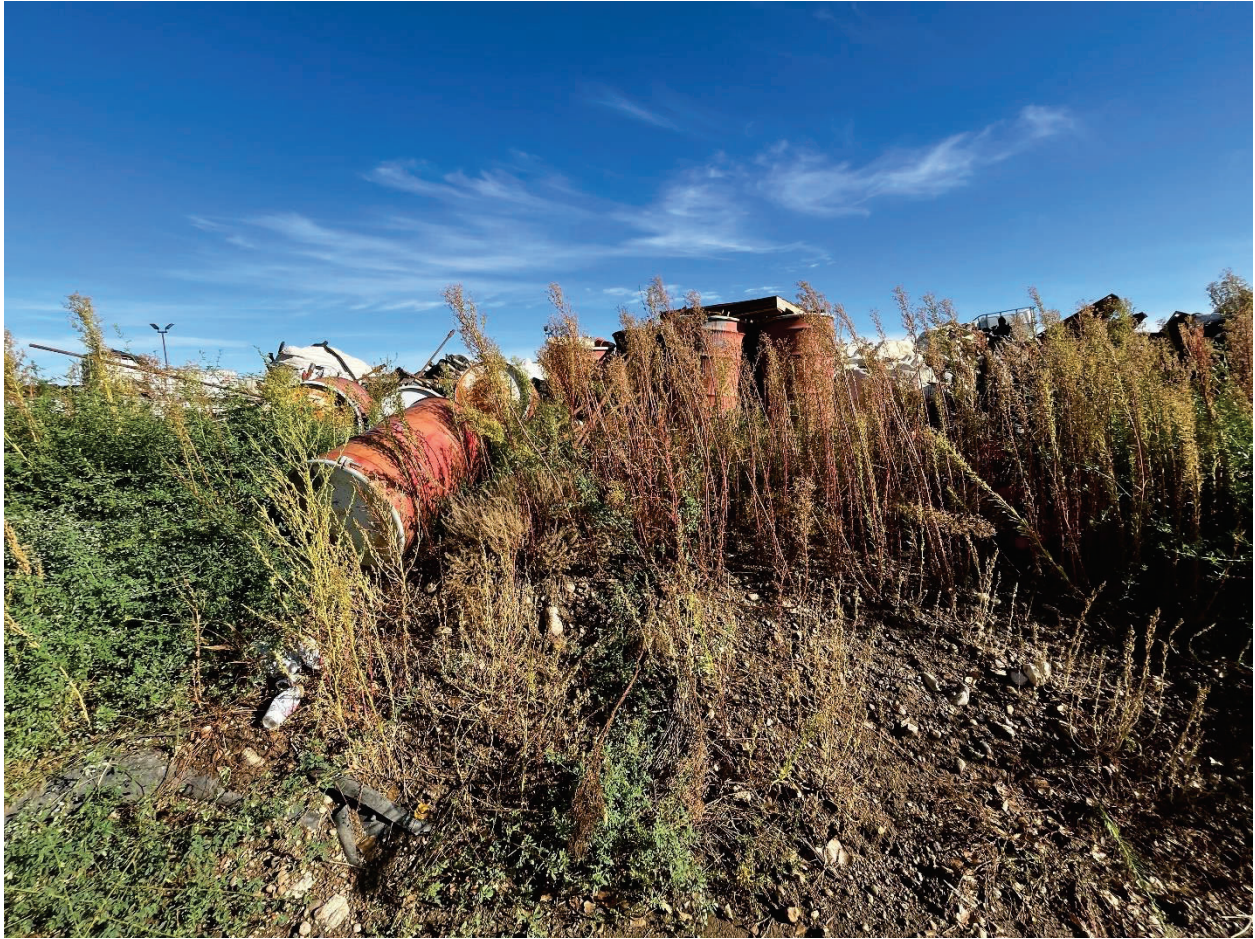
Photo 15: IMG\_0119.jpg, 9/18/2024, 10:22 a.m. – photo panned left from photo 14.

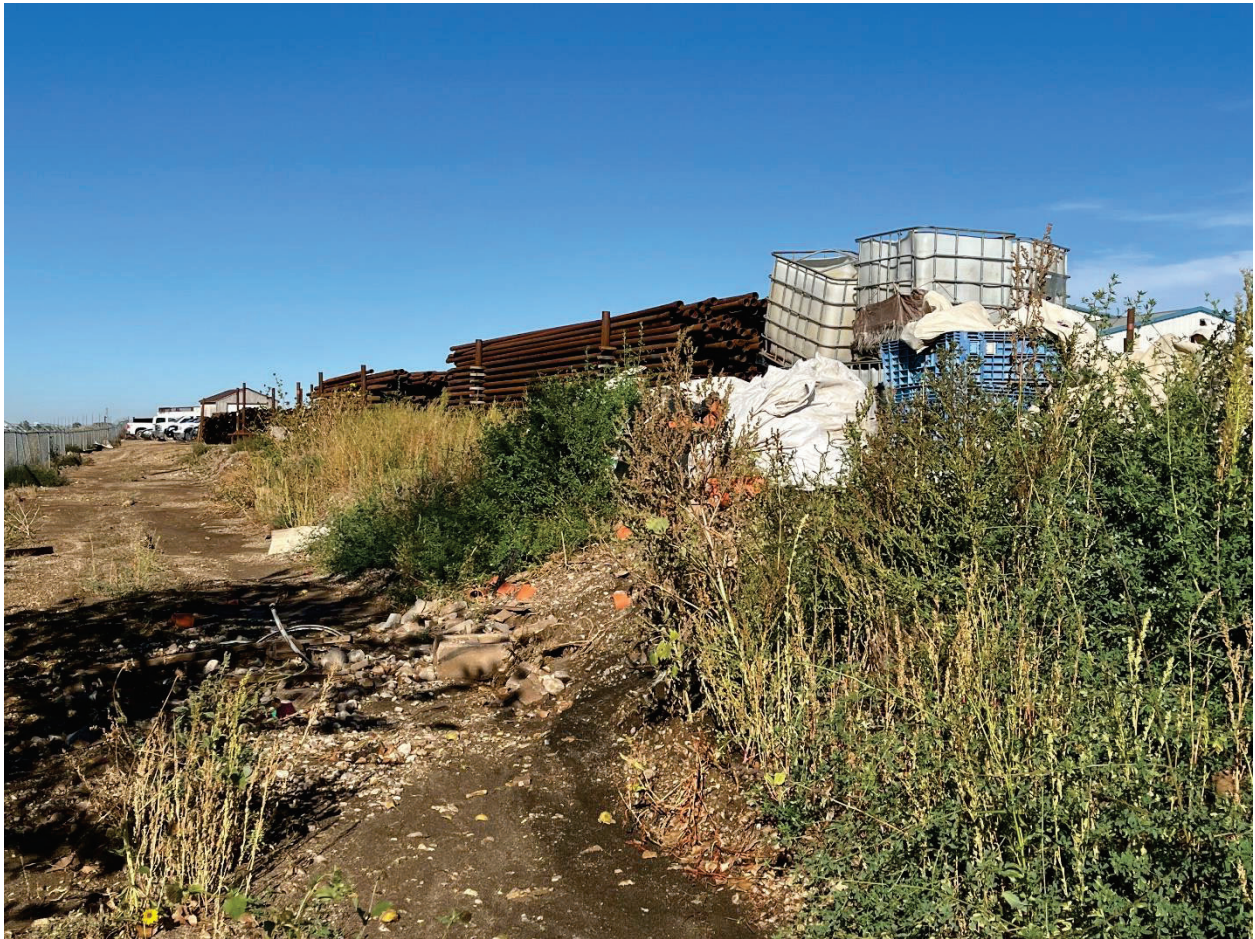
At the south fence near the southeast corner, it appeared that waste material had been either spilled or carried by precipitation to the fence line. See Attachment 3, photo 16 and 19.

Photo 16: IMG\_0120.jpg, 9/18/2024, 10:22 a.m. – photo taken near photos 13-15, panned left toward the west/northwest. Waste that has fallen off the slope toward the property boundary is visible at center in the photo.

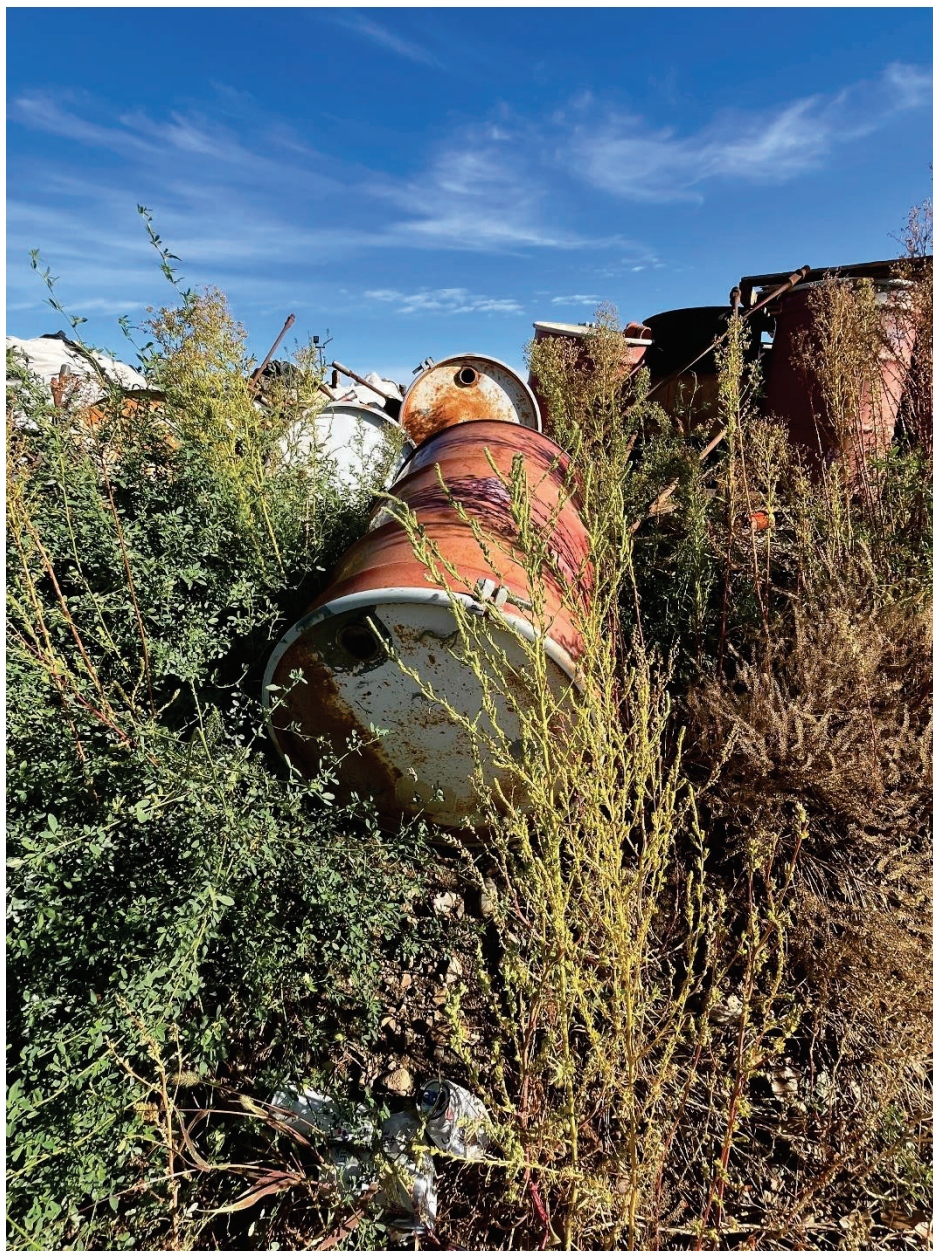
Photo 17: IMG\_0121.jpg, 9/18/2024, 10:22 a.m. – photo of drums shown in photos 14 and 15.

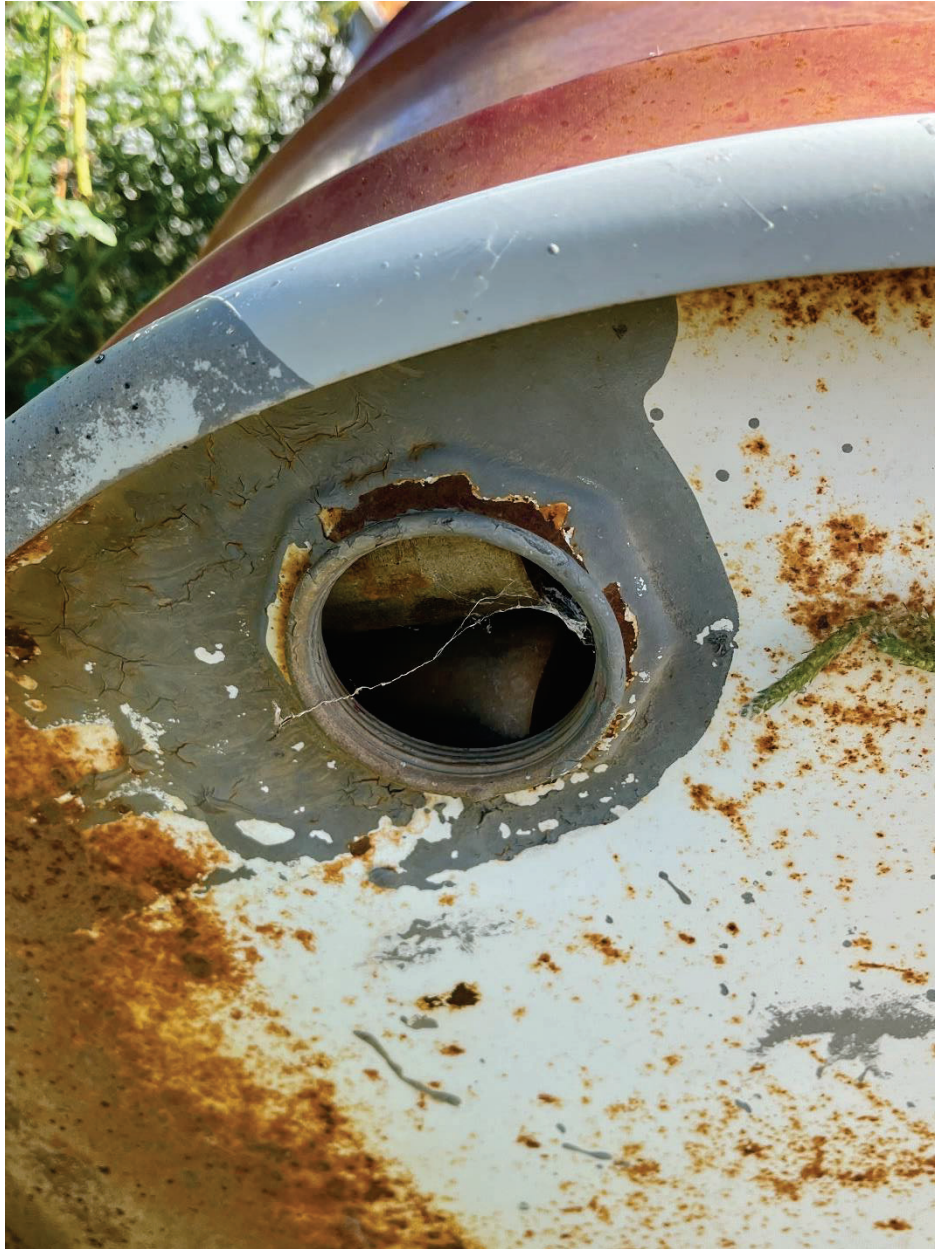
Photo 18: IMG\_0122.jpg, 9/18/2024, 10:22 a.m. – close-up of the open bung on the drum shown in photo 17, showing that the contents are solids.

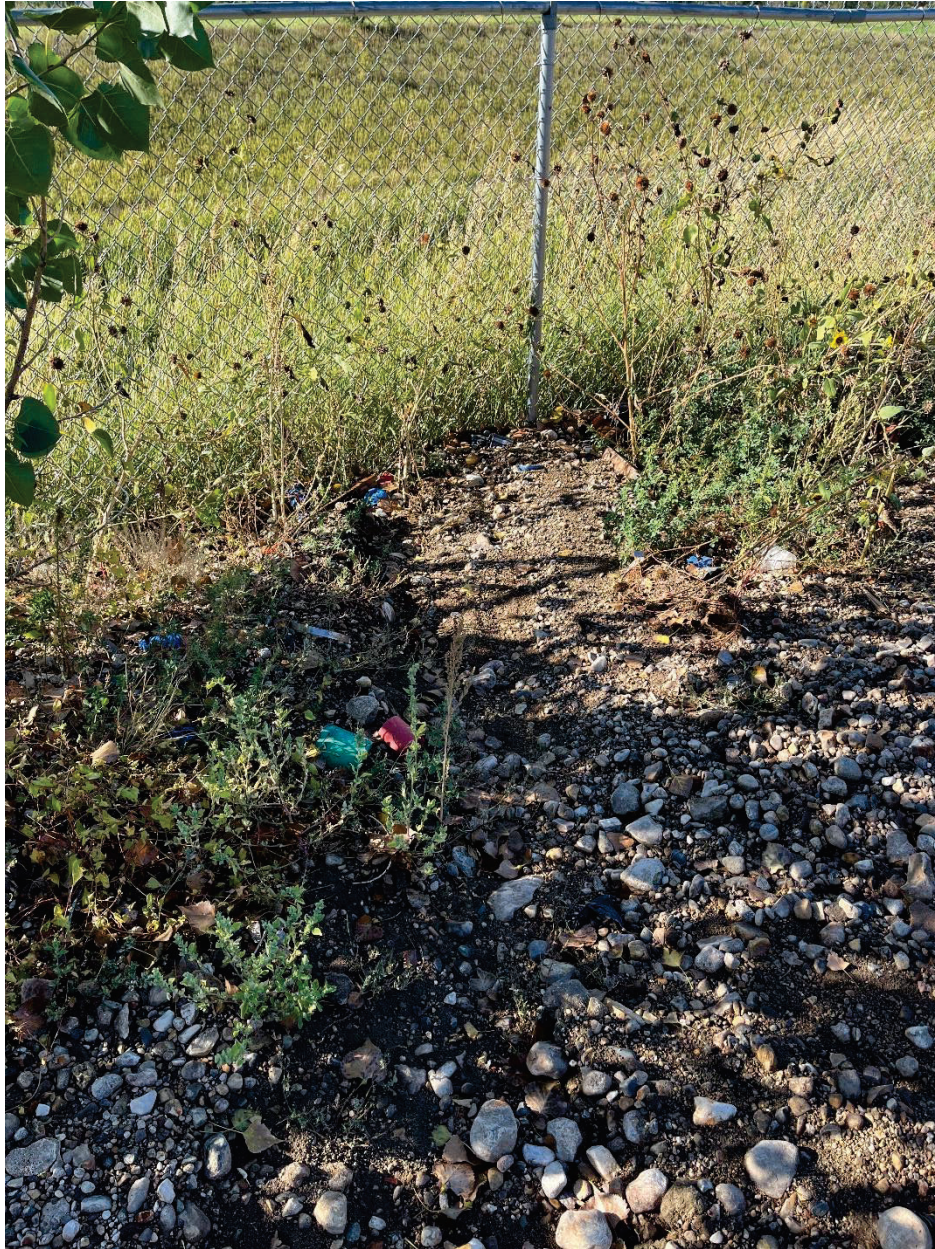
Photo 19: IMG\_0123.jpg, 9/18/2024, 10:23 a.m. – photo of the area shown in photo 16, facing south to the property boundary, with waste material visible against the property fence line.
