**UNITED STATES ENVIRONMENTAL PROTECTION AGENCY  
REGION 8  
RESOURCE CONSERVATION AND RECOVERY ACT**

**Facility Name:** Estvold Oilfield Services Pipe Yard    **RCRA ID:** NDR000014183

**Date of Inspection:** September 18, 2024  
**Arrival Time:** 9:40 a.m.  
**Departure Time:** 10:30 a.m.

**Type and Purpose of Inspection:**    Compliance Evaluation Inspection  
Compliance with RCRA Subtitle C

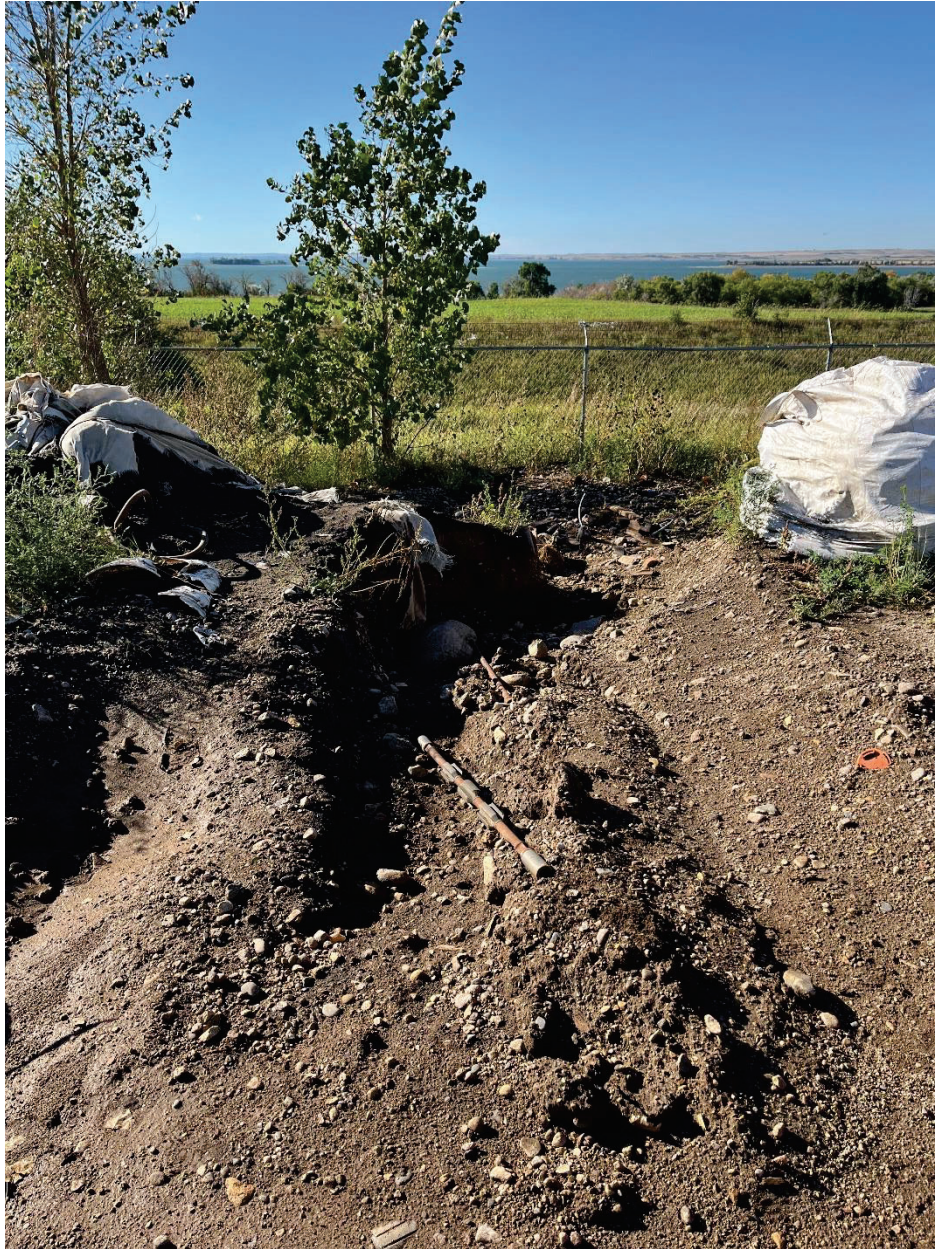
Photo 20: IMG\_0124.jpg, 9/18/2024, 10:25 a.m. – photo of the same area shown in photo 19, with the Van Hook Arm of the Missouri River visible in the background.

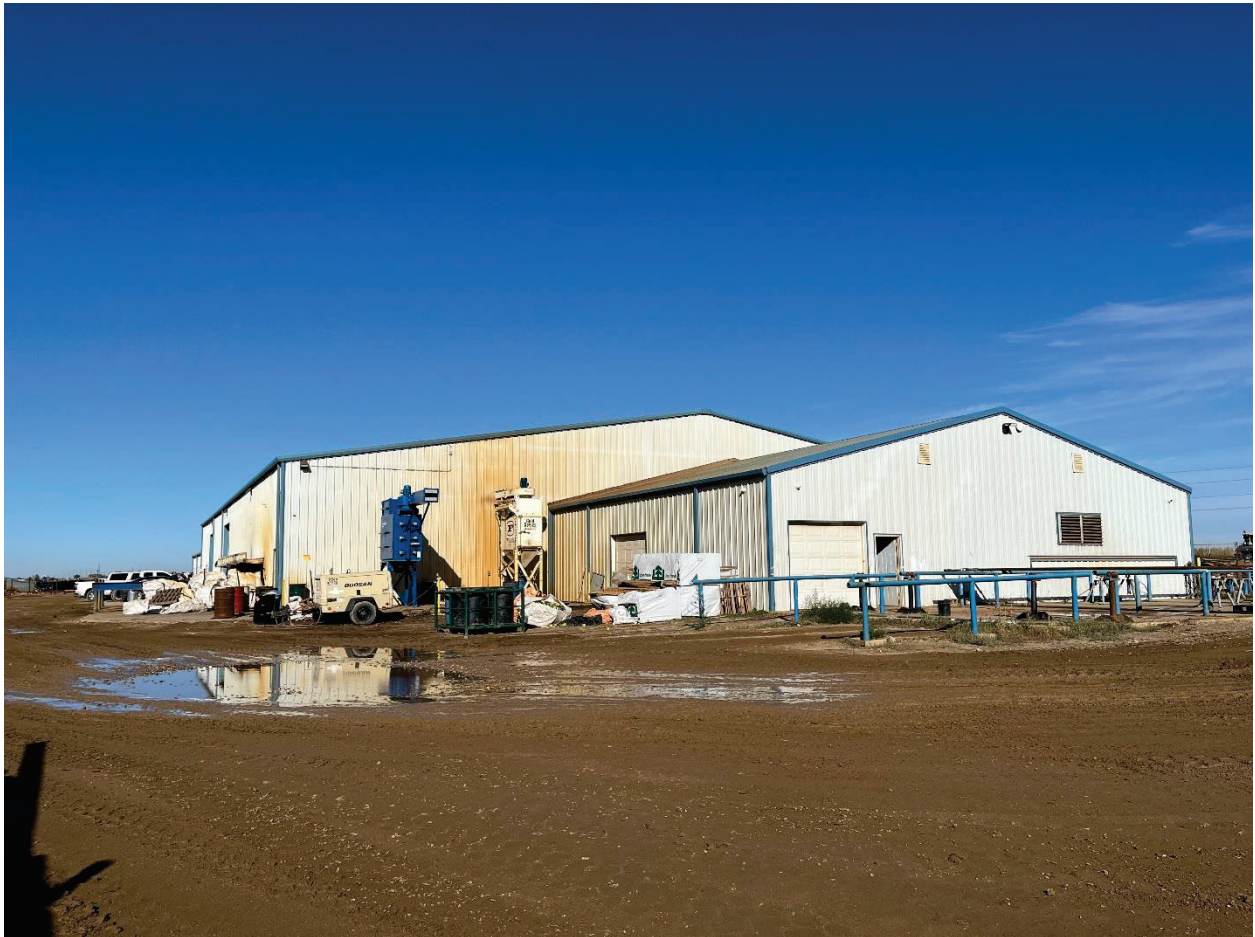
Photo 21: IMG\_0125.jpg, 9/18/2024, 10:26 a.m. – photo of the facility building facing northwest, with the drum shown in photo 2 visible near the southeast corner of the building and the baghouse visible near the photo center.

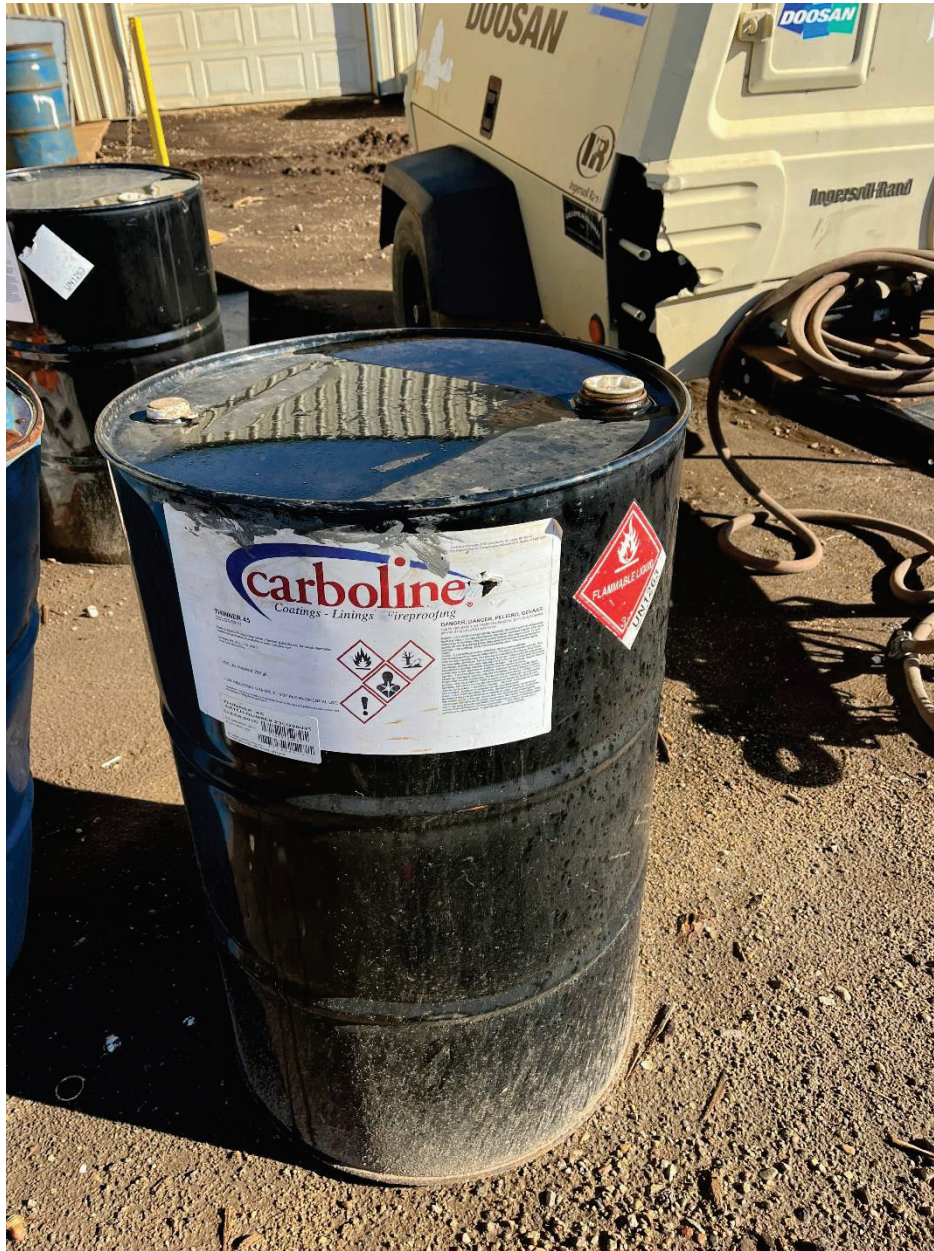
Near the southeast corner of the building, I observed a drum labeled Thinner 45 and marked with a flammable placard, Attachment 3, photo 22. The drum was closed and in good condition. Mr. Cisneros wasn't sure what this material was used for. It appeared the material was unused product and not waste.

Photo 22: IMG\_0126.jpg, 9/18/2024, 10:28 a.m. – photo of a chemical container marked “Thinner 45” and with a flammable placard.
