**Region 6 - Enforcement & Compliance Assurance Division**  
**INSPECTION REPORT**

| Company Name: | <b>CapturePoint, LLC</b> | |
| Facility Name: | <b>North Burbank Unit (NBU) 24 Battery</b> | |

Environmental Protection Agency (EPA) Region 6 inspector Matthew Allen arrived at the CapturePoint, LLC / North Burbank Unit (NBU) 24 Battery (EPA ID No. OKU002197) at 12:40PM on 3/11/2026 for an announced inspection. This was a follow-up inspection to an inspection conducted by EPA on 2/5/2026 in response to a National Response Center Spill Report (NRC No. 1454114) received by EPA Region 6. The inspection was conducted by the authority of the Clean Water Act (CWA) to determine compliance with EPA regulations. There were no other federal, state, or local agency representatives present at the time of the inspection.

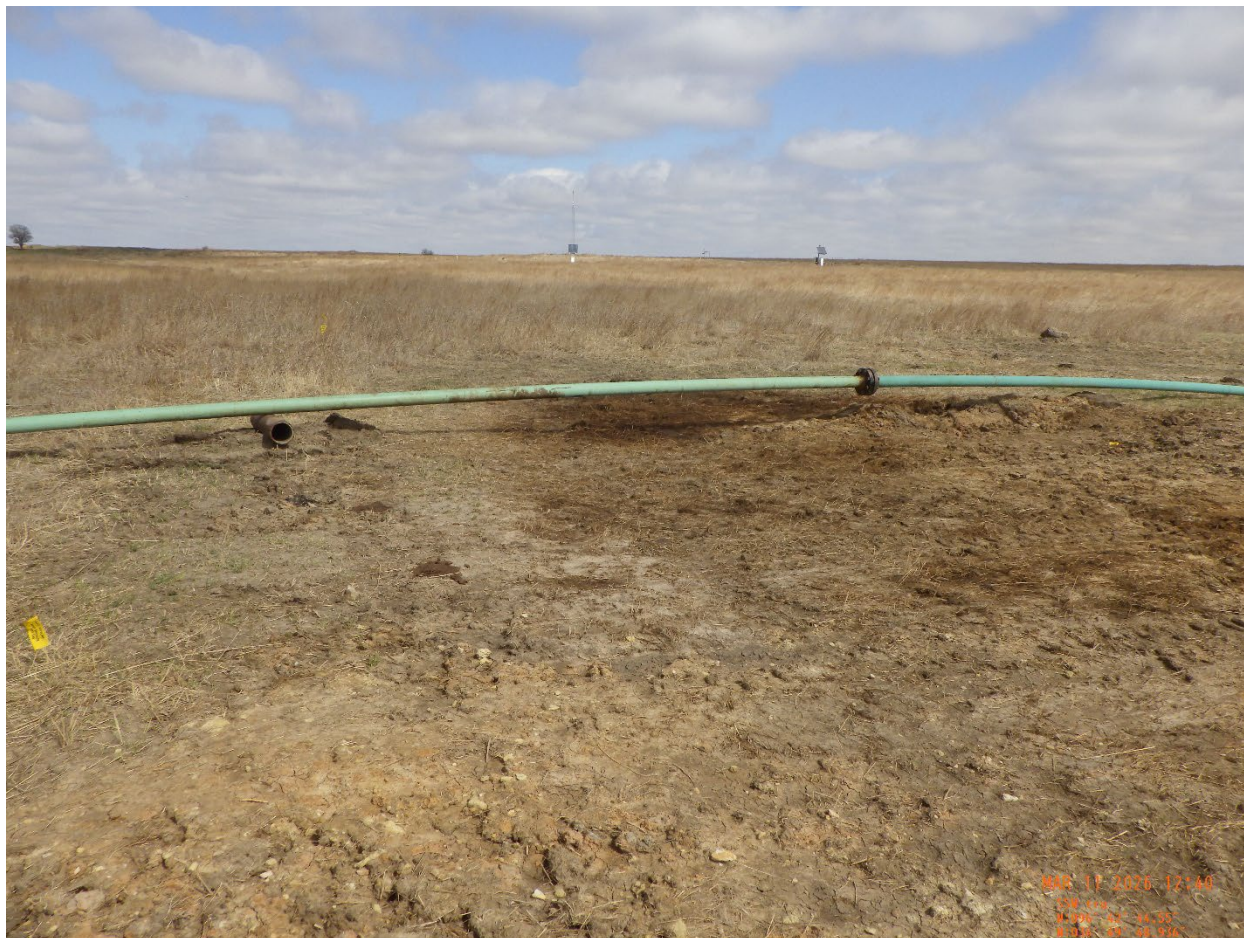
Photo No. 1

I observed the release point of the spill which was a 4" steel flowline. At the time of the inspection, CapturePoint, LLC had repaired and returned the line to service, see photo No. 1, Appendix 1 (Photo Log). For additional GPS location information and photo metadata, see the attached photo log.

**Description:** This photo shows the release point of the spill and shows a flowline that CapturePoint, LLC repaired and returned to service.

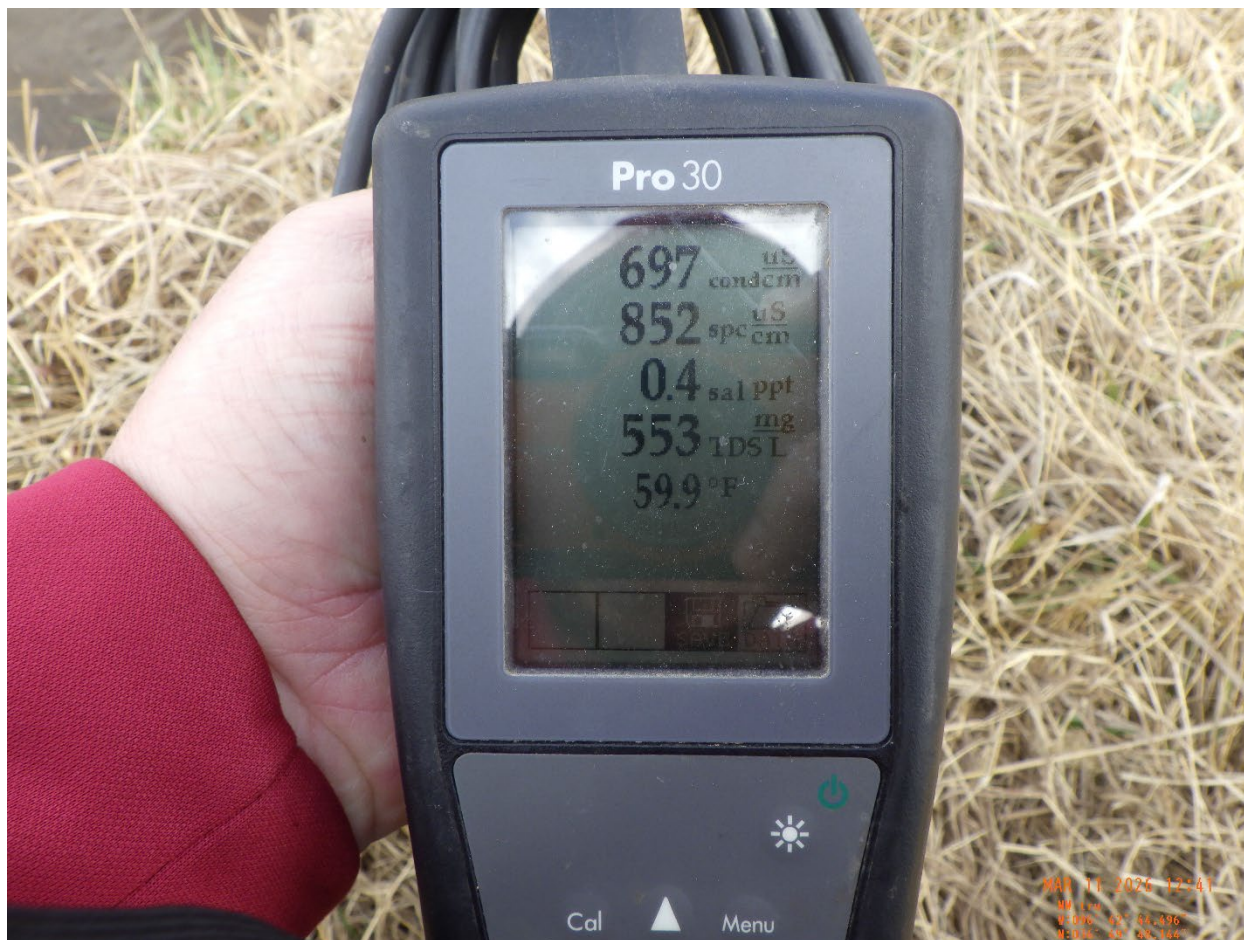
Photo No. 2

I observed the point of entry (POE) into the unnamed tributary of Hay Creek. At the same location, I observed a TDS field reading of 553 mg/L, which represented a return to "background" TDS levels for the area. See photo No. 2 and No. 3.

**Description:** This photo shows a TDS field reading of 553 mg/L observed at the point of entry into the unnamed tributary of Hay Creek. This reading was consistent with “background” TDS levels in the area.

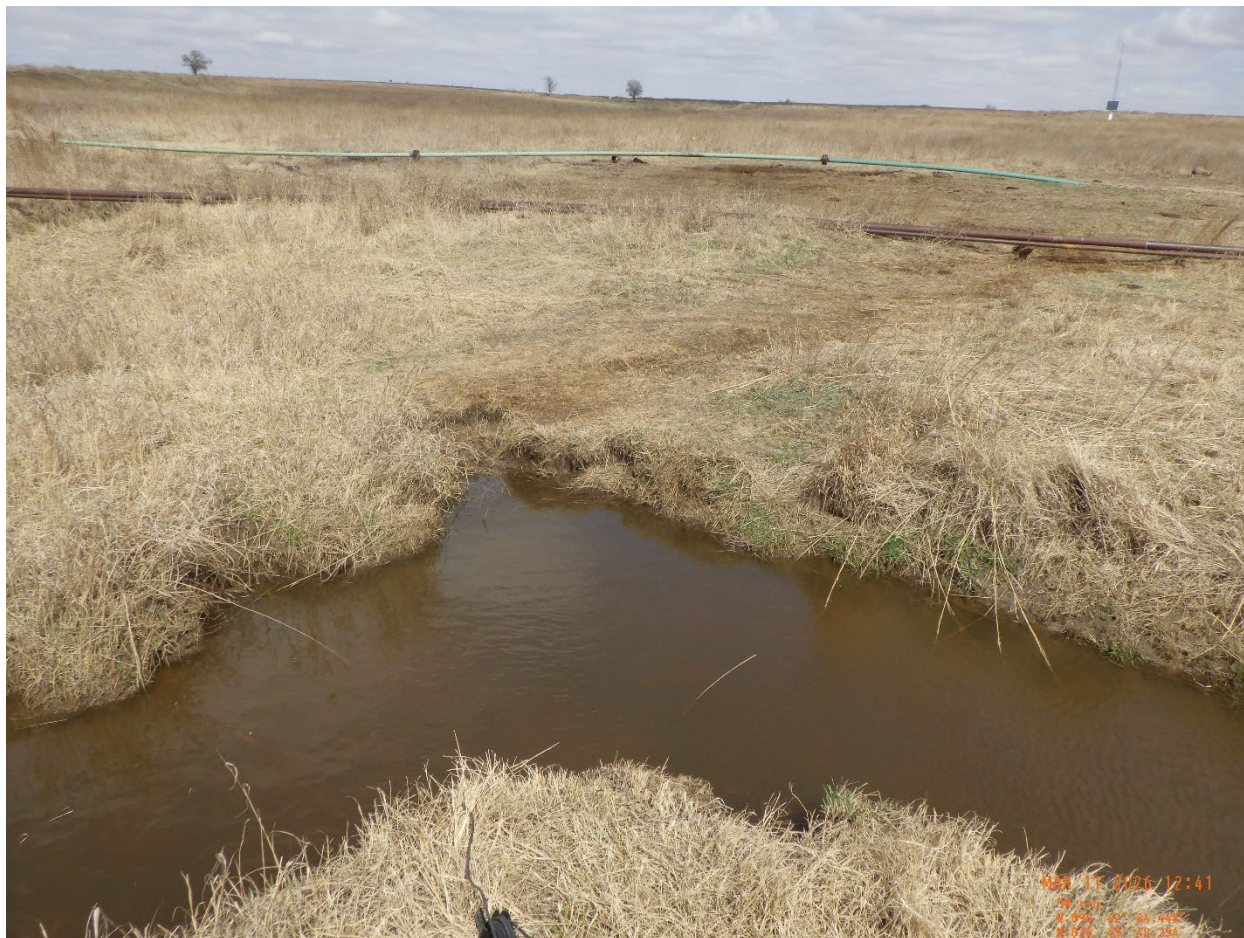
Photo No. 3

**Description:** This photo shows the location of the TDS field reading from photo No. 2.

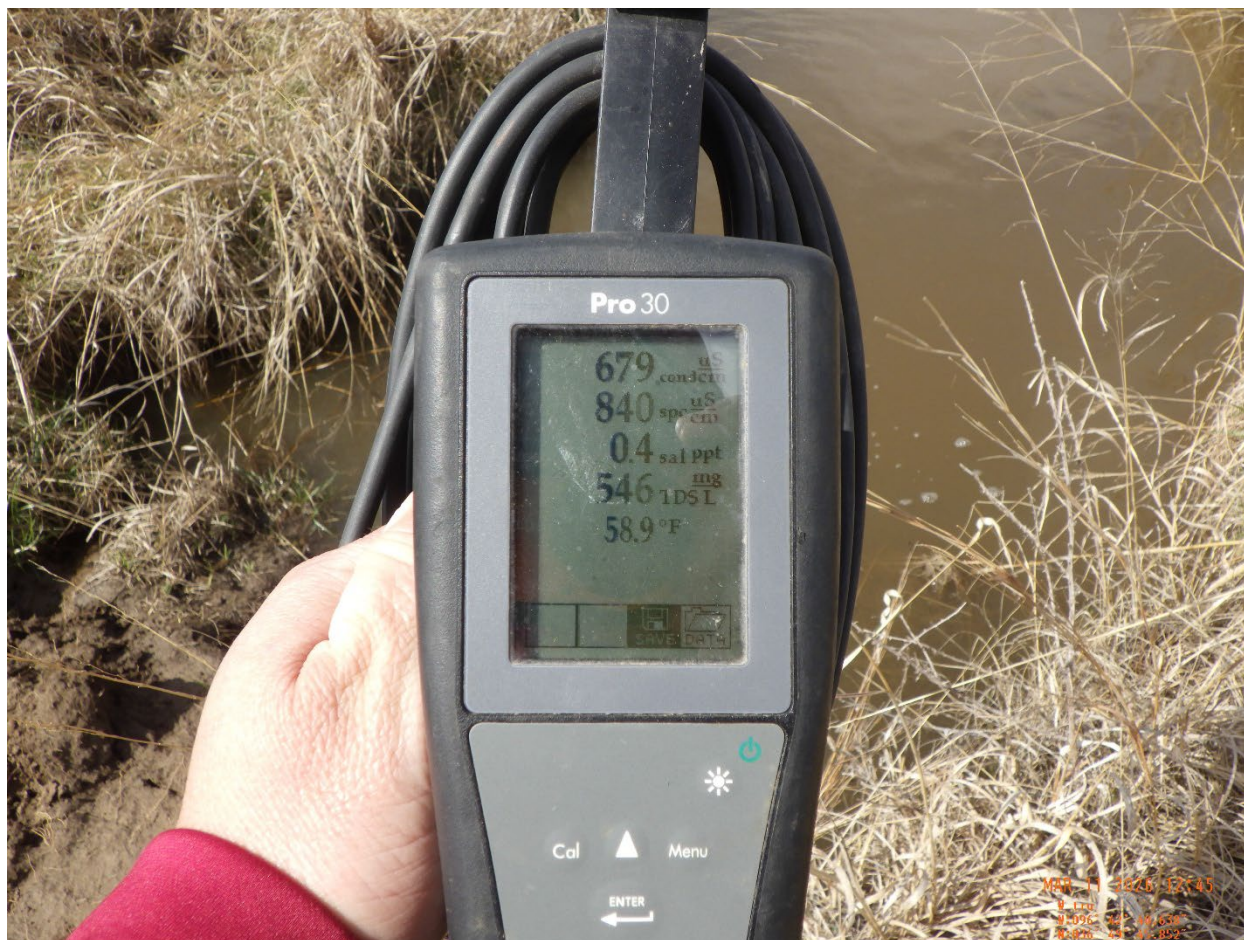
Photo No. 4

At the lowermost containment dam, which was also the end of observed spill impacts, I observed a TDS field reading of 546 mg/L on the upstream side of the dam. This TDS field reading represented a return to pre-spill or "background" TDS levels. See photo No. 4 and No. 5.

**Description:** This photo shows a TDS field reading of 546 mg/L observed on the upstream side (impacted side) of the lowermost containment dam constructed during cleanup operations. This TDS reading was consistent with "background" TDS levels for the area.

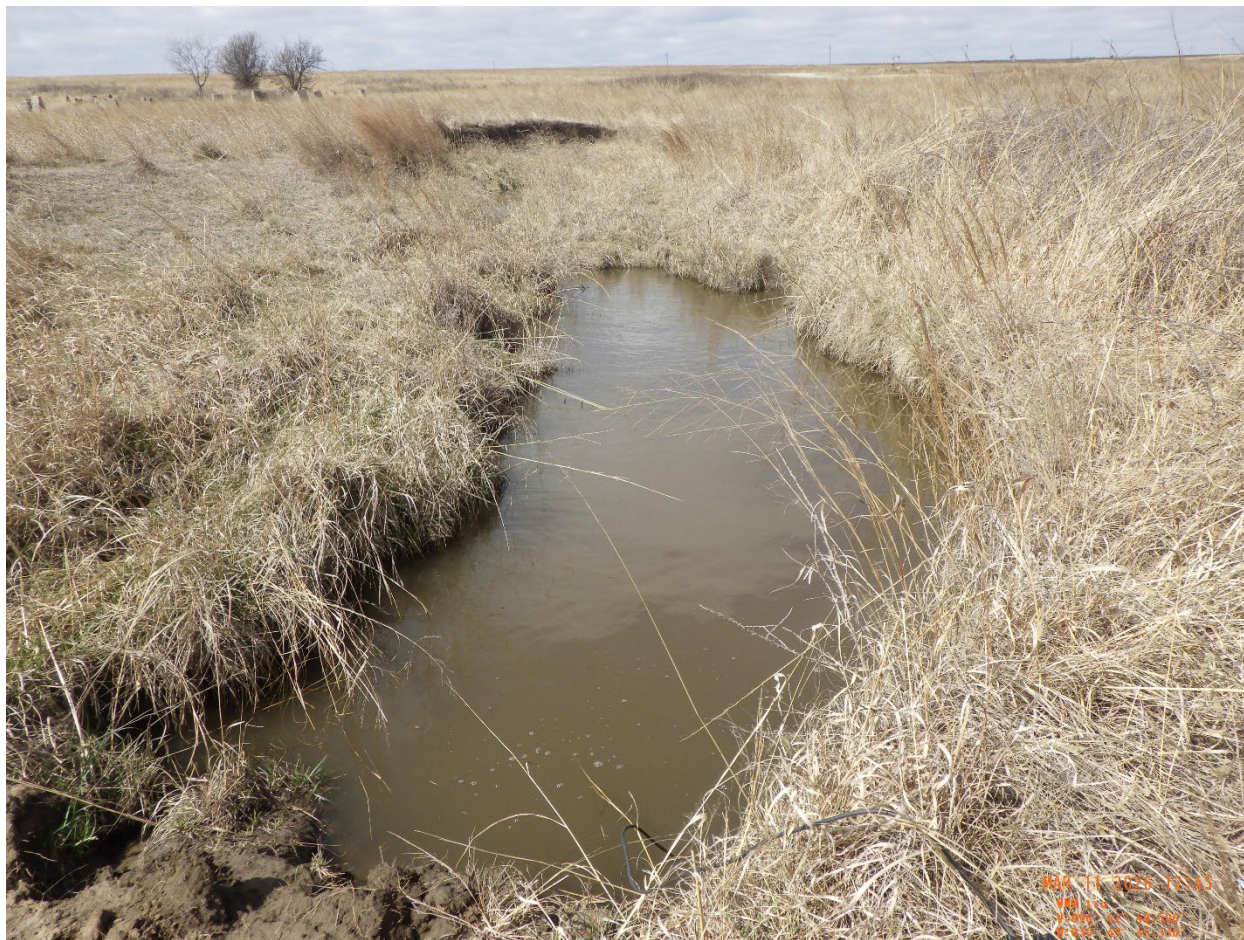
Photo No. 5

**Description:** This photo shows the location of the TDS field reading from photo No. 4.
