**Region 6 Compliance Assurance and Enforcement Division  
INSPECTION REPORT**

| Inspection Date(s): | 10/19/2017 | | |
| Facility Name: | [REDACTED] | | |
| Identification/Permit Number: | LAU000479 | | |

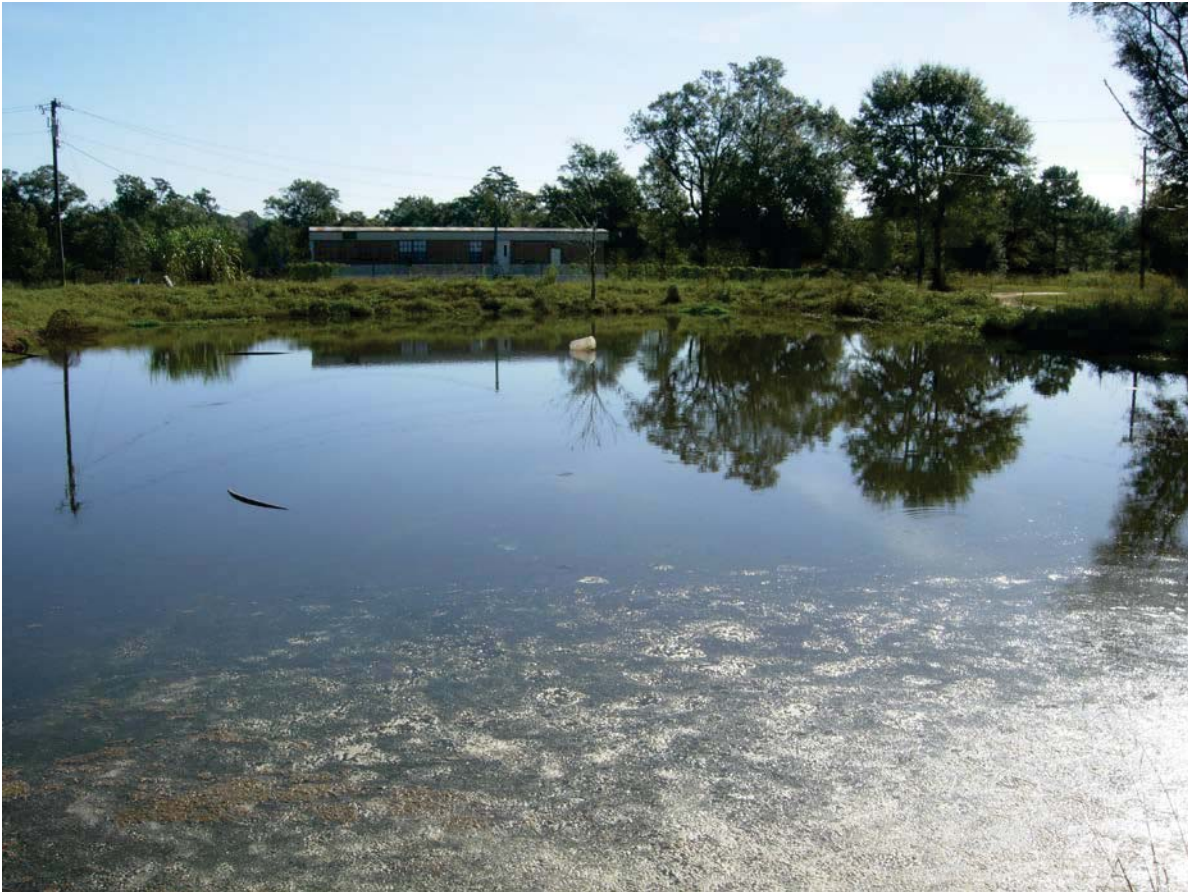
Photo No. 1

At the time of the inspection, [REDACTED] had one RCS. According to [REDACTED], this RCS was approximately twenty years old and was last cleaned out around five years ago. We observed the RCS to be in good condition and observed no evidence of discharge.

Description: Photo Taken facing east across RCS.

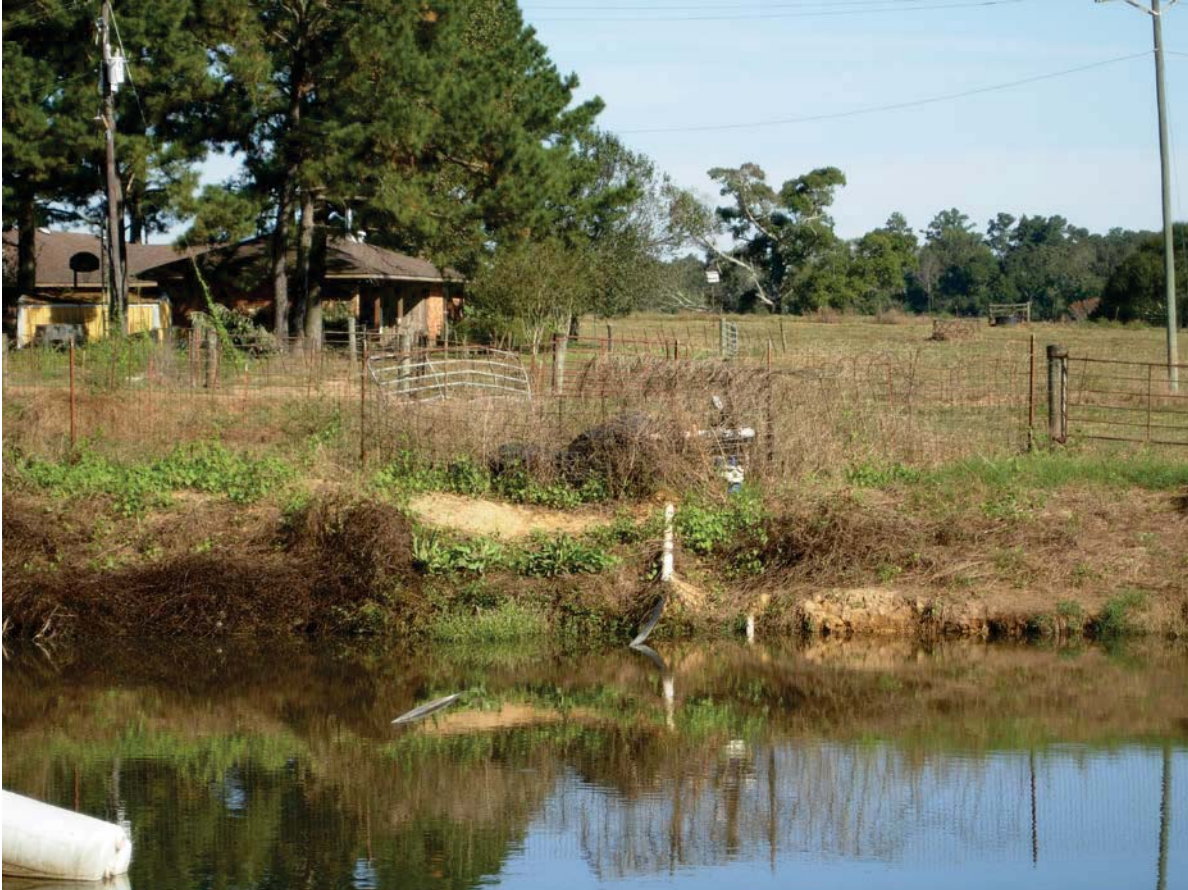
Photo No. 2

At the time of the inspection, [REDACTED] had one small pump available for dewatering the lagoon. [REDACTED] informed us that he utilizes the pump whenever he notices the wastewater approaching the crest of the RCS berm.

Description: Phot taken facing north towards dewatering pump.
