## **RCRA Inspection Report**

Hyundai Motor Manufacturing Alabama, LLC  
700 Hyundai Boulevard  
Montgomery, Alabama 36105  
Montgomery County

EPA ID No.: ALR000025486

July 26, 2021 at 1:05 p.m. and July 27, 2021 at 9:10 a.m.

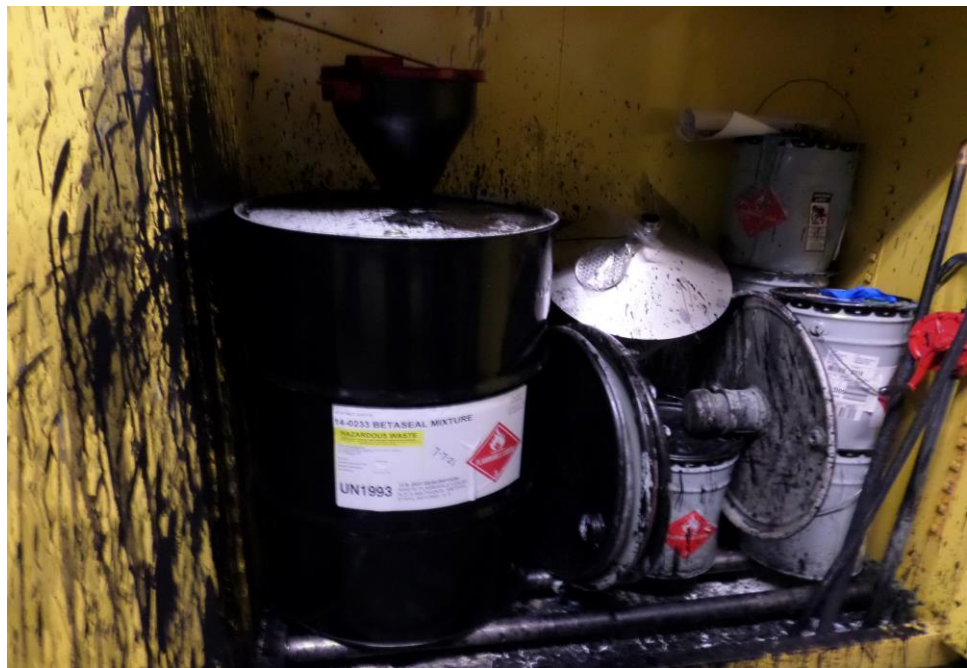
TRIDUM is Hyundai's contractor that manages hazardous waste in the contractor 90-Day Area. Mr. Gerado Pantaleon, the TRIDUM Site Manager, joined the inspectors for the inspection of this area. The inspectors observed a locked yellow flammable two-door cabinet in the contractor paint area posted with warning and security signs. Inspectors observed a 55-gallon container in the cabinet accumulating waste "betaseal mixture" (paint, methanol and methyl ethyl ketone, D001, D035, F005). Inspectors observed assorted equipment, tools, strainers, filters, several unused 5-gallon containers, container lids, and other materials stored in the cabinet. The inspectors observed spills in the cabinet's secondary containment system and on the cabinet inside walls and doors (Photograph 2). The inspectors observed a latching funnel attached to the top of the container was closed. The container was observed in good condition, labeled with the words "hazardous waste", labeled with a DOT Class 3 flammable hazard indicator, and marked with the date July 7, 2021. The inspectors observed the additional equipment, tools and other materials in the cabinet appeared not to allow for an adequate visual inspection (Photograph 2).

Hyundai. Contractor Paint Area. Inspectors observed a 55-gallon container in a yellow two door cabinet accumulating waste Betaseal Mixture. Inspectors observed equipment, tools, strainers, filters, empty containers, container covers, and other assorted materials stored in the cabinet. Inspectors did not observe aisle space and observed spills in and out of the cabinet's secondary containment system. Photograph 2 taken July 26, 2021 at 2:39 p.m.

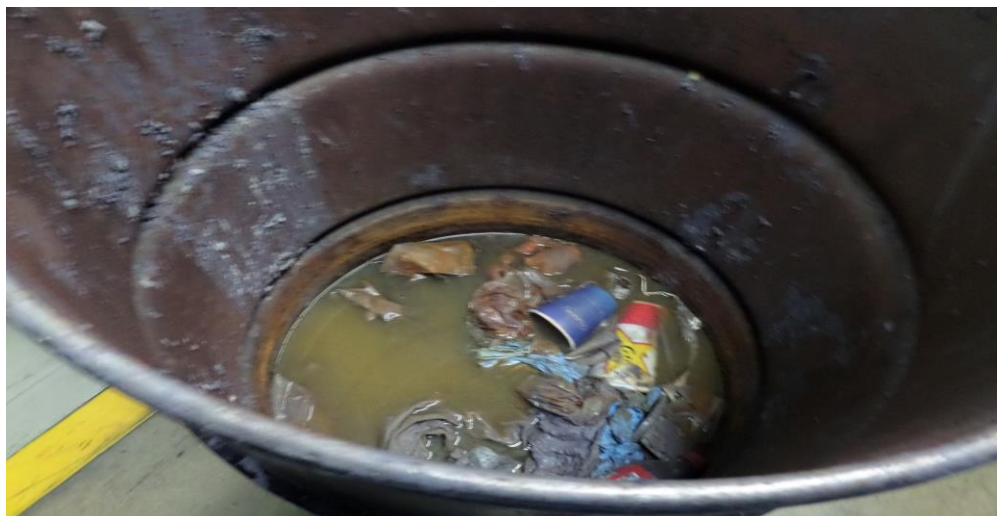
The inspectors observed seven additional 55-gallon containers on wooden pallets along the wall accumulating various amounts of solid waste. Mr. Pantaleon indicated one 55-gallon container was accumulating non-hazardous waste sealer and two 55-gallon containers appeared to be accumulating water and trash. The inspectors observed four 55-gallon containers appeared to be accumulating waste paint related liquid (Photographs 3, 4, and 5).

Documentation that an accurate waste determination was performed on the solid waste accumulating in the four 55-gallon containers was not observed in the record review.

Hyundai. Contractor Paint Area. Inspectors observed seven 55-gallon containers on pallets along the wall accumulating unknown solid waste. One open container was accumulating waste liquid and trash (paper towels and cups). Inspectors observed four containers were accumulating various amounts solid waste. Photograph 4 taken July 26, 2021 at 3:03 p.m.

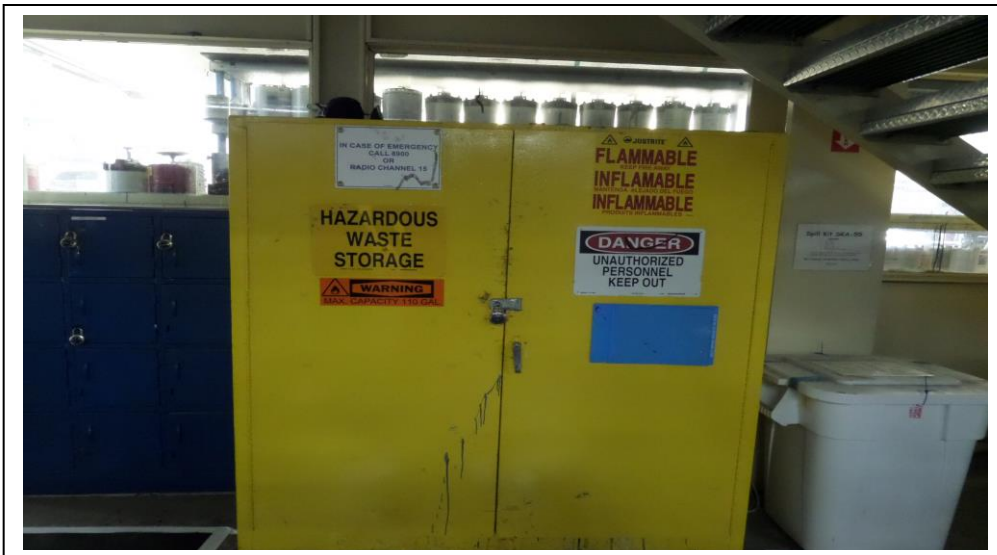
The inspectors observed a locked yellow flammable cabinet located in the spot repair area posted with warning and security signs. The inspectors observed two 55-gallon containers in the cabinet accumulating solvent contaminated absorbents, wipes, and personal protective equipment (PPE). The containers were closed, in good condition, with aisle space, labeled with the words “hazardous waste”, marked with the waste codes D001 and D035, labeled with a DOT Class 3 flammable hazard indicator, and both marked with the date July 15, 2021 (Photographs 8 and 9).

Hyundai. Spot Repair 90-Day Area. Inspectors observed a locked two-door yellow cabinet for two 55-gallon containers accumulating absorbents, PPE and cans contaminated with Betaseal Mixture identified in Photograph 8. Inspectors observed signs indicating a hazardous waste storage area. Photograph 9 taken July 26, 2021 at 3:32 p.m.

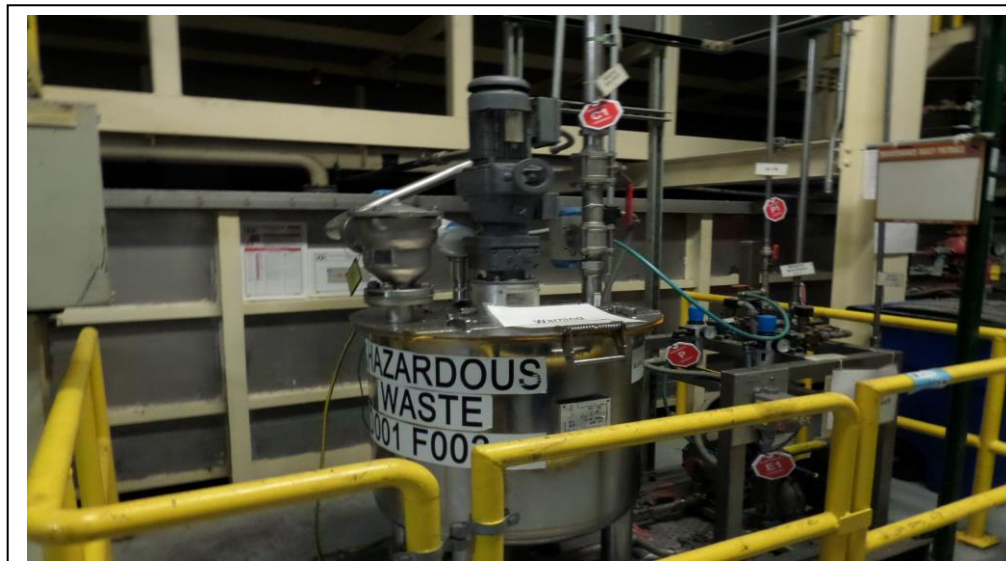
The hazardous waste is circulated in the Tanks to prevent solidification and pumping begins when the Tanks are 70 percent full and pumping stops when the Tanks are 60 percent full. The hazardous waste is pumped by pipeline to two 55-gallon containers in the Solvent-Related Paint Mix Room. The inspectors observed the Tanks were closed, in good condition, labeled with the words “hazardous waste”, and marked with the waste codes D001 and F003. The inspectors observed the Tanks were not marked or labeled with an indication of the hazards (Photographs 10 and 12).

The inspectors observed the Tanks ancillary equipment components (pipe connections, flanges, valves, pumps) appeared not to be marked in a manner that could be distinguished readily from other pieces of equipment (Photographs 10, 11, 12, 13, 14 and 15). Mr. Ron Bishop indicated that the Tanks and ancillary equipment were regulated under Subpart W - National Emission Standards for Hazardous Air Pollutants (NESHAP).

Hyundai. Kettle Purge Tank 1 Area. Inspectors observed a 35-gallon purge tank (tank 1) accumulating waste paint and solvent. The inspectors observed the tank was not marked/labeled with an indication of the hazards. Inspectors observed red octagonal shaped lockout tags and yellow diamond shaped tags designated with the letters C, P, E or RC and followed by a number (1, 2, or 3) secured by plastic cable ties to the tanks and the tank's ancillary equipment (valves, pumps, flanges, connectors, electrical and pneumatic equipment). Photograph 10 taken July 26, 2021 at 3:44 p.m.

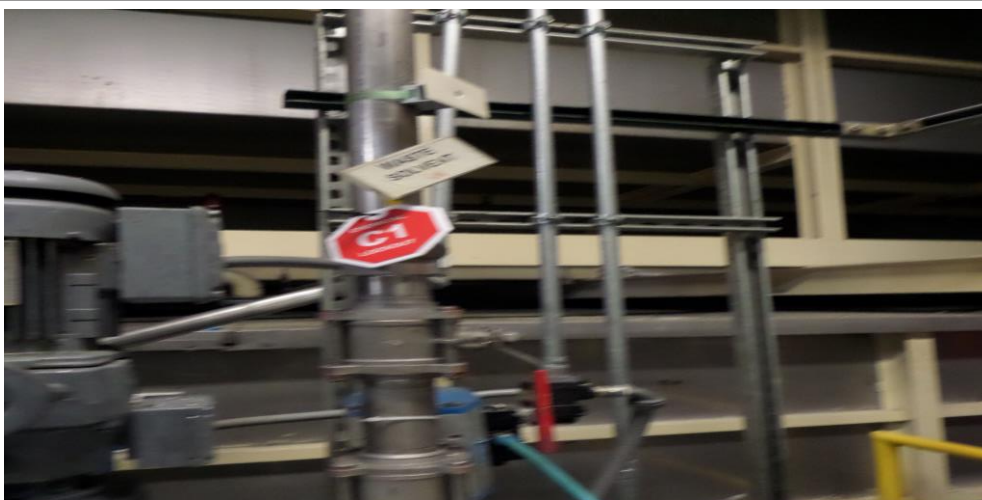
Hyundai. Kettle Purge Line 1 Area. Inspectors observed red octagonal shaped lockout tags and yellow diamond shaped tags designated with the letters C, P, E or RC and followed by a number (1, 2, or 3) secured by plastic cable ties to the tanks and the tank's ancillary equipment (valves, pumps, flanges, connectors, electrical and pneumatic equipment). Photograph 11 taken July 26, 2021 at 3:44 p.m.

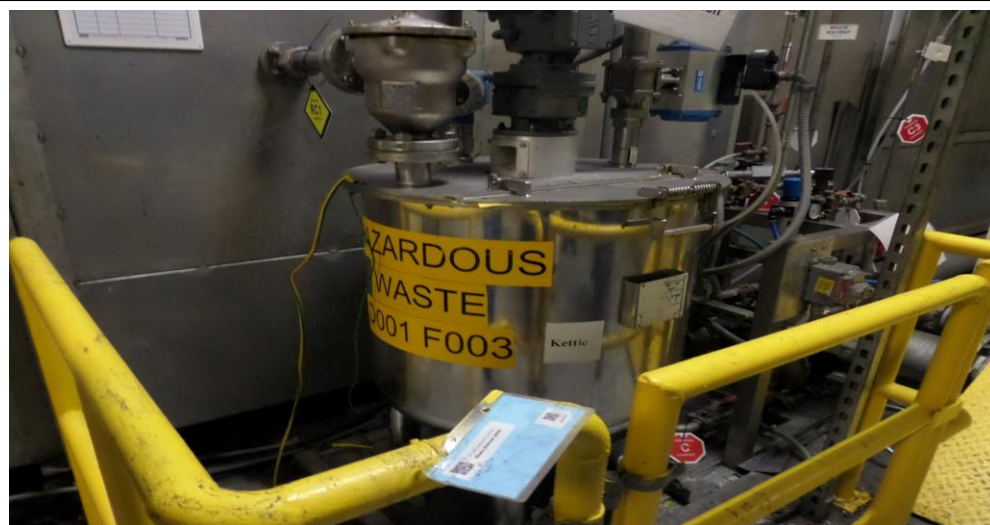
Hyundai. Kettle Purge Tank 2 Area. Inspectors observed a 35-gallon purge tank (tank 2) accumulating waste paint and solvent. The inspectors observed the tank was not marked/labeled with an indication of the hazards. Inspectors observed red octagonal shaped lockout tags and yellow diamond shaped tags designated with the letters C, P, E or RC and followed by a number (1, 2, or 3) secured by plastic cable ties to the tanks and the tank's ancillary equipment (valves, pumps, flanges, connectors, electrical and pneumatic equipment). Photograph 12 taken July 26, 2021 at 3:50 p.m.

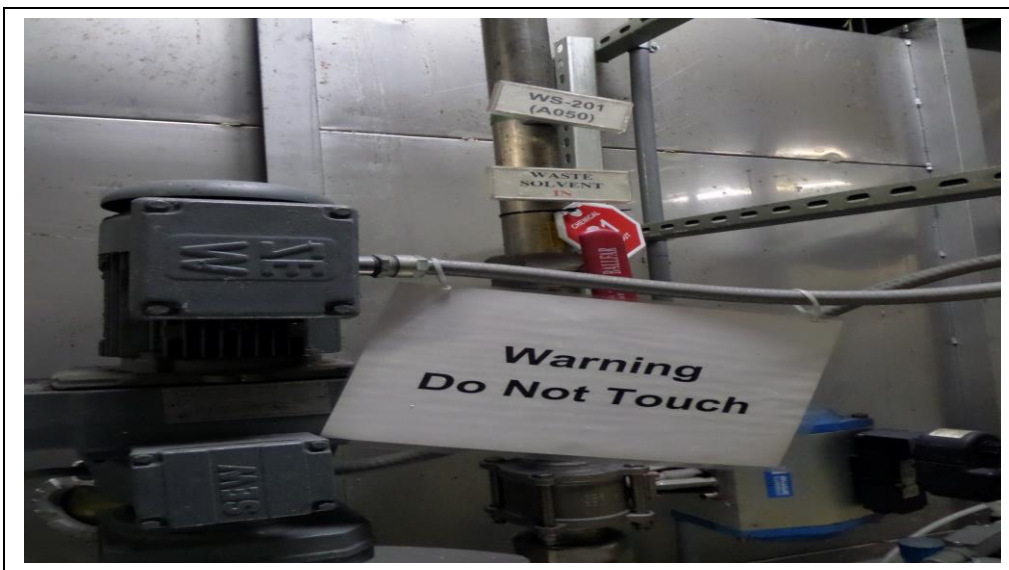
Hyundai. Kettle Purge Line 2 Area. Inspectors observed red octagonal shaped lockout tags and yellow diamond shaped tags designated with the letters C, P, E or RC and followed by a number (1, 2, or 3) secured by plastic cable ties to the tanks and the tank's ancillary equipment (valves, pumps, flanges, connectors, electrical and pneumatic equipment). Photograph 13 taken July 26, 2021 at 3:50 p.m.

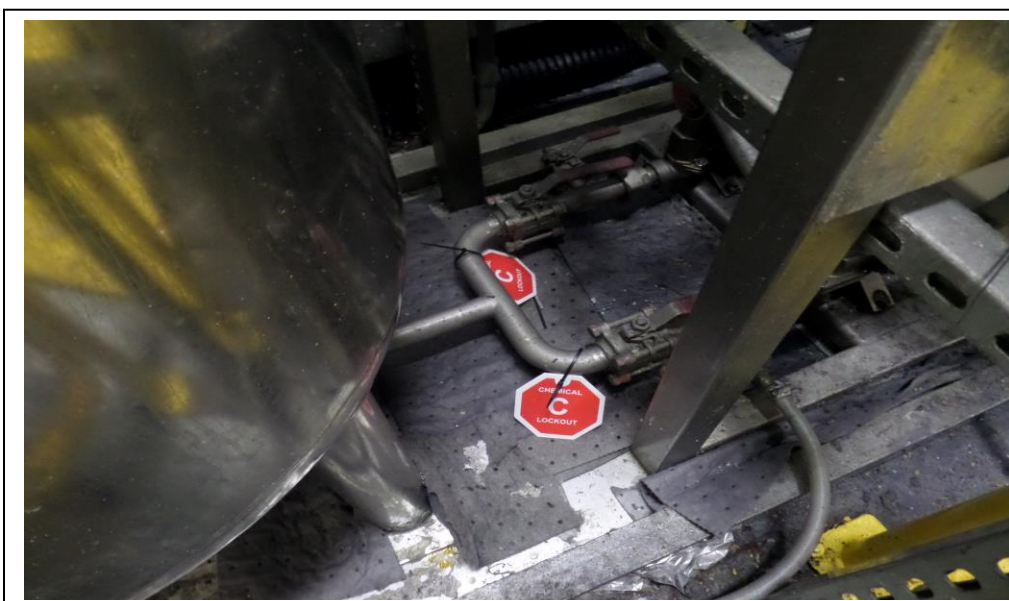
Hyundai. Kettle Purge Line 2 Area. Inspectors observed red octagonal shaped lockout tags and yellow diamond shaped tags designated with the letters C, P, E or RC and followed by a number (1, 2, or 3) secured by plastic cable ties to the tanks and the tank's ancillary equipment (valves, pumps, flanges, connectors, electrical and pneumatic equipment). Photograph 14 taken July 26, 2021 at 3:50 p.m.

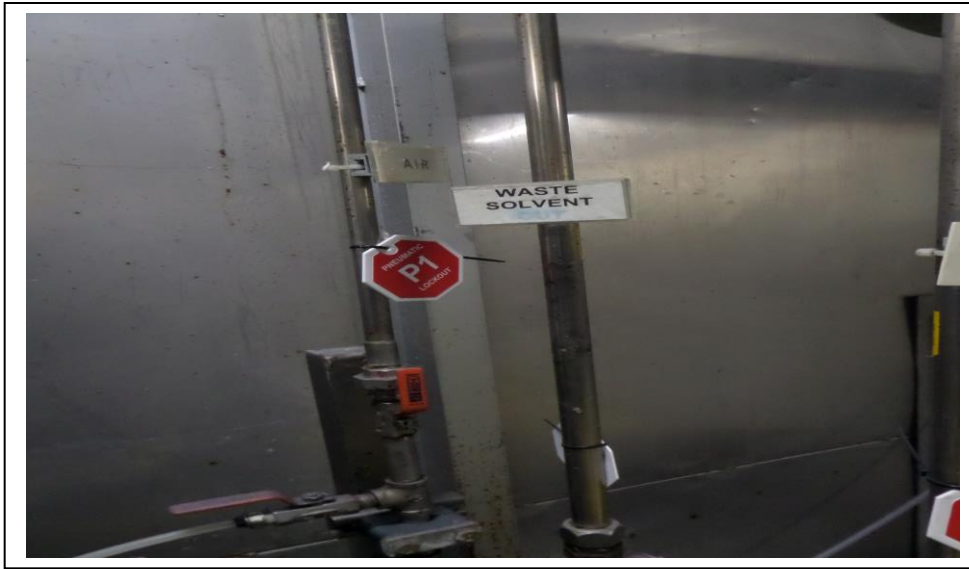
Hyundai. Kettle Purge Line # Area. Inspectors observed red octagonal shaped lockout tags and yellow diamond shaped tags designated with the letters C, P, E or RC and followed by a number (1, 2, or 3) secured by plastic cable ties to the tanks and the tank's ancillary equipment (valves, pumps, flanges, connectors, electrical and pneumatic equipment). Photograph 15 taken July 26, 2021 at 3:50 p.m.

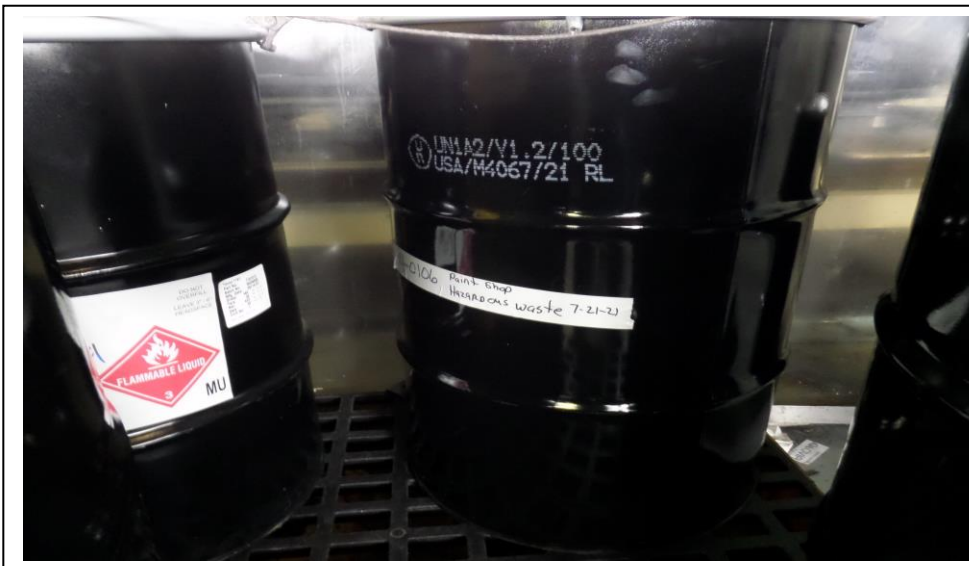
The inspectors also observed four 55-gallon containers accumulating solvent-saturated absorbents, wipes, and PPE on secondary containment pallets. The inspectors observed warning and security signs posted in this area. The containers were closed, in good condition, with aisle space, labeled with the words “hazardous waste”, marked with dates July 19, 2021, July 20, 2021, or July 21, 2021. The inspectors observed the access was not restricted to the four 55-gallon containers accumulating hazardous waste in the topcoat two 90-day storage area. The inspectors observed one 55-gallon container was not marked or labeled with a hazard indicator and not marked with EPA waste codes (Photographs 16 and 17). The facility marked the word “ignitable” and the EPA waste codes on the one 55-gallon container’s label, prior to inspectors leaving this area.

Hyundai. Top-Coat 90-Day Area. The inspectors observed four 55-gallon containers accumulating hazardous waste on a poly pallet. One container was not marked/labeled with a hazard indication and not marked with waste codes. The facility marked the container with an ignitability indication and with the waste codes D001, F003. Photograph 16 taken July 26, 2021 at 3:59 p.m.

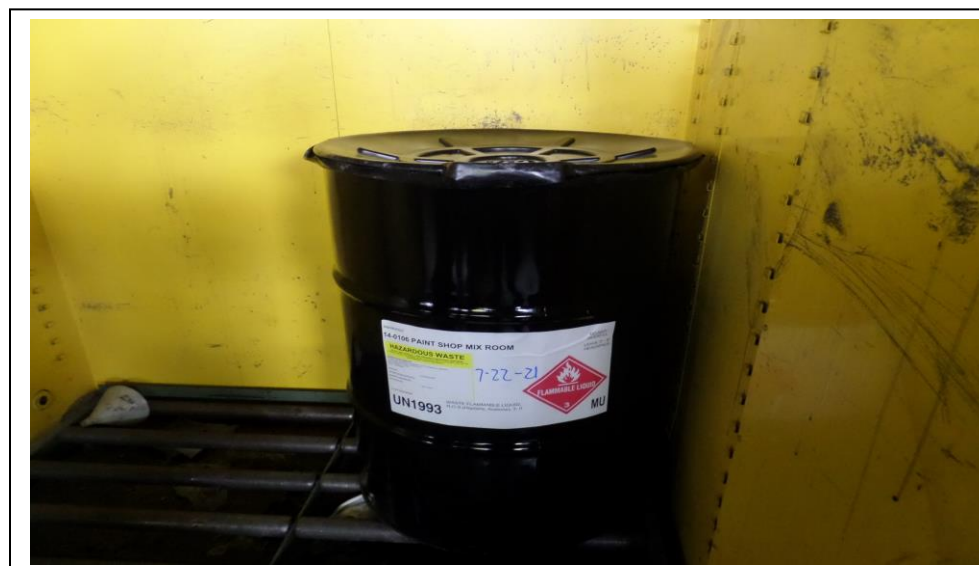
cabinet accumulating solvent-saturated absorbents, wipes, and PPE. The container was covered with a plastic “Profit Lid”, that did not securely keep the container closed. The inspectors observed the container was in good condition, with aisle space, labeled with the words “hazardous waste”, marked with the waste codes D001 and F003, labeled with a DOT Class 3 flammable hazard indicator, and marked with the date July 22, 2021 (Photograph 18).

Hyundai. Top-Coat Flammable Locker. The inspectors observed one 55-gallon containers accumulating hazardous waste in a yellow locker on a poly pallet. The inspectors observed the container was not kept closed by a plastic "Profit Lid". Photograph 18 taken July 26, 2021 at 4:06 p.m.

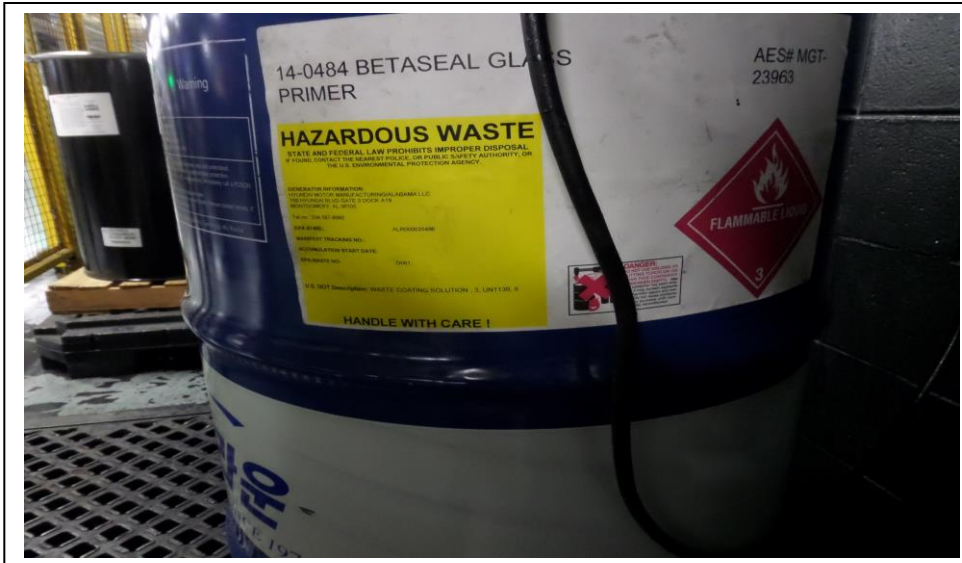
The inspectors observed one 55-gallon container accumulating waste absorbent, aerosol cans and PPE and one 55-gallon container accumulating waste “betaseal glass primer” on poly pallets inside a locked wire enclosure posted with warning and security signs. The inspectors observed the containers were closed, in good condition, with aisle space, labeled with the words “hazardous waste”, marked with waste codes (D001, D035), and labeled with a hazard indicator. The containers were marked with the dates July 18, 2021 and July 10, 2021, respectively (Photographs 19 and 20).

Hyundai. General Assembly Building - Trim Three Beta Seal 90-Day Area. The inspectors observed two 55-gallon containers accumulating hazardous waste absorbent and PPE and hazardous waste Betaseal on a poly pallet inside a locked wire cage enclosure. One container was dated July 18, 2021, the second container was marked with the date July 10, 2021, shown in Photograph 20. Photograph 19 taken July 26, 2021 at 4:23 p.m.

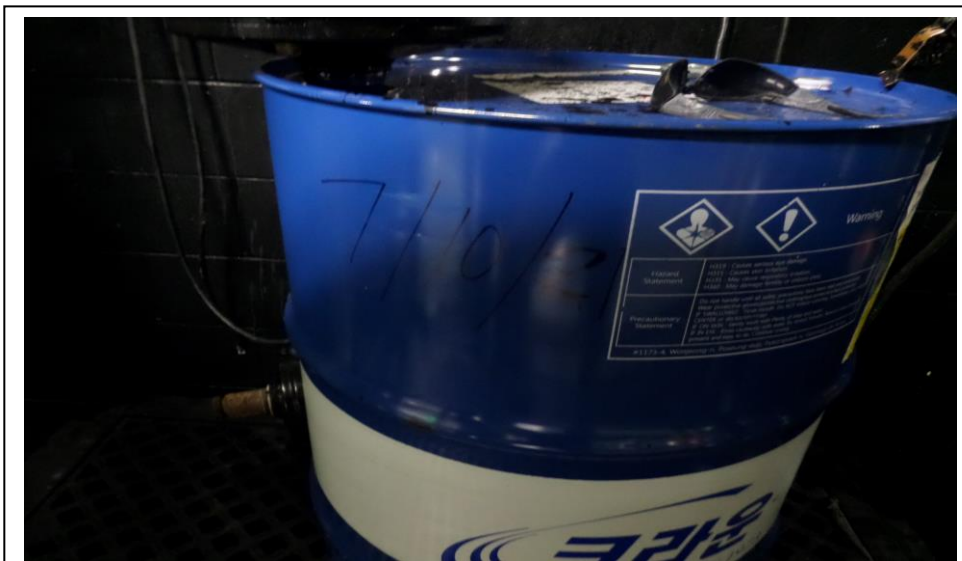
Hyundai. General Assembly Building - Trim Three Beta Seal 90-Day Area. The inspectors observed one 55-gallon containers accumulating hazardous waste Betaseal on a poly pallet inside a locked wire cage enclosure. The inspectors observed the container was marked with the date July 10, 2021. Photograph 20 taken July 26, 2021 at 4:23 p.m.

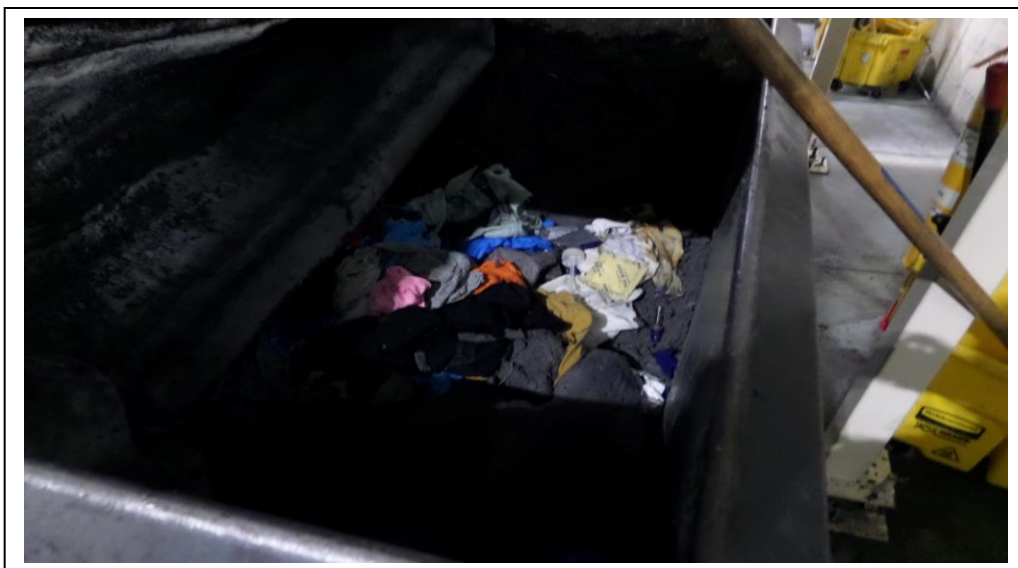
Hyundai. Engine Building 1. Inspectors observed a container accumulating metal solids, grease and oily grime from filtering coolant used in the engine machining operation. The filtered metal solids are accumulated in a 0.5 cubic yard container. Photograph 21 taken July 27, 2021 at 11:09 a.m.
