## Region 6 - Enforcement & Compliance Assurance Division

### INSPECTION REPORT

| Company Name: | <b>CapturePoint, LLC</b> | |
| Facility Name: | <b>North Burbank Unit (NBU) 24 Battery</b> | |

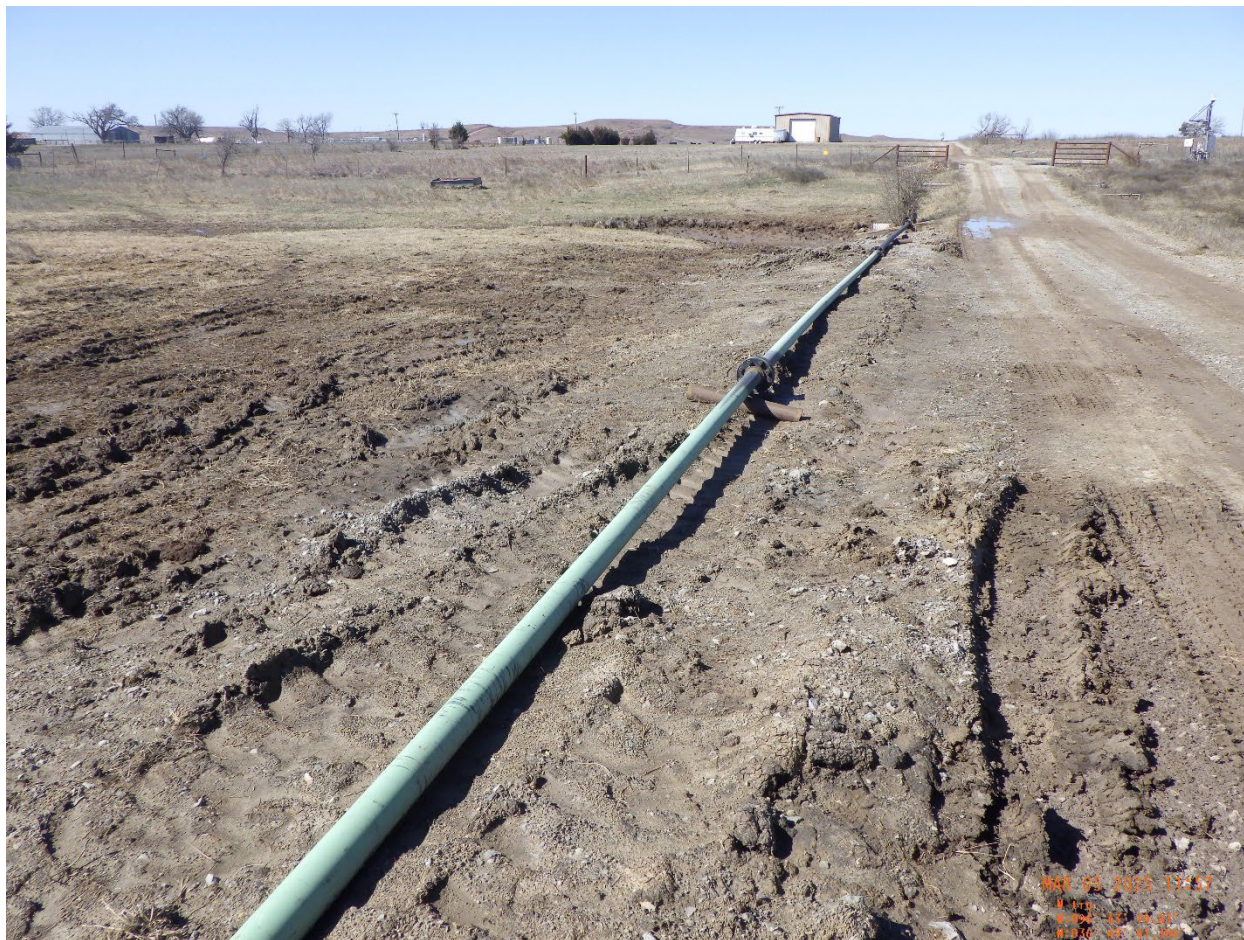
Photo No. 1

I observed the release point and flowpath of the spill. The release point was a 4" steel injection line which failed, releasing a company reported 40 barrels of produced water to the soil surface. The produced water migrated west along the road ditch approximately 100 feet before flowing into a drainage feature south of the road. See photo No. 1, Appendix 1 (photo log). For additional GPS location information and photo metadata, see the attached photo log.

**Description:** This was the release point, a 4" steel injection line which failed, releasing a company estimated 40 barrels of saltwater to the land surface.

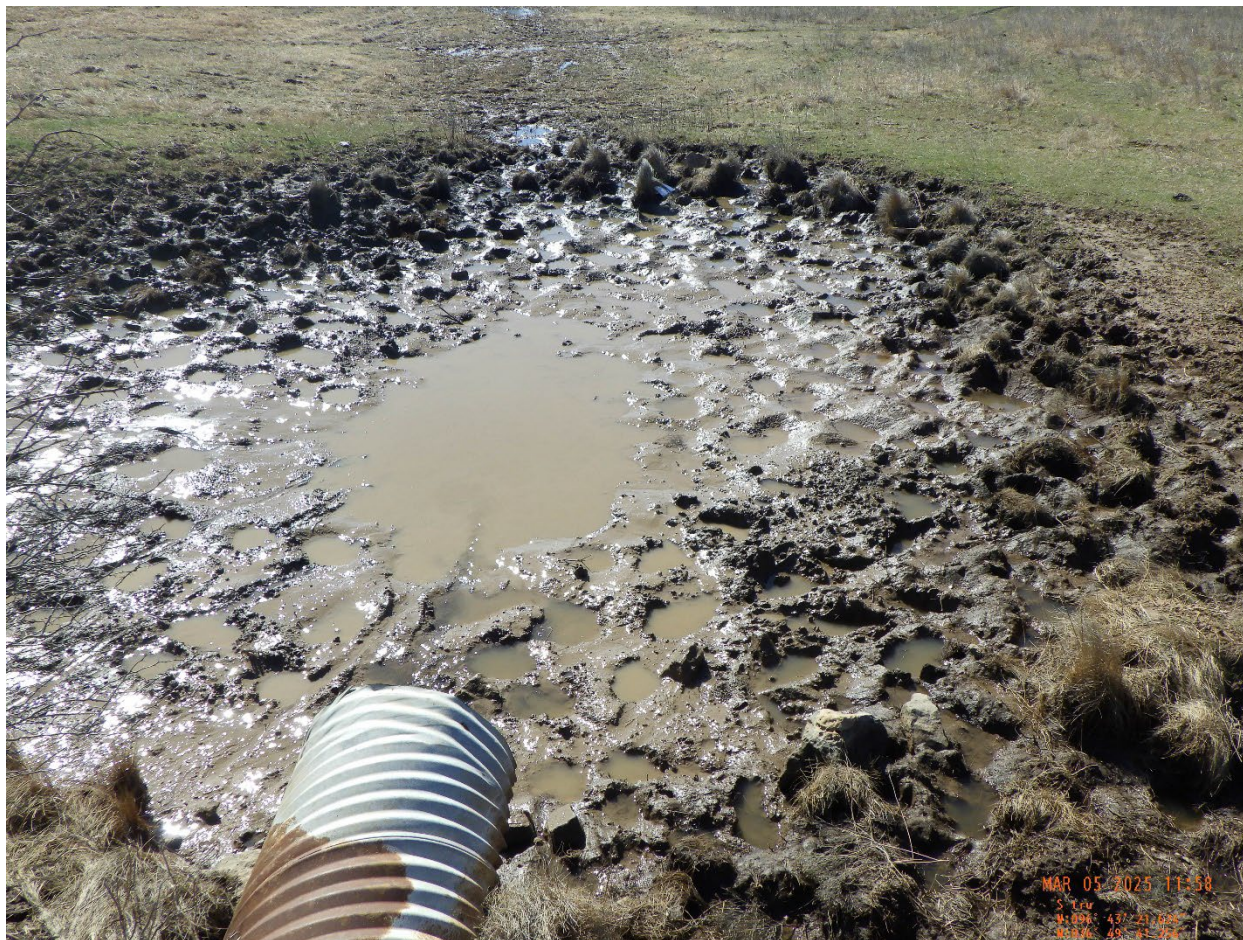
Photo No. 2

I observed an impacted pool of water immediately below the road crossing. At the time of the inspection a vacuum truck had just finished emptying the pool leaving only a skim of water atop mud. See photo No. 2.

**Description:** This was a pool of water below the road crossing where the spill entered a drainage feature. At the time of the inspection, a vacuum truck had just finished emptying the pool.
