**DCN RECYCLING, CORP. , Carolina, Puerto Rico**

**PRN008026791**

**CEPD-RCRA-22-0425**

**Eduardo Gonzalez  
August 22, 2022**

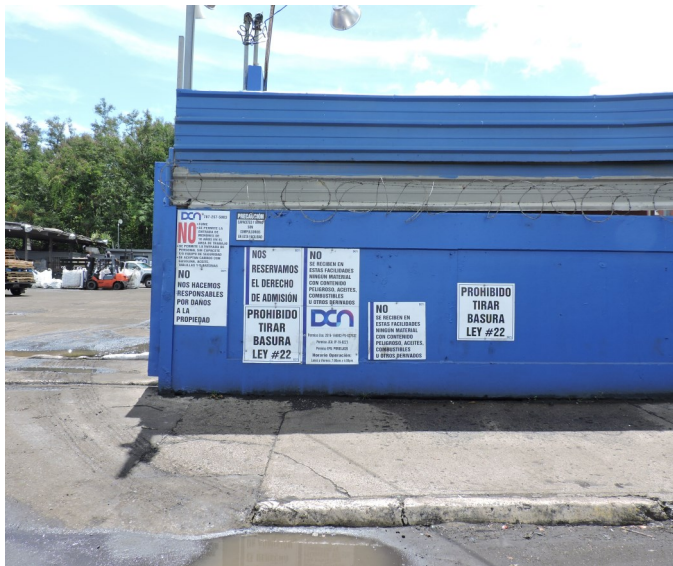
**Picture 1 - DCN RECYCLING, CORP.** — It is a 6,736 m2 scrap metal recycling facility located in Sector La Palmita, PR Road - 887, km 0.9 Carolina, Puerto Rico.

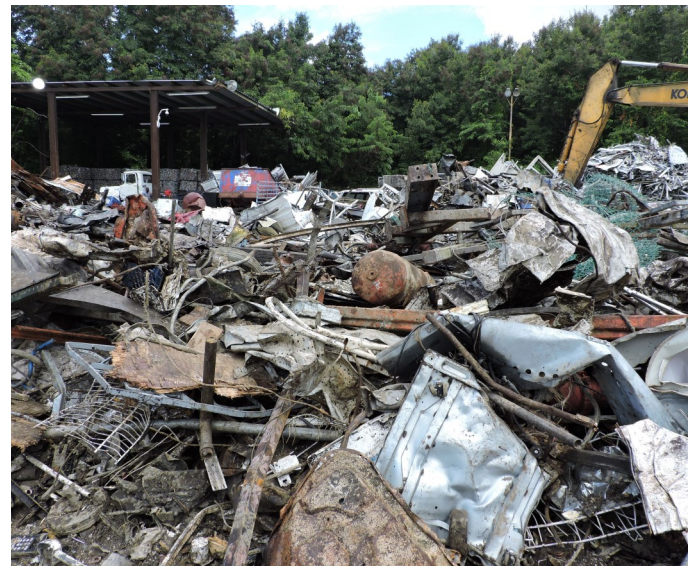
**Picture 2—DCN RECYCLING, CORP.** - The Facility operates as a scrap metal recycler processor and exporter of ferrous and nonferrous metals to China, Korea, Panamá and United States.

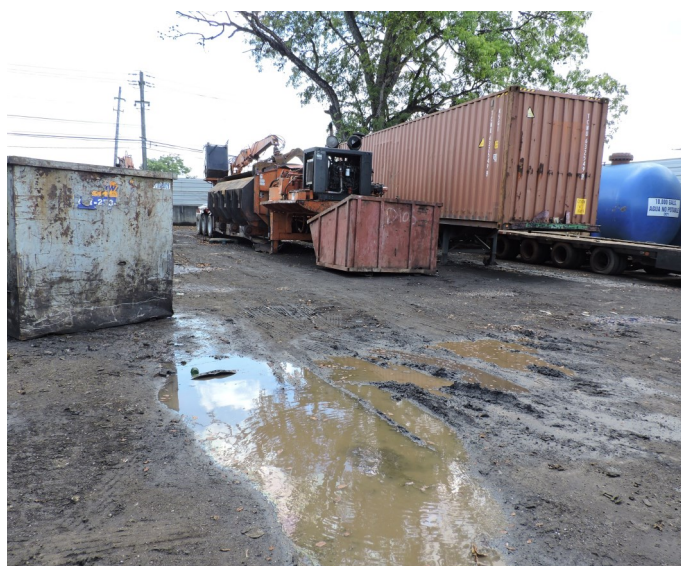
**Picture 3—DCN RECYCLING, CORP.** - The Facility also operates as an auto salvage yard, buying and taking in abandoned vehicles, partially dismantling, crushing, storing, then reselling as scrap steel to scrap yard metal facilities in Puerto Rico and the United States

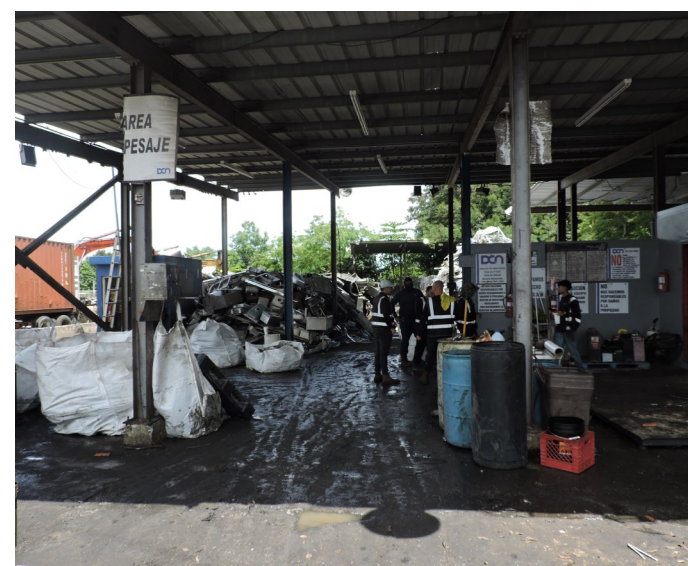
**Picture 4— DCN RECYCLING, CORP.** - As part of its crushing operations, DCN Administrative & Recycling Corp. generates used oil and other vehicle fluids some hazardous.

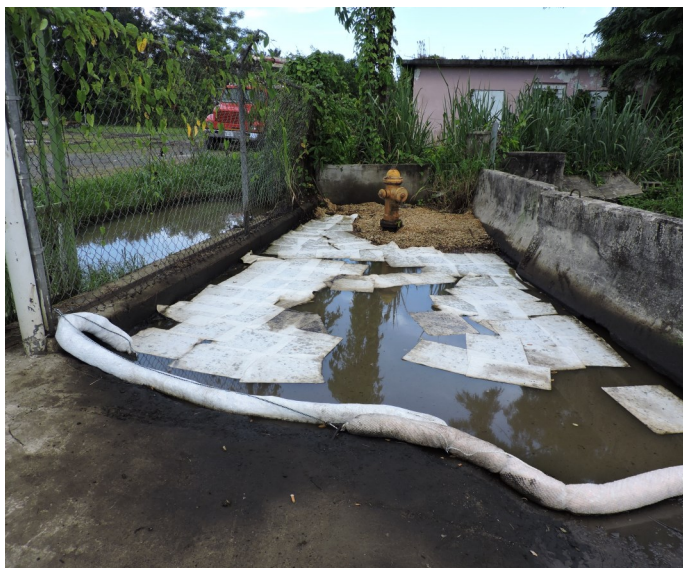
**Picture 5- DCN RECYCLING, CORP.** - As recorded at the Facility, any fluids generated from rainwater or auto crushing operations flow into the ground and downgradient towards the community and into an unnamed creek and flows into the Blasino Channel.

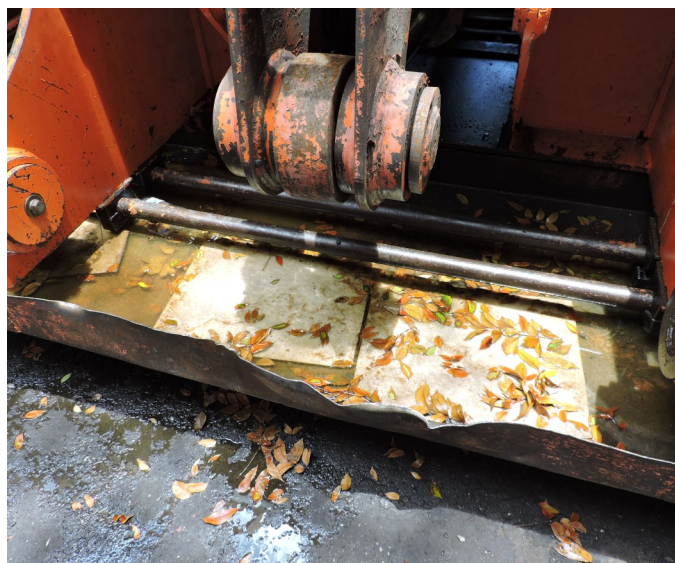
**Picture 6 - DCN RECYCLING, CORP.** - As observed during EPA Inspection, all mixed fluids generated from crushing and compacting operations are trapped into a metal tray-typed and collected with absorbent materials.

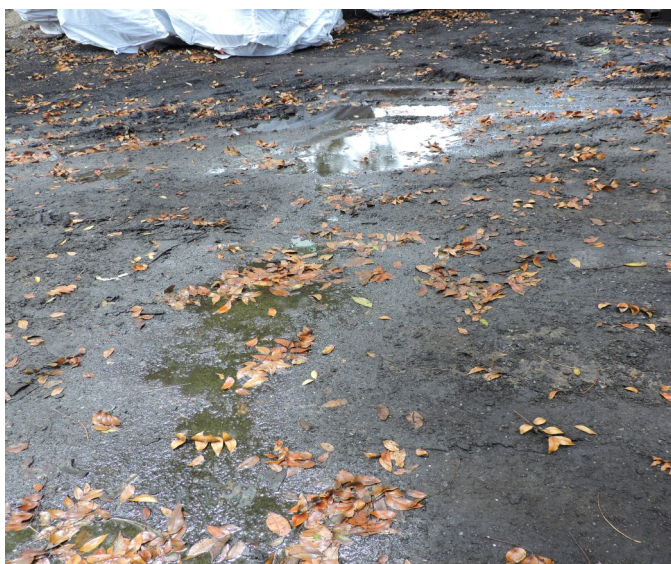
**Picture 7—DCN RECYCLING, CORP.** - As evidenced during EPA Inspection, once the tray is full, it leaks onto bare soils and flow downgradient and off the property.

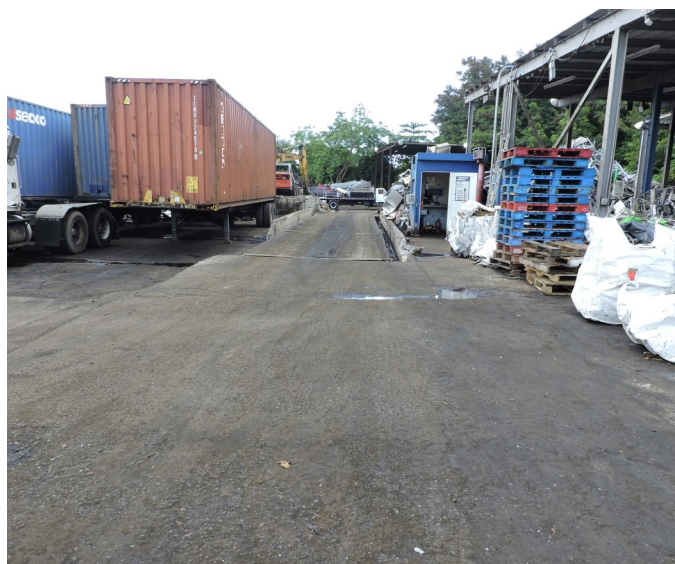
**Picture 8 - DCN RECYCLING, CORP.** — As observed during EPA Inspection, the entrance gate and weighting scale station area is where all cargo trucks are visually inspected before segregating into small-scale stations.

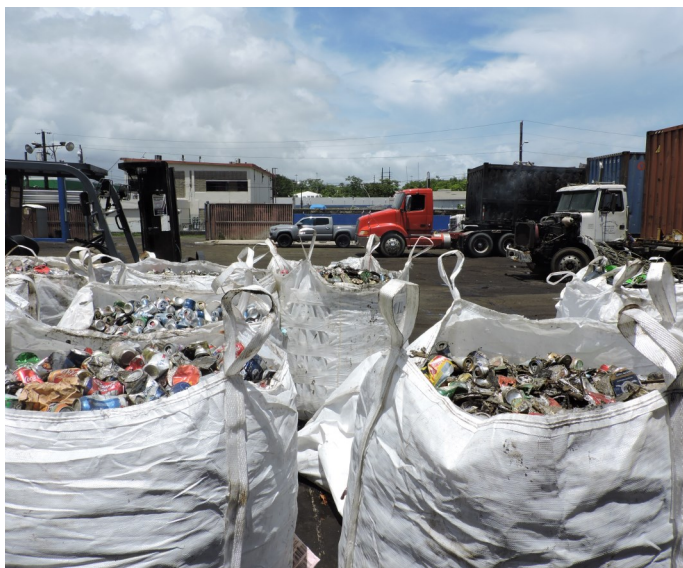
**Picture 9- DCN RECYCLING, CORP.** — The weighing scale station area is located at the center of the property. A loading concrete pad area is located north of the entrance where all scrap metals are collected and segregated according to material properties.

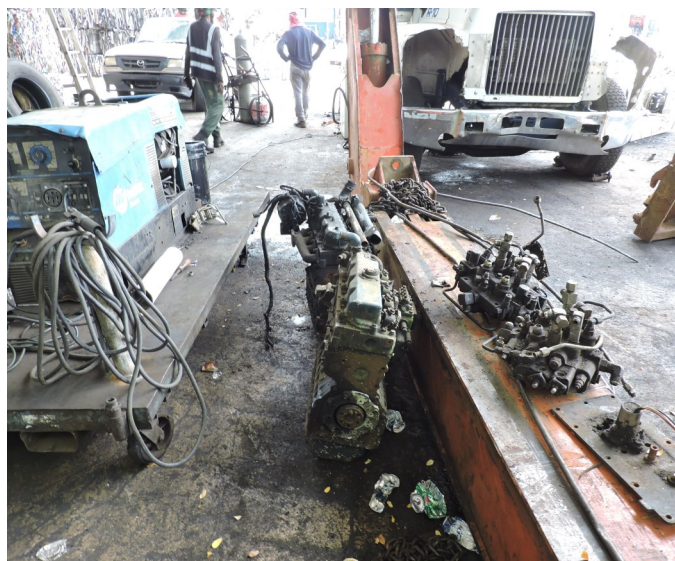
**Picture 10 - DCN RECYCLING, CORP.** - At the Entrance Gate and Weighing Scale Area, dismantled motor engines with no control or prevention of releases of used oil or stormwater runoff contaminated with transmission fluids, gasoline, diesel, and other motor oil fluids.

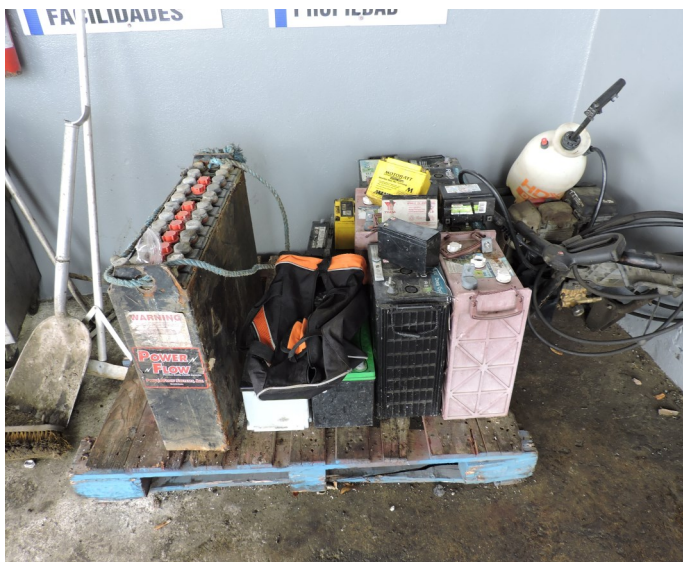
**Picture 11—DCN RECYCLING, CORP.** - Approximately twenty-five (25) discarded auto batteries placed on a wood pallet without any means of containment measures or labels. According to Ms. Cordero a battery carrier would be contacted to recycle the auto batteries at the Entrance Gate and Weighing Scale Area.

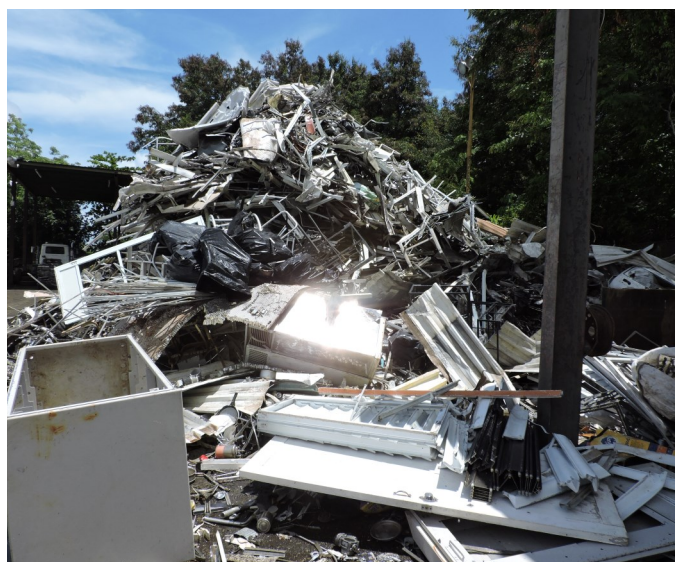
**Picture 12 - DCN RECYCLING, CORP.** - The Aluminum Accumulation Area consisted of steel shed with concrete pad in which a weighing scale is also used before and after segregating all aluminum metals before being transfer into 1-cy textile bags.

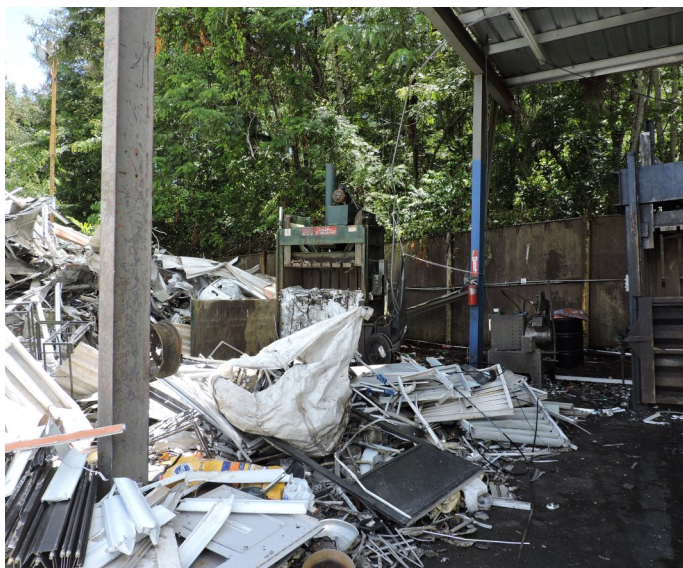
**Picture 13- DCN RECYCLING, CORP.** - EPA Inspector observed aluminum scrap metals are first segregated by metal properties (i.e., aluminum cans), crushed with compacting machines to reduce metals size, and then immediately transferred to 1-cy white cloth bags.

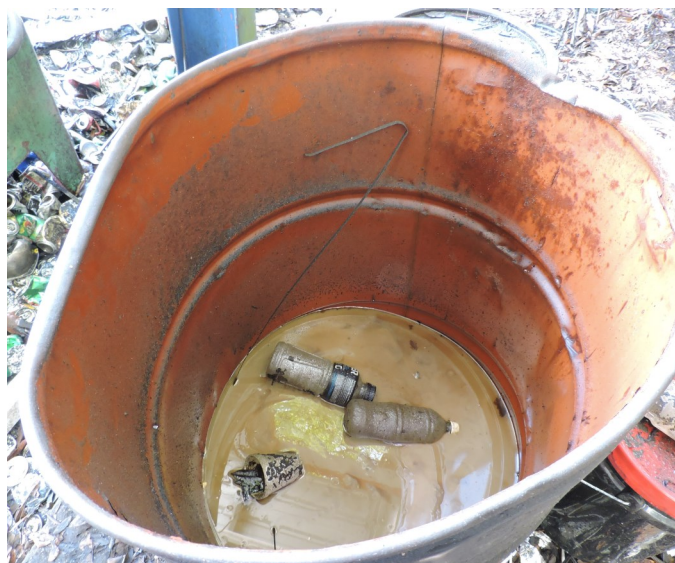
**Picture 14 - DCN RECYCLING, CORP.** - As observed, at the Entrance Gate and Weighing Scale Area there two (2) 55-gallon steel drums open with used oil waste content not properly labelled with the words, "Used Oil," and surrounded with scrap metals heavily impacted with used oil.

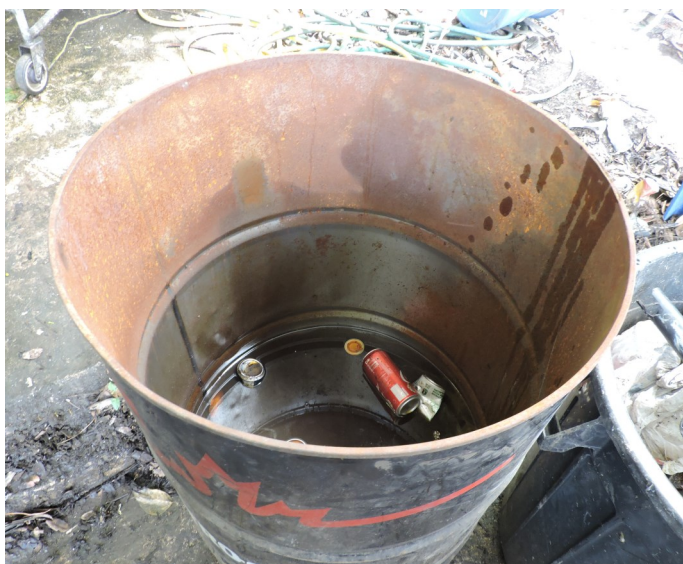
**Picture 15—DCN RECYCLING, CORP.** — As observed, at the Entrance Gate and Weighing Scale Area there two (2) 55-gallon steel drums open with used oil waste content not properly labelled with the words, "Used Oil," and surrounded with scrap metals heavily impacted with used oil.

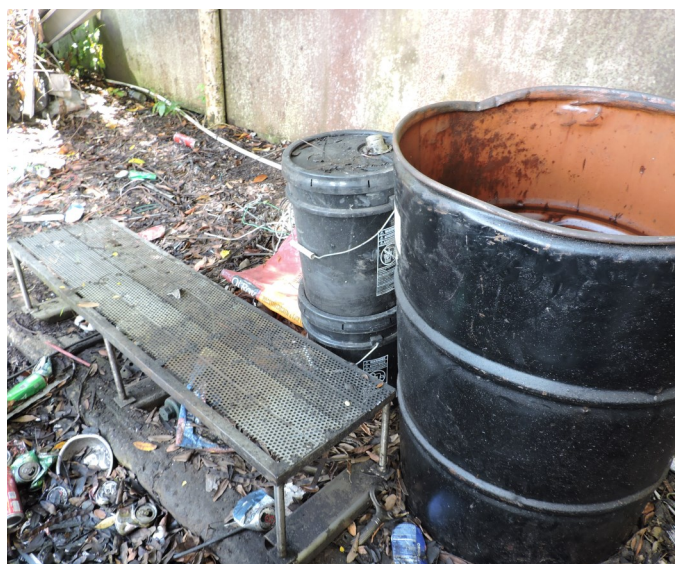
**Picture 16 - DCN RECYCLING, CORP.** - As observed, at the Entrance Gate and Weighing Scale Area there were two (2) 5-gallon plastic containers with used oil not properly labeled with the words, "Used Oil."

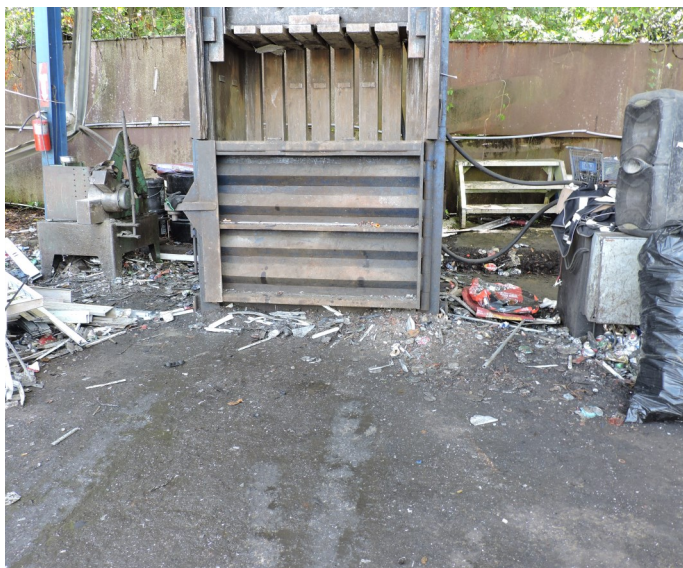
**Picture 17- DCN RECYCLING, CORP.** - As observed by the EPA Inspector at the Compacting Aluminum Accumulation Area, there were leaks incidents on the concrete floor that appears to contain used oil from crushing machines and heavily impacting soils in the backyard with used oil.

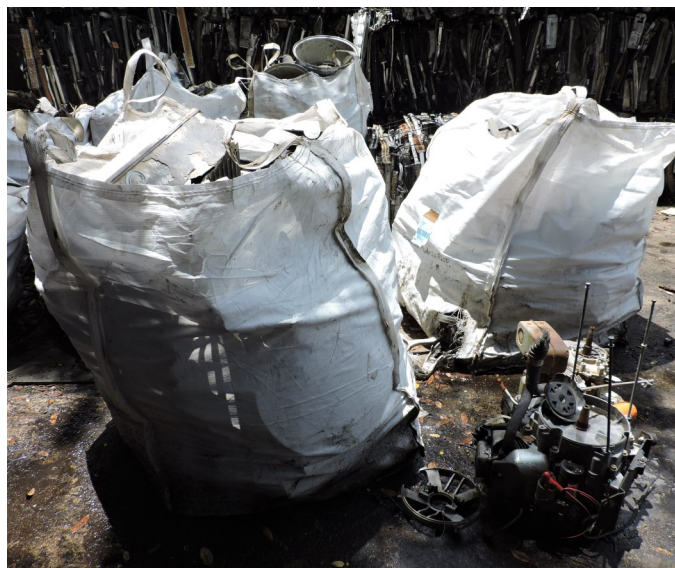
**Picture 18 - DCN RECYCLING, CORP.** - At the Material Processing & Storage Area there were approximately four (4) 1-cy yard "white cloth" bags with motor engine parts and other metals leaking used oils on the concrete floor without any means of control.

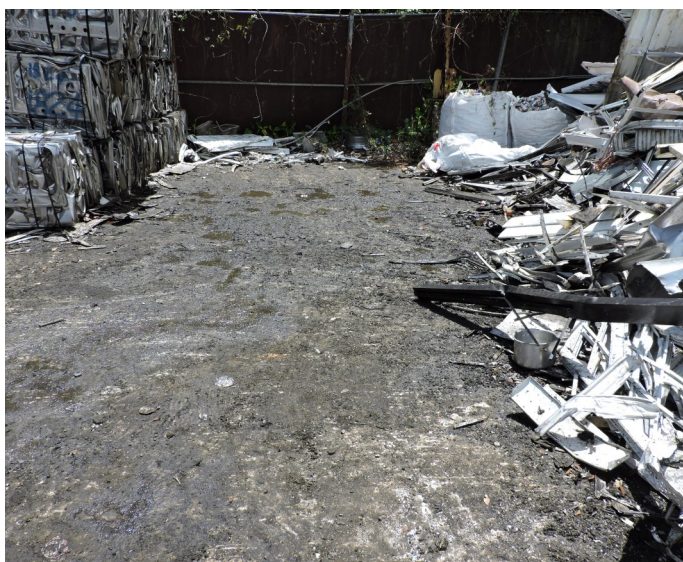
**Picture 19—DCN RECYCLING, CORP.** - As observed at the Material Processing & Storage Area, there were lots of leak incidents on the concrete floor that appears to contain motor engine fluids that migrated and heavily impacted with used oils the backyard soils near the property perimeter fence.

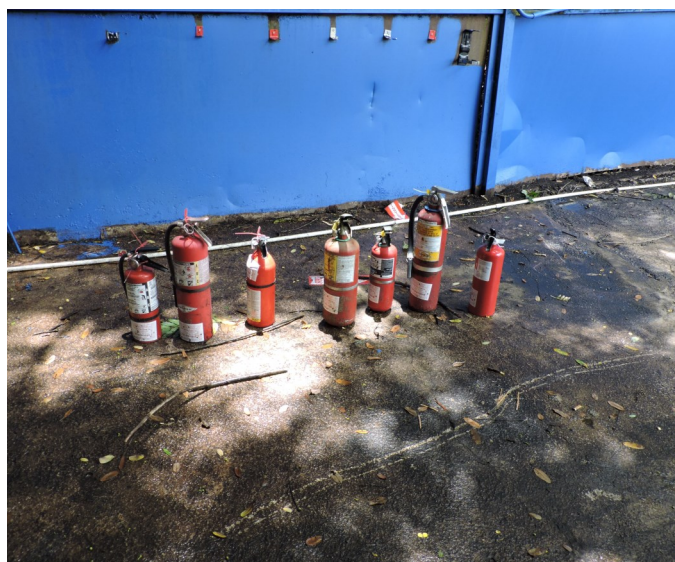
**Picture 20 - DCN RECYCLING, CORP.** - As observed at the Machine Shop Area , there were approximately seven (7) discarded extinguishers placed on the concrete floors without any containment measures or labels.

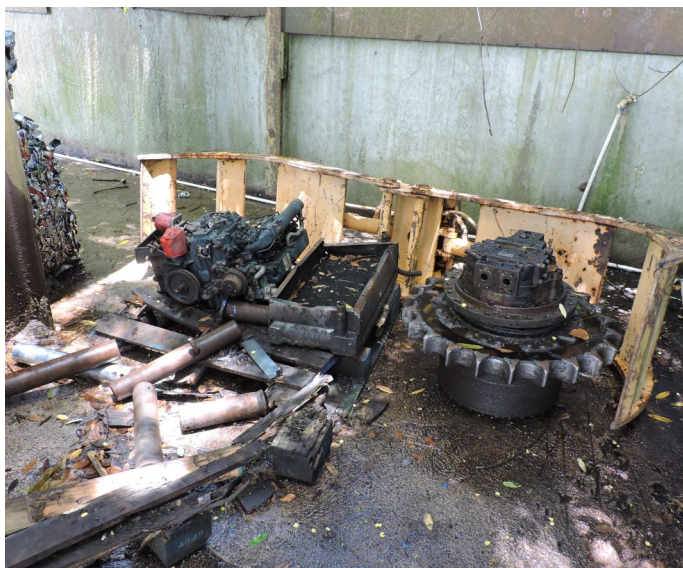
**Picture 21- DCN RECYCLING, CORP.** - As observed at the Machine Shop Area, dismantled motor engines with no control or prevention of releases of used oil or stormwater run-off contaminated with transmission fluids, gasoline, diesel, and other motor oil fluids.

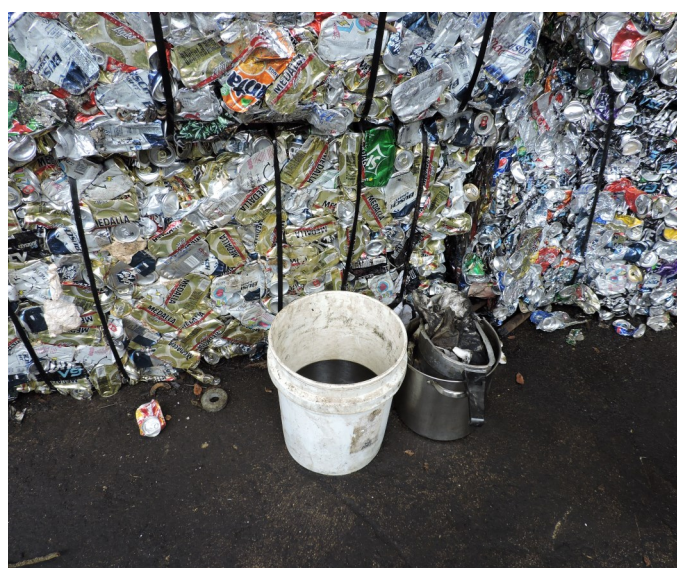
**Picture 22 - DCN RECYCLING, CORP.** - As observed at the Machine Shop Area, there was one (1) 5-gallon plastic container open and with used oil not properly labeled with the words, "Used Oil."

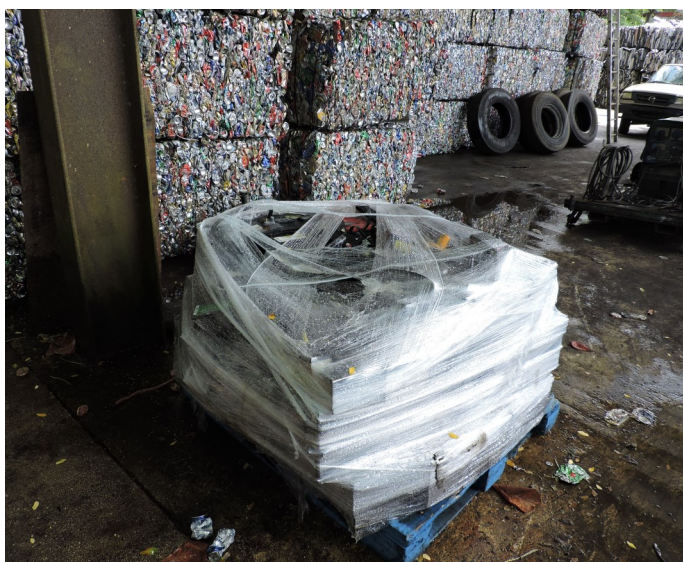
**Picture 23—DCN RECYCLING, CORP.** - As observed by the EPA Inspector at the Machine Shop Area, there were approximately over one hundred (100) discarded batteries rolled in plastic film and placed on a wood pallet without any means of containment measures or labels.

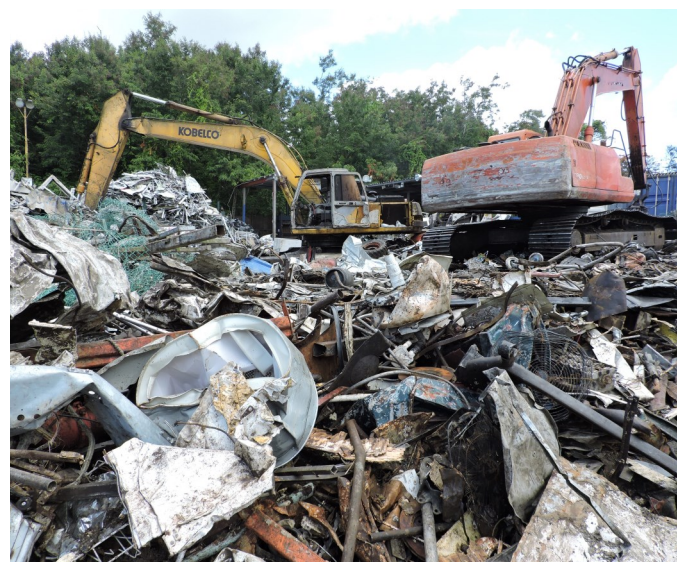
**Picture 24 - DCN RECYCLING, CORP.** - As observed by the EPA Inspector at the Ferrous Metal Collection Area, scrap metals are first segregated by metal properties, crushed with the excavator to reduce metals size, and then immediately sent to the cargo trucks.

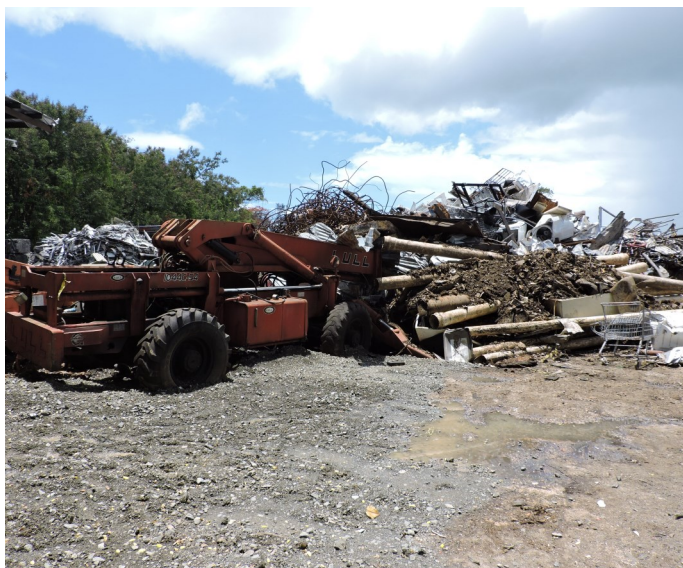
**Picture 25- DCN RECYCLING, CORP.** - As observed by the EPA Inspector at the Ferrous Metal Collection Area, there were two (2) abandoned heavy equipment machine “Sky Tracks” leaking engine motor fluids on soil grounds.

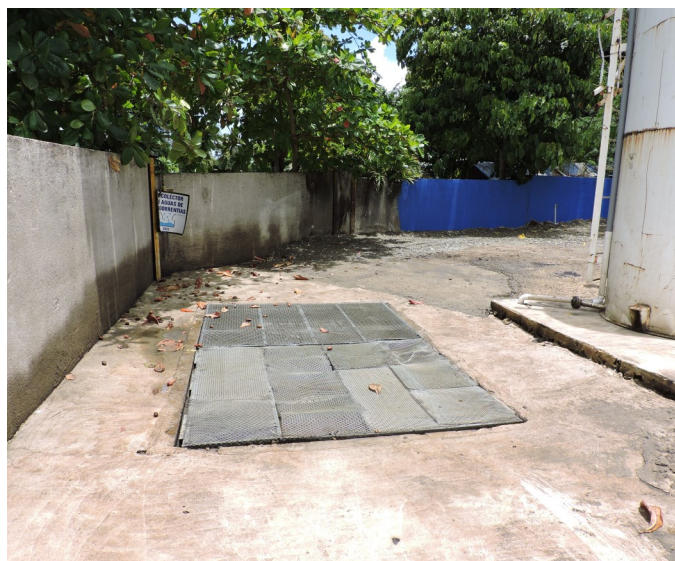
**Picture 26 - DCN RECYCLING, CORP.** - At the Ferrous Metal Collection Areas, there was one water tower and seep collection sump to control and manage stormwater run-on and run-off of the property. The water tower was out of service and the sump was fully filled with sediments and heavily impacted with used oils.

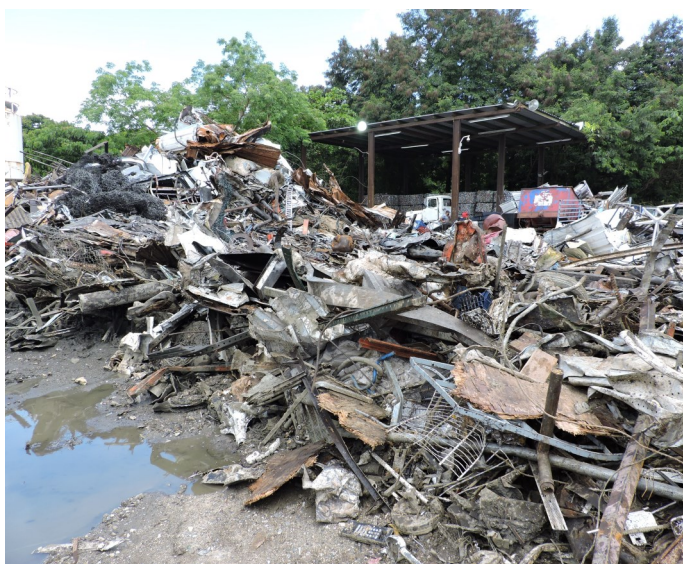
**Picture 27—DCN RECYCLING, CORP.** - The EPA Inspector observed at the Ferrous Metal Collection Areas, piles of scrap metals placed on bare soils and being operated by an excavator leaking oily fluids on the ground.

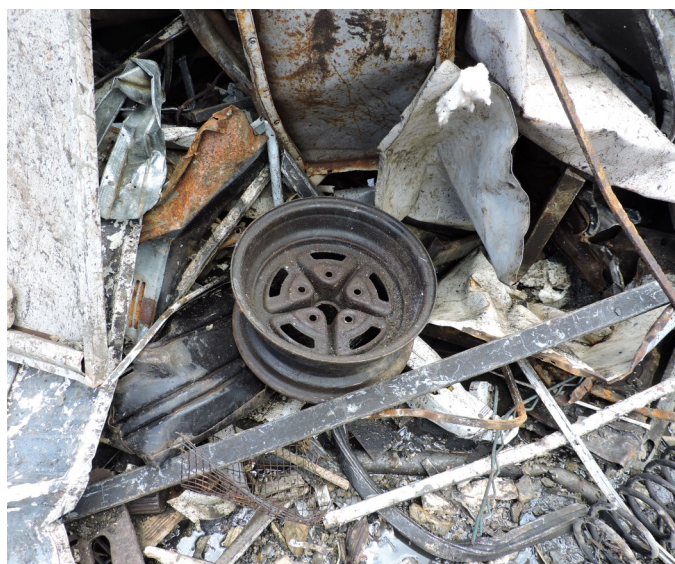
**Picture 28 - DCN RECYCLING, CORP.** - TThe EPA Inspector observed at the Ferrous Metal Collection Areas, several auto wheels rims some containing lead weights which were not removed along with gas-contained cylinders which were mixed with the scrap metals.

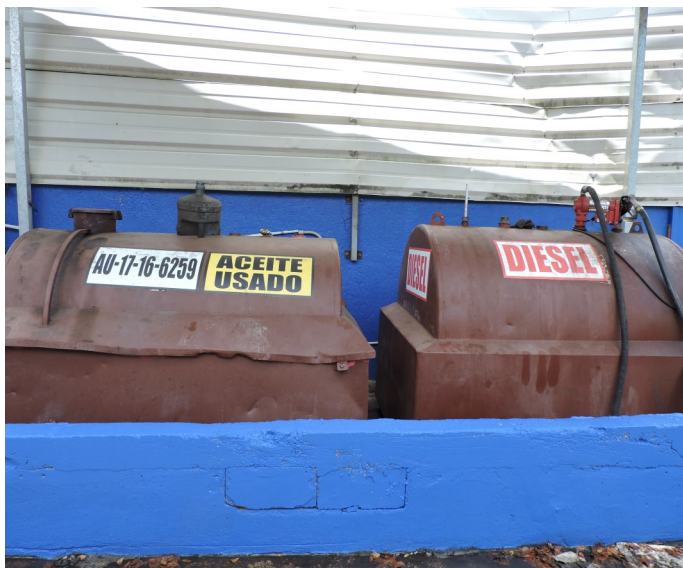
**Picture 29 - DCN RECYCLING, CORP.** - As observed, the Fuel and Used Oil Storage Area consisted of a metal shed with a ceiling and a secondary containment system and housed two (2) 500-gallon above ground-doble wall tanks to store used oils and diesel clearly labeled.

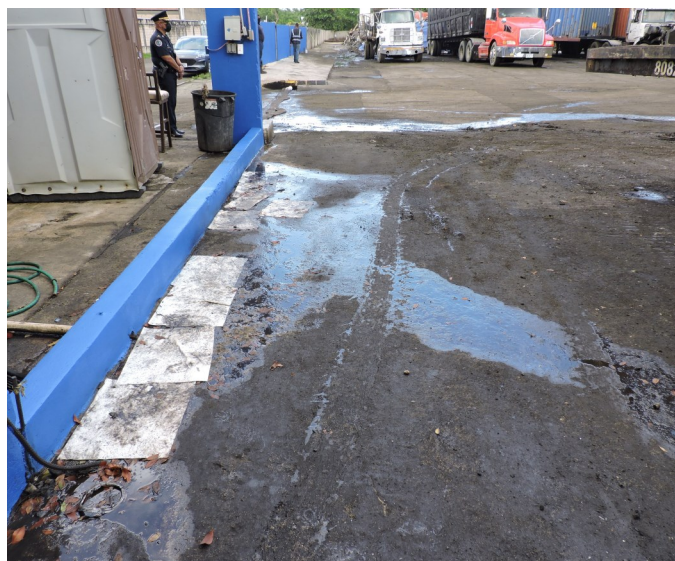
**Picture 30 - DCN RECYCLING, CORP.** - As observed during the EPA Inspection, there were run-offs from the Facility were accumulated at the Fuel-Oil Station during rain events and were discharged directly toward a nonfunctional sump and then into the sidewalk curb nearby water creek located northwest of the property edge.

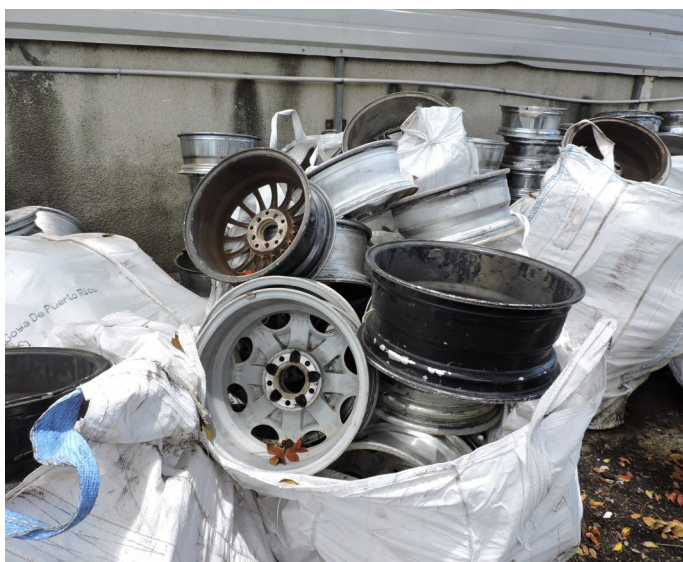
**Picture 31—DCN RECYCLING, CORP.** - At the Alloy Wheel Collection Area, all alloy wheels are received, collected and packed in 1-cy white cloth bags. It was observed the most alloy wheel rims contained lead weights were not properly removed before packaging.

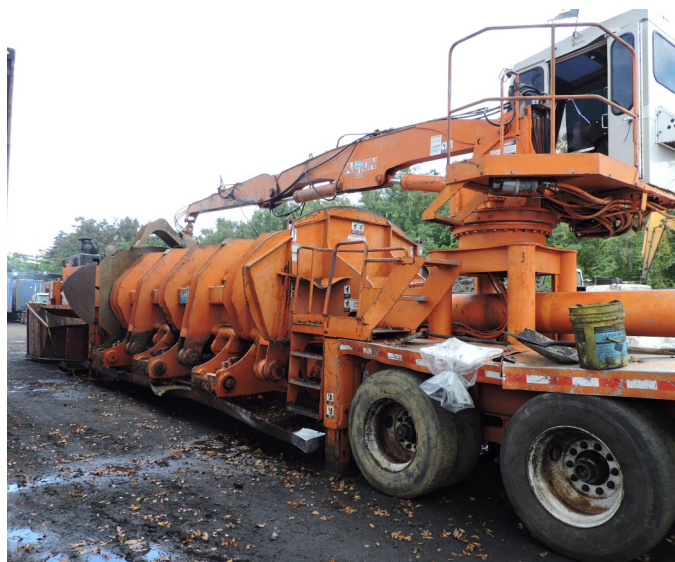
**Picture 32 - DCN RECYCLING, CORP.** - The EPA Inspector proceeded to inspect the Compacting Cars Area where crushing and bailing of junked cars is performed. using an ALJON 580 CL machine (i.e., crusher, bailer) at the site.

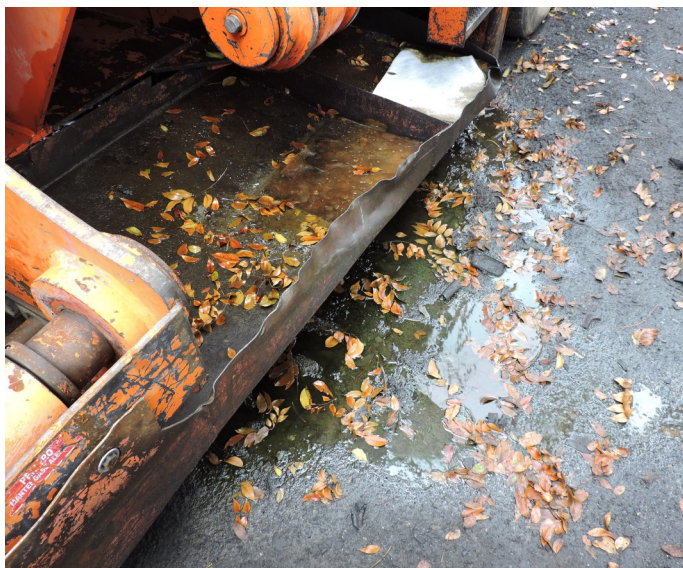
**Picture 33 - DCN RECYCLING, CORP.** - As stated by EPA, junked cars contained components that were potential hazardous materials such a gasoline residue in the gas tank and any fluid leaks generated during crushing is collected in the steel tray and/or 55-gallon drums.

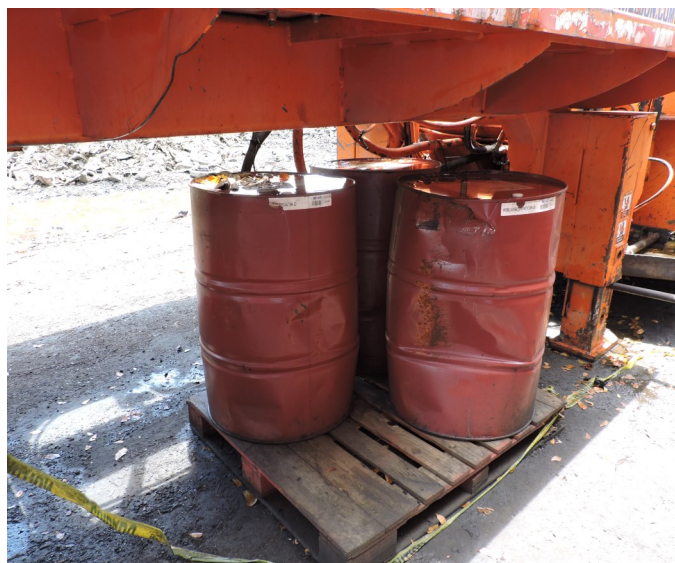
**Picture 34 - DCN RECYCLING, CORP.** - As observed during the EPA Inspection, all drums containing leaking fluids from crushing operations are managed as used oil and disposed of with Ruben Martinez Used Oil Collection Services. No hazardous waste characterization is performed on the leaking fluids from the crushing operations on routine basis.

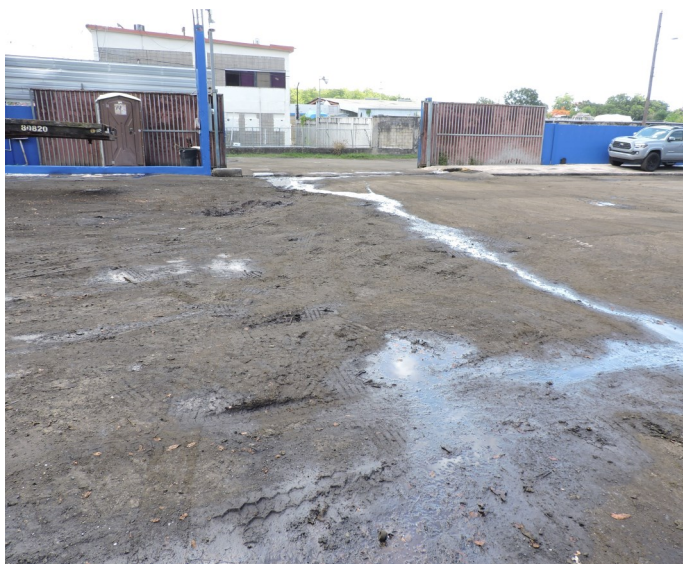
**Picture 35—DCN RECYCLING, CORP.** - As observed by the EPA Inspectors at the Compacting Cars Area, there were fluids leaking on the soils and pavement areas flowing toward the entrance and nearby unnamed creek situated northwest of the Facility.

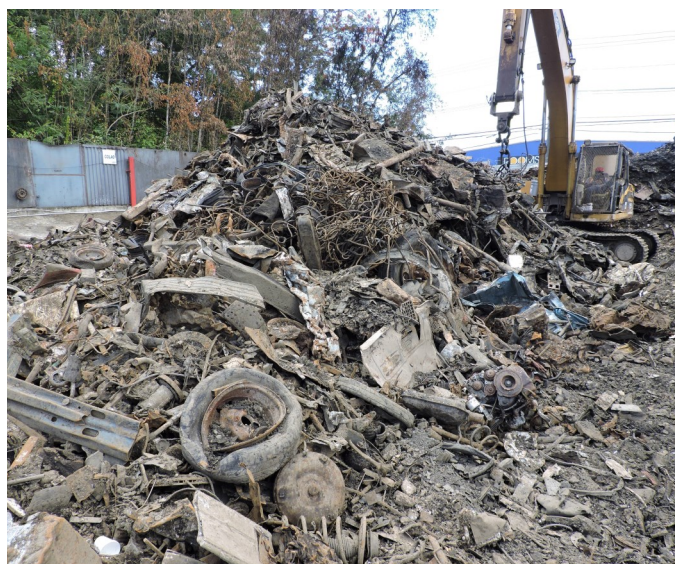
**Picture 36 - DCN RECYCLING, CORP.**—As observed at the Fire Incident Scrapyard Site Area, there were several piles of mixed destroyed and burned scrap metals accumulated at the site including motor engines, car fragments, spent tires, alloy wheels, seats, dashes, steel frames, and PVC pipes.

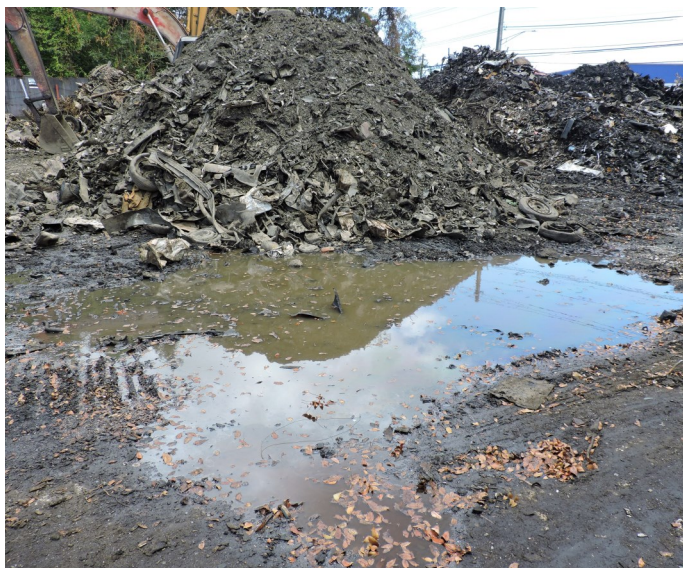
**Picture 37- DCN RECYCLING, CORP.** - It was also observed by the EPA Inspector at the Fire Incident Scrapyard Site Area, fluids leaking on the soils and pavement areas flowing toward the entrance and nearby unnamed creek situated northwest of the Facility.

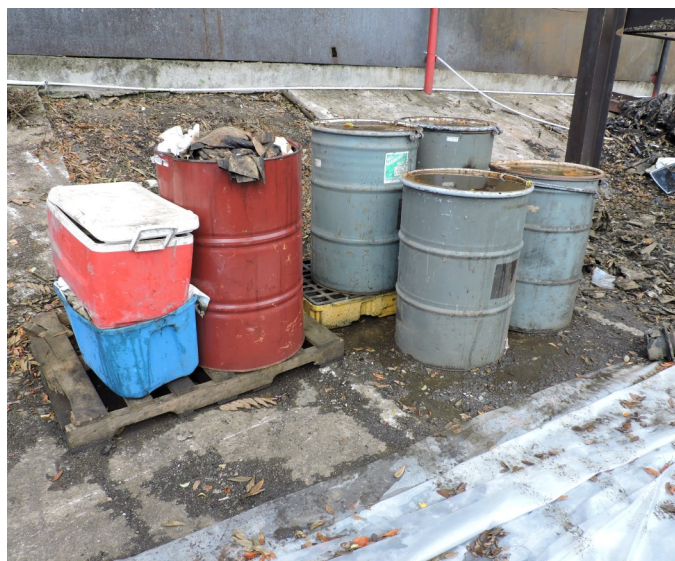
**Picture 38 - DCN RECYCLING, CORP.** - The EPA Inspector observed at Fire Incident, four (4) 55-gallon steel drums with used oil waste content and one (1) 55-gallon drum open and with rags heavily impacted with used not properly labeled with the words, "Used Oil."
