INSPECTION REPORT

| <b>Type of Inspection</b> | Focused Compliance Inspection (FCI) | | | |
| <b>Facility or Site Name</b> | C-Port, LLC | | | |
| <b>Type of Operation</b> | C-Port, LLC operates a cargo terminal at Port Fourchon | | | |

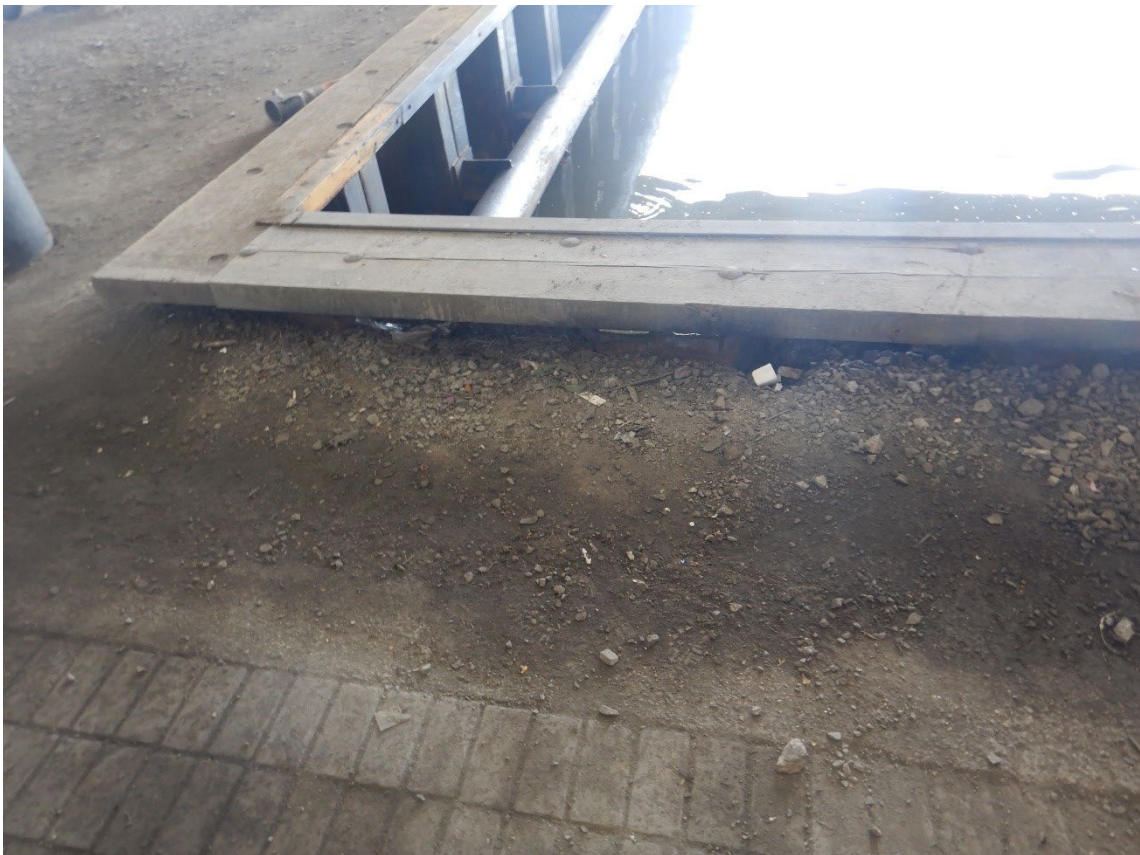
**Photo No. 1**

| Tenant: C-Port, LLC | | |
|---|---|---|
| <b>AOC #1</b> – CP did not make a hazardous waste determination for the spilled material at Slip 6. | <b>Citation:</b> 40 CFR 262.11 | Section: 2.1 |

Description: View of spilled material along the edge of Slip 6.

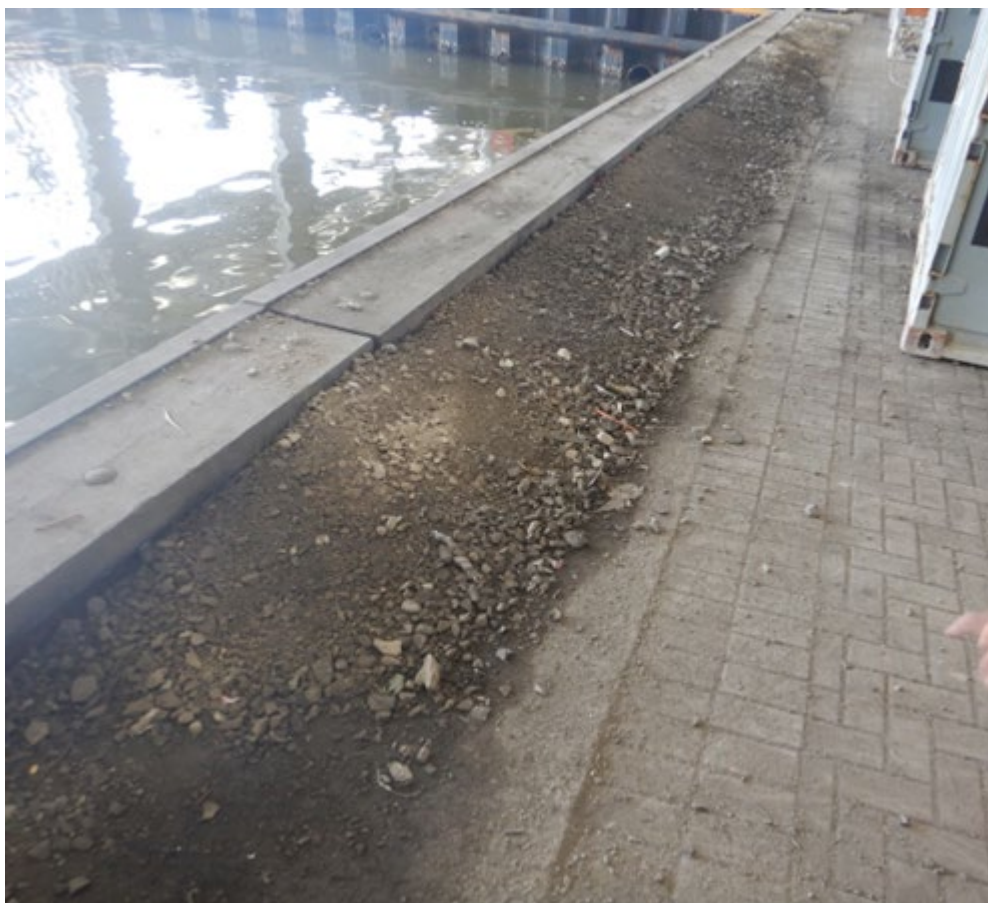
Photo No. 2

Description: View of spilled material along the edge of Slip 6.

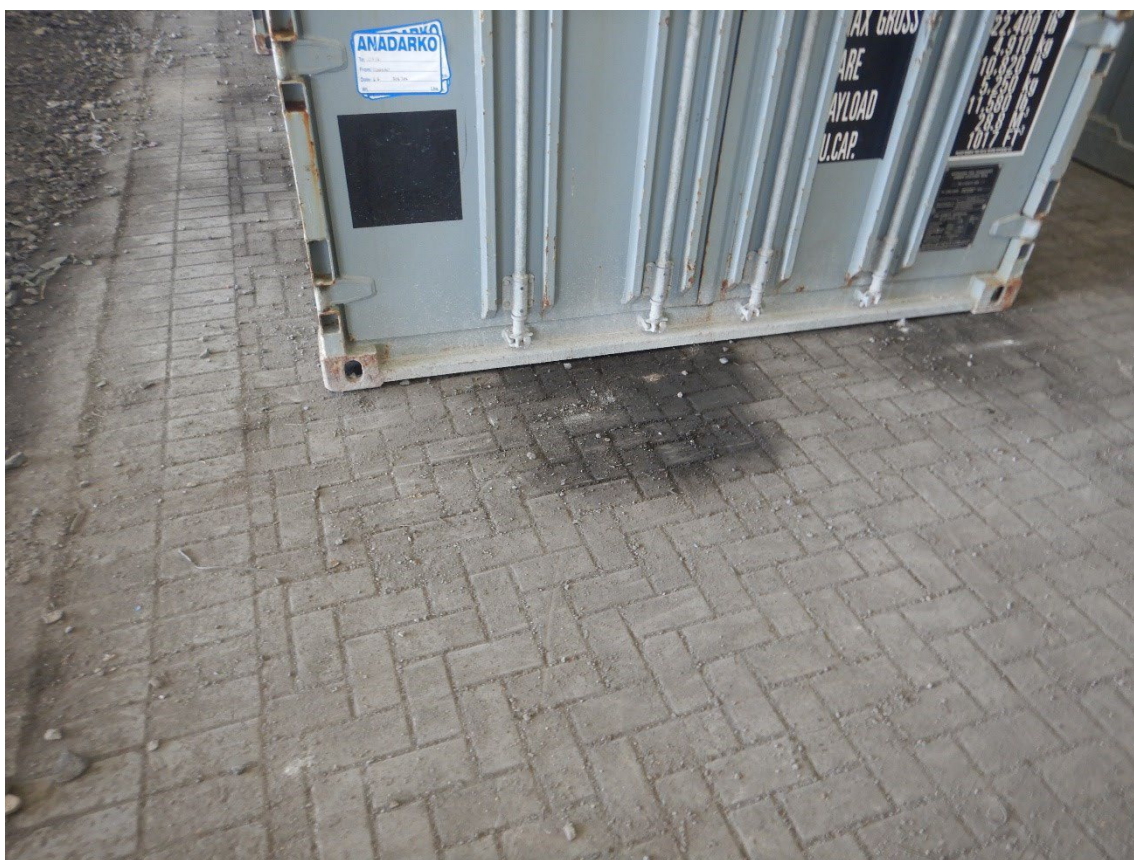
Photo No. 3

Description: View of spilled material along the edge of Slip 6.

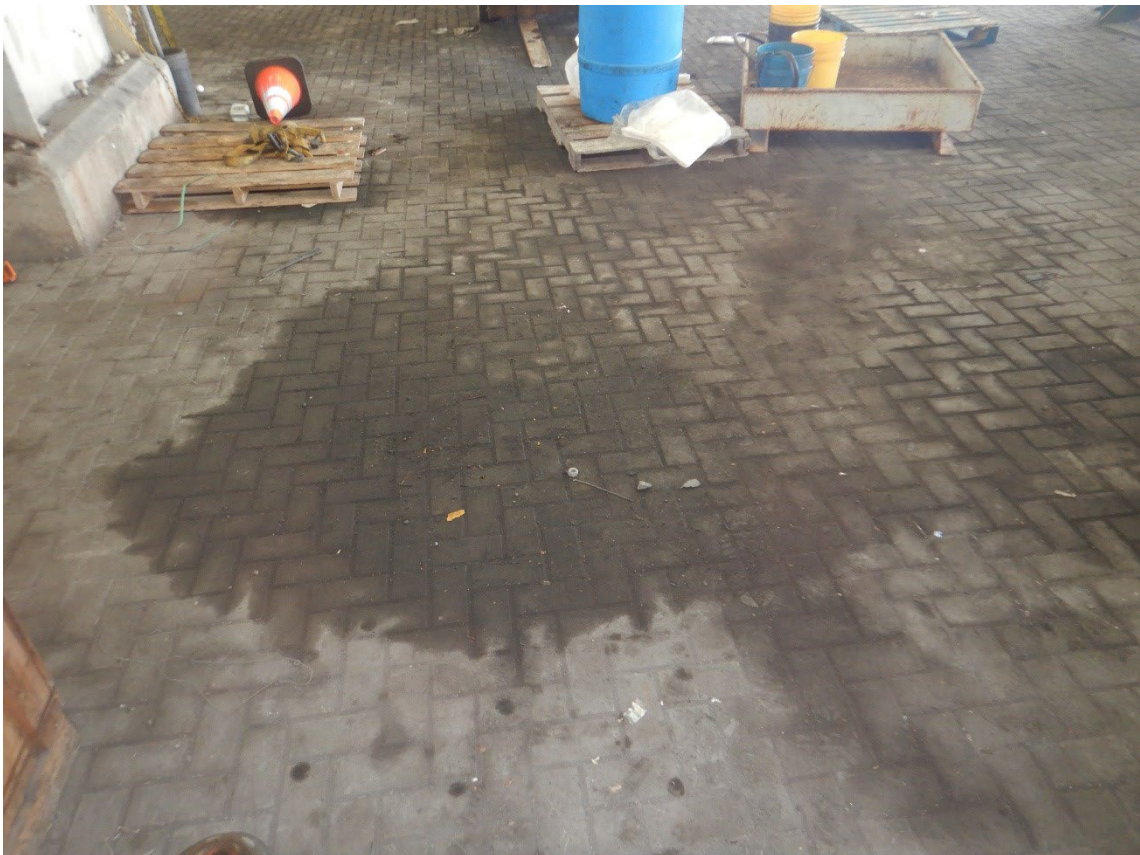
Photo No. 4

Description: View of spilled material by fuel shack at Slip 6.

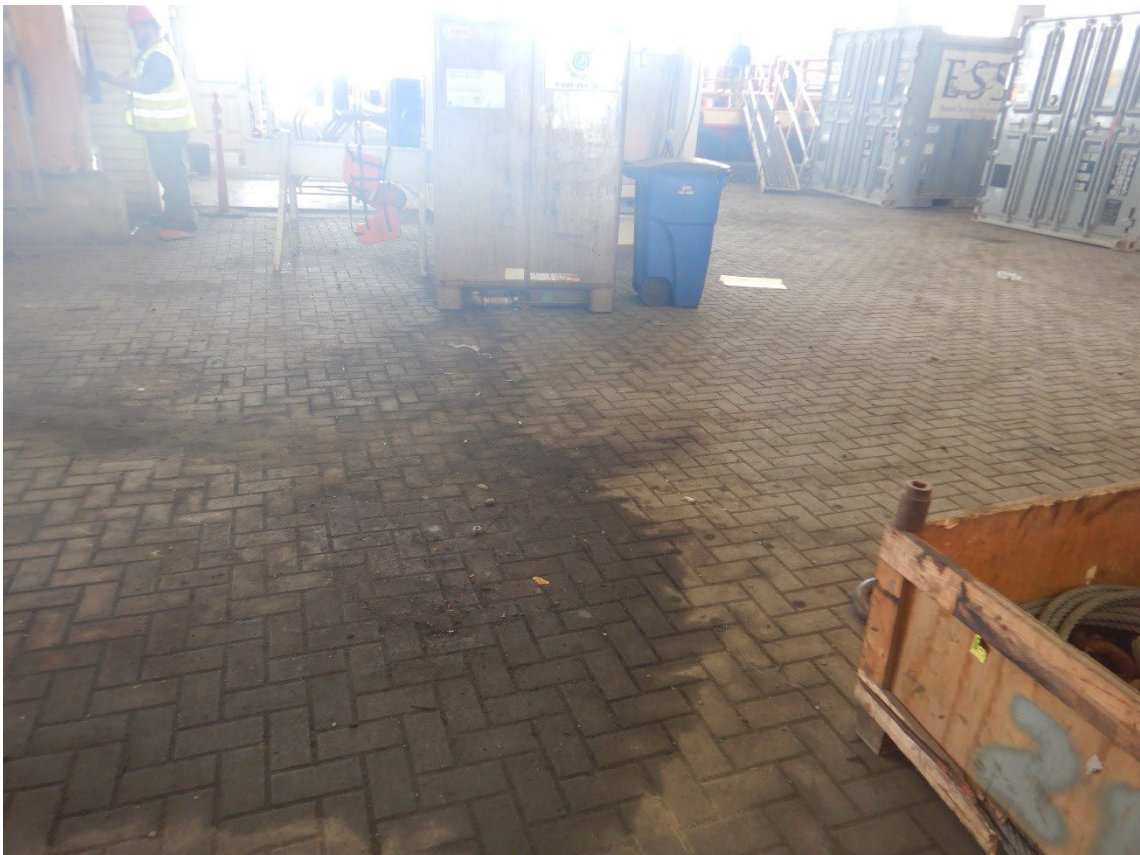
Photo No. 5

Description: View of spilled material by fuel shack at Slip 6.

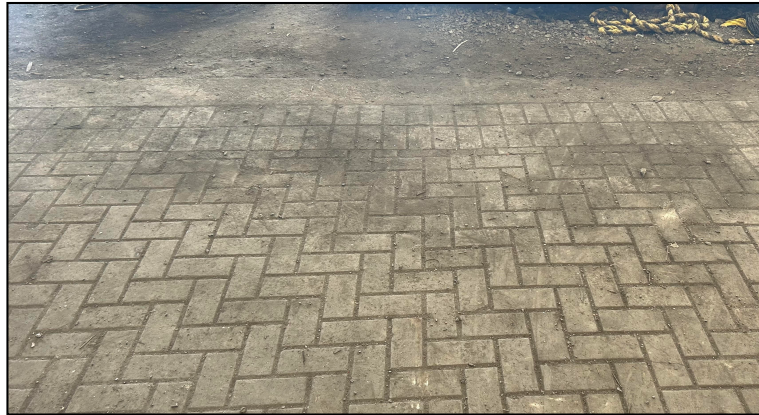
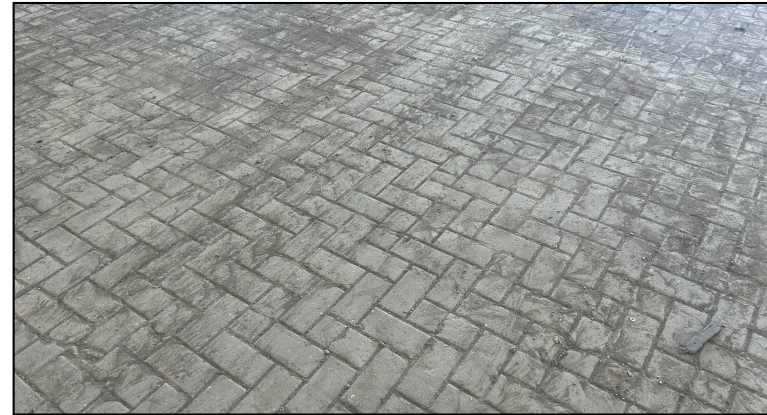
Description  
Stained pavers located in slip 6

Auditor's Comments  
Stained pavers indicate a potential release of product

| <b>Description:</b> | Stained pavers | | |

Pavers were pressure washed

Pavers were pressure washed and any recovered product was placed in a DOT drum. A forklift operator had knocked over a drum containing used oil filters and pads. The area was cleaned appropriately.
