UNITED STATES ENVIRONMENTAL PROTECTION AGENCY

**Subj:** Inspection Report  
Clean Water Act - National Pollutant Discharge Elimination System  
("NPDES")  
Town Easton MS4

- A. *Facility Name:* Town Easton MS4
- B. *Facility Location:* 116 Randall St  
Easton, MA 02356
- C. *Facility Contacts:* Greg Swan, Asst Town Engineer  
130 Center St  
North Easton, MA 02356
- Sarah Welcome  
116 Randall St  
North Easton, MA 02356
- D. *NPDES ID No(s):* MAR041111

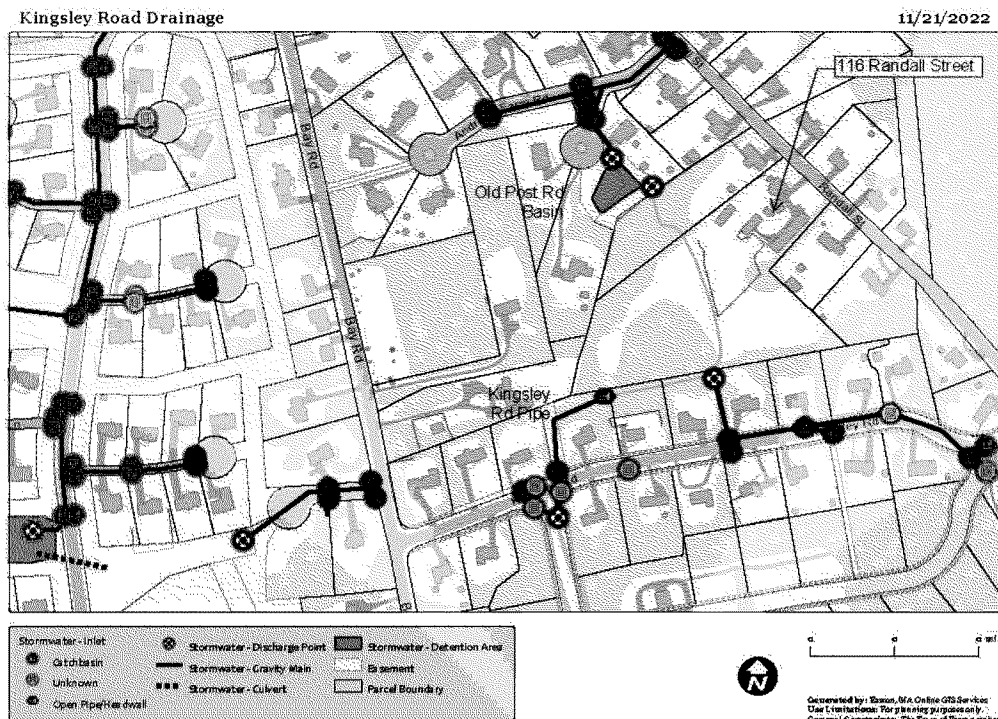
Figure 1: Kingsley Road Drainage- Annotated (Source: Town of Easton)

We began the inspection at the downstream end of the Kingsley Rd Pipe, which conveys water from an area just south of Ms. Welcome's property under Kingsley Road to an open channel adjacent to Kensington Drive (see Figure 1). The outfall was covered in leaves and other debris; however, a low volume of flow was visible in the surface of the surface water in the channel downstream of the outfall (see Photo 1). A Town representative opened the manhole on the top of the discharge structure and water was visible in the sump. It appeared to me that the level of water in the manhole shaft was above the water level in the stream, suggesting a backwater effect, but this could not be confirmed without tools to measure the elevations of the two surfaces (see Photo 2). To assess whether the Kingsley Rd Pipe was conveying all the flow of Beaver Brook, we observed the upstream end of the pipe, behind the house at 14 Kingsley Rd. It appeared that the pipe was conveying the flow of Beaver Brook with no apparent backwatering immediately upstream of the pipe inlet (see Photo 3). I noted that without a visual evaluation of the pipe, it was not possible to determine if the pipe would be able to convey higher volumes during a rain event and I made the observation that the ability of the pipe to convey the current flow did not demonstrate its ability to convey higher volumes of flow during a rain event. A town representative said that they couldn't inspect the pipe while there was flow in it but agreed that an inspection might be possible during a low flow period, such as August.

We next went to a stormwater outlet to Beaver Brook approximately 400 feet upstream of the Kingsley Rd Pipe between 22 and 26 Kingsley Road that also appears on maps provided by the Town (see Figure 1). There was no observable flow from this outlet during the inspection; however, whether due to backwater effects or topography, standing water was visible in this area upstream of the Kingsley Rd Pipe intake (see Photo 4). Beaver Brook flows to the south from 116 Randall Street under a fence near this location (see Photo 5). Figure 2 provides a graphic representation of the origin of Beaver Brook on Ms. Welcome's property and the surface flow of Beaver Brook to the outlet of the Kingsley Rd Pipe.

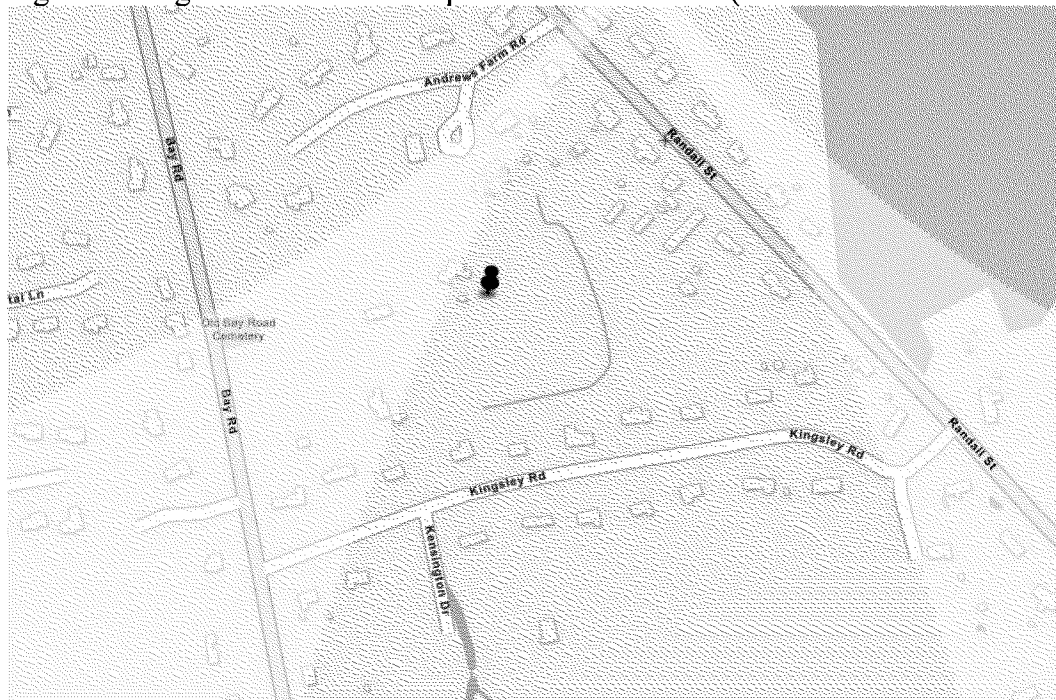
Figure 2: Origin and surface flow path of Beaver Brook (Source: EPA EJTracker Website)

The Town MS4 discharges from the Detention Basin to 116 Randall Street, a private property owned by Ms. Sarah Welcome that is comprised of approximately 3.5 acres. It is operated as a small farm with horses, sheep, llamas, and other animals. According to USGS Topo maps, Beaver Brook appears to begin on Ms. Welcome's property just south of the Detention Basin and discharges to the south, under Kingsley Rd via the Kingsley Rd Pipe behind 14 Kingsley Rd.

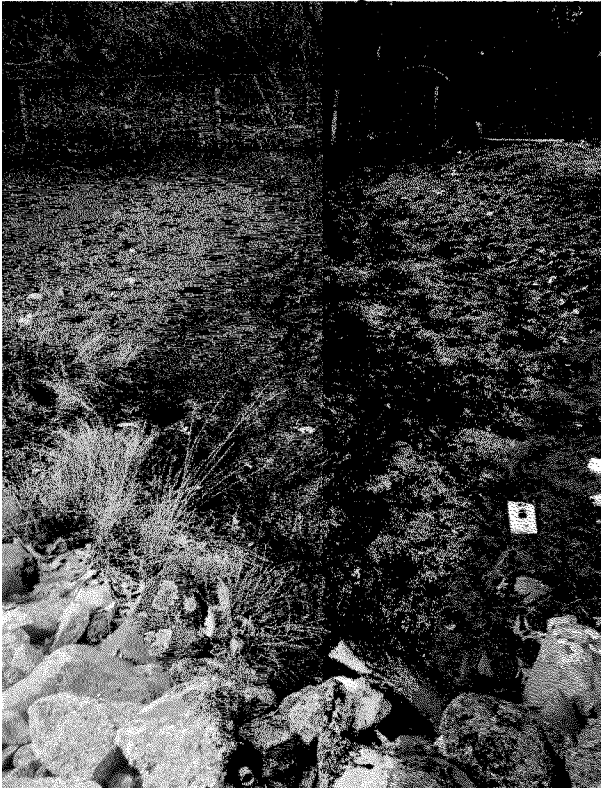
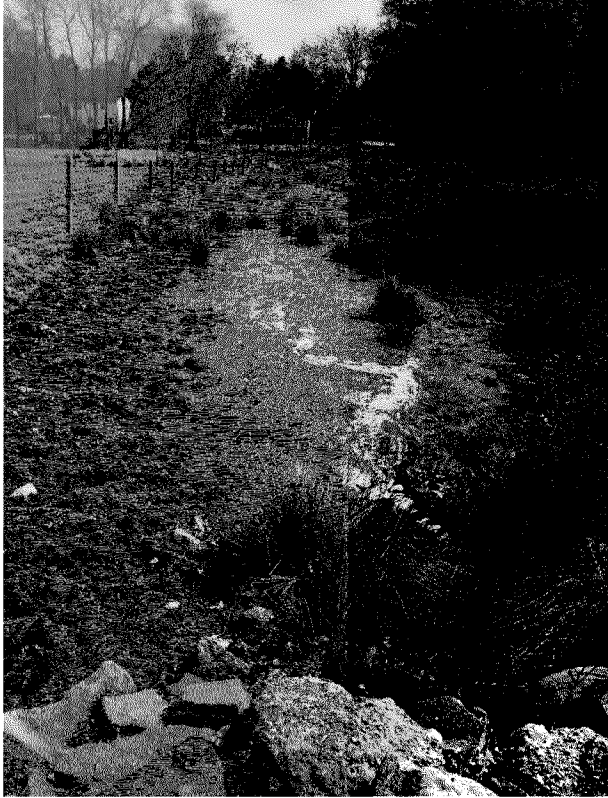
At this point, the Town representatives left, and I went to 116 Randall St with Ms. Welcome. At her property, I observed standing water up and downstream of a short, culverted segment of the stream (see Photos 6 and 7). Ms. Welcome described negative impacts on the health of her animals, including, specifically, that the standing water is providing breeding ground for meningeal worm, which has infected at least one of her animals, a baby llama. Following the inspection, Ms. Welcome provided a letter from her large animal veterinarian that stated the baby

Photo 6: 116 Randall St - Upstream toward Detention Basin

Photo 7: 116 Randall St - Downstream towards Kingsley Rd

After the Town representatives left, Ms. Welcome and I discussed the potential benefit of channelizing the stream to reduce the area of standing water. Ms. Welcome said that mosquito control has done so in the past, but the channelization does not last and the stream spreads out across her property again after a while. We discussed the potential for longer term channelization and Ms. Welcome said that she had expressed willingness to pay for a pipe to convey the water across her property but could not afford the studies that the Town of Easton Conservation Commission indicated would be necessary to support such a project. Any such channelization of the stream may require federal, state and/or local permits or other approvals.
