**Region 6 - Enforcement & Compliance Assurance Division**  
**INSPECTION REPORT**

| Inspection Date(s): | 03/06/2025 | |
| Company Name: | USA Feedyard LP | |
| Facility Name: | USA Feedyard | |

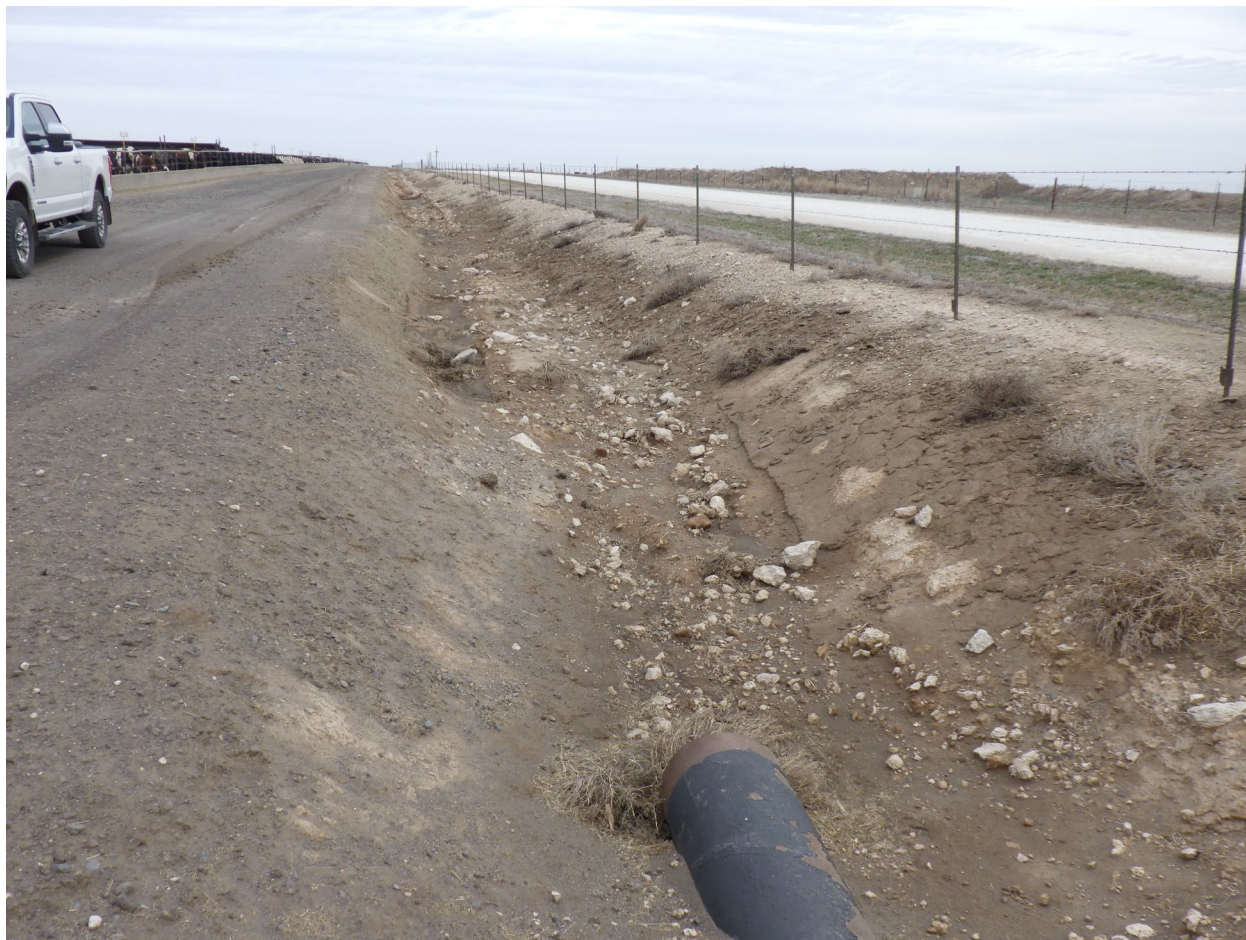
Photo No. 1

All the berms on-site were in good condition. Drainage channels were properly routing runoff to the RCSs during the inspection without any signs of problems (Appendix 1, Photos 1, 3, 4, & 5).

Description: View to the north. Drainage channel on eastern perimeter of the facility. Leads to RCS 1.

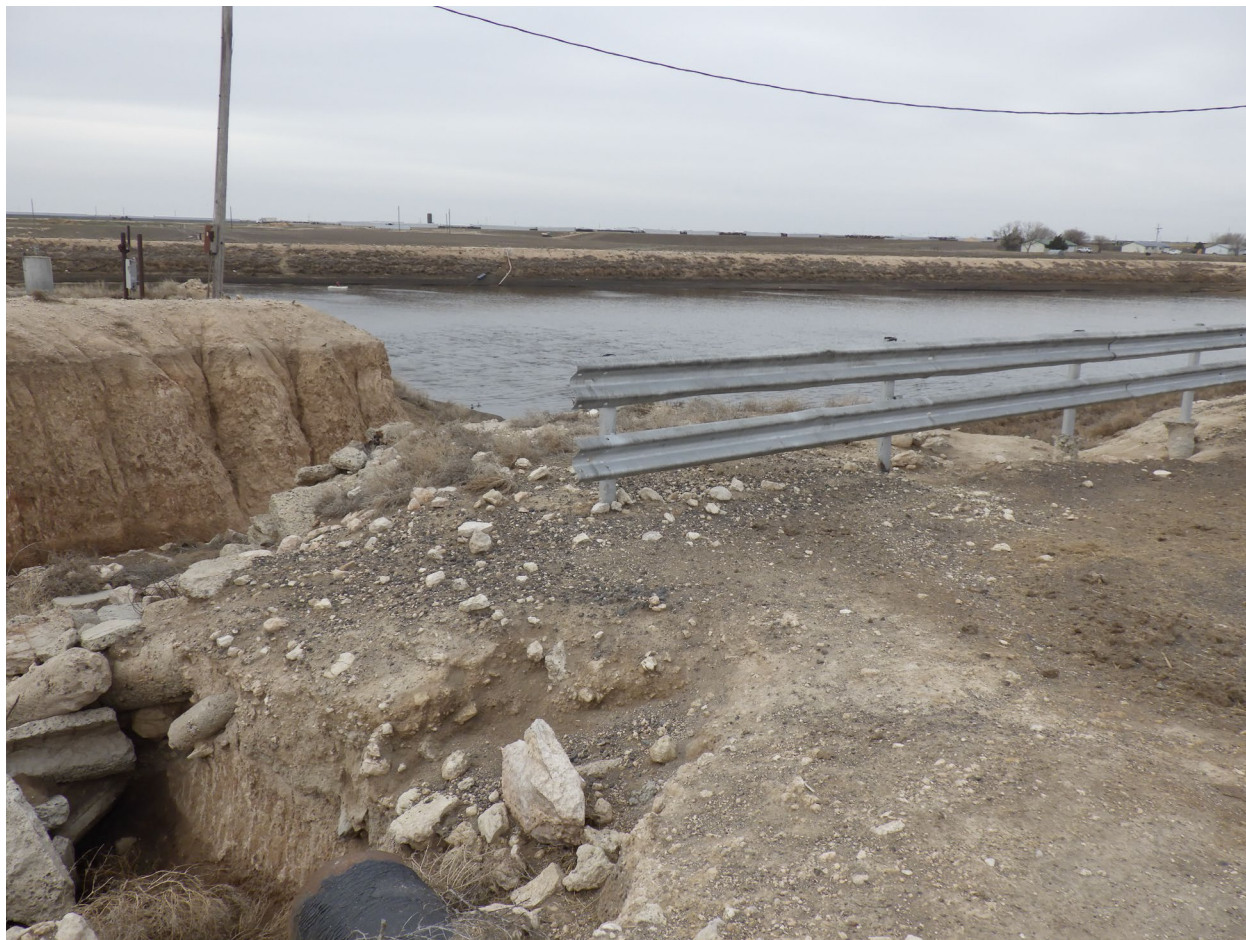
Photo No. 2

Description: View to the south. Outfall of drainage channel on eastern perimeter of facility. View of RCS 1.

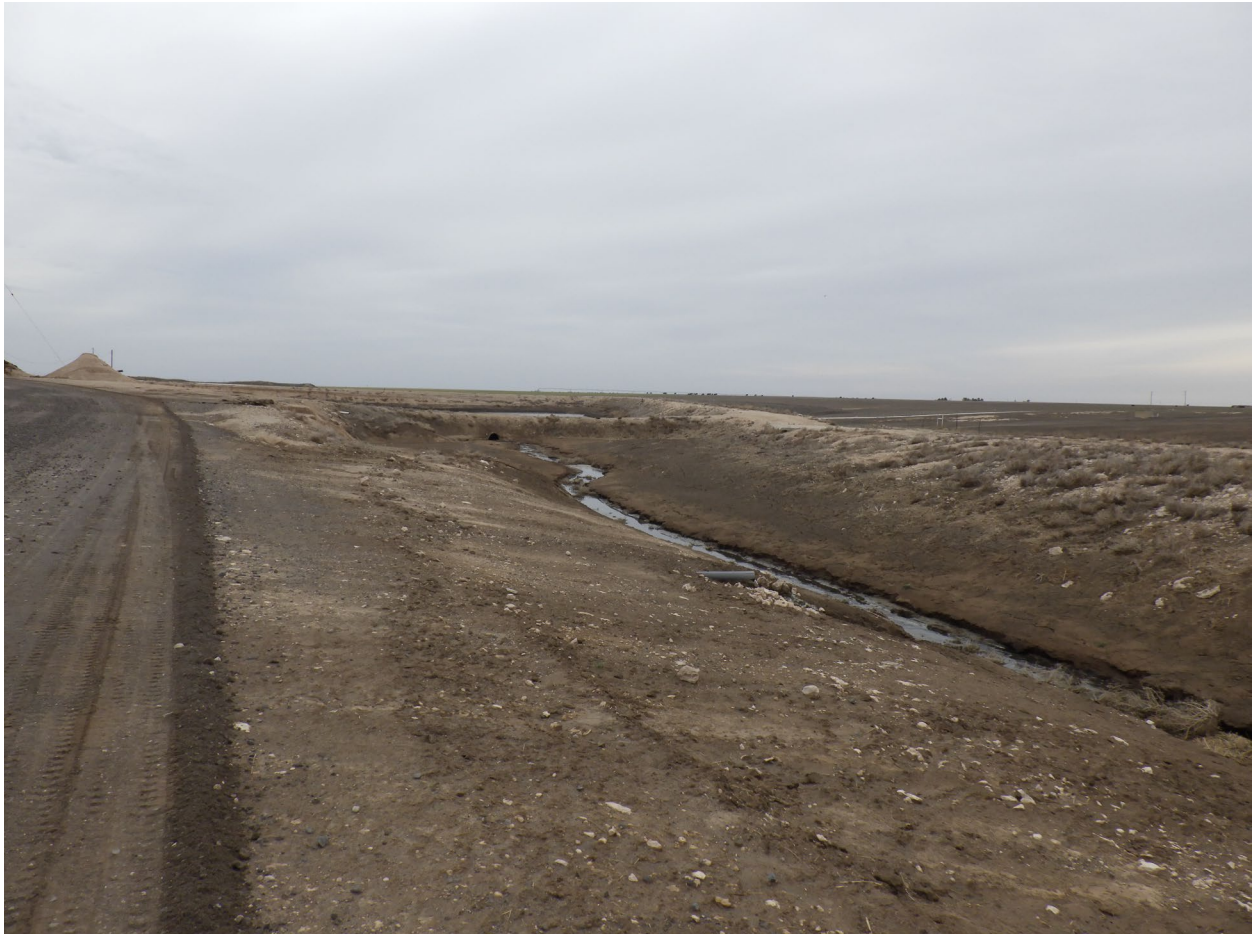
Photo No. 3

Description: View to the east. Drainage channel that leads to RCS 1.

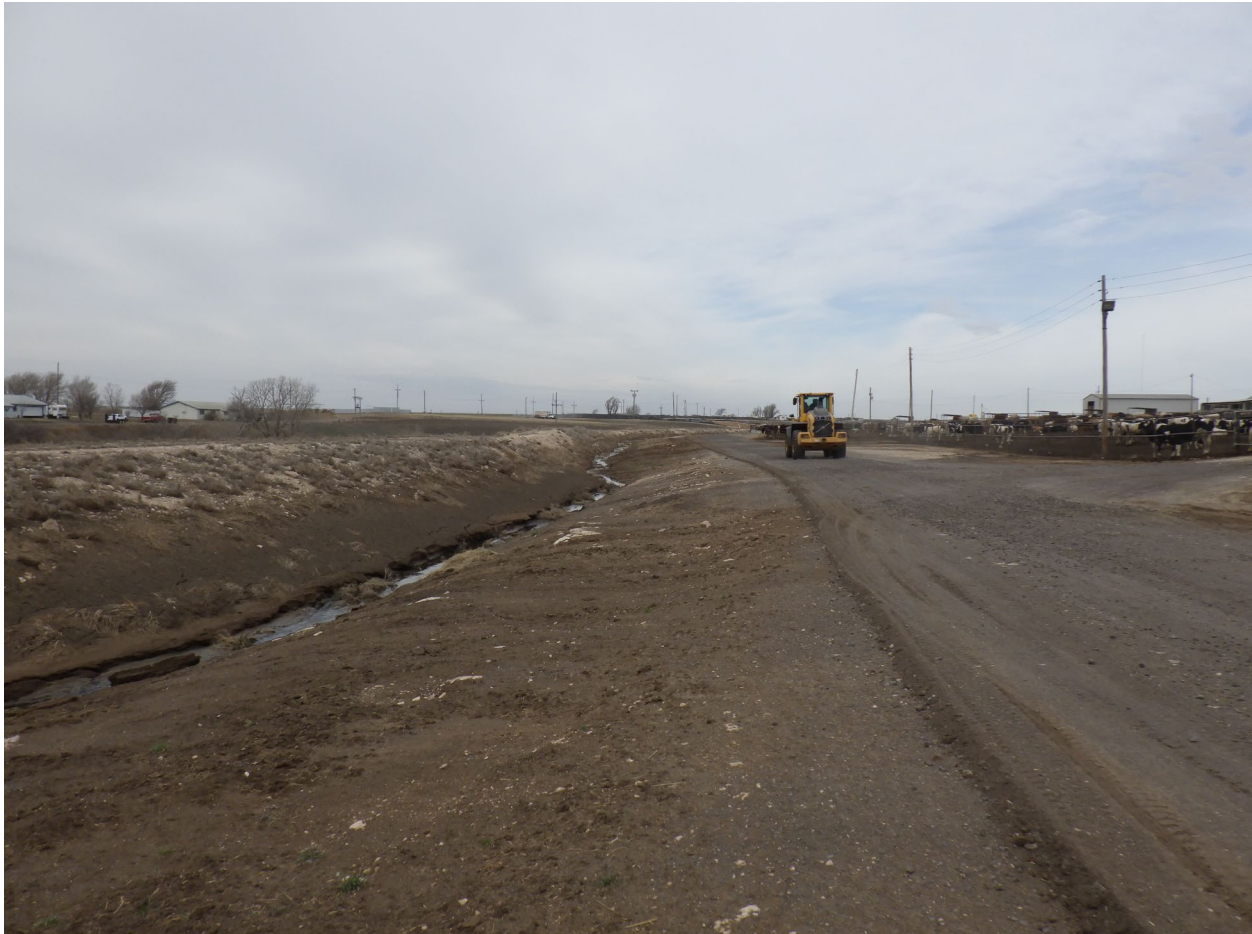
Photo No. 4

Description: View to the west. Drainage channel that leads to RCS 1.

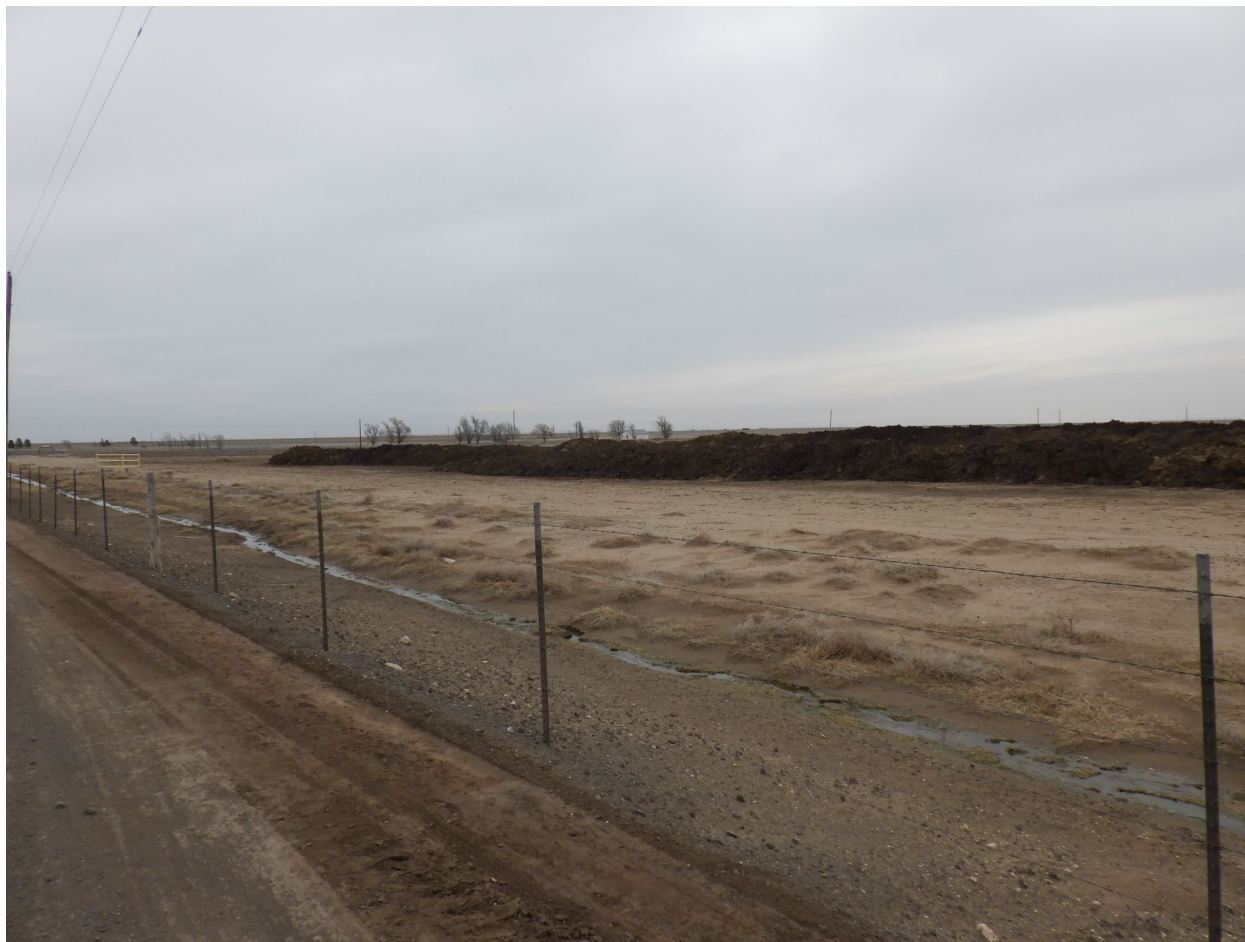
Photo No. 5

The open lot pens were clean and without any visible manure piles or ponding inside the pens. All manure stockpiles on-site were within the drainage of an RCS (Appendix 1, Photo 5).

Description: View to the southeast. Manure stockpile within drainage of channel that leads to RCS.
