**Region 6 Compliance Assurance and Enforcement Division  
INSPECTION REPORT**

| Inspection Date(s): | 06/20/2018 | | |
| Facility Name: | Petal Dairy | | |
| Identification/Permit Number: | WQ0004905000 (TX0132357) | | |

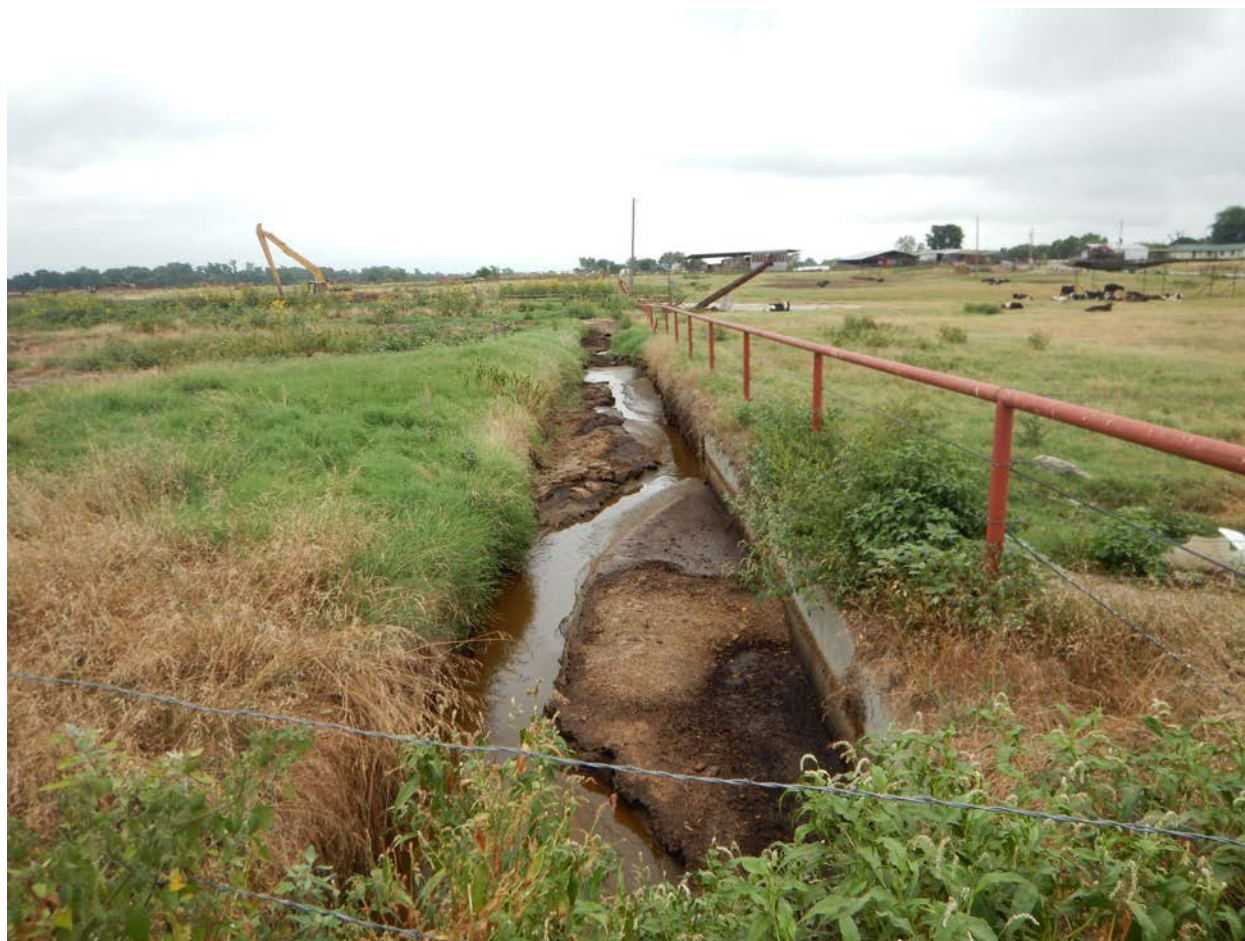
Photo No. 4

On the day of our inspection, we observed an area approximately 0.5 acres in size which was covered in dried solids (Photo #6). Mr. Boekhorst informed us that this was a result of a pipe blockage and subsequent overflow from the concrete-lined solid conveyance channel (Photo #4). Additionally, we observed that the wastewater collection pit on the east side of the loafing shed contained a significant accumulation of solids which might inhibit the flow of wastewater as designed (Photo #5).

Description: This photo was taken facing north across the solids settling channel which led to RCS #1.

- We observed evidence of an overflow of wastewater and manure solids from the solids settling channel. The wastewater and manure solids flowed to a low spot south of RCS #1 and were contained there. This overflow resulted from manure solids blocking the conveyance leading to RCS #1. At the time of the inspection, these manure solids were still present in this low spot. The manure solids will need to be cleaned out of this area and the permittee shall resume proper operation and maintenance of this system per WQ0004905000 Part IX.E.

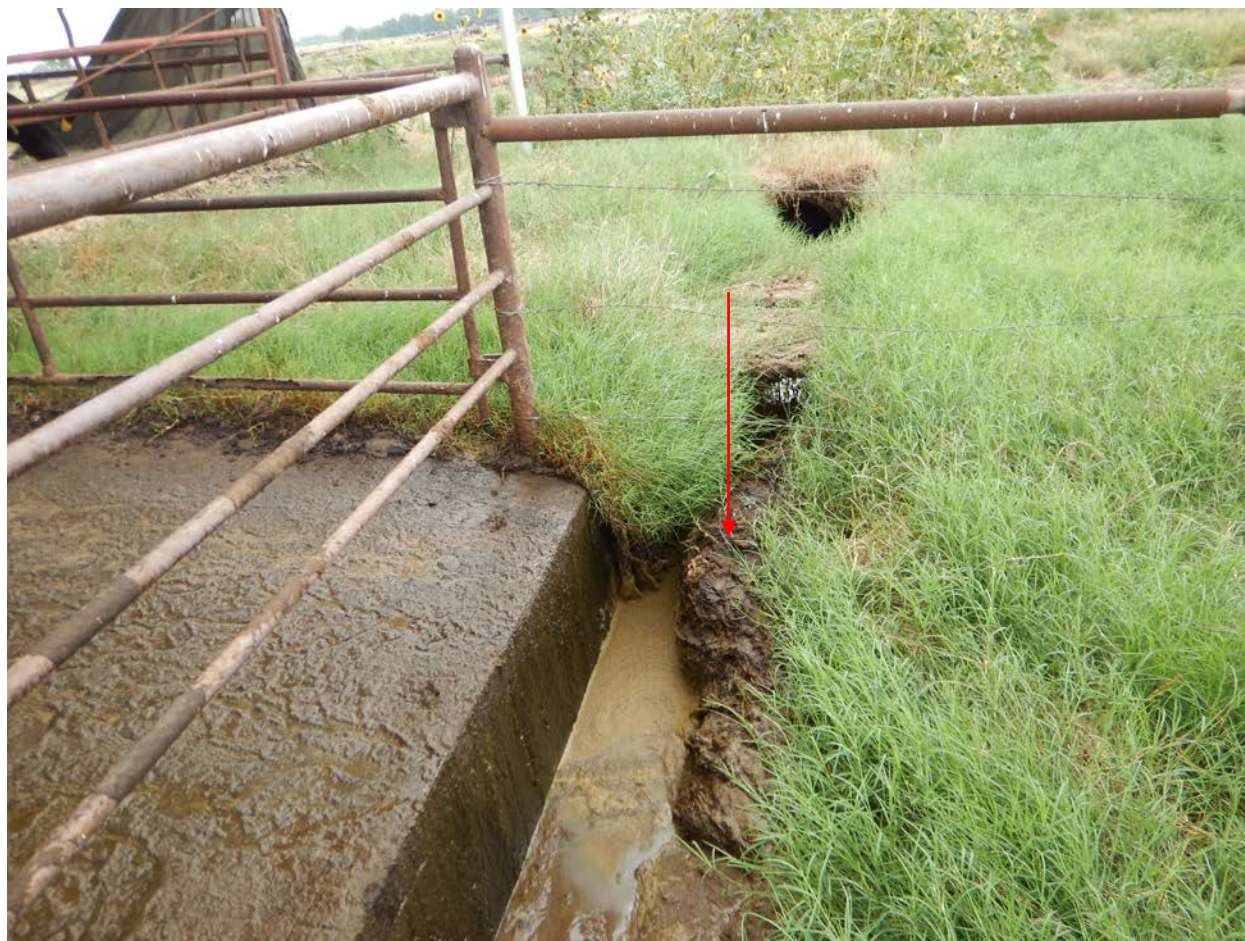
Photo No. 5

Description: This photo was taken facing north towards the basin on the east end of the north freestall barn which received freestall barn flushwater. Note the accumulation of solids at the point where the flushwater exits the basin.

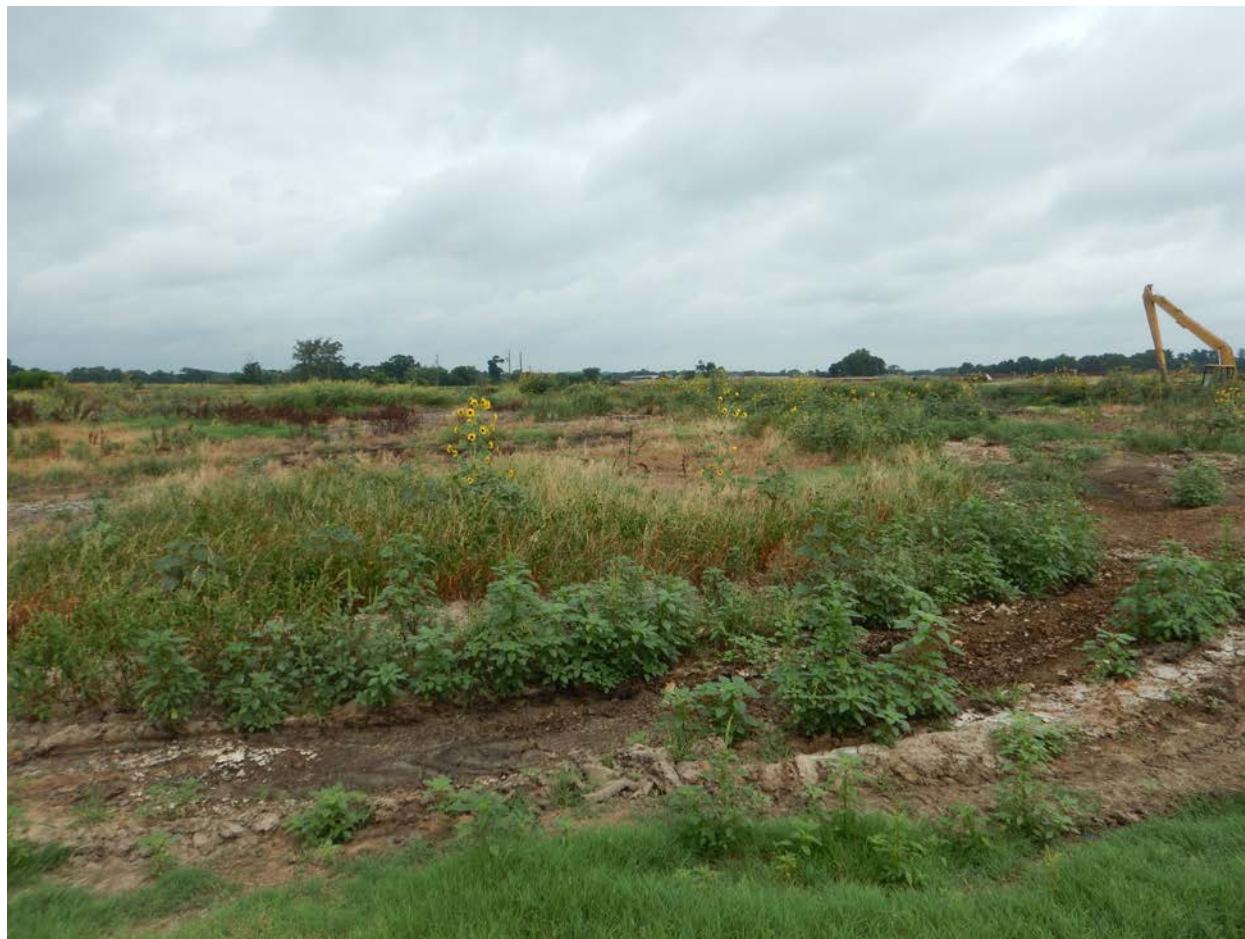
Photo No. 6

Description: This photo was taken facing northeast towards the 0.5-acre area of dried out solids which were deposited during an overflow of the solids settling channel.

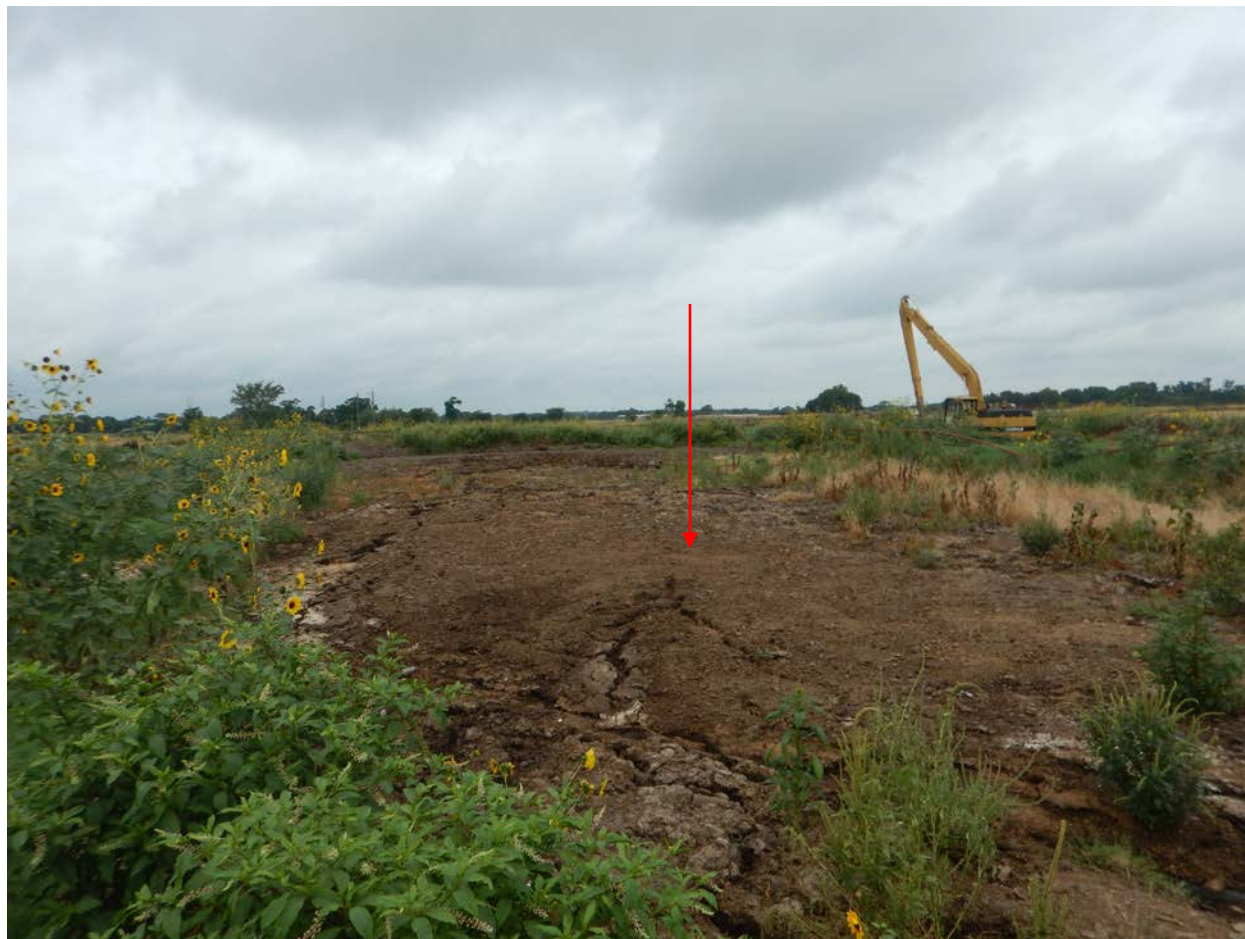
Photo No. 8

On the day of our inspection we observed that the first three RCSs were filled with accumulated solids (Photos #8-12). The berms of these RCSs were overgrown with grasses which prohibited us from

Description: This photo was taken facing northwest from the southeast corner of RCS #1. Note the accumulation of solids and lack of berm maintenance.

- The lagoon embankments on RCS #1-5 have not been maintained according to TCEQ CAFO General Permit WQ0004905000 Part VII.A.5(f) or Natural Resource Conservation Service (NRCS) Best Management Practices (BMPs), which prohibit trees and woody vegetation from growing on the lagoon embankment to minimize the potential for lagoon and/or liner failure.

- The wastewater and manure solid level in RCSs #1-3 had encroached into the storage volume reserved for the 25-yr/24-hr rain event and the two feet of freeboard required by the facility's permit. The facility needs to adhere to its sludge cleanout schedule per part VII.A.5(f) and maintain the storage volume reserved for the 25-yr/24-hr rain event per VII.A.5(b).

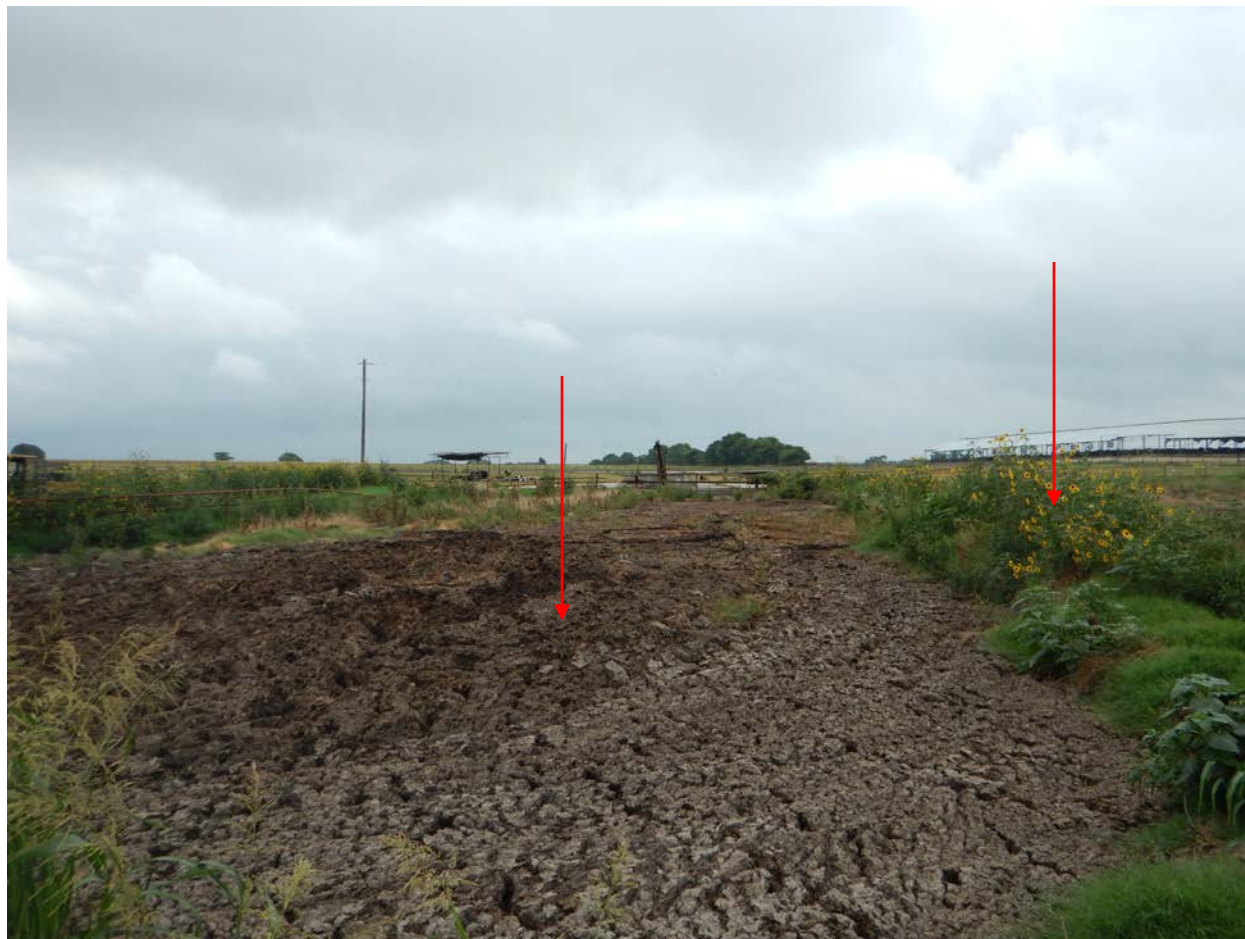
Photo No. 9

Description: This photo was taken facing east from the southwest corner of RCS #1. Note the accumulation of solids and lack of berm maintenance.

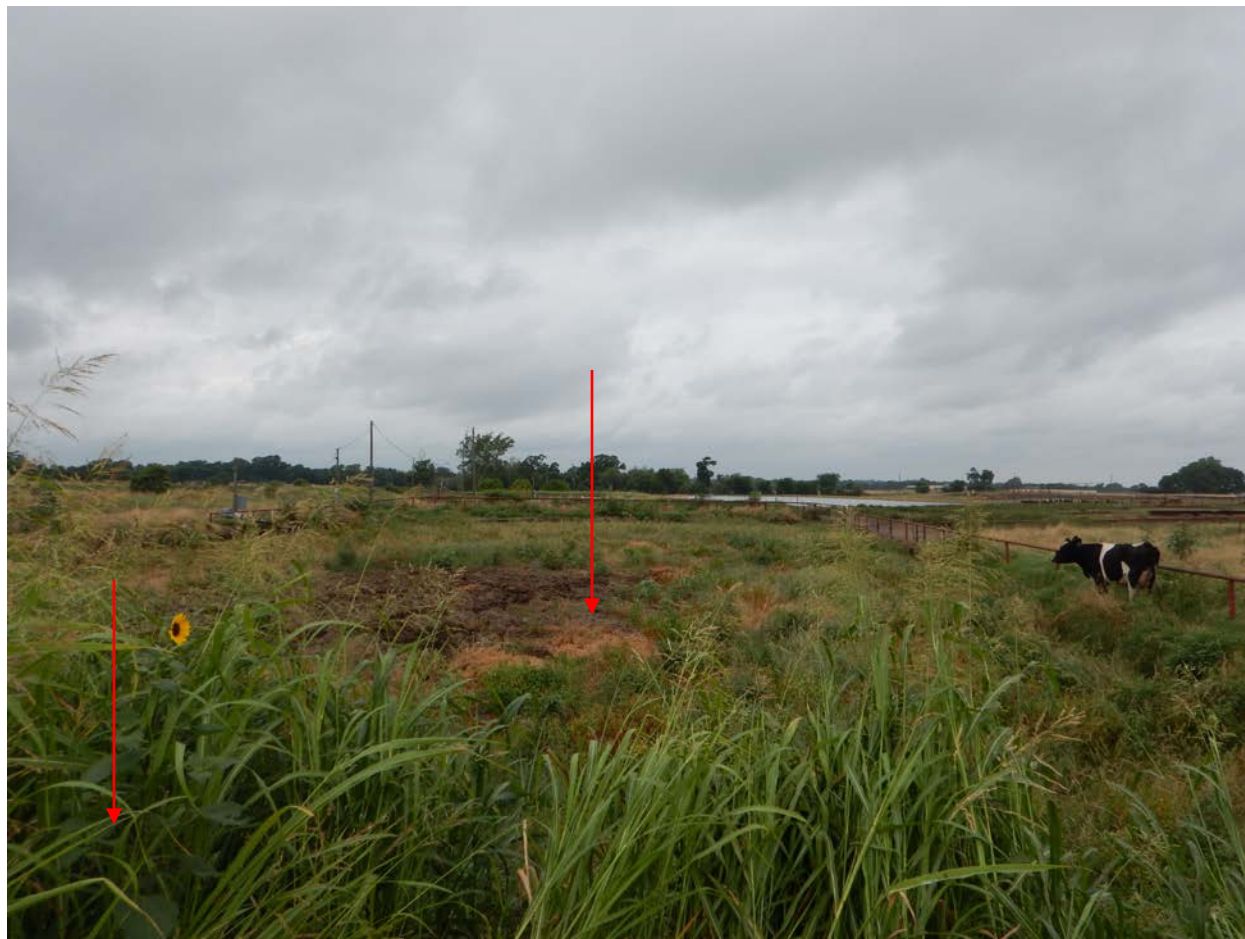
Photo No. 10

Description: This photo was taken facing northeast across RCS #2. Note the accumulation of solids and the lack of berm maintenance.

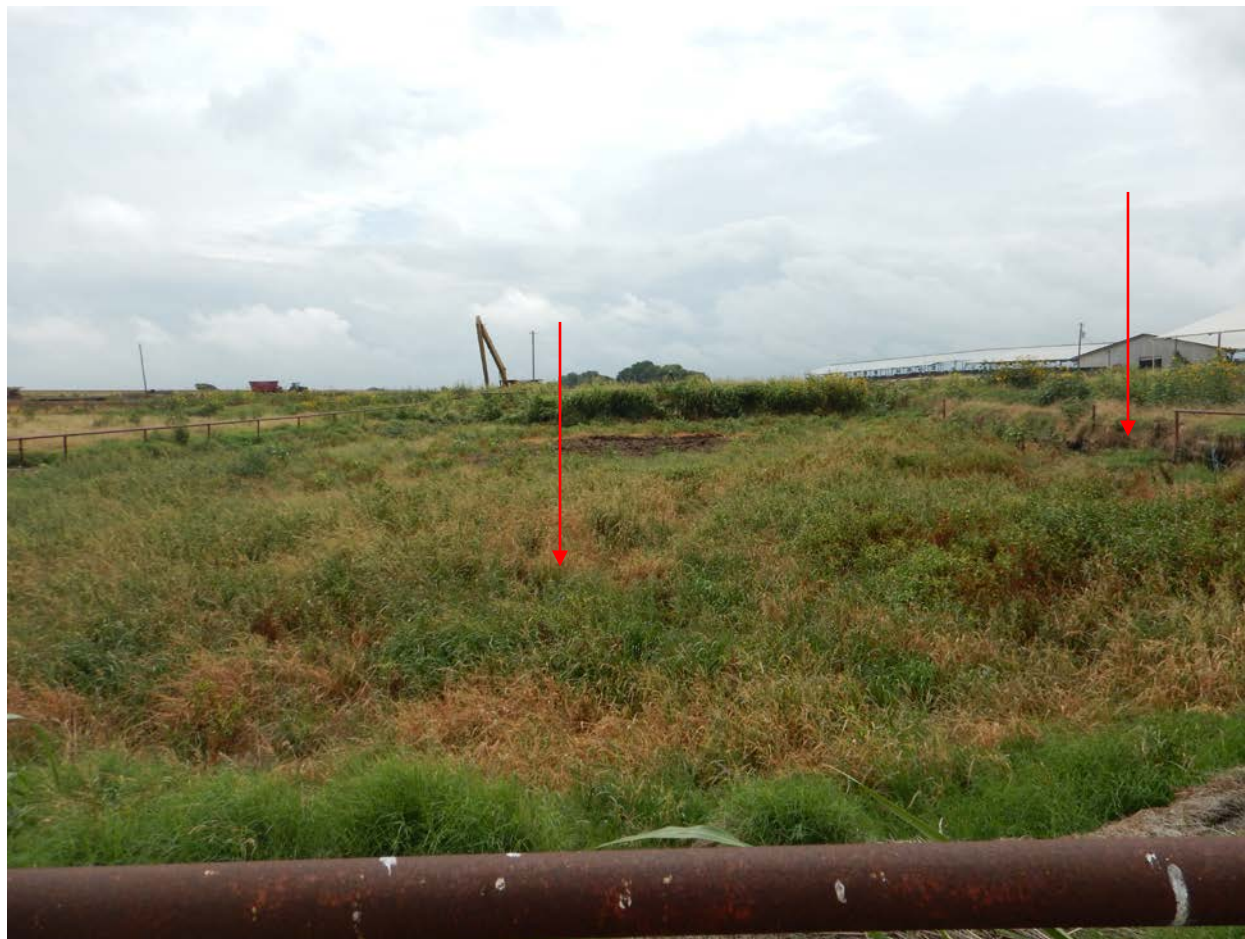
Photo No. 11

Description: This photo was taken facing east across RCS #2. Note the accumulation of solids and the lack of berm maintenance.

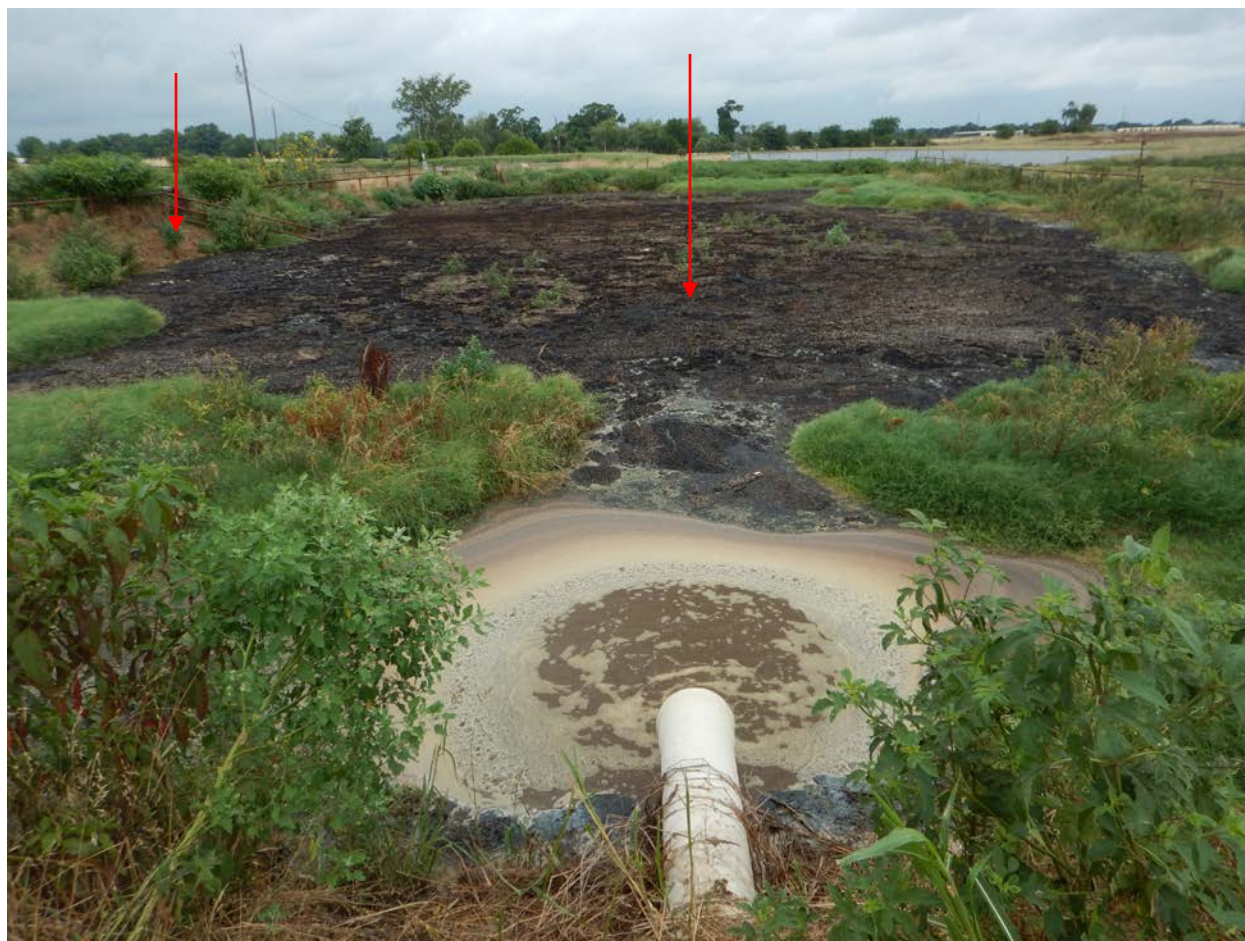
Photo No. 12

Description: This photo was taken facing northwest across RCS #3. Note the accumulation of solids and the lack of berm maintenance.

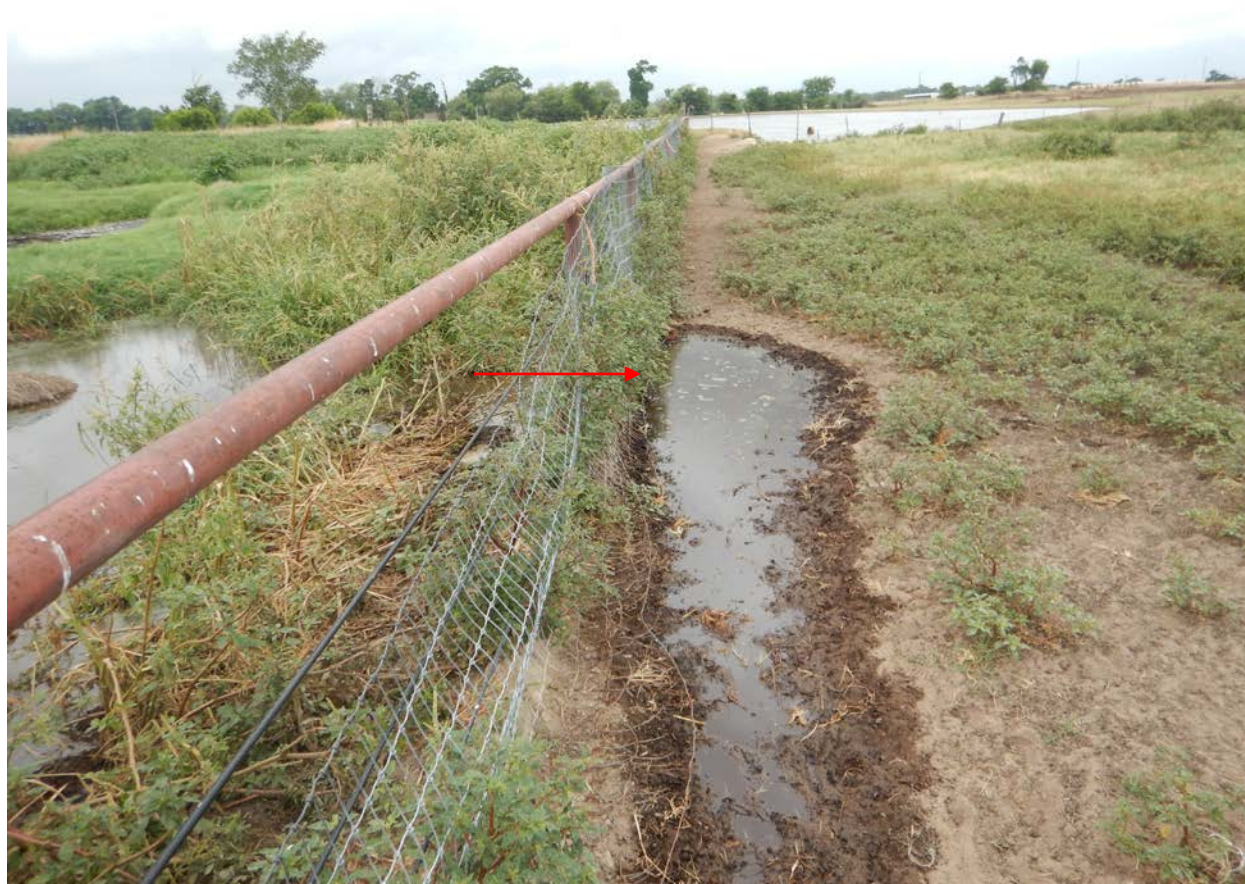
Photo No. 13

inspecting them more thoroughly. In addition, the fences surrounding these RCSs were largely in disrepair. We observed RCS #3 to have less than one foot of available freeboard as well as evidence of a recent overflow event (Photo #13). RCS #4, the final RCS in series, had approximately two feet of available freeboard (Photo #16). We observed the berms of this RCS to be generally in good condition except for the one tree which was rooted within the west berm (Photo #17). This RCS contained a pole marker which appeared to be representative of the freeboard which was available. While observing RCS #5, we noticed excess accumulated solids in addition to berms which had not been maintained (Photo #19). On the day of the inspection, we observed that cattle had direct access to RCS #6 and were using it as a cooling pond (Photo #18).

Description: This photo was taken facing northwest towards a low point in RCS #3. Note the overflow of wastewater into the pasture adjacent to RCS #3.

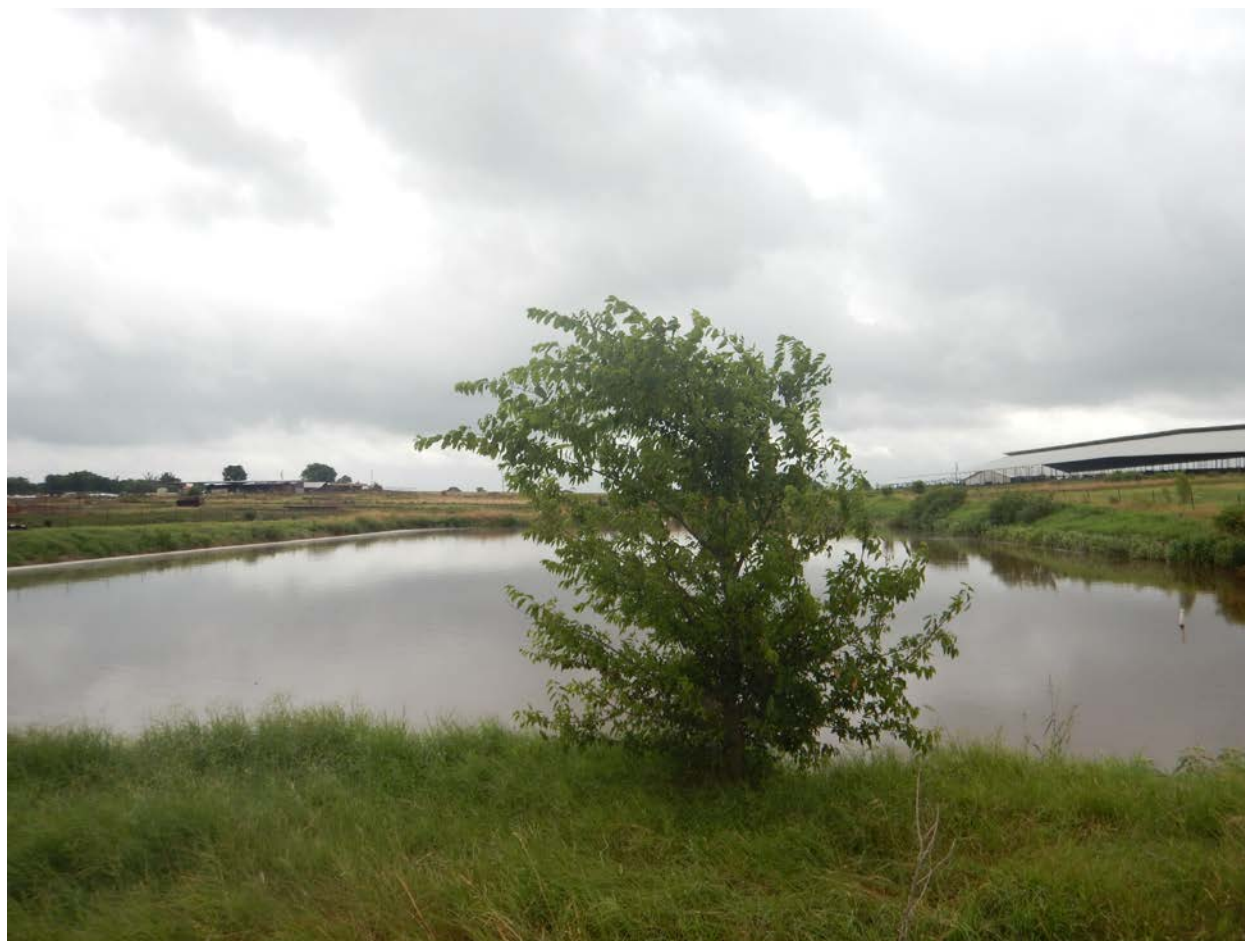
Photo No. 17

Description: This photo was taken facing east across RCS #4. Note the tree which is rooted within the berm of the RCS.

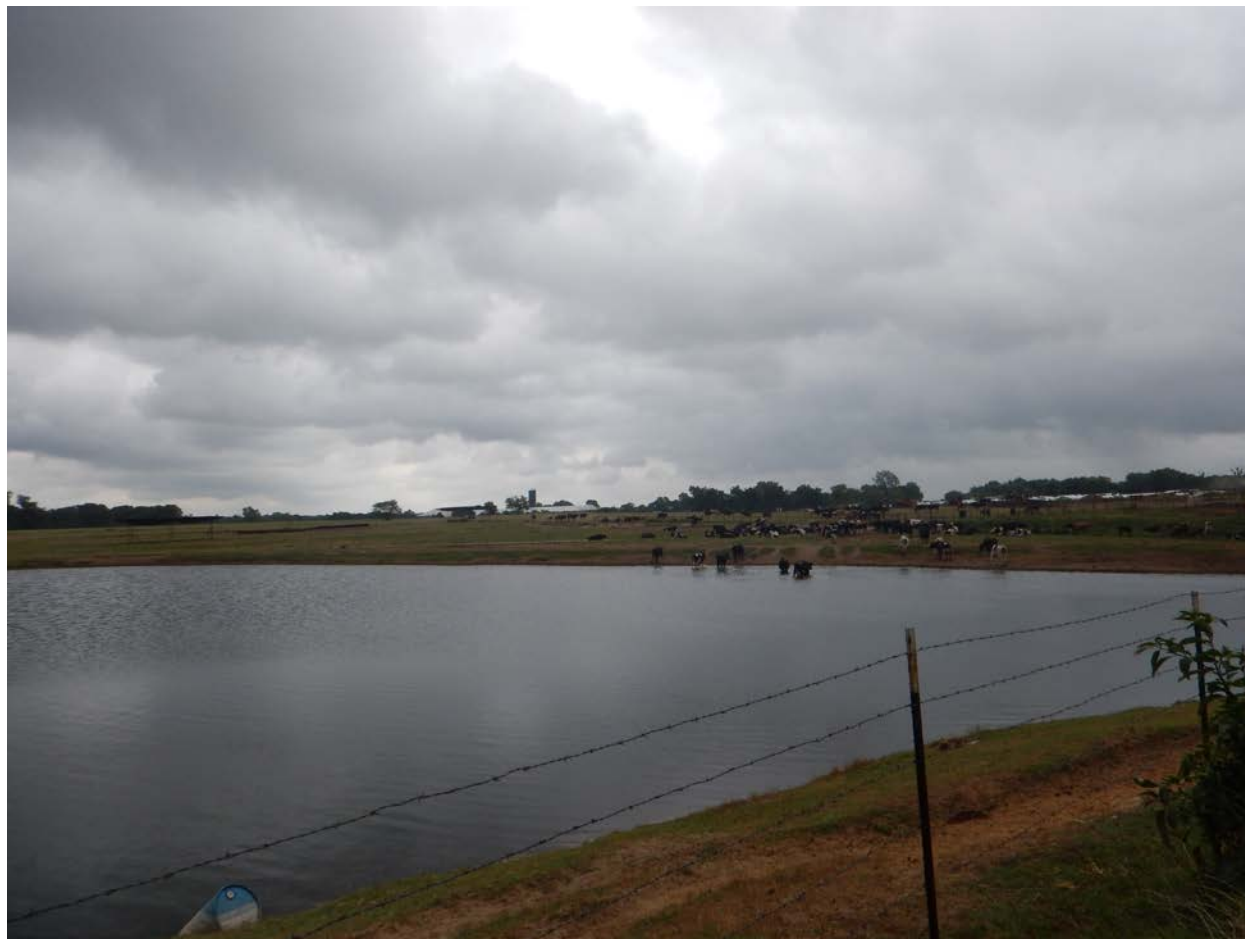
Photo No. 18

Description: This photo was taken facing northeast across RCS #6. Note that the animals had direct access to the RCS and were utilizing it as a cooling pond.

- There were no fences protecting the liners of RCSs #1-5 from damage by livestock per WQ0004905000 Part VII.A.3(f)(6). We observed that cattle had direct access to RCS #6 and were using it as a cooling pond. Cattle should be kept out of all RCSs always.

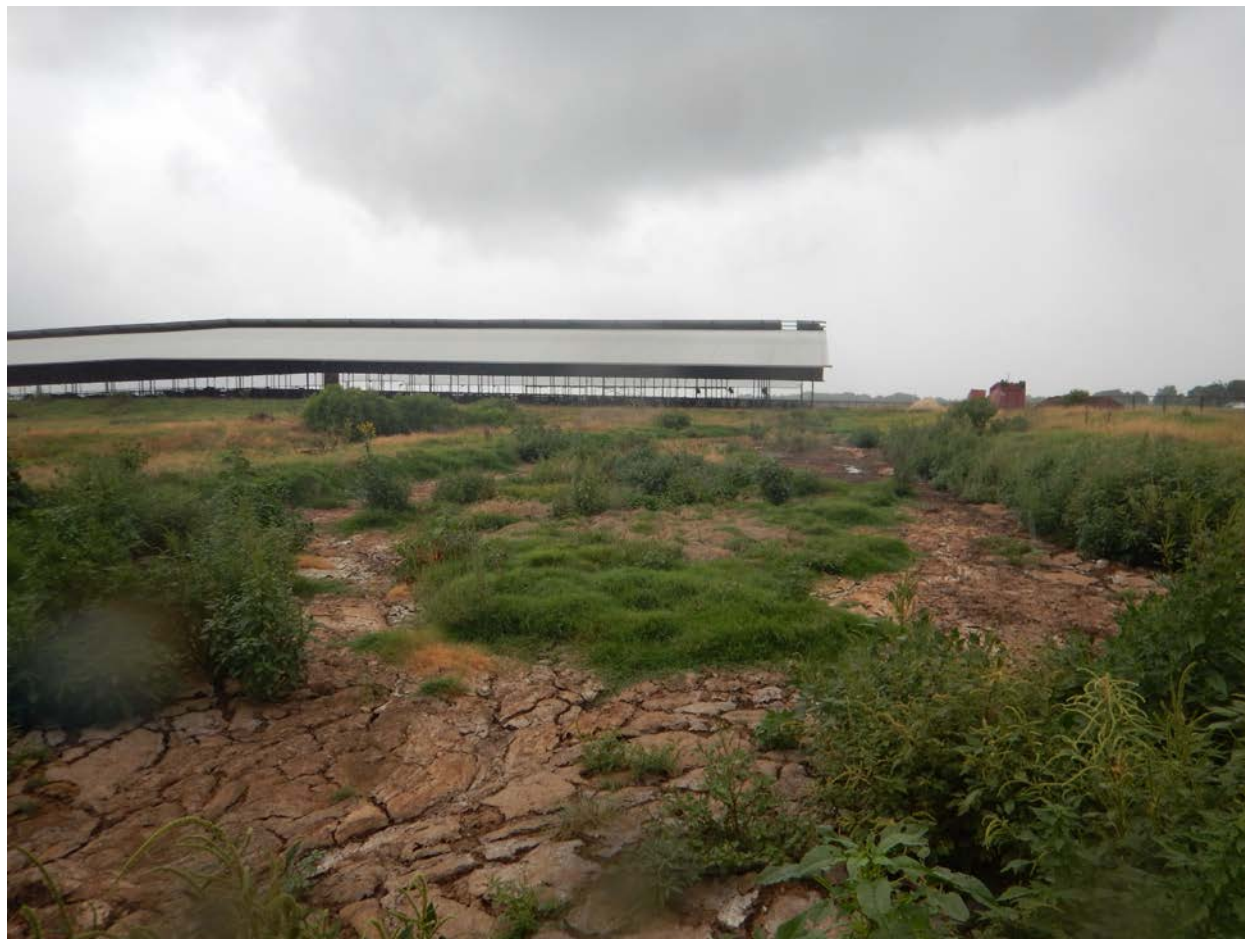
Photo No. 19

Description: This photo was taken facing south across RCS #5. Note the accumulation of solids and the lack of berm maintenance.

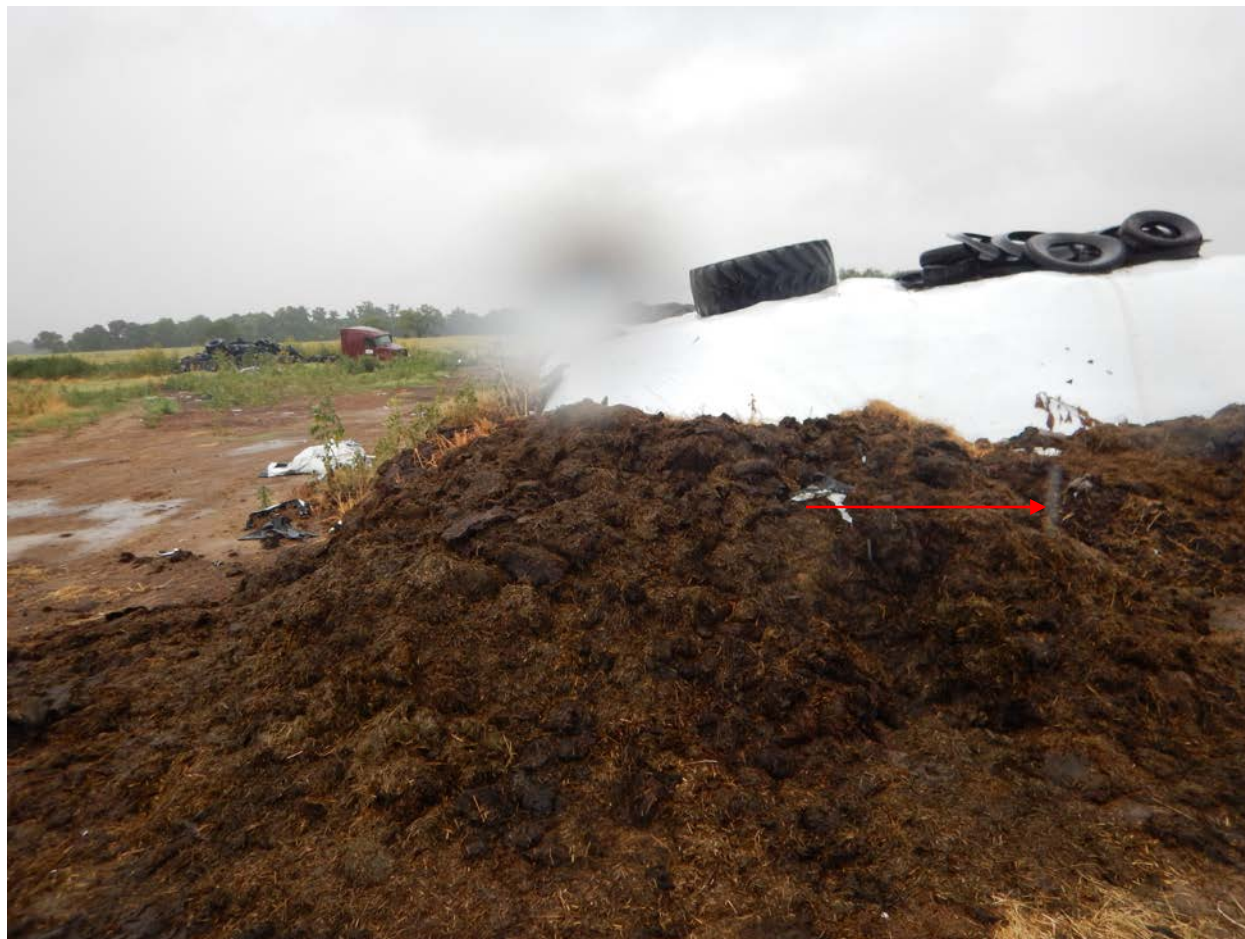
Photo No. 21

On the day of our inspection we observed the commodity storage barns to be in good condition. We observed silage which was stored under large plastic tarps secured by both tires and old silage (Photo #21).

Description: This photo was taken facing north toward the facility's silage storage area. Note the use of silage to secure the plastic tarp. The owner should verify that no contaminated stormwater from the silage storage area is being discharged off-site.

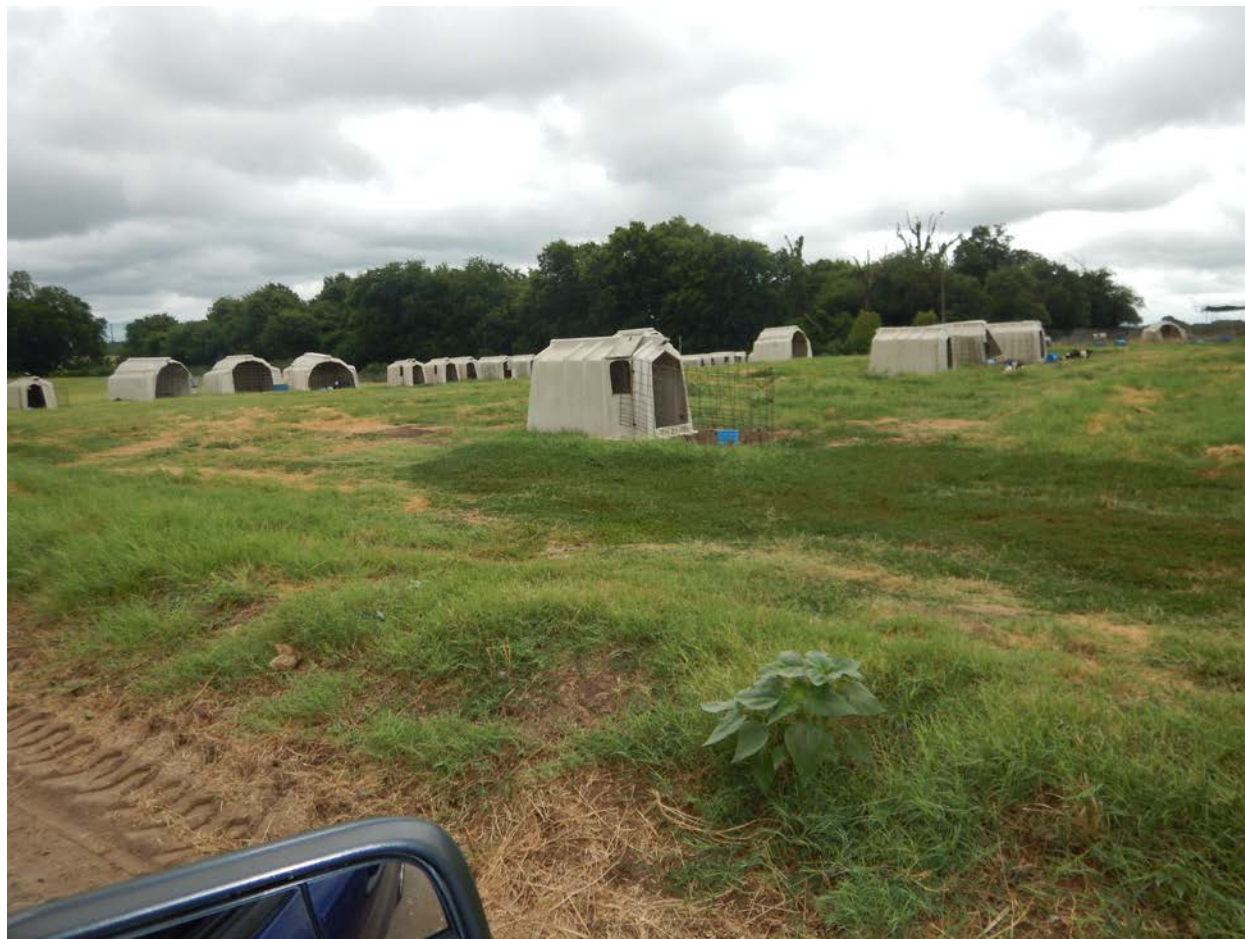
Photo No. 23

Description: This photo was taken facing northeast toward the facility's calf hutch area. Note that the area is well vegetated.
