## Clean Water Act Section 404: Site Visit/Case Development

| Site Name | South Alabama Materials, Inc., Sardine Pit | | | | |

**ATTACHMENT D**  
**South Alabama Materials, Inc.**

Sardine Pit  
Photographic Log  
Escambia County, Alabama  
January 30-31, 2024

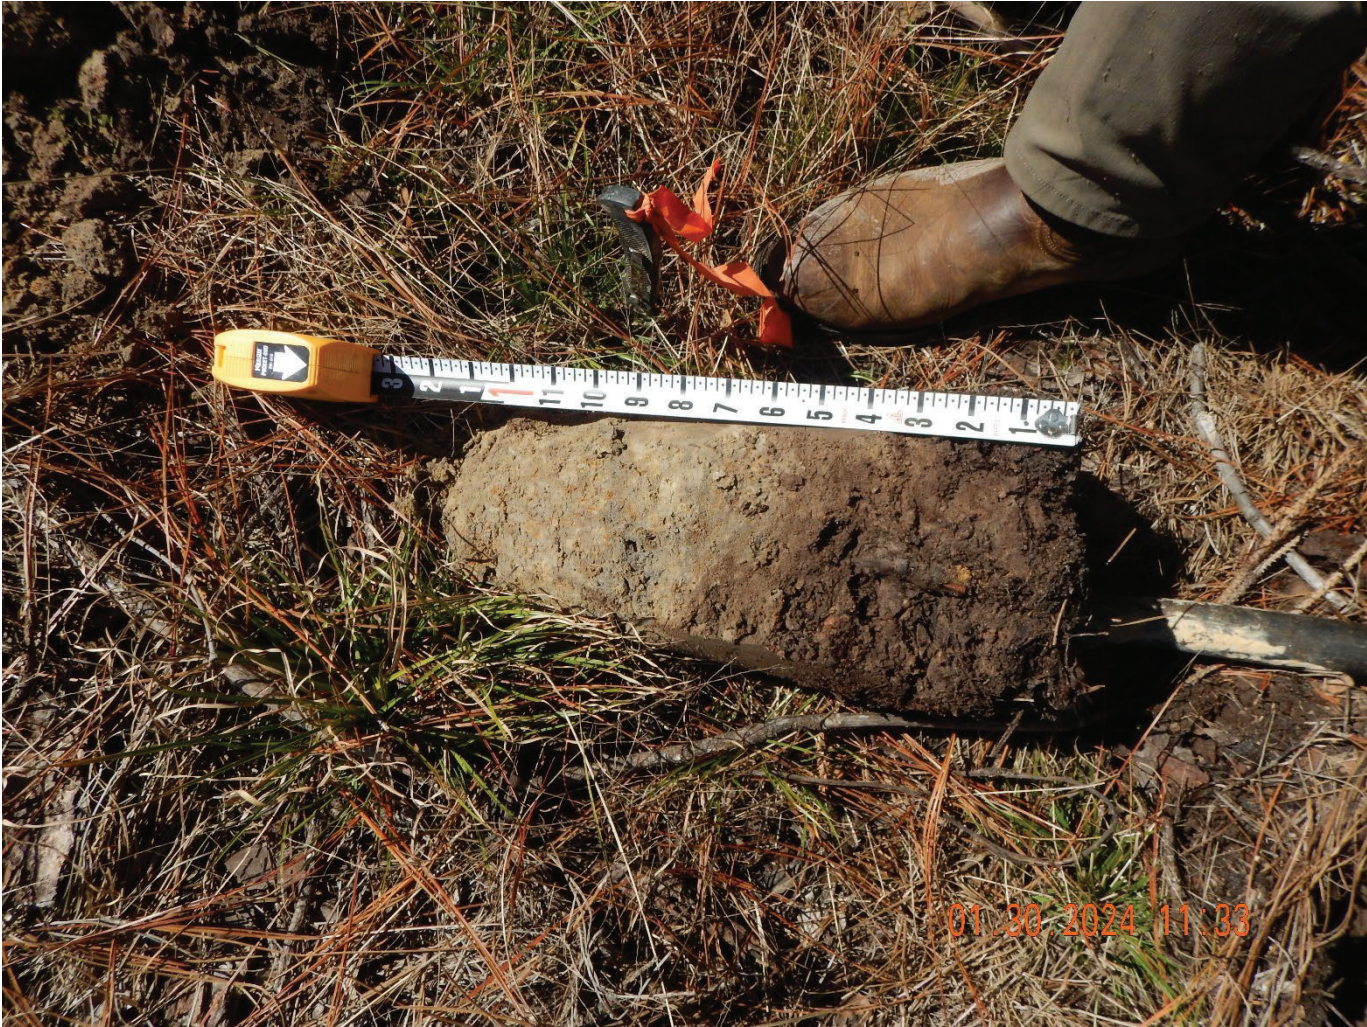
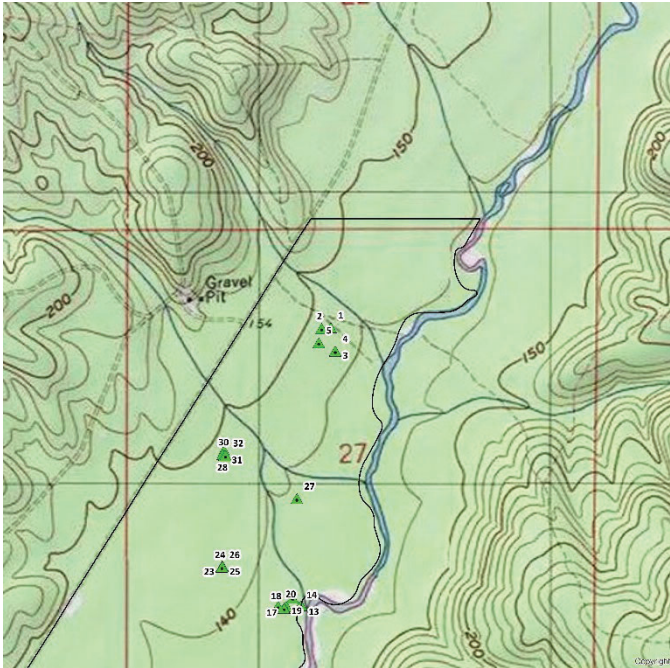
PHOTO 1

| Description | Soil profile at Data Point A1. |

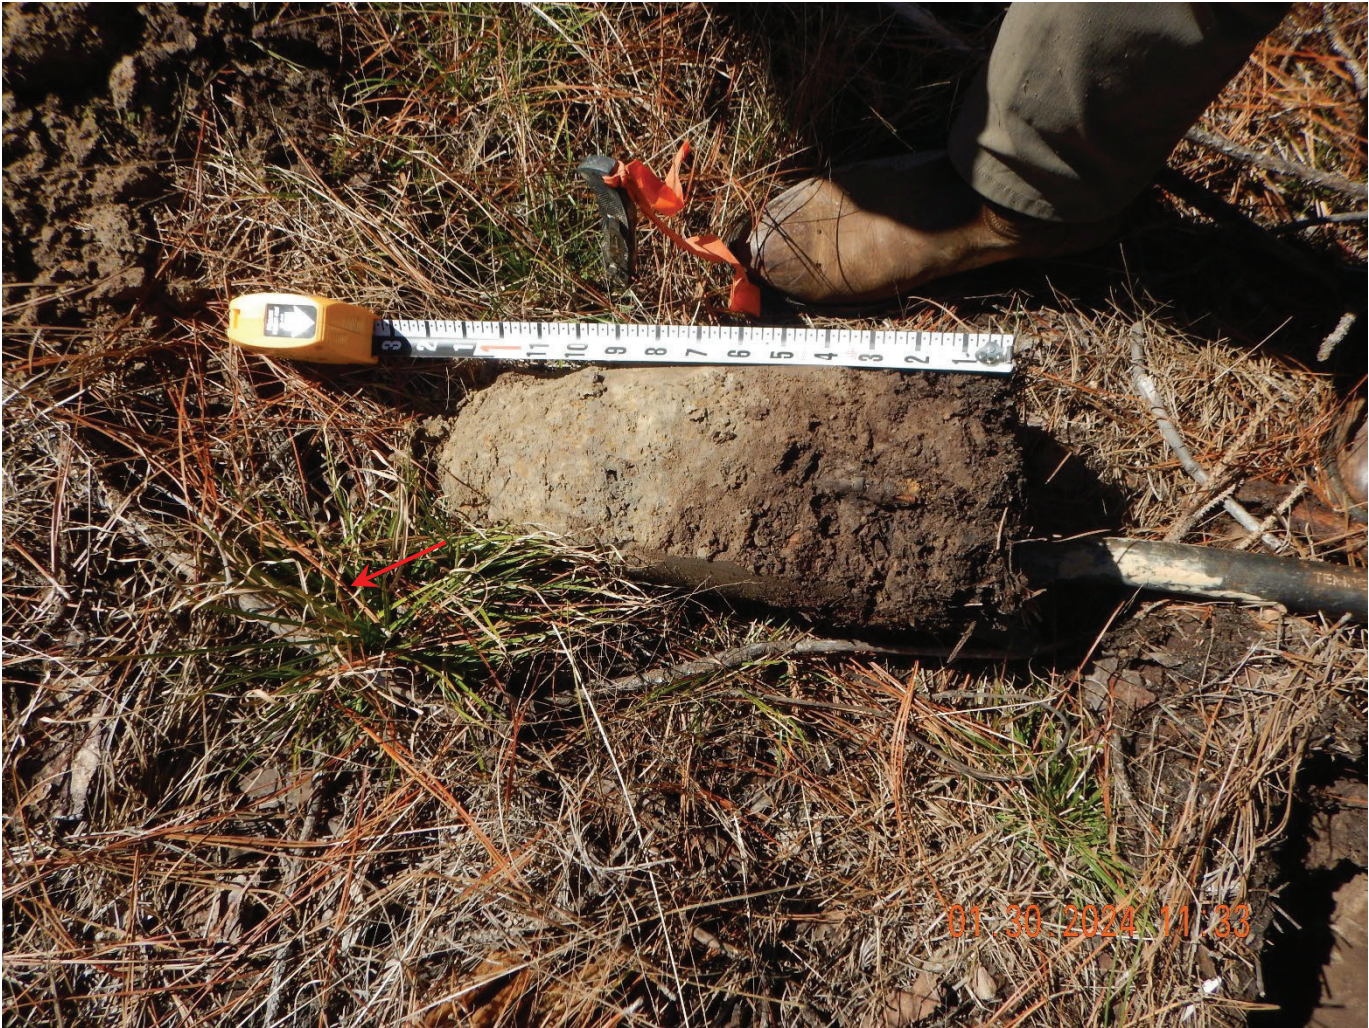
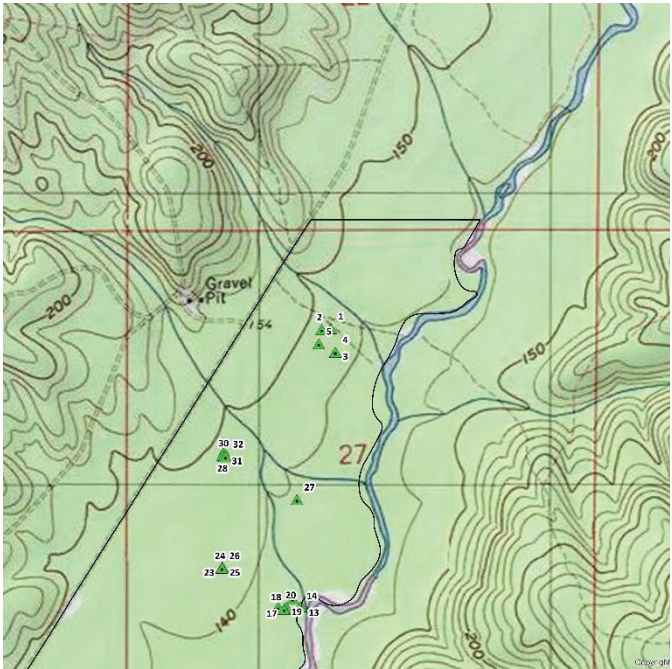
PHOTO 2

| Description | Soil profile at Data Point A1. |

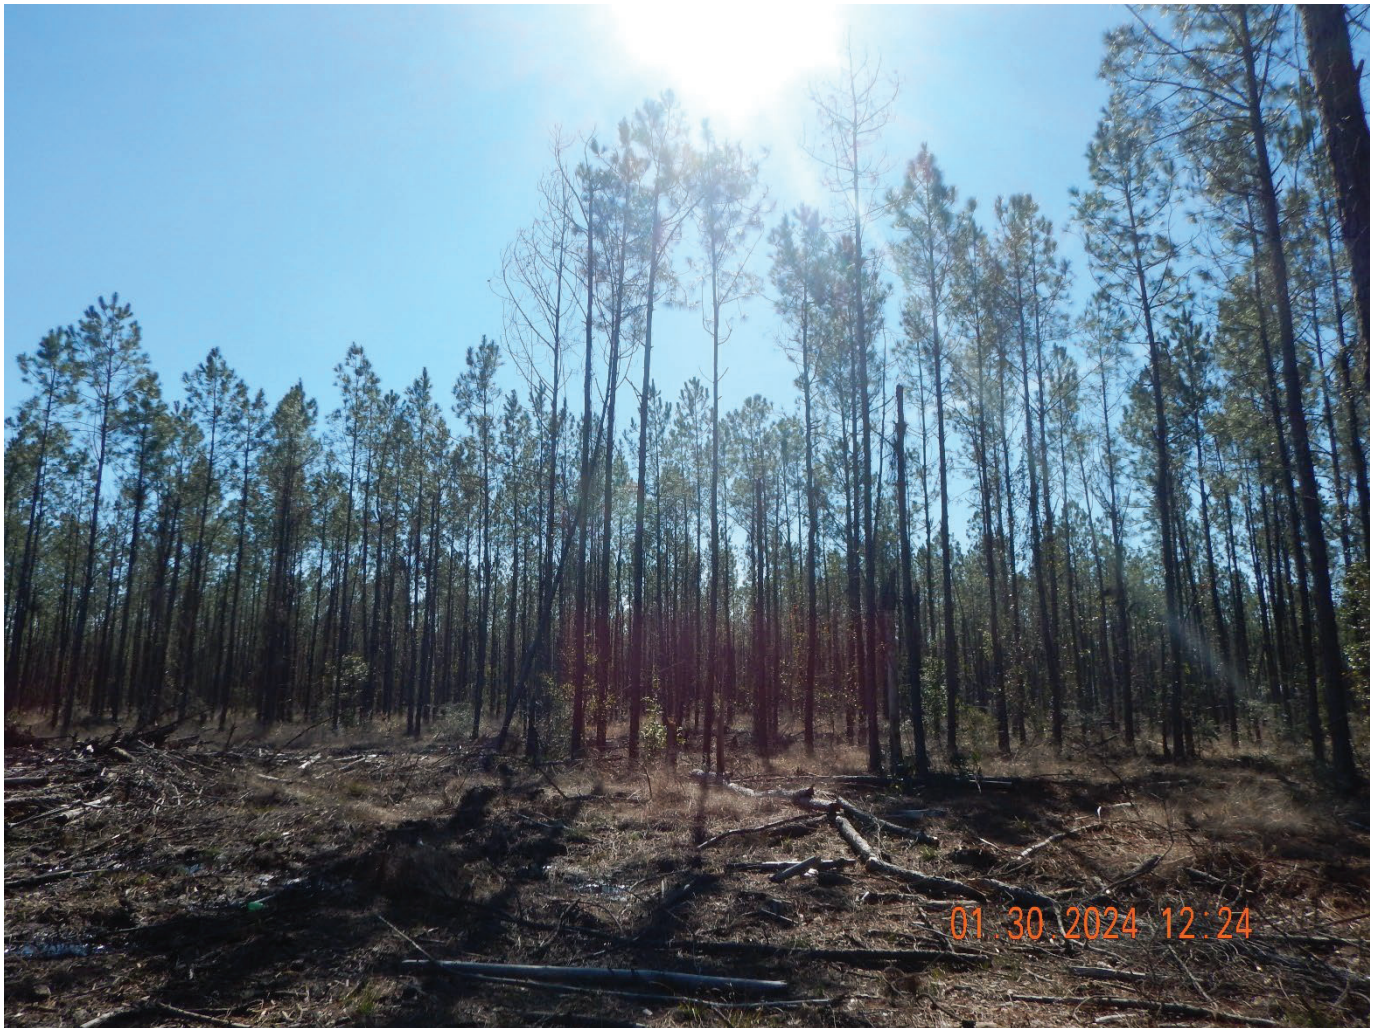
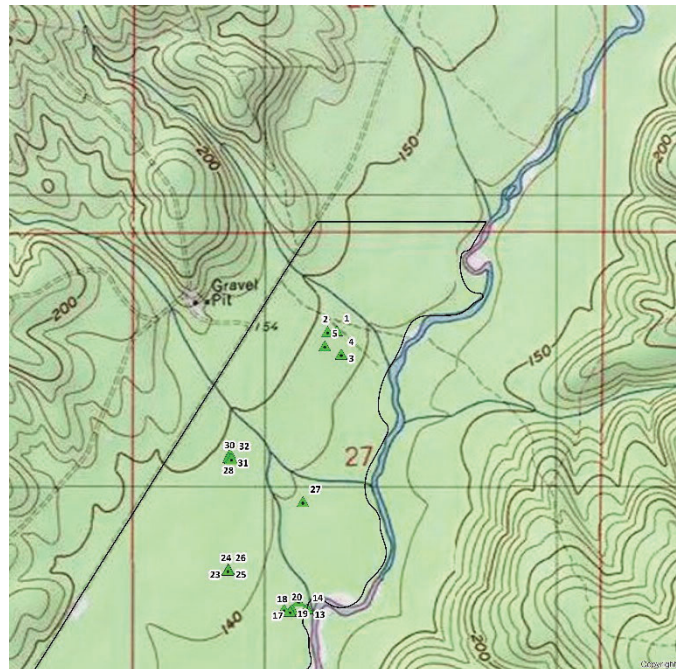
PHOTO 3

| Description | Striking south over Data Point A1. |

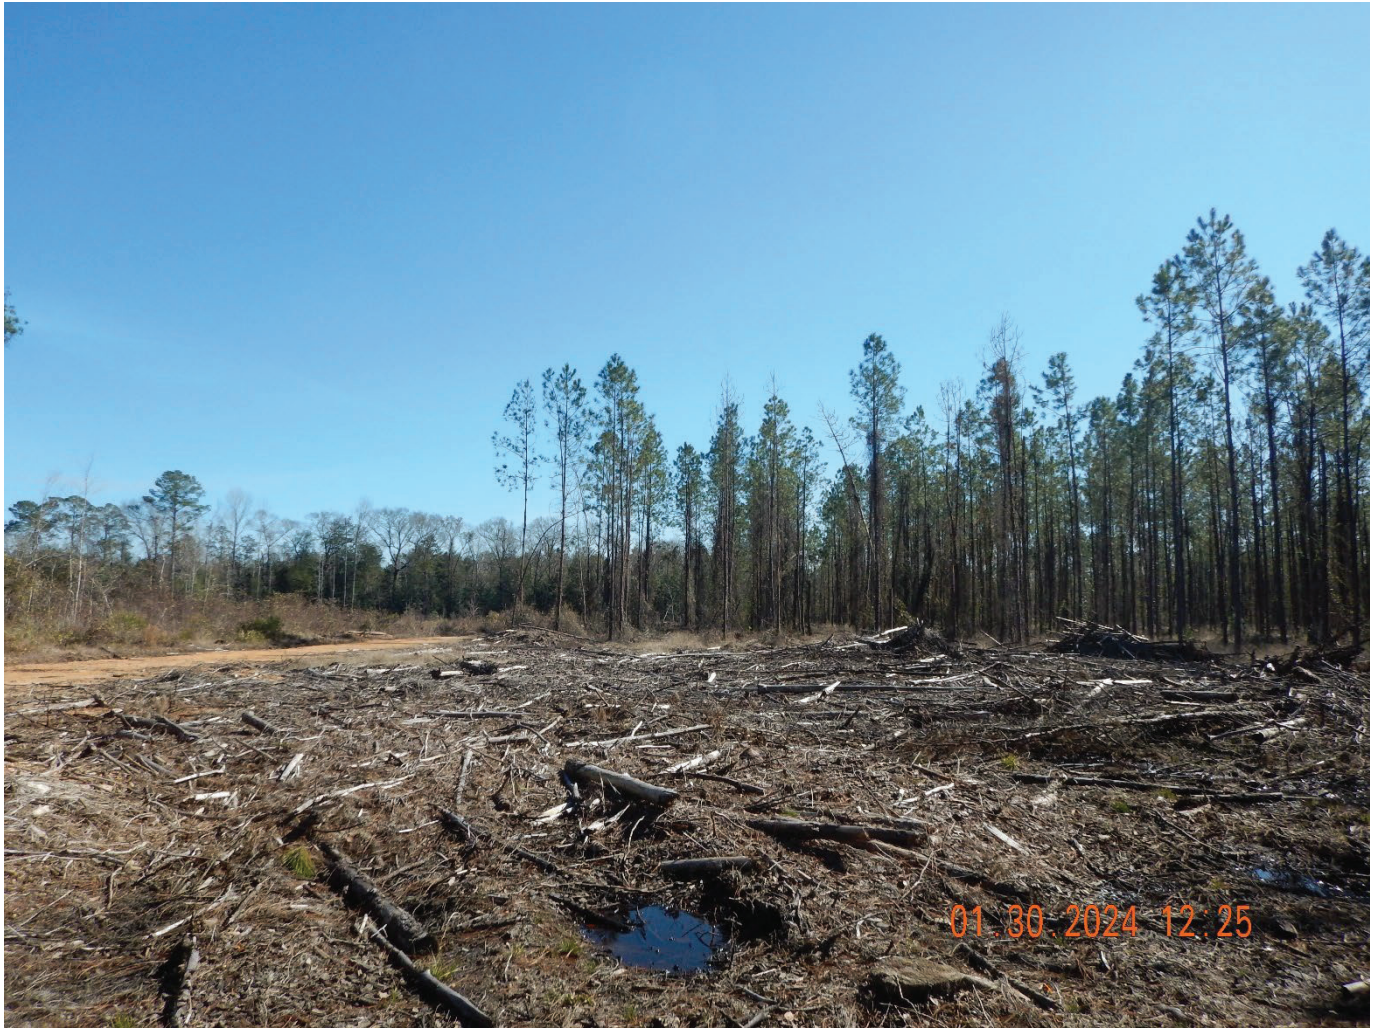
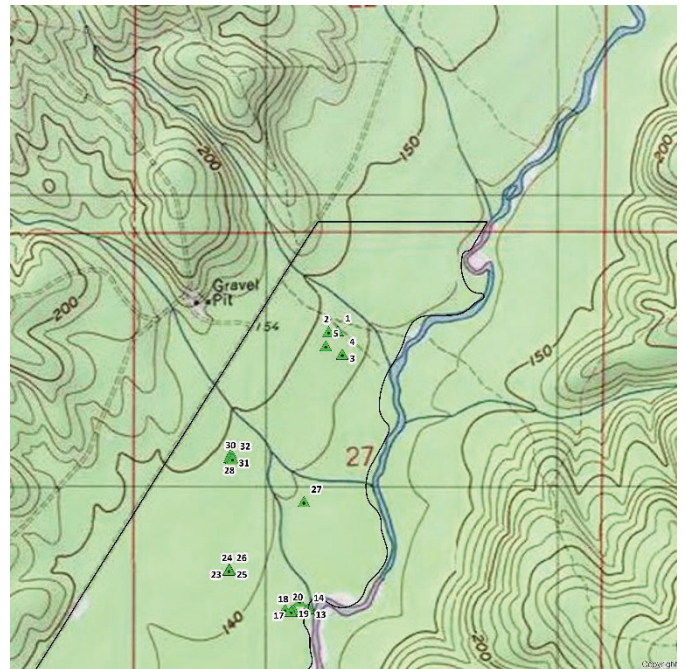
# PHOTO 4

| Description | Striking east over Data Point A1. |

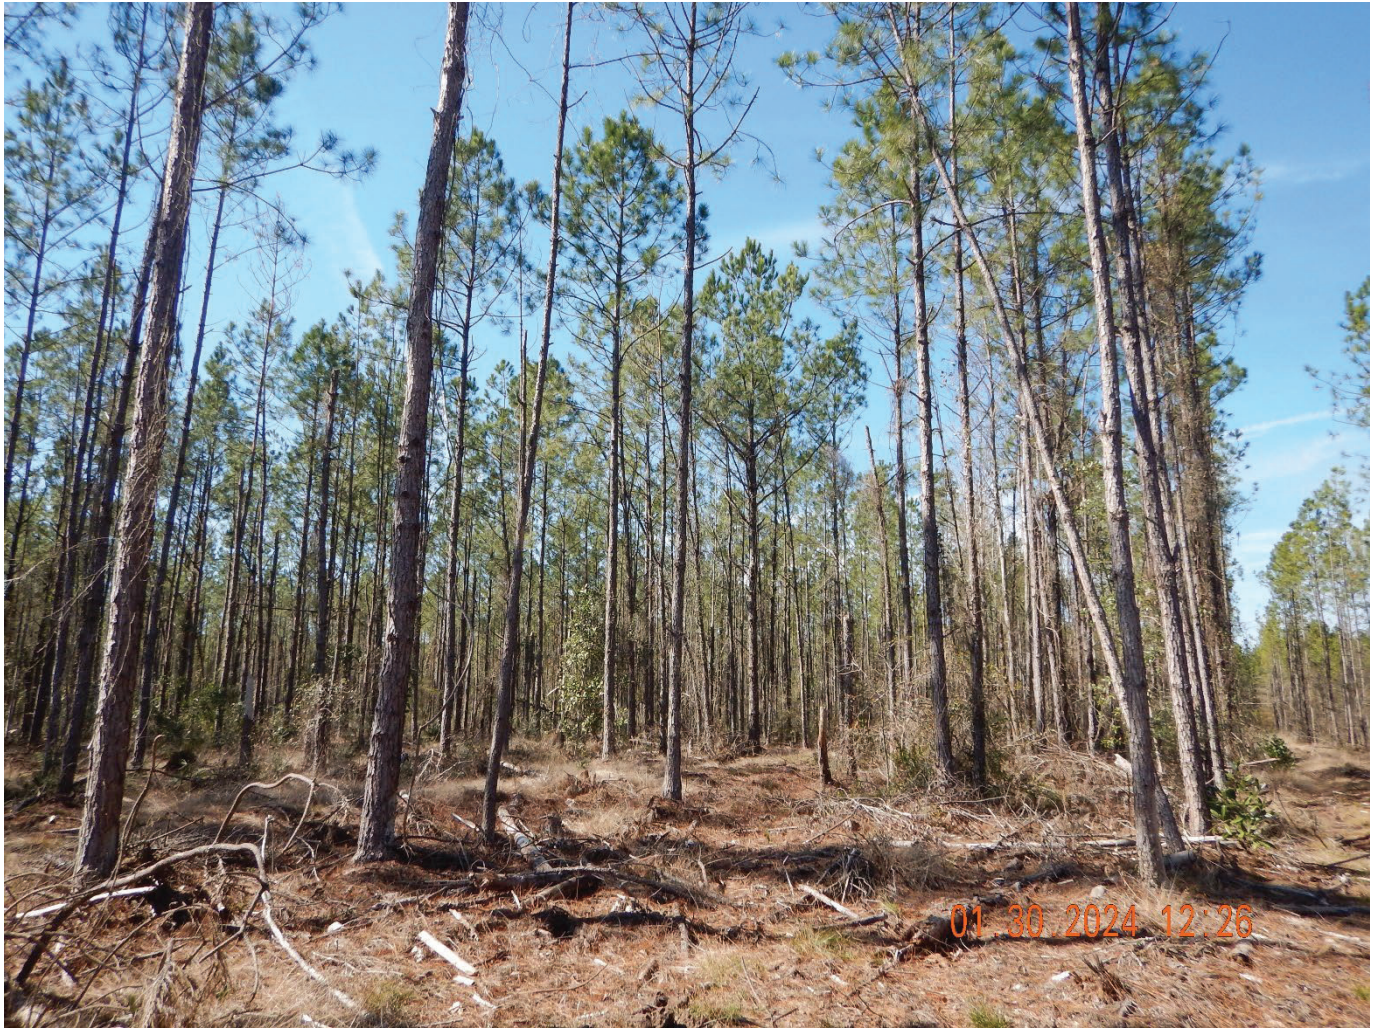
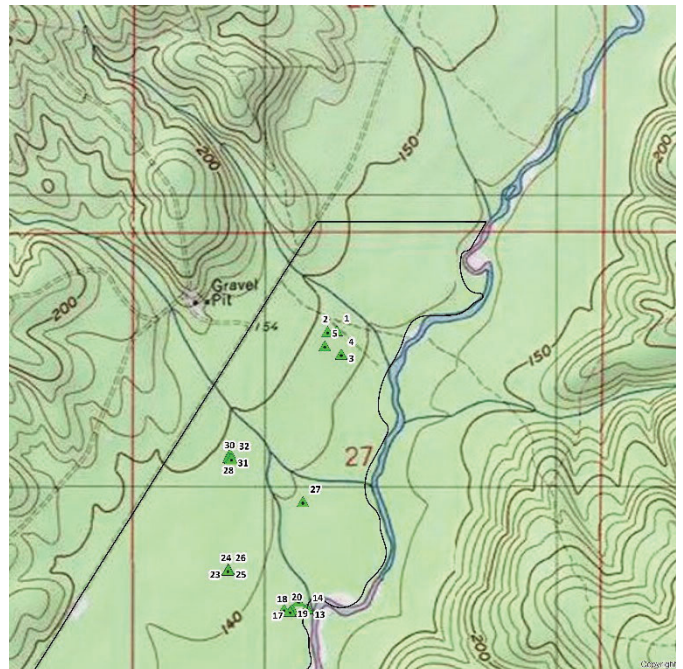
PHOTO 5

| Description | Striking west over Data Point A1. |

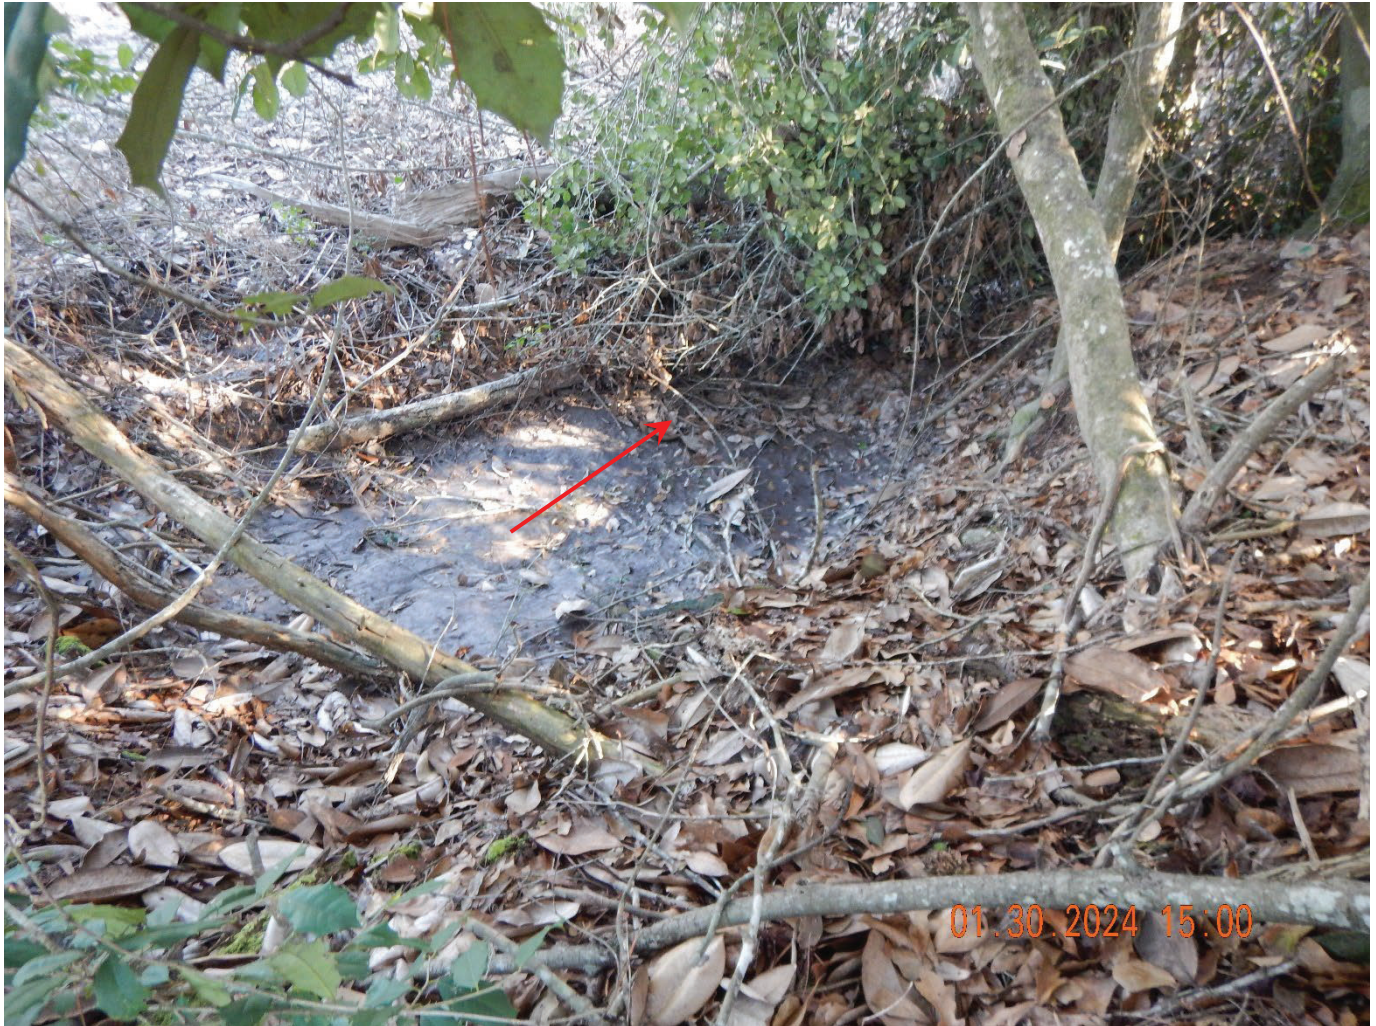
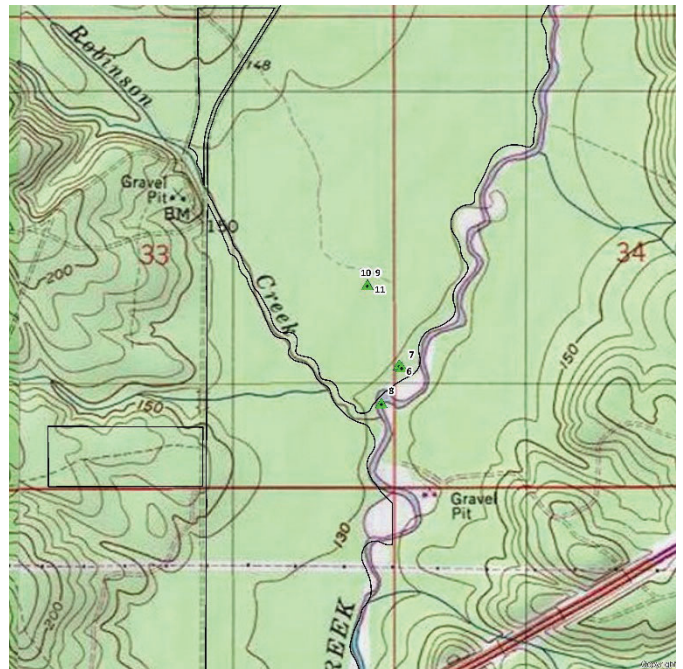
# PHOTO 6

| Description | Striking downstream, unnamed tributary (UT) east of berm, just upstream of the UT's confluence with Big Escambia Creek. Red arrow indicates direction of flow. |

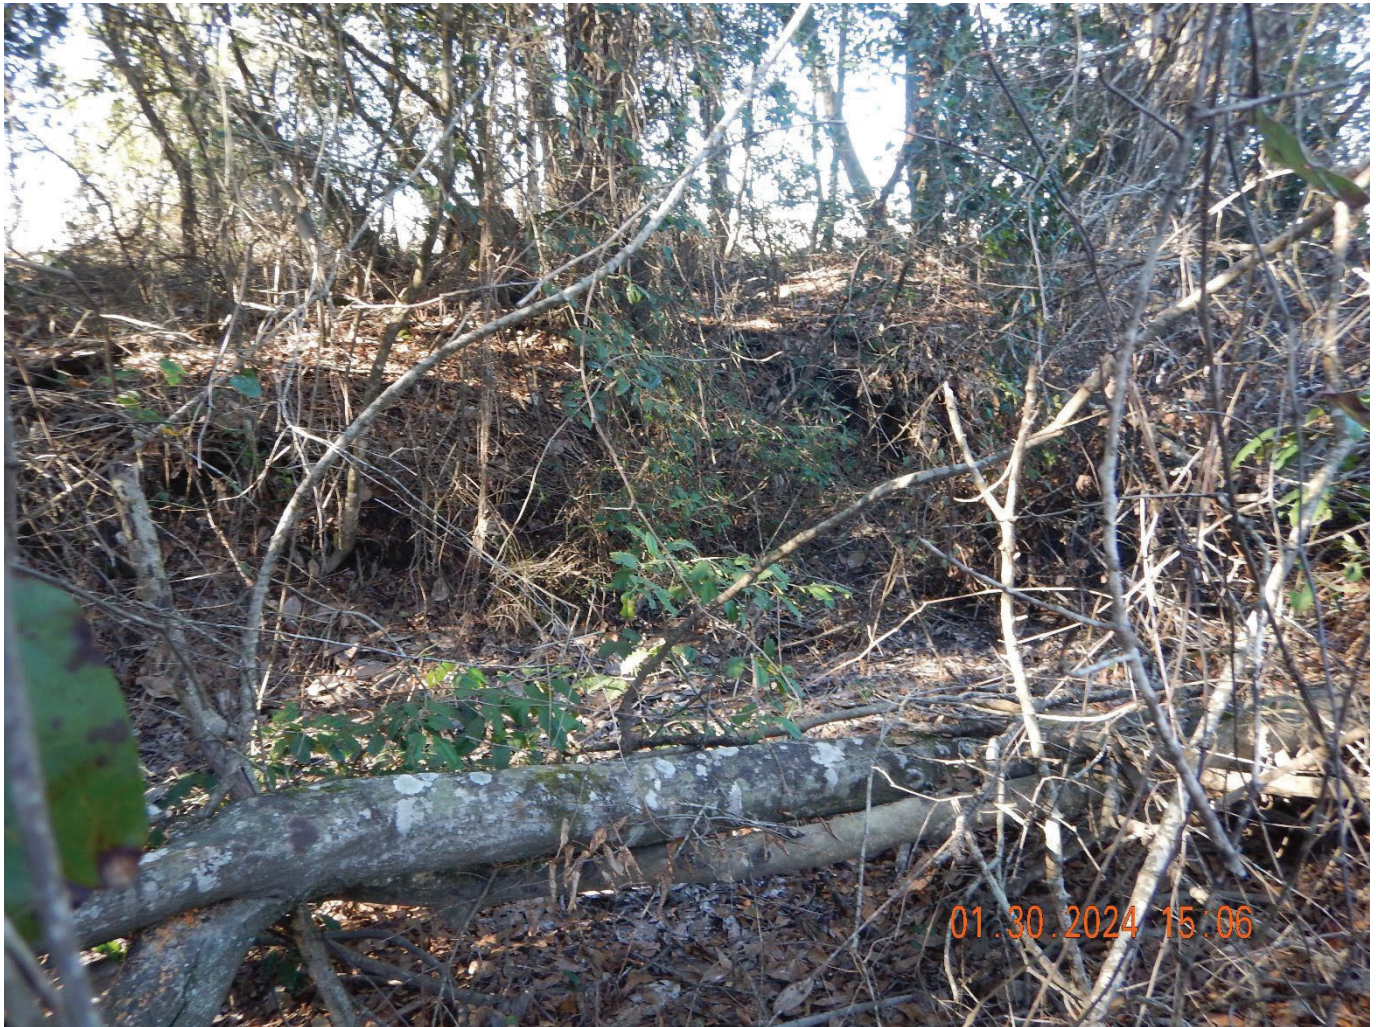
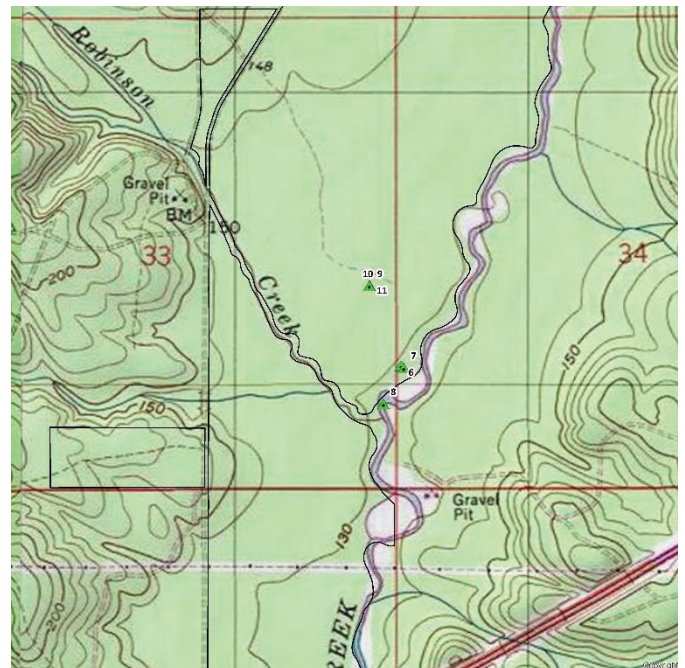
PHOTO 7

| Description | Striking northwest from same location as Photo 6 in UT channel, Big Escambia Creek's natural levee. |

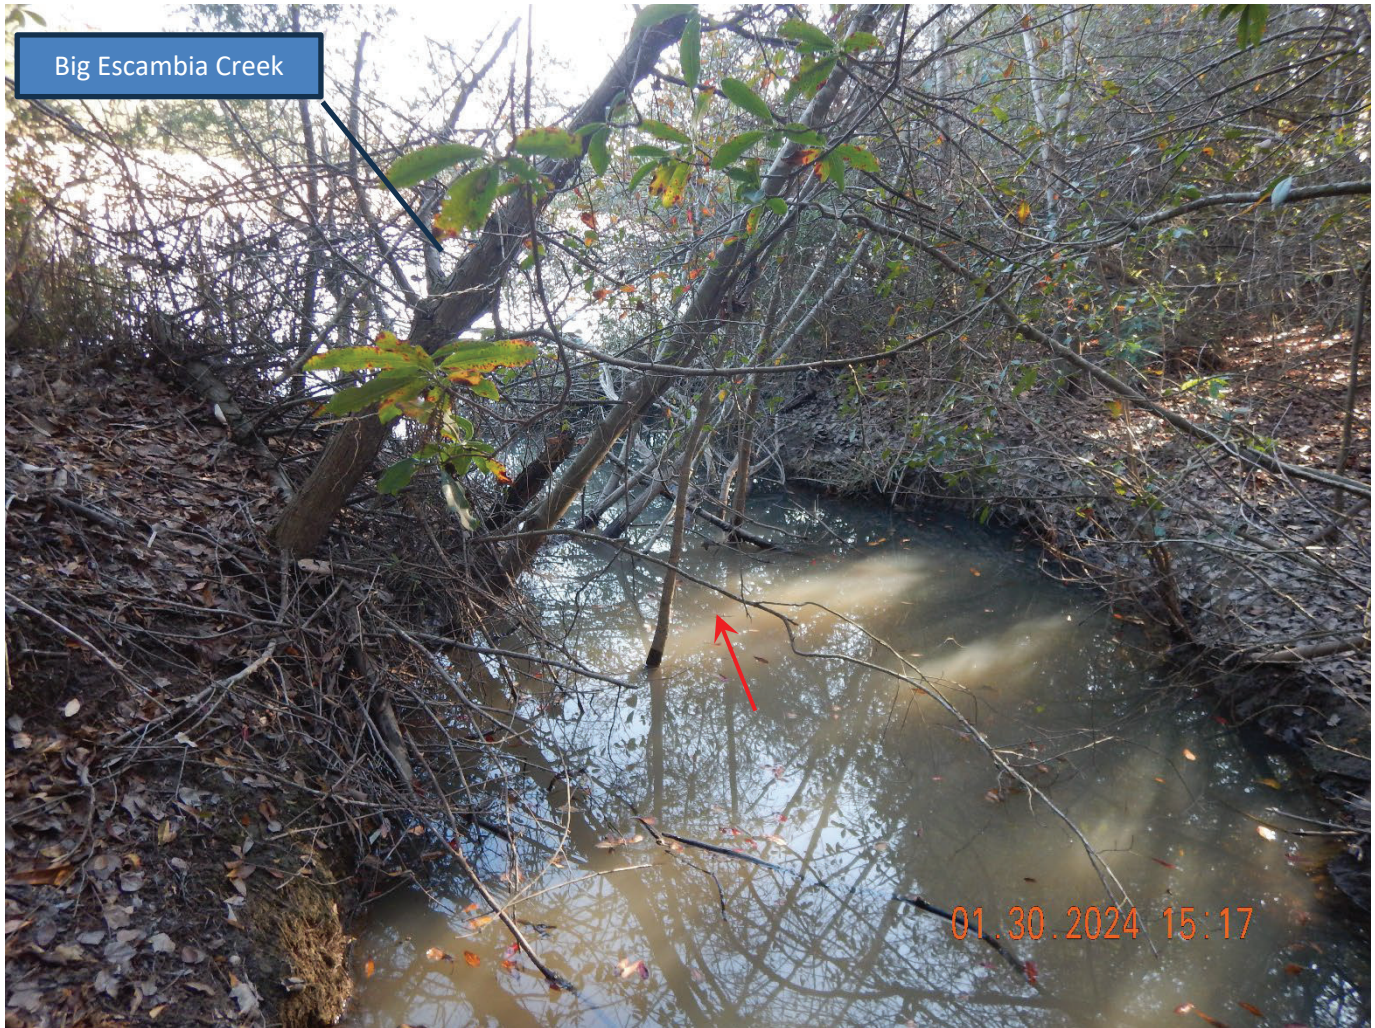
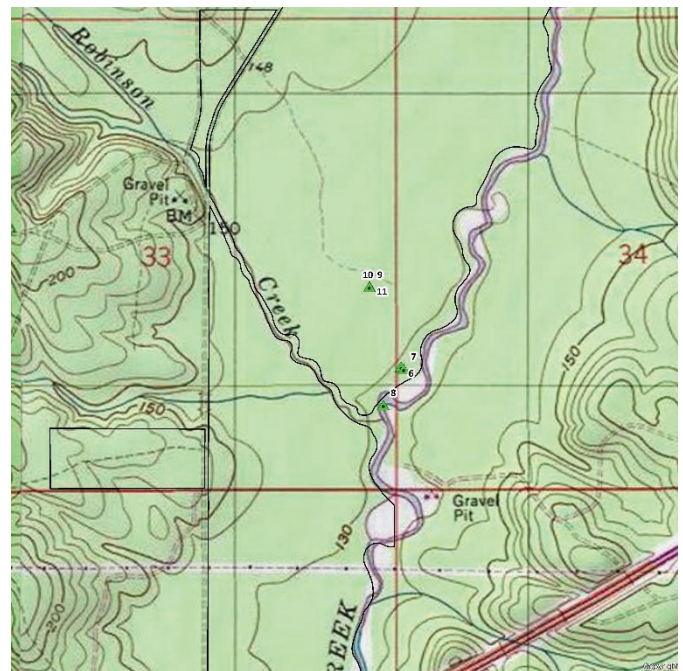
# PHOTO 8

| Description | Striking downstream, unnamed tributary (UT) east of berm, at the UT's confluence with Big Escambia Creek. Red arrow indicates direction of flow. |

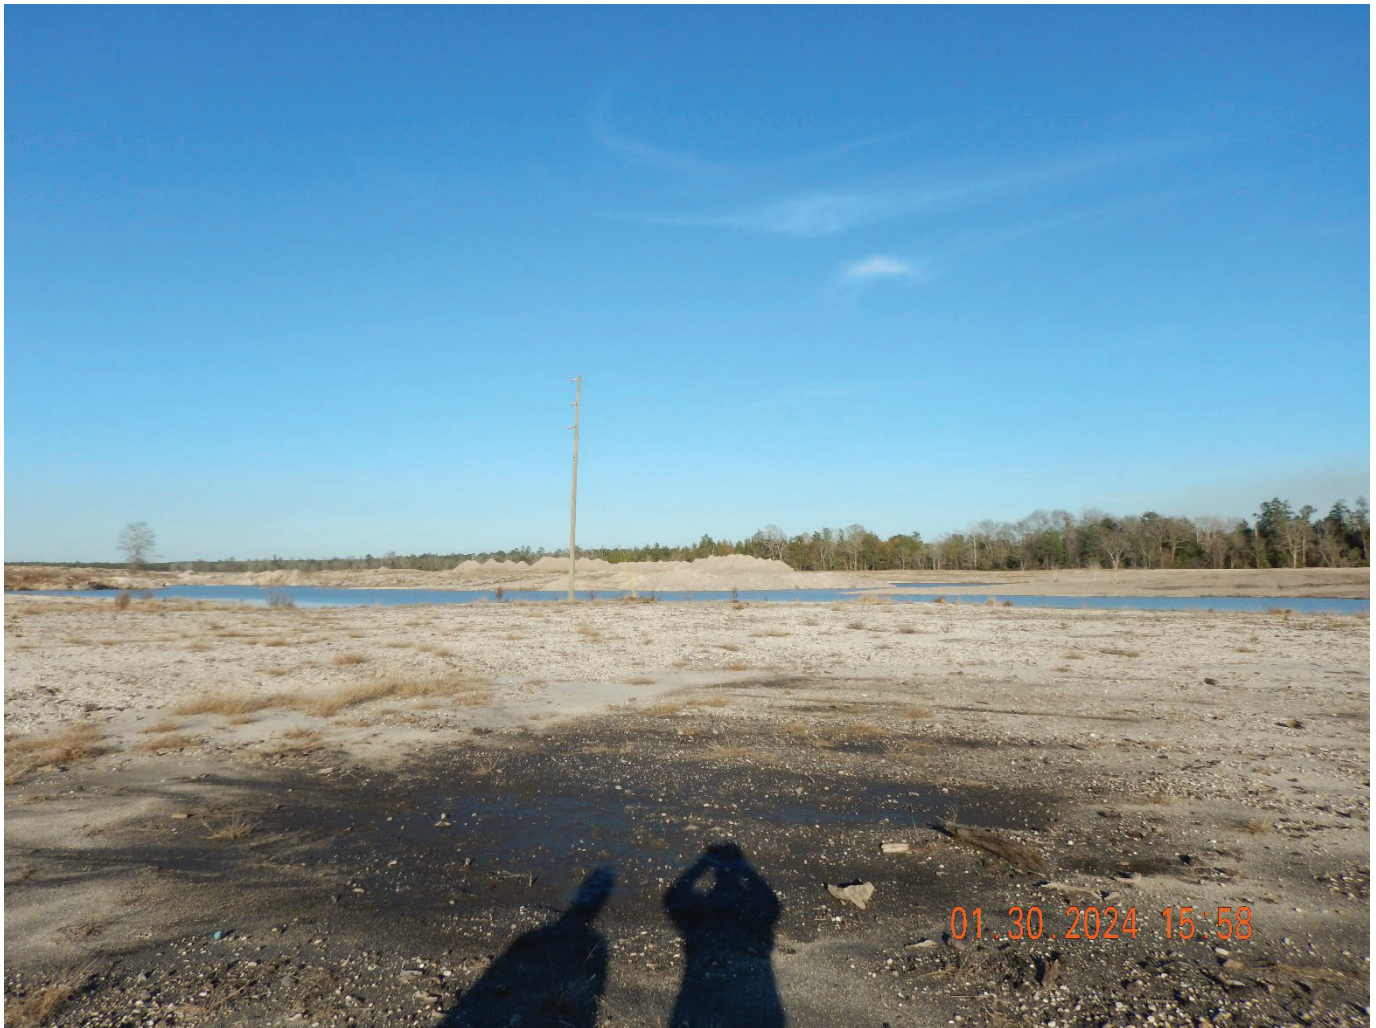
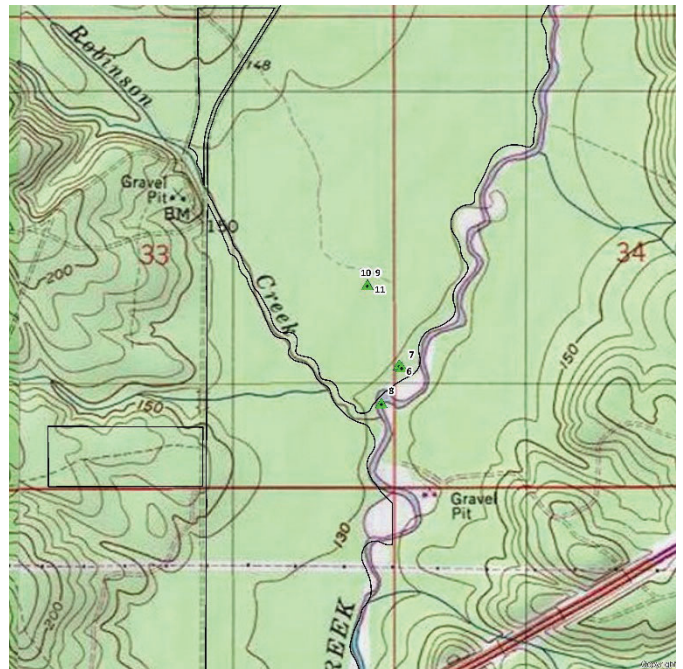
PHOTO 9

| Description | Striking northeast from interior of mine, spoil pile in background. |

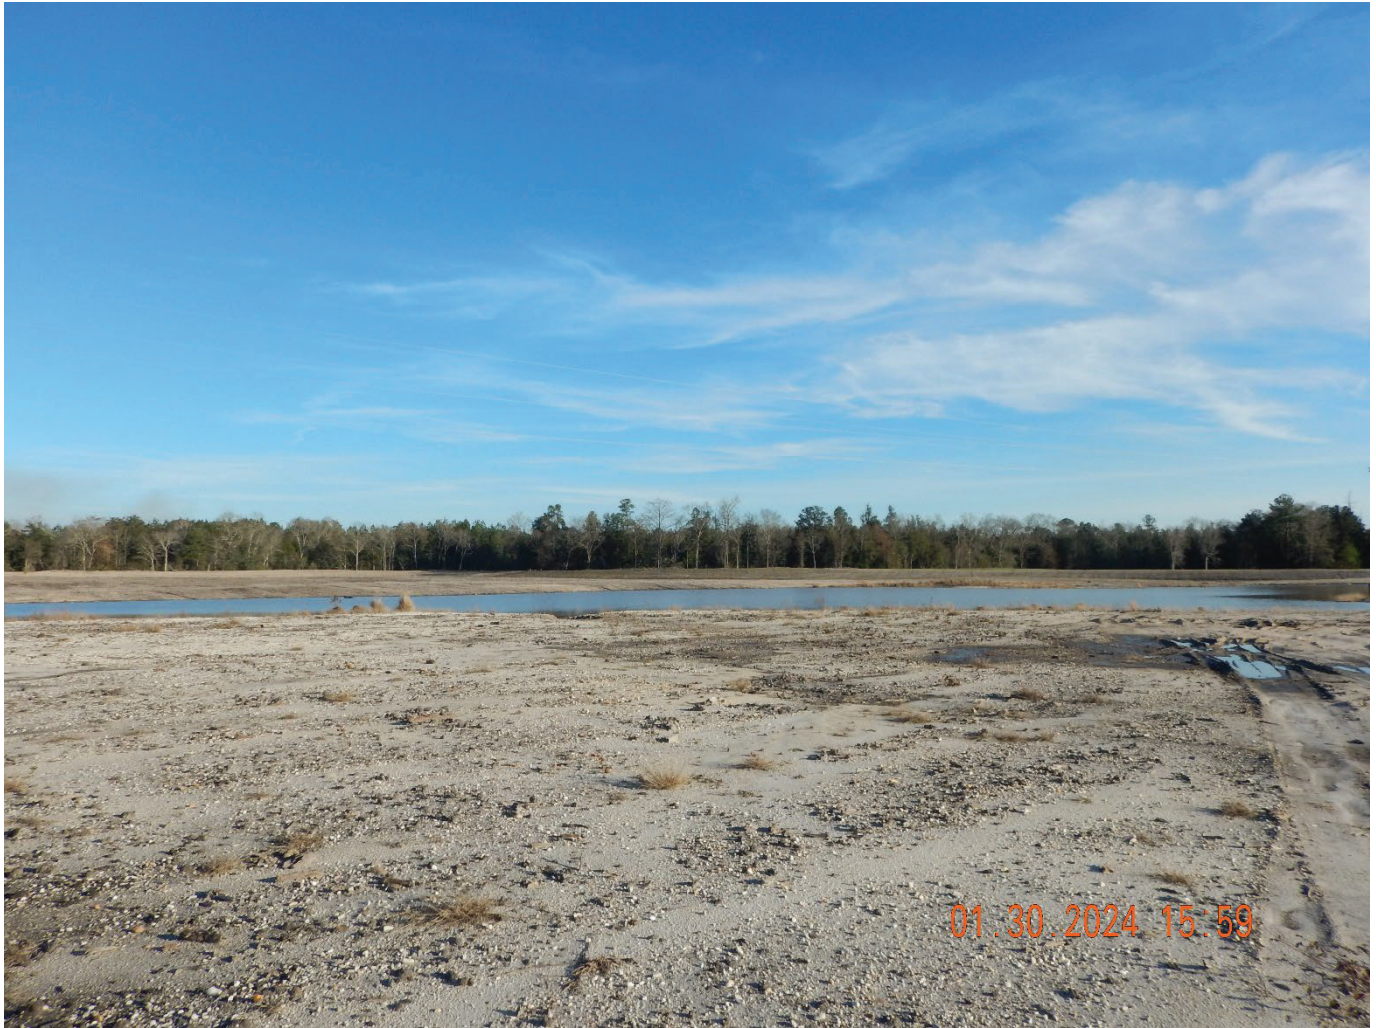
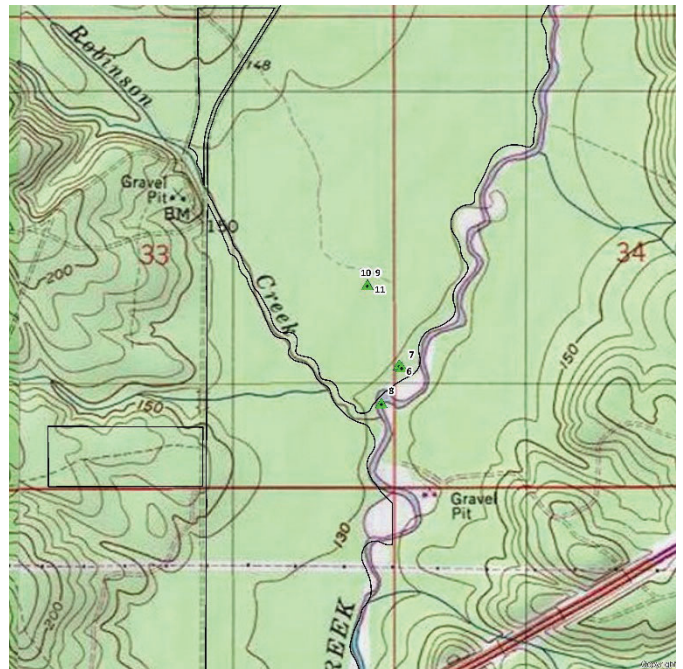
PHOTO 10

| Description | Striking southeast of mined area, berm in background. |

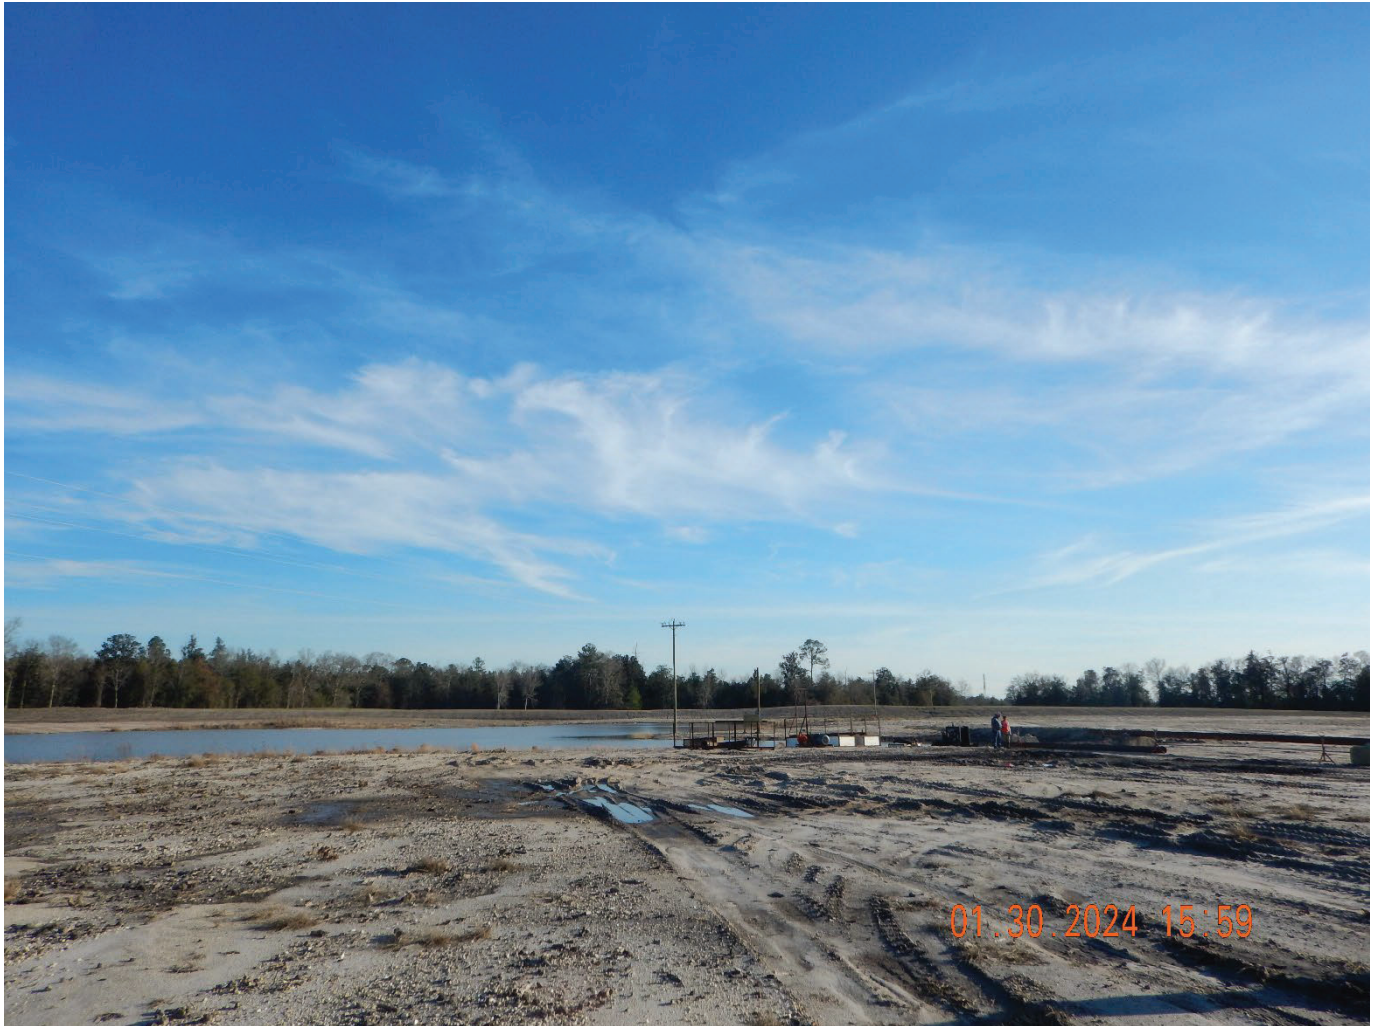
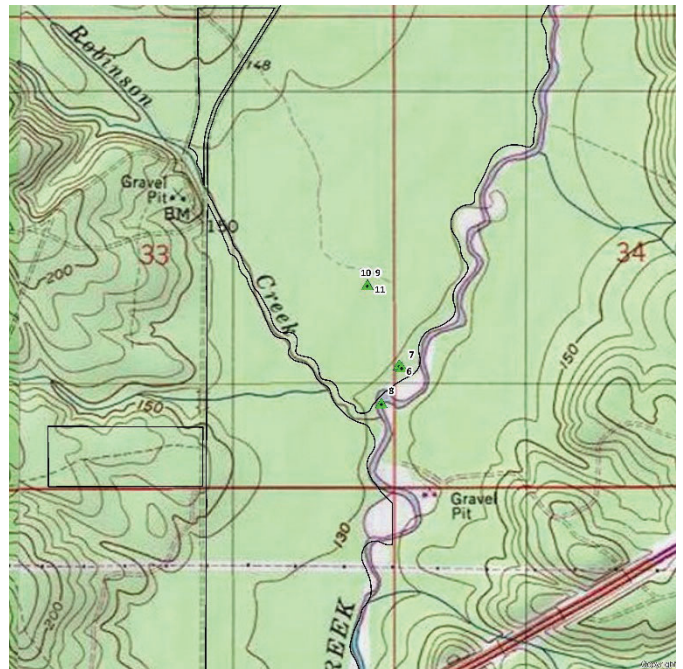
PHOTO 11

| Description | Striking south of mined area, berm in background. |

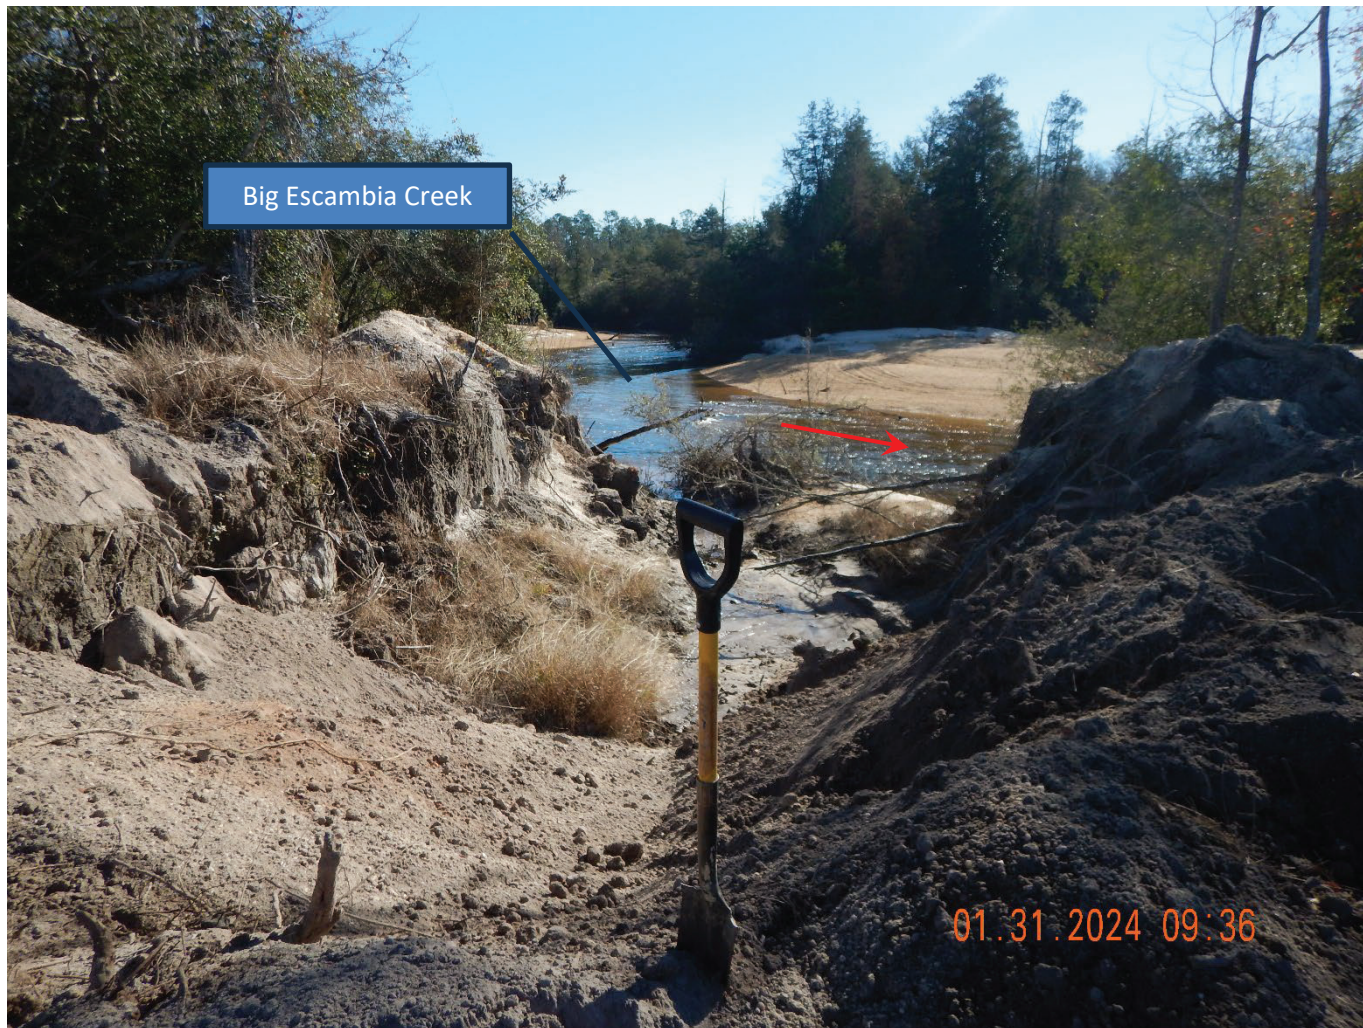
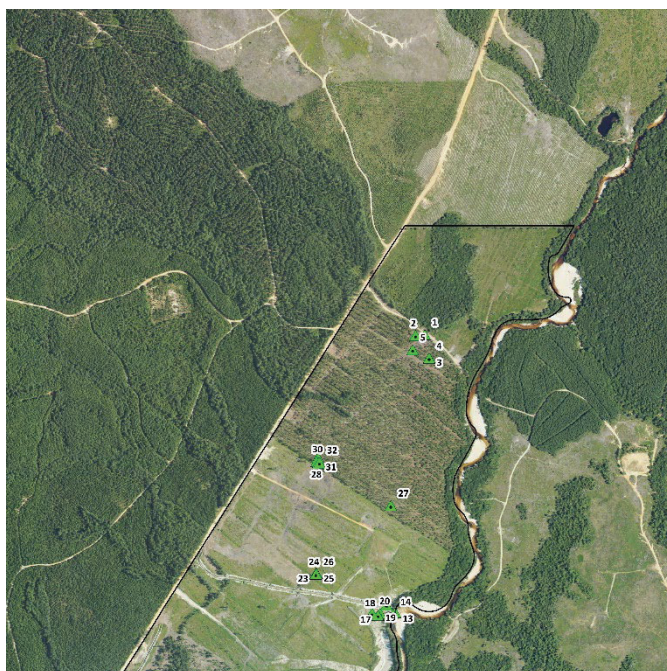
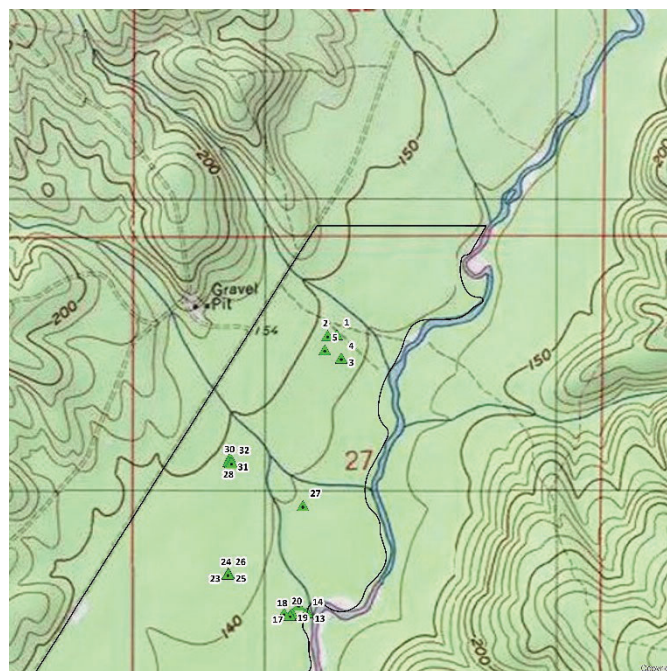
# PHOTO 12

| Description | Striking E/SE at the end of a recently filled ditch and its confluence with Big Escambia Creek. Red arrow indicates direction of flow. (No GPS data for this photograph) |
