## Clean Water Act Section 404: Site Visit/Case Development

| Site Name | South Alabama Materials, Inc., Sardine Pit | | | | |

**ATTACHMENT D**  
**South Alabama Materials, Inc.**

Sardine Pit  
Photographic Log  
Escambia County, Alabama  
January 30-31, 2024

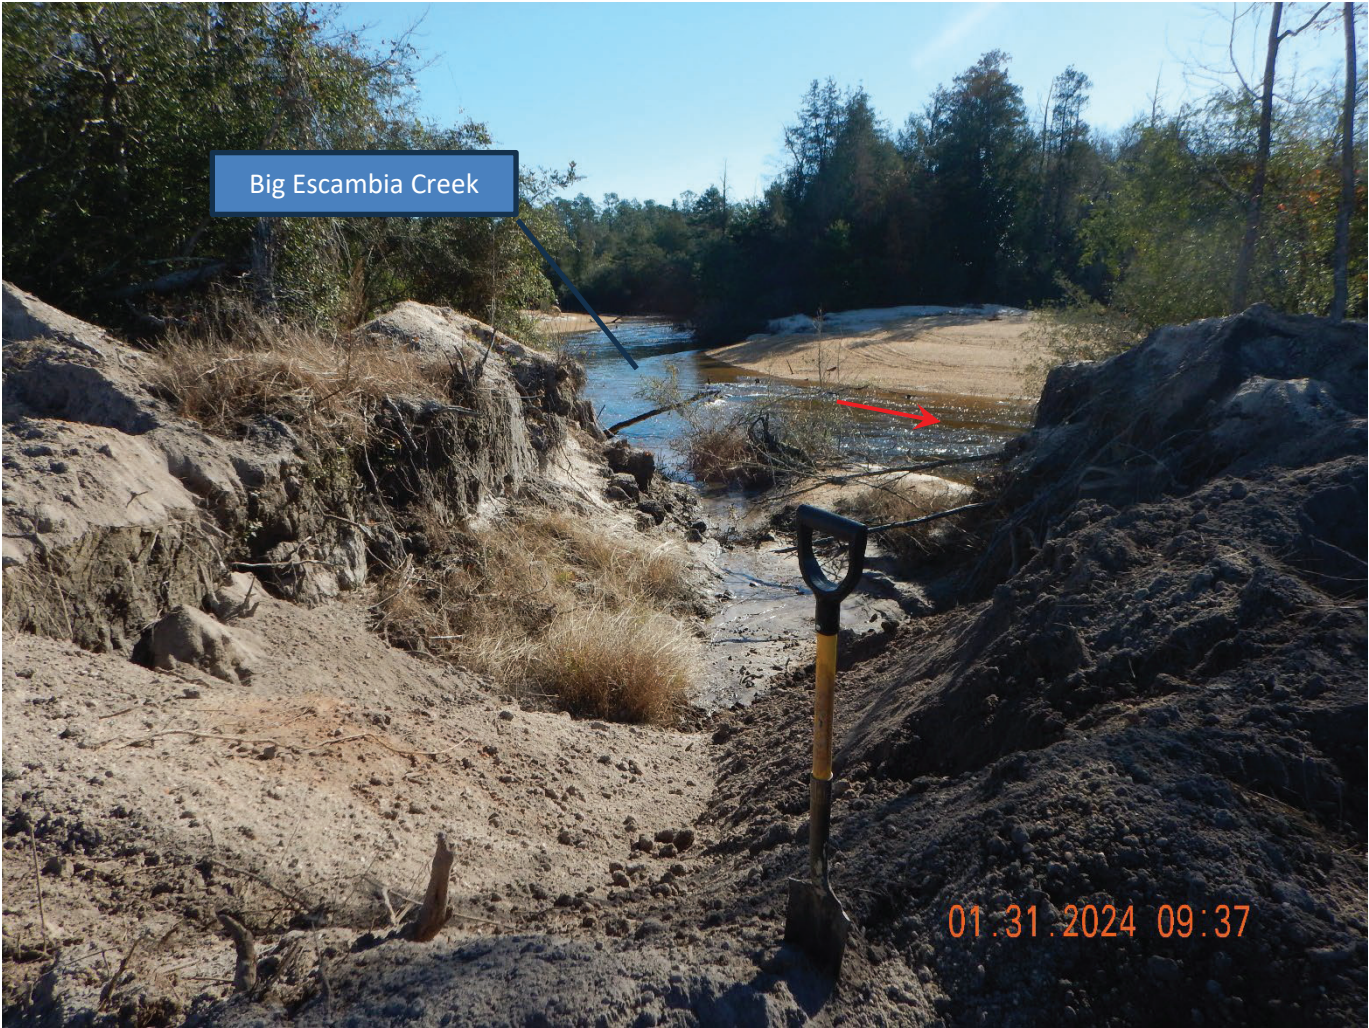
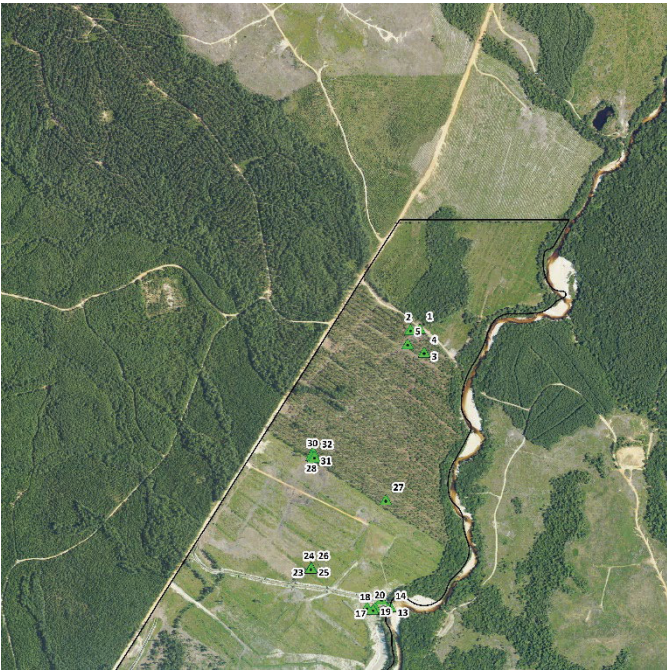
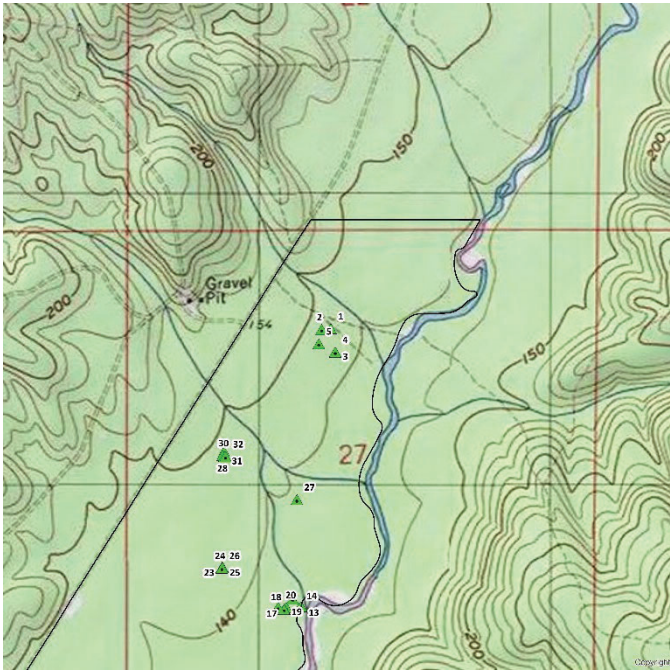
PHOTO 13

| Description | Same as Photo 12, GPS data collected. Red arrow indicates direction of flow. |

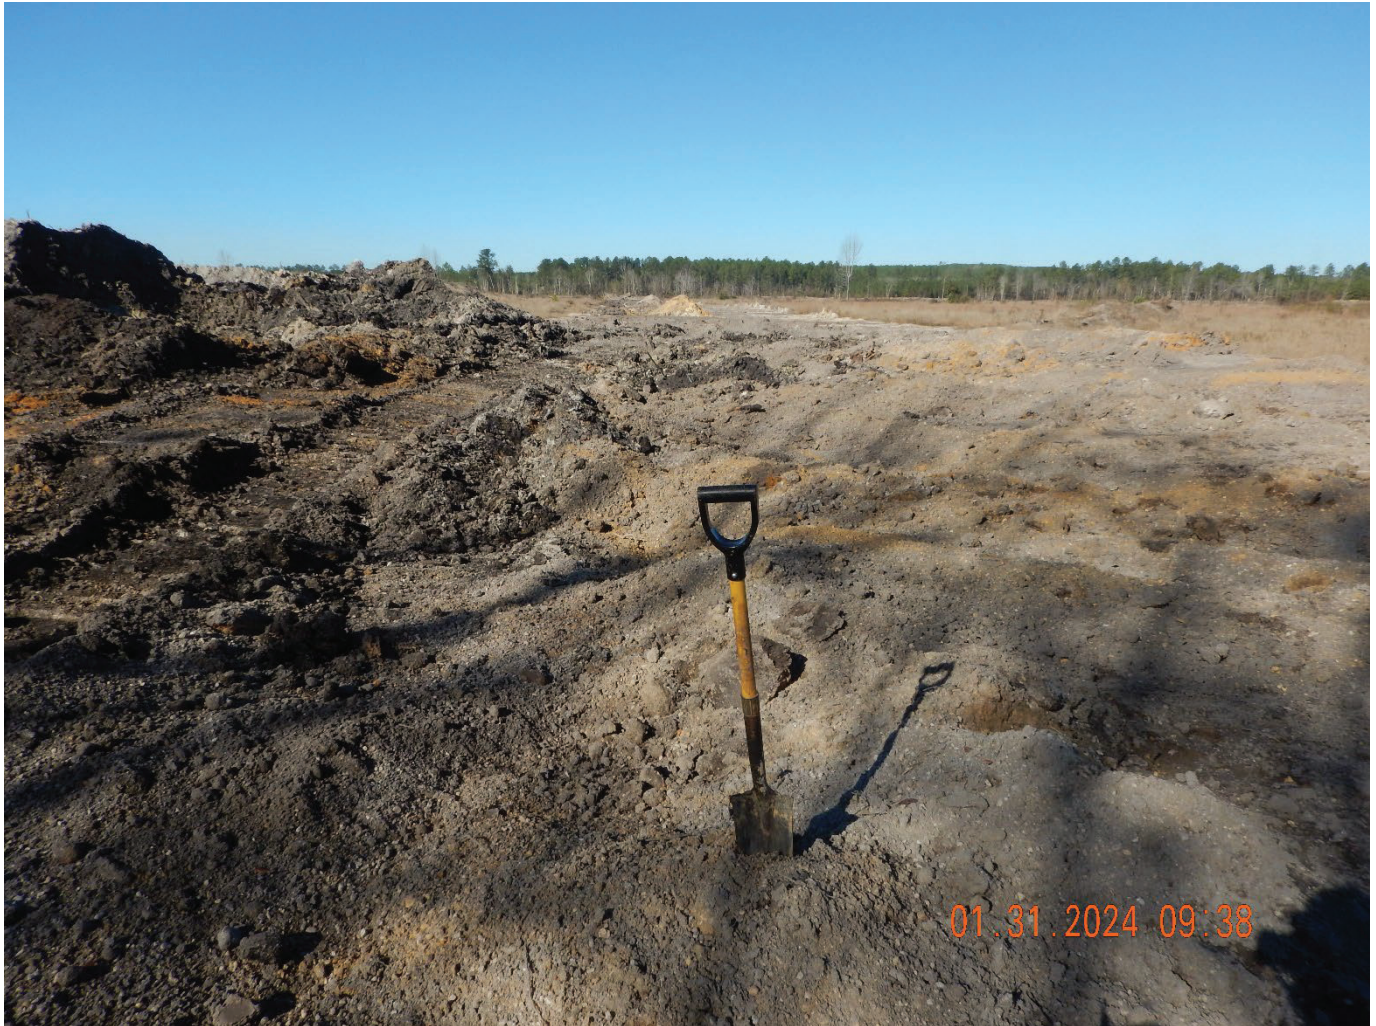
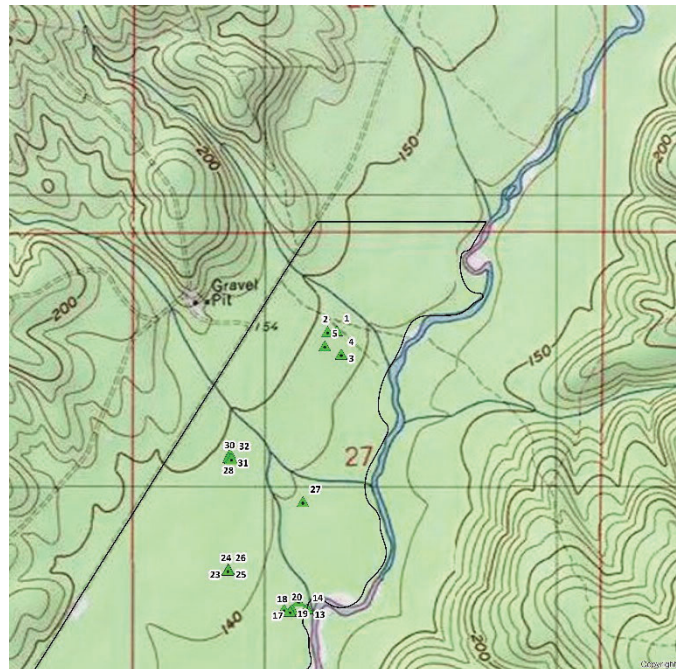
PHOTO 14

| Description | Striking west of ditch that had been recently filled. |

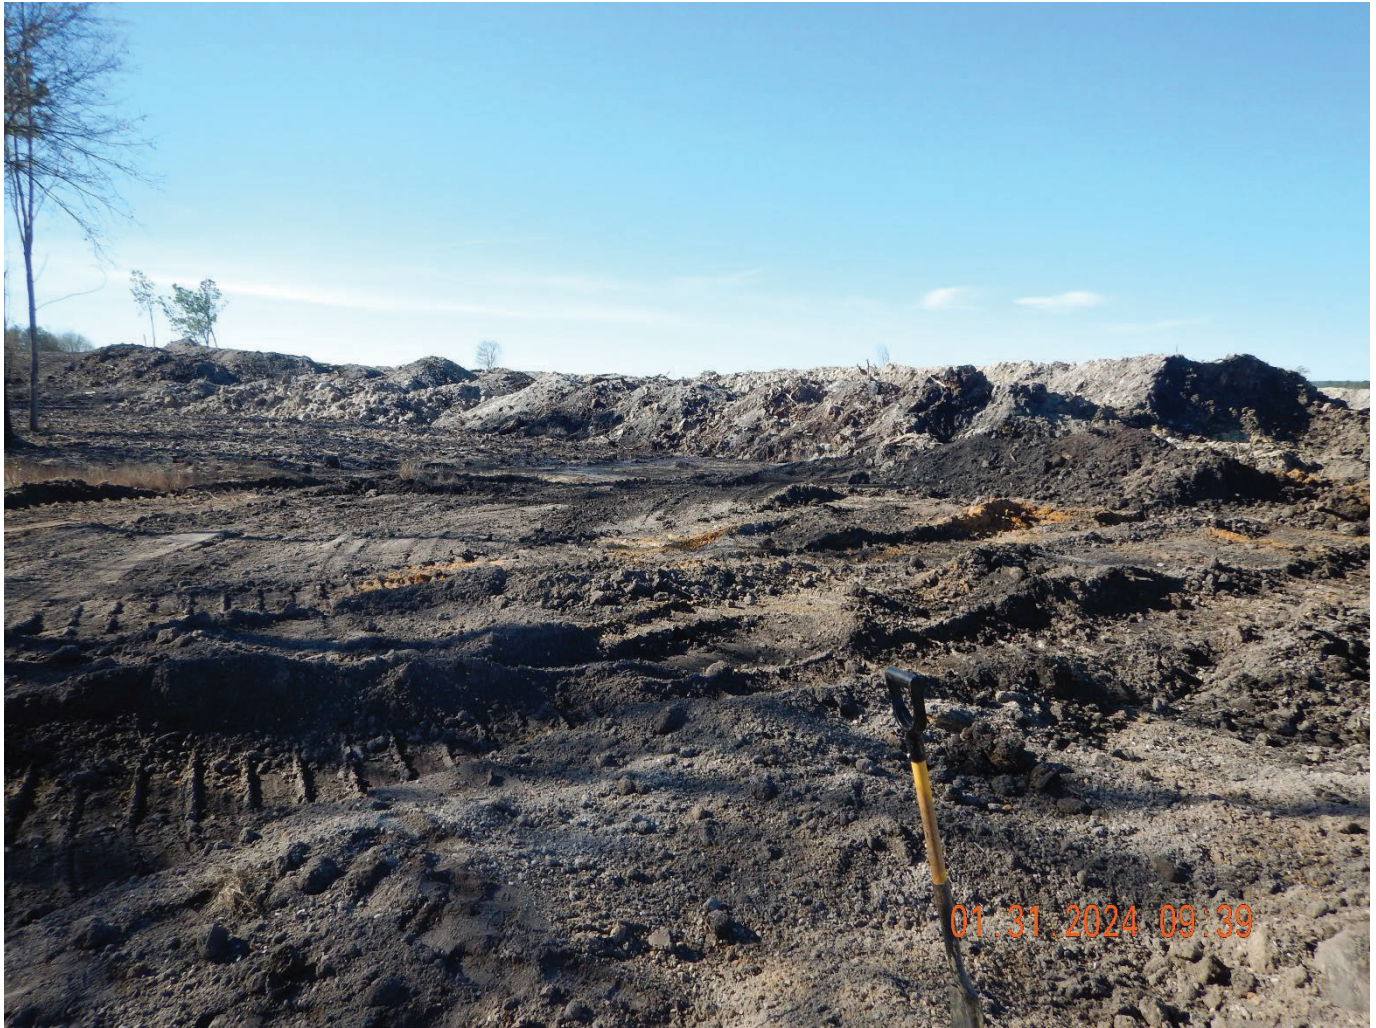
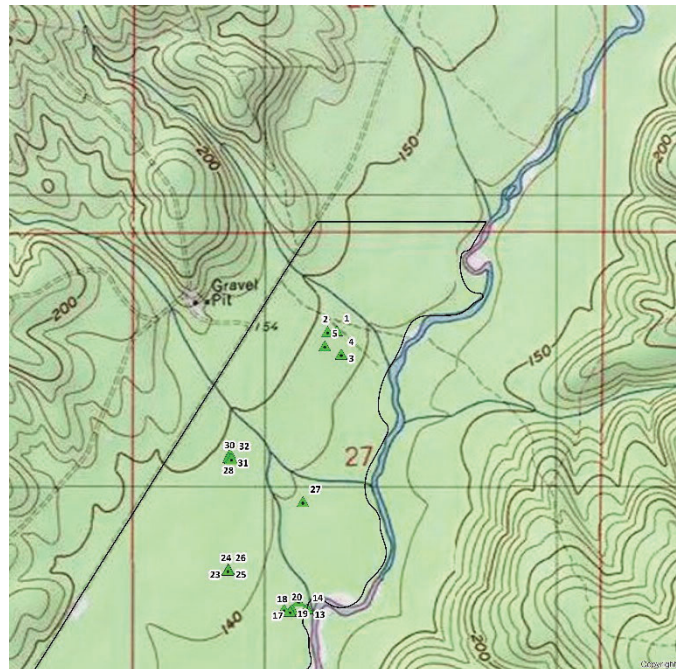
PHOTO 15

| Description | Striking southwest of mechanically cleared area and fill material. |

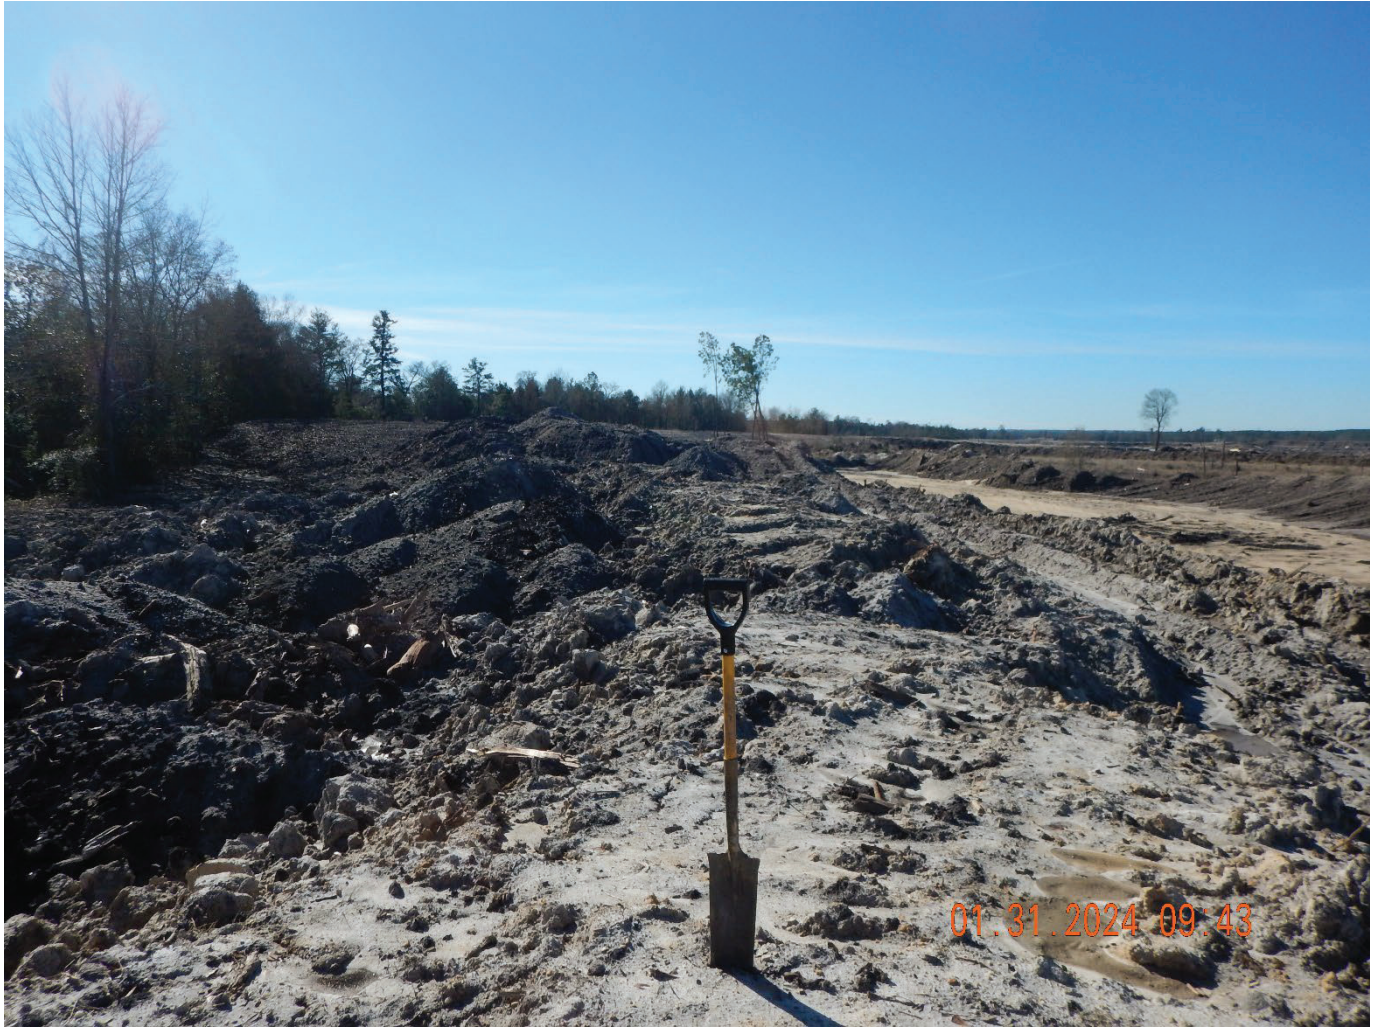
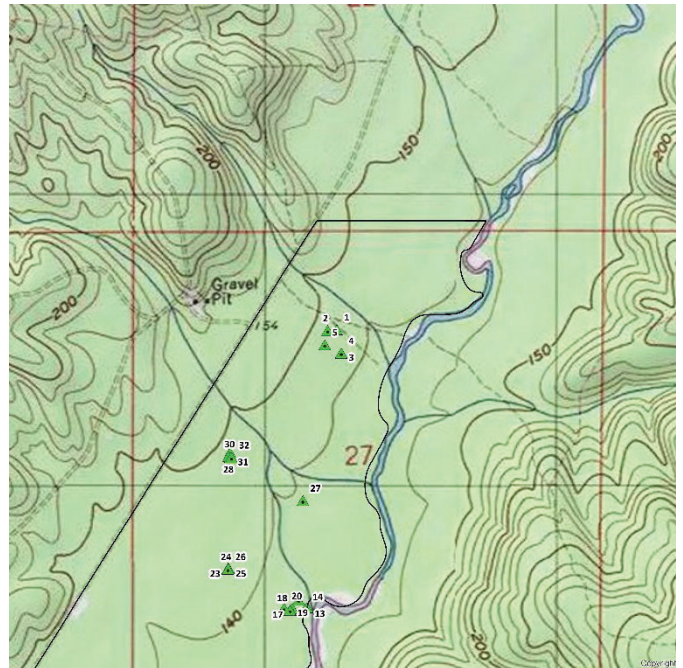
PHOTO 16

| Description | Striking south of fill material. |

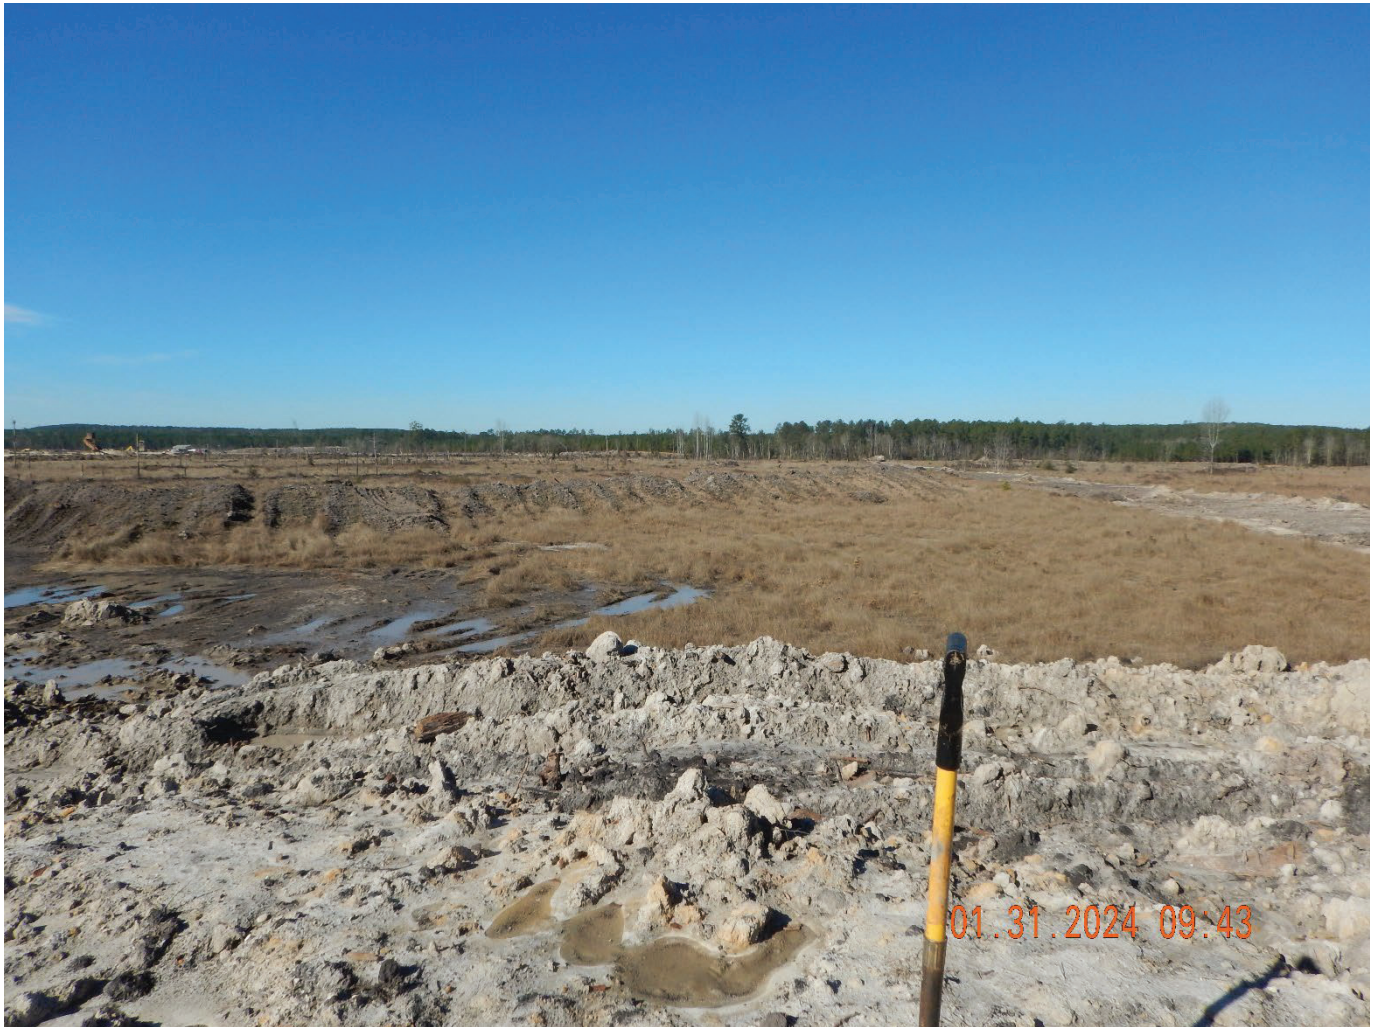
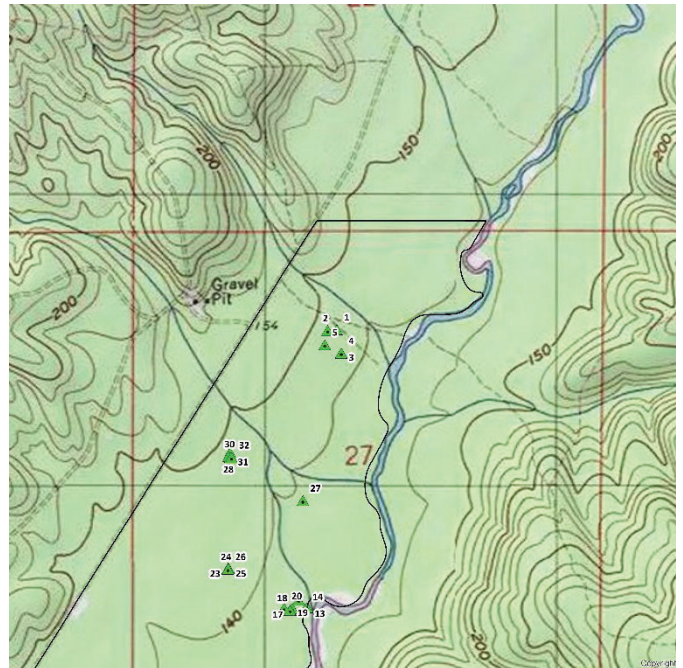
PHOTO 17

| Description | Striking west from berm of mechanically cleared area, fill material, and recently filled ditch. |

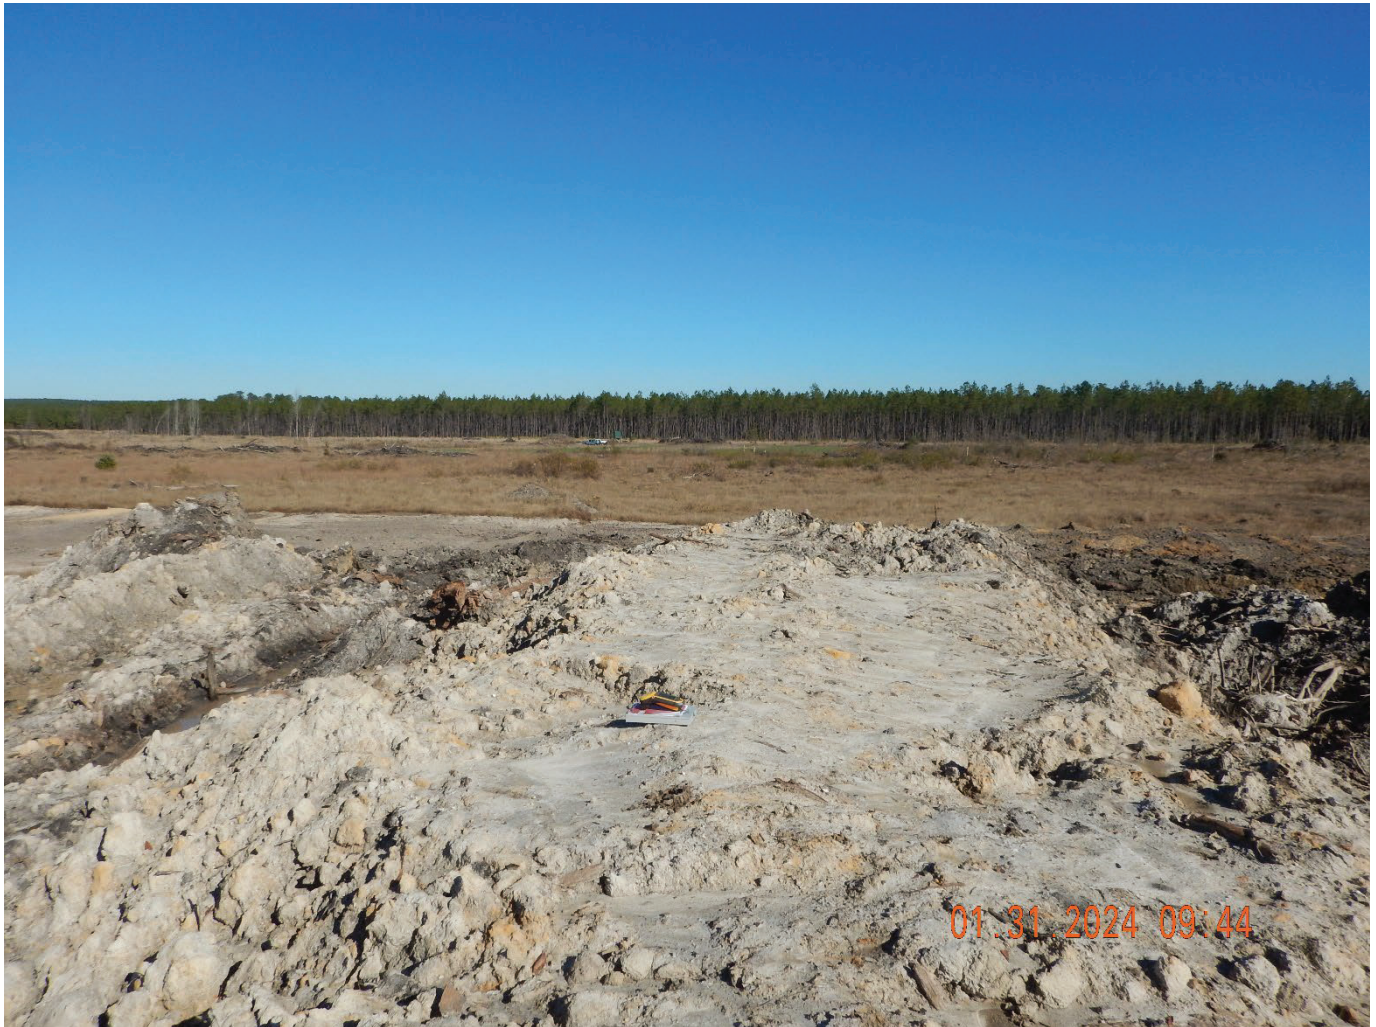
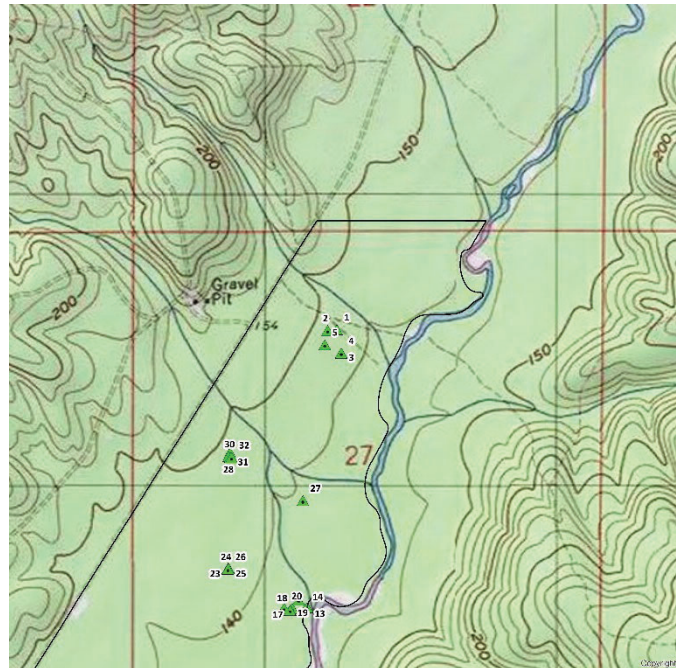
PHOTO 18

| Description | Striking north from berm of mechanically cleared area, fill material, and recently filled ditch. |

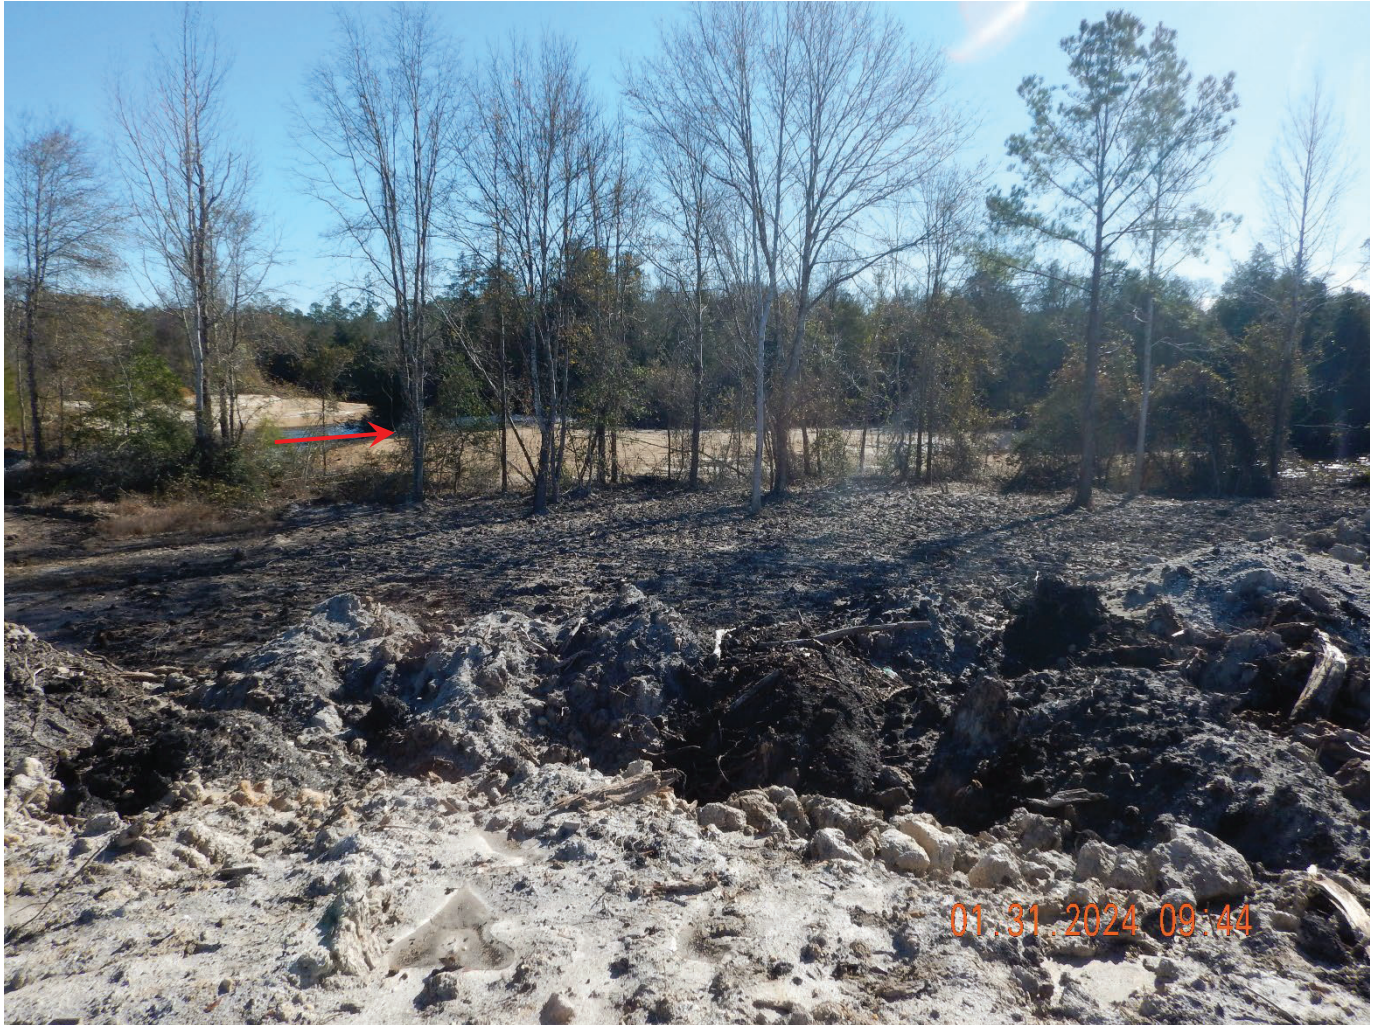
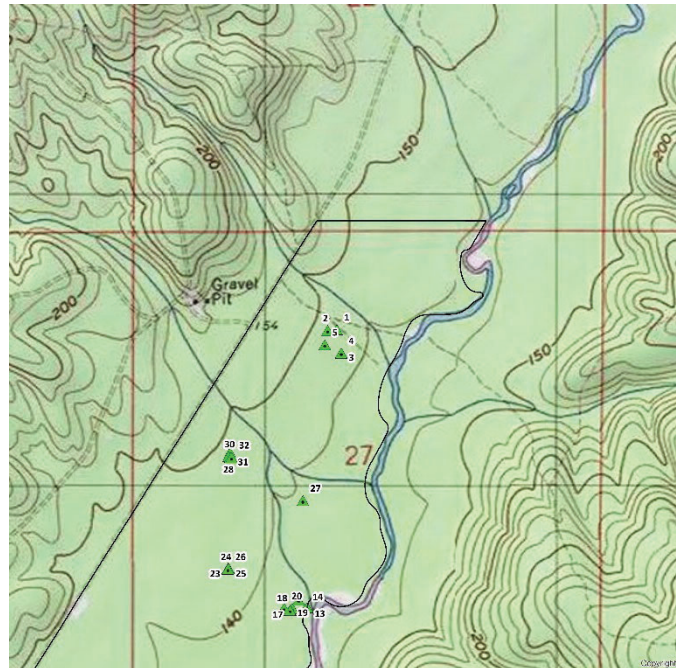
PHOTO 19

| Description | Striking east from berm of mechanically cleared area and Big Escambia Creek. Red arrow indicates direction of flow. |

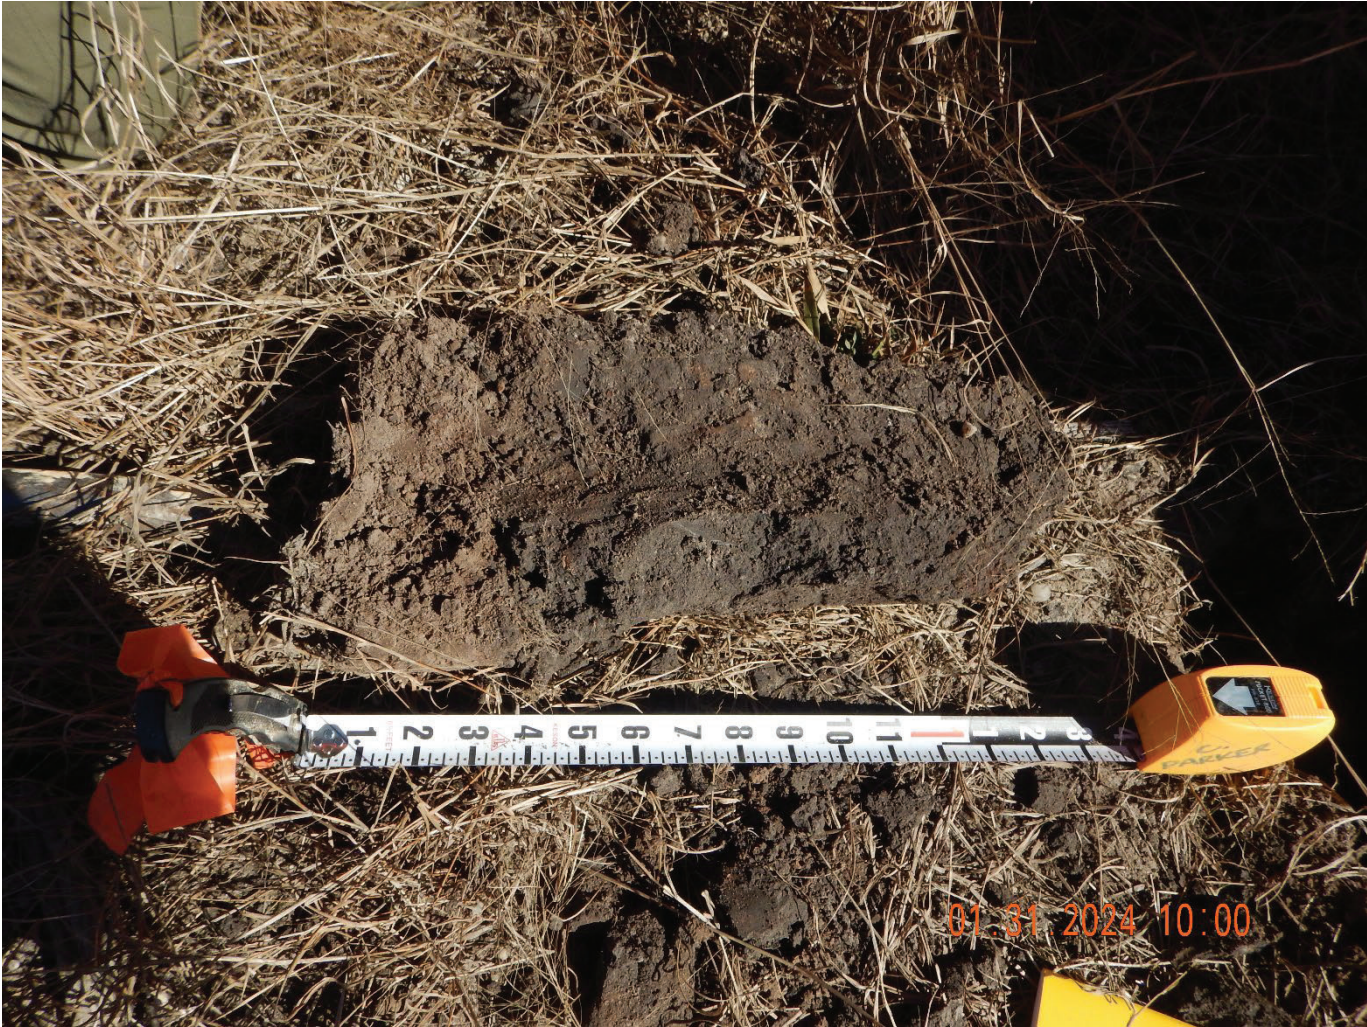
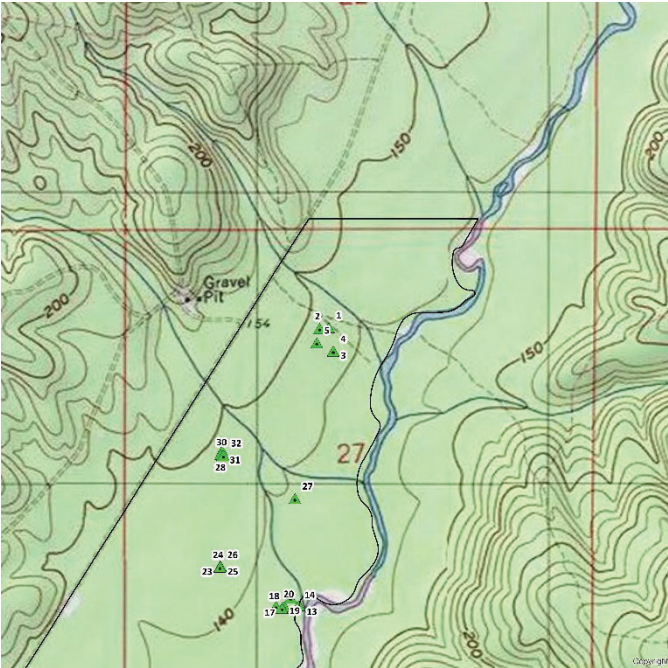
PHOTO 20

| Description | Soil profile at Data Point A2. |

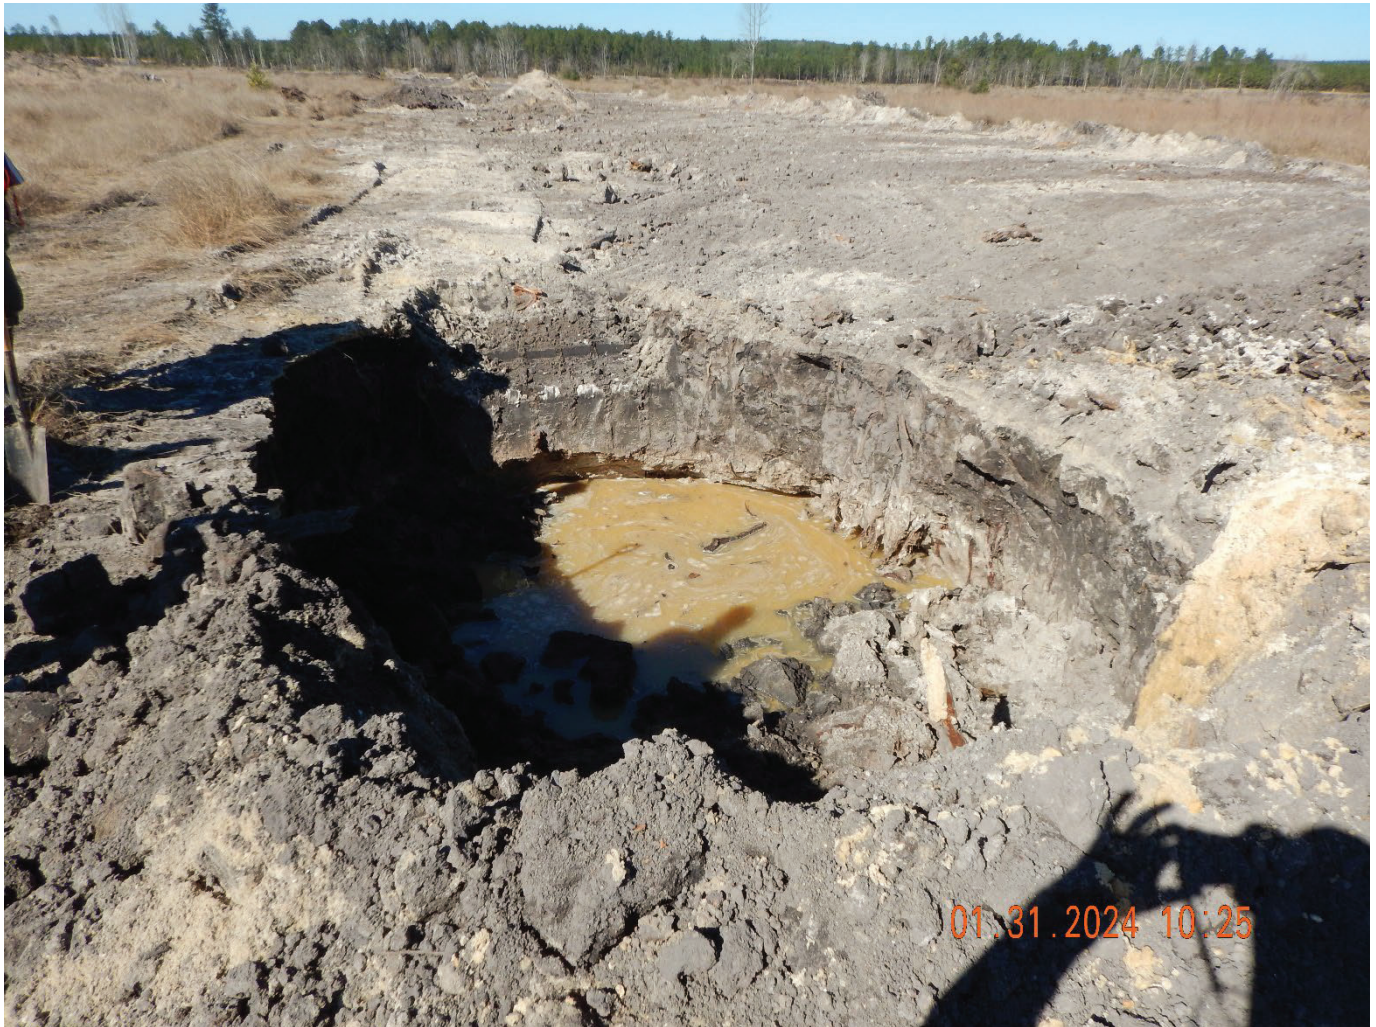
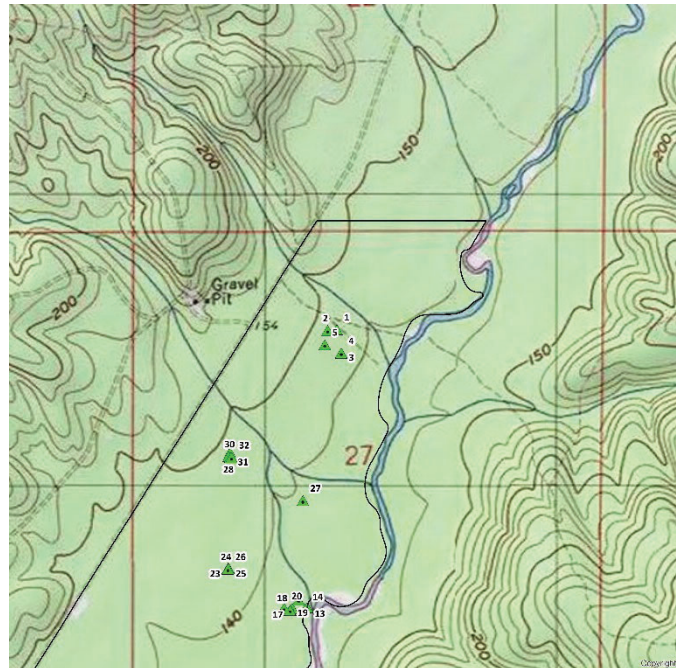
PHOTO 21

| Description | Striking northwest of recently filled ditch and area left unfilled or excavated after filling. |

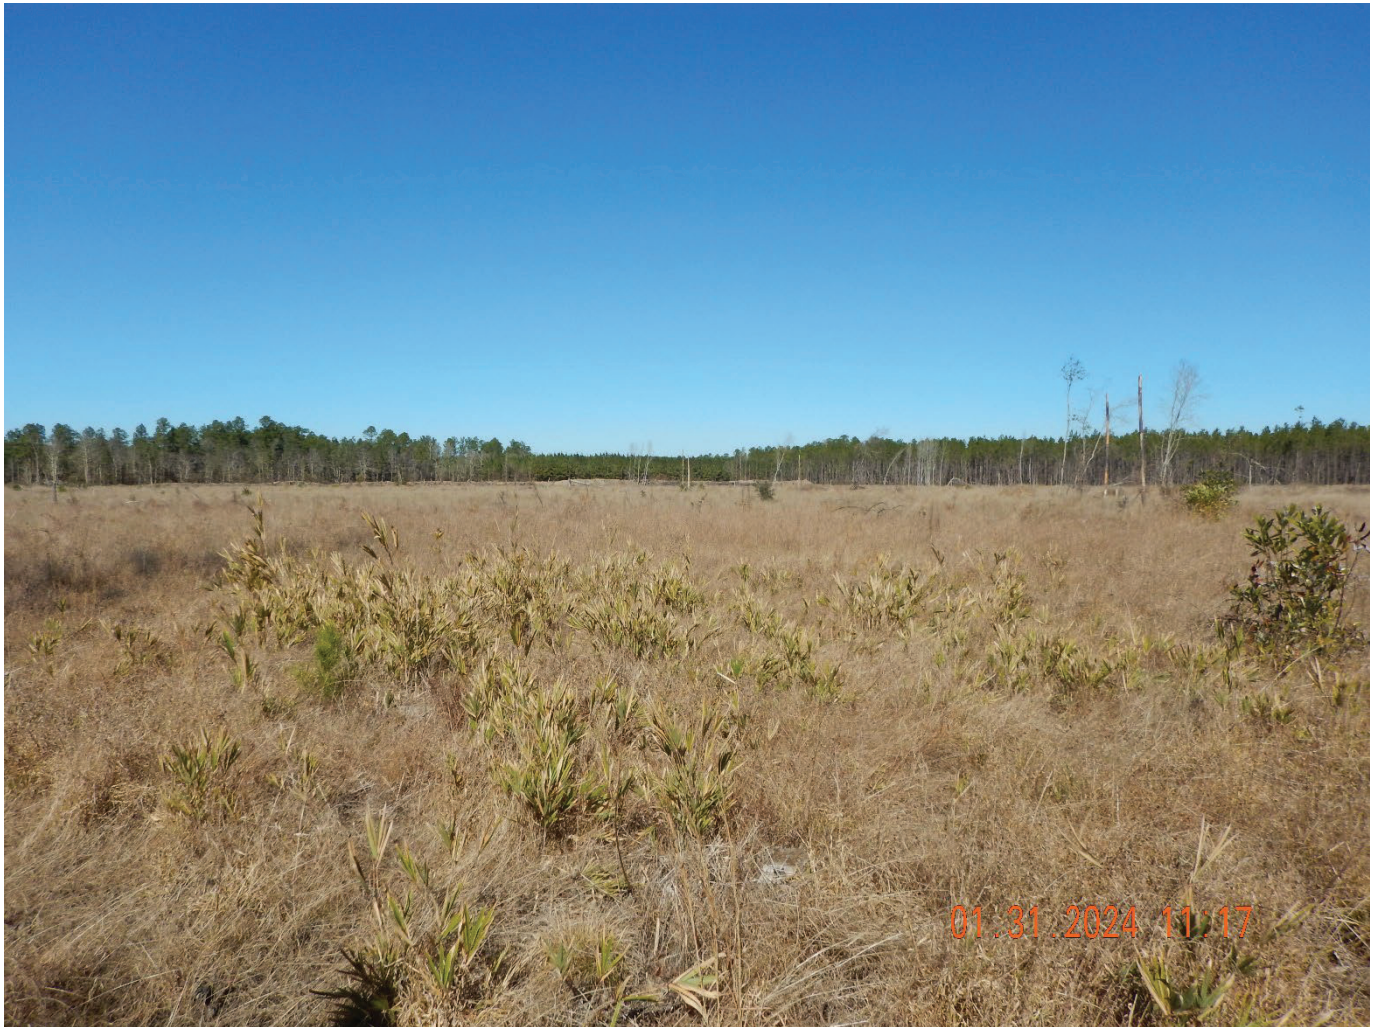
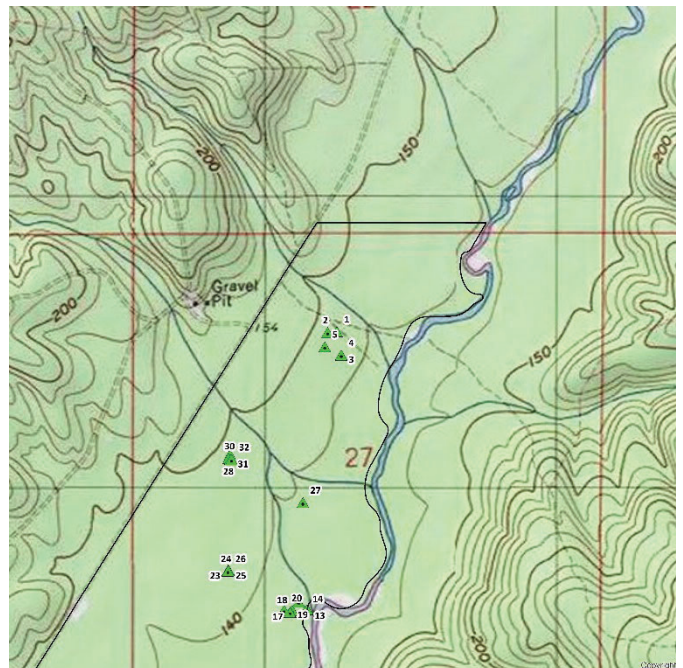
PHOTO 22

| Description | Striking north over Data Point A3. |

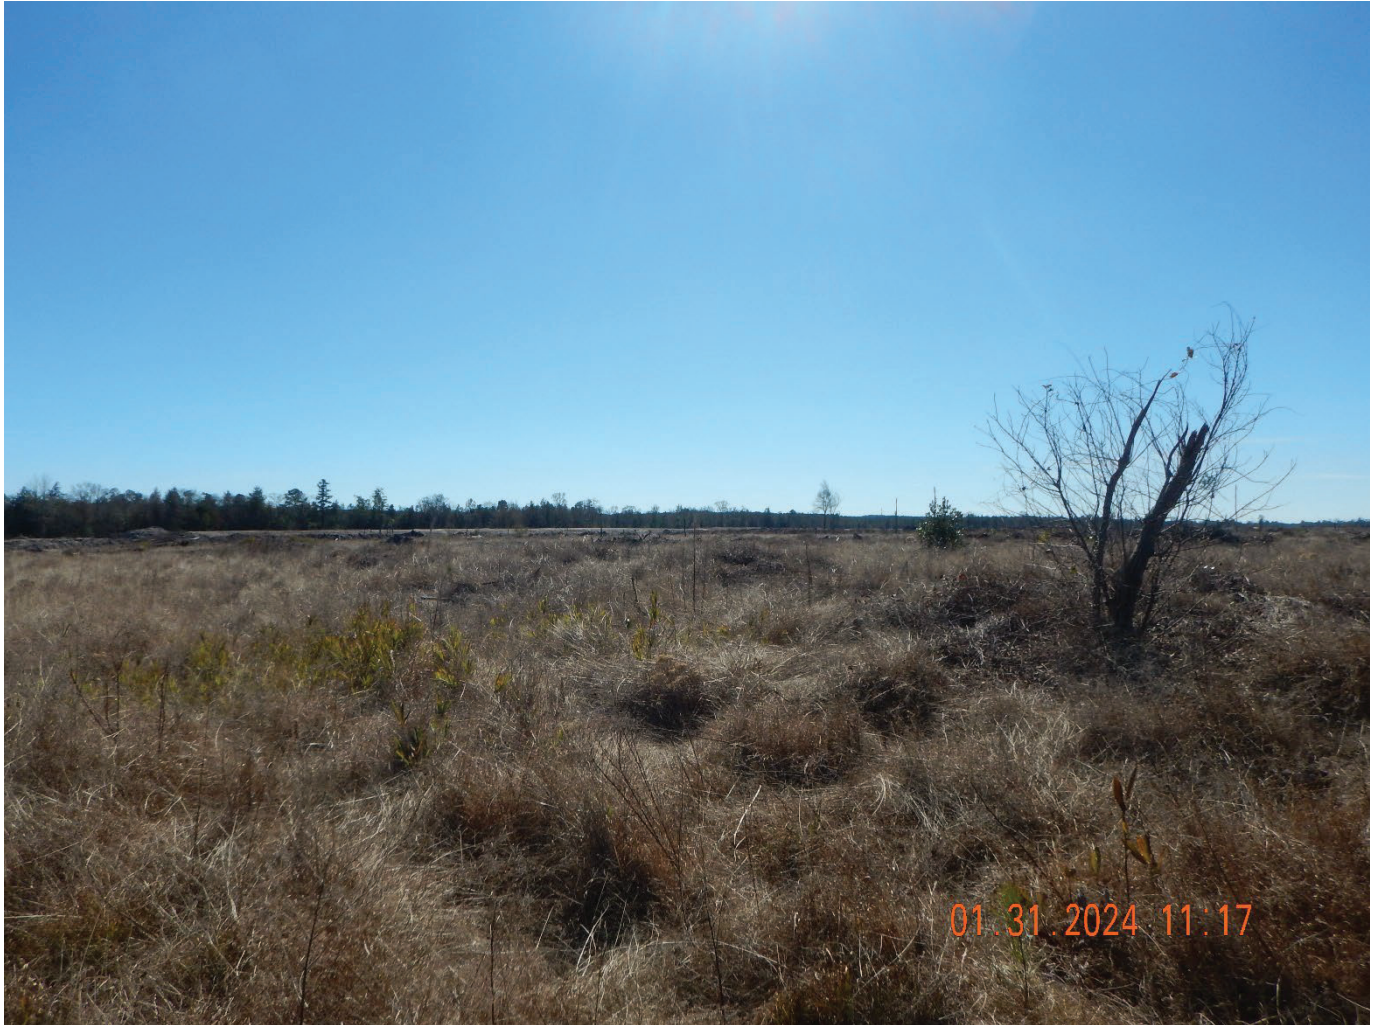
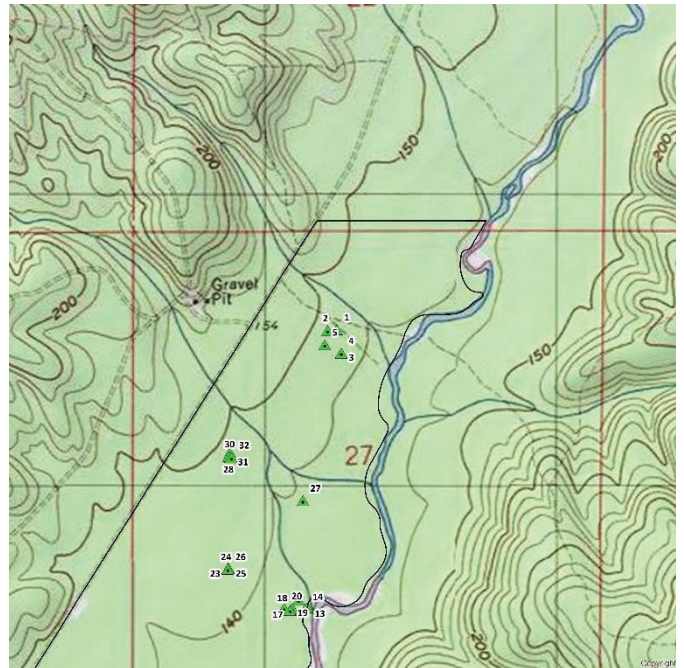
PHOTO 23

| Description | Striking south over Data Point A3. |

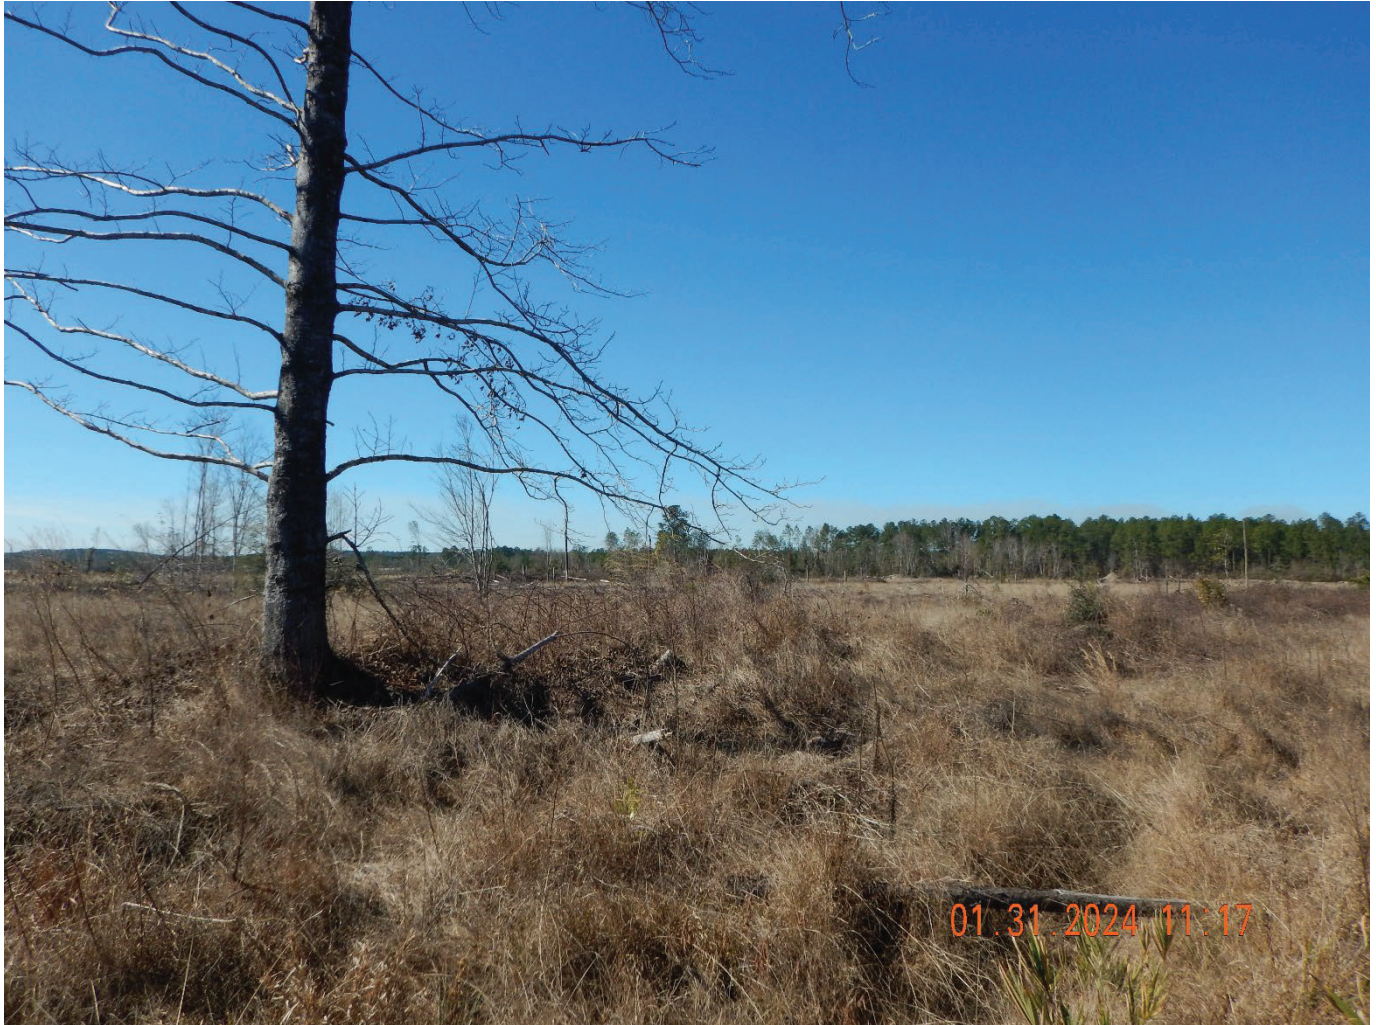
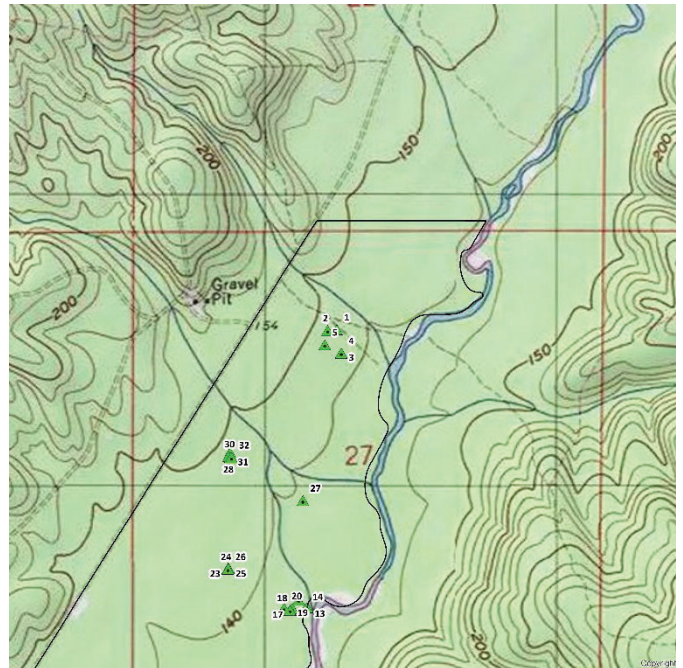
PHOTO 24

| Description | Striking west over Data Point A3. |
