## Clean Water Act Section 404: Site Visit/Case Development

| Site Name | South Alabama Materials, Inc., Sardine Pit | | | | |

**ATTACHMENT D**  
**South Alabama Materials, Inc.**

Sardine Pit  
Photographic Log  
Escambia County, Alabama  
January 30-31, 2024

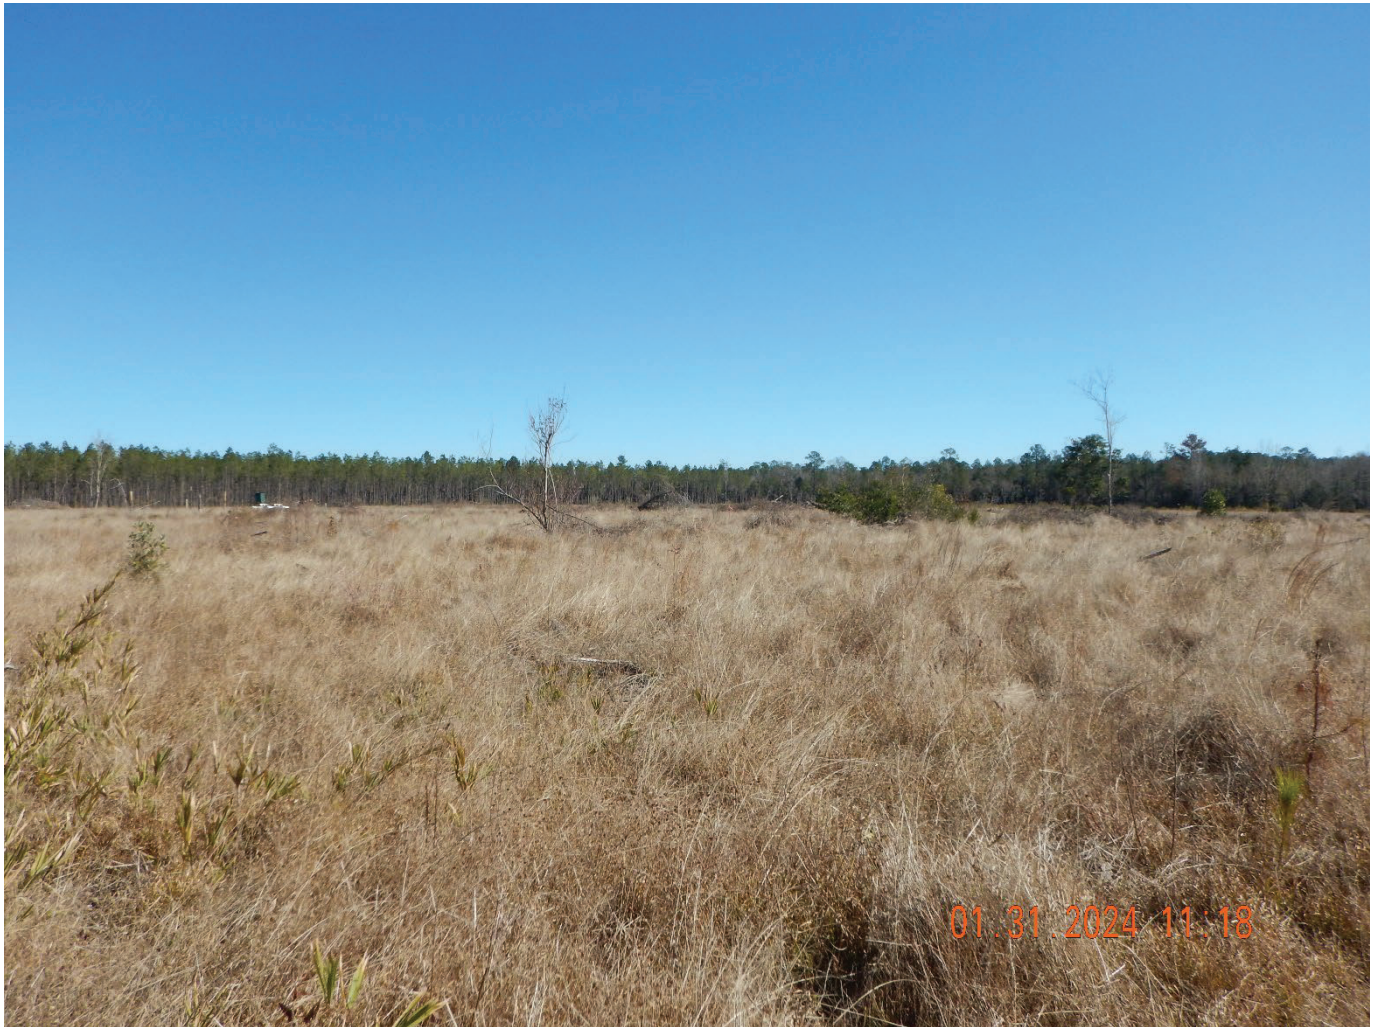
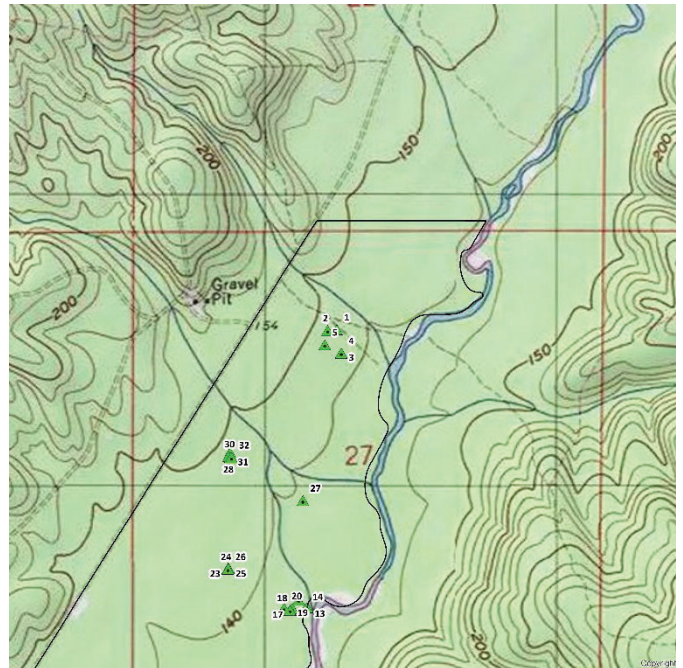
PHOTO 25

| Description | Striking east over Data Point A3. |

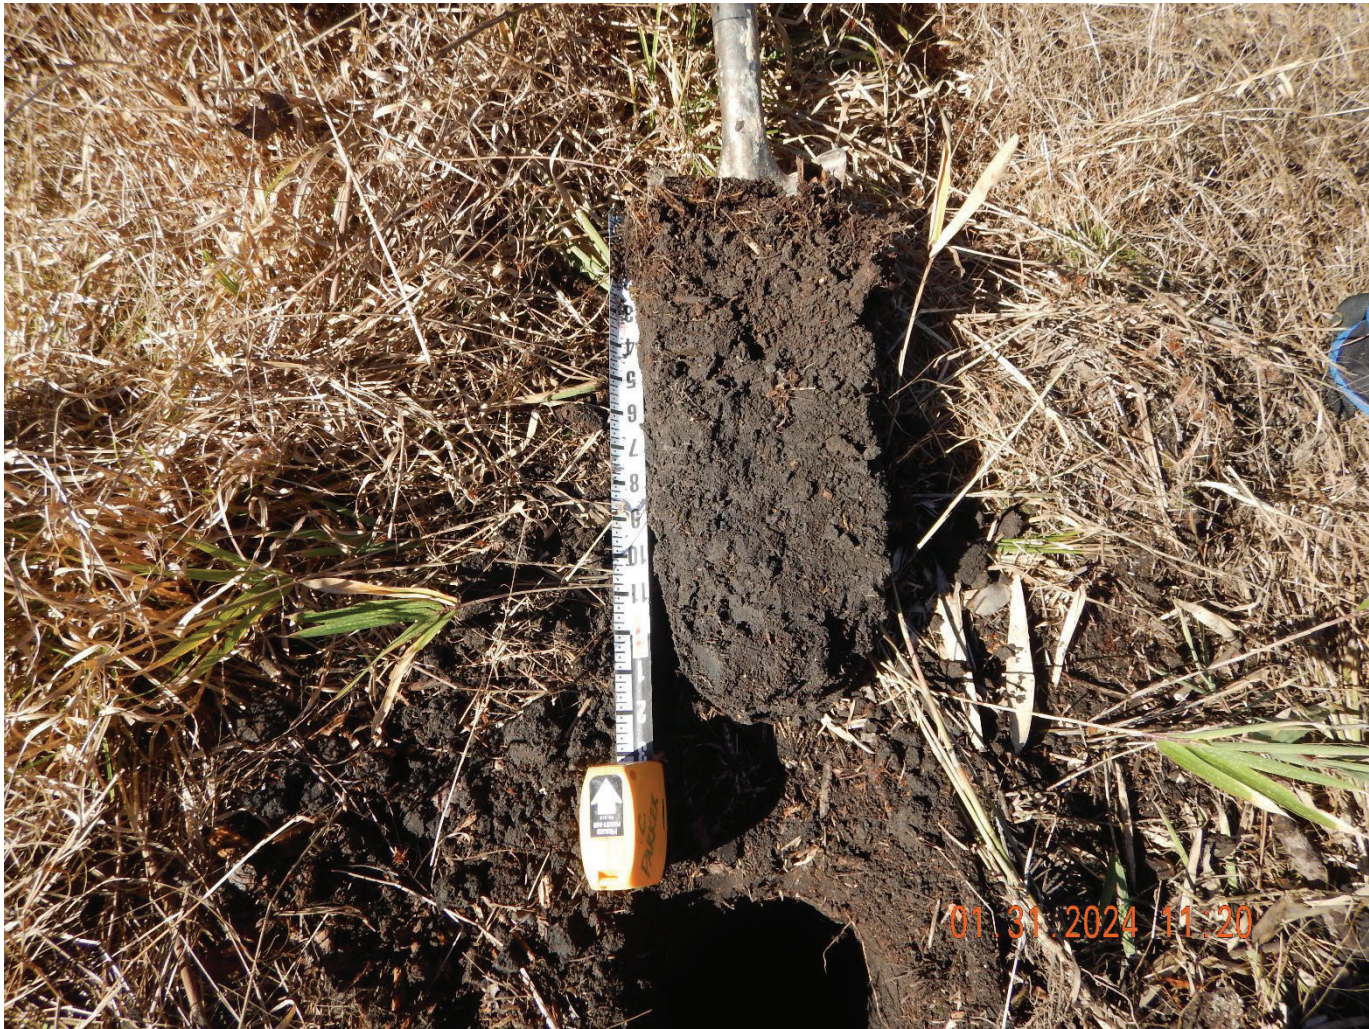
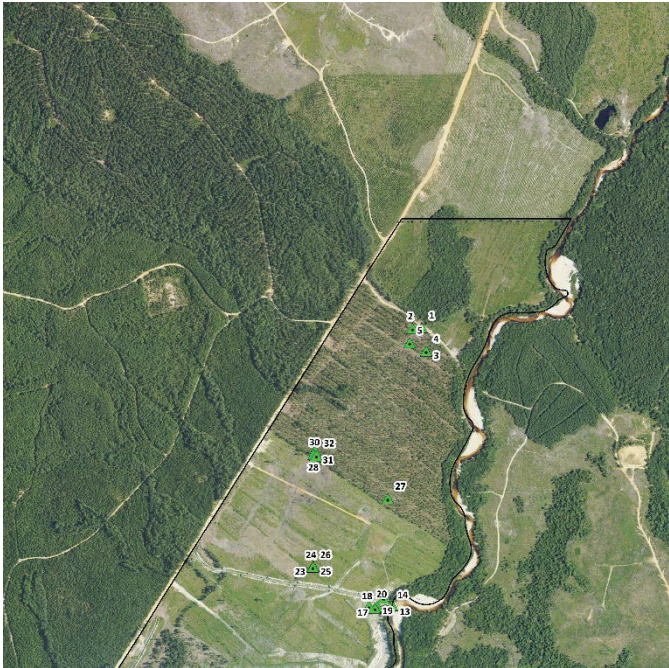
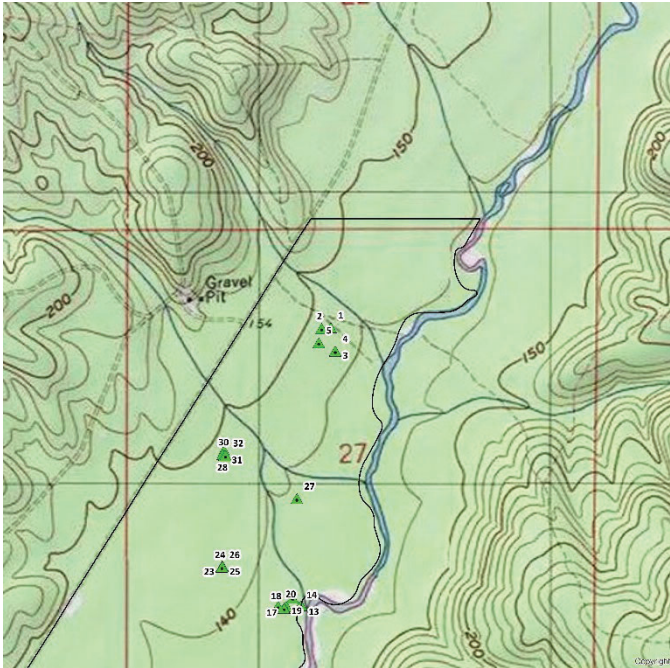
PHOTO 26

| Description | Soil profile at Data Point A3. |

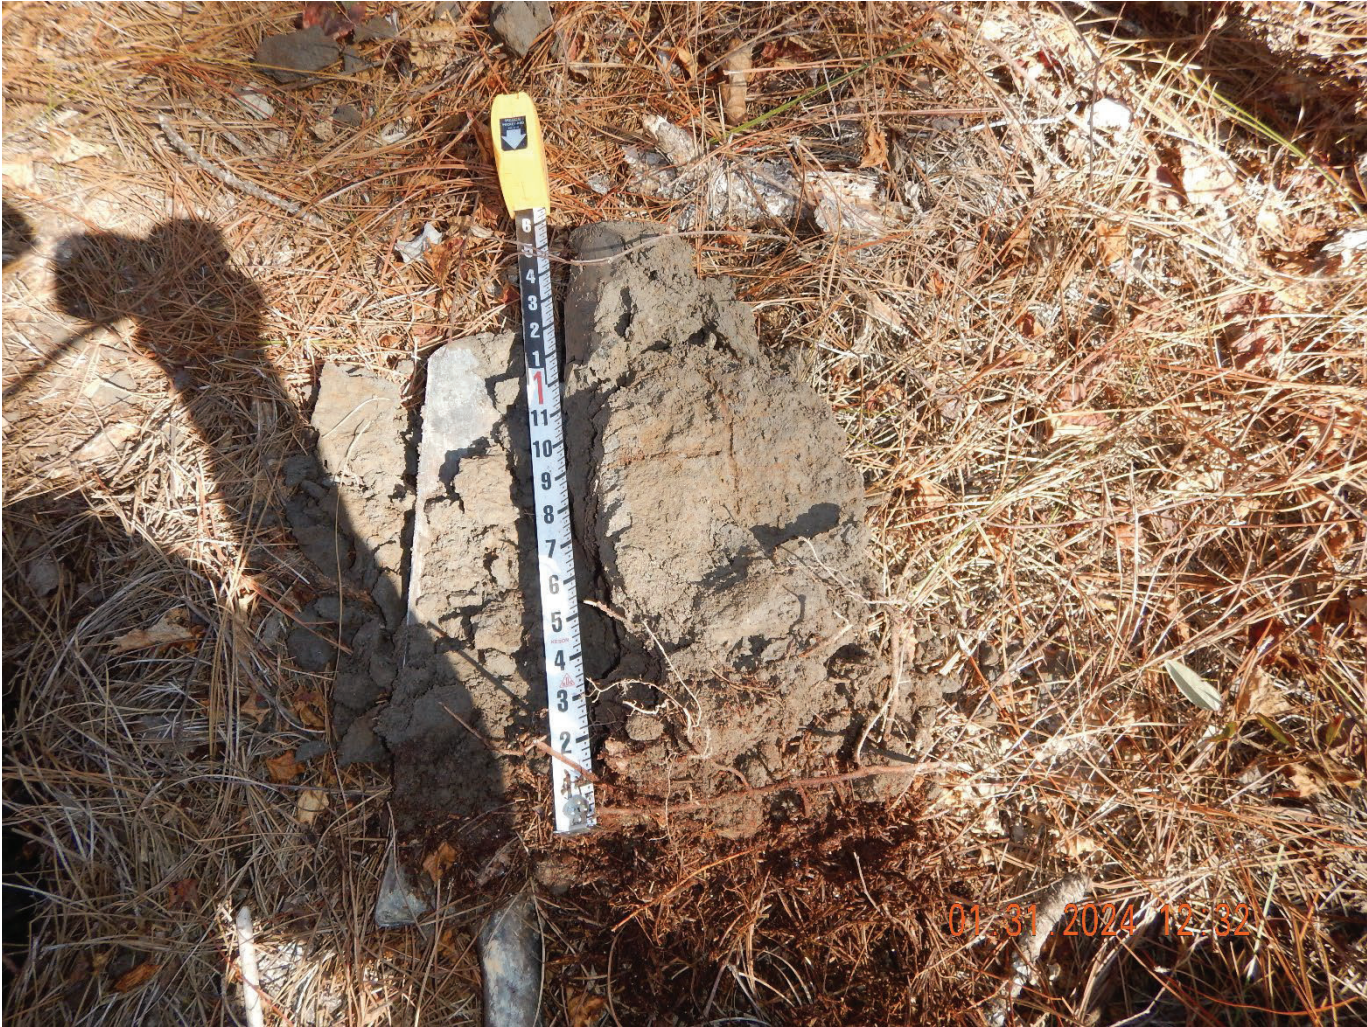
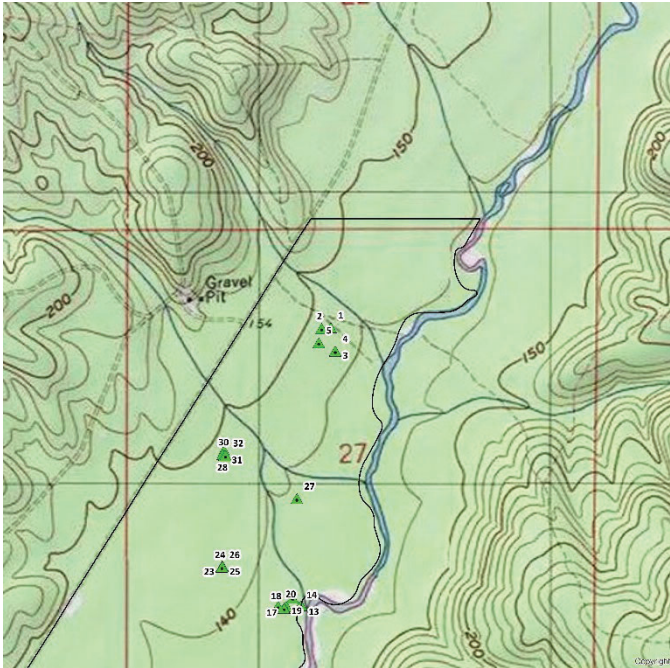
PHOTO 27

| Description | Soil profile at Data Point A4. |

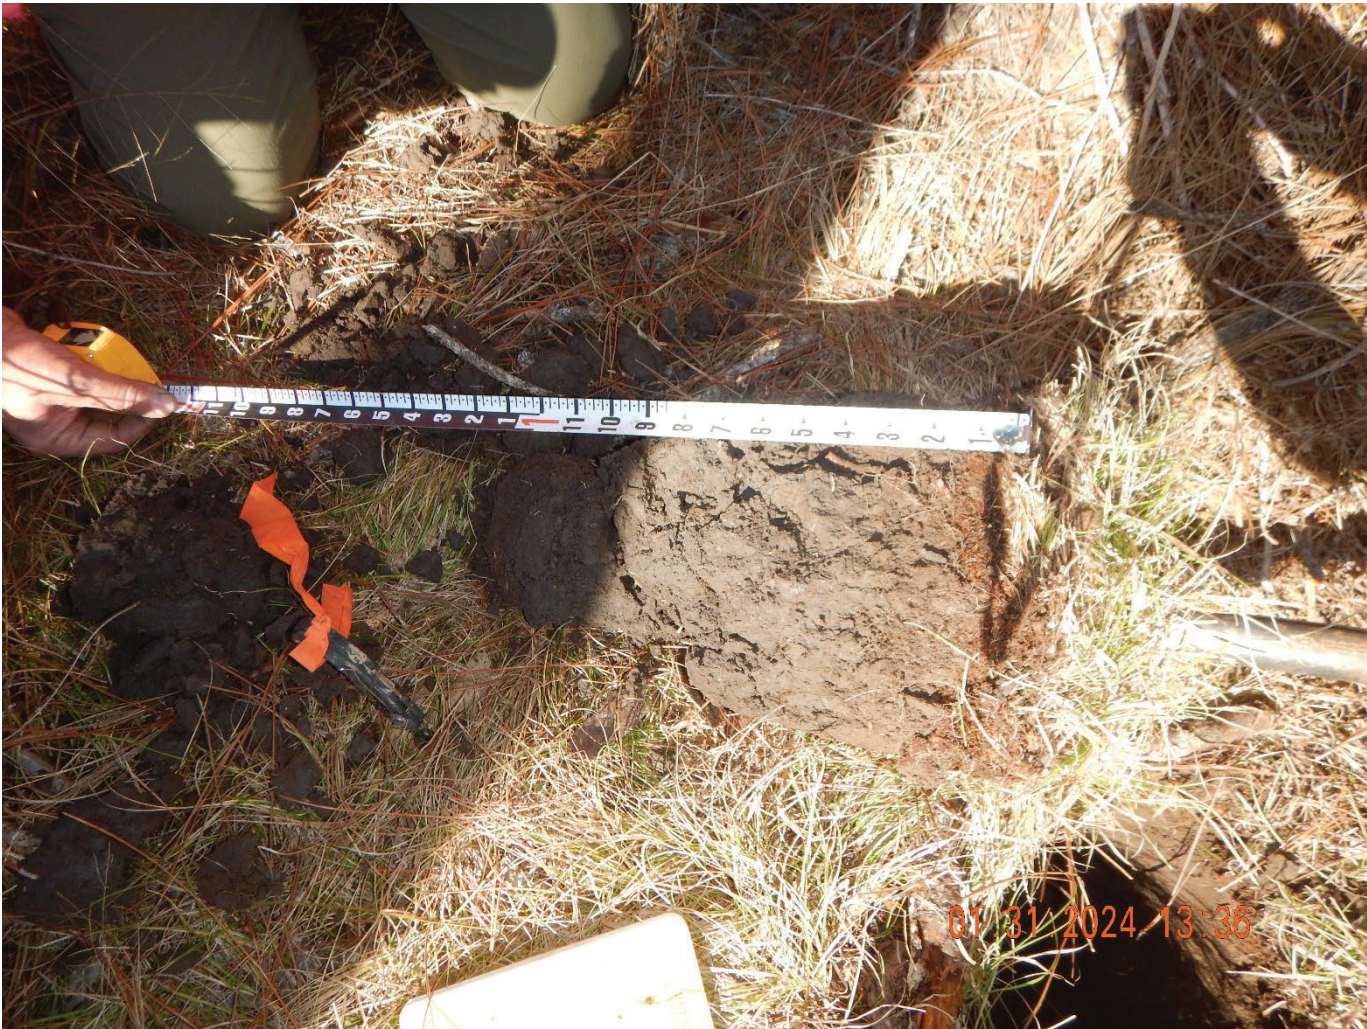
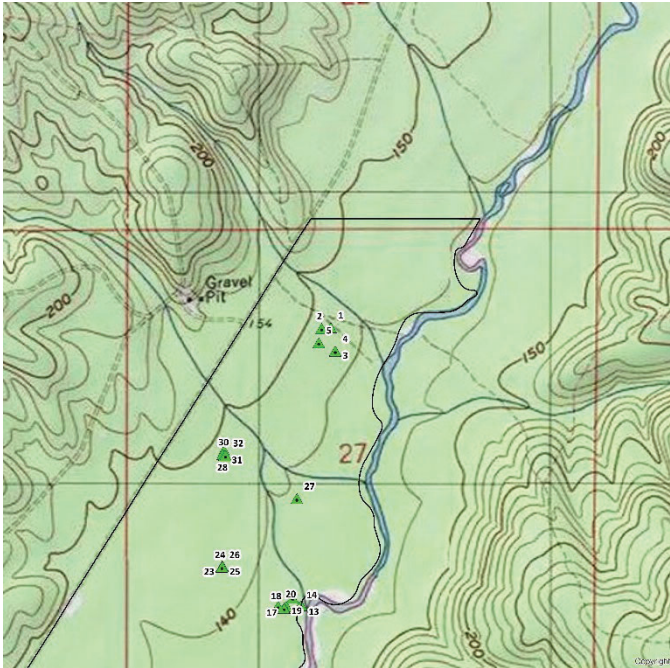
PHOTO 28

| Description | Soil profile at Data Point A5. |

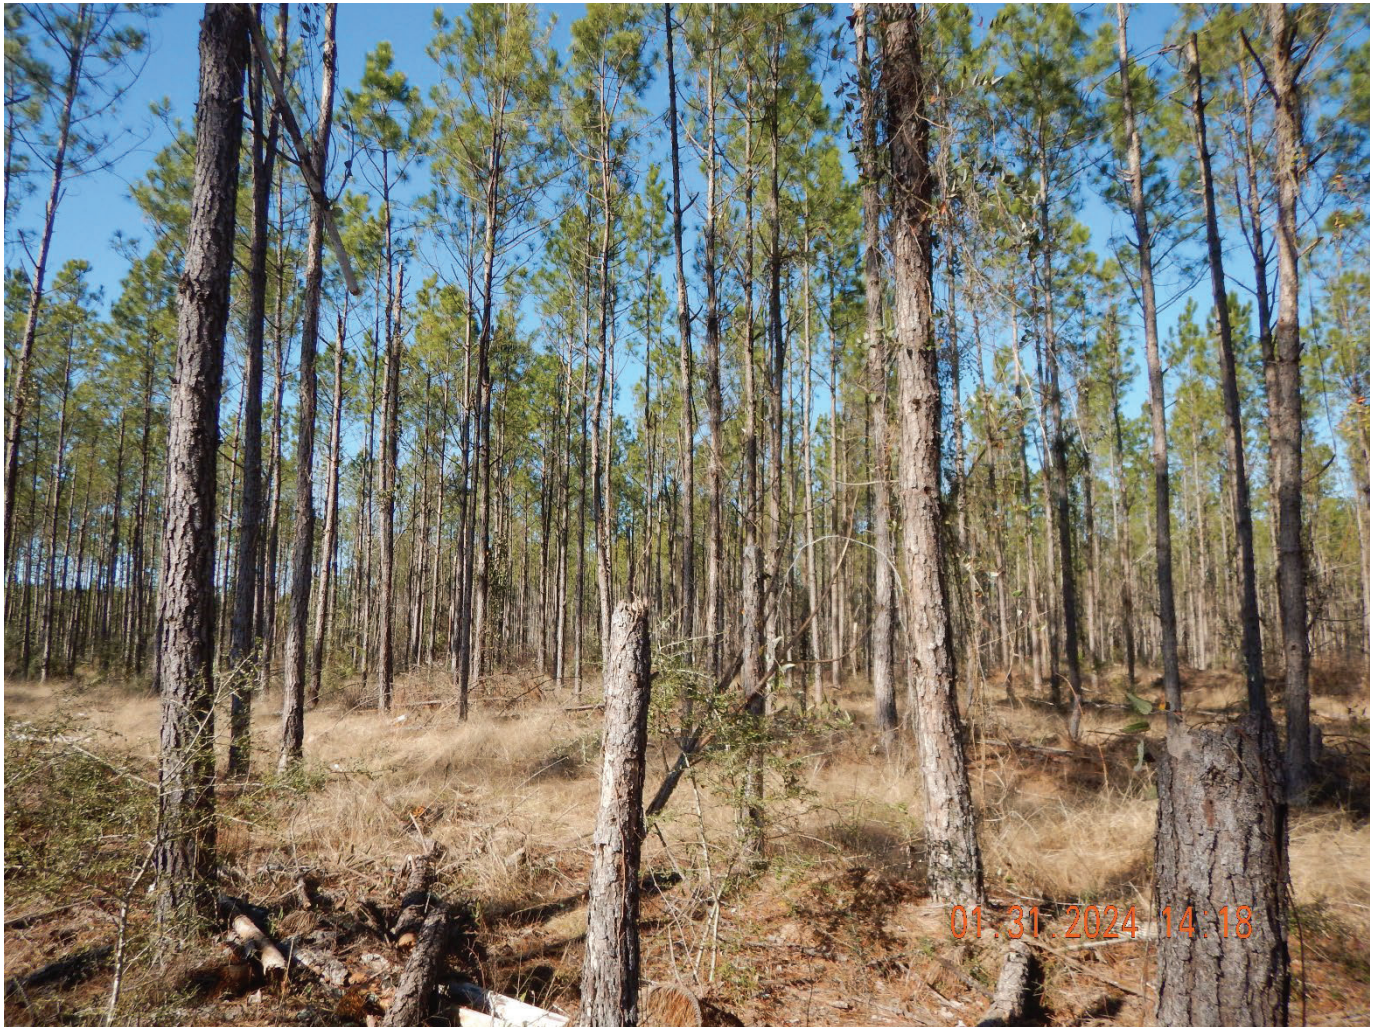
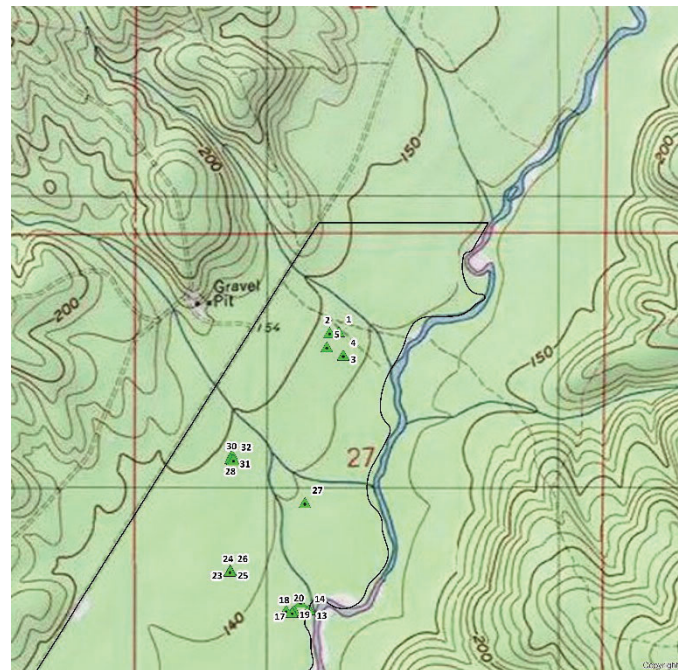
PHOTO 29

| Description | Striking north over Data Point A5. |

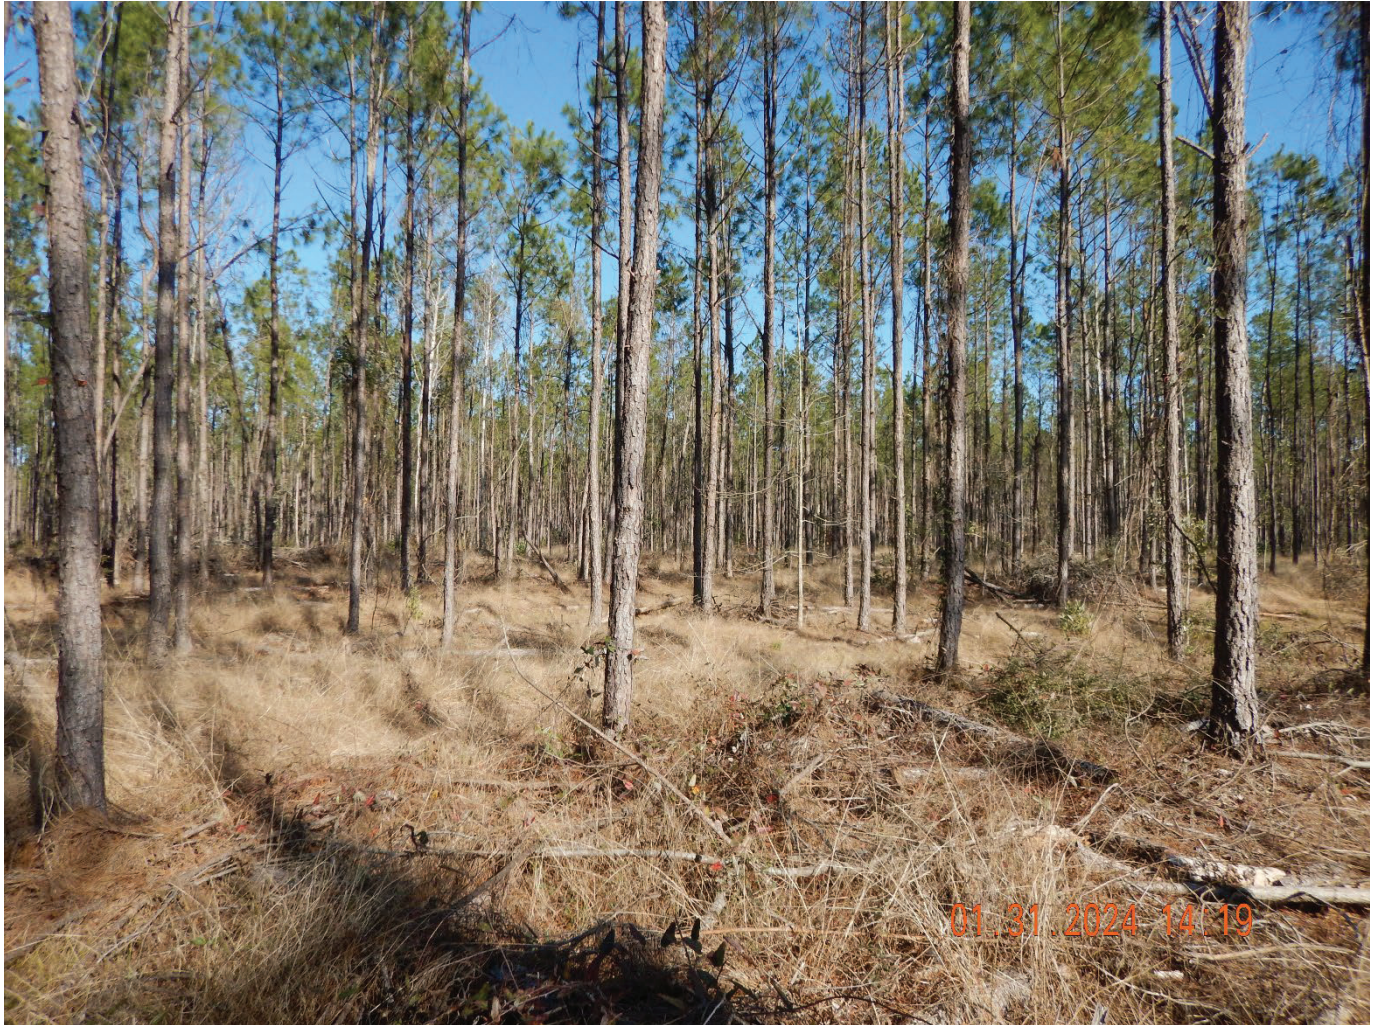
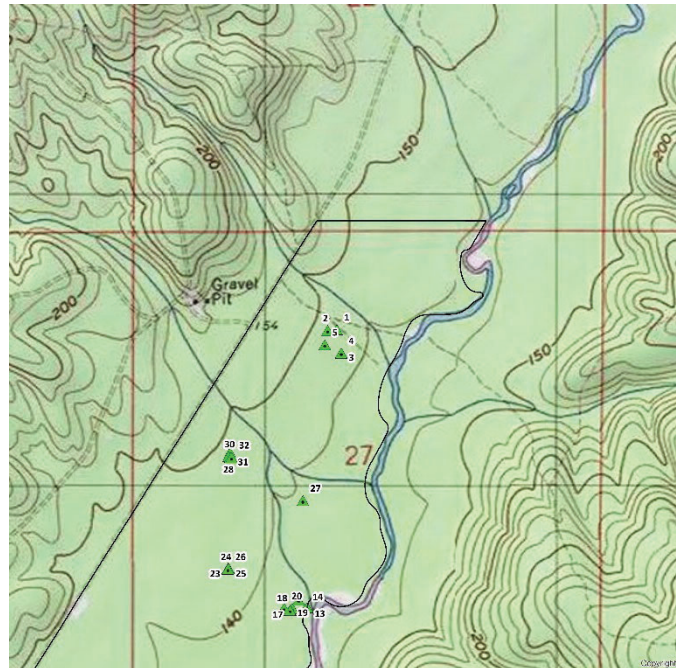
PHOTO 30

| Description | Striking east over Data Point A5. |

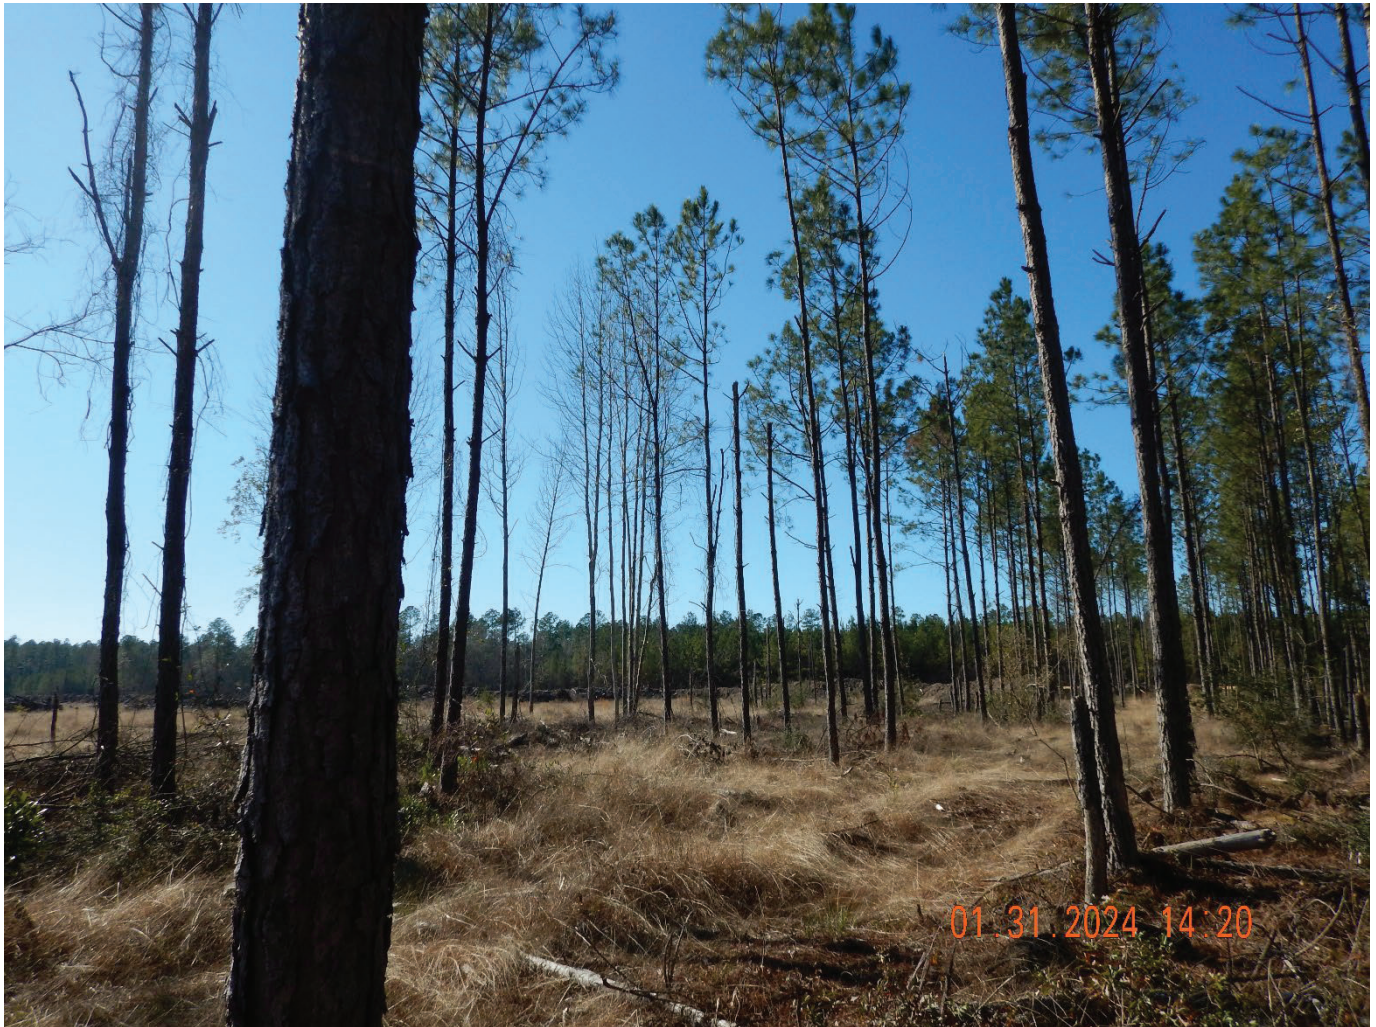
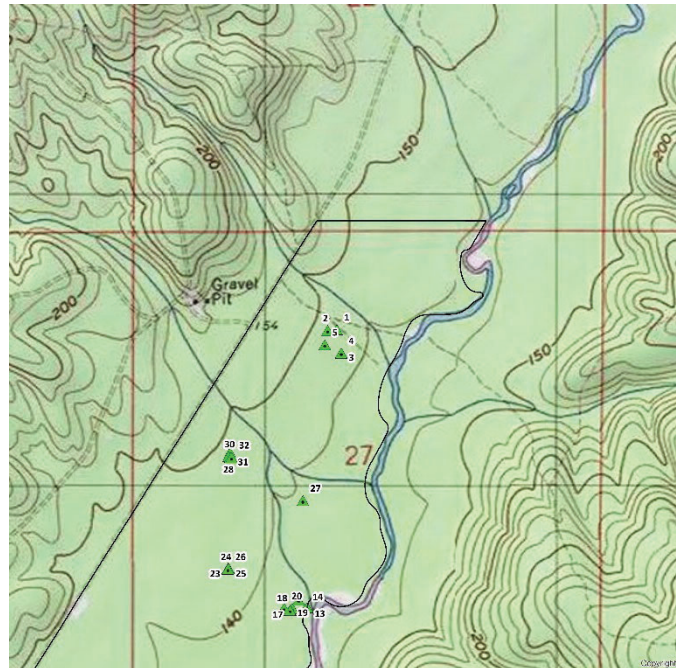
PHOTO 31

| Description | Striking west over Data Point A5. |

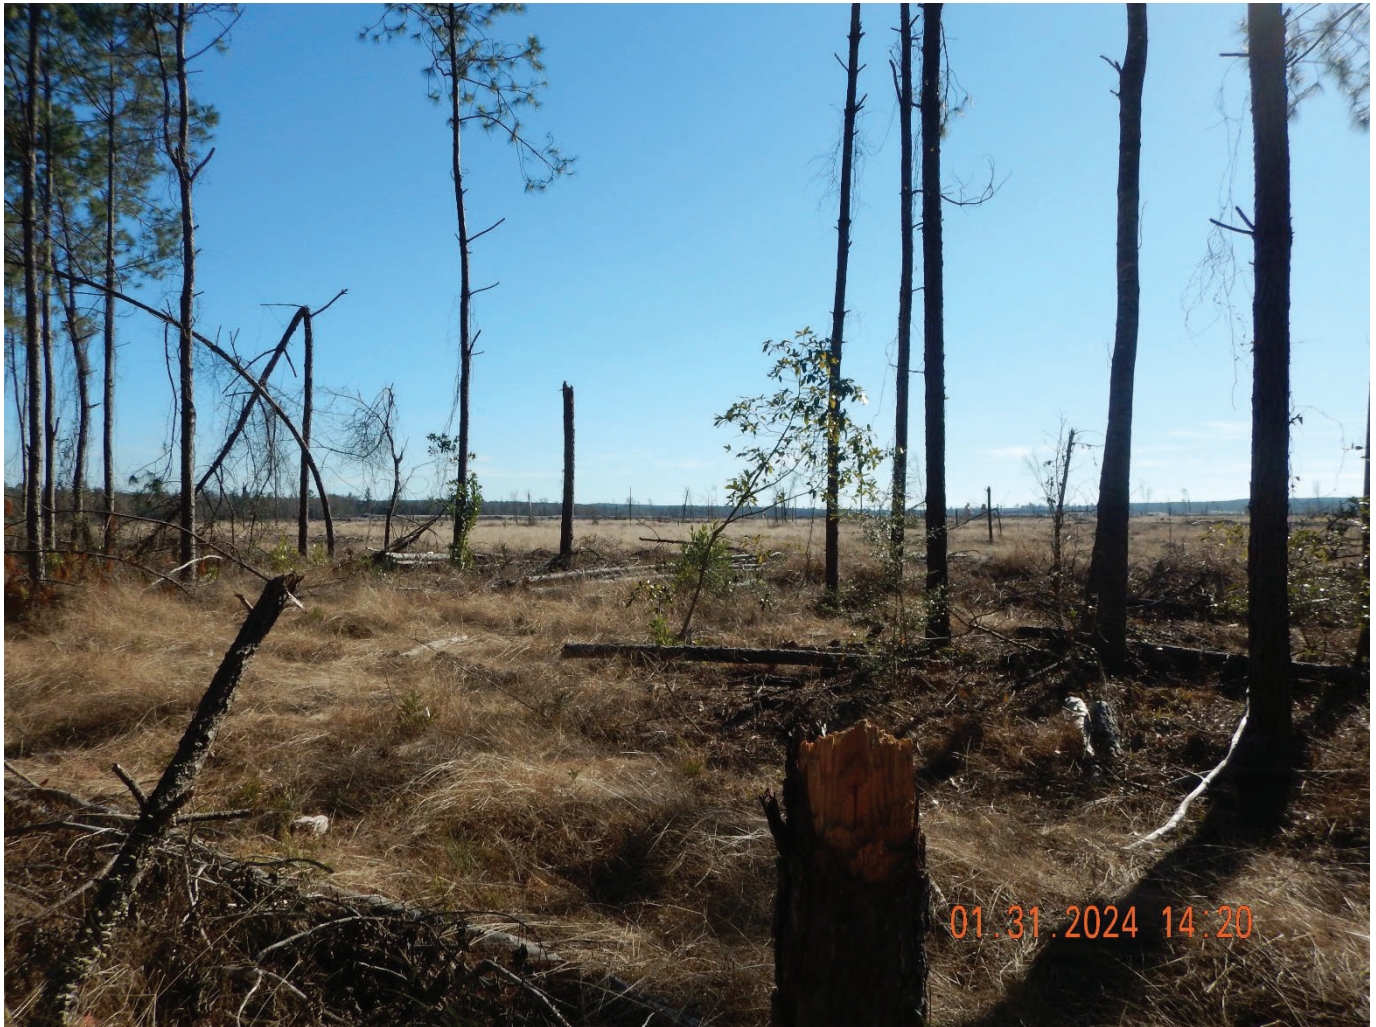
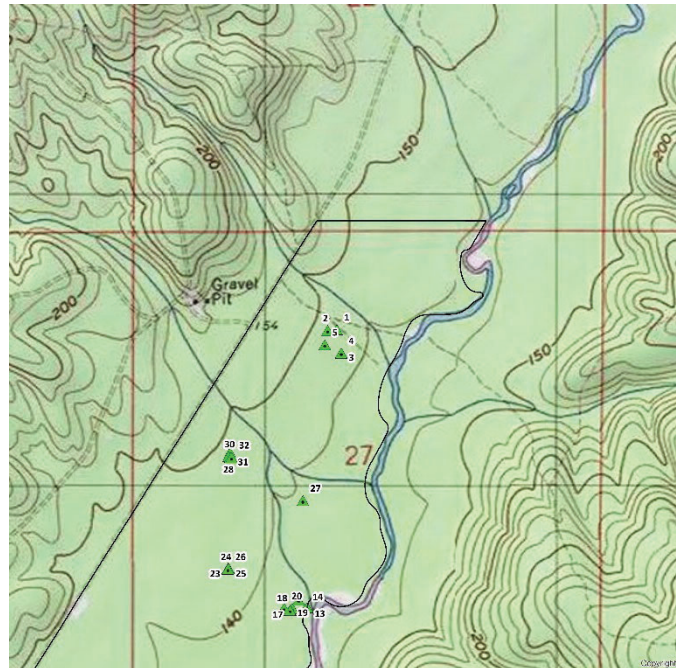
PHOTO 32

| Description | Striking south over Data Point A5. |
