**CWA COMPLIANCE EVALUATION INSPECTION REPORT**  
**U.S. ENVIRONMENTAL PROTECTION AGENCY, REGION 5**

**Facility:** Kettle Cuisine, LLC.  
808 Packerland Drive  
Green Bay, Wisconsin 54303

**NPDES Permit Number:** WIR05IA0E

**Date of Inspection:** April 29, 2025

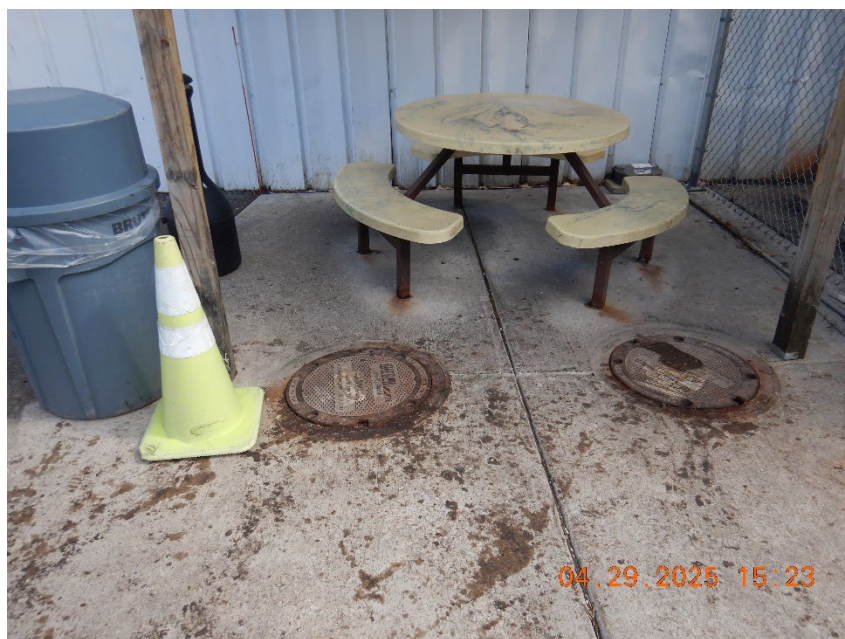
1: DSCN1082

At approximately 3:20 P.M., the EPA Inspection Team began its walkthrough of the Facility, accompanied by Mr. Campoli, Mr. Klimek, and Mr. Mike Martin, Production Manager. Beginning outdoors on the northwest side of the Facility, the EPA Inspection Team noted two grease traps connected to an underground tank in the back of the Facility (Photograph 1 in Attachment A). To the southwest, inspectors observed the location where food remnants from the inedible room are picked up by the contractor. The EPA Inspection Team observed a thick layer of grease and tan-colored media near this area (Photographs 2-3 in Attachment A). Proceeding further to the southwest, Facility personnel highlighted the area below the loading dock, which collects water that is pumped into the building via sump and discharged back outside through a small white pipe (Photograph 4 in Attachment A). Inspectors also observed five Facility dumpsters for solid waste collection; two of these dumpsters were uncovered at the time of the inspection (Photograph 5 in Attachment A). Mr. Campoli stated that Green For Life comes to the Facility four days a week to collect solid waste and, if necessary, to replace damaged dumpsters. The EPA Inspection Team observed a trail of grease leading to the Outfall 003 (Photograph 6 in Attachment A).

Description: Grease Traps Connected to a Tank in Back of Facility

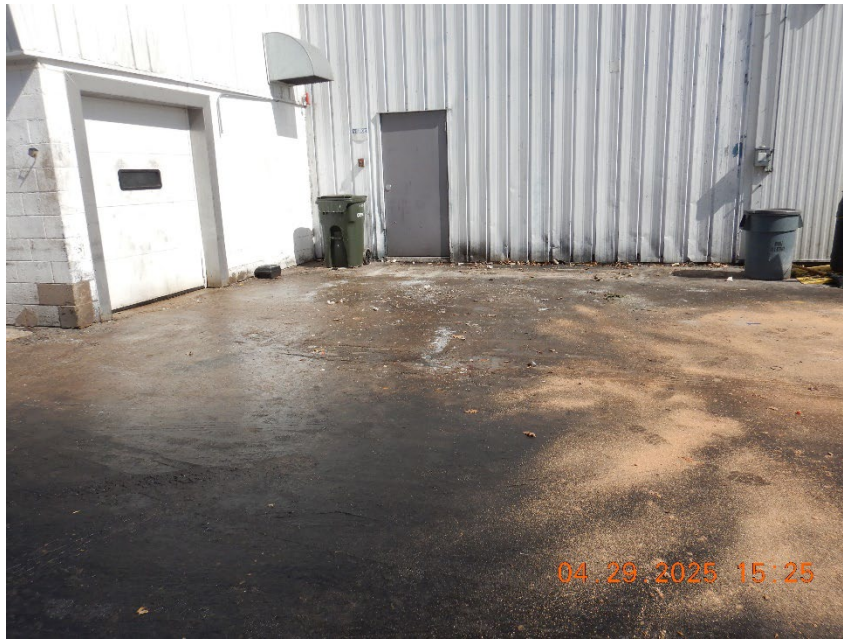
2: DSCN1083

1. Grease in Parking Lot and Proximity to Outfall 003: During the EPA inspection, the EPA Inspection Team observed grease and inedible room media near Outfall 003 and around the northwestern side of the Facility (see Photographs 2-4 and 6 in Attachment A). The EPA Inspection Team observed a trail of grease leading to Outfall 003 (Photograph 6 in Attachment A).

Description: Area Outside of Inedible Room

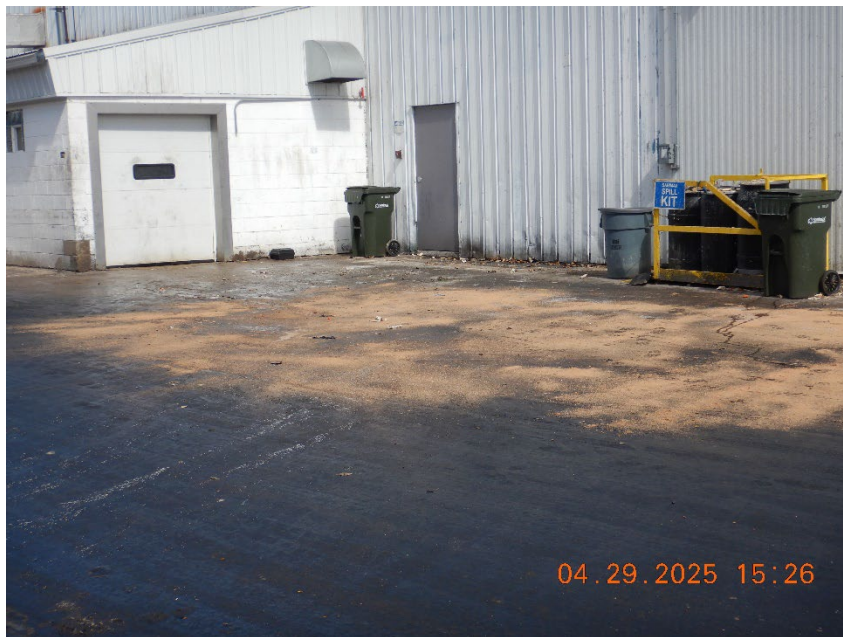
3: DSCN1084

Description: Area Outside of Inedible Room

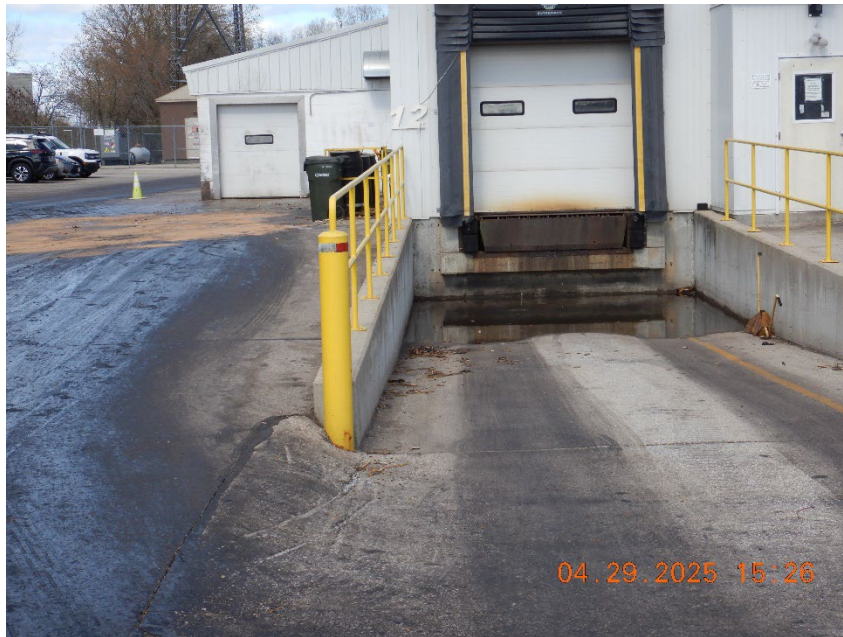
4: DSCN1085

Description: Area Outside of Inedible Room and Loading Dock

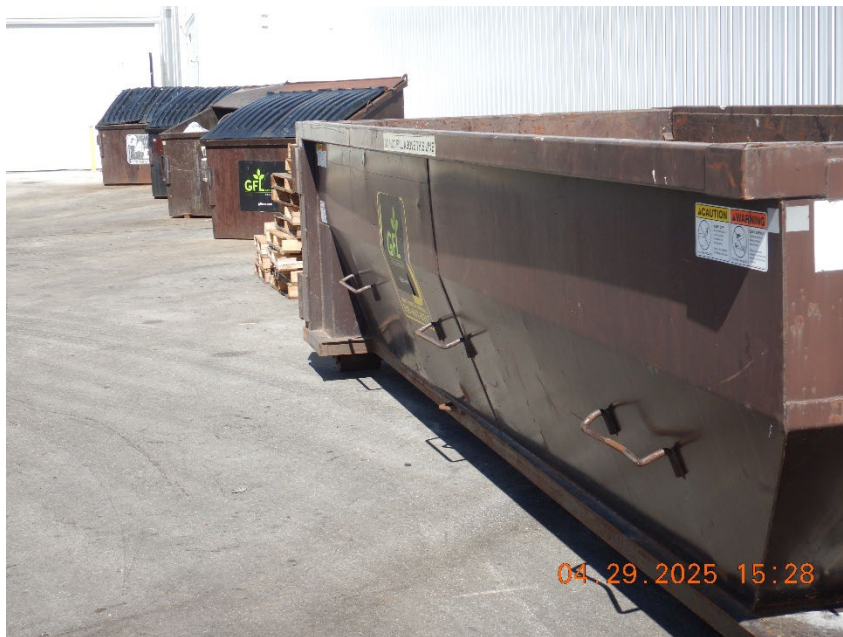
5: DSCN1086

8. Dumpster with Lid Not in Place: Section 2.1.2.2.c of the Permit states that “good housekeeping” entails “...keep[ing] all dumpster lids closed when not in use.” During the inspection, the EPA Inspection Team observed two dumpsters not covered (see Photograph 5 in Attachment A).

Description: Facility Dumpsters for Solid Waste Collection

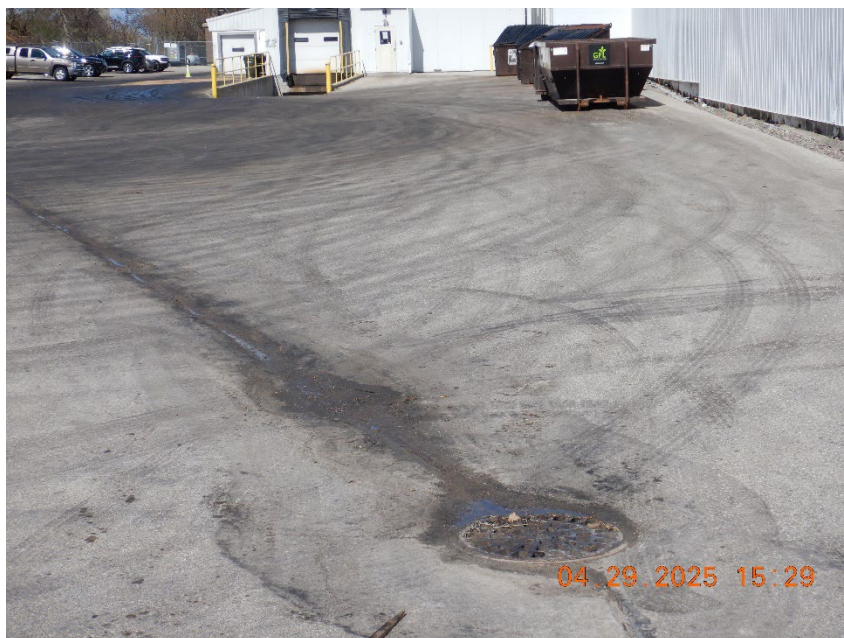
6: DSCN1087

Description: Outfall 003

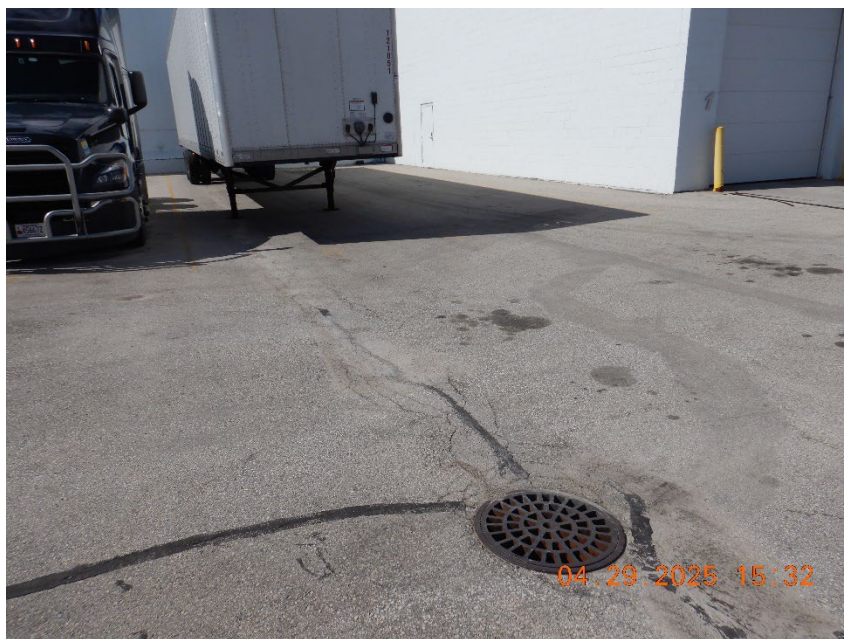
7: DSCN1088

Traversing to the Facility's southeastern side, the EPA Inspection Team observed Outfall 002 near a vehicle storage area (Photograph 7 in Attachment A). The EPA Inspection Team then asked to remove one of the grease trap covers in the front of the Facility to observe how much grease it was holding. After opening the cover, it appeared as though the grease trap was approximately half-full (Photographs 8-9 in Attachment A). Mr. Campoli then guided the EPA Inspection Team to Outfall 001 prior to returning inside to observe the Facility's indoor operations (Photograph 10 in Attachment A). Mr. Peyton Hagerstrom, Maintenance Manager, proceeded to escort members of the EPA Inspection Team through the Facility's maintenance room, where one drain was observed near an ammonia tank (Photographs 11 and 13 in Attachment A). It was not known at the time of the inspection if this drain connected to the main sewer system. Inspection information indicates that the 10,000-gallon ammonia storage tank is serviced by Kuhlman Inc. Inspectors also observed a used oil aboveground storage tank

Description: Outfall 002

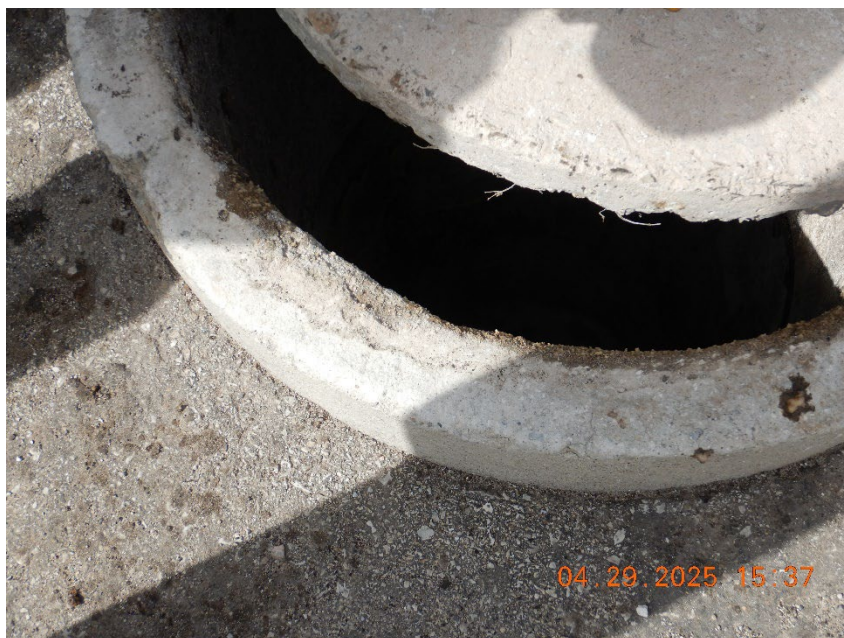
8: DSCN1089

Description: Grease Trap in Front of Facility

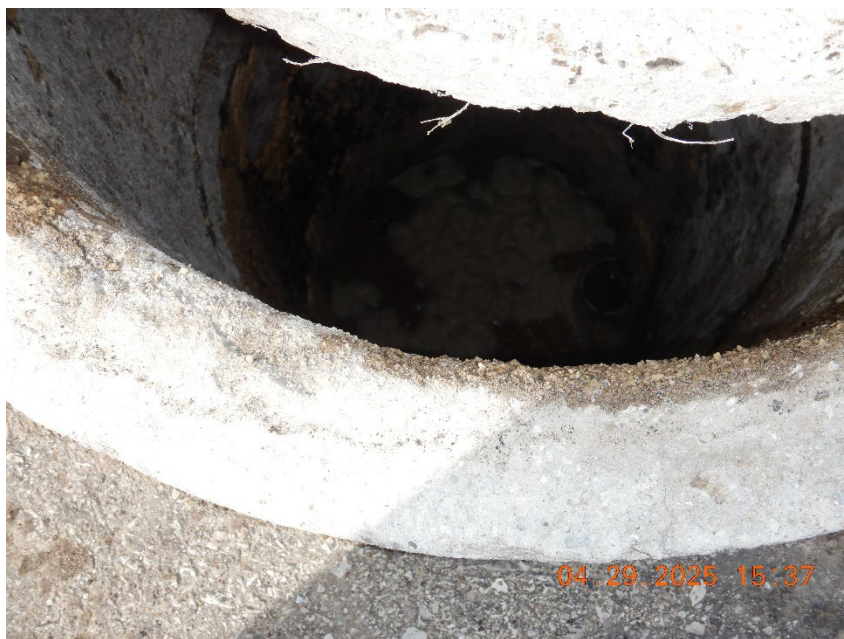
9: DSCN1090

Description: Grease Trap in Front of Facility

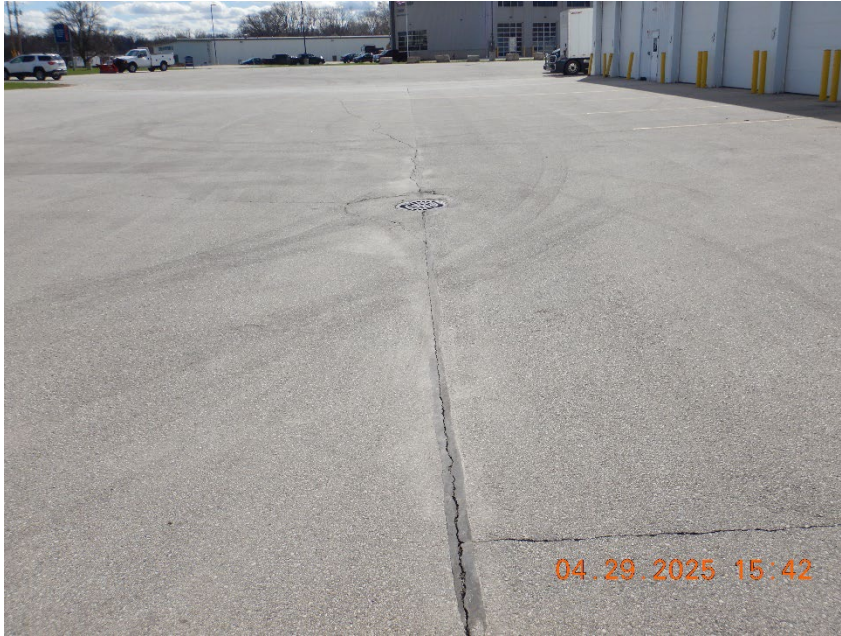
10: DSCN1091

Description: Outfall 001

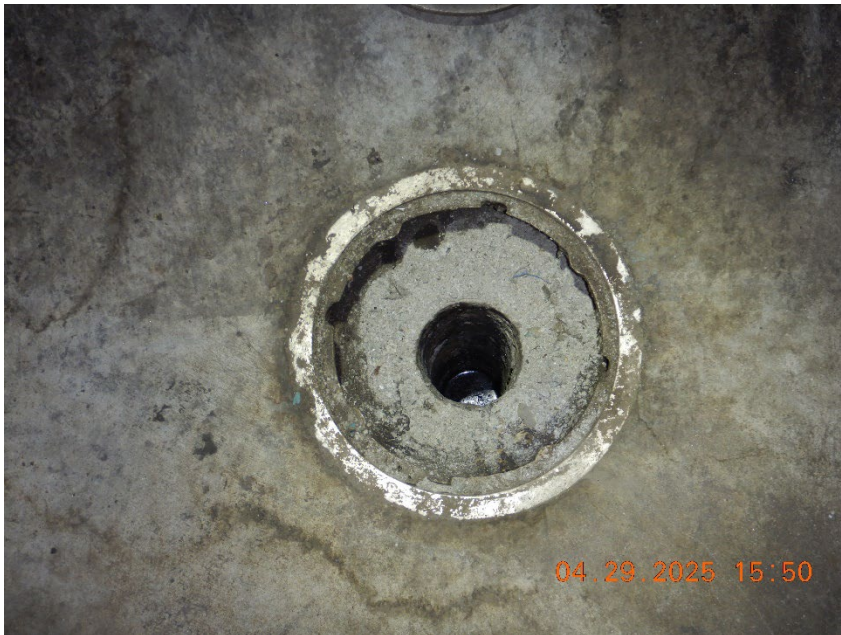
11: DSCN1092

7. Absence of Secondary Containment in Maintenance Room: Section 2.1.2.4 of the Permit requires the Facility to minimize the potential for leaks and implement procedures for material storage and handling, including the use of secondary containment and barriers between material storage and traffic areas, or a similarly effective means designed to prevent the discharge of pollutants from these areas. During the inspection, the EPA inspectors observed a 10,000-gallon ammonia tank and used oil tank near a drain that may be connected to the storm sewer. No secondary containment was observed in this area at the time of the inspection.

Description: Drain in Maintenance Room

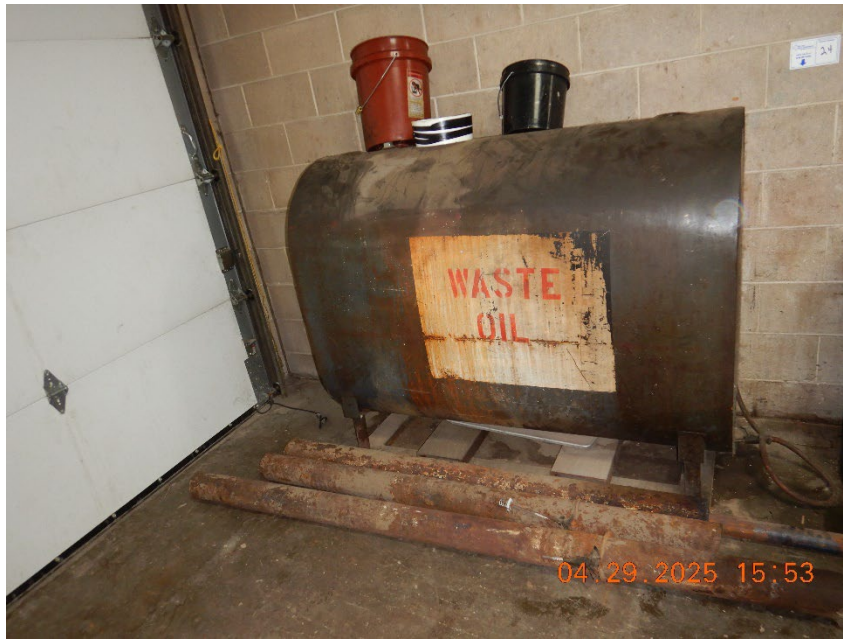
12: DSCN1093

in this area (Photograph 12 in Attachment A). No secondary containment was observed for either the used oil or ammonia tanks.

Description: Used Oil Storage Tank

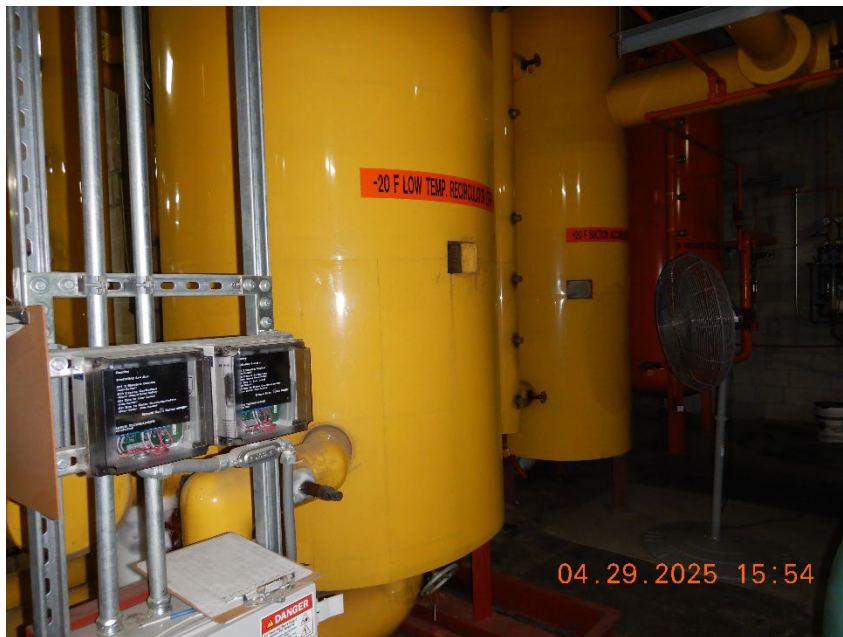
13: DSCN1094

Description: 10,000-Gallon Ammonia Storage Tank

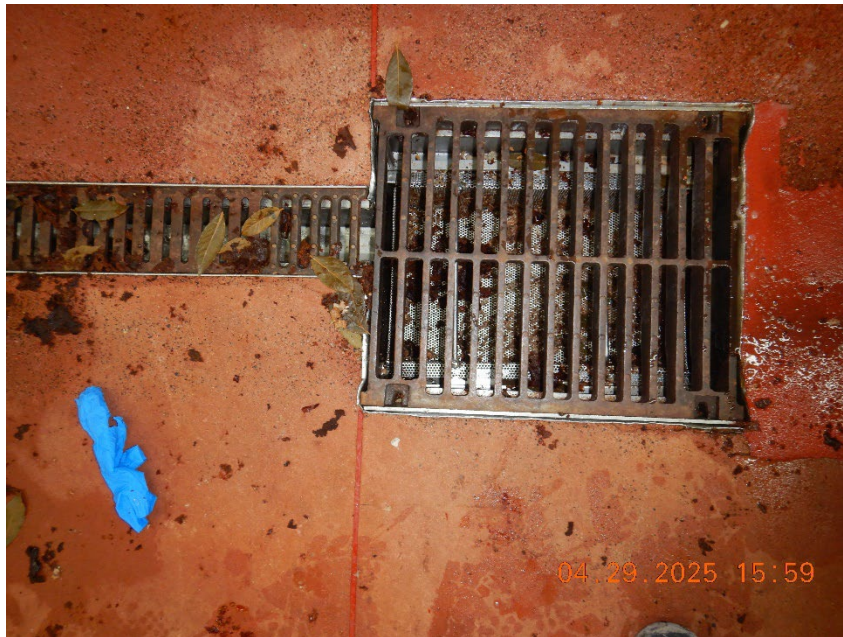
14: DSCN1095

The EPA Inspection Team next donned the appropriate clothing to enter the production area. Walking through a portion of the production area, the EPA Inspection Team noted a trench drain in the food process room which Facility personnel indicated is connected to the front grease trap (Photograph 14 in Attachment A). Mr. Klimek stated that every room within the production area has a drain similar to the one observed. The EPA Inspection Team then walked to the inedible room which abuts the Facility's northwestern exterior wall. Mr. Klimek also stated that the Facility's contractor comes twice a day to collect this media. The inedible area is also cleaned twice a day and cleaned during a late Friday or Saturday shutdown, per Mr. Klimek. At the time of the inspection, the EPA Inspection Team observed 13 bins of inedible waste product, which Mr. Klimek said had been generated within the course of approximately 12 hours (Photograph 15 in Attachment A). The EPA Inspection Team also observed the Facility's northwestern grease trap, which was opened with a crowbar by Facility personnel (Photograph 16 in Attachment A). A couple of additional photos showing the condition of the northwestern side of the Facility were taken prior to the EPA Inspection Team commencing a closing conference (Photographs 17-18 in Attachment A).

Description: Drain in Food Process Room

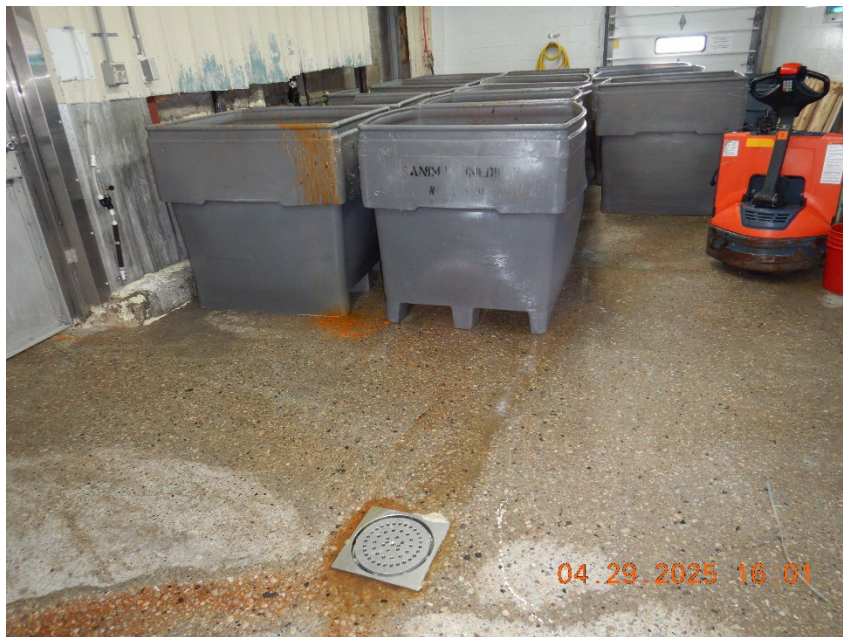
15: DSCN1096

Description: Twelve Hours of Generated Waste Product in Inedible Room

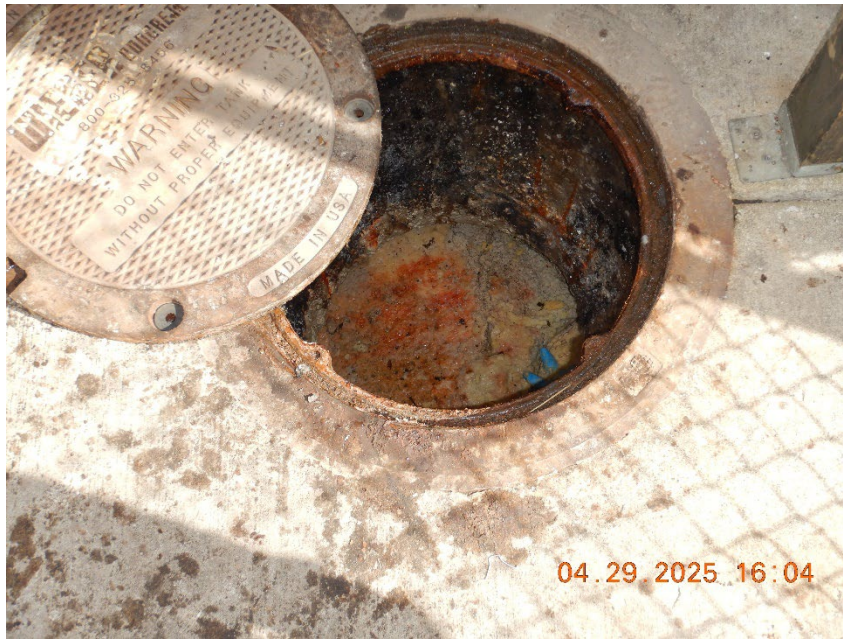
16: DSCN1097

Description: Grease Trap in Back of Facility

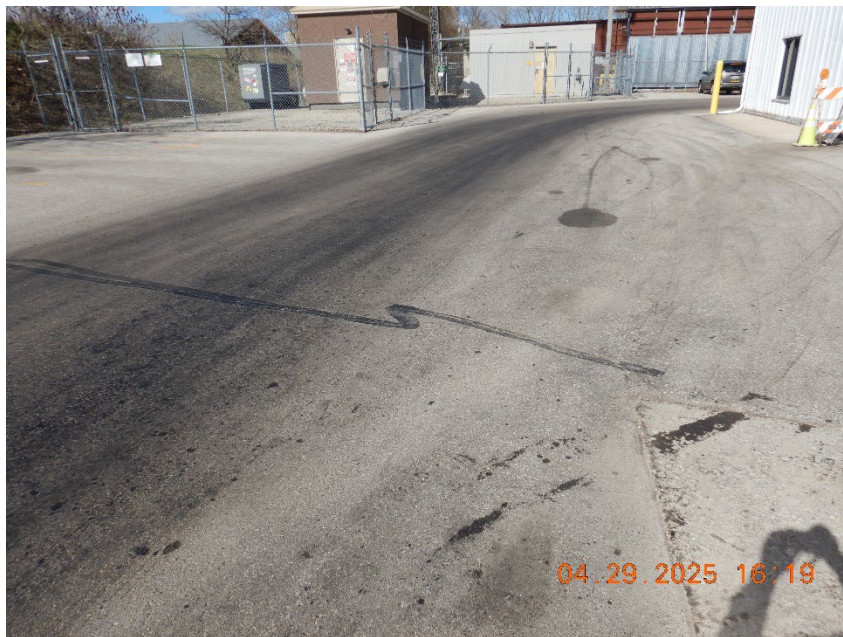
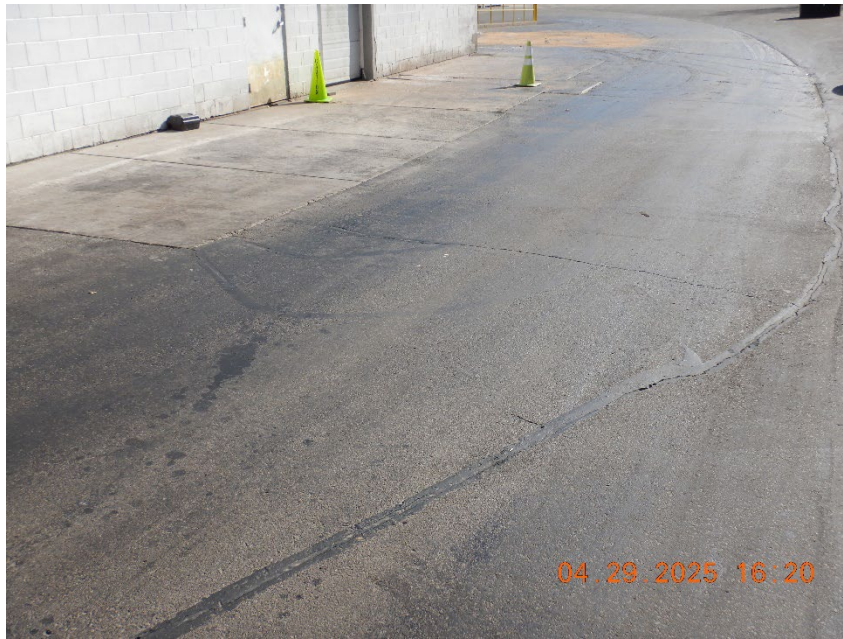
Description: Parking Lot Near Inedible Room
