**CWA COMPLIANCE EVALUATION INSPECTION REPORT  
U.S. ENVIRONMENTAL PROTECTION AGENCY, REGION 5**

**Facility:** City of Peoria – Combined Sewer System/Consent Decree Oversight Inspection  
3505 North Dries Lane, Peoria, Illinois 61604

**NPDES Permit Number:** IL0037800

**Date of Inspection:** May 20, 2025

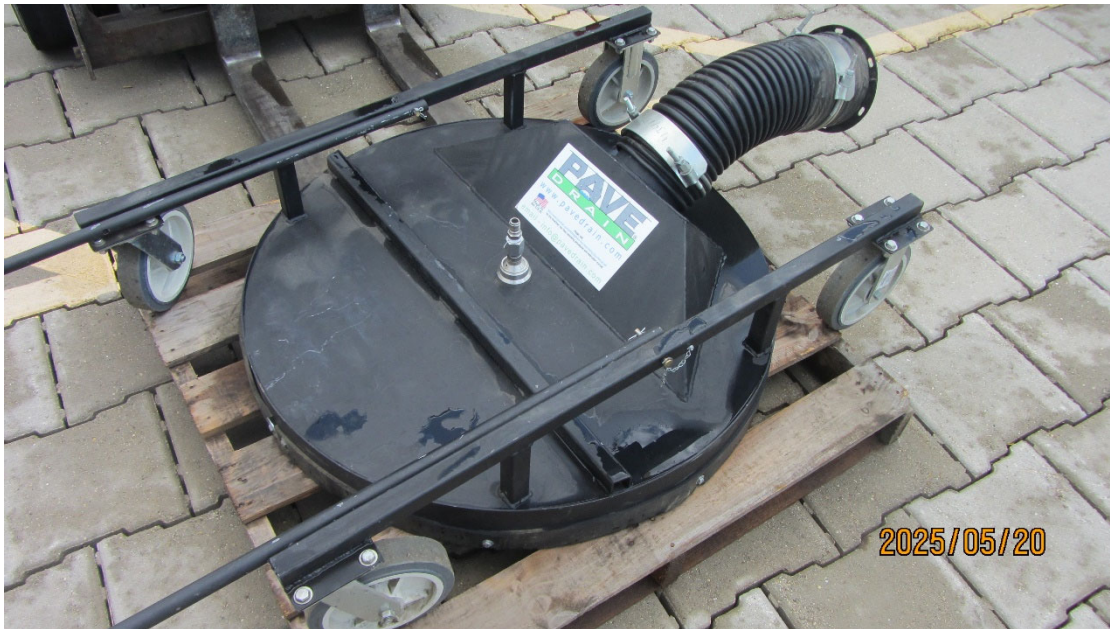
1: IMG\_1283

At approximately 1:00 pm, Mr. Middleton, Mr. Jones, Ms. Soucie, Mr. Phelps, Ms. Klopfenster, Ms. Mendez-Silvagnoli, Ms. Post, and Mr. Carlson, began a walk-through of selected GI infrastructure and associated maintenance equipment. The EPA and Illinois EPA inspectors observed 1 of the 2 vacuum trucks used by Peoria (Photographs 2 and 4 in Attachment A) and 1 of 2 of Peoria's vacuum sweeper trucks (Photograph 3 in Attachment A) in the parking lot just outside of the public works building. A cleaning attachment used for the vacuum trucks (Photograph 1 in Attachment A) was also available for EPA and Illinois EPA to view.

Description: Vacuum Truck Cleaning Attachment

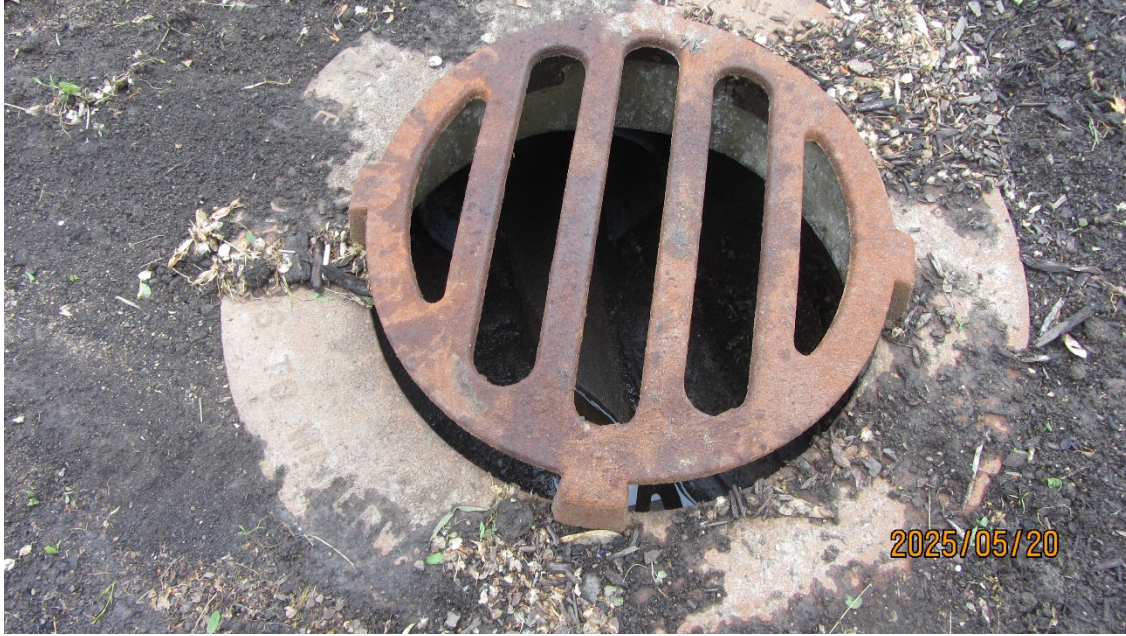
6: IMG\_1288

After observing the GI infrastructure maintenance equipment, EPA, Illinois EPA, Peoria, and Mead & Hunt representatives left Peoria's public works building to drive to different implemented GI infrastructure throughout the Peoria's combined sewer system. These sites were chosen by EPA, with input from Peoria and Mead & Hunt representatives. The first location that was observed was permeable paver sections and stormwater bump-outs at the intersection of Perry Avenue and Mary Street within the Year 1 CSO project area. The stormwater bump-out shown in Photograph 5 in Attachment A are connected to StormChambers stormwater subsurface storage units located underneath the permeable pavers in Photograph 8 in Attachment A. There is another inlet upstream of the permeable pavers that collects flow on Mary Street, in addition to the collection of stormwater flow from Perry Avenue via the stormwater bump-out. In the stormwater bump-outs located in this area, EPA observed that there was little/no vegetation present. Ms. Klopfenster told EPA that these stormwater bumps would be replanted in the next couple of weeks as discussed earlier in the inspection. Near the stormwater inlet within the southern stormwater bump-out on Perry Avenue, EPA noticed evidence of prior erosion of soil and mulch from the stormwater bump-out into the inlet (Photograph 6 in Attachment A).

Description: Inlet Within Stormwater Bump-Out in IMG\_1187

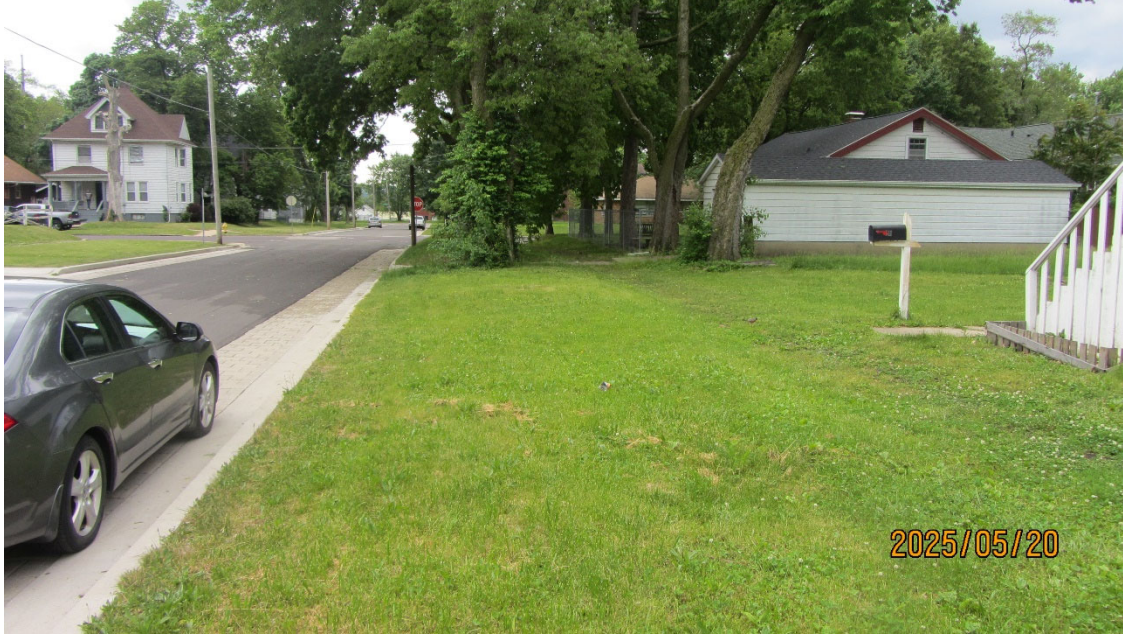
10: IMG\_1292

Next, EPA, Illinois EPA, Peoria, and Mead & Hunt representatives drove to another permeable pavers section on Laveille Street, between Monroe Street and Madison Avenue in the Year 1 CSO Control Project area. Photograph 10 in Attachment A shows the permeable paver section in this area with a zoomed in view of the permeable pavers in Photograph 11 in Attachment A. The permeable pavers are setup differently here than previously observed on Mary Street, with only aggregate used within the subsurface storage and a 12-inch perforated pipe that runs within the subsurface storage to distribute the influent. Peoria representatives noted that this section of permeable pavers had been cleaned within the last two weeks. EPA observed very little debris within the permeable pavers in this area. The cleanout associated with the permeable pavers also had fewer solids and debris than the cleanout viewed on Mary Street (Photograph 12 in Attachment A). EPA then walked to the northwest up Laveille Street to observe the stormwater bump-out on the southside of Perry Street (Photograph 13 in Attachment A). EPA noticed at this stormwater bump-out that there was additional evidence of prior soil erosion into the inlet connected to the subsurface storage under the permeable paver section on Laveille Street. Peoria and Mead & Hunt representatives then informed EPA that this stormwater bump-out would also be replanted in a similar fashion to the stormwater bump-outs observed previously. EPA next walked to the northeast along Perry Street to observe the permeable paver section located here (Photograph 14 in Attachment A). Mead & Hunt representatives noted that the design of the inlet being in the street and not located on the curb was different than other permeable paver project implementations throughout Peoria. EPA learned that this was due to the use of previous inlets located here to save costs.

Description: Permeable Paver Section on Laveille Street

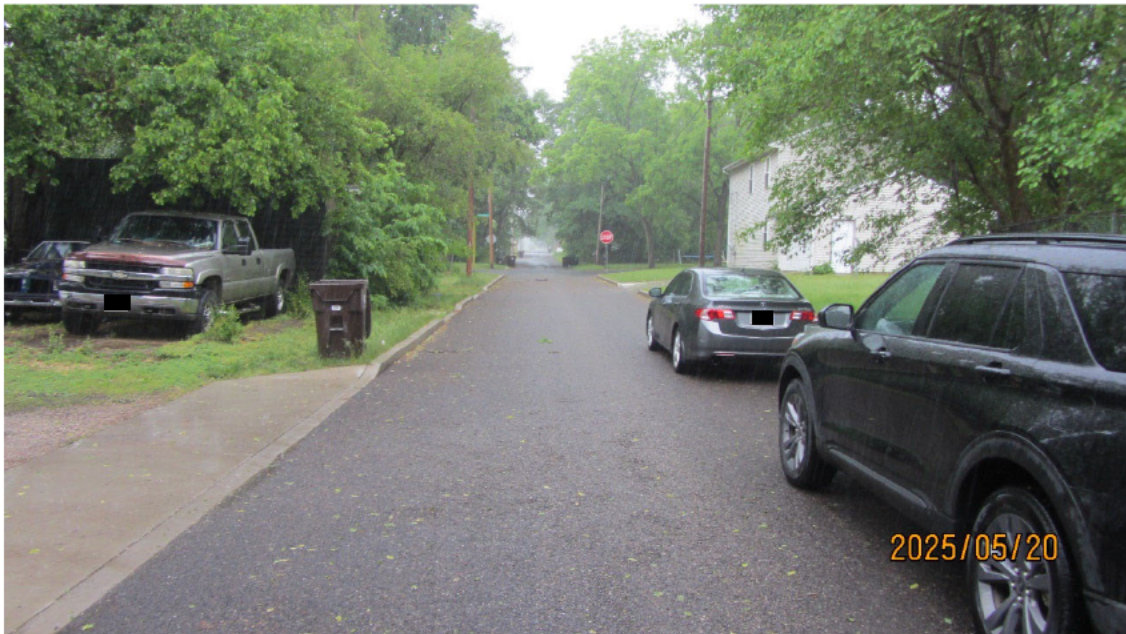
19: IMG\_1301

Next, EPA, Illinois EPA, and Mead & Hunt representatives drove south down Webster Street to Aiken Street to observe a porous asphalt implementation on Aiken Street between Webster Street and Charlton Street (Photographs 19 and 20 in Attachment A). Mead & Hunt representative mentioned to EPA that this section of Aiken Street was chosen for porous asphalt because the width of the roadway was short and there was no garbage pickup on this street. EPA observed areas of heavy ponding on the porous asphalt, which indicated problems with infiltration through the pavement due to clogging. Mead & Hunt representatives indicated that the new Bucher sweeper vacuum truck had recently cleaned the street and increased the infiltration of the porous asphalt from 5 inches per hour to 59 inches per hour. While at this location, EPA observed a number of mature bushes and trees in this area that could contribute debris that could clog the porous pavement, along with garbage cans out for pickup.

6. Porous Asphalt Project Location: During the inspection, EPA went to a porous asphalt GI implementation on Aiken Avenue (Photograph 19 in Attachment A) and observed

Description: Porous Asphalt Section on Aiken Ave.

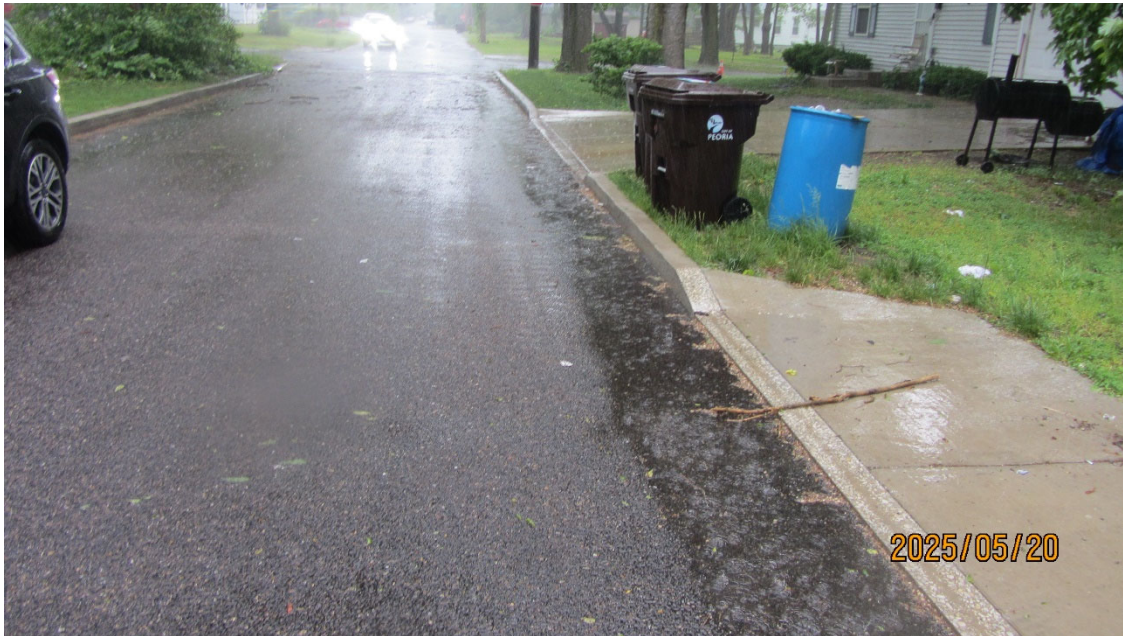
20: IMG\_1302

Description: Porous Asphalt Section on Aiken Ave. (2)

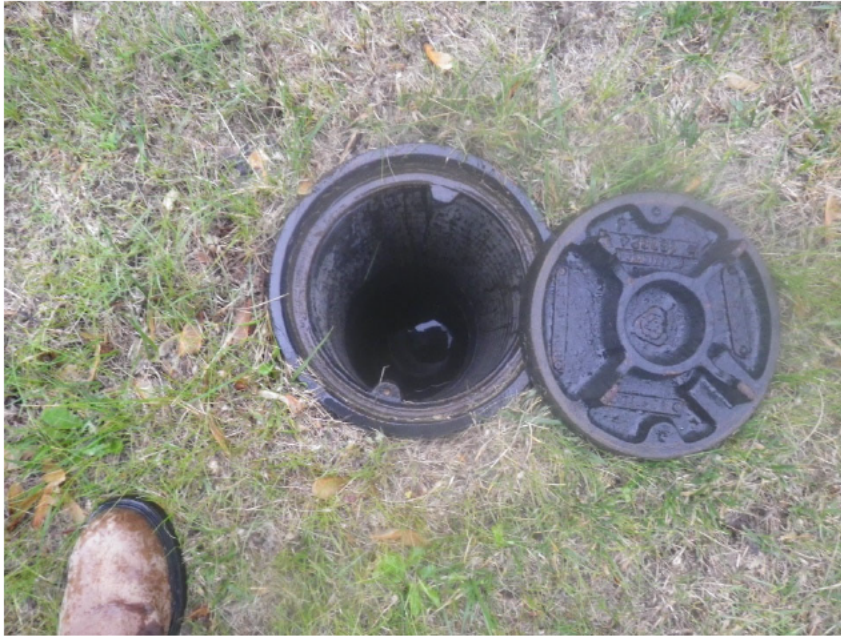
22: IMGP0002

that it is currently working through this issue. EPA also observed the cleanout associated with the subsurface storage (Photograph 22 in Attachment A); this cleanout appeared to have little to no debris within it.

Description: Cleanout Associated with Subsurface Storage

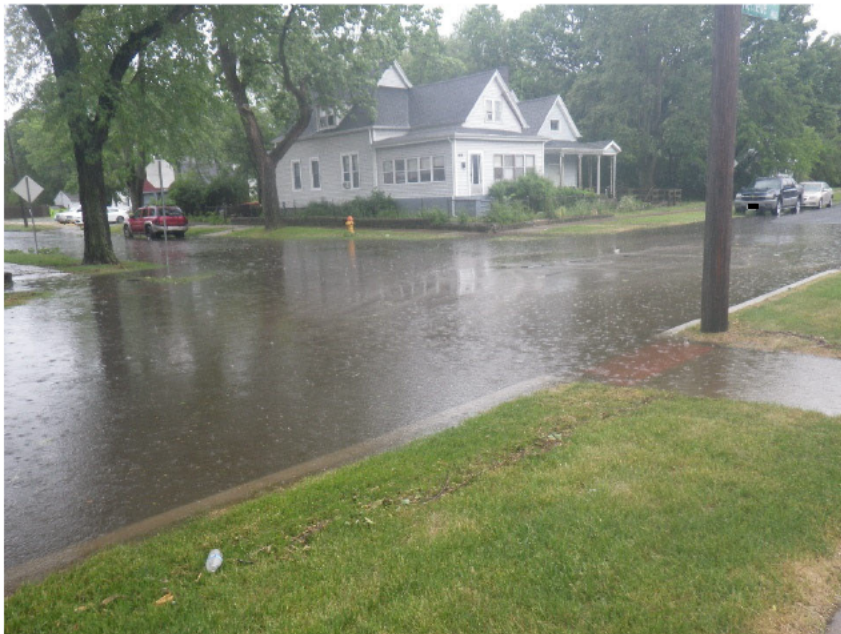
25: IMGP0005

Description: Flooded Intersection Associated with Subsurface Infiltration Below Pavement

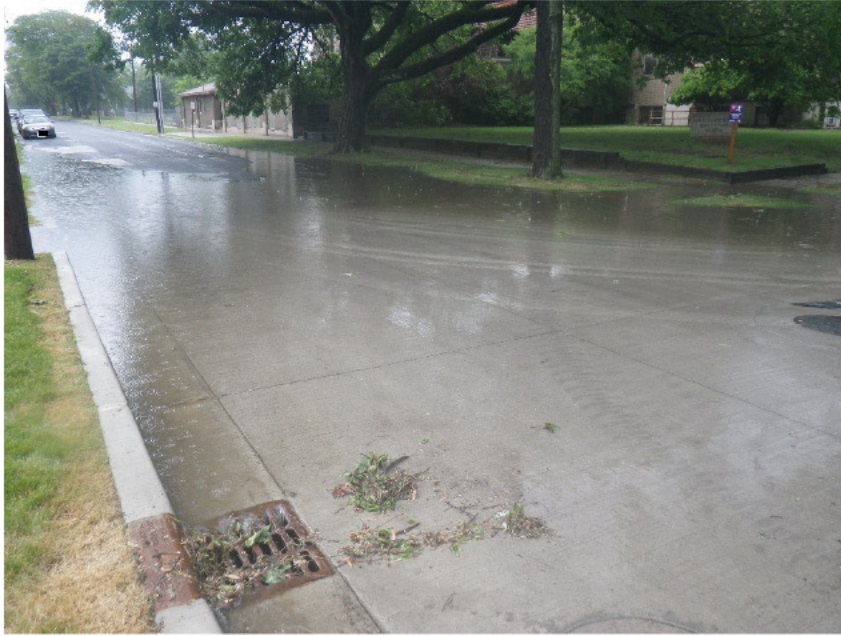
26: IMGP0006

Description: Flooded Intersection Associated with Subsurface Infiltration Below Pavement (2)

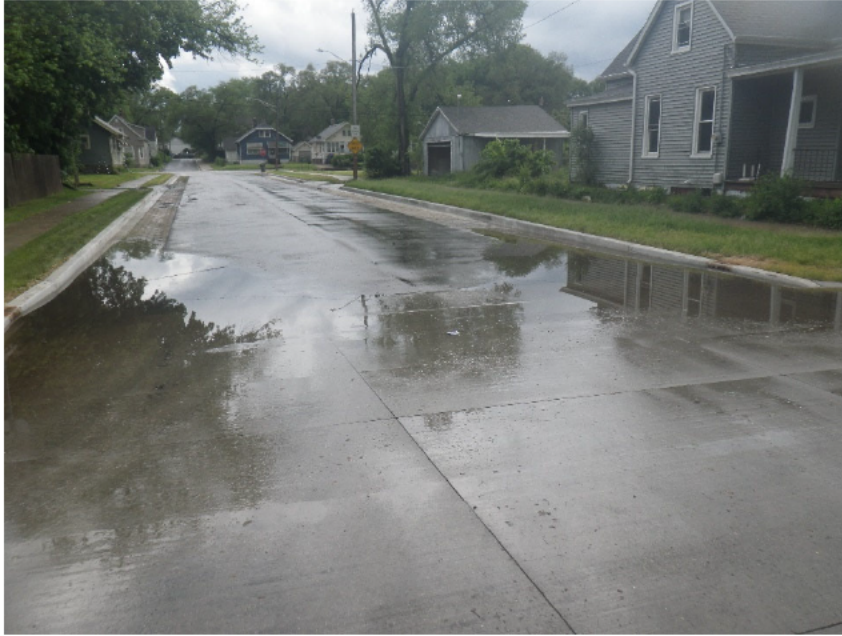
30: IMGP0010

Next, EPA, Illinois EPA, and Mead & Hunt representatives drove back to the east to see a permeable pavement section on Blaine Street, between Smith Street and Martin Street (Photograph 30 in Attachment A). This permeable project was implemented as a part of the Year 3 CSO Project. EPA observed heavy ponding on most of the implemented permeable pavement, indicating that the permeable pavement here was clogged and/or not performing as designed. Mead & Hunt representatives told EPA that this project was finished near the end of 2024, but had not been turned over to Peoria for ownership and therefore maintenance was not occurring.

Description: Permeable Pavement Section on Blaine Street

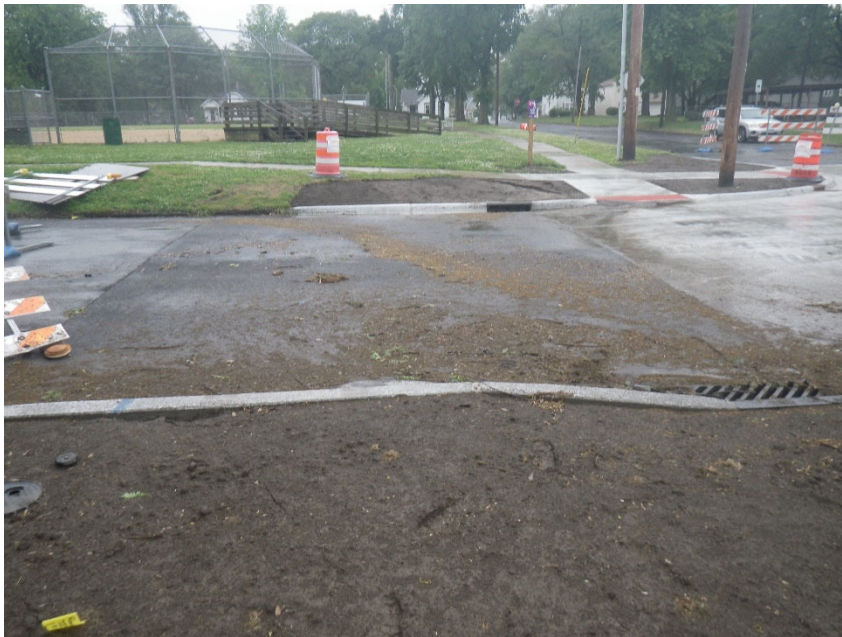
33: IMGP0013

EPA, Illinois EPA, and Mead & Hunt representatives then drove southeast to the intersection of Martin Street and Warren Street to observe a subsurface infiltration, located below the intersection, similar to the project located at the intersection of Kettealle Street and DuSable Street (Photograph 31 in Attachment A). Mead & Hunt representatives told EPA that the aggregate storage was located in a crescent shape on the east and south of the intersection. There were also two inlets shown on Photograph 33 there were connected to the storage. EPA observed that a dirt area was up gradient of both inlets was not stabilized and could have the potential to erode into the inlets. There was also dirt from the construction located around the inlets.

5. Temporary Best Management Practices to Address Soil Erosion for GI Projects: EPA learned during the inspection that some of the vegetation in the stormwater bump-outs in the Year 1 CSO Control Projects had died off and the stormwater bump-outs needed to be replanted. EPA's understanding is that this replanting is either completed or on-going. EPA is concerned that until this replanting occurs without a plan for best management practices, soil erosion can occur into the subsurface storage features. EPA also observed some potential for soil erosion that could enter the stormwater inlets connected to the subsurface infiltration GI project located at the intersection of Kettealle Street and DuSable Street.

Description: Erosion Around the Inlets Associated with the Subsurface Infiltration

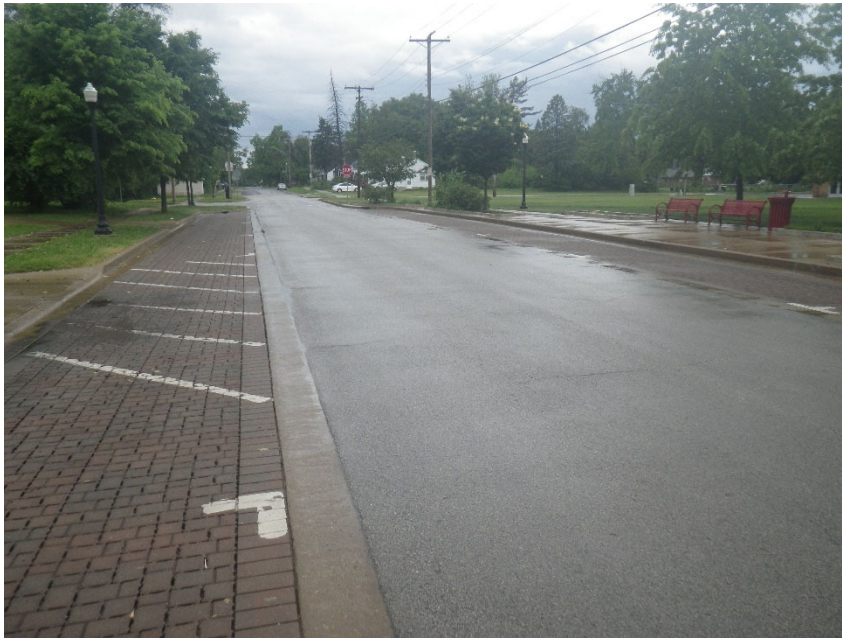
34: IMGP0014

Then, EPA, Illinois EPA, and Mead & Hunt representatives drove west to the Trewyn Middle School to observe permeable paver sections on Folkers Avenue, between Fremont Street and Latrobe Street (Photograph 34 in Attachment A). Like the Western Street permeable paver sections, the Folkers Avenue permeable paver project was implemented before the consent decree was finalized. Mead & Hunt representatives indicated it performs maintenance on these GI projects, just not at the level that it does maintenance on the Year 1 or Year 2 CSO projects. EPA observed some standing water on portions of the permeable paver section (Photograph 34 in Attachment A), indicating some potential clogging. EPA, Illinois EPA, and Mead & Hunt representatives also walked over to the intersection of Folkers Street and Humboldt Street to view a dry well implementation before leaving the area.

7. Folkers Avenue Permeable Pavement Clogging: EPA observed during the inspection that there was water ponding on the permeable pavement that had been implemented on Folkers Avenue. This ponding may indicate that the permeable pavement is clogged, at least in certain sections of this GI.

Description: Permeable Paver Sections; West of Trewyn Middle School

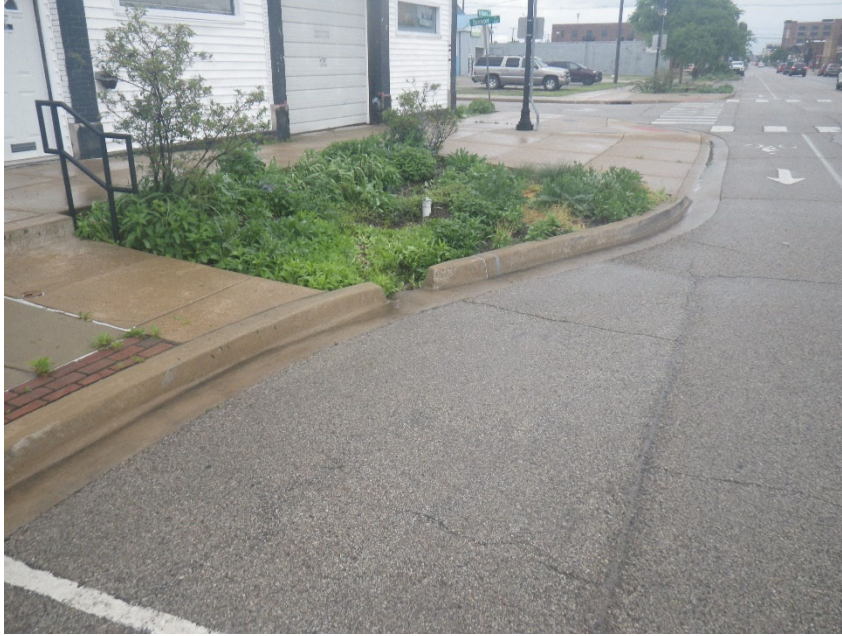
36: IMGP0016

The last area that EPA, Illinois EPA, and Mead & Hunt representatives observed was the GI projects implemented on Adams Street (Photograph 36 and 37 in Attachment A). Mead & Hunt representatives explained to EPA and Illinois EPA inspectors that Peoria implemented bioswales near the street that accepted runoff from the street through curb cuts in 2016. There are also dry wells located near the intersection of Spencer Street and Adams Street. These were some of the first GI projects implemented in Peoria and were considered pilot projects. Mead & Hunt representatives informed EPA and Illinois EPA that it was determined that permeable pavers had a better infiltration rate than the bioswales and the permeable paver GI projects were less expensive than the bioswales.

Description: Bioswale; North side of Street

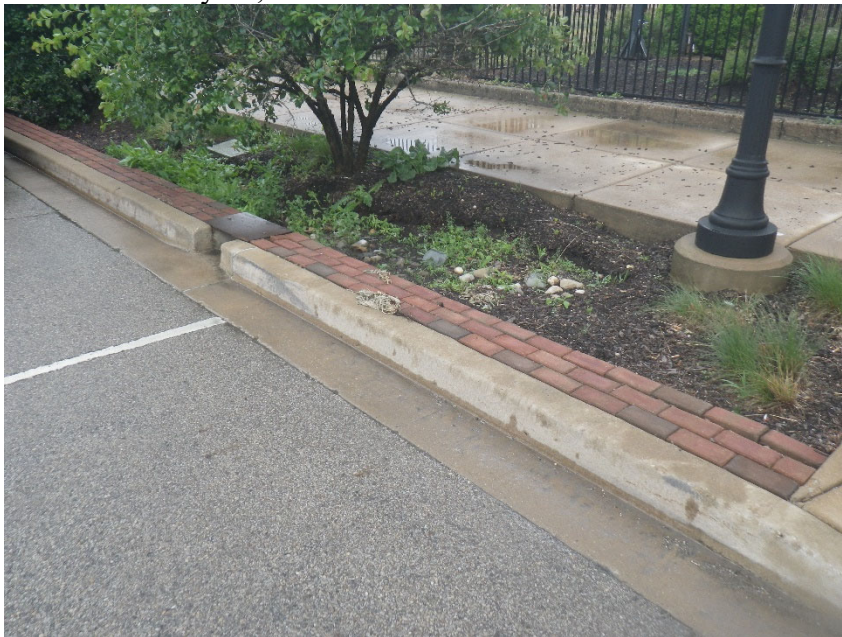
37: IMGP0017

Description: Bioswale South side of Street
