**INSPECTION REPORT**

| <b>Inspection Date:</b> | 05/24/2021 | |
| <b>Regulatory Program:</b> | CWA NPDES/Industrial Stormwater | |
| <b>Facility Name:</b> | Darigold Caldwell Facility | |

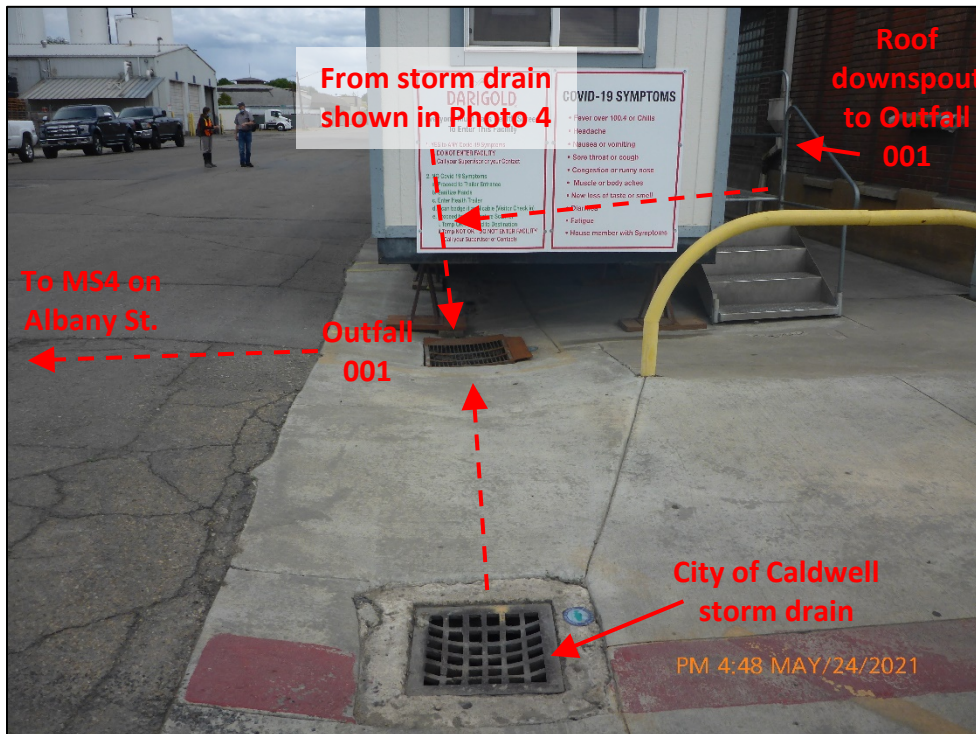
**Photograph 2.** View of Outfall 001 and adjacent City of Caldwell MS4 storm drain. Note the City storm drain flows into the Facility's Outfall 001 storm drain catch basin via pipe before discharging into the MS4 along Albany St. The Outfall 001 storm drain also receives flow from an adjacent storm drain to the southeast and the building downspouts. Red arrows depict flow.

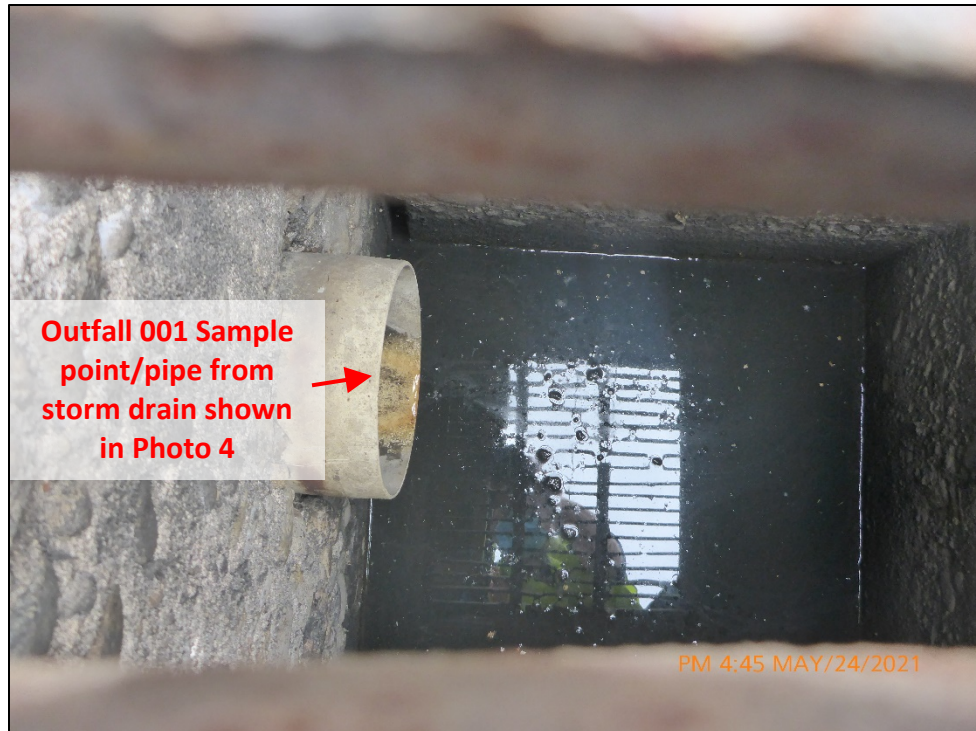
**Photograph 3.** View of the PVC pipe into the Outfall 001 storm drain catch basin where compliance samples for Outfall 001 are collected.

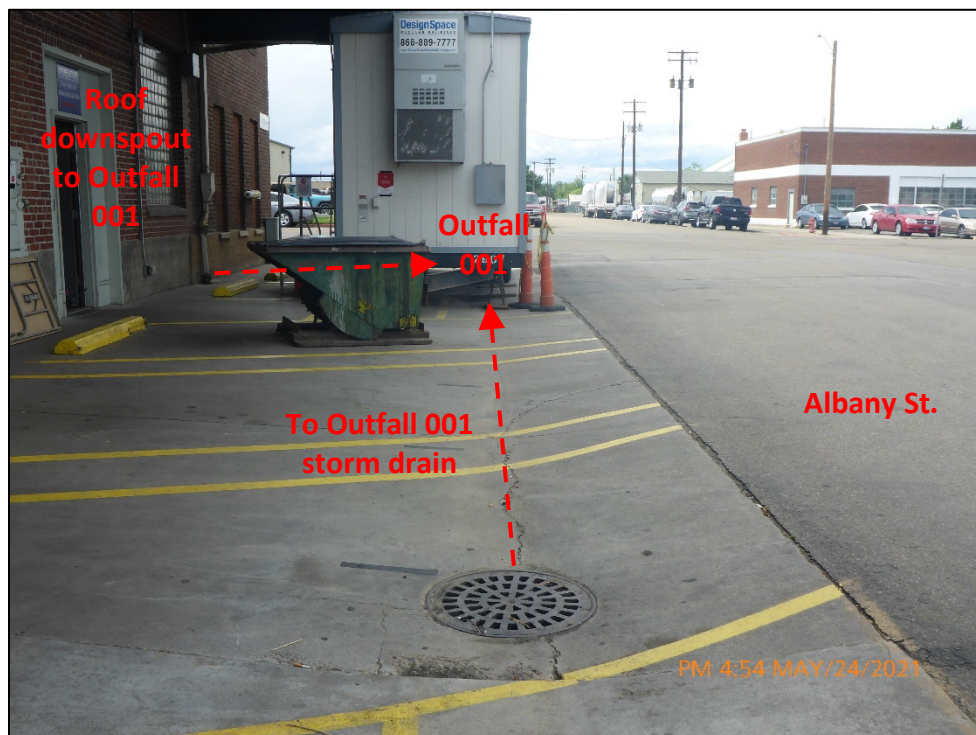
**Photograph 4.** View of a storm drain located southeast of Outfall 001 which receives stormwater runoff from the Facility and Albany St. This storm drain flows to Outfall 001 via the PVC pipe where Outfall 001 samples are collected.

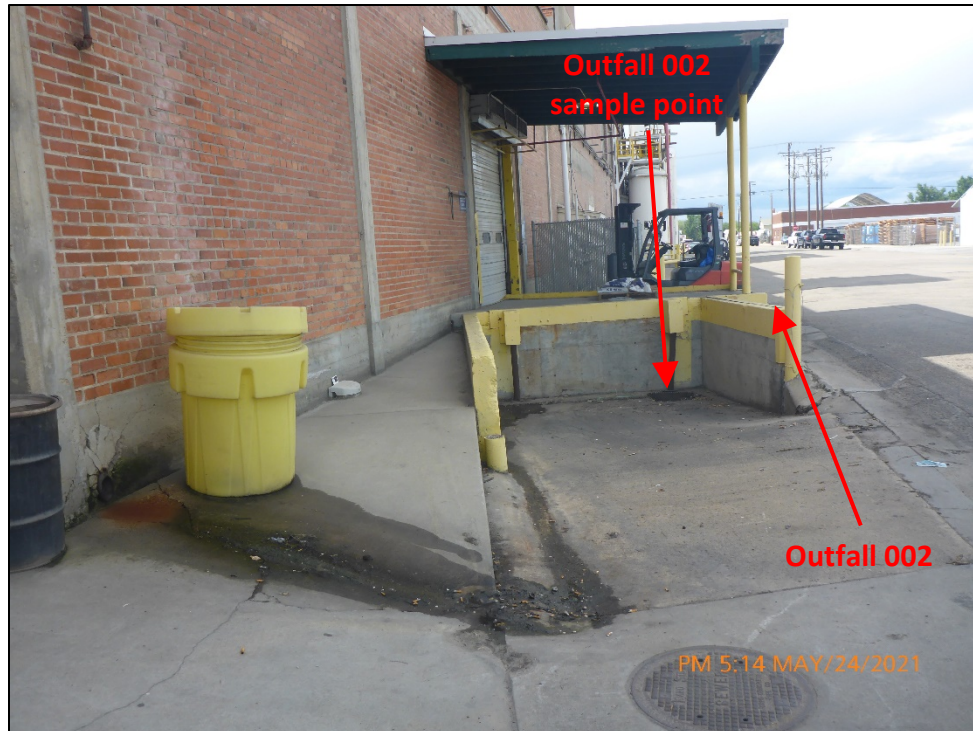
- d. We observed accumulated sediment, grit, trash, and standing water at the Facility’s sample collection point for Outfall 002. Mr. Algate stated that samples for Outfall 002 are collected from the catch basin of a drain in a nearby loading dock. He explained that this drain gravity flows into an adjacent catch basin which he identified as Outfall 002 (refer to Photographs 7 through 9). Mr. Algate also stated that trash, grit, and standing water accumulation at this sample location is problematic and typically prohibits him from collecting a “clean sample.” The Maintenance of Stormwater Drainage and Treatment Systems section of the SWPPP (following Section 1.4.6 and before Section 1.4.7) states, “Stormwater drainage and treatment systems within the Facility are operated and maintained in such a manner to keep them functional and free of contamination.”

**Photograph 7.** View, facing northwest, of the loading bay storm drain that flows to Outfall 002. Samples for Outfall 002 are collected from the catch basin of this loading bay storm drain.

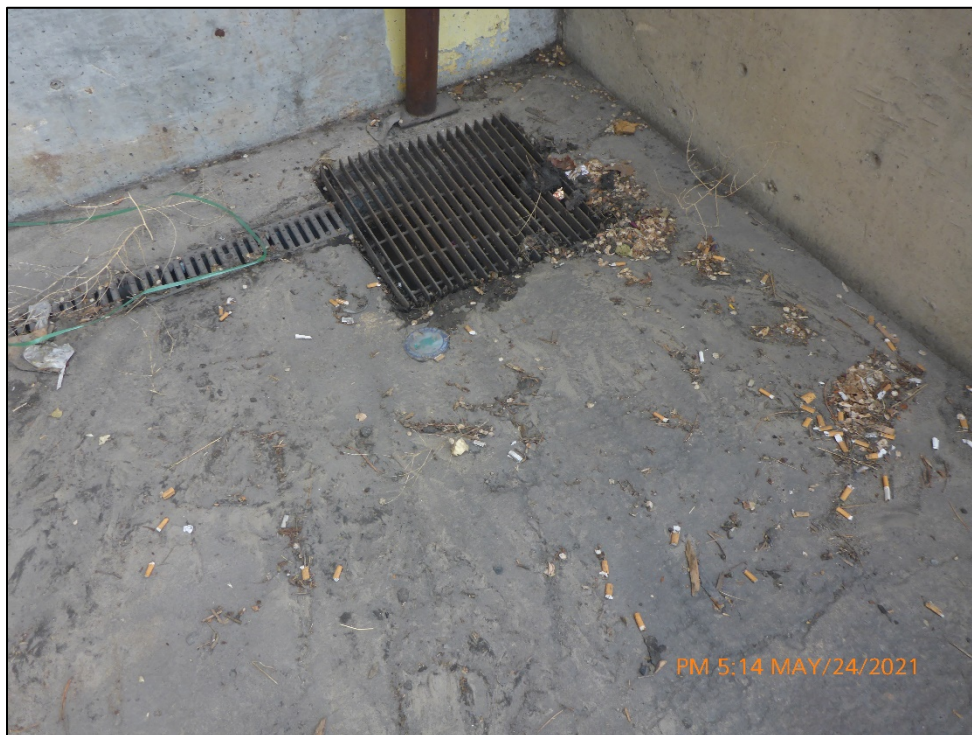
**Photograph 8.** Close-up view of sediment, grit, trash, and cigarette butts accumulated around the loading bay storm drain (Outfall 002 sample point) shown in Photograph 7. Note the drain was labeled with a storm drain placard.

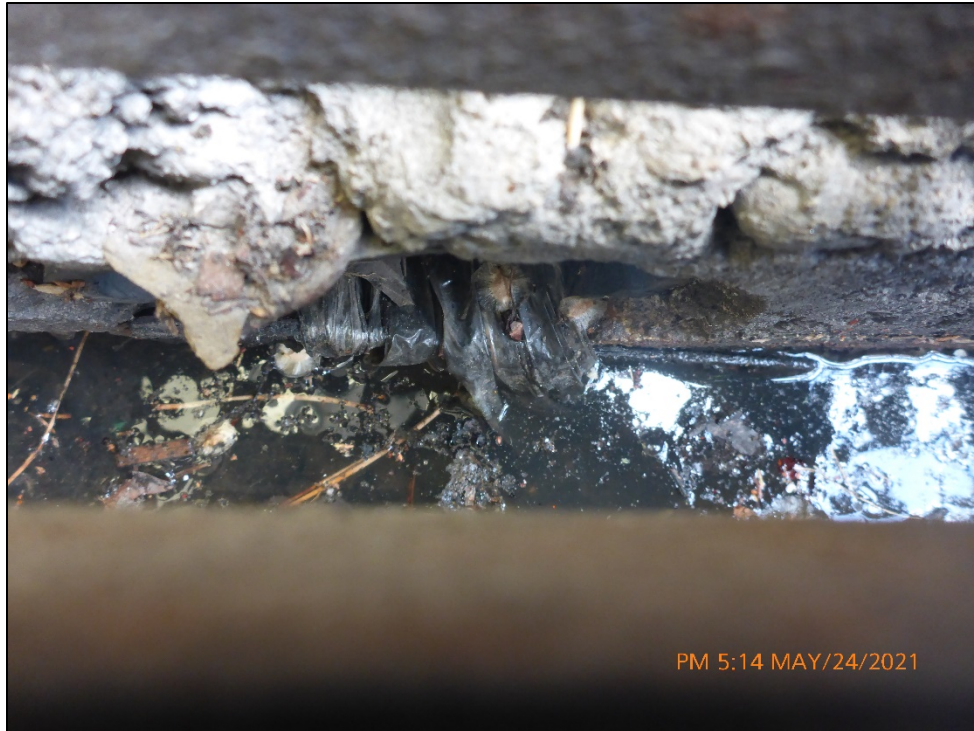
**Photograph 9.** View of the outlet pipe of the loading bay storm drain (Outfall 002 sample point).

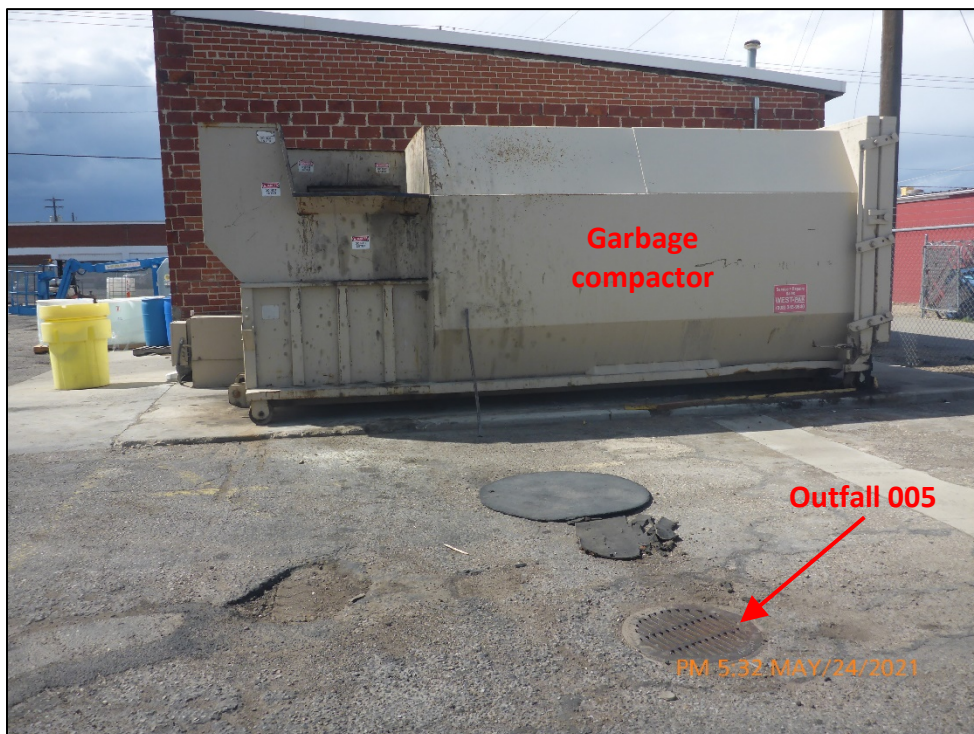
**Photograph 10.** View of Outfall 005 located adjacent to the garbage compactor in the eastern parcel of the Facility. Note the rubber mat is used as a storm drain cover when the compactor is emptied.

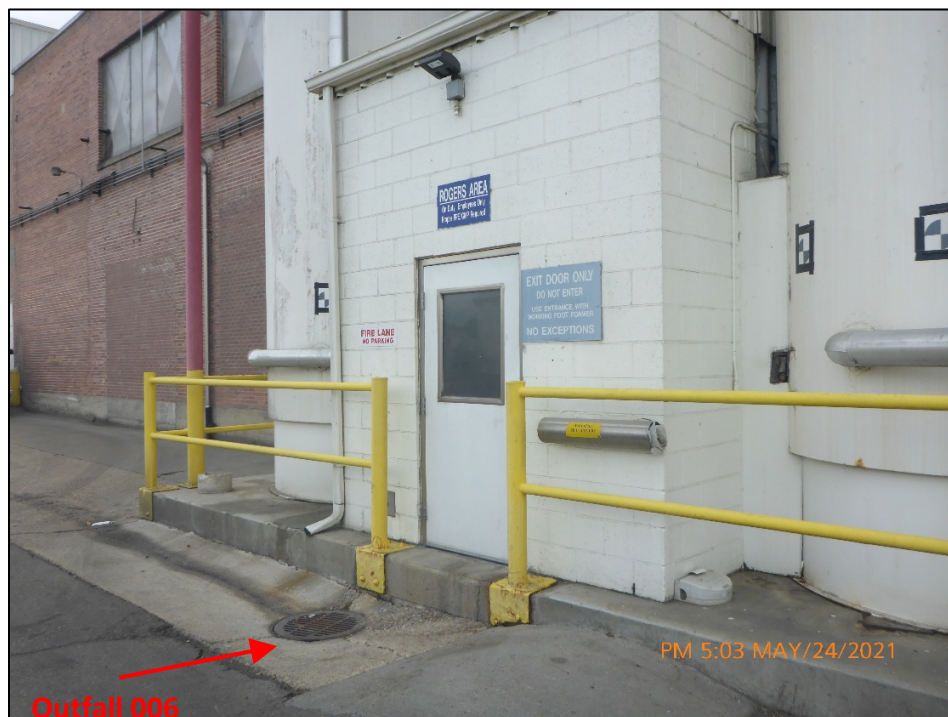
During the inspection, Mr. Algate stated that the Facility previously identified Outfall 006 on its 2015 MSGP NOI as substantially identical to Outfall 002, and therefore, had exempted the outfall from monitoring during the Permit term. However, he explained that the outfall was reassessed in 2020 during the 2021 MSGP NOI development and was determined not to be substantially identical due to its ability to receive spills from inside the main processing plant. Therefore, the Facility has included Outfall 006 as an outfall on its 2021 MSGP NOI. However, Facility conditions at this outfall had not changed since 2015; therefore, this outfall should have been monitored during the Permit term as it is not substantially identical to other outfalls that had been monitored during the Permit term (i.e., Outfalls 001, 002, and 005). Additionally, Section 2.2, Spills and Leaks, of the 2021 SWPPP does not identify the spill potential to Outfall 006 as identified by Mr. Algate during the inspection.

**Photograph 12.** View of the existing storm drain/outfall identified on the Facility's 2021 MSGP NOI as Outfall 006. Multiple inspection reports (starting with March 5, 2020 inspection) have identified a corrective action to berm this Facility entrance to prevent a spill of process water from inside the main production building from discharging to this storm drain; however, this corrective action had not been completed.

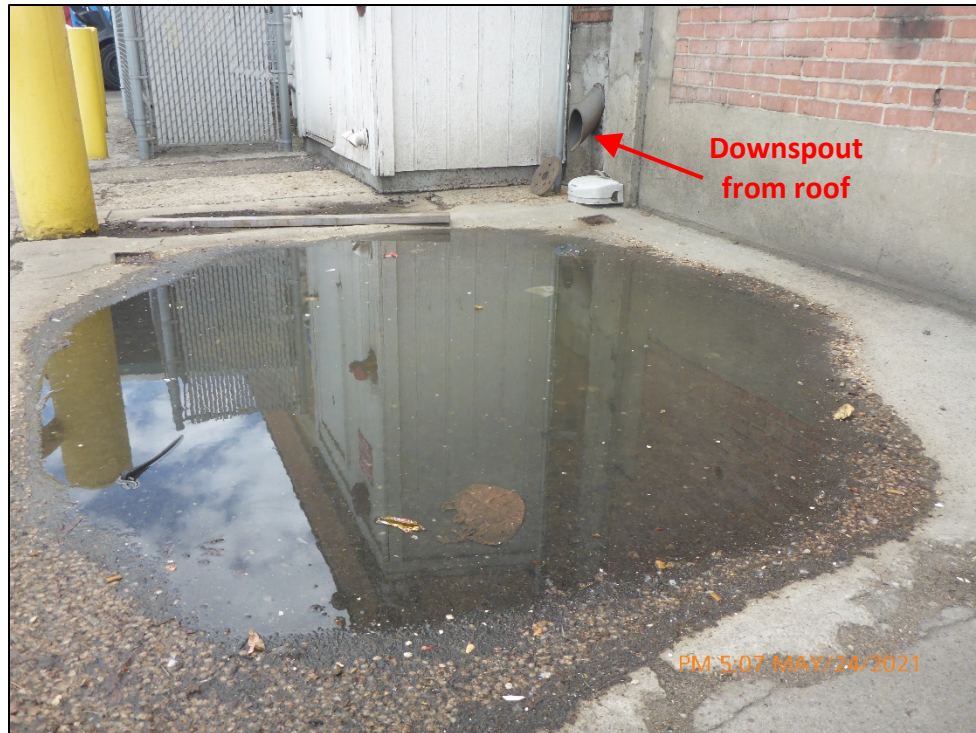
**Photograph 13.** View of a roof downspout that discharges to Outfall 006 shown in Photograph 12. Note the evidence of recent precipitation.

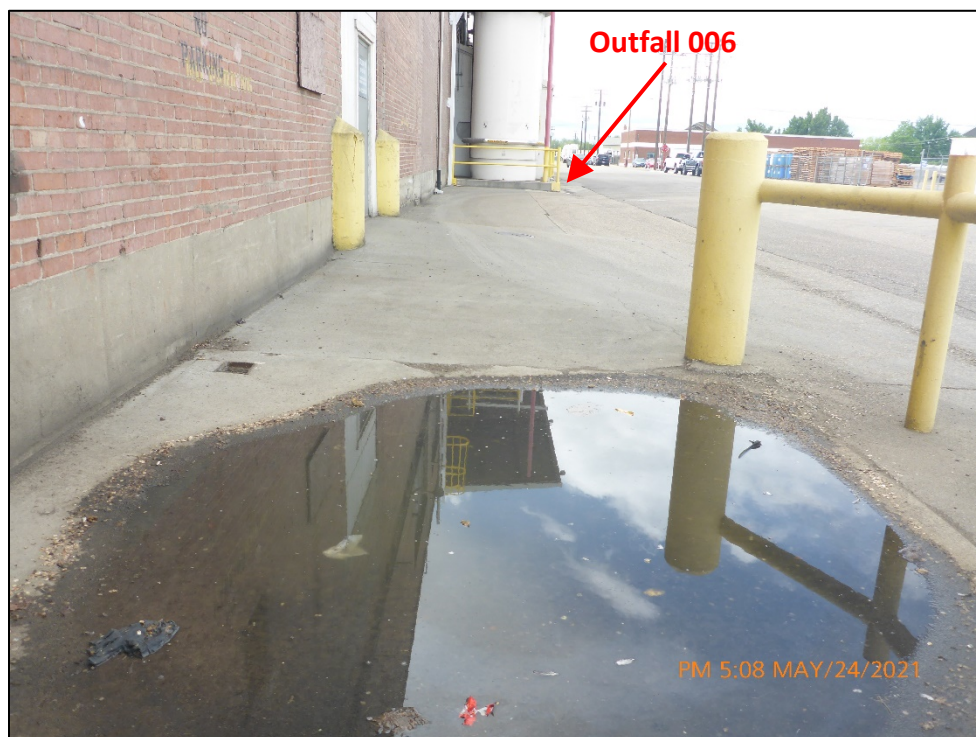
**Photograph 14.** View of the accumulated stormwater shown in Photograph 13. This portion of the Facility discharges to Outfall 006 shown in Photograph 12.

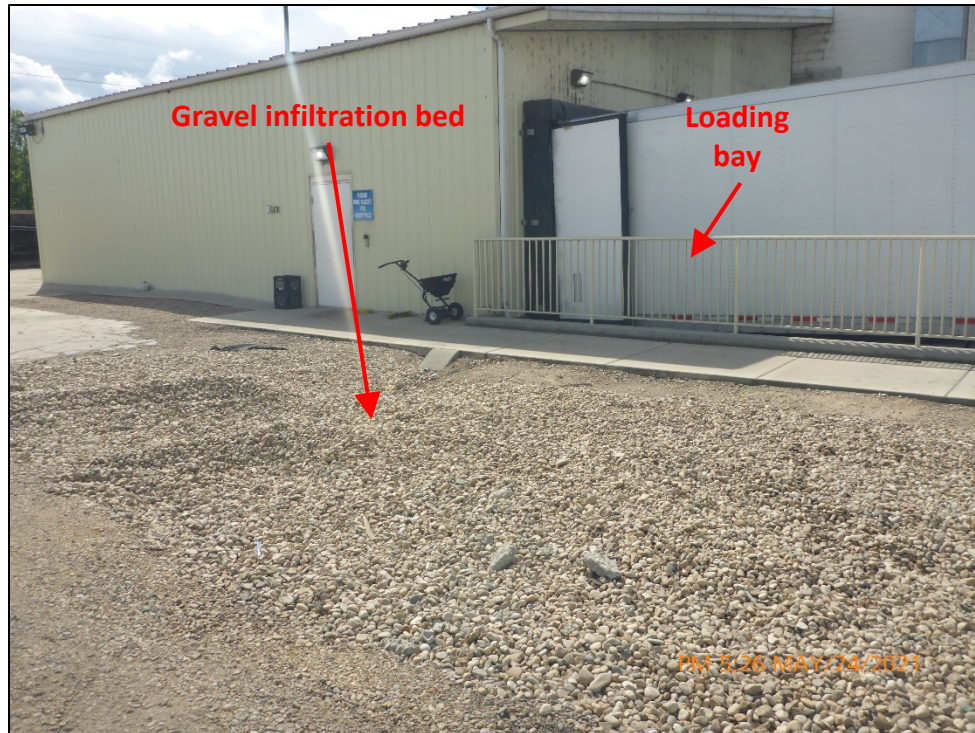
**Photograph 15.** View of the gravel infiltration bed which receives stormwater runoff from the adjacent loading bay storm drain (previously referred to by the Facility as Outfall 003).

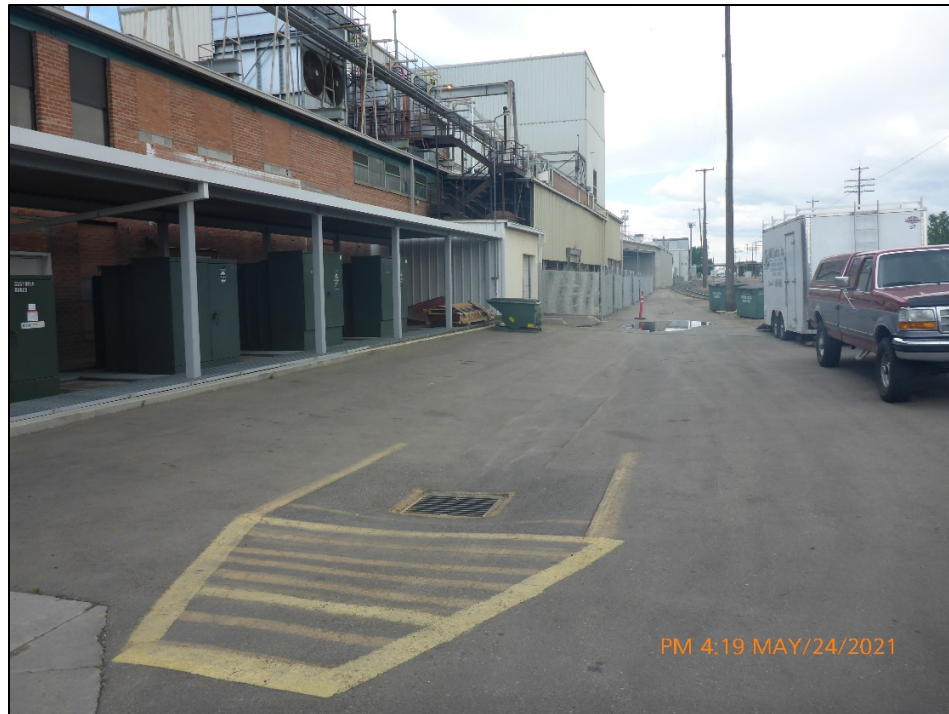
Furthermore, the Facility is also authorized to discharge process wastewater to the City of Caldwell publicly owned treatment works (POTW) under a significant Industrial User Discharge Permit issued by the City. The Inspection Team noted three storm drains in the northwest portion of the Facility that ultimately discharge to the Facility's wastewater equalization tank and subsequently to the City's POTW (refer to Photograph 17).

**Photograph 17.** View, facing southeast, of multiple storm drains along the southwestern side of the main production building that receive stormwater runoff and convey it to the Facility's wastewater treatment system. These are not identified on the SWPPP site maps.

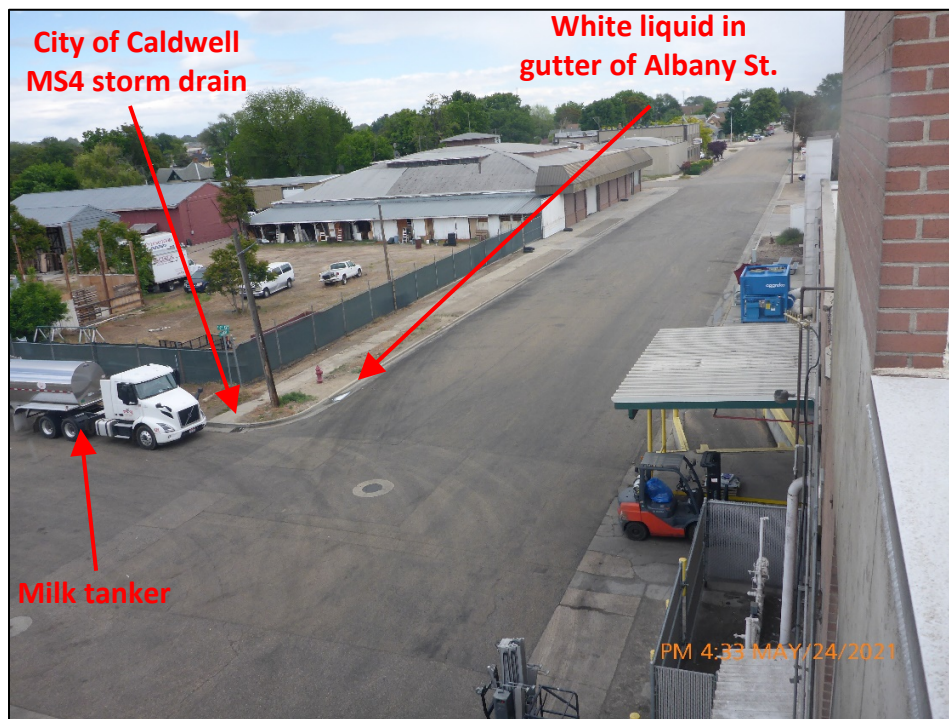
**Photograph 18.** View, facing east from the main processing building rooftop, of the intersection of Albany St. and N. 6<sup>th</sup> Ave. Note the milk tanker truck and the storm drain and white liquid shown in Photographs 19 through 25.

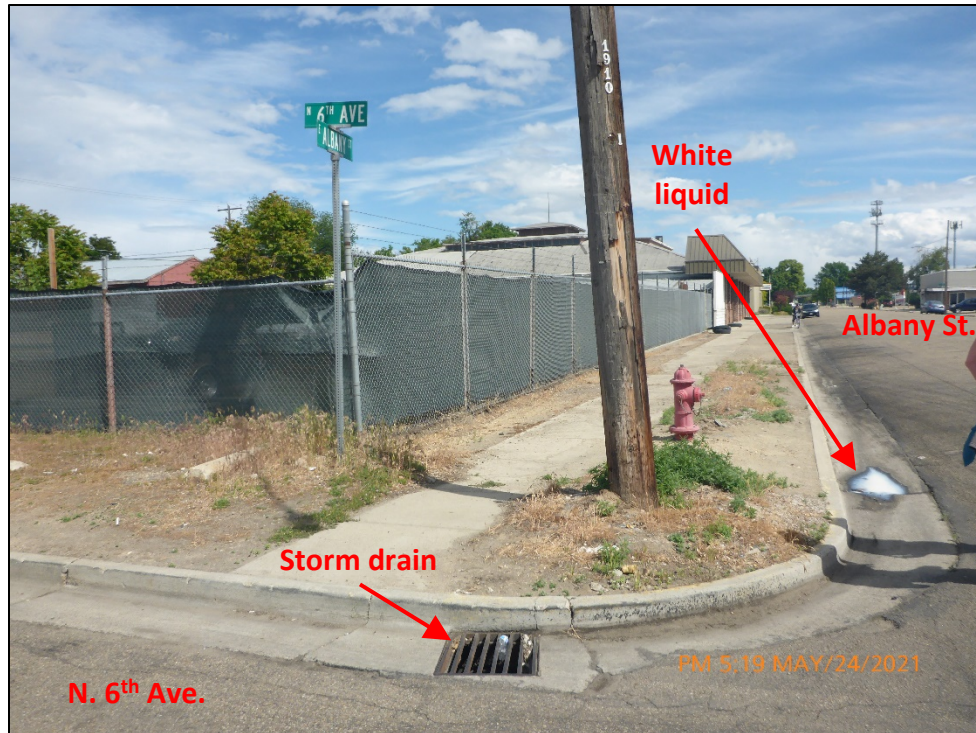
- a. We observed evidence of a previous non-stormwater discharge to an offsite storm drain on the east side of the intersection of Albany St. and N. 6<sup>th</sup> Ave. The date, time, and source of the potential non-stormwater discharge was undetermined during the inspection. Specifically, we observed a white liquid (consistent with the appearance of milk) and a dried, white chalky material in the curb and gutter line of Albany St. Additionally, we observed a white liquid on the pavement and in the curb and gutter line of N. 6<sup>th</sup> Ave. Furthermore, we observed a white liquid accumulated in the catch basin on the east side of the intersection of Albany St. and N. 6<sup>th</sup> Ave. (refer to Photographs 18 through 25). Mr. Algate stated he was unaware of any recent spills or releases that may have occurred near this storm drain. Clean-up efforts at this location were not initiated during the inspection.

**Photograph 19.** View, facing east, of a storm drain inlet at the east corner of Albany St. and N. 6<sup>th</sup> Ave. Note the white liquid in gutter line of Albany St. upgradient of storm drain inlet.

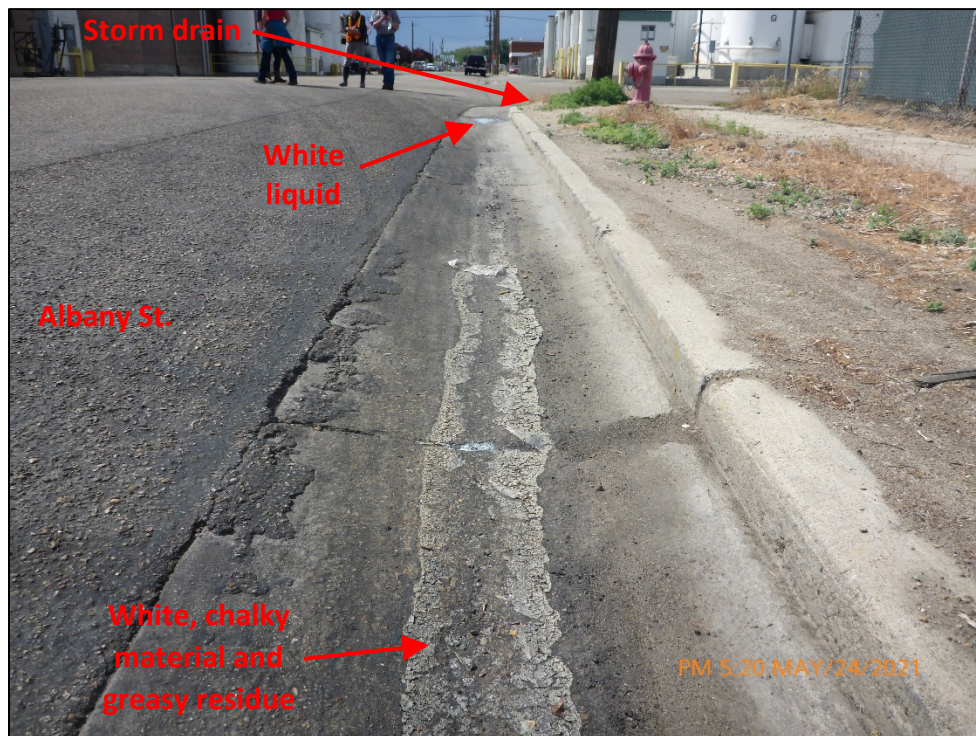
**Photograph 20.** View, facing northwest, of dried white, chalky material and greasy residue in gutter line of Albany St., upgradient of white liquid and storm drain shown in Photograph 19.

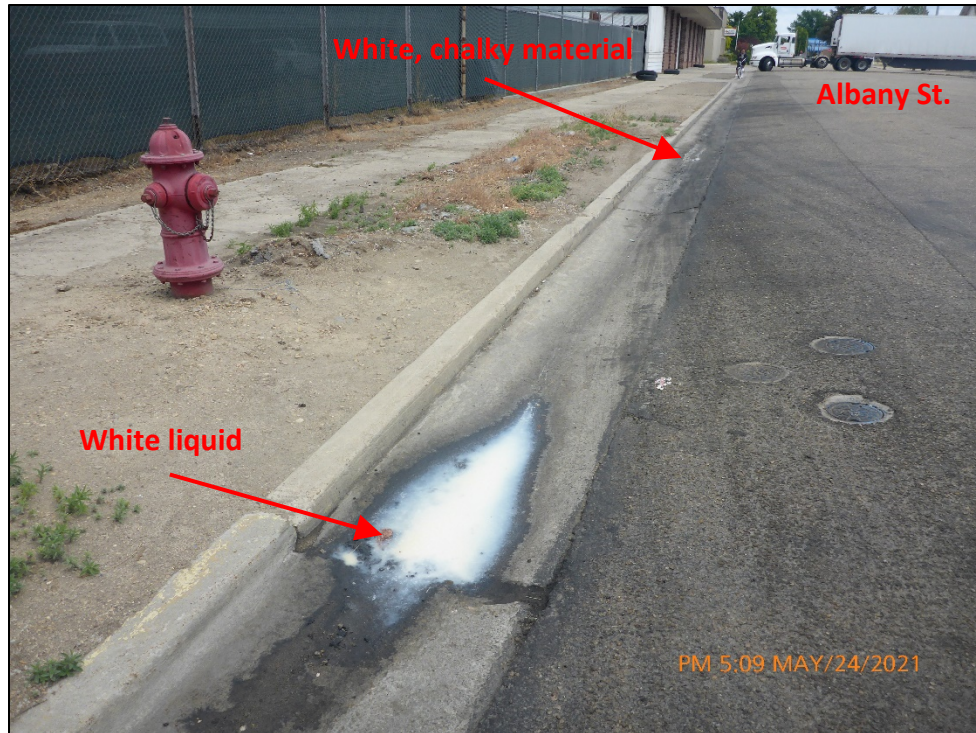
**Photograph 21.** Close-up view of white liquid in gutter line of Albany St. shown in Photographs 19 and 20. Also shown is dried white, chalky material and greasy residue in gutter line of Albany St., shown in Photograph 20.

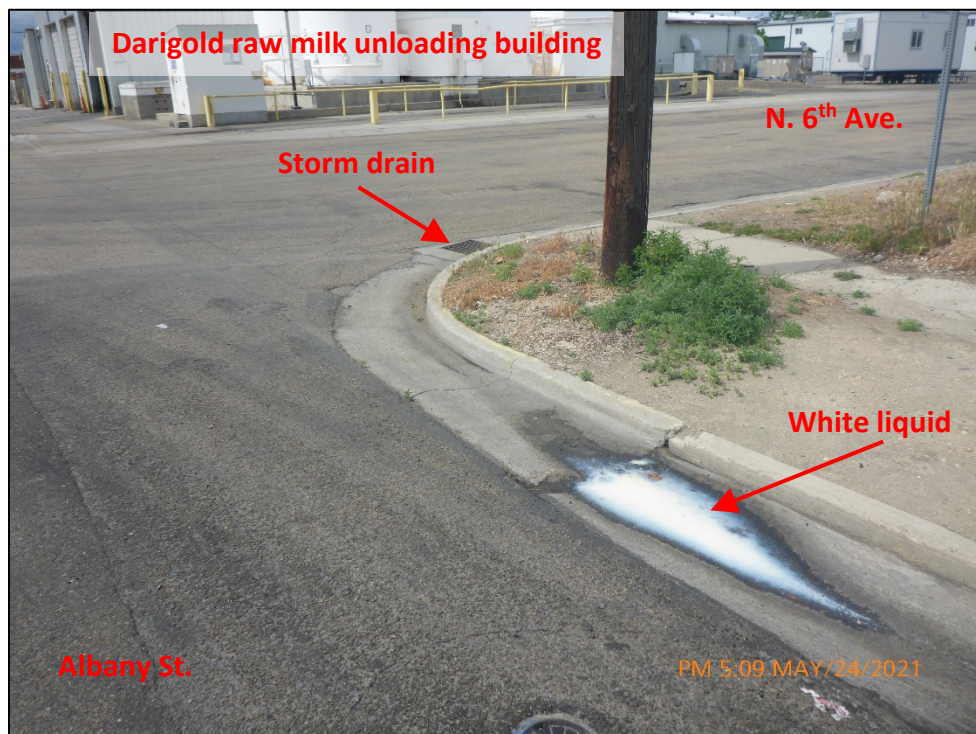
**Photograph 22.** Additional view, facing northwest, of white liquid in gutter line of Albany St., upgradient of the storm drain at Albany St. and N. 6<sup>th</sup> Ave, shown in Photographs 19 through 21.

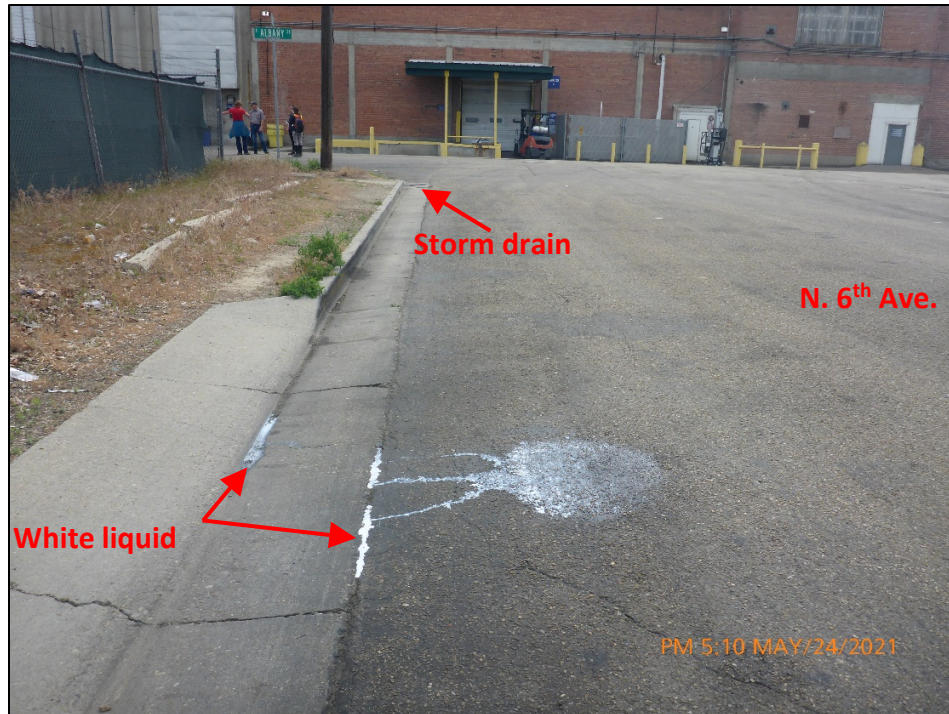
**Photograph 23.** View, facing southwest, of a white liquid in the gutter line of N. 6<sup>th</sup> Ave., upgradient of the storm drain inlet at the intersection of Albany St. and N. 6<sup>th</sup> Ave., shown in Photographs 19, 20, and 22. A milk tanker truck shown in Photo 18 is parked at this location.

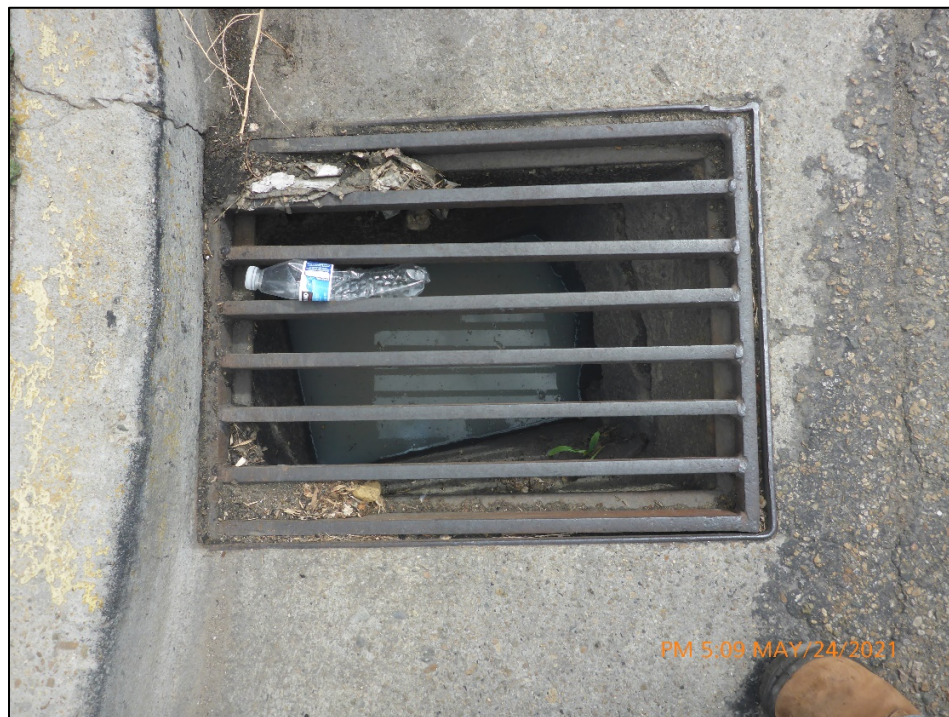
**Photograph 24.** Close-up view of the storm drain inlet at Albany St. and N. 6<sup>th</sup> Ave. shown in Photographs 19, 20, 22, and 23. Note the trash in the grate inlet and the white liquid in the storm drain catch basin.

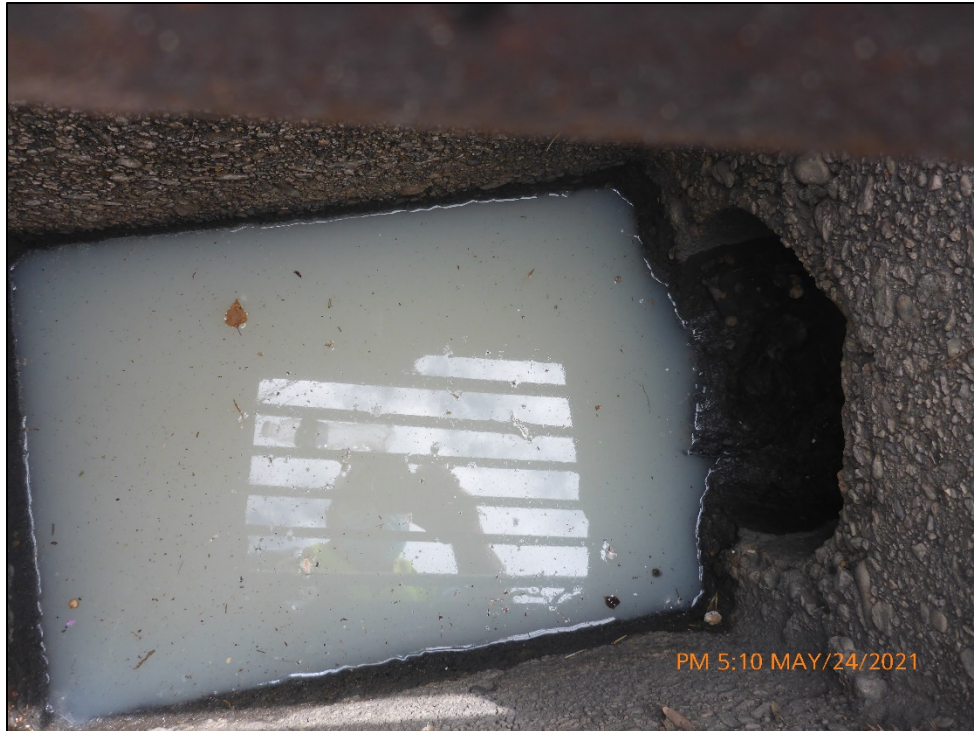
**Photograph 25.** Close-up view of white liquid in the catch basin of the storm drain at Albany St. and N. 6<sup>th</sup> Ave. shown in Photographs 19, 20, 22, 23, and 24.

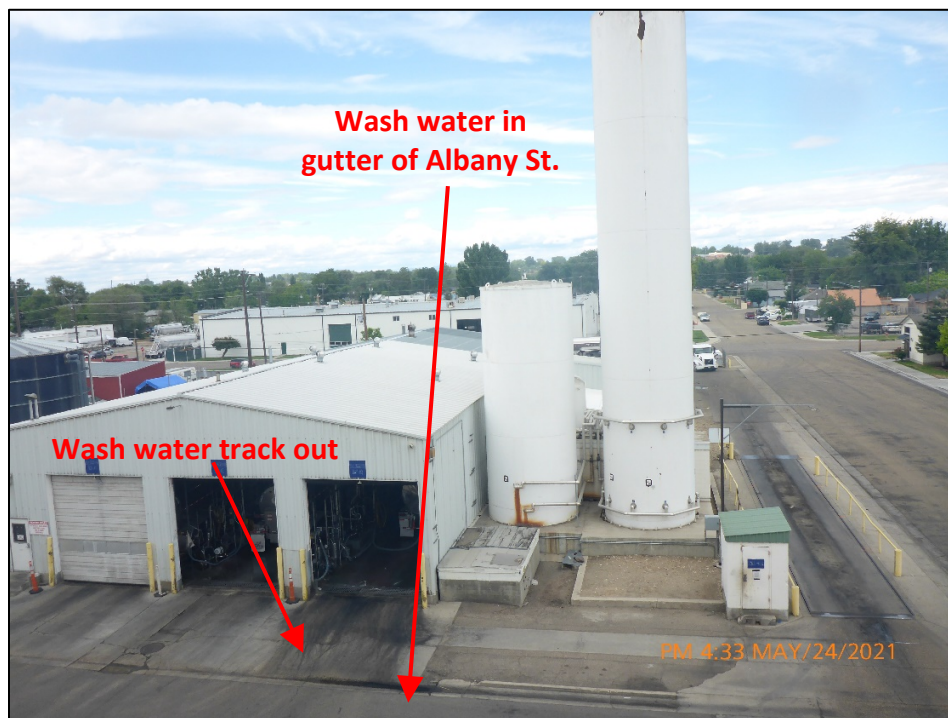
- b. We observed evidence of wash water from the Facility's tanker loading/unloading building in the curb and gutter line of Albany St. (refer to Photographs 26 through 28). It appeared that wash water track out from tanker truck traffic out of the building was

**Photograph 26.** View, facing northeast from the main production building rooftop, of the milk tanker loading/unloading building on the northeast side of Albany St. (eastern parcel). Note the wash water track out and accumulated wash water in the gutter line of Albany St.

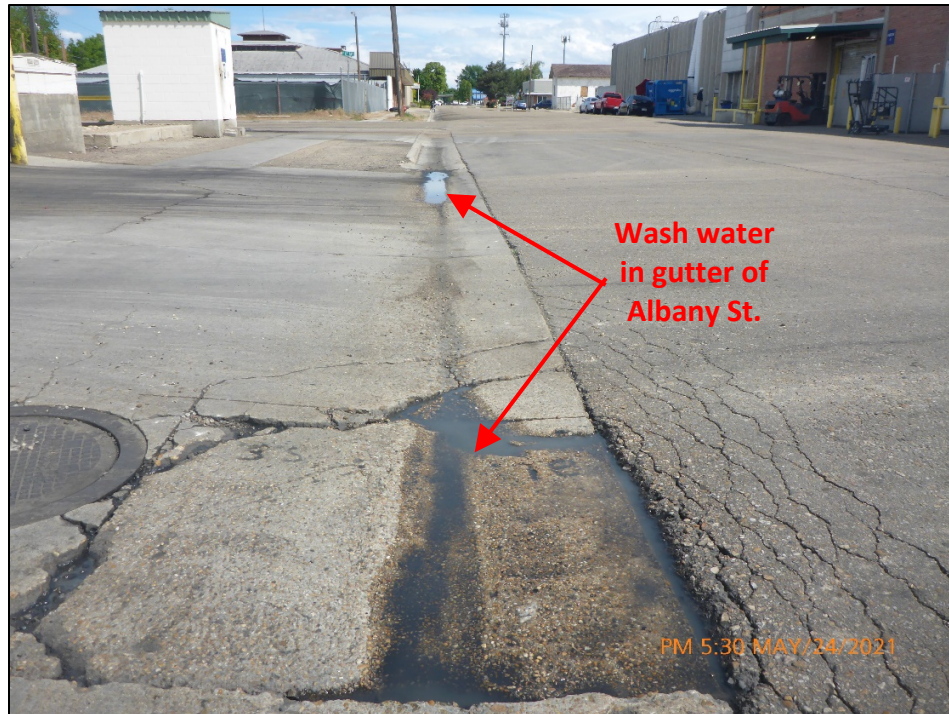
**Photograph 27.** Close-up view of the wash water in the gutter line of Albany St. as shown in Photograph 26.

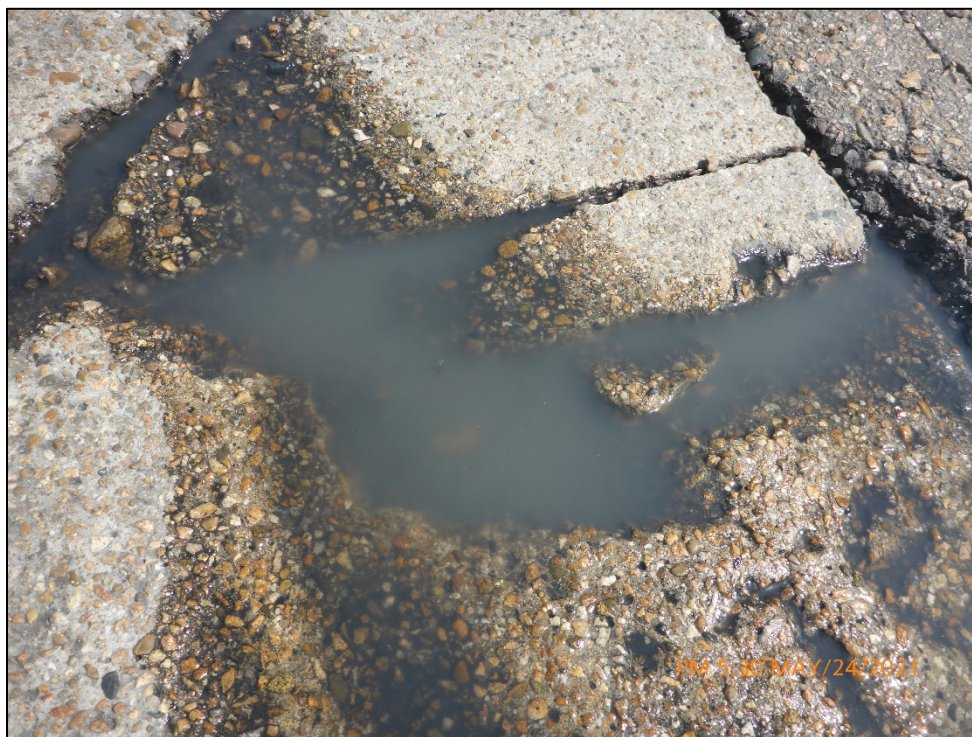
**Photograph 28.** Additional close-up view of the wash water in the gutter line of Albany St. as shown in Photographs 26 and 27.

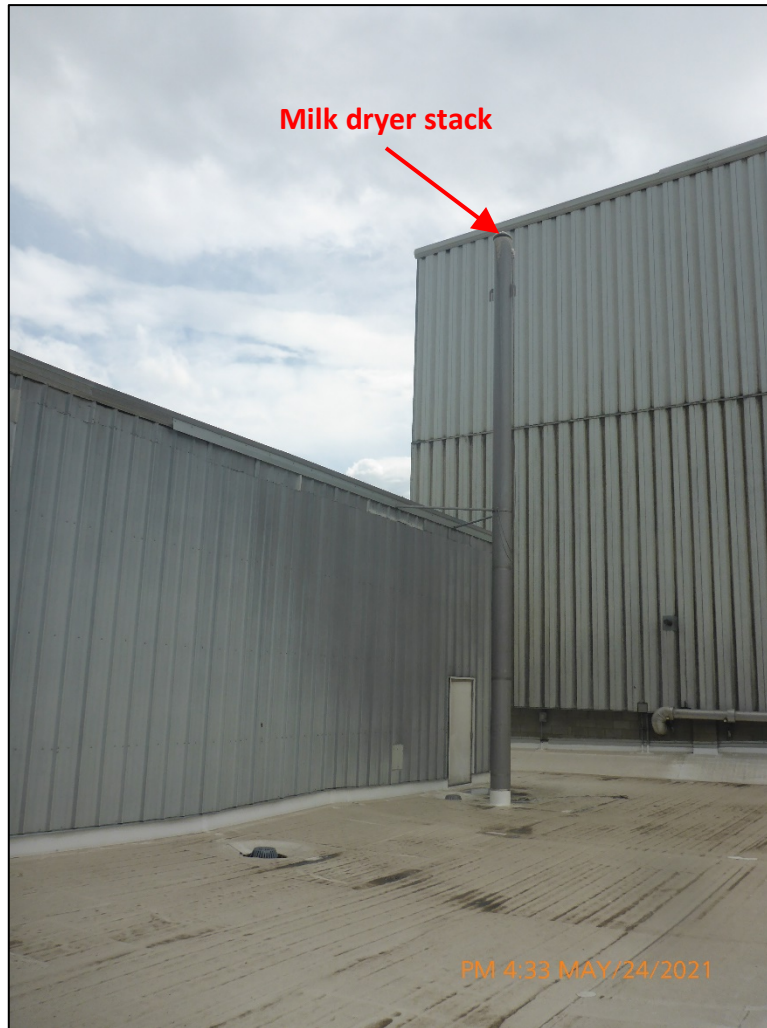
- c. We observed a powdery residue on the roof of the main processing building. Mr. Algate confirmed the residue to be milk powder released from the stacks and receiving vents associated with the Facility’s two milk dryers. We also observed that puddles of stormwater present on the roof near the stacks and receiving vents were cloudy and white (refer to Photographs 29 through 32). Mr. Algate confirmed that runoff from the roof around the milk dryer stacks and baghouses drains through downspouts that ultimately flow to Outfalls 001, 002, and 006. He added that a third-party vendor has been contracted to sweep and wash the roof of the main processing building quarterly (identified in Section 3.1.1 of the 2021 SWPPP). Following the inspection, Mr. Algate confirmed that the roof was last washed in March of 2021, as well as in September of 2020, but was not washed in Quarter 4 of 2020 due to safety concerns. When asked about disposal methods for roof wash water, Mr. Algate stated that he was unsure but that wash water is most likely allowed to flow down the building downspouts and discharge to the Facility’s outfalls.

**Photograph 29.** View of a stack that services one of the Facility's two milk dryers. Powdery residue accumulated on the roof was attributed to milk powder released from this stack, as well as other stacks and receiving vents in this portion of the main production plant roof.

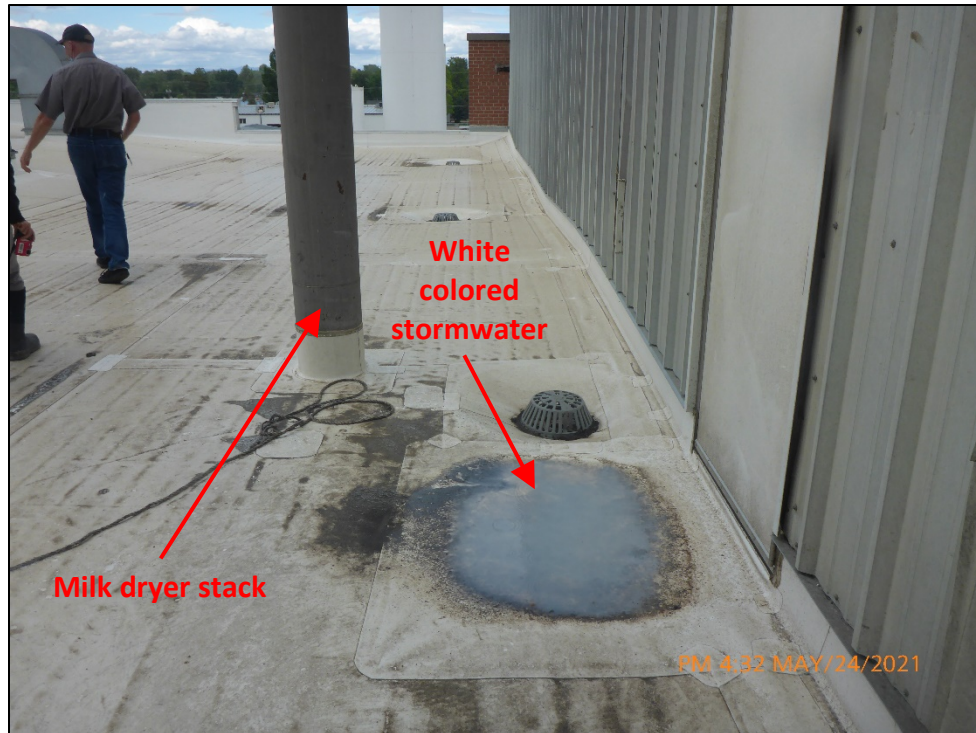
**Photograph 30.** View of white-colored stormwater on the roof of the main production plant, adjacent to the stack shown in Photograph 29.

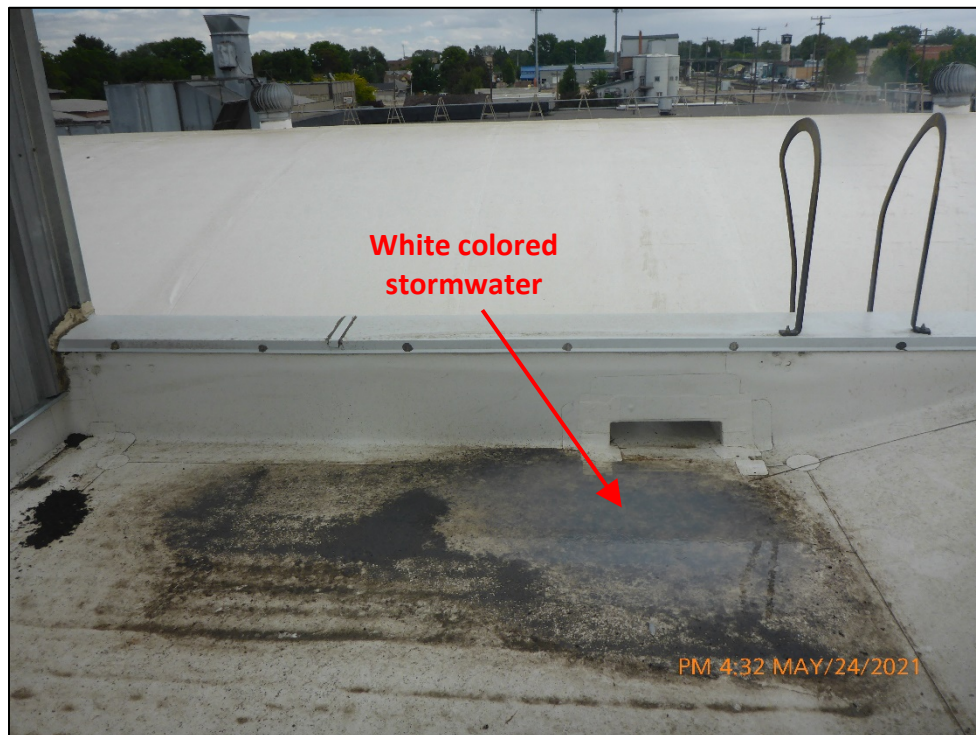
**Photograph 31.** View of white-colored stormwater on the roof of the main production plant, adjacent to the stack shown in Photograph 29.

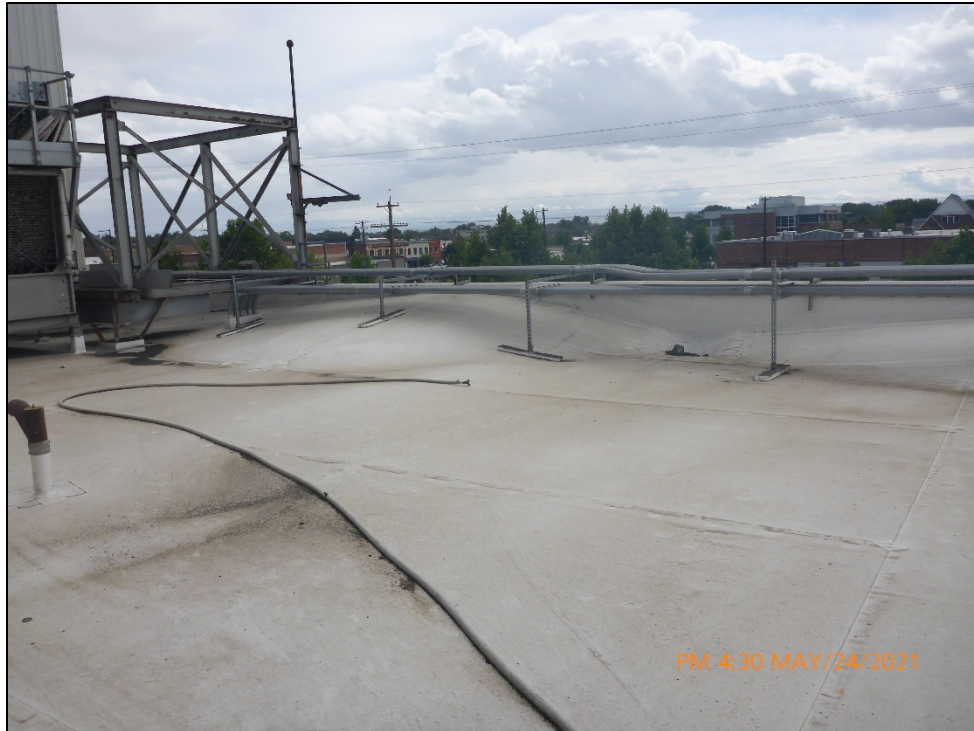
**Photograph 32.** View of the roof of the main production building. Milk powder residue and dust was observed on the roof in this location.

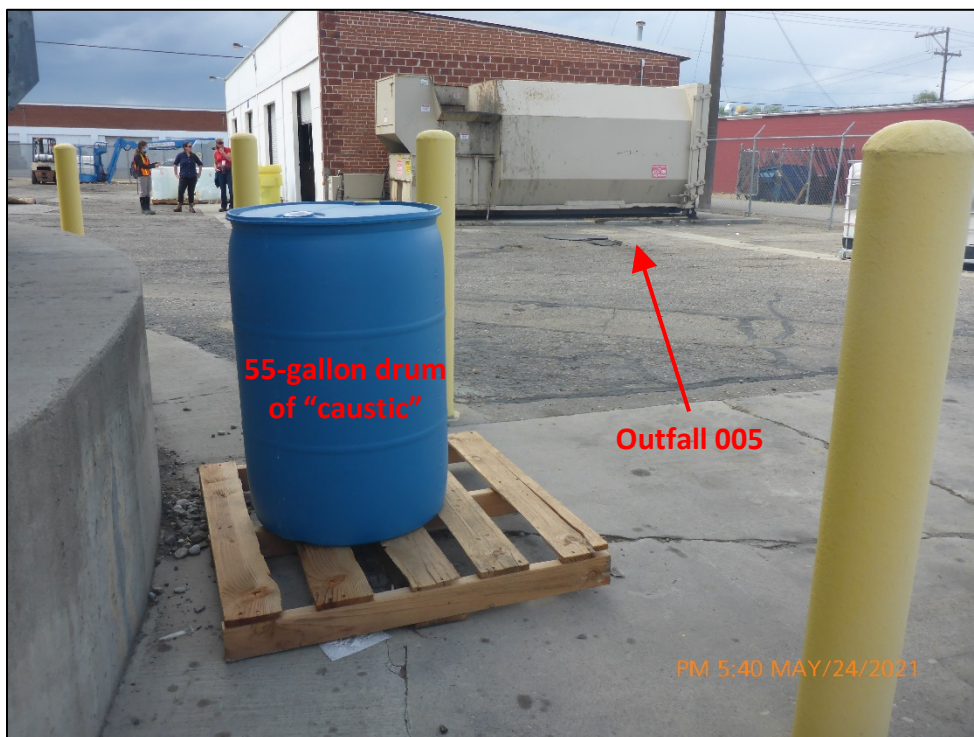
- e. We observed an uncovered, uncontained 55-gallon drum labeled only as “caustic” located upgradient of Outfall 005 (refer to Photographs 33). Another full 55-gallon drum observed immediately outside of the bulk chemical storage building (but within a contained area) was labeled with a blank hazardous waste label (refer to Photographs 34 and 35). Mr. Algate stated that he believed the label was added by mistake and that it was new sanitizing chemical like the others. Section 3.1.2, Good Housekeeping – Container Storage, states, “All containers are labeled to show the name and type of substance, stock number, expiration date, health hazards, suggestions for handling, and first aid information ("Right to Know" program).”

**Photograph 33.** View of an uncovered, uncontained 55-gallon drum labeled as "caustic" located upgradient of Outfall 005.

Following the inspection, on May 26, 2021, Mr. Algate emailed the Inspection Team informing us that the 55-gallon drums observed near the wastewater equalization tank and immediately outside the bulk chemical storage building had been moved inside the building, and that the missing bung cap had been replaced.
