**INSPECTION REPORT**

| <b>Inspection Date:</b> | 05/24/2021 | |
| <b>Regulatory Program:</b> | CWA NPDES/Industrial Stormwater | |
| <b>Facility Name:</b> | Darigold Caldwell Facility | |

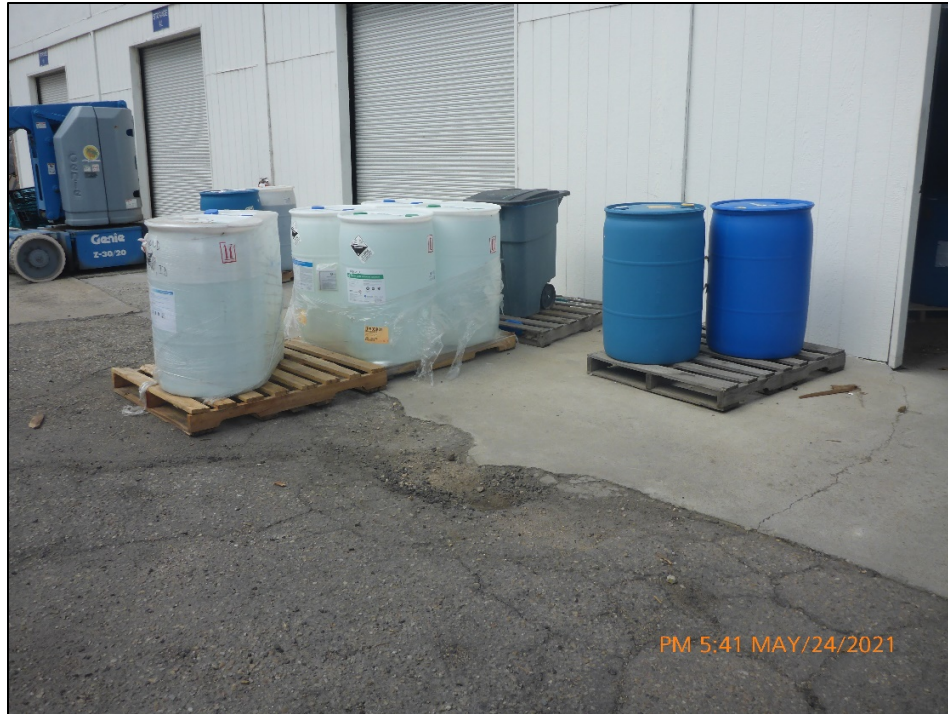
- e. We observed an uncovered, uncontained 55-gallon drum labeled only as “caustic” located upgradient of Outfall 005 (refer to Photographs 33). Another full 55-gallon drum observed immediately outside of the bulk chemical storage building (but within a contained area) was labeled with a blank hazardous waste label (refer to Photographs 34 and 35). Mr. Algate stated that he believed the label was added by mistake and that it was new sanitizing chemical like the others. Section 3.1.2, Good Housekeeping – Container Storage, states, “All containers are labeled to show the name and type of substance, stock number, expiration date, health hazards, suggestions for handling, and first aid information ("Right to Know" program).”

**Photograph 34.** View of multiple 55-gallon drums of sanitizing chemical stored outside of the bulk chemical storage building in the eastern parcel. The drum on the left had a blank hazardous waste label, as depicted in Photograph 35.

Following the inspection, on May 26, 2021, Mr. Algate emailed the Inspection Team informing us that the 55-gallon drums observed near the wastewater equalization tank and immediately outside the bulk chemical storage building had been moved inside the building, and that the missing bung cap had been replaced.

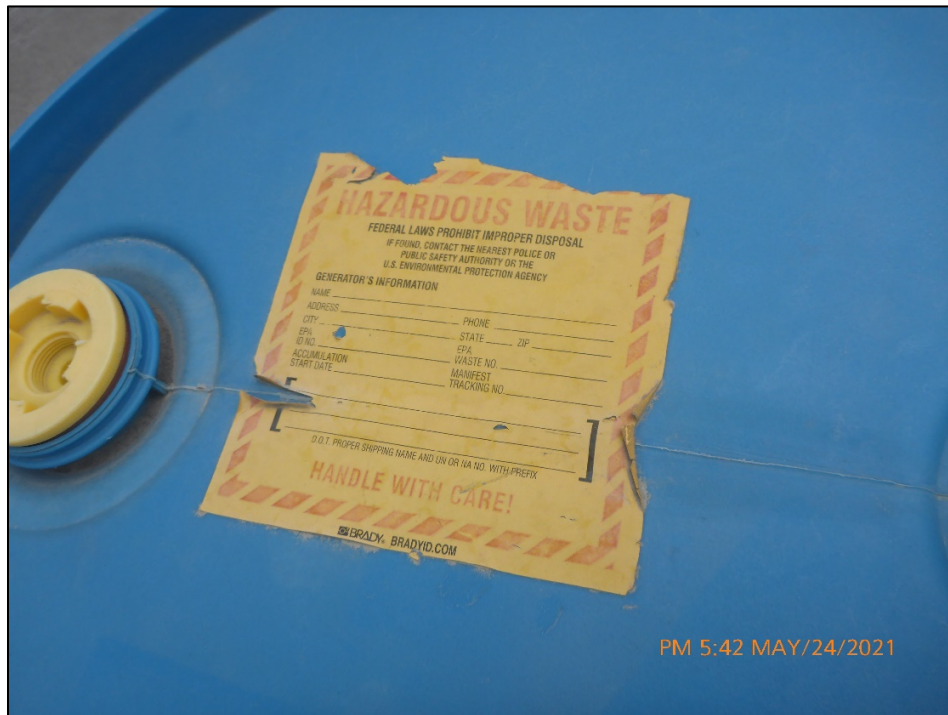
**Photograph 35.** View of a hazardous waste label on one of the full 55-gallon drums shown in Photograph 34.

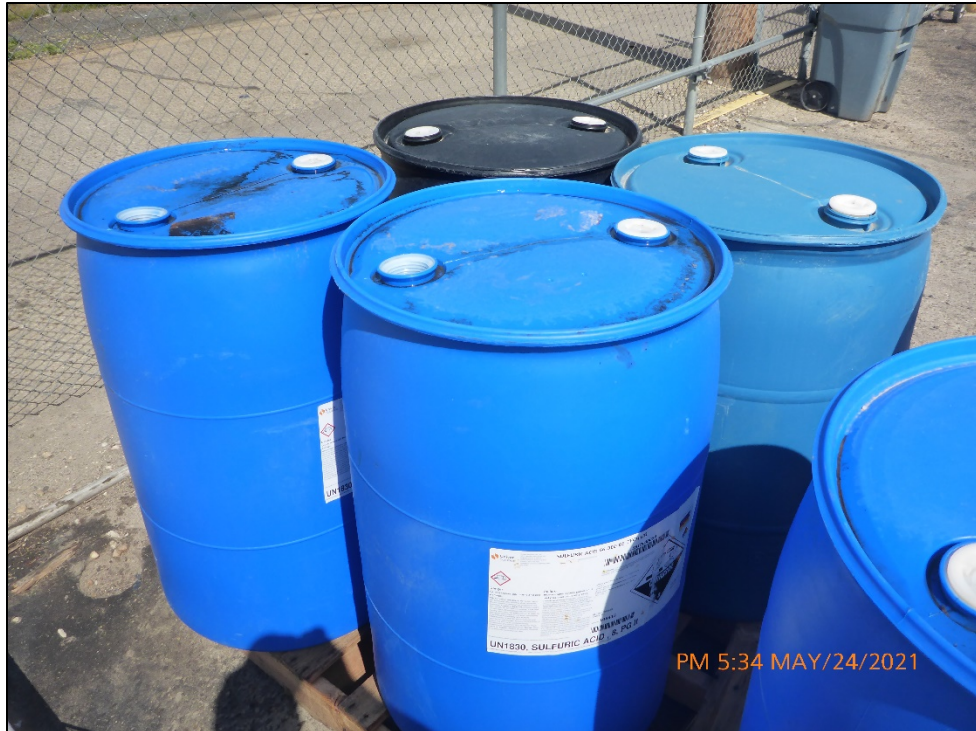
Additionally, we observed the empty 55-gallon drum storage area located in the eastern parcel of the Facility, upgradient of Outfall 005. One of the bung caps on an empty 55-

gallon drum of sulfuric acid was missing (refer to Photographs 36 and 37). Section 3.1.1 of the SWPPP states “Empty 55-gallon drums are rinsed indoors and recapped before they are stored outside.”

**Photograph 36.** View of empty 55-gallon drums stored outside near the wastewater treatment system and Outfall 005. Note one of the drums did not have a bung cap in place.

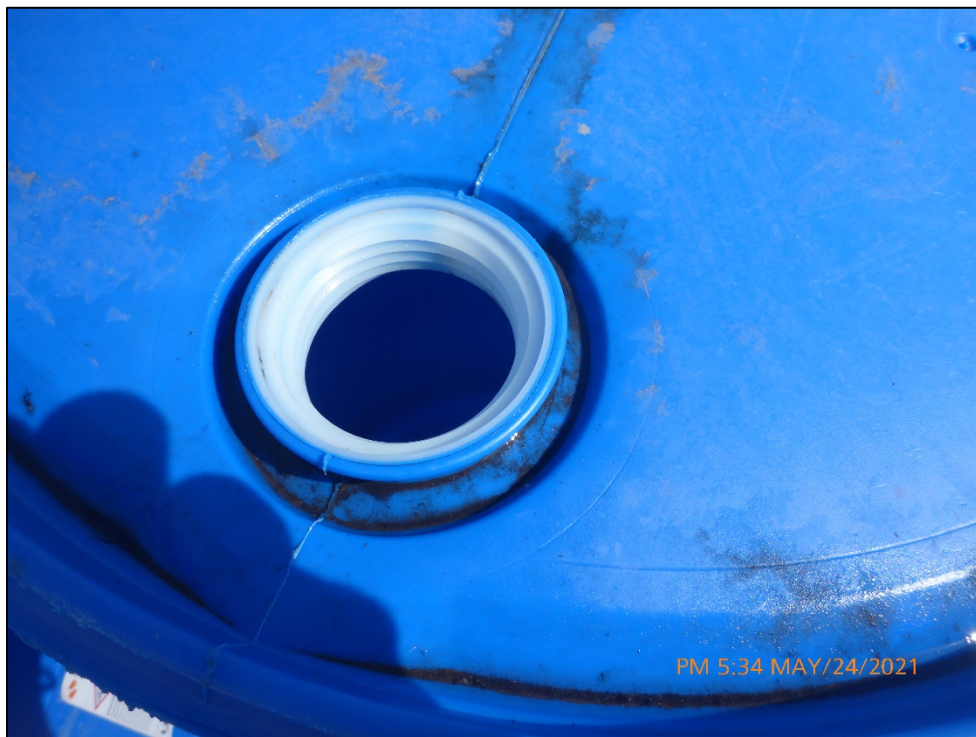
**Photograph 37.** Close-up view of the empty 55-gallon drum without a bung cap in place, as shown in Photograph 36.

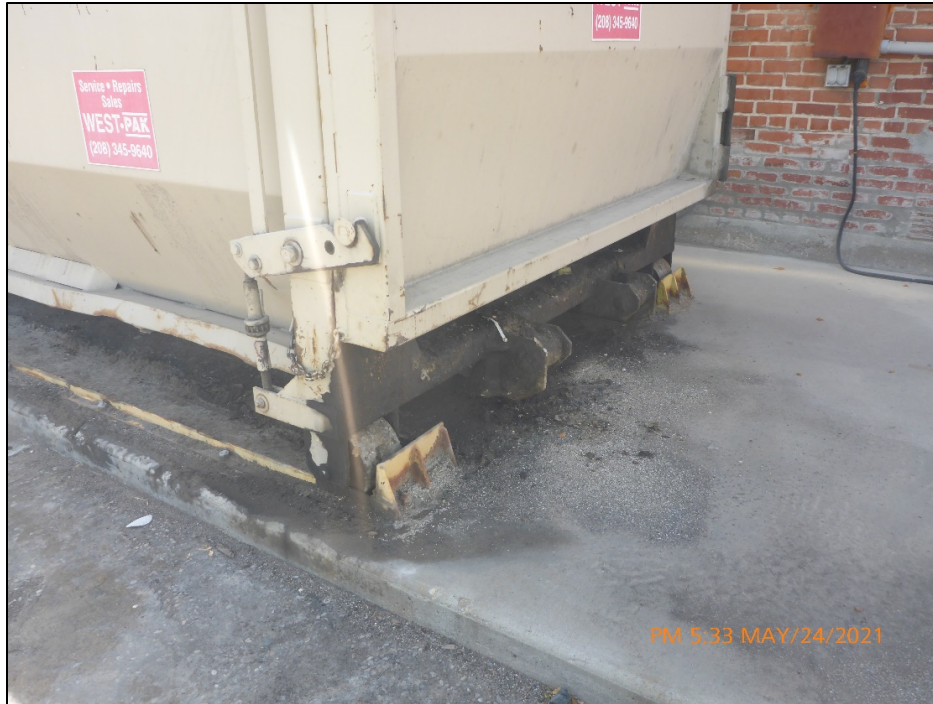
- f. We observed evidence of leaking fluid on the impervious surface around the trash compactor located immediately adjacent to Outfall 005. Specifically, absorbent material had been applied underneath the trash compactor and dark staining was observed on the impervious surface surrounding the compactor (refer to Photographs 38 and 39). Section 2.2, Spills and Leaks, of the SWPPP identifies the trash compactor as an area of the Facility where potential spills/leaks could occur; however, the Control Measures section of the SWPPP does not identify how spills/leaks in this location will be prevented or remediated.

**Photograph 38.** View of dark staining on the impervious surface under the Facility's trash compactor located immediately upgradient of Outfall 005, as shown in Photograph 10 and 33. Note the absorbent material that had previously been applied to fluid underneath the compactor but which had not been cleaned up at the time of the inspection.

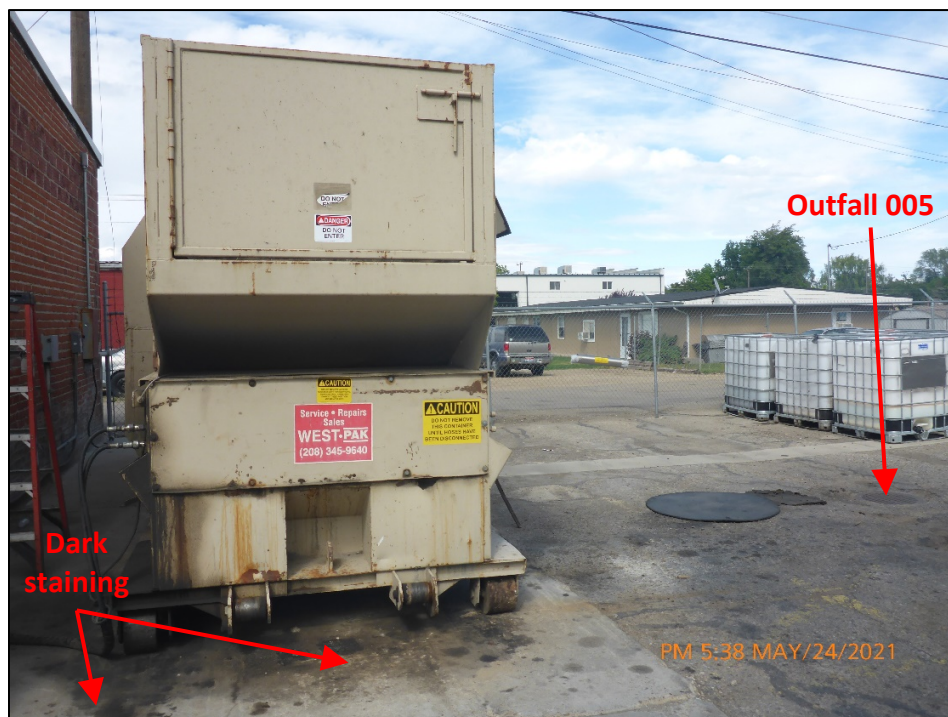
**Photograph 39.** View, facing east, of dark staining on the impervious surface underneath the trash compactor upgradient of Outfall 005, shown in Photographs 10, 33, and 38.

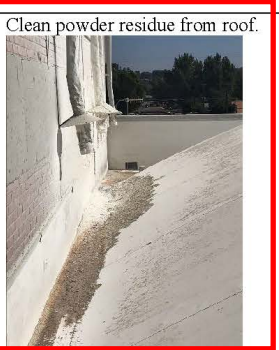
**Exhibit 3.** Page 2 of 5. Stormwater Industrial Routine Facility Inspection Report, dated September 10, 2020. This report identifies a corrective action to “clean powder residue from roof” (page 2).

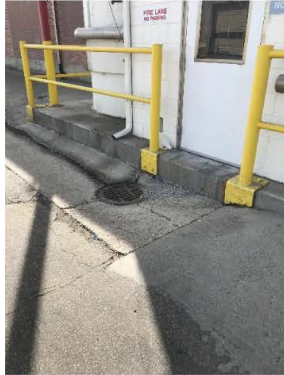
We need to move entrance to this SW manhole to the East and seal this opening. Remove the berm to allow process water from the building to flow to the process drain located to the West of this SW drain in the event there is a release from this door.
