## Clean Water Act Section 404: Site Visit/Case Development

| Site Name | Henry Brick Company, Inc. (Claude Jack Mine) | | | | |

**Henry Brick Company, Inc. - Claude Jack Mine**  
**Selma, Dallas County, Alabama**  
**January 22, 2024**

### Henry Brick Company, Inc. Claude Jack Mine Site Inspection Photographic Log

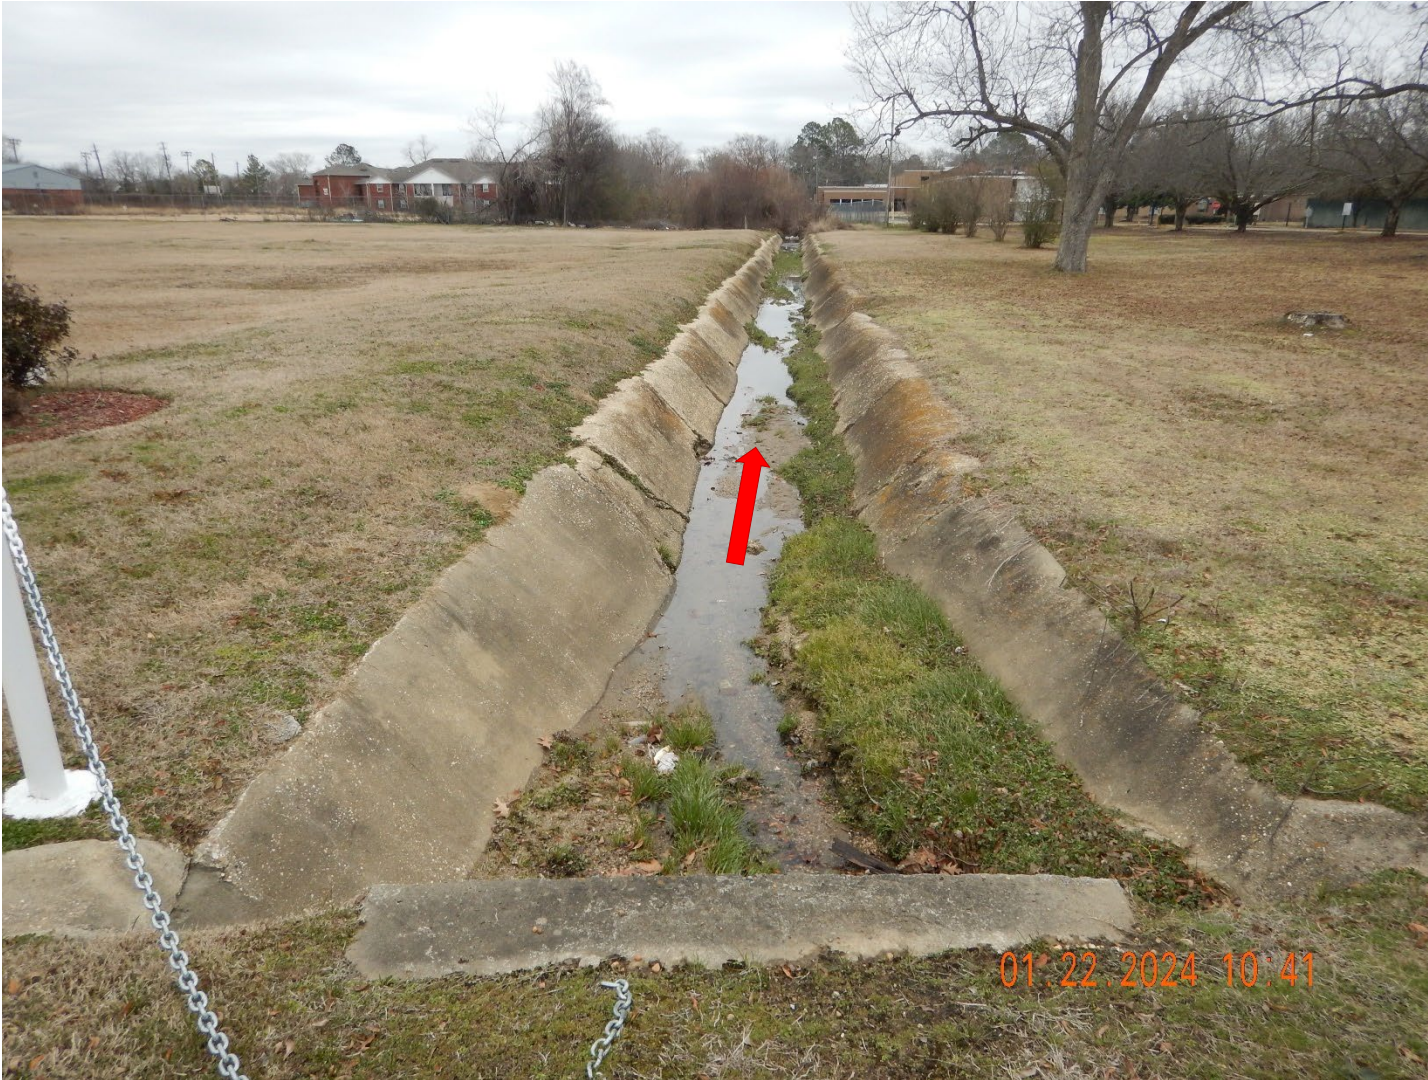
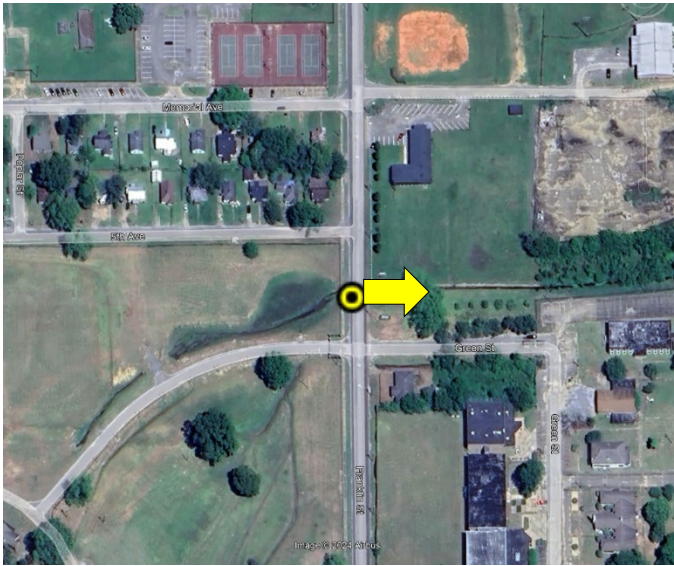
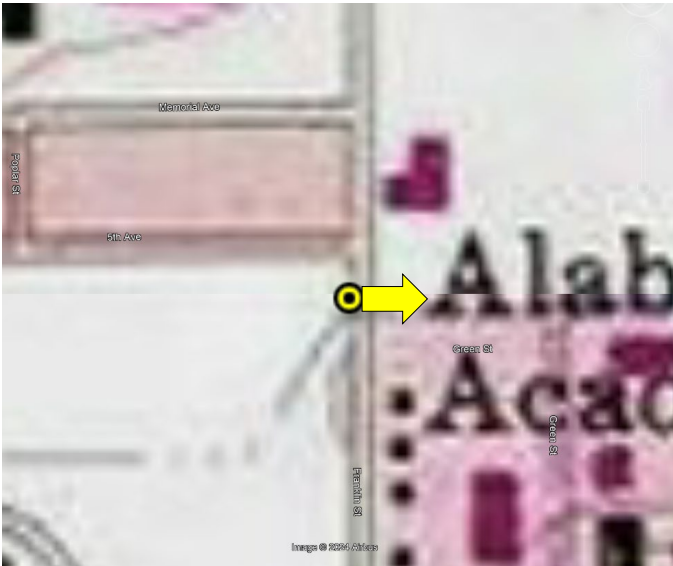
| Title | Photo 1 |

| Description | Striking east, downstream. Tributary (relatively permanent water, "RPW") site-side of Franklin Street. Beginning of channelization. Red arrow in top photo indicates direction of flow. |

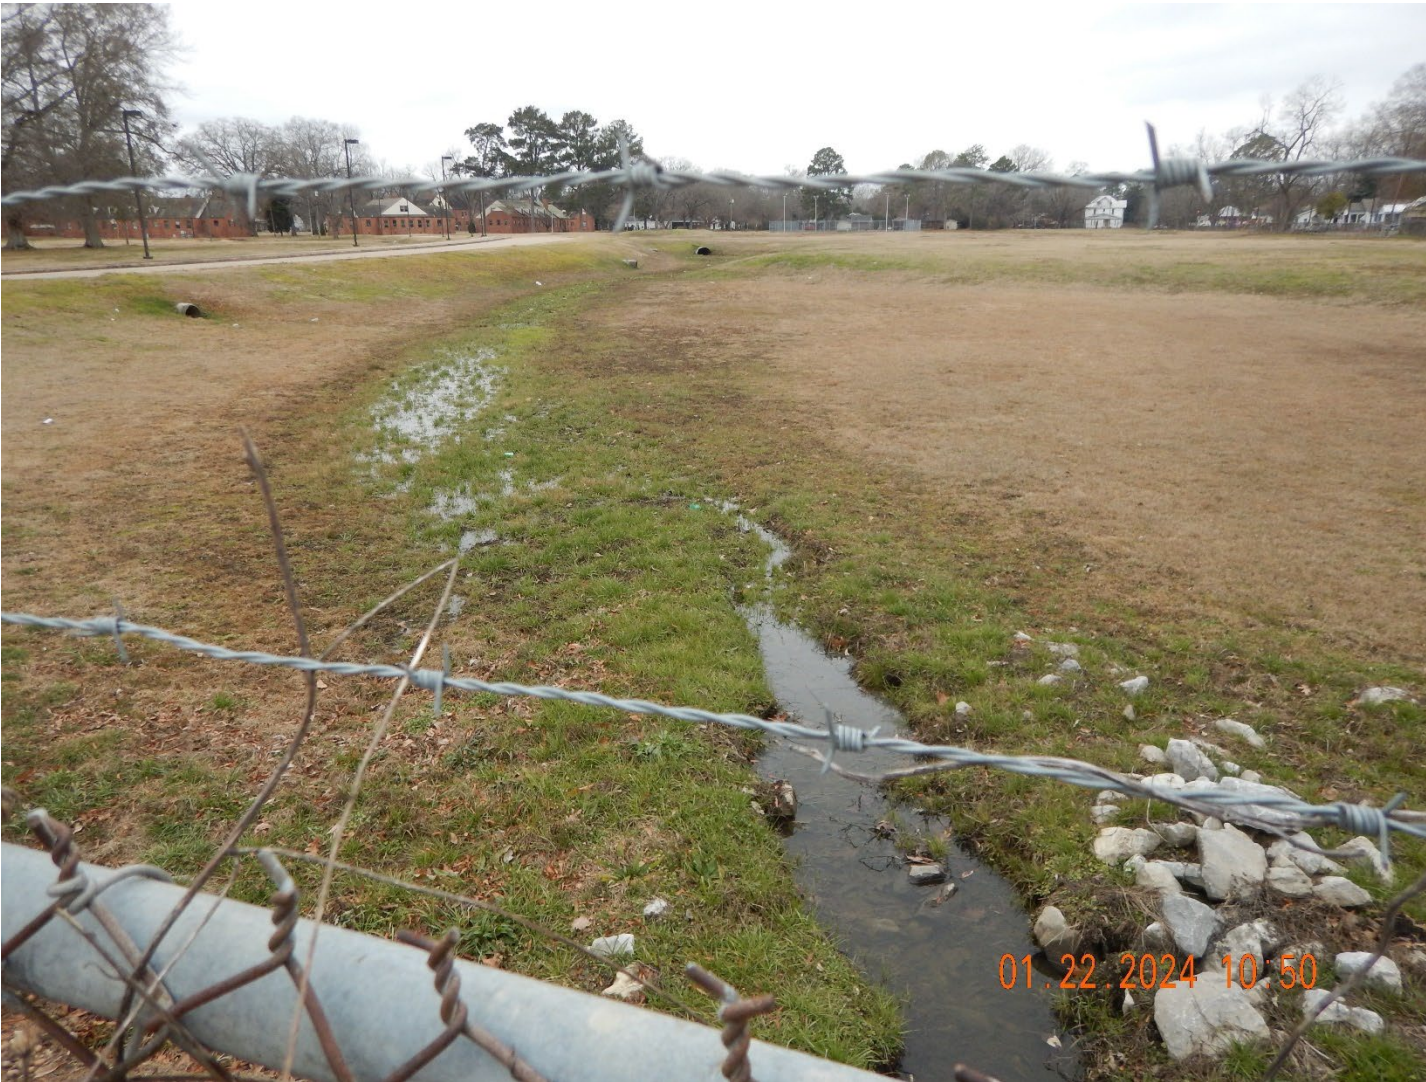
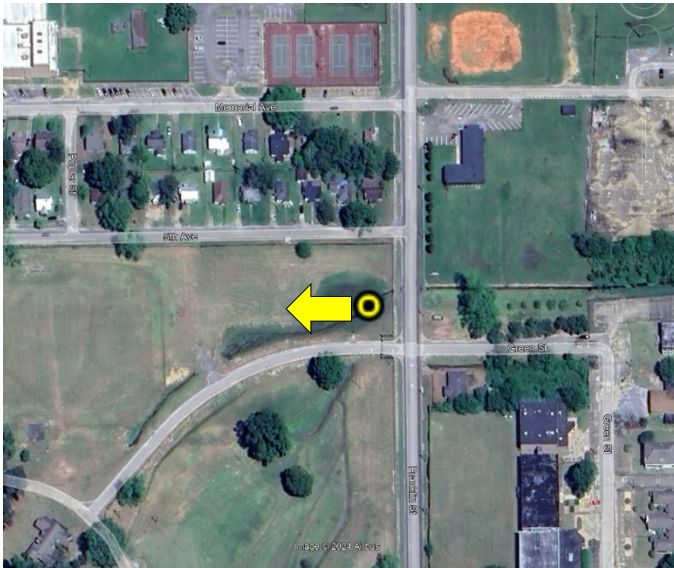
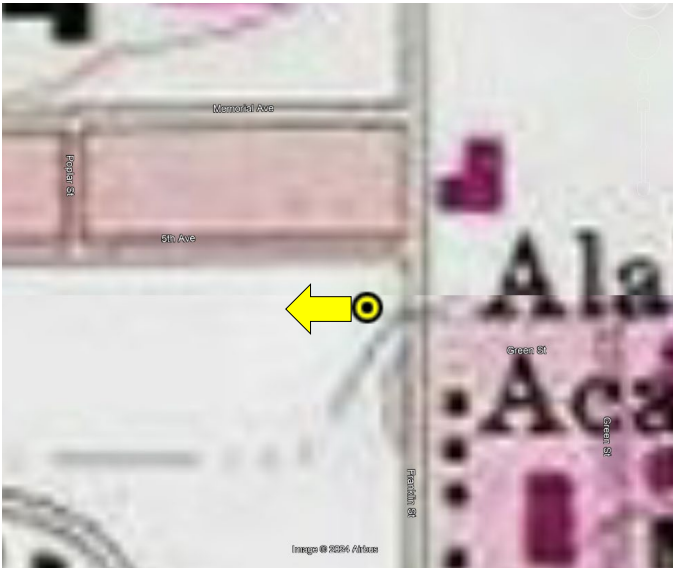
| Title | Photo 2 |

| Description | Striking west, upstream. RPW on opposite side of Franklin Street. Culverted under road. No directional flow observed. |

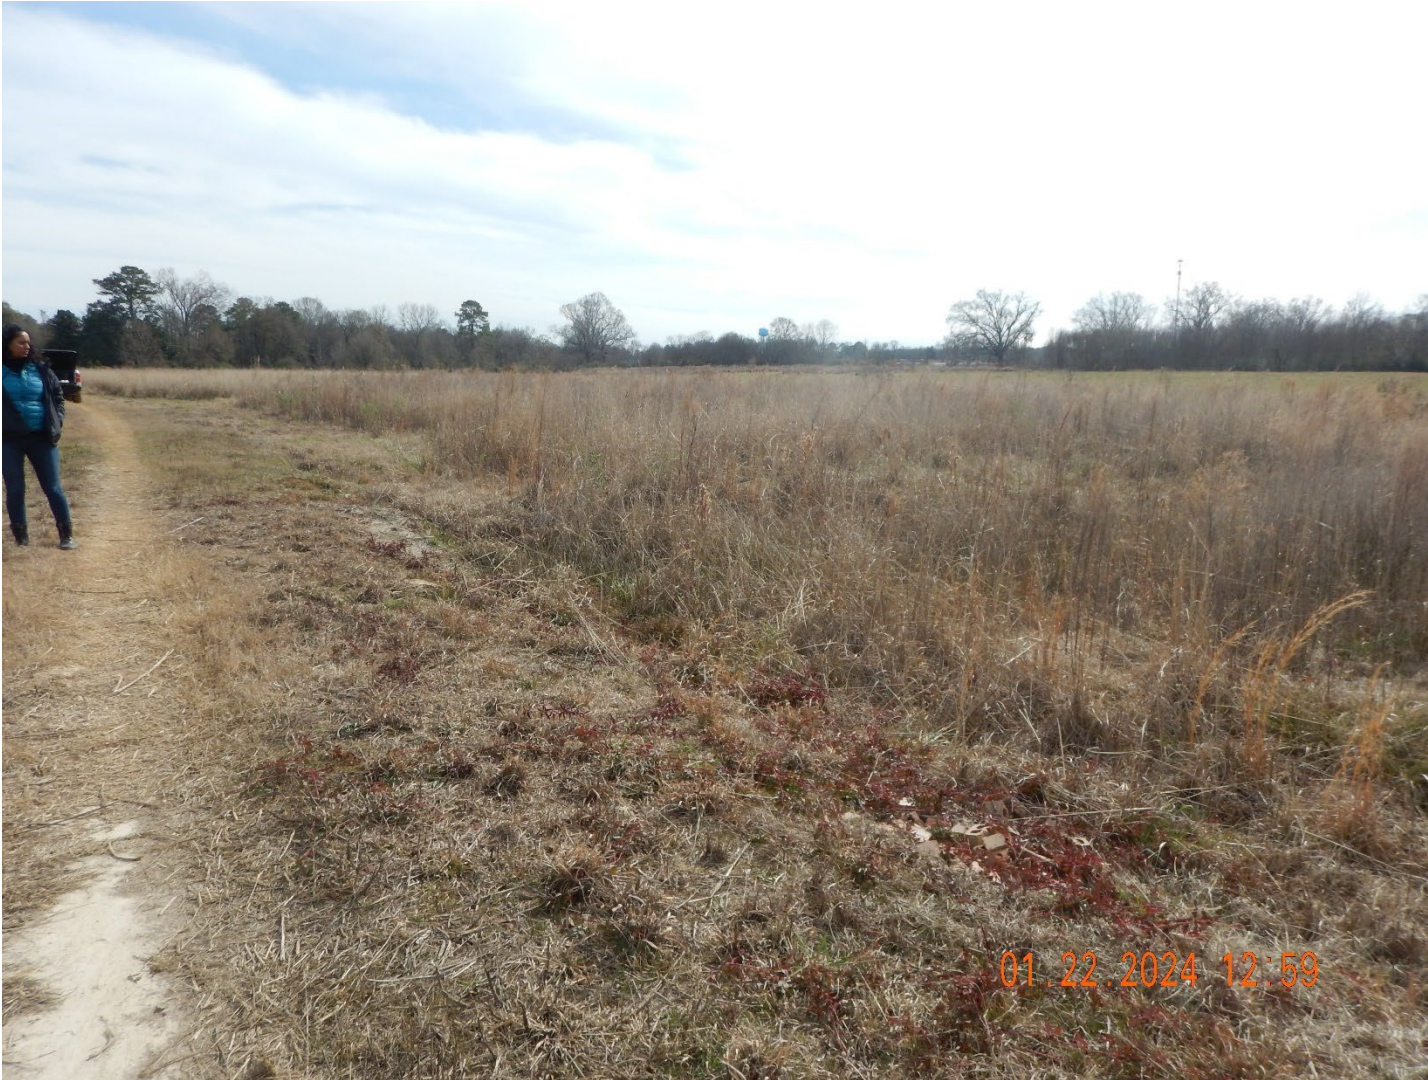
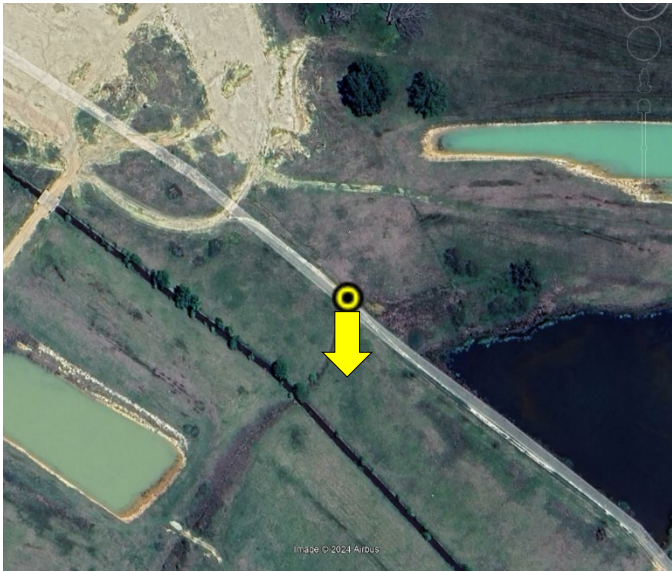
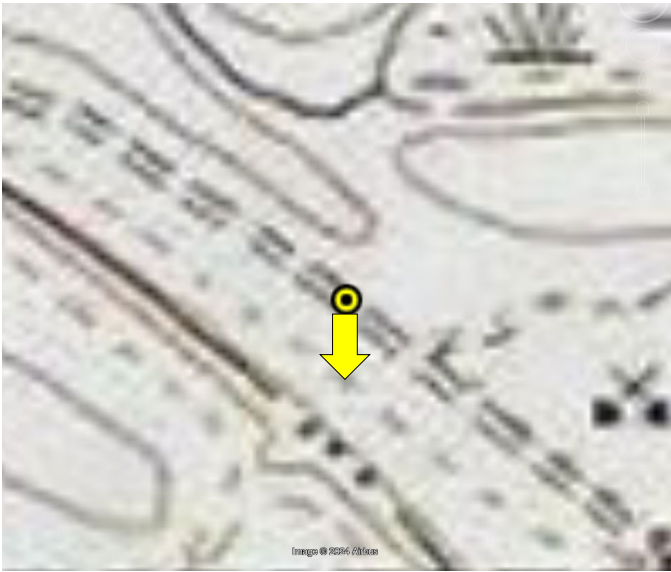
| Title | Photo 3 |

| Description | Striking south. Looking from dirt road to the channelized tributary-side of the landscape. Notice brick material near road. <i>Juncus effusus</i> common. |

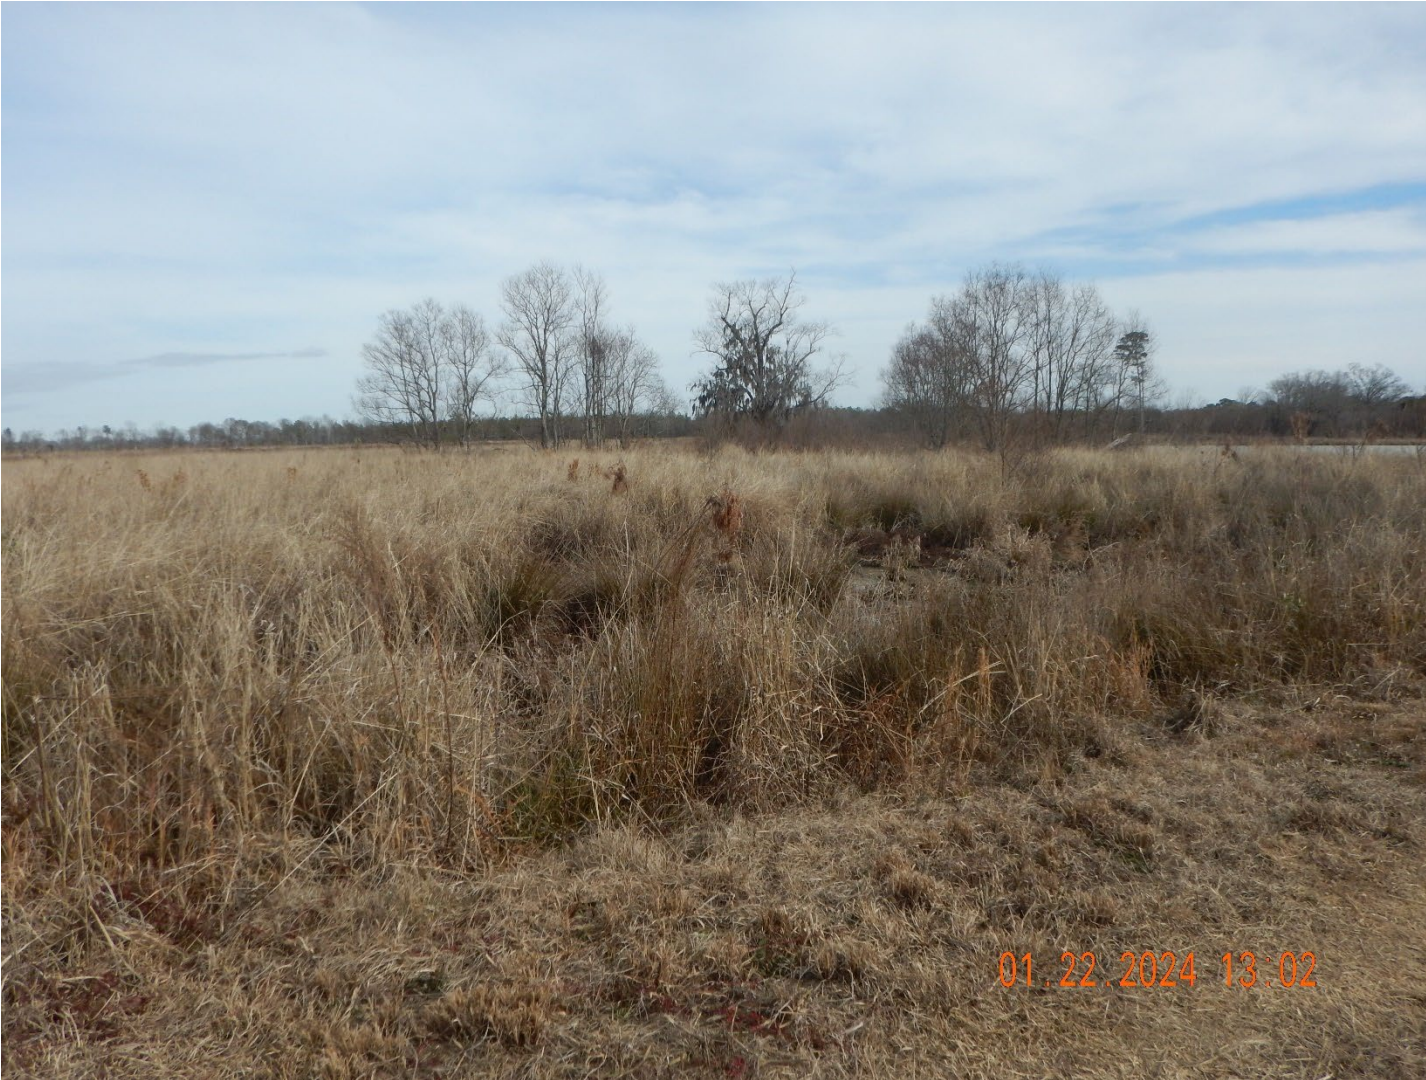
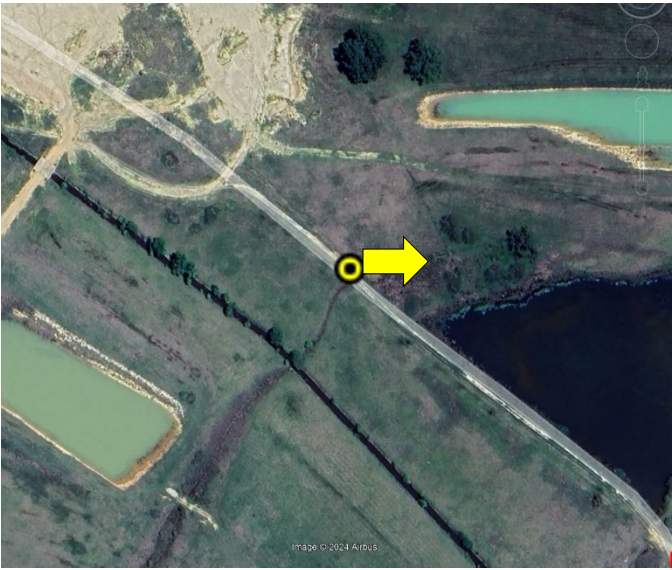
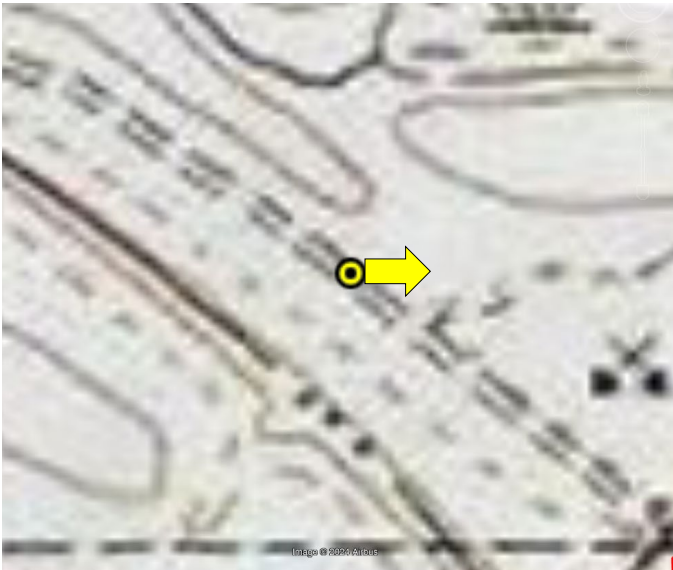
| Title | Photo 4 |

| Description | Striking east. Other side of dirt road. |

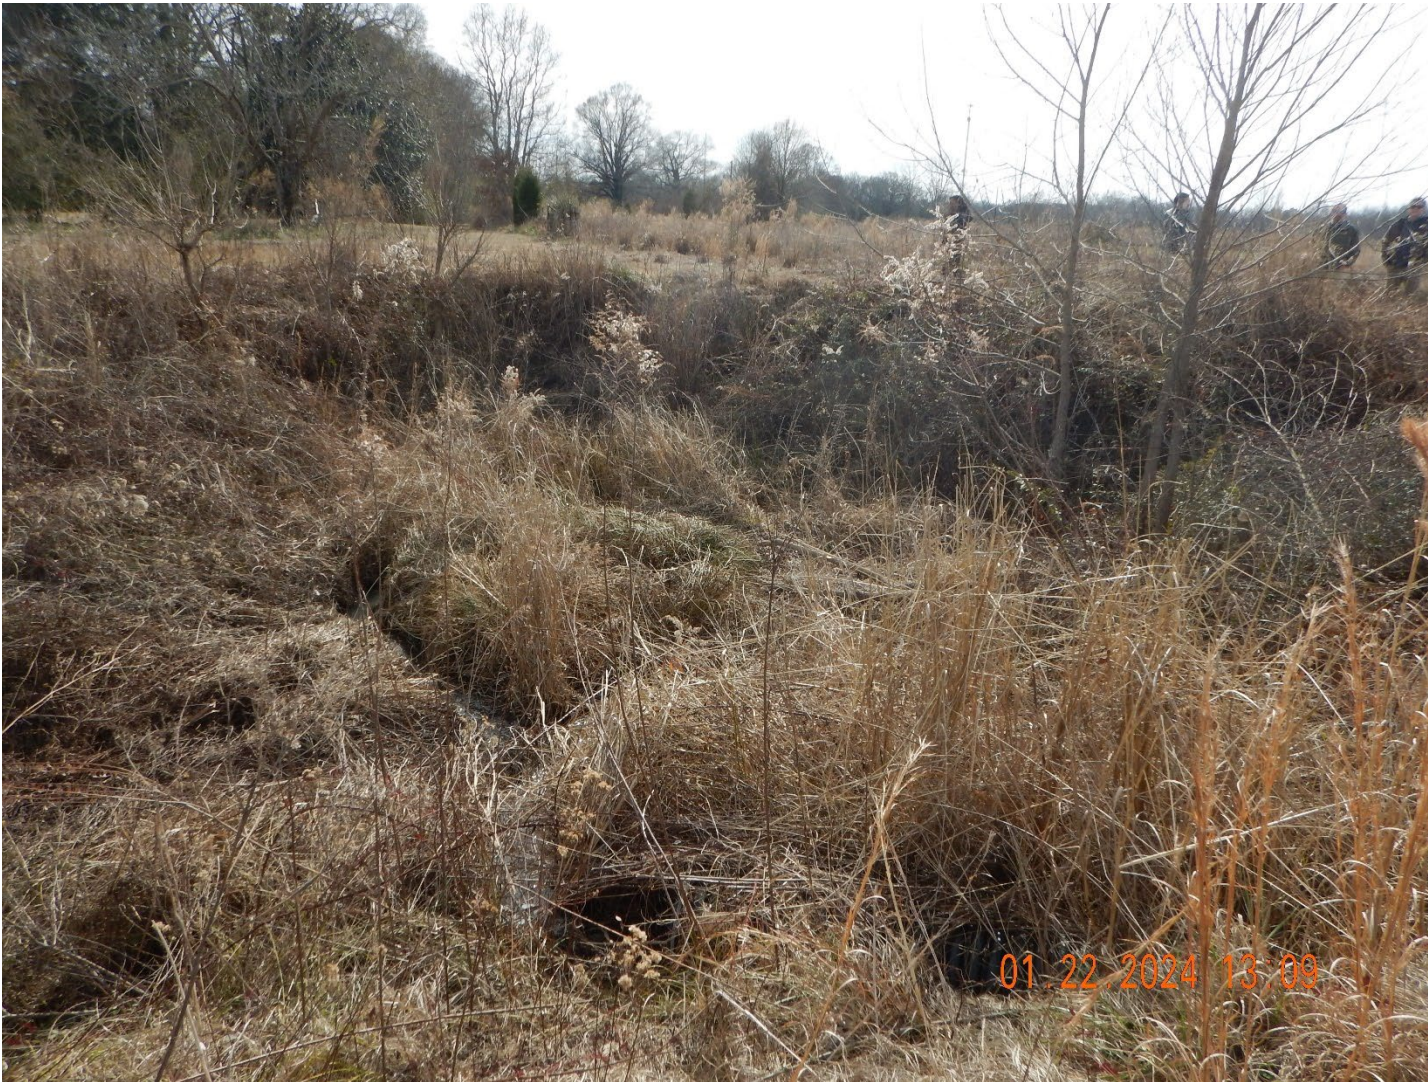
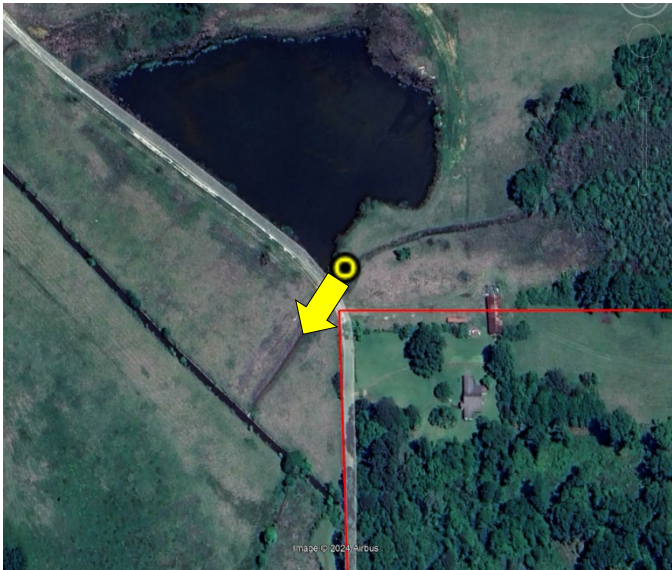
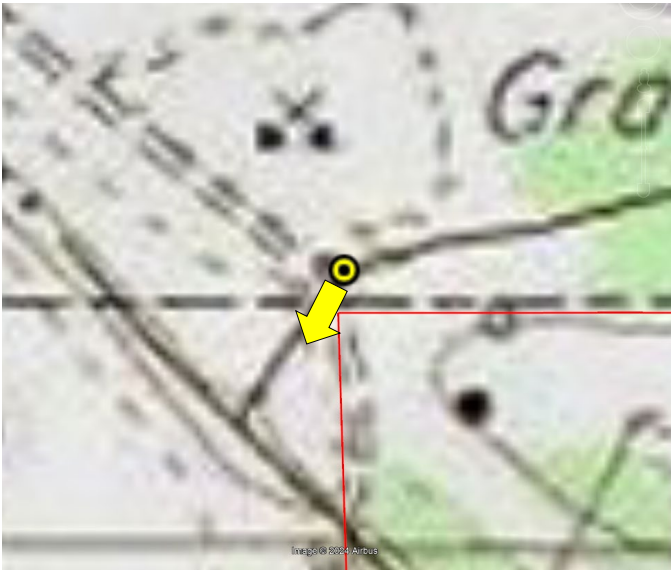
| Title | Photo 5 |

| Description | Striking south, southwest. Overflow area from open water/pond. Evidence of flow over the dirt road/berm. |

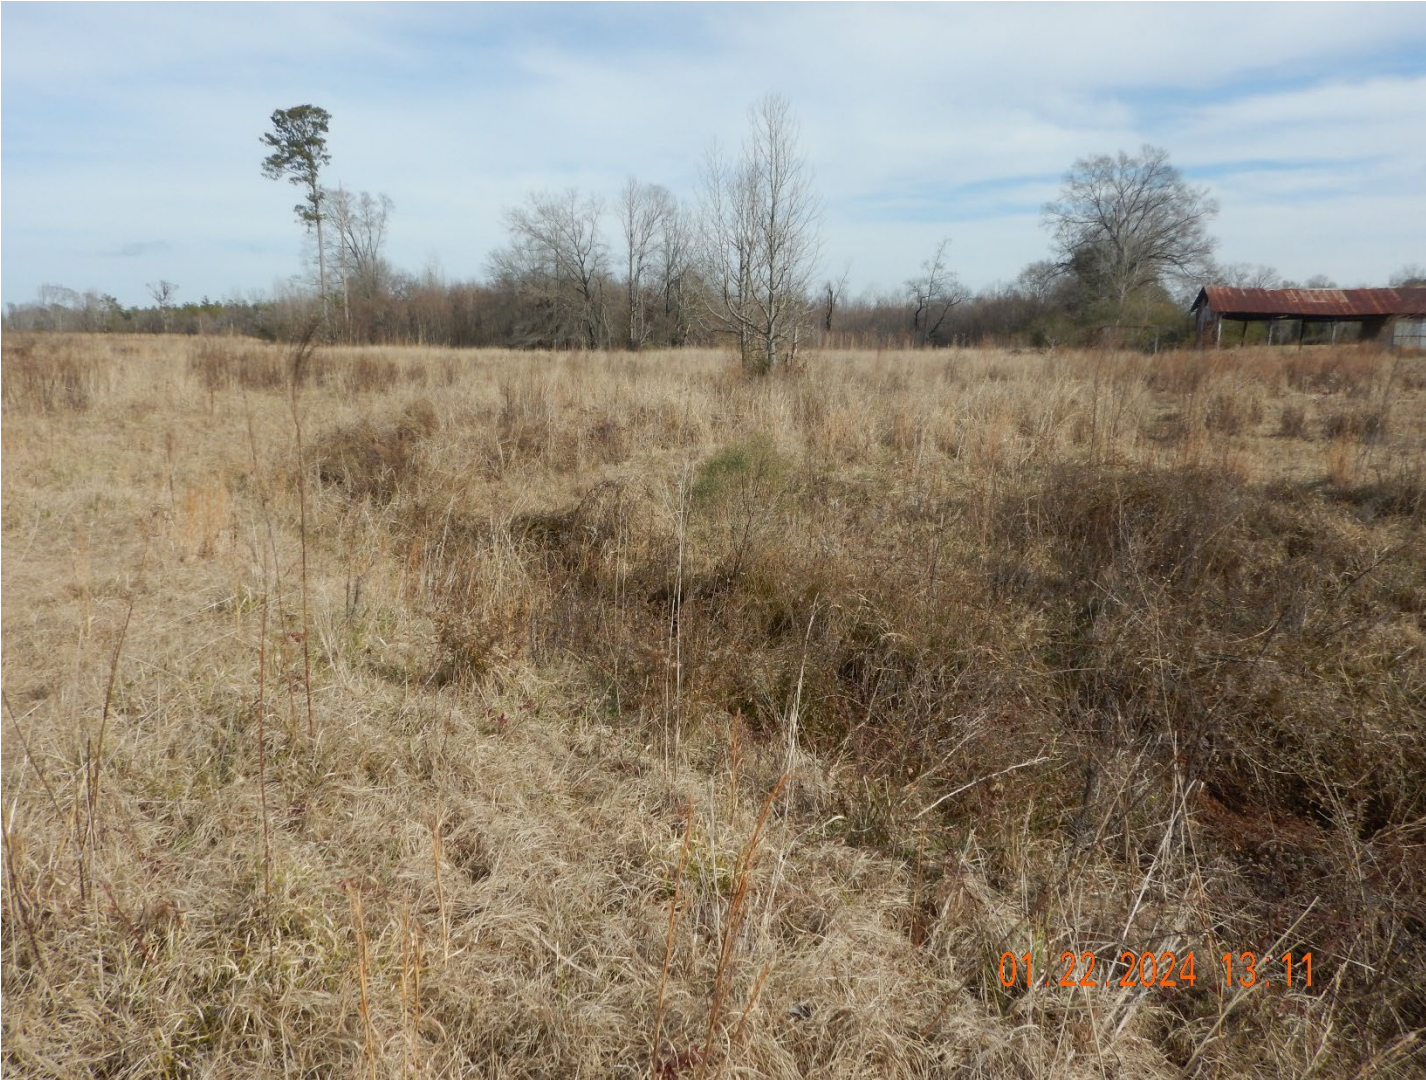
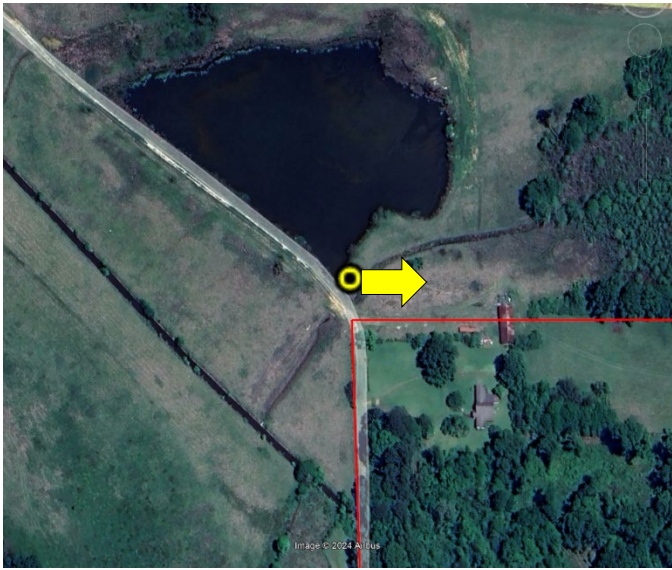
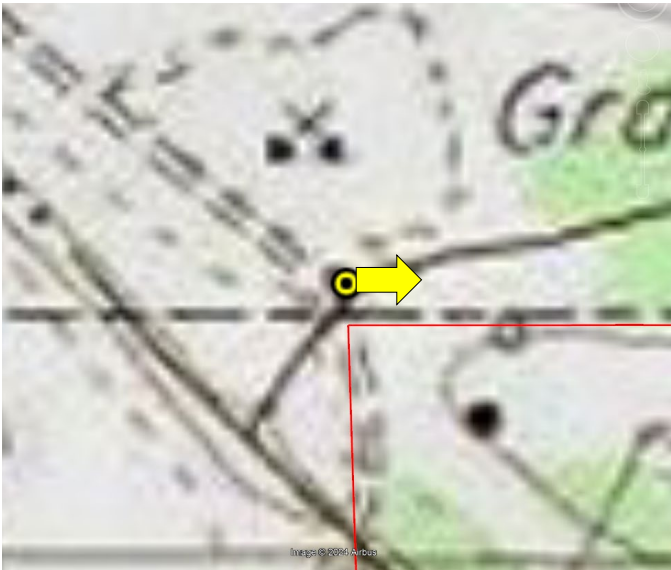
| Title | Photo 6 |

| Description | Striking east, upstream of channel (RPW). |

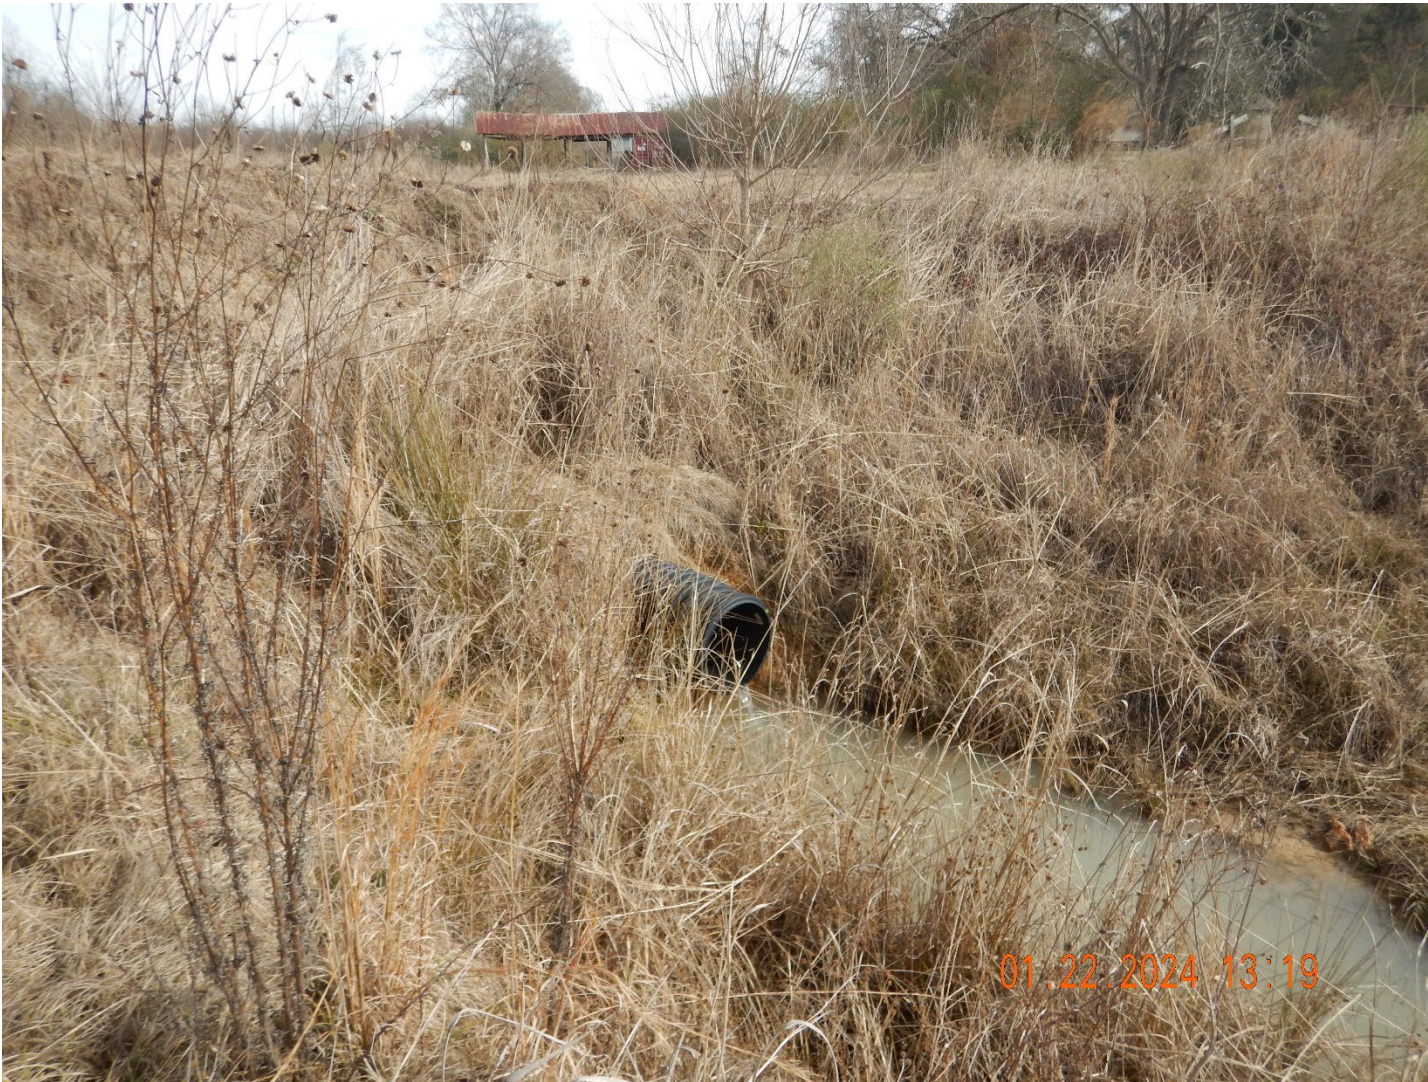
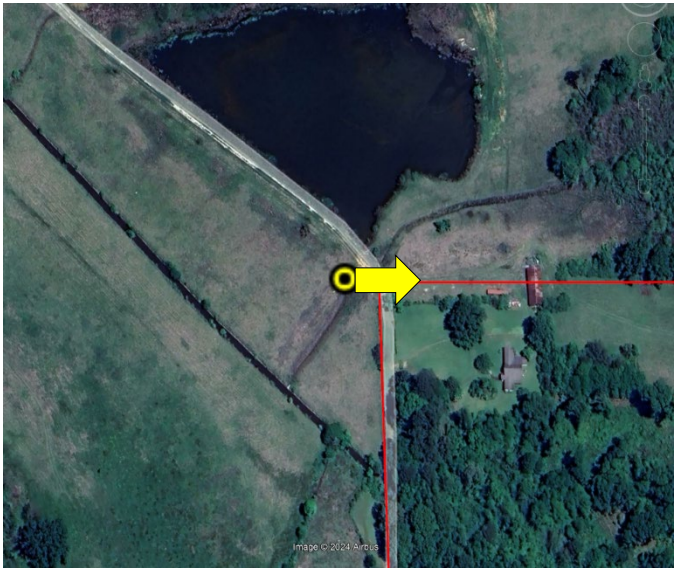
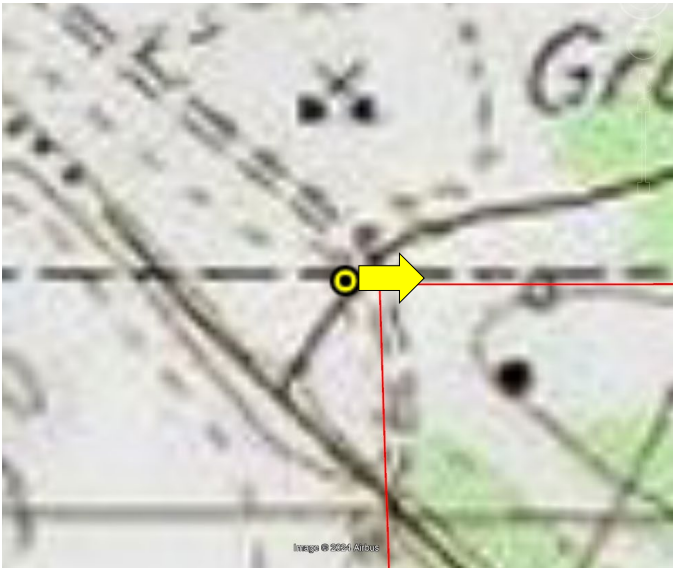
| Title | Photo 7 |

| Description | Striking east. Continuation of the channel on the other side of the dirt road/berm. |

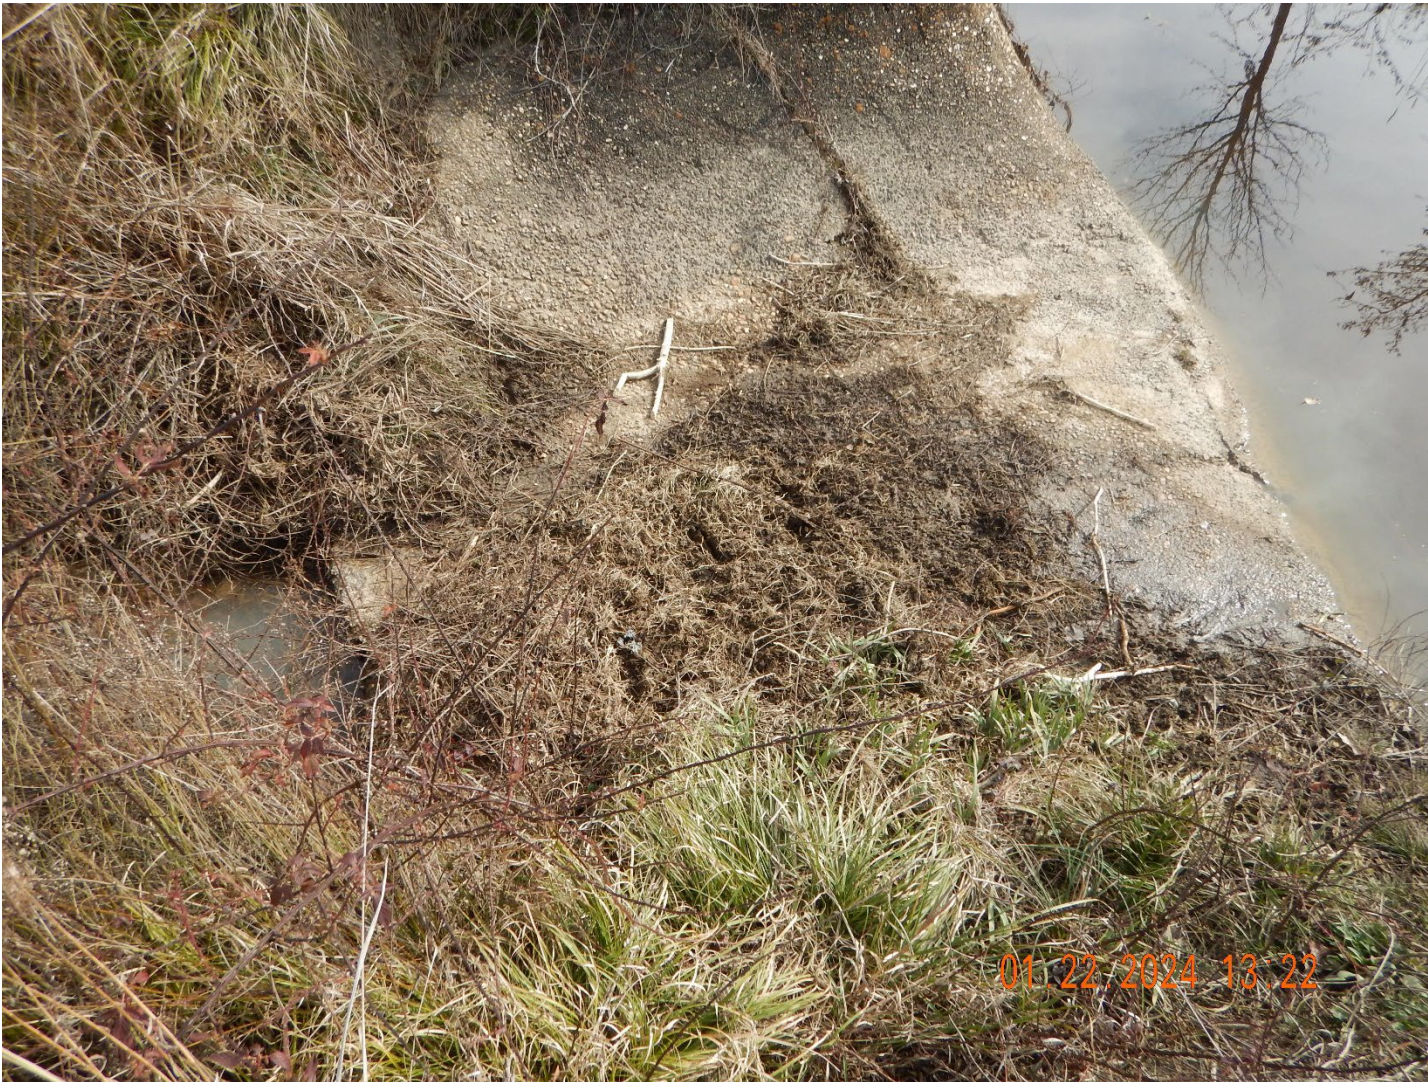
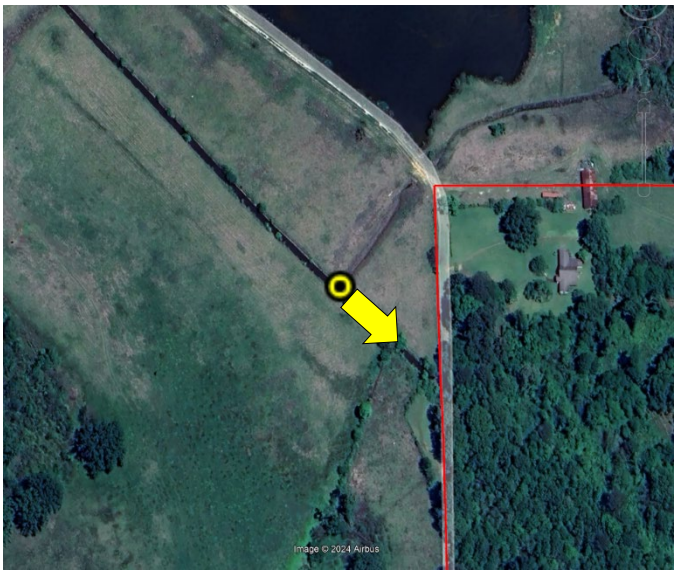
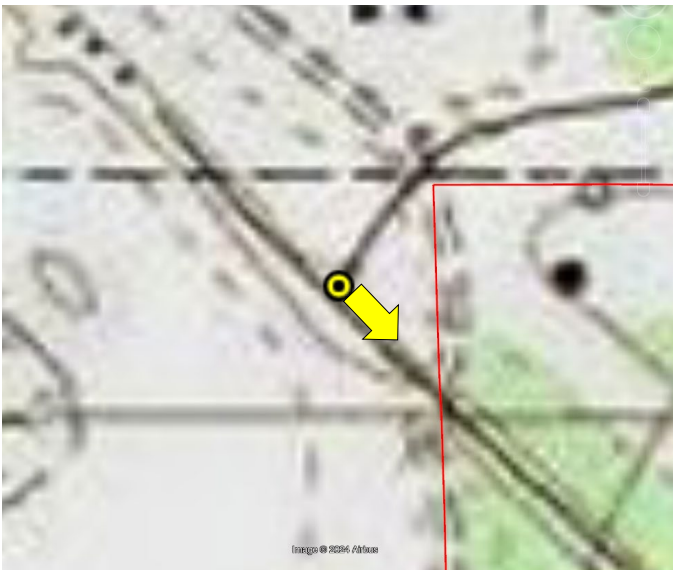
| Title | Photo 8 |

| Description | Striking southeast. Confluence of channel in Photos 5-7 with the channelized tributary (RPW) that transverses the property. Notice plum; evidence of flow moving under the concrete. |

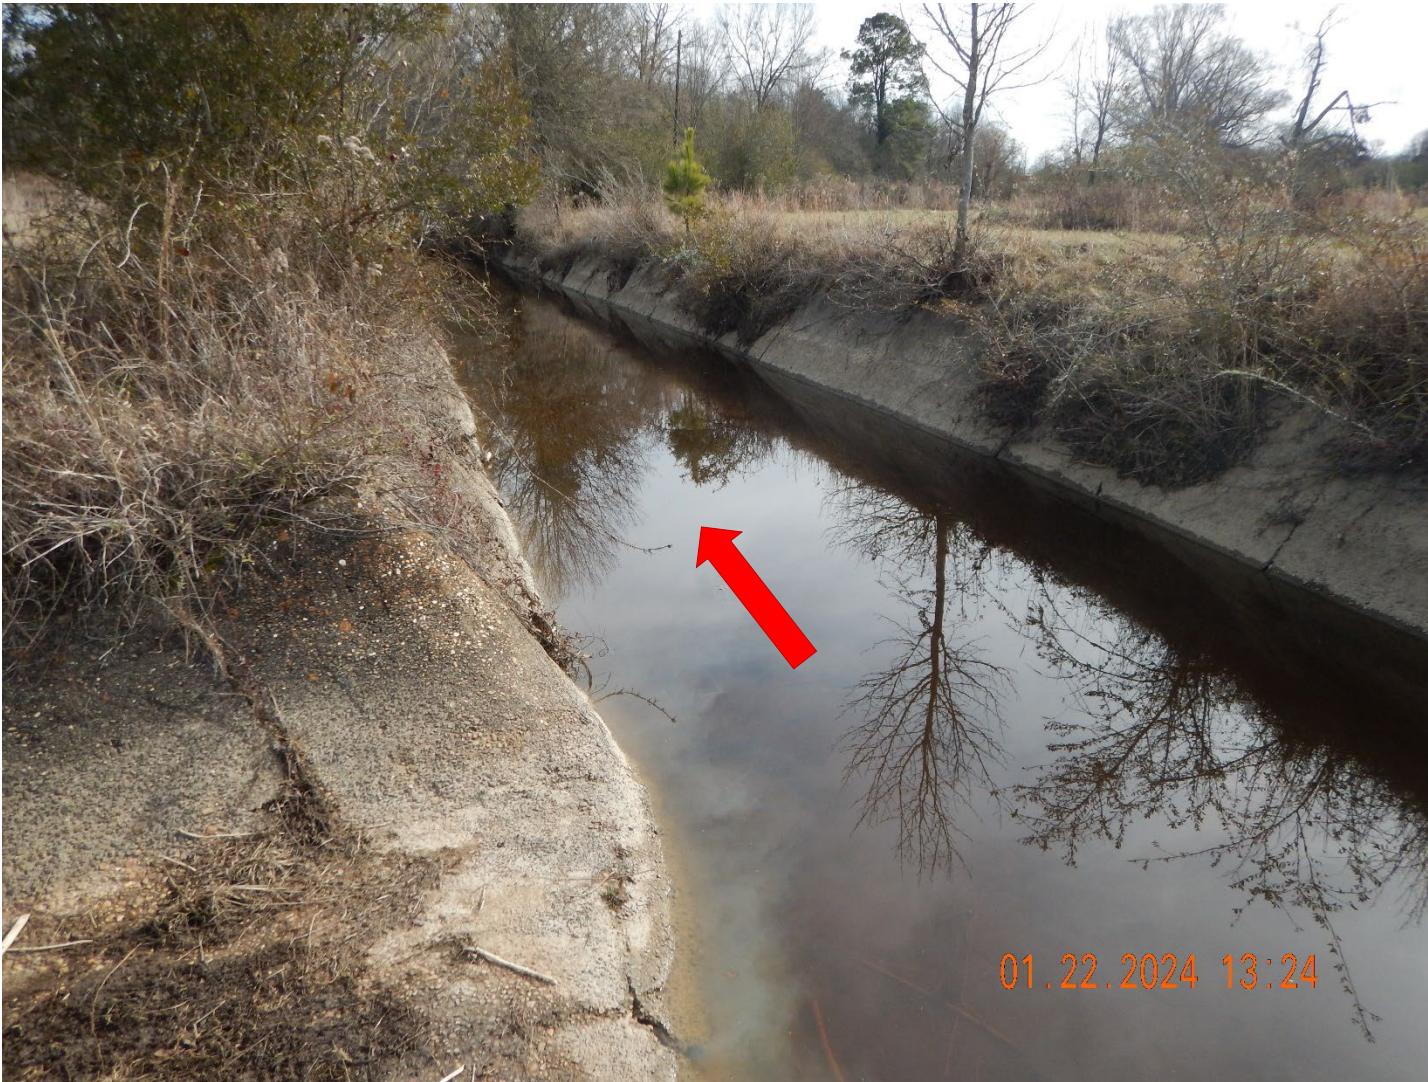
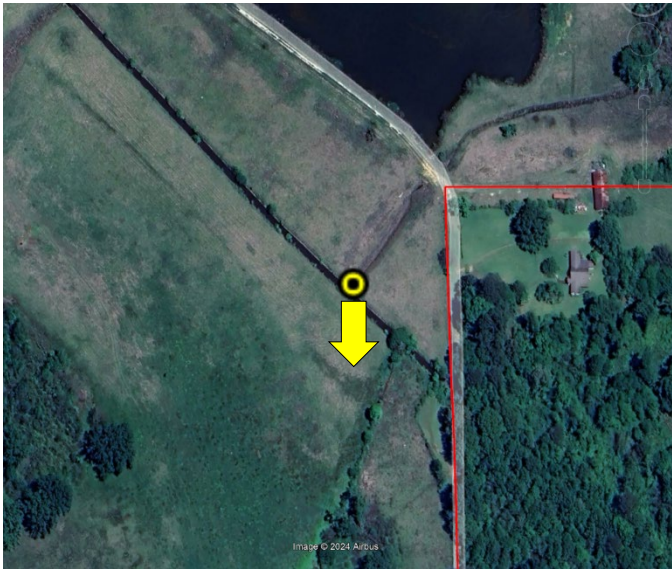
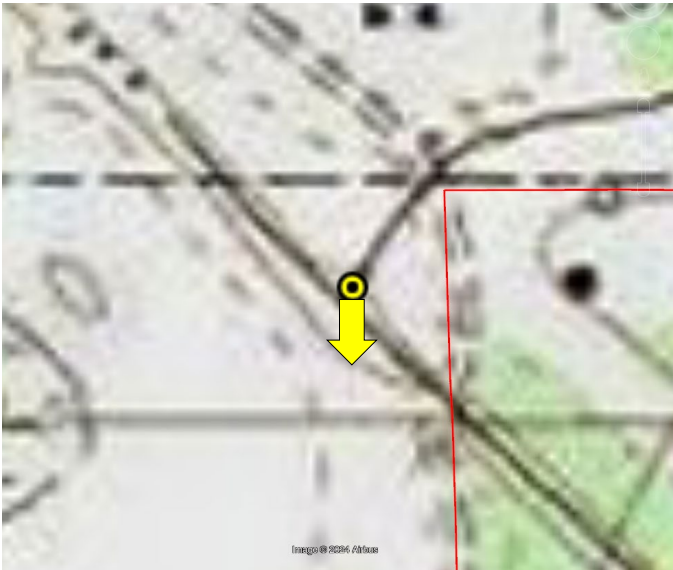
| Title | Photo 9 |

| Description | Striking south. Downstream of the channelized tributary. |
