## Clean Water Act Section 404: Site Visit/Case Development

| Site Name | Henry Brick Company, Inc. (Claude Jack Mine) | | | | |

**Henry Brick Company, Inc. - Claude Jack Mine**  
**Selma, Dallas County, Alabama**  
**January 22, 2024**

### Henry Brick Company, Inc. Claude Jack Mine Site Inspection Photographic Log

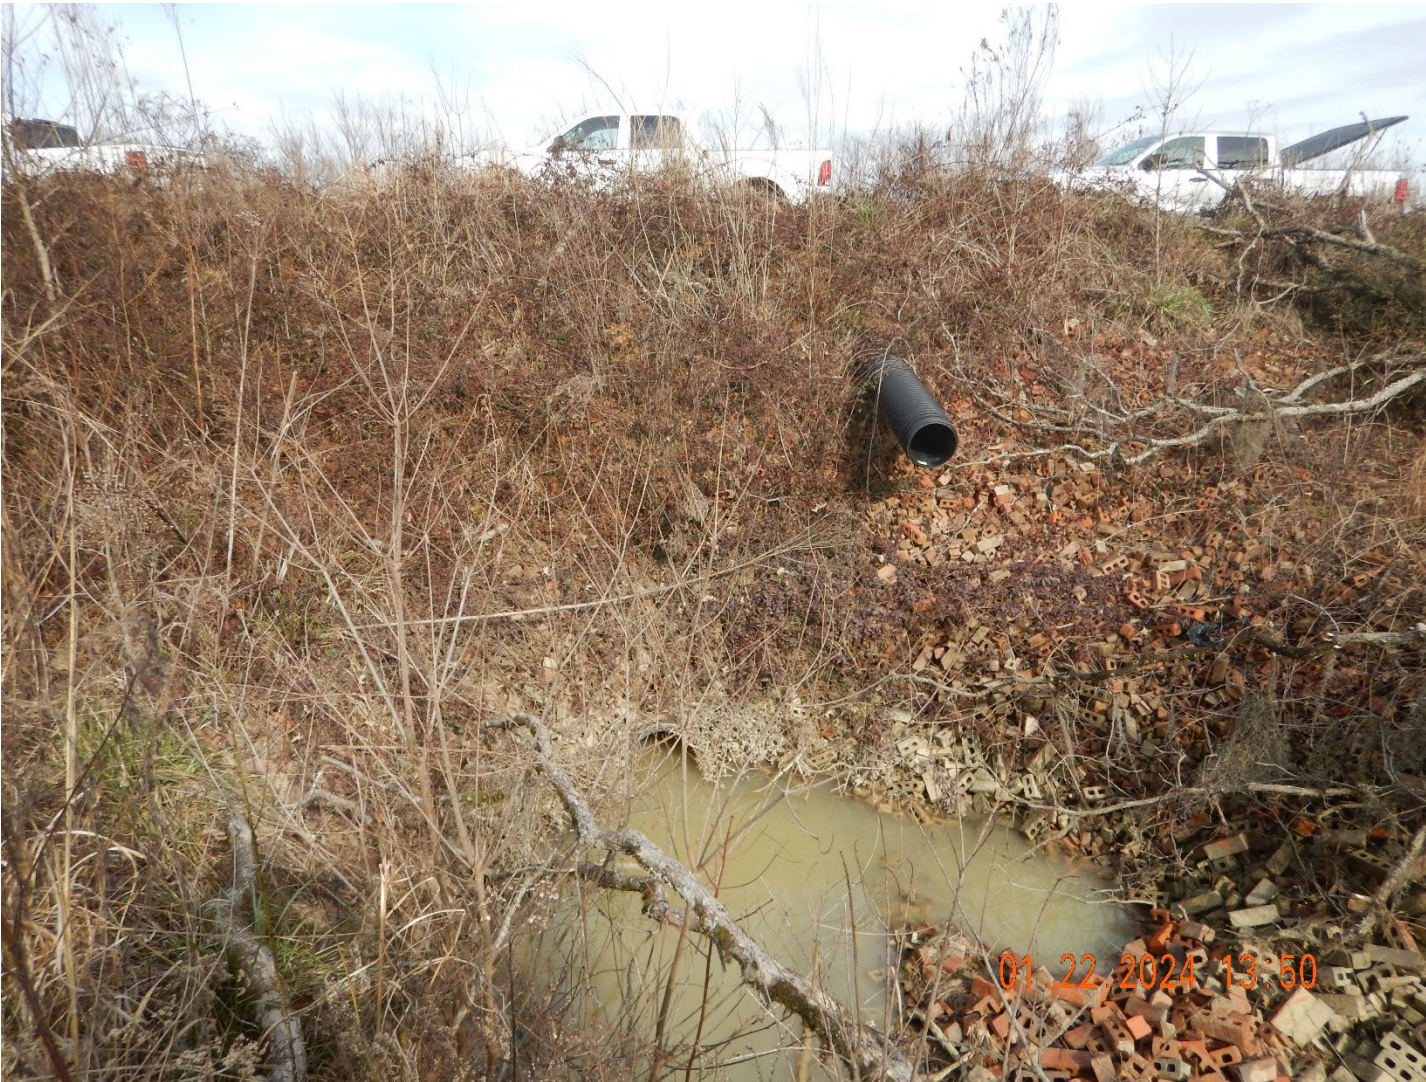
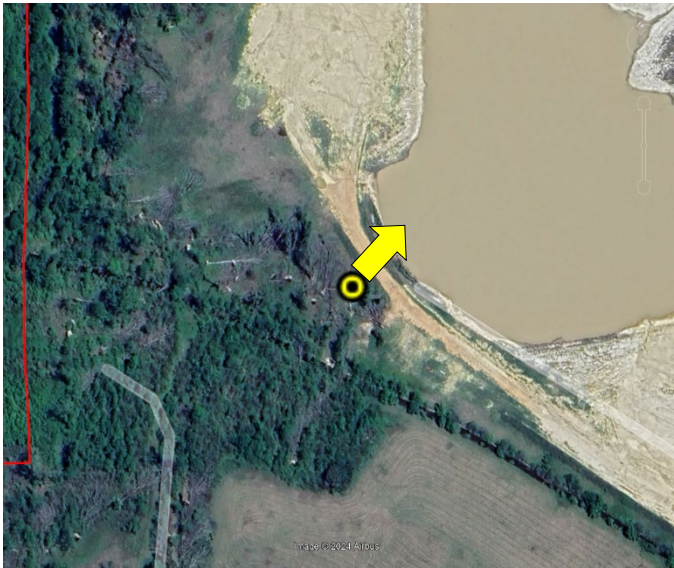
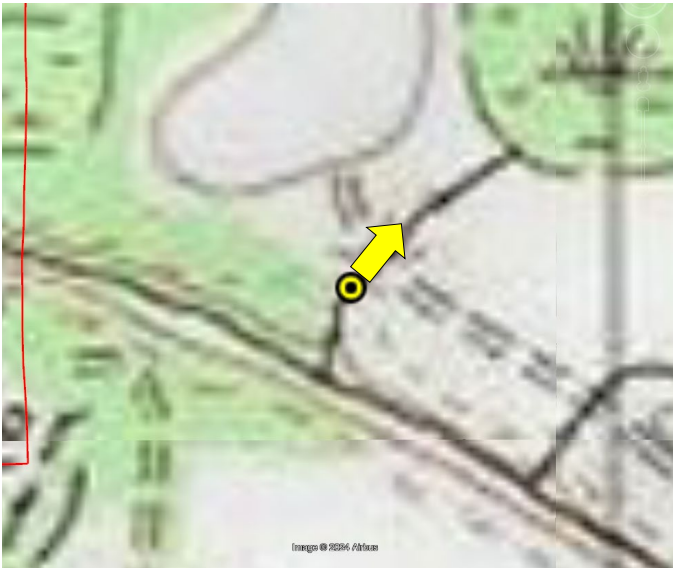
| Title | Photo 10 |

| Description | Striking northeast. Across the road from the excavated area. Notice the two corrugated pipes; initially installed pipe located at the water's surface. |

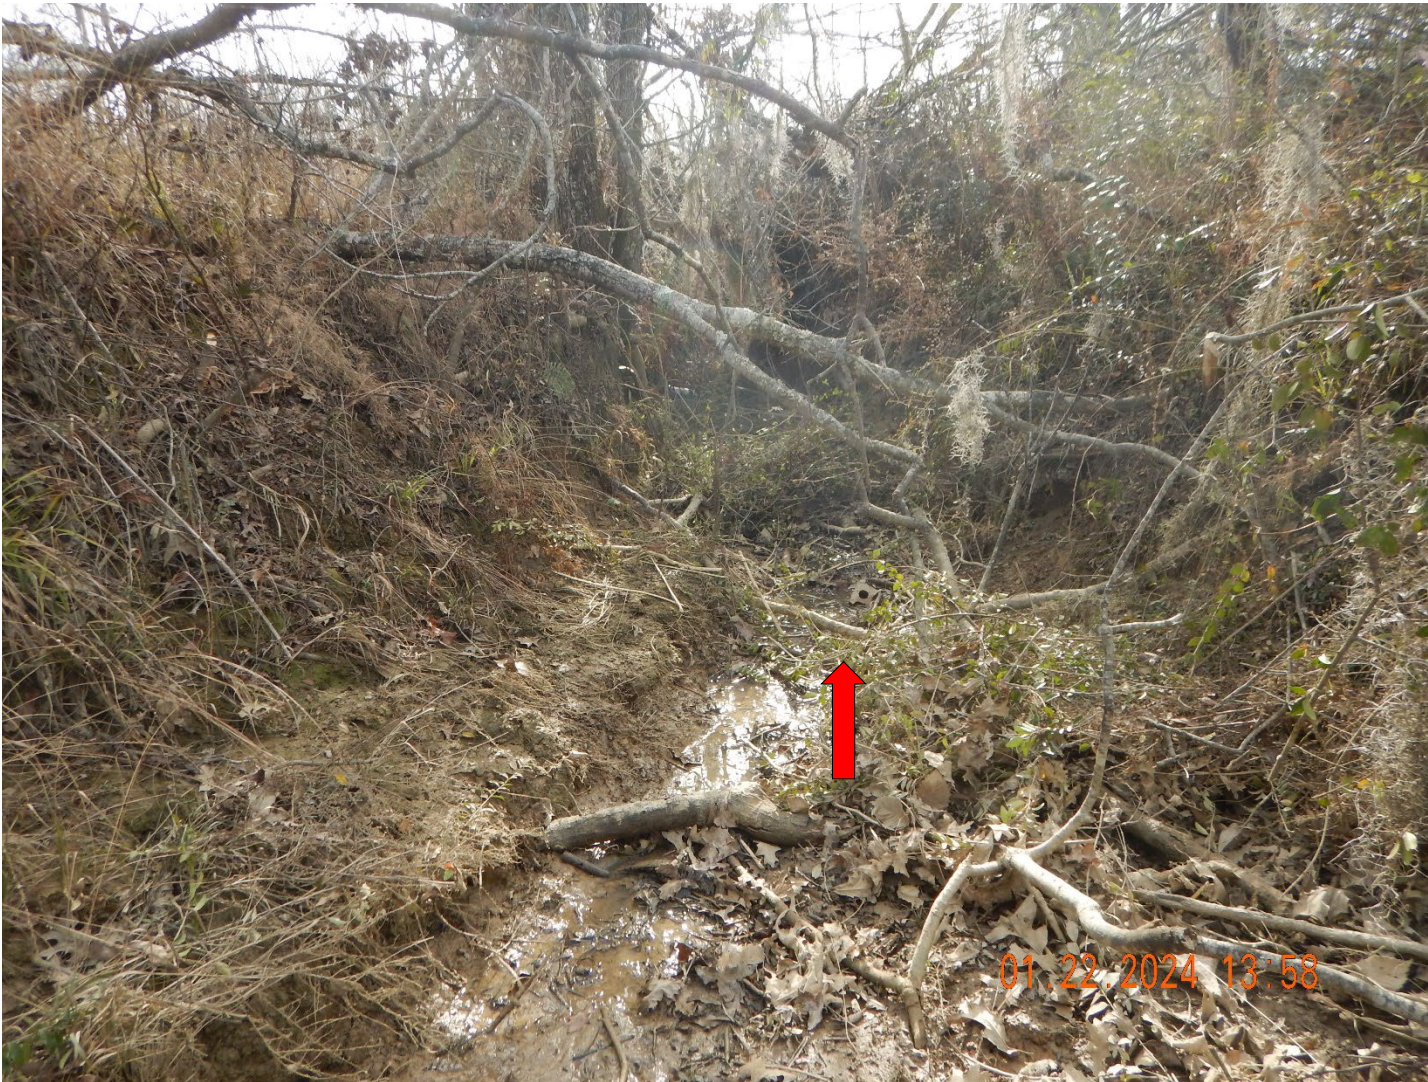
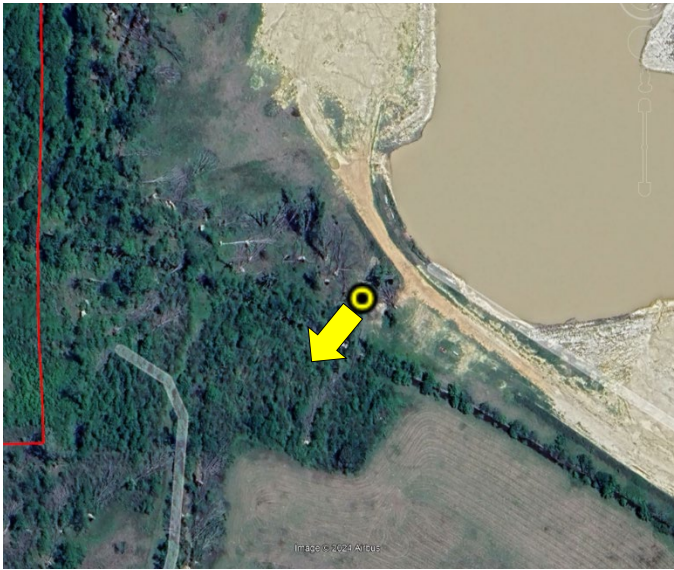
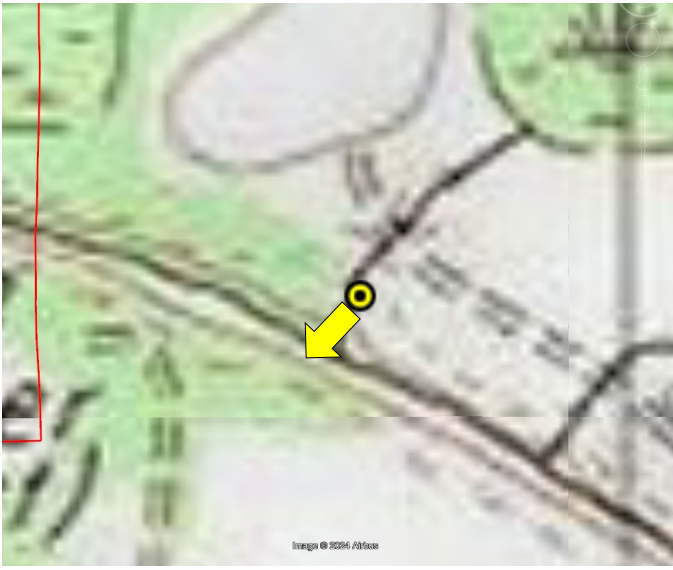
| Title | Photo 11 |

| Description | Striking southwest. Downstream of Intermittent Stream 1, or "IS-1" (per GMC's Figure 6B, dated 8/2/2022 ). |

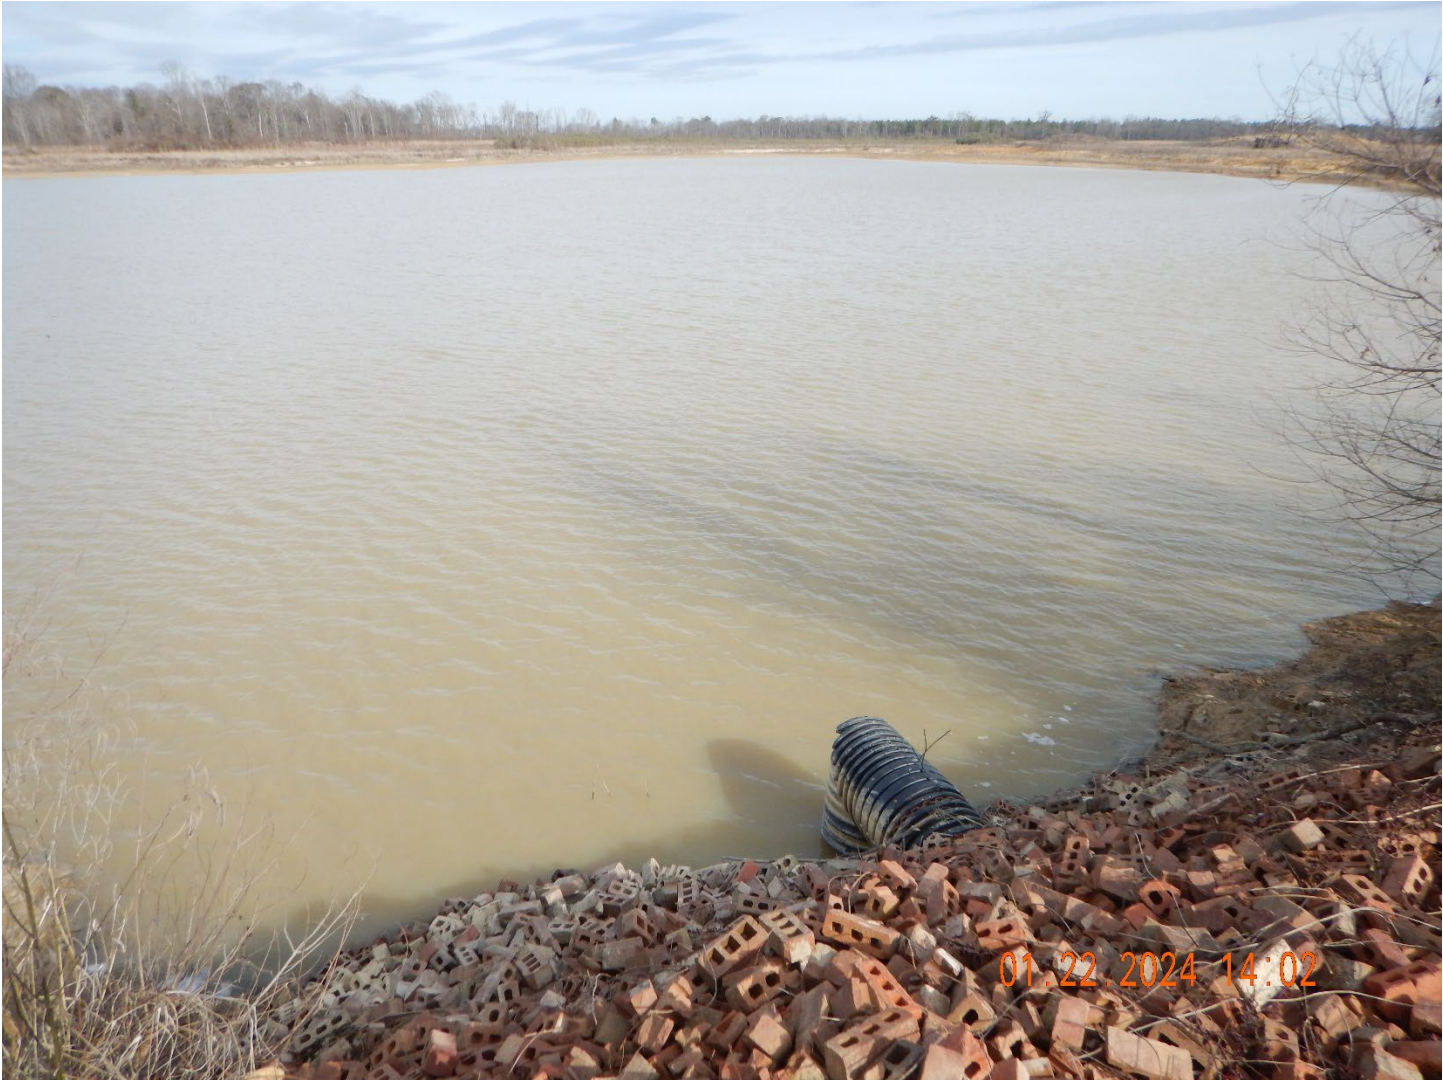
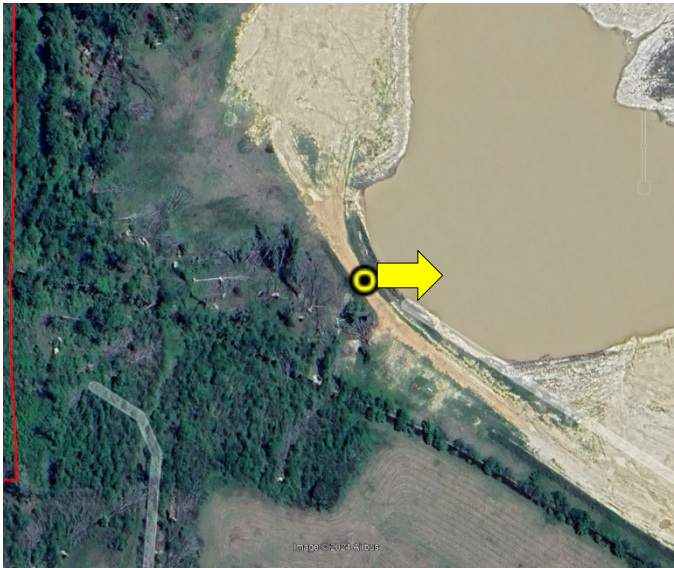
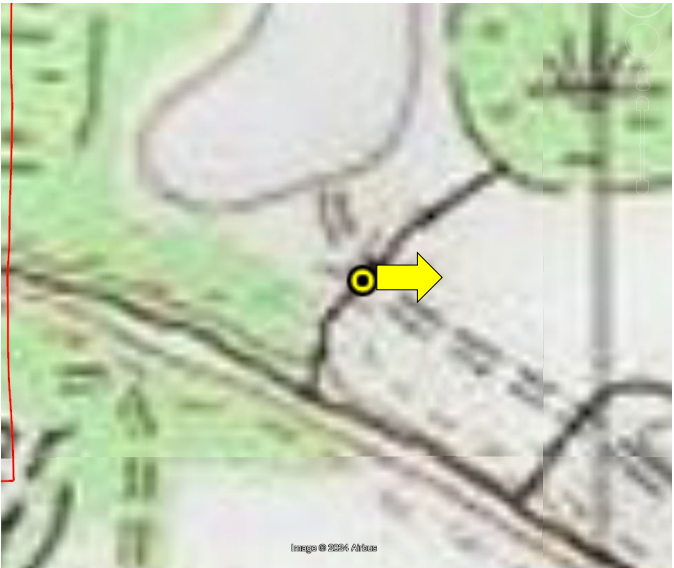
| Title | Photo 12 |

| Description | Striking east. Pond-side of the culvert that runs under the dirt road/berm. Approximately 11 acres have been excavated. |

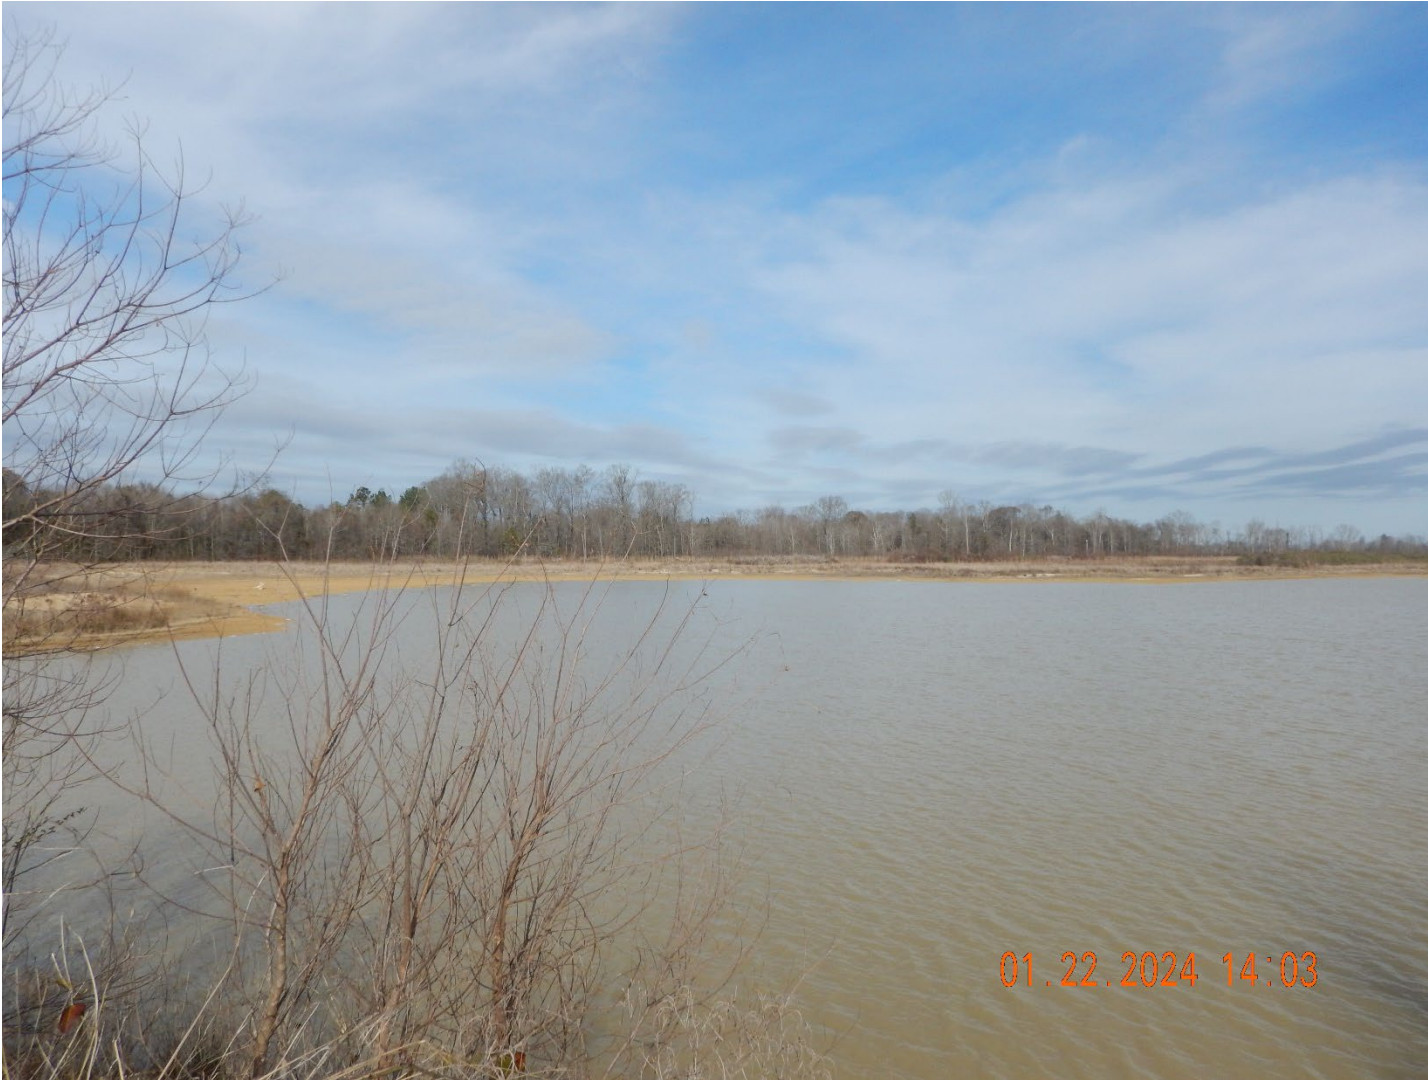
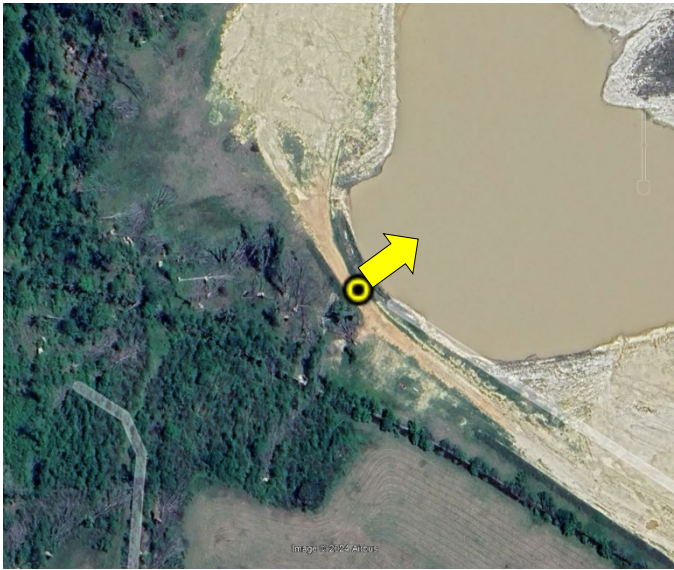
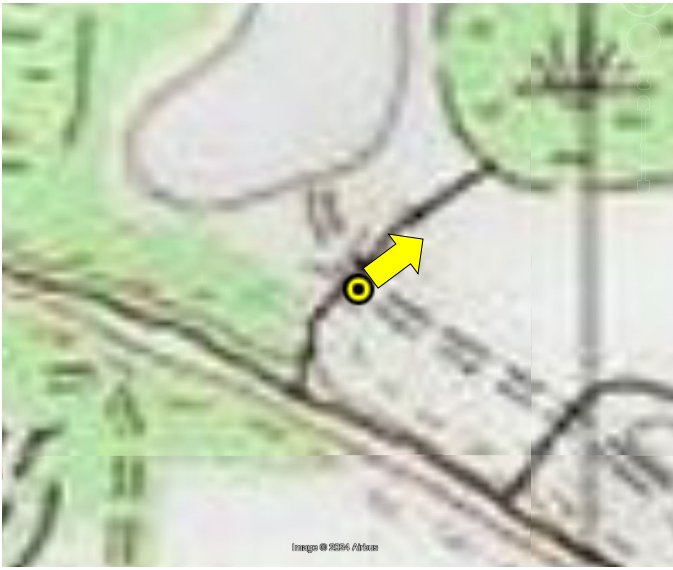
| Title | Photo 13 |

| Description | Striking northeast. Landscape across the open water where wetlands were mechanically land-cleared (approx. 55.09 acres) and excavated (approx. 11 acres). |

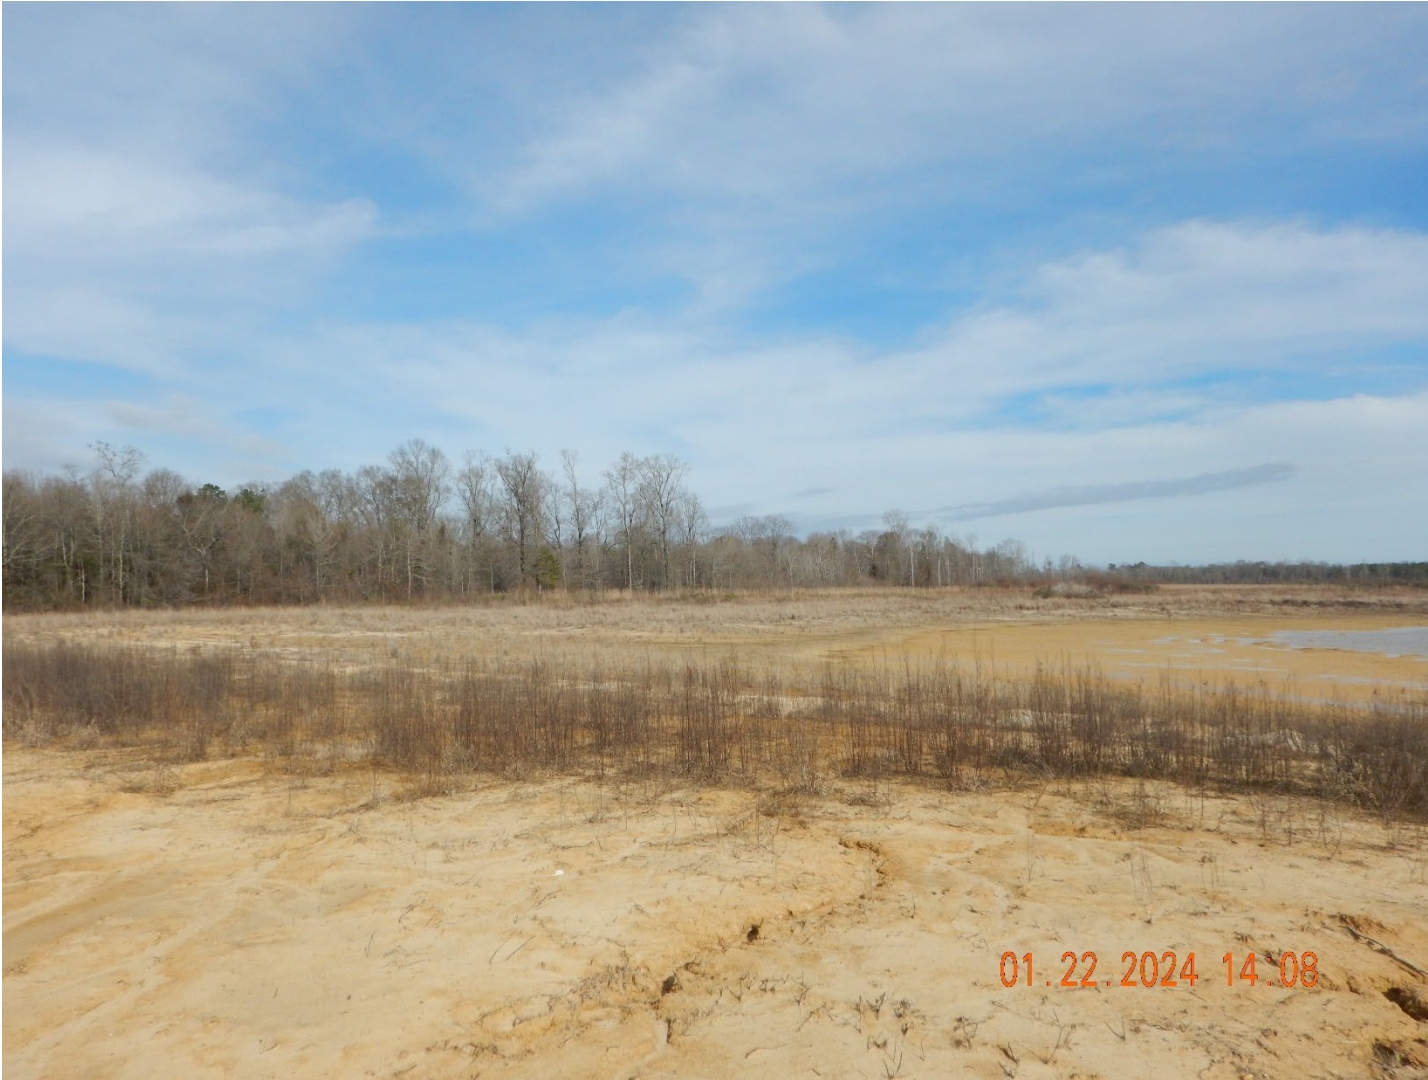
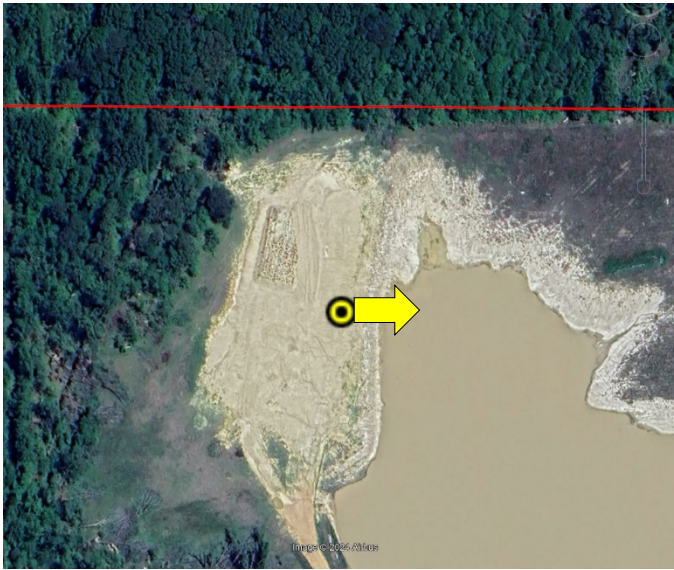
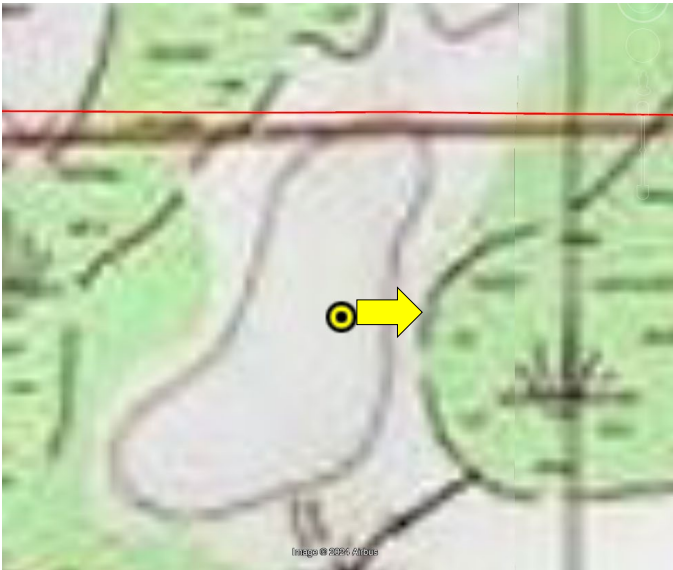
| Title | Photo 14 |

| Description | Striking east. View of mechanically cleared wetlands. |

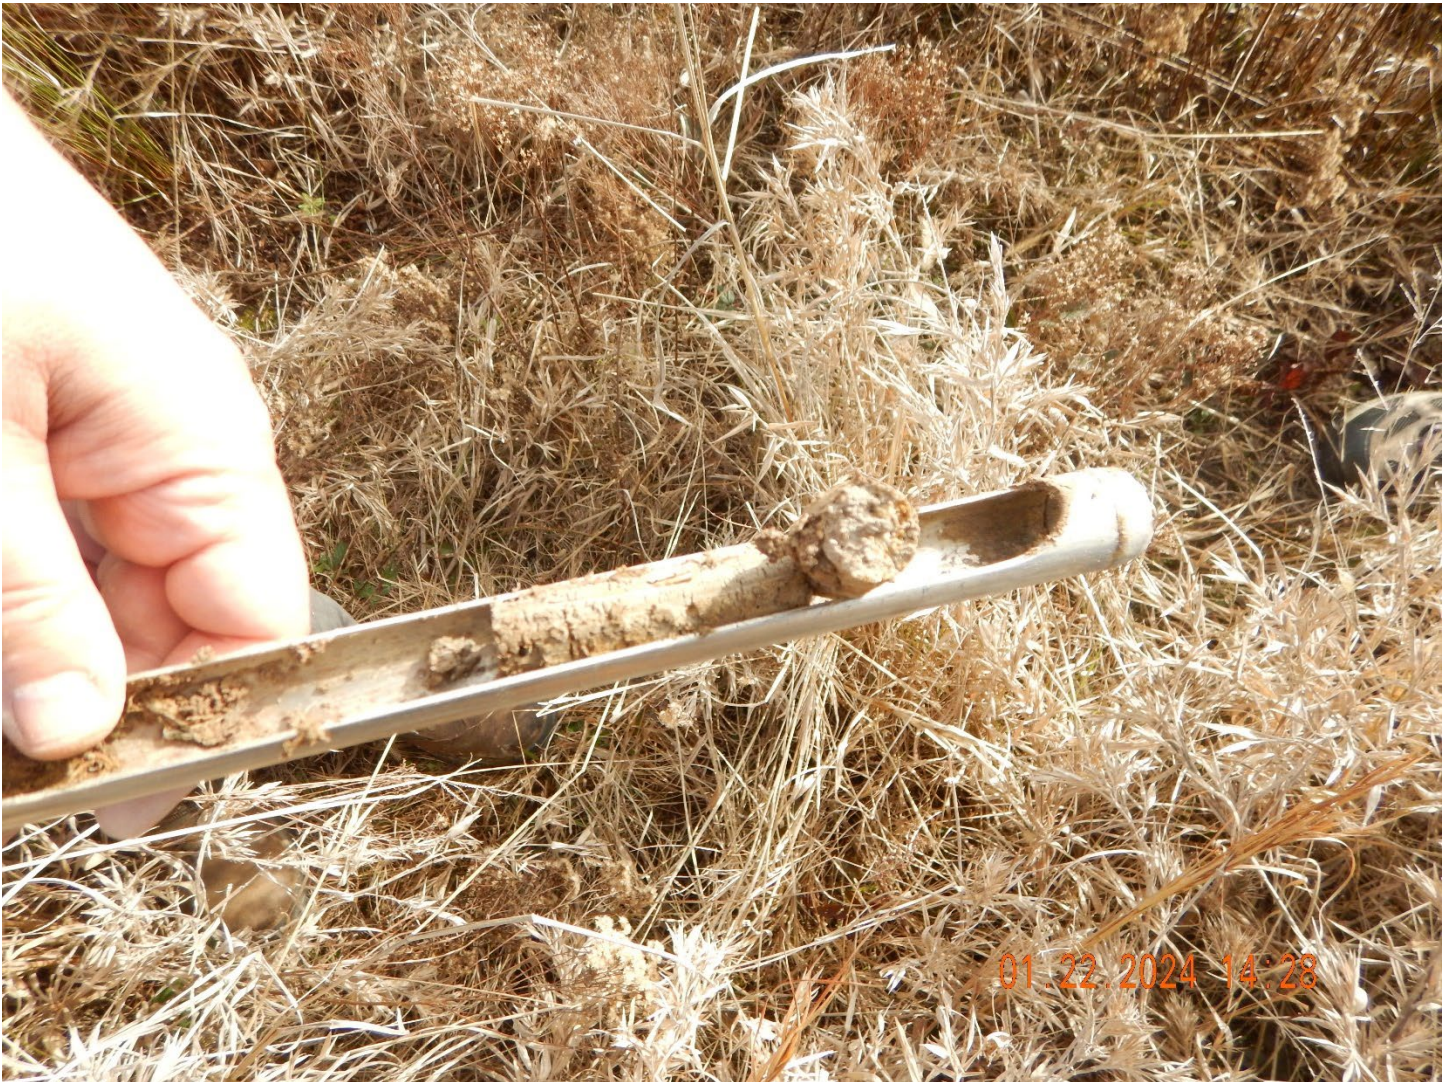
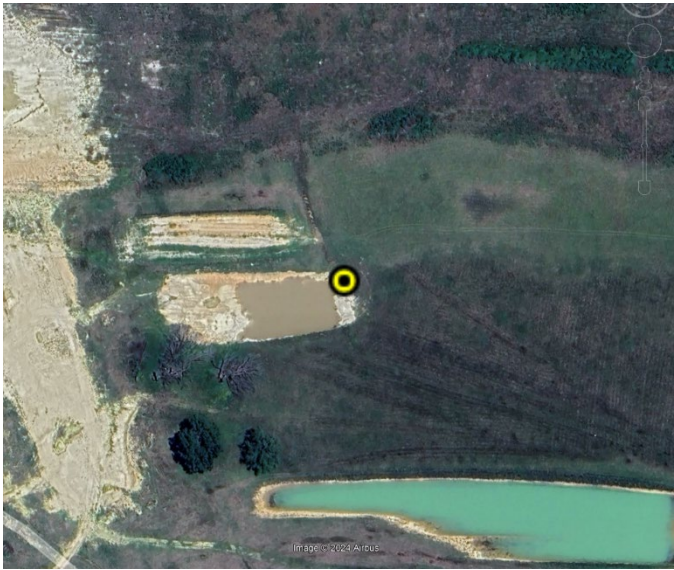
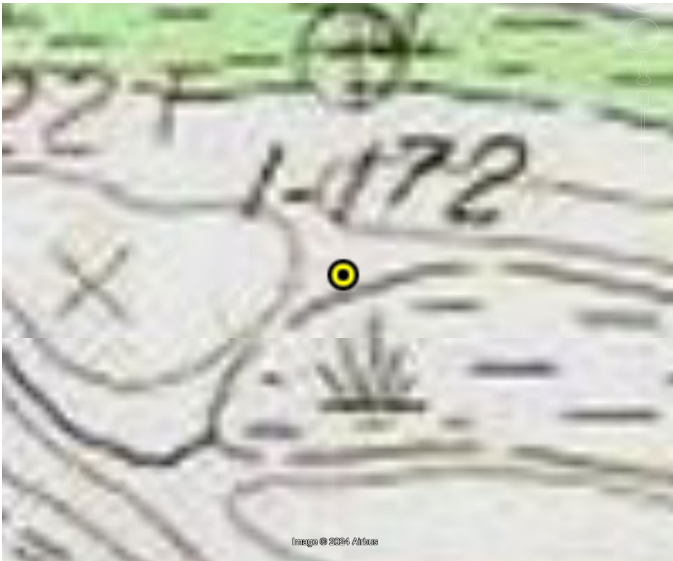
| Title | Photo 15 |

| Description | Hydric soil indicator, per U.S. Army Corps of Engineers Regional Supplement to the Delineation Manual, observed at this sampling location. |

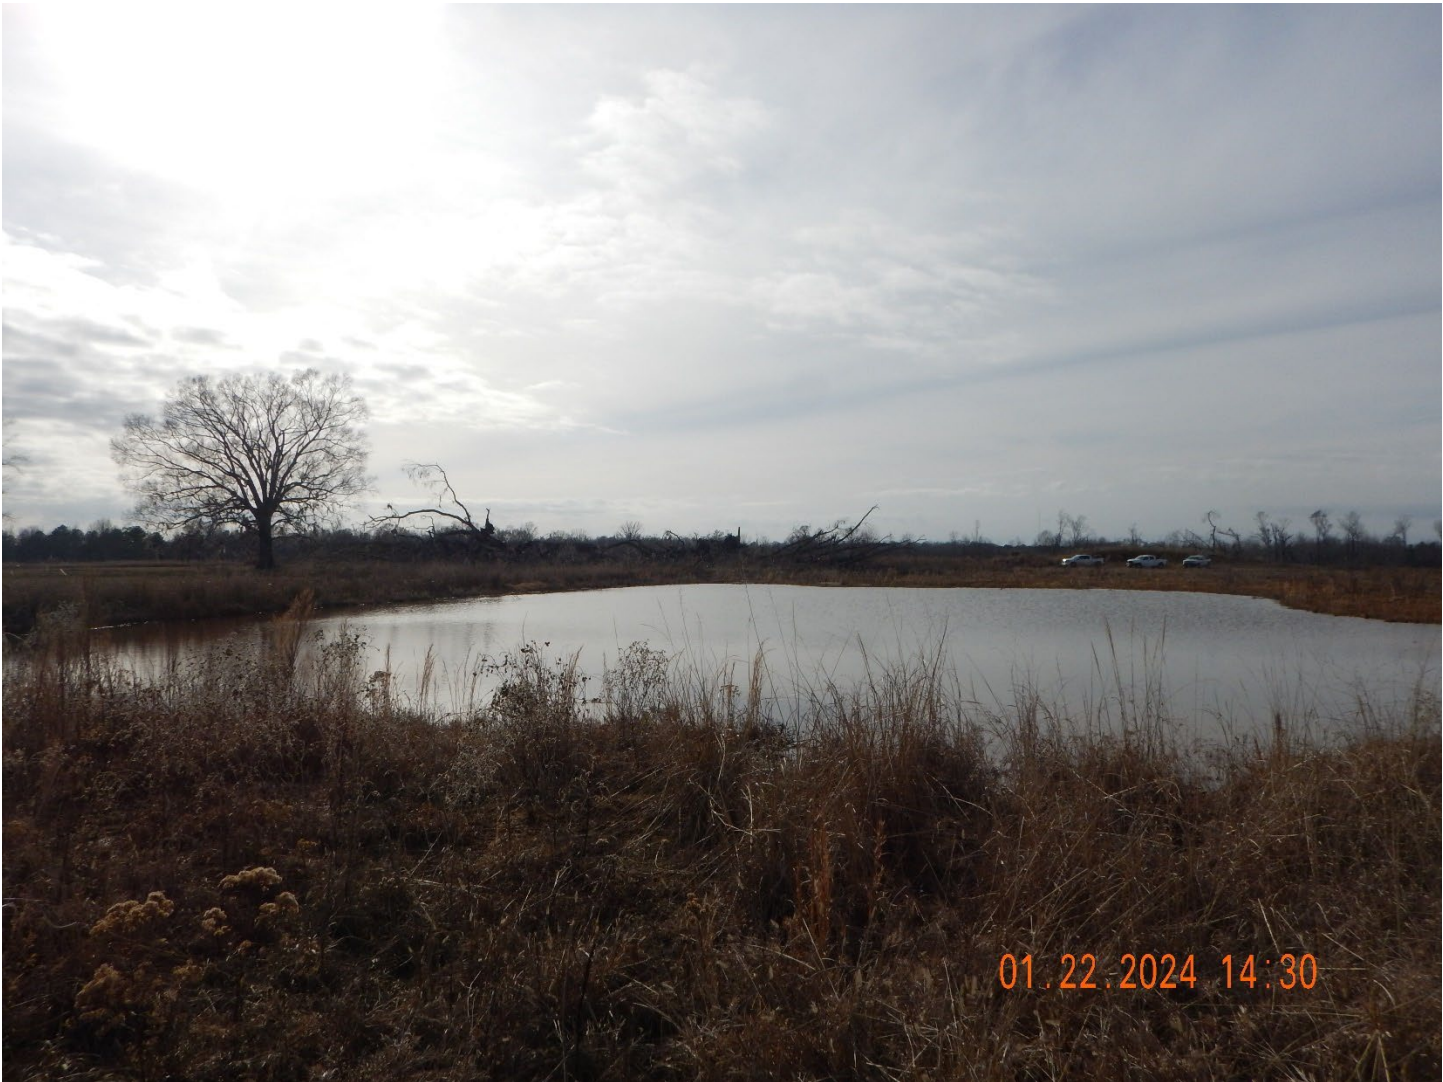
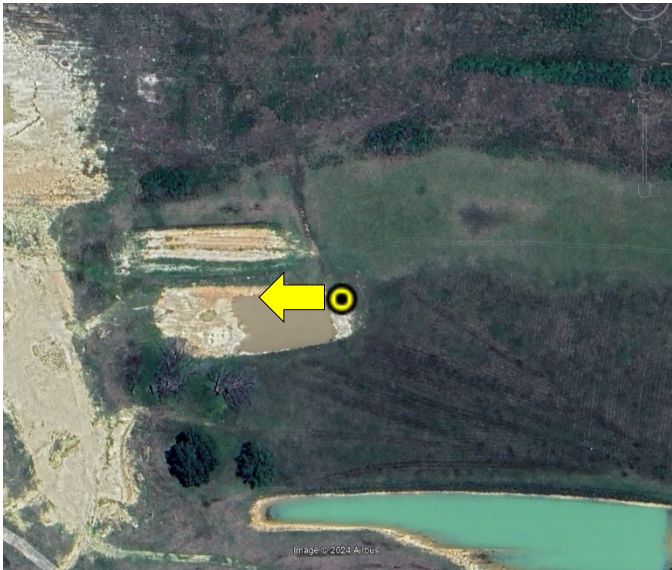
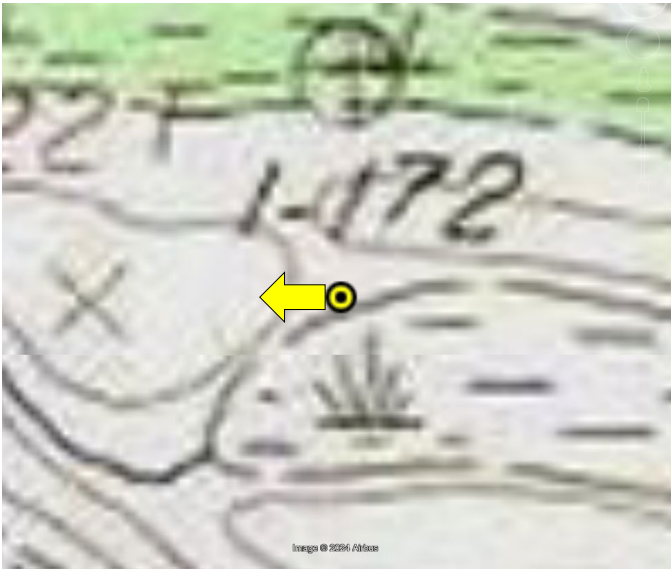
| Title | Photo 16 |

| Description | Striking west. Newly dug pond that has its fill material placed to the right of the image. Southern end of the Wetland 1 ("W-1" per GMC report) swale is also to the right of where this photo was taken. |

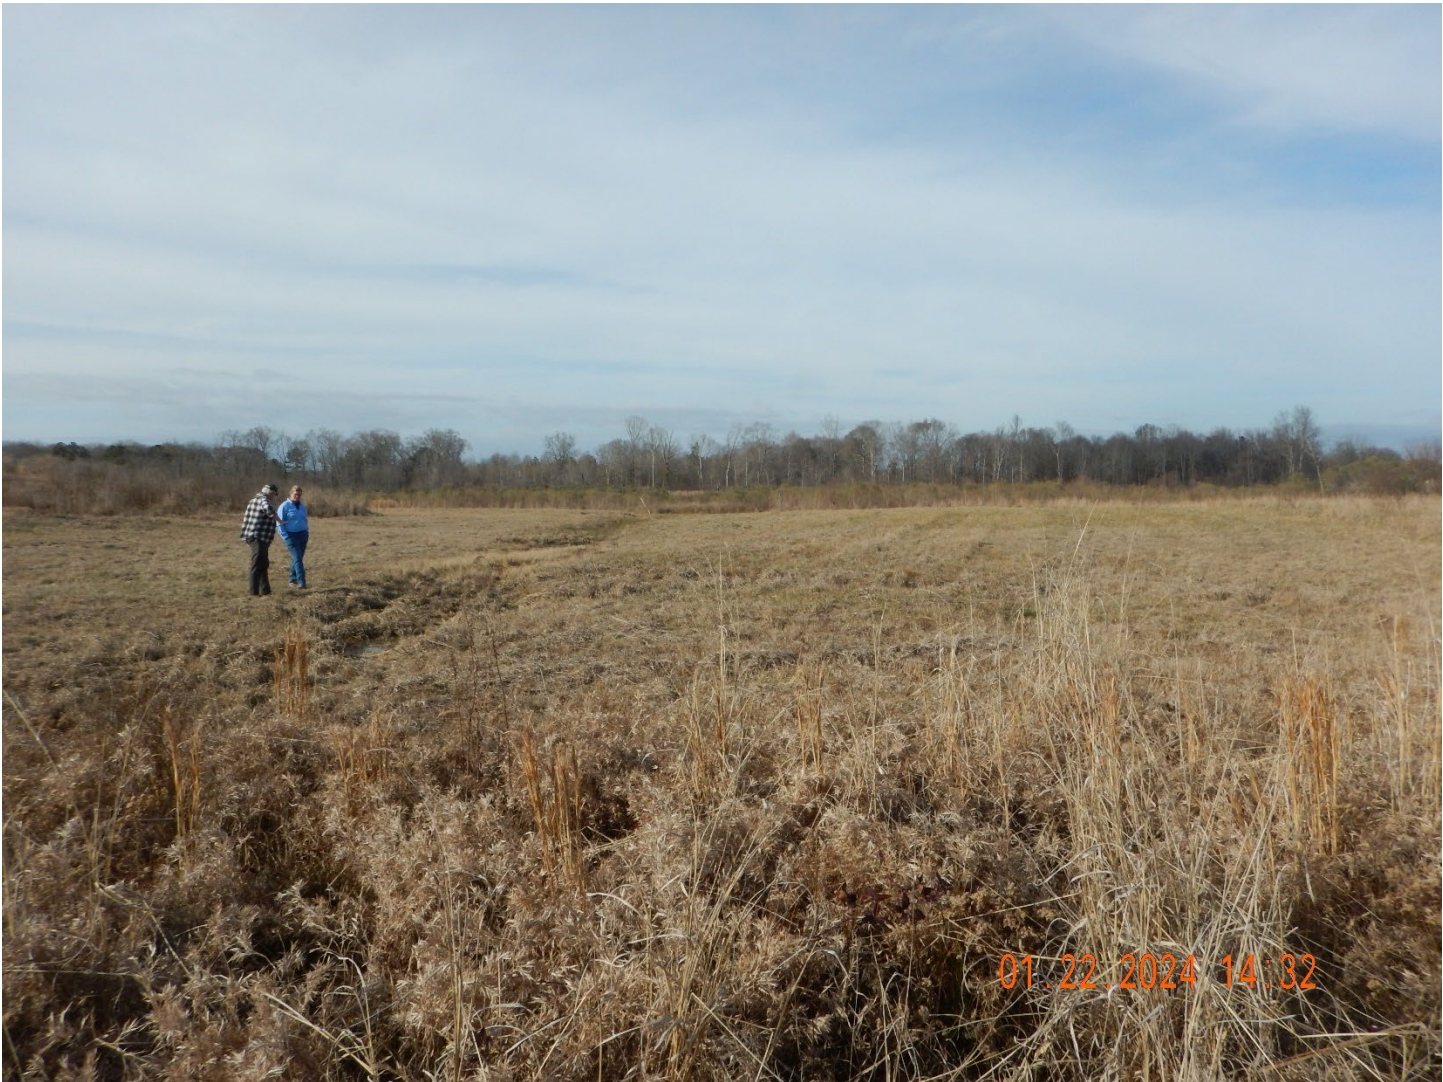
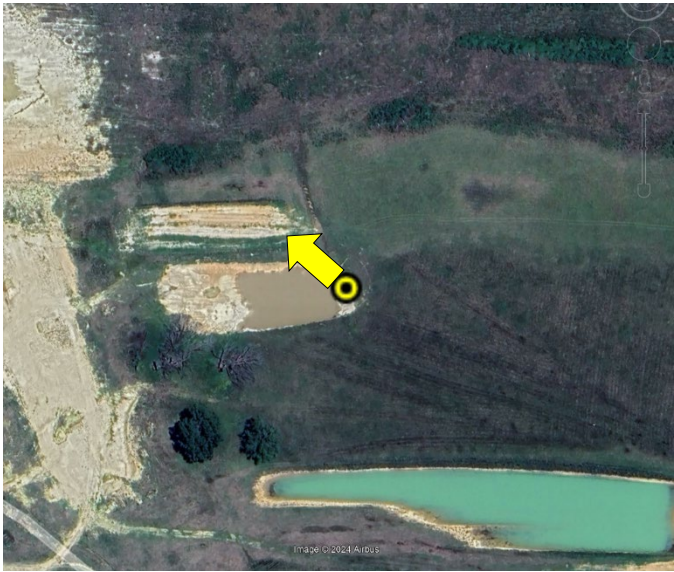
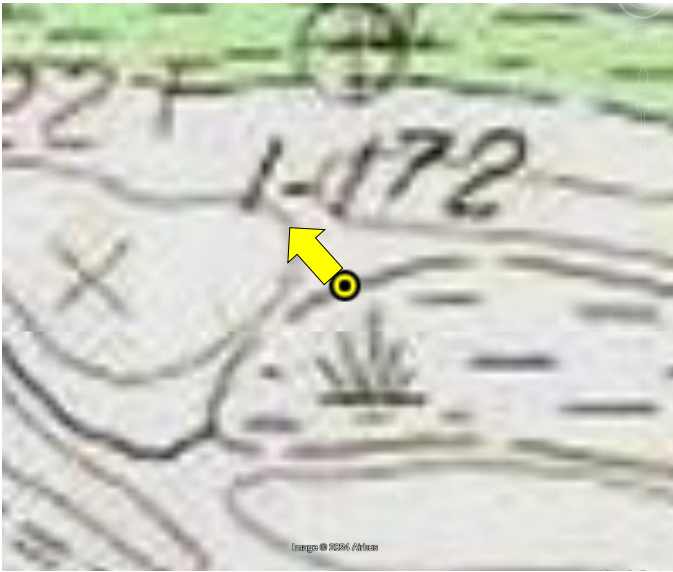
| Title | Photo 17 |

| Description | Striking northwest. Looking up the swale toward W-1's northern portion, as delineated by GMC. |

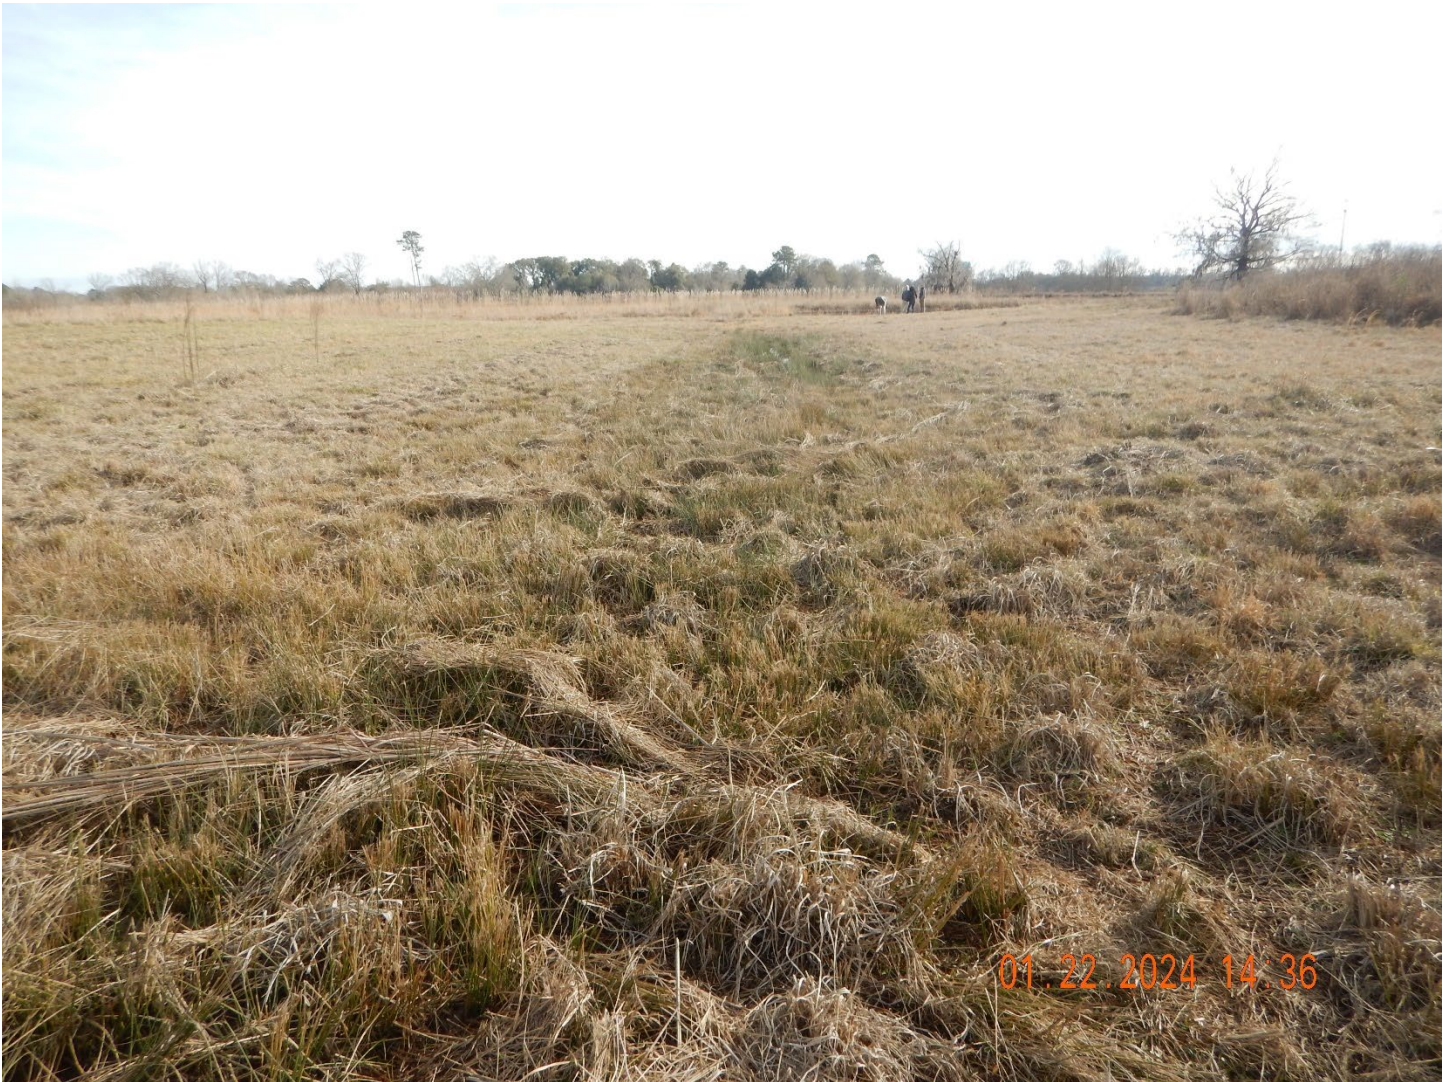
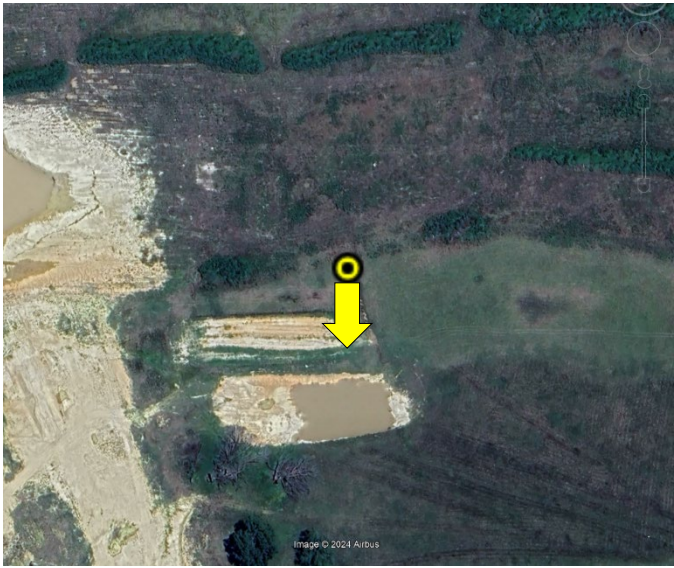
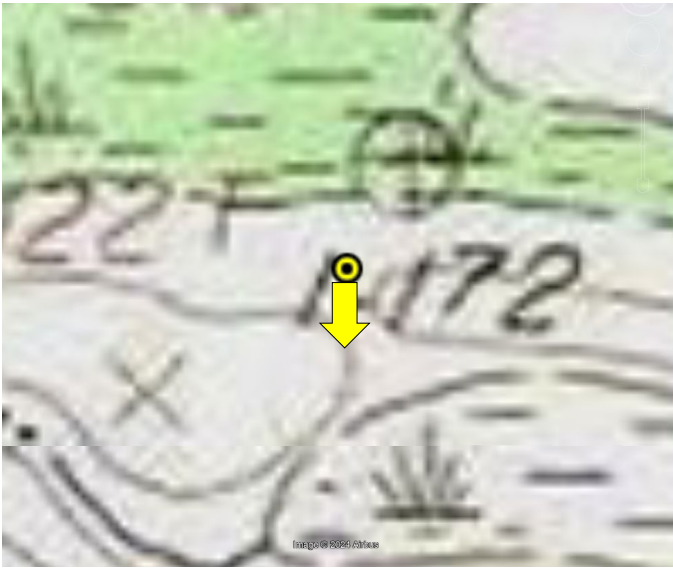
| Title | Photo 18 |

| Description | Striking south. Looking down the swale from the southern boundary of W-1's northern portion. |
