## Clean Water Act Section 404: Site Visit/Case Development

| Site Name | Henry Brick Company, Inc. (Claude Jack Mine) | | | | |

**Henry Brick Company, Inc. - Claude Jack Mine**  
**Selma, Dallas County, Alabama**  
**January 22, 2024**

### Henry Brick Company, Inc. Claude Jack Mine Site Inspection Photographic Log

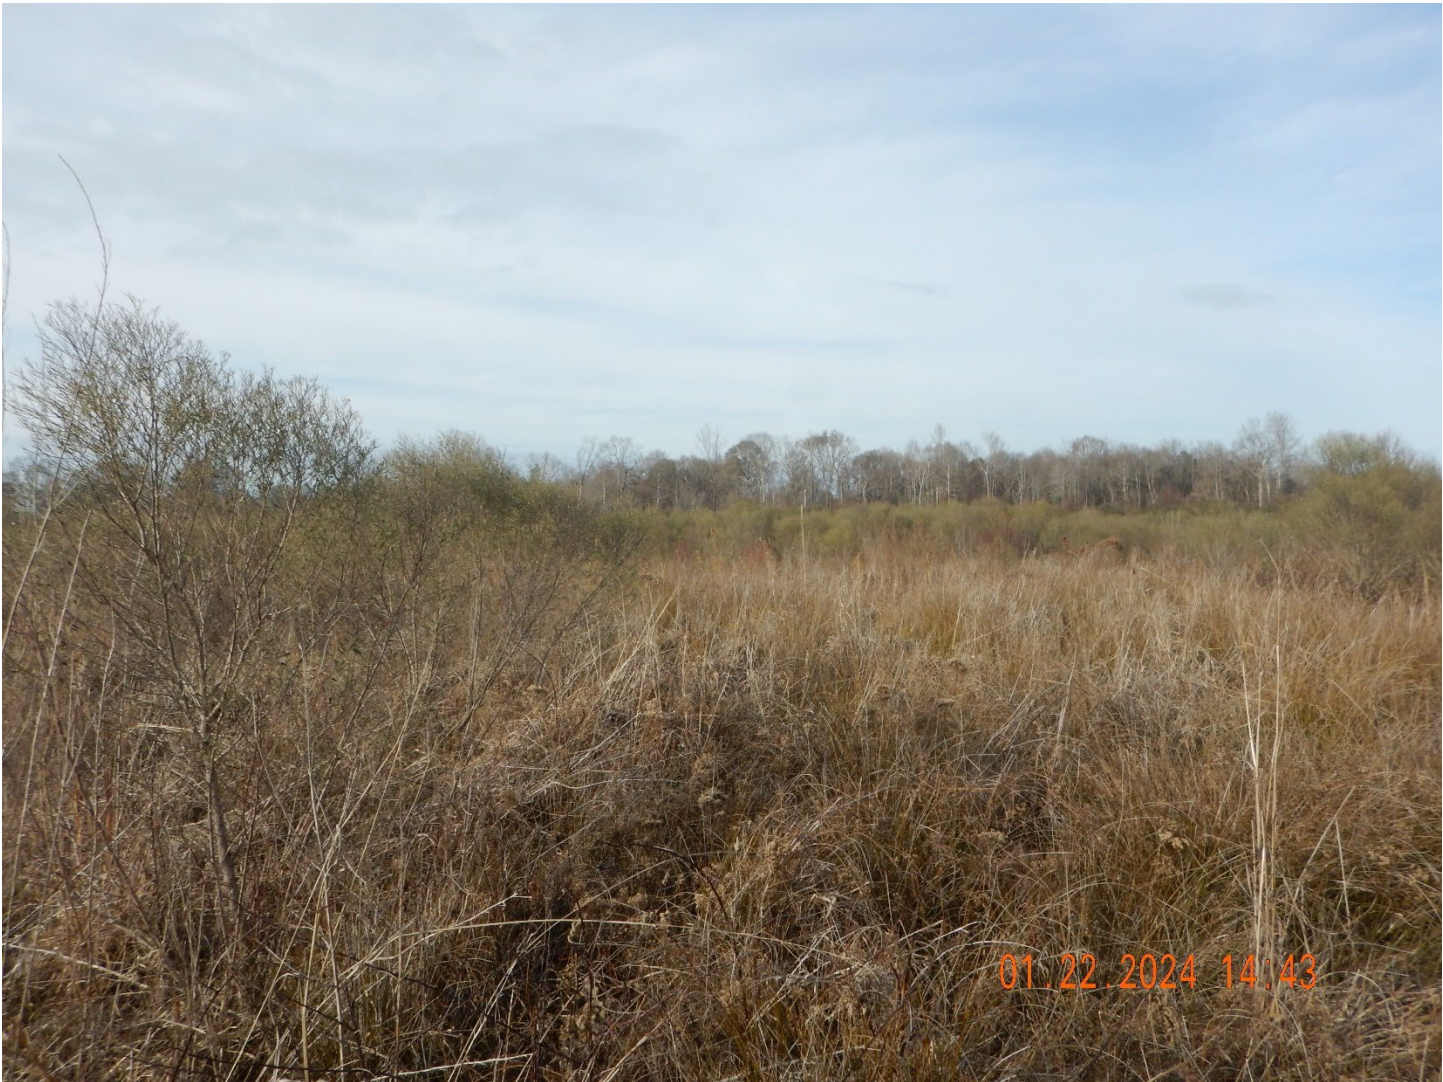
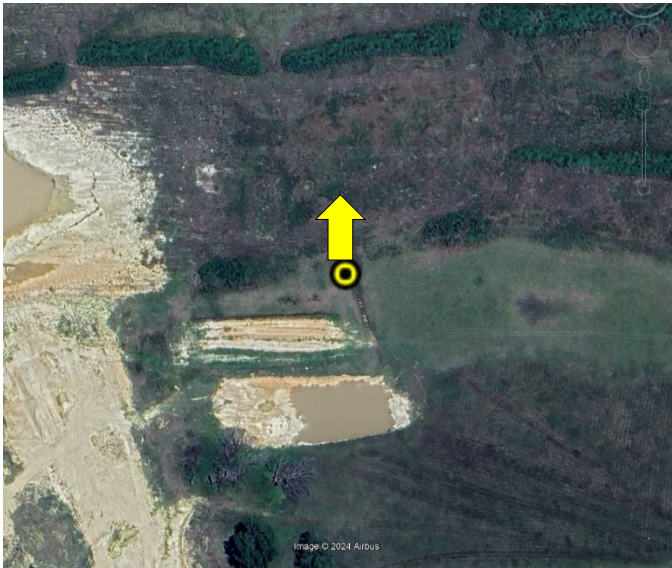
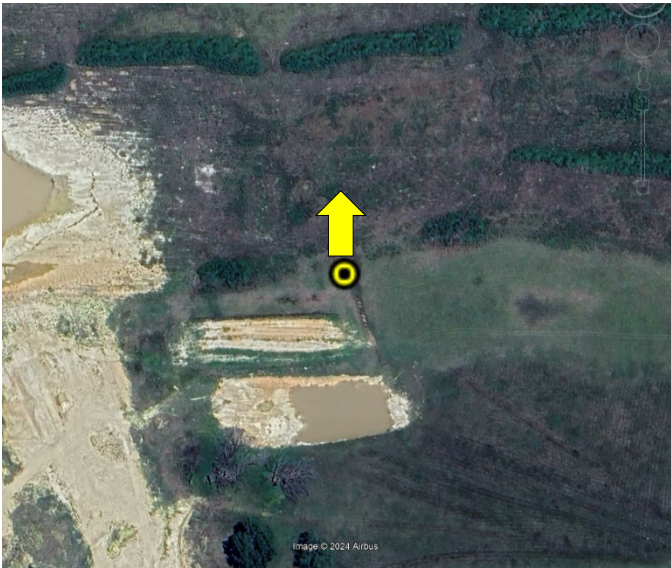
| Title | Photo 19 |

| Description | Striking north. Looking toward the cleared W-1 from its northern portion's southern boundary. |

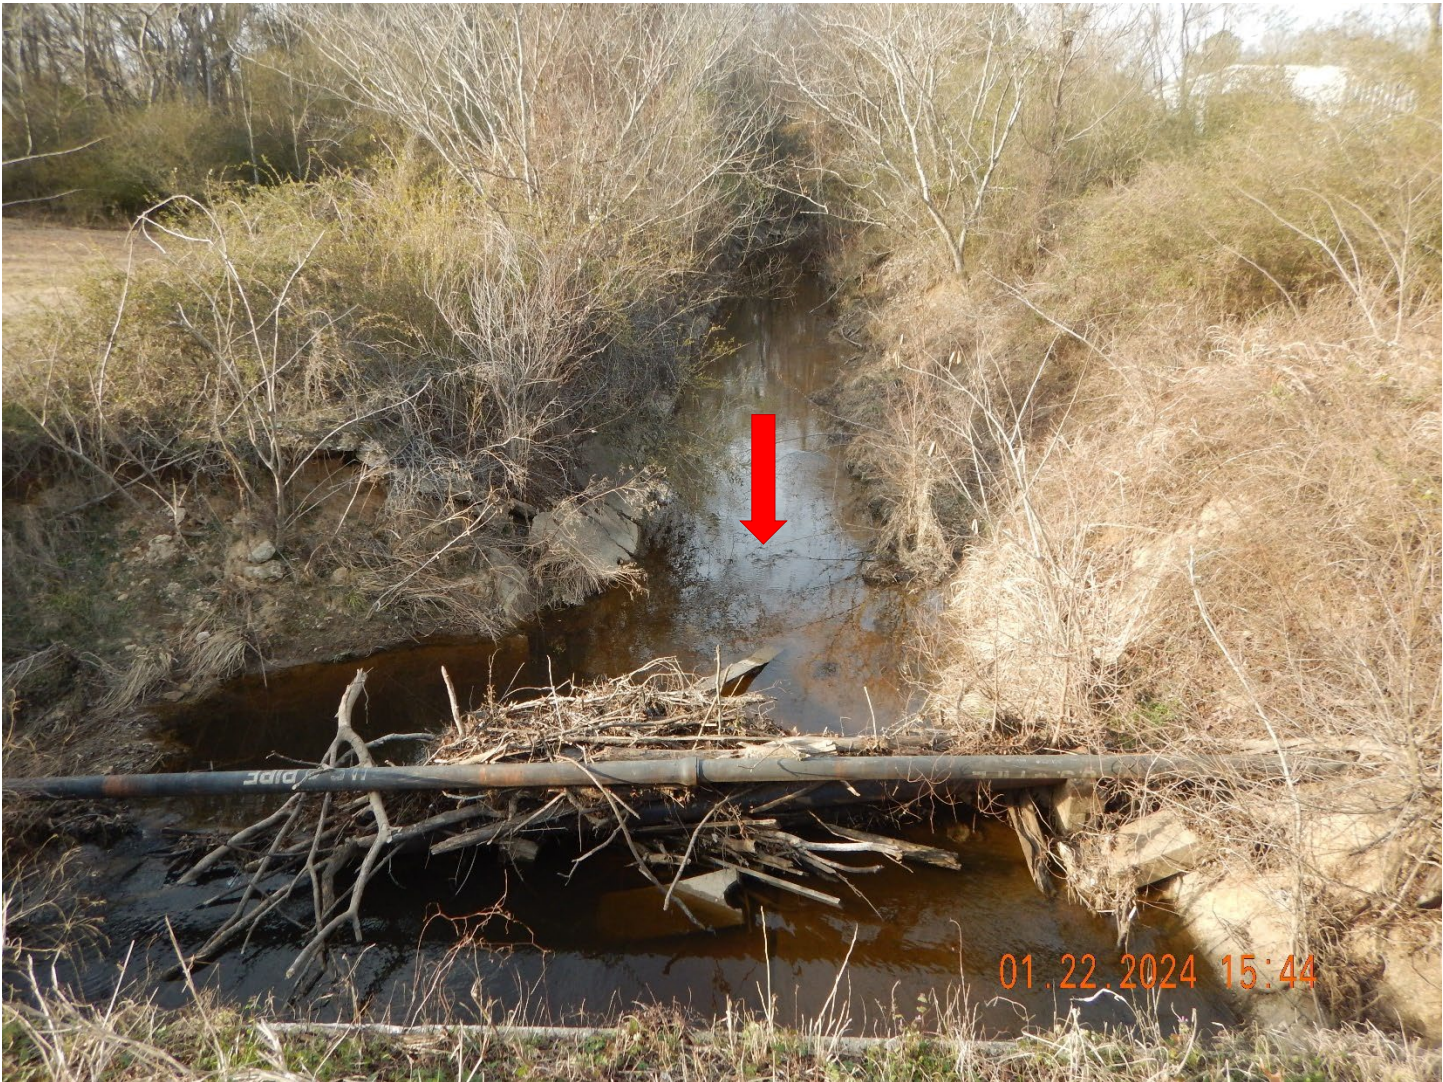
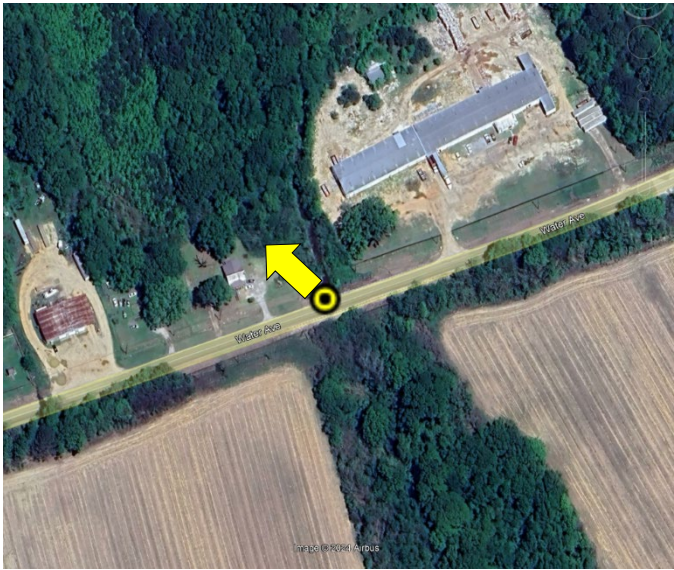
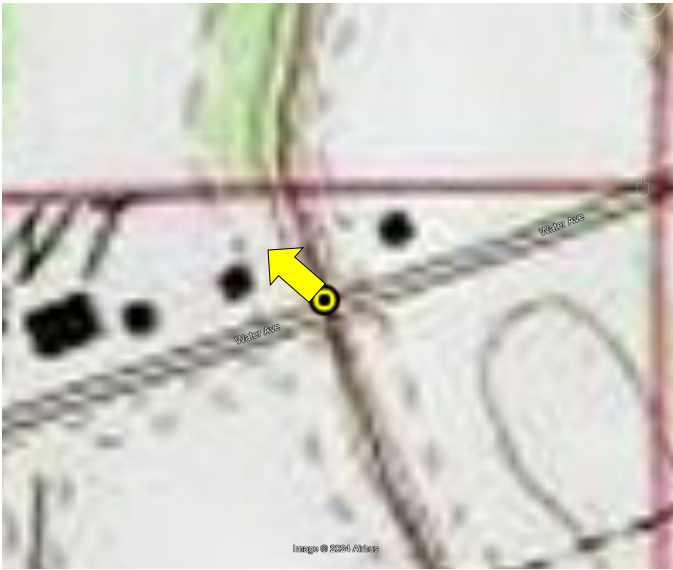
| Title | Photo 20 |

| Description | Striking northwest, upstream. Beech Creek from Water Avenue. |

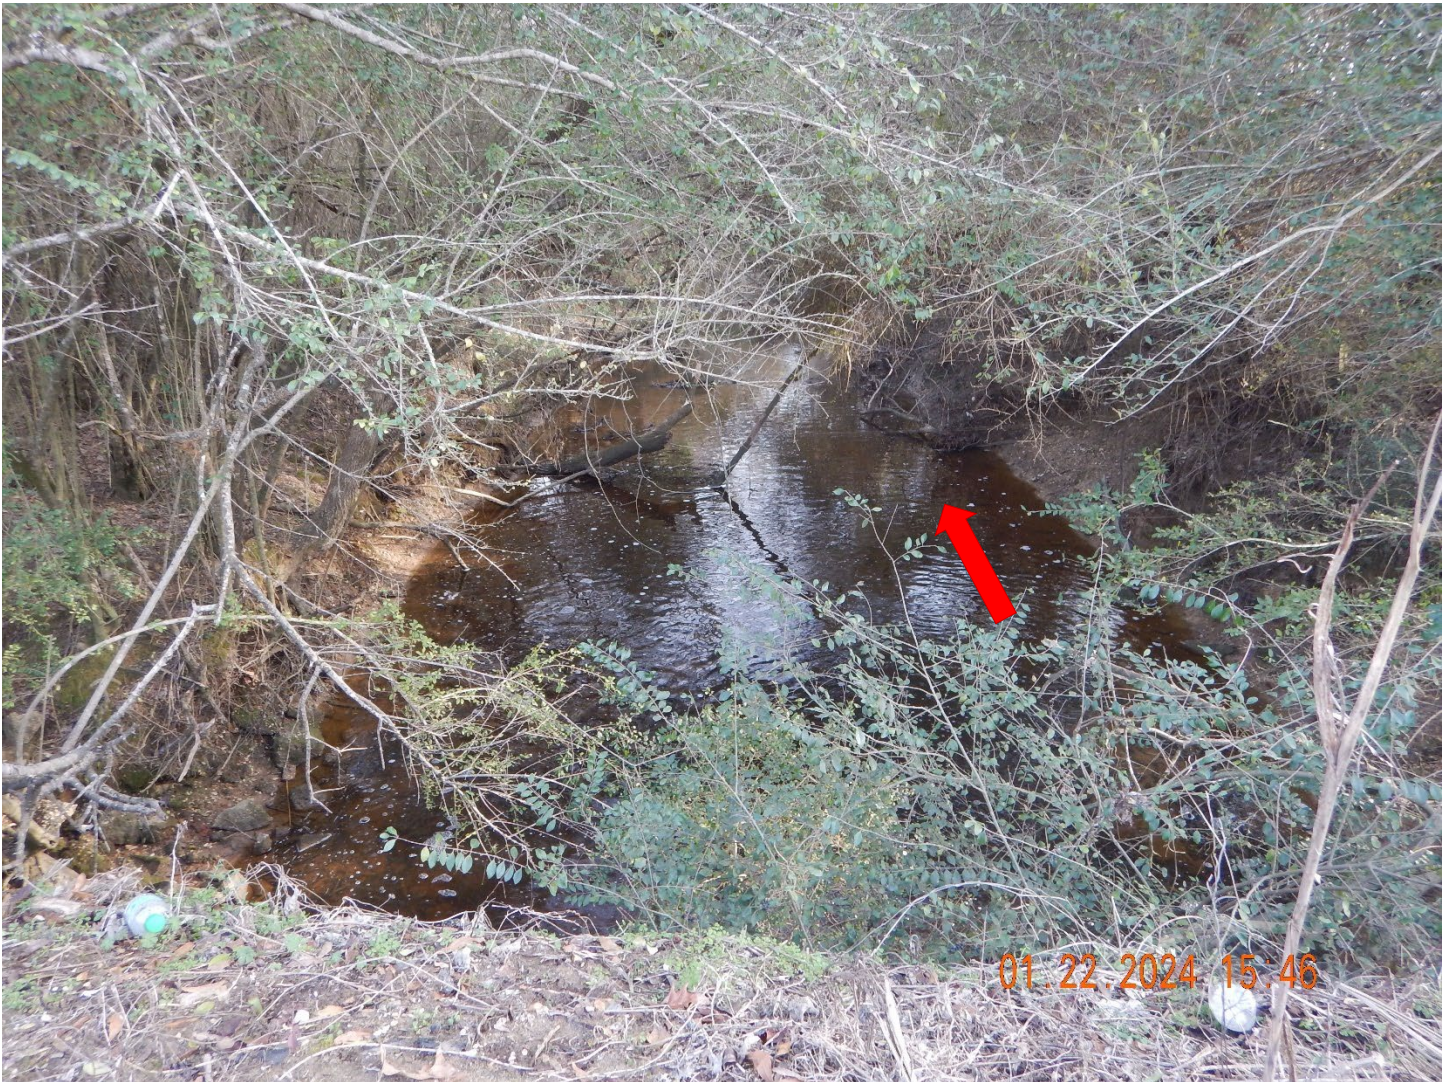
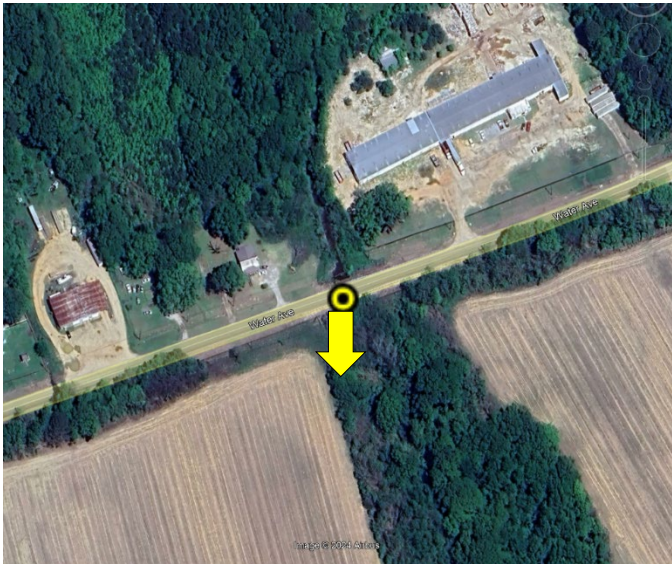
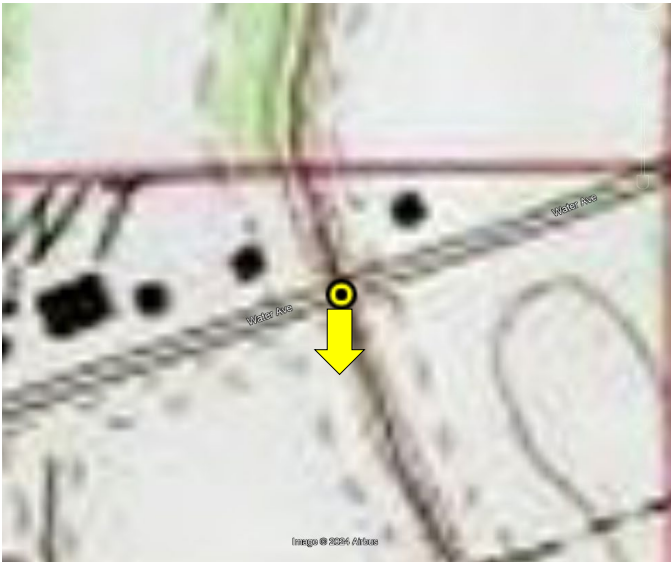
| Title | Photo 21 |

| Description | Striking south, downstream. Beech Creek from Water Avenue. |

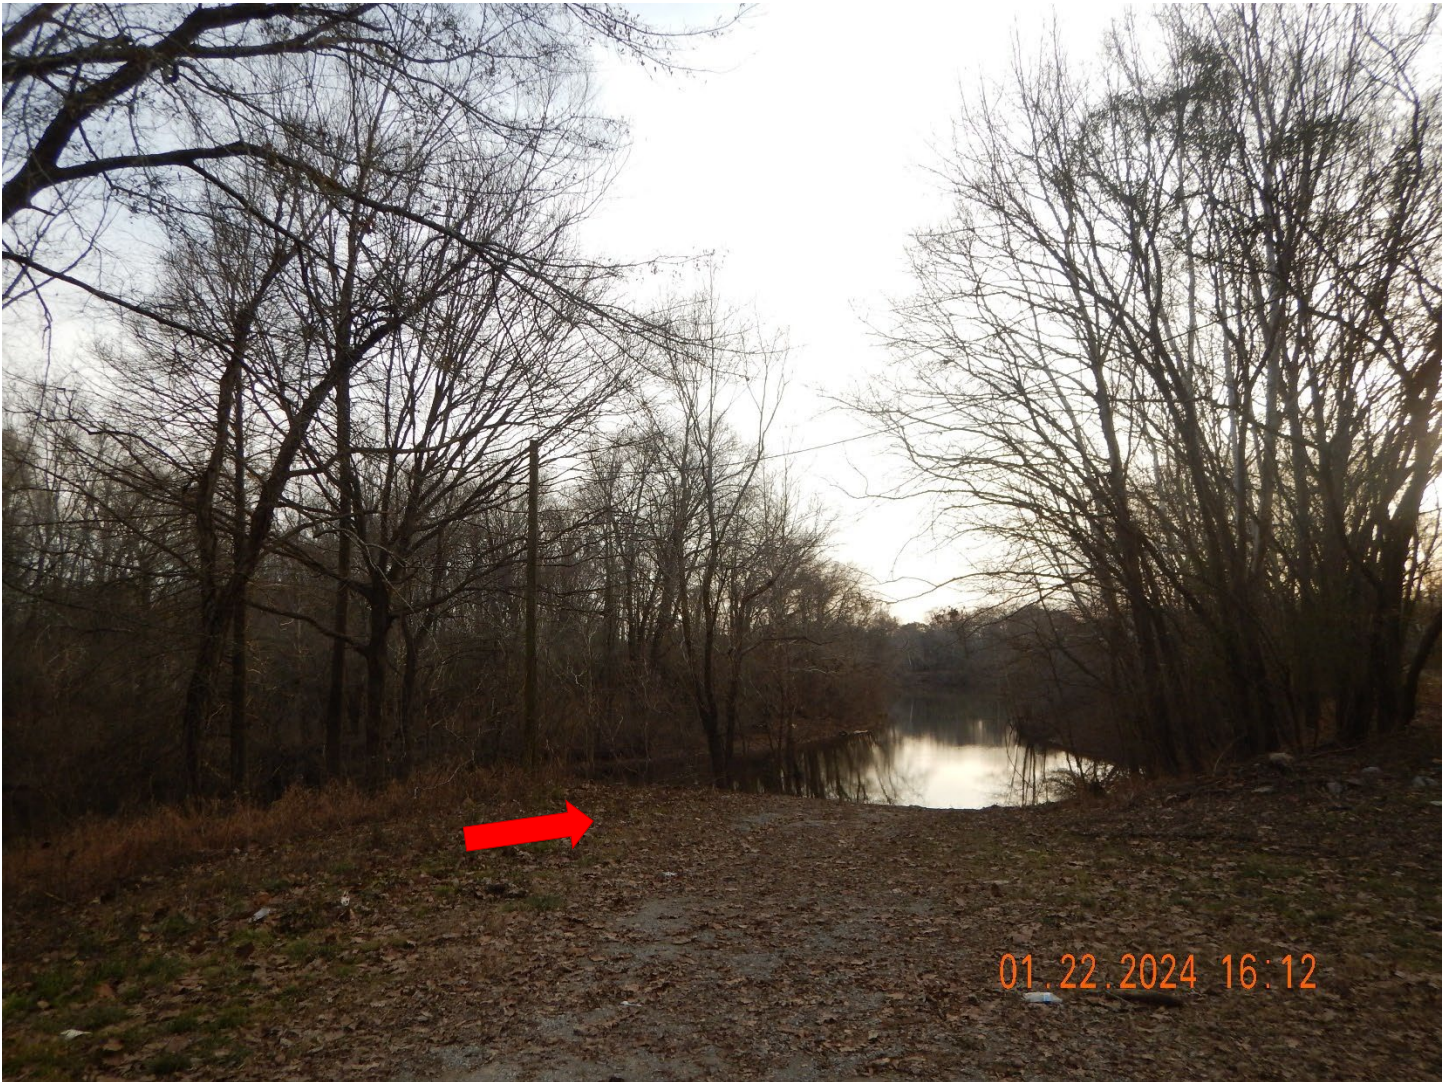
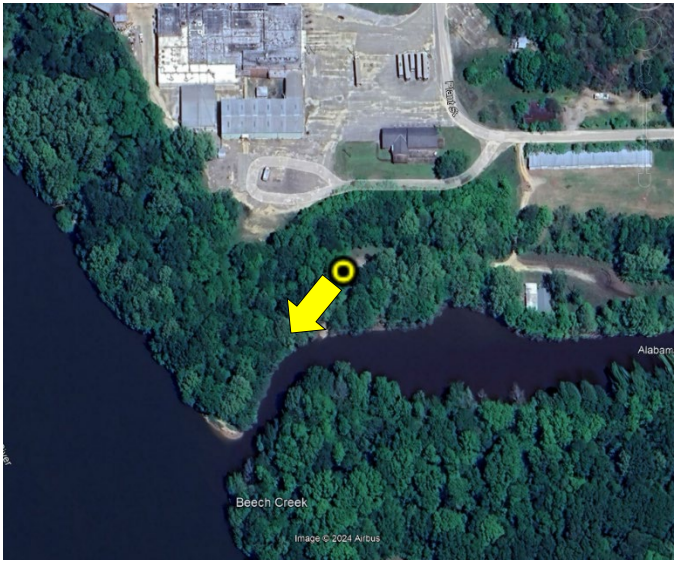
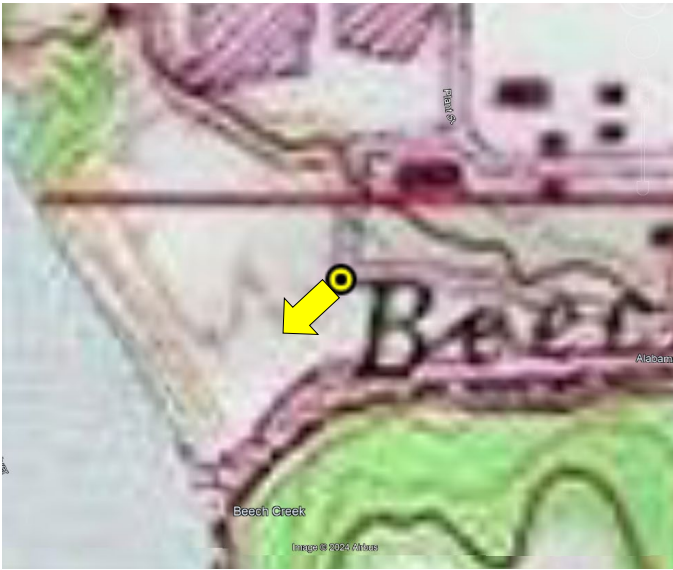
| Title | Photo 22 |

| Description | Striking southwest. Confluence of Beech Creek and the Alabama River, a Section 10 Water at this location. |
