## Region 6 - Enforcement & Compliance Assurance Division

### INSPECTION REPORT

| Company Name: | Universal City, City of | | |
| Facility Name: | Wastewater Utility Department | | |

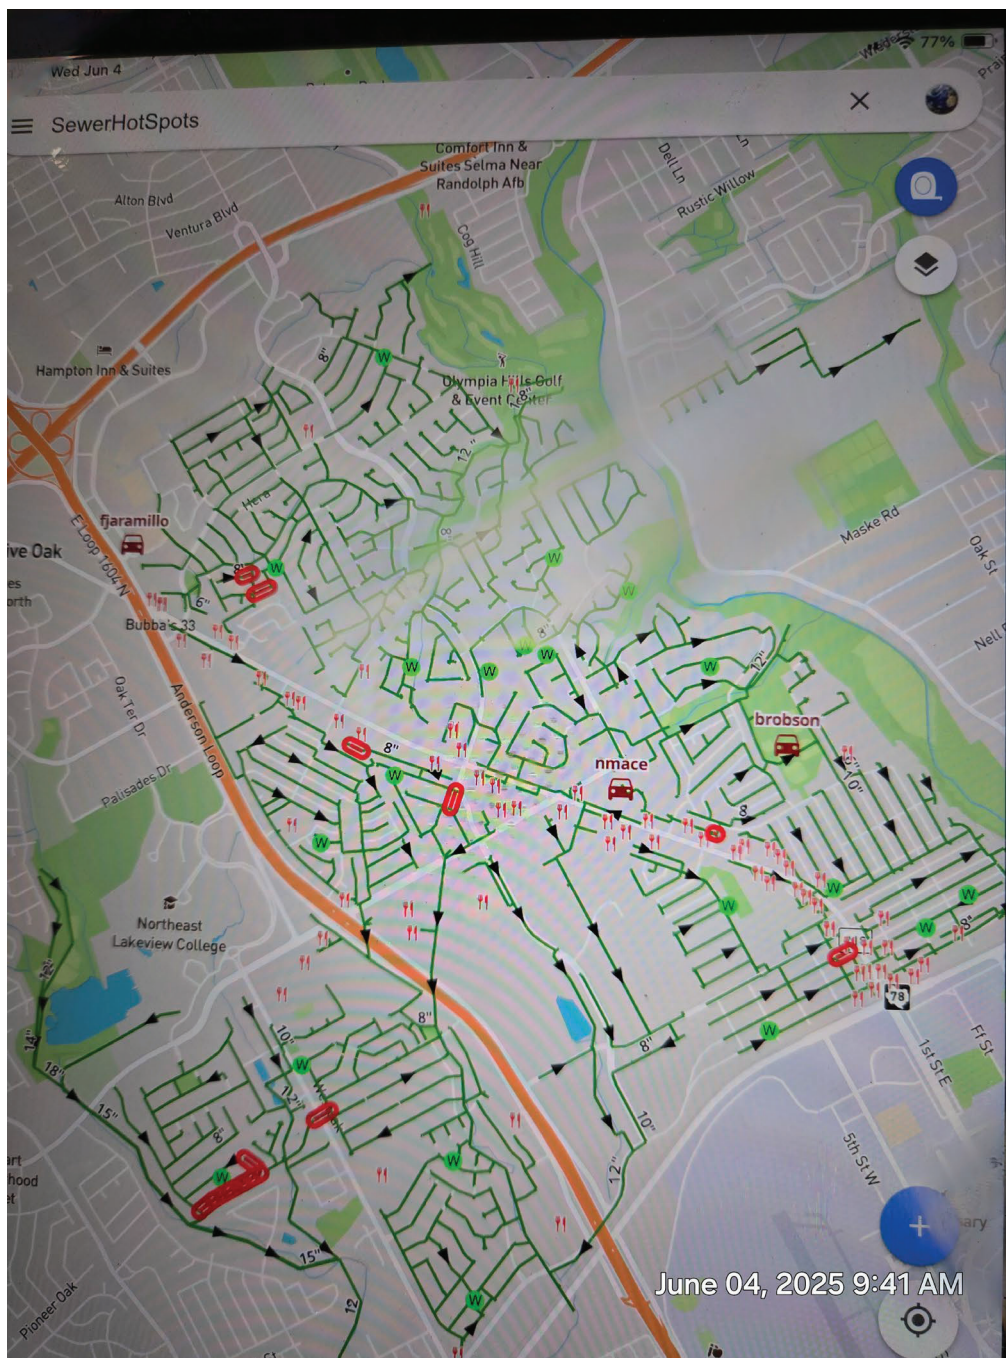
Photo No. 1

- The city maintains 12 working sewer "Hot Spot" areas as shown on a wastewater (WW) site map in "red" marker (reference Appendix 1, Photo 1) where maintenance activities are completed about two or three times through the year as needed to prevent blockages and SSOs as follows:

Description: Sanitary Sewer Site Map showing Hot Spot areas in "red" marker where city jet-truck cleans gravity mains regularly (two or more times throughout the year) to prevent SSOs.

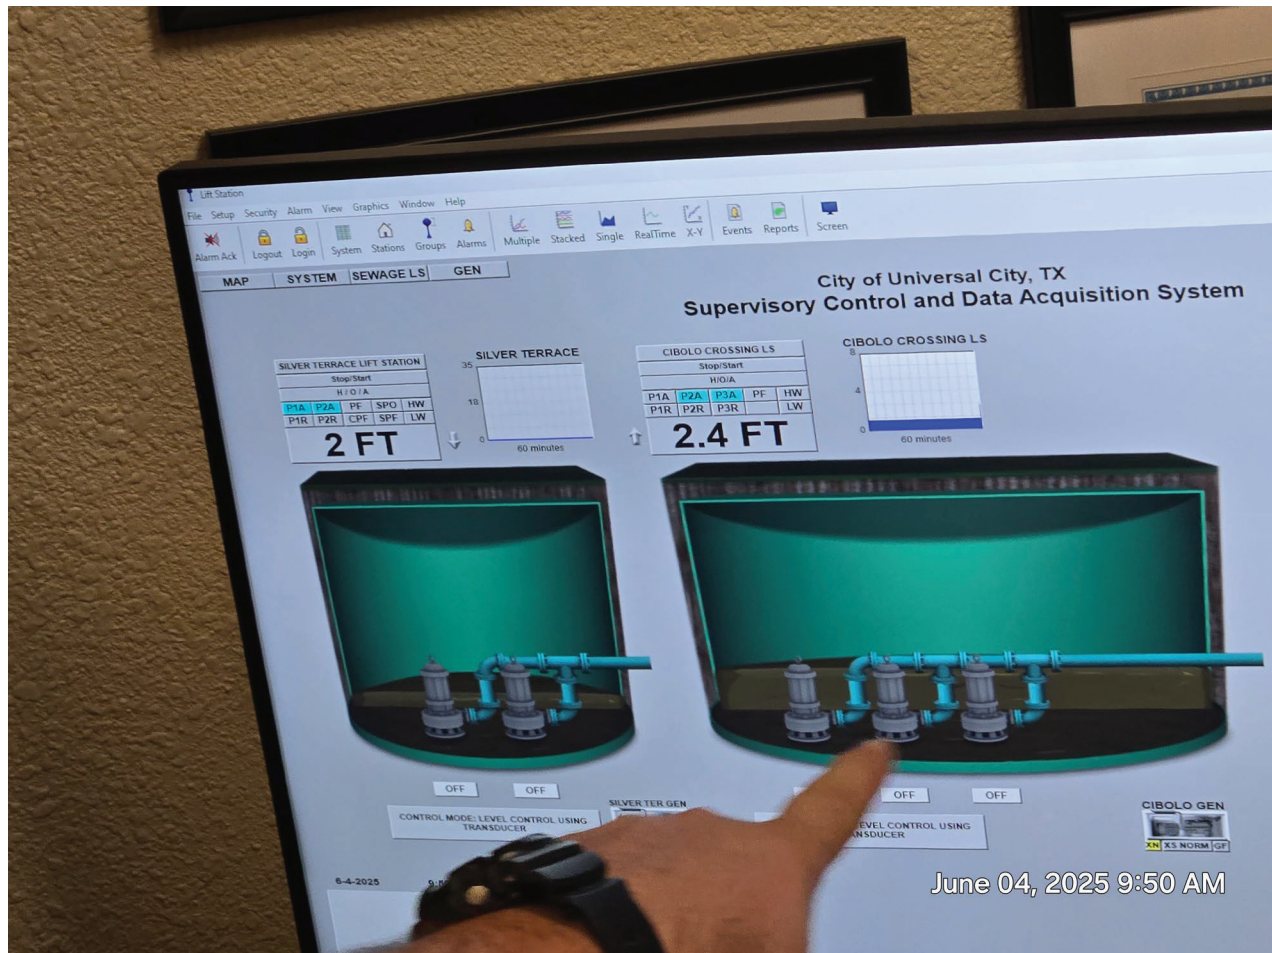
Photo No. 2

Description: Supervisory Control and Data Acquisition System (SCADA) installed on Universal City work-computer showing monitoring and control of both the city's lift stations.

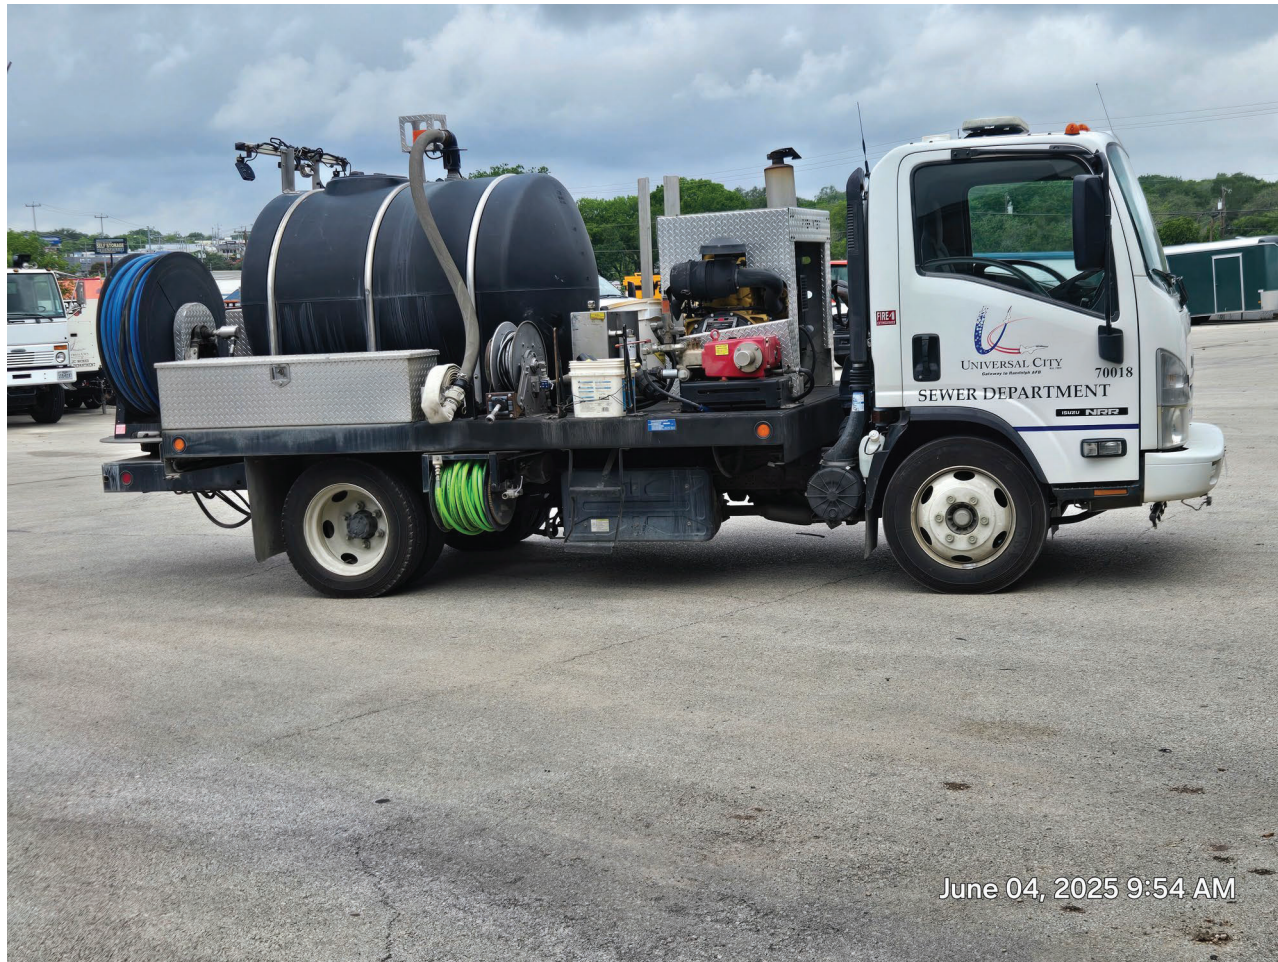
Photo No. 3

Description: City Jet-Truck.

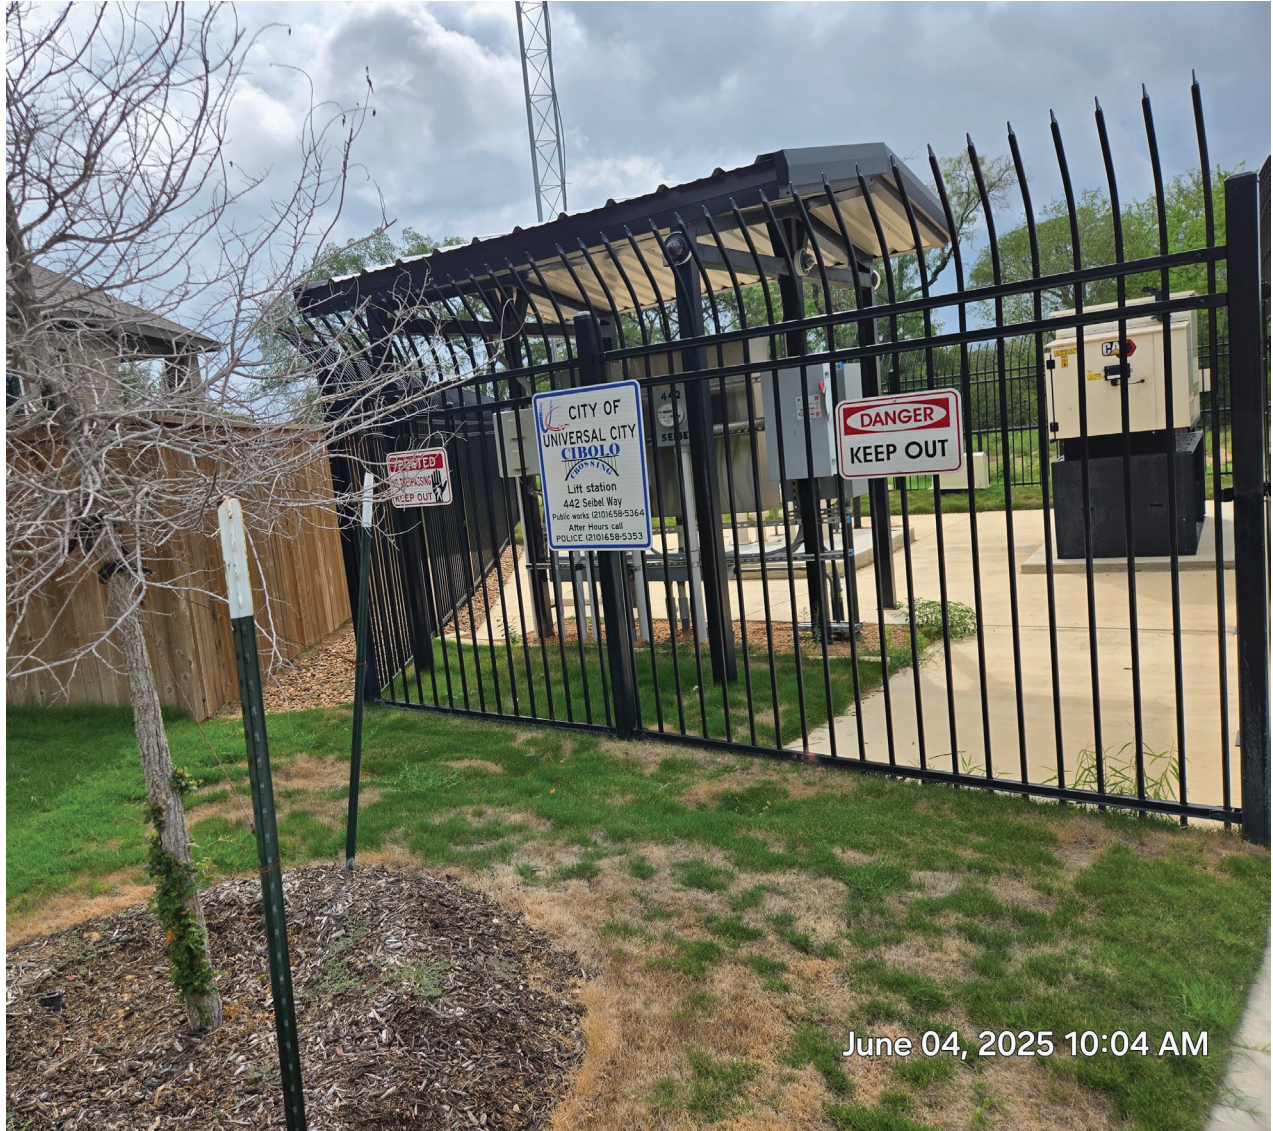
Photo No. 4

| ID | LS Name | Observations | Appendix 1 Photo Nos. |
|---|---|---|---|
| 1 | Cibolo Crossing | SCADA monitoring telemetry, security cameras, back-up generator, on-site visual alarm, no observed quick connect. | 4 & 5 |

Description: Cibolo Crossing LS, Outside View.

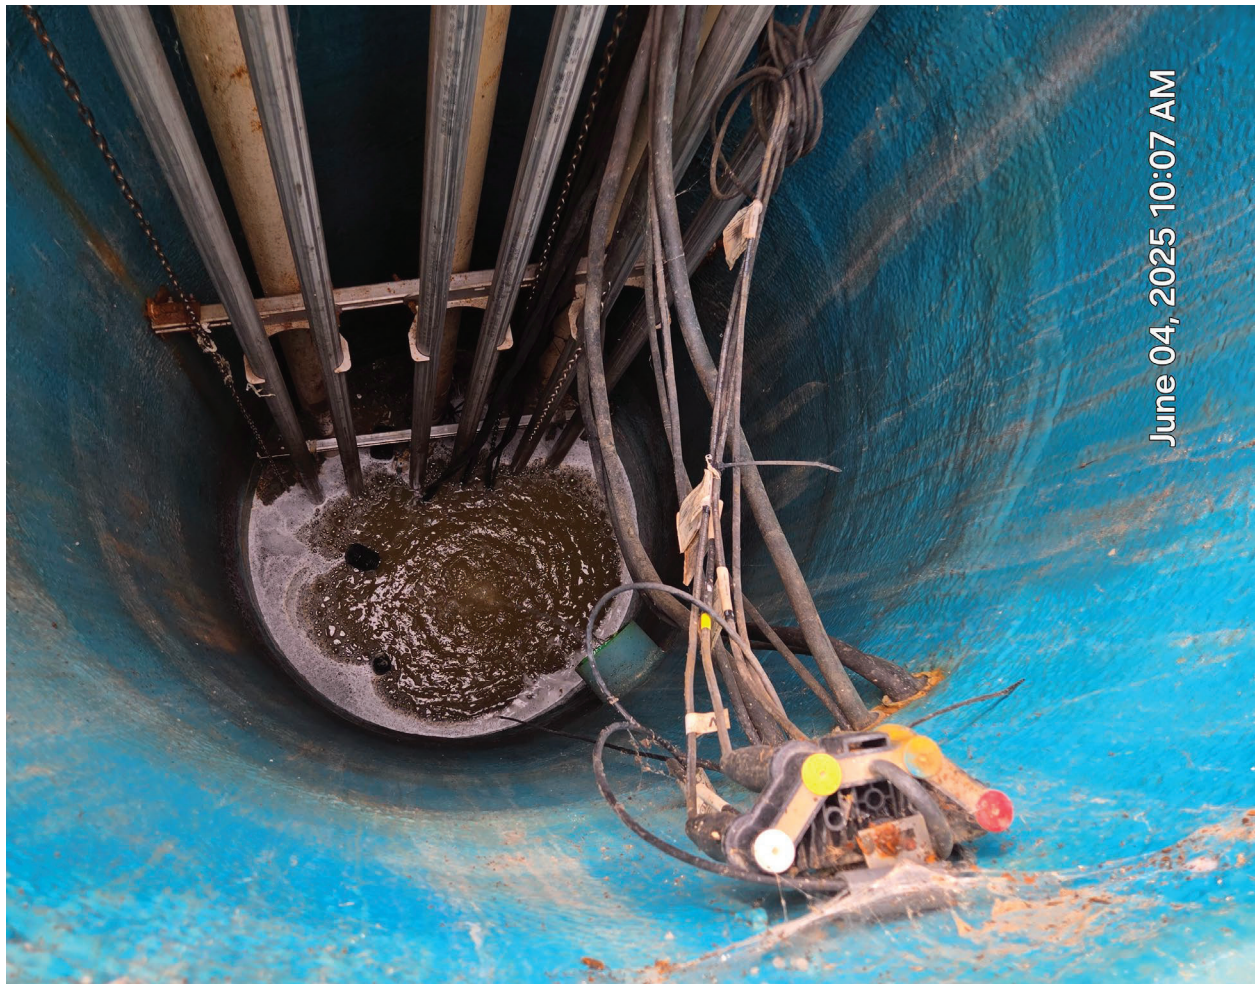
Photo No. 5

Description: Cibolo Crossing LS inside wet well, clean and in good visible condition.

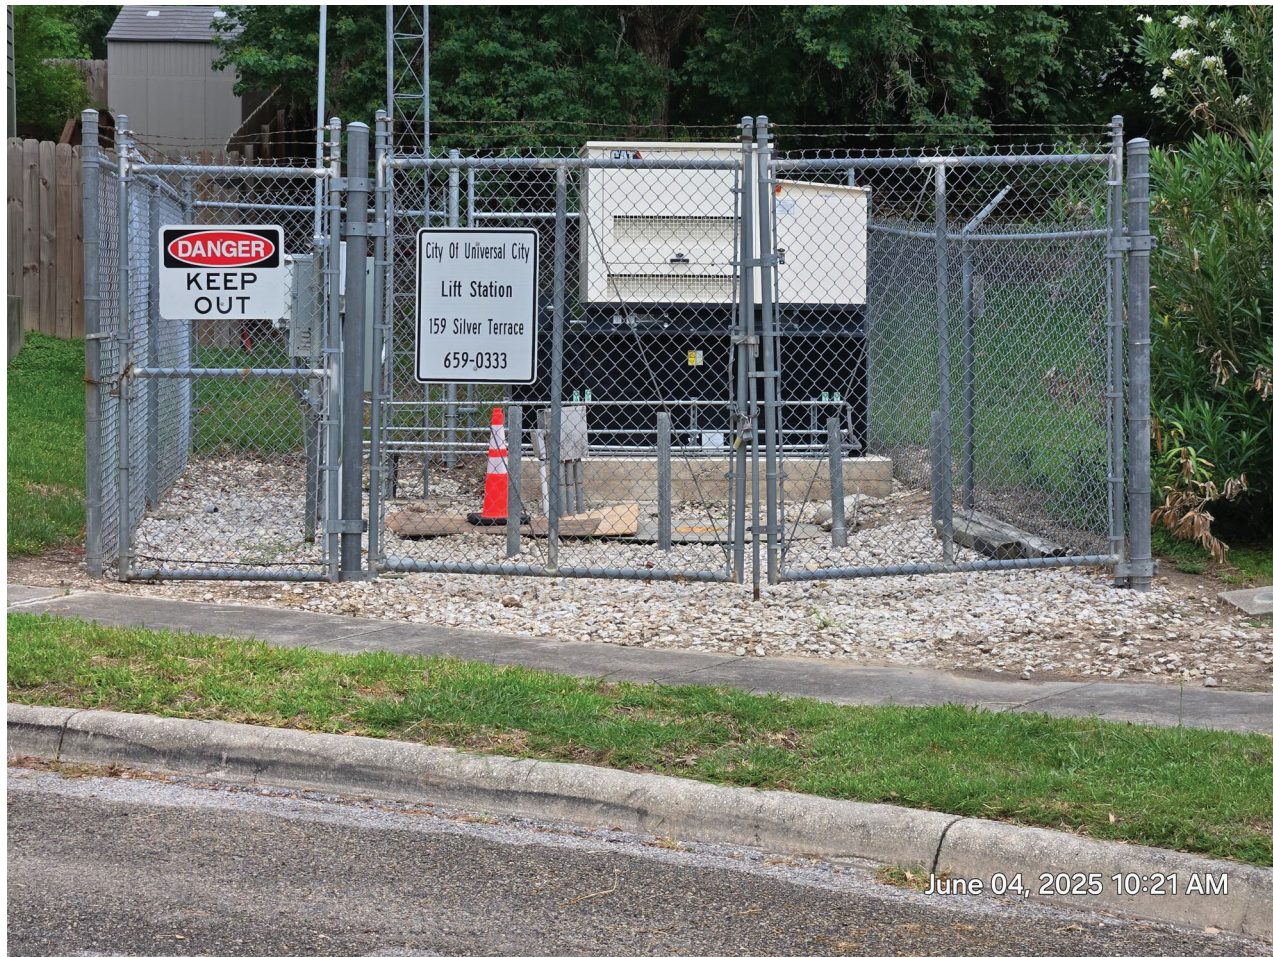
Photo No. 6

| ID | LS Name | Observations | Appendix 1 Photo Nos. |
|---|---|---|---|
| 2 | Silver Terrace | SCADA monitoring telemetry, on-site visual alarm, back-up generator. | 6 & 7 |

Description: Silver Terrace LS outside view.

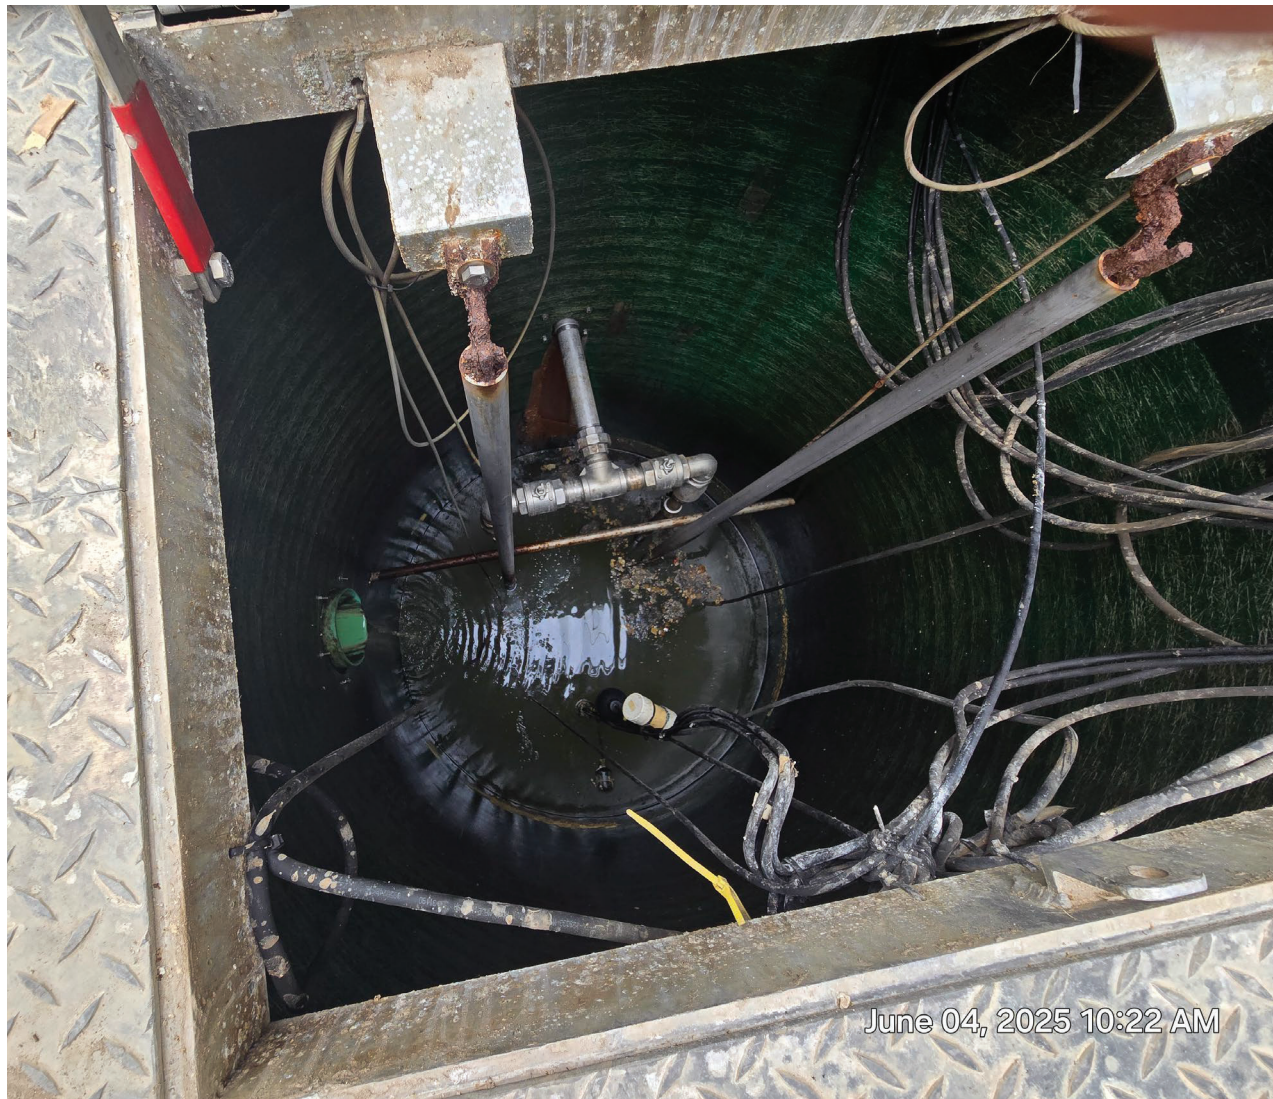
Photo No. 7

Description: Silver Terrace LS inside wet well, clean and in good visible condition.
