**Subj:** Inspection Report  
Clean Water Act - National Pollutant Discharge Elimination System ("NPDES")  
Marina at Admirals Hill

- A. *Facility Name:* Marina at Admirals Hill
- B. *Facility Location:* 305 Commandant's Way  
Chelsea, MA 02150
- C. *Facility Contacts:* Donnie Randolph, Operator  
Donnie@mybostonmarina.com  
6179974772
- Rob Waters, Owner  
174 Plaistow Road  
Plaistow, NH 03865  
603 366-5000  
RWaters@WatersLegalGroup.com
- D. *NPDES ID No(s):* MAR05J07M

- A. *Date(s) of inspection:* October 7, 2024
- B. *Weather Conditions:* 60 degrees, raining.  
Approximately 0.5" inches of rain fell between 11:30 AM and 2:00 PM on the day of inspection according to the website Weather Underground.
- C. *US EPA Representative(s):* Alex Rosenberg
- D. *State/Local Representative(s):* N/A

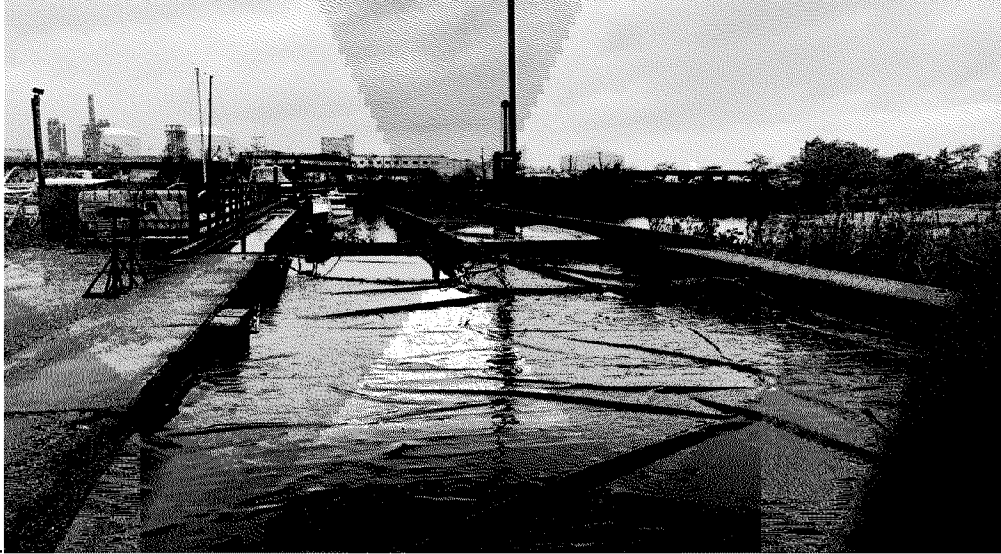
PHOTO 1

I began the site walk by asking Mr. Randolph about the boat wash water collection system at the marine travel lift (photos 1 & 2).

- Shortly after EPA's last inspection in November of 2022, Mr. Waters purchased a Wash water recycling system. After payment he was told that it would be 2 years until delivery. Considering the long waiting period, Mr. Randolph built a wash water recycling system;
- The filters are changed every two or three weeks;
- The plastic mat below the washing area is changed every year;
- Roofing mastic is used to glue the plastic to the sides of the rail system; and
- Some overspray occurs, but he tries to wash it back onto the plastic.

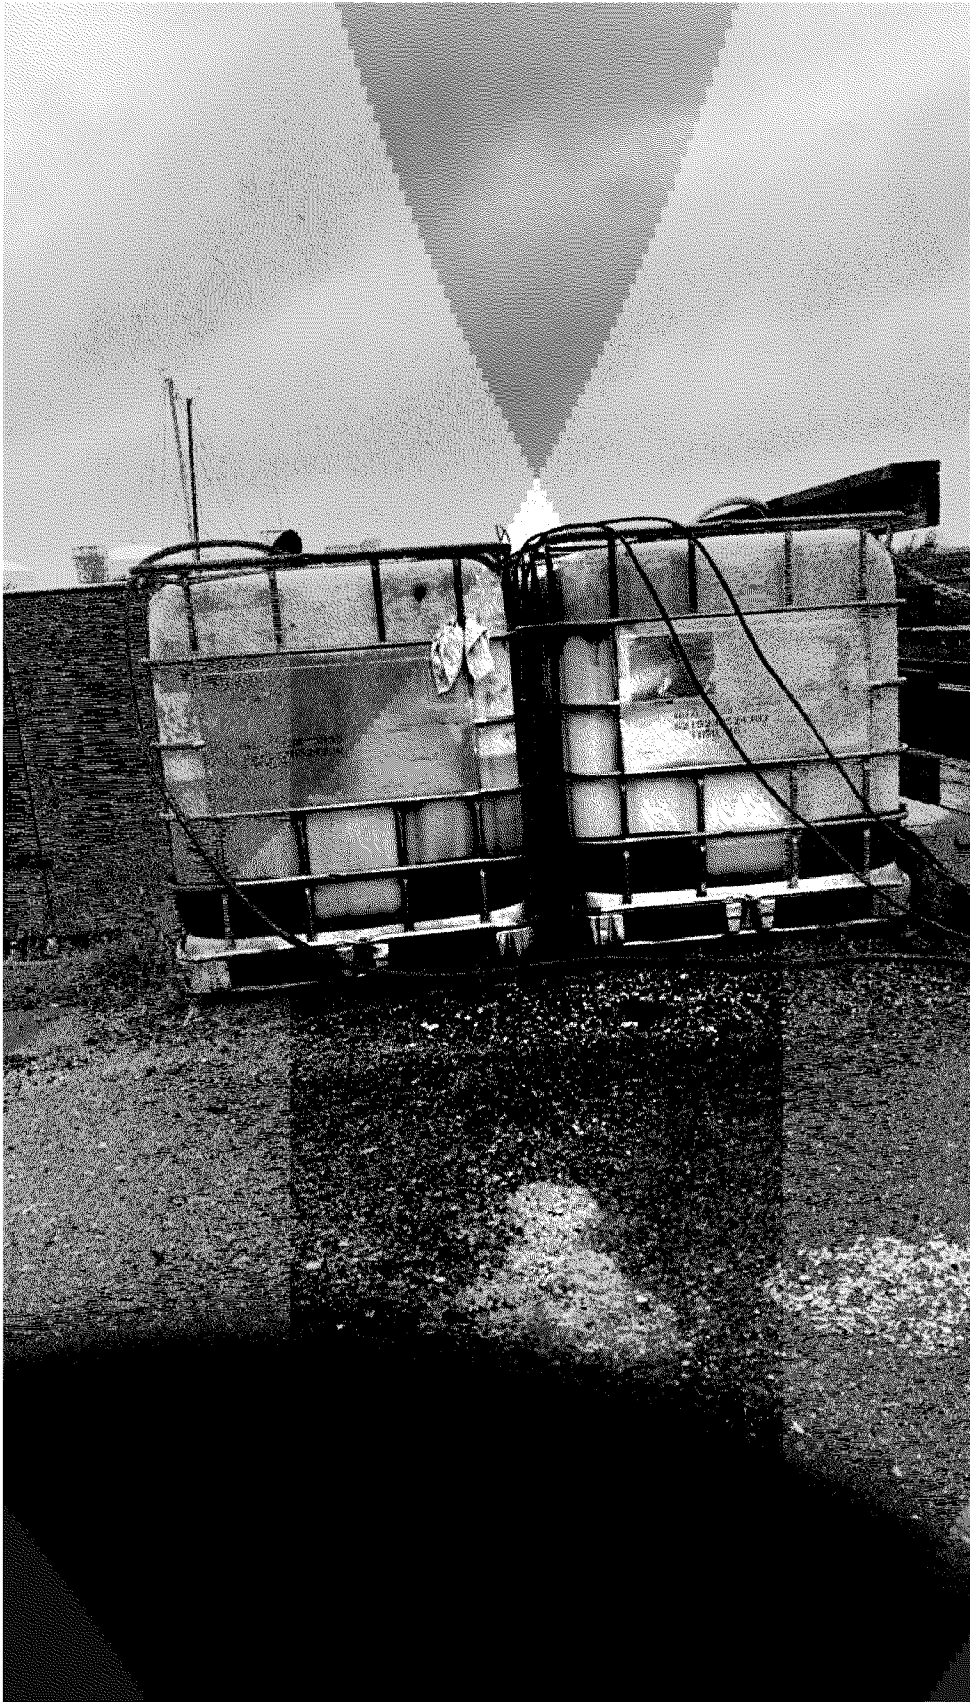
Photo 3

The filters are on the shore-side of the two 250-gallon capacity plastic totes (photo 3). Mr. Randolph took a photo of the filters and showed it to me during the inspection. The photo was sent by Mr. Randolph to EPA the day after the inspection.

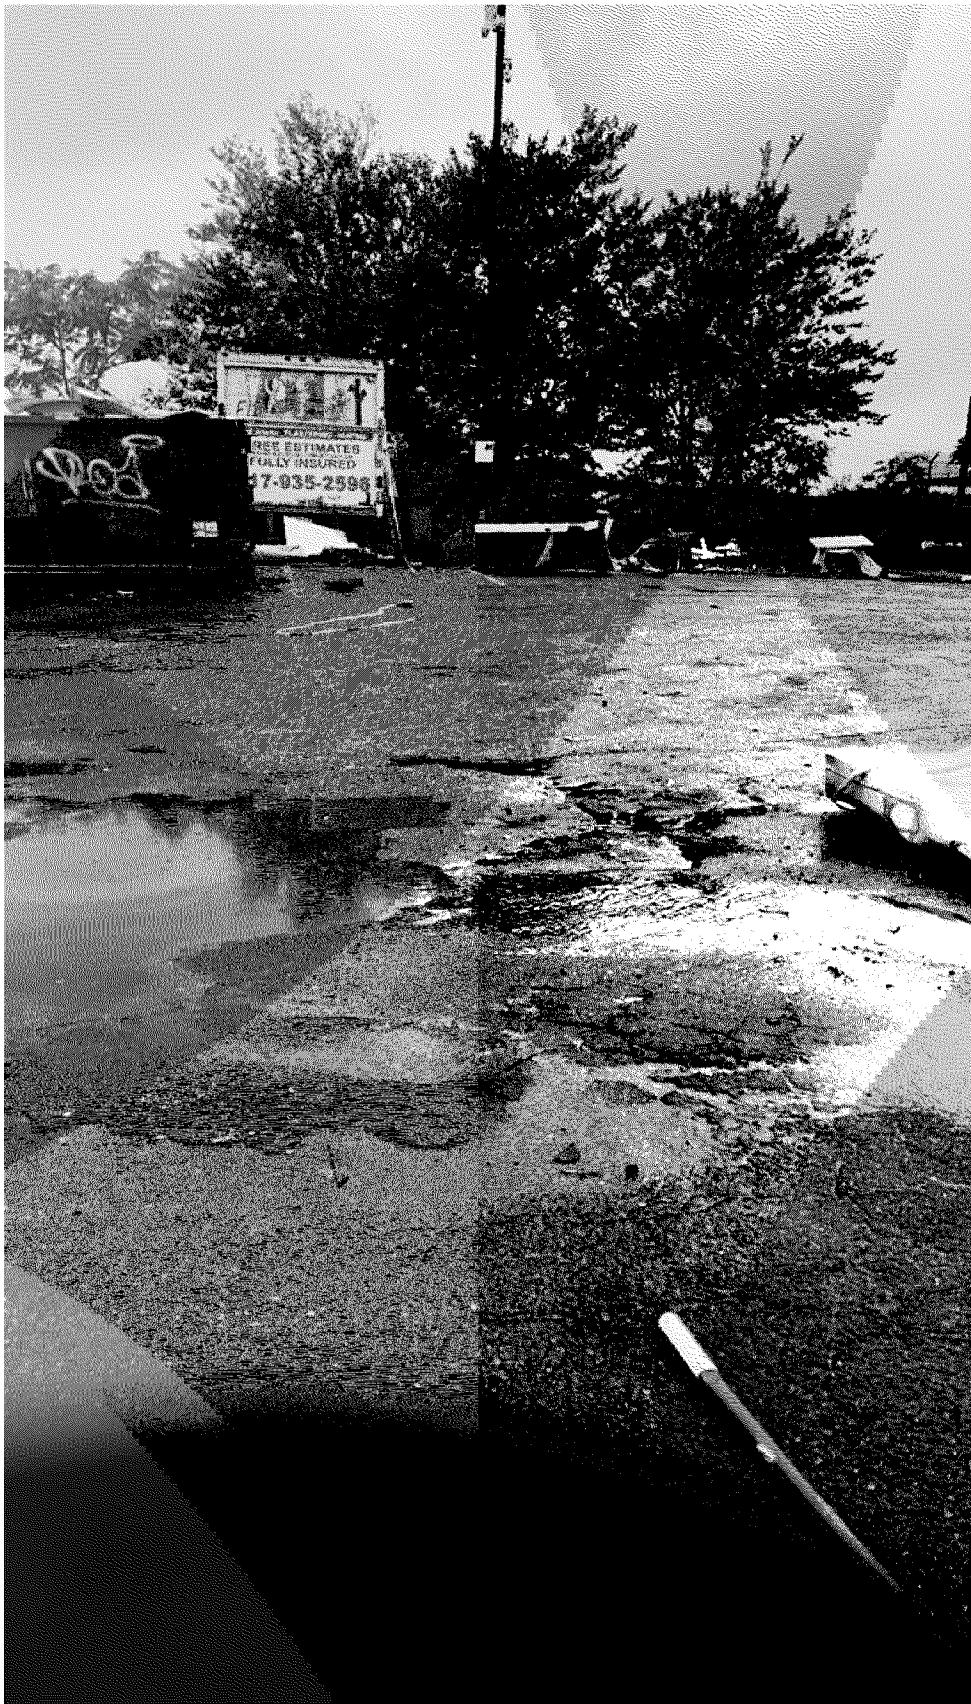
Photo 4

Oil sheen was observed on the surface of stormwater runoff discharging into the centrally located catch basin (photos 4, 5, & 6). EPA inspector recommended that oil absorbing filter socks be put around the catch basin, and that other Storm Water Control Measures be implemented based on needs determined by stormwater monitoring results.

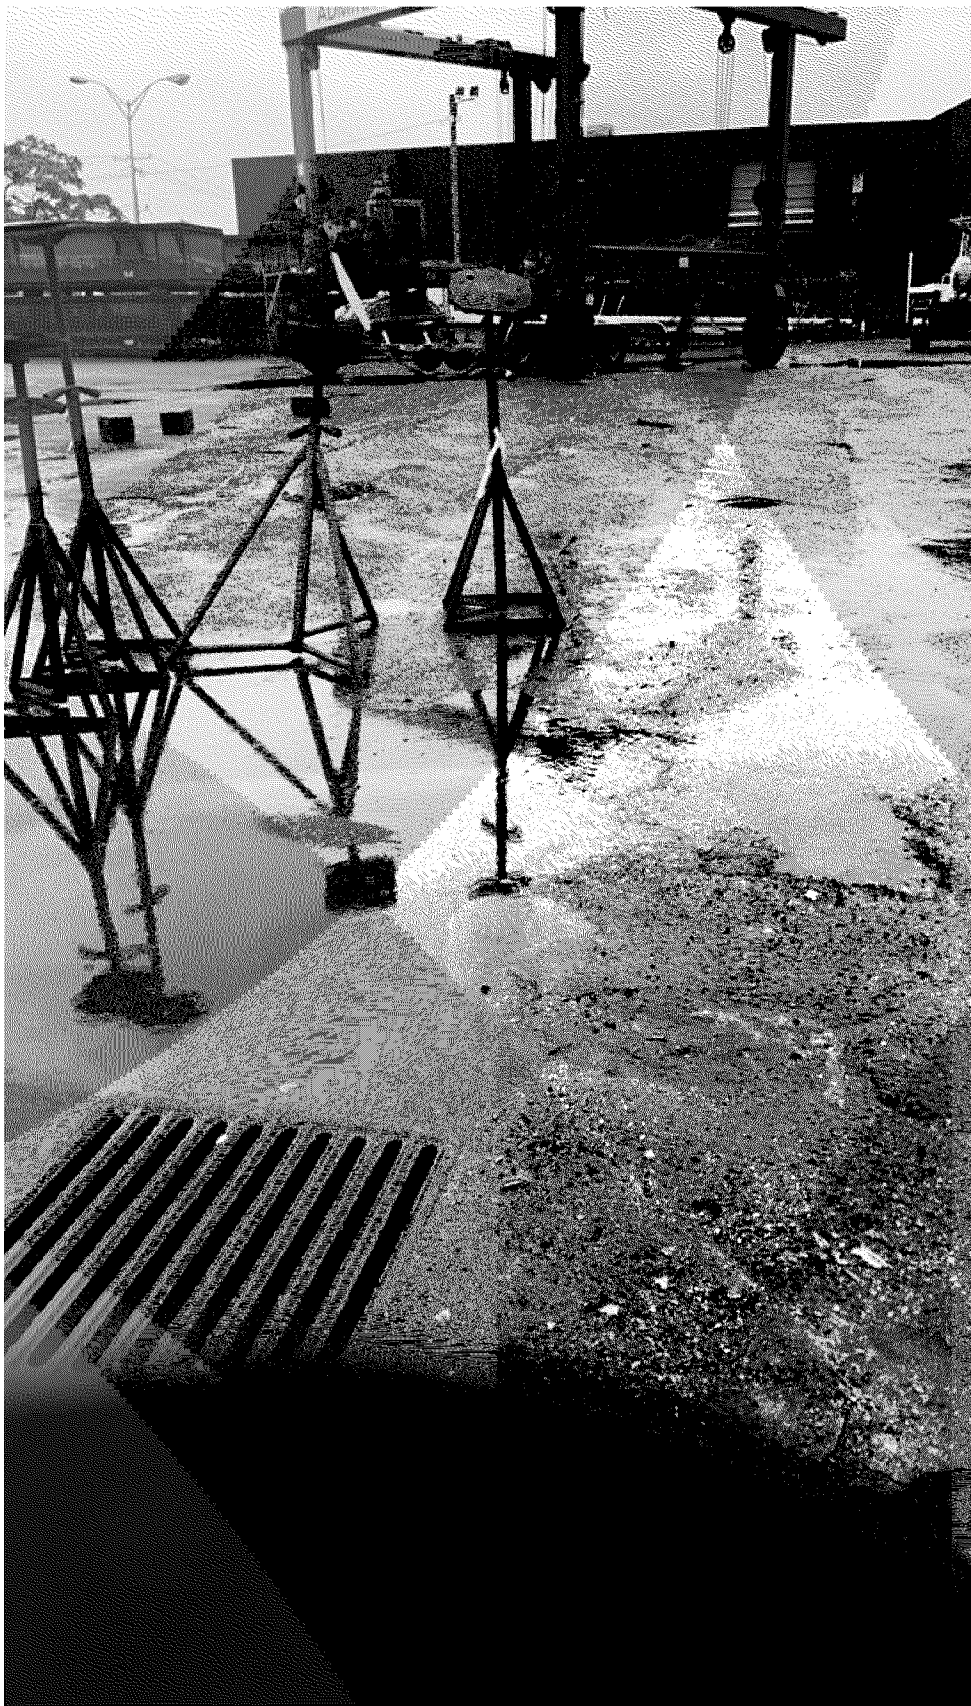
Photo 5

One possible source of the oil sheen is the travel lift that was parked in the area (photo 5).

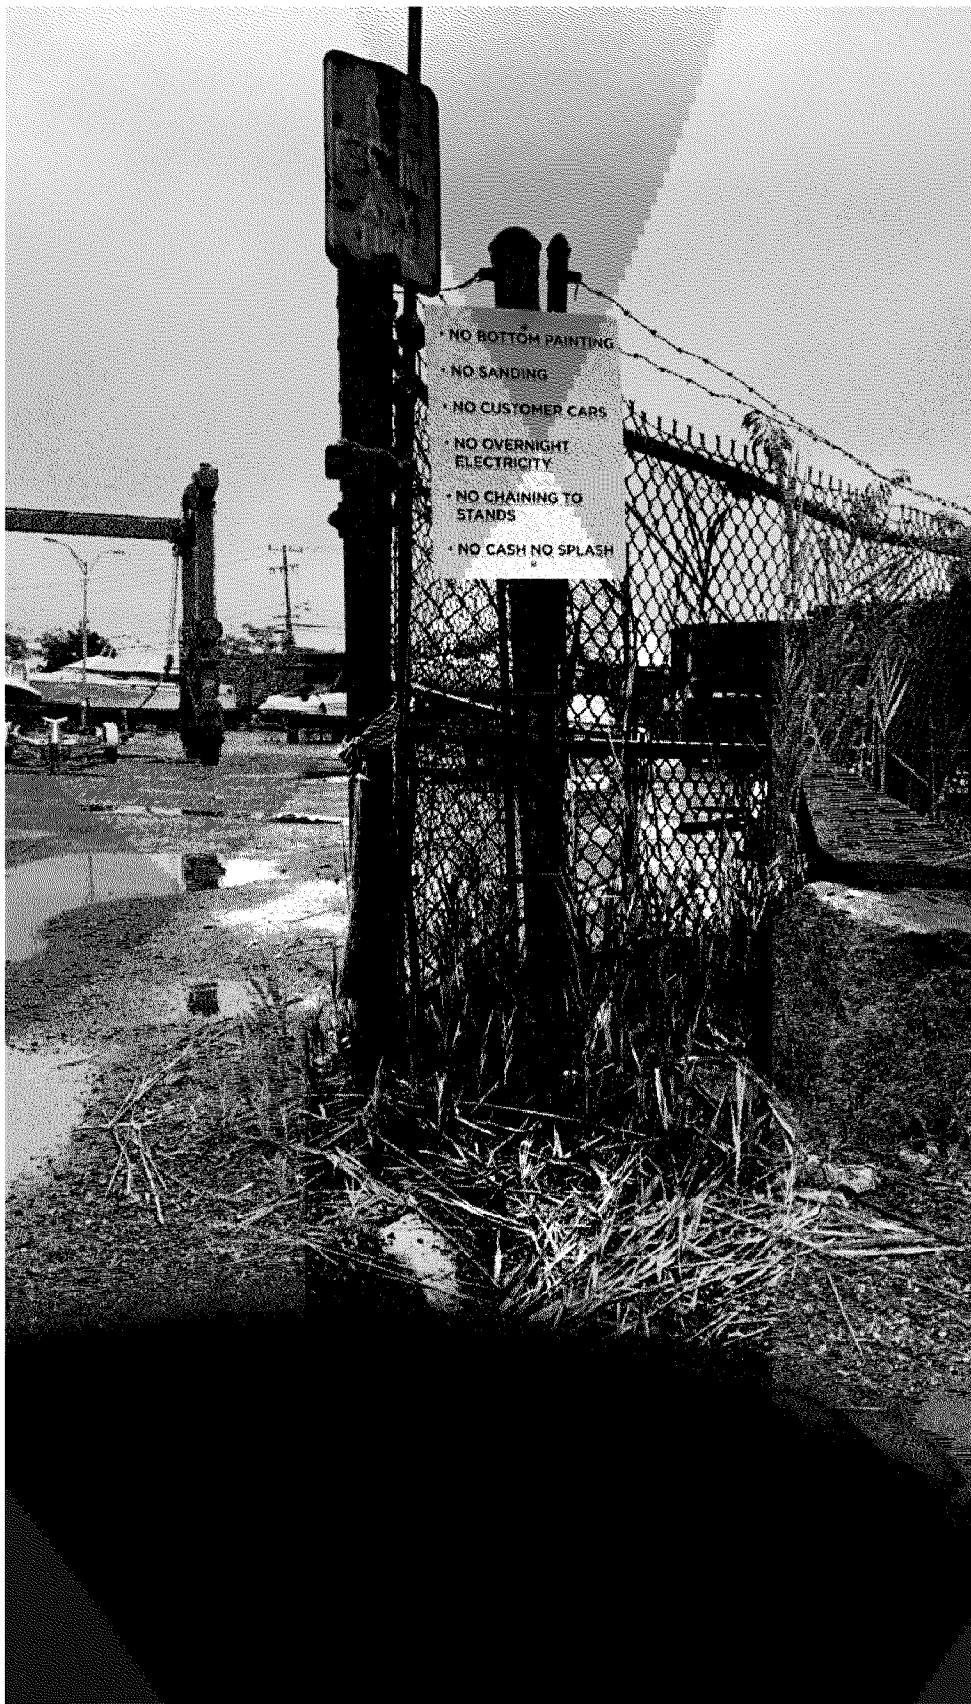
Photo 8

Mr. Randolph indicated that maintenance of any kind is no longer permitted to be conducted in the boat storage area, as indicated by a posted sign (photo 8).
