**CWA COMPLIANCE EVALUATION INSPECTION REPORT  
U.S. ENVIRONMENTAL PROTECTION AGENCY, REGION 5**

**Purpose:** Compliance Evaluation Inspection

**Facility:** Benton Dairy, LLC  
8444 South 900 West  
Ambia, Indiana 47917-003

**Date of Inspection:** April 28 and 29, 2021

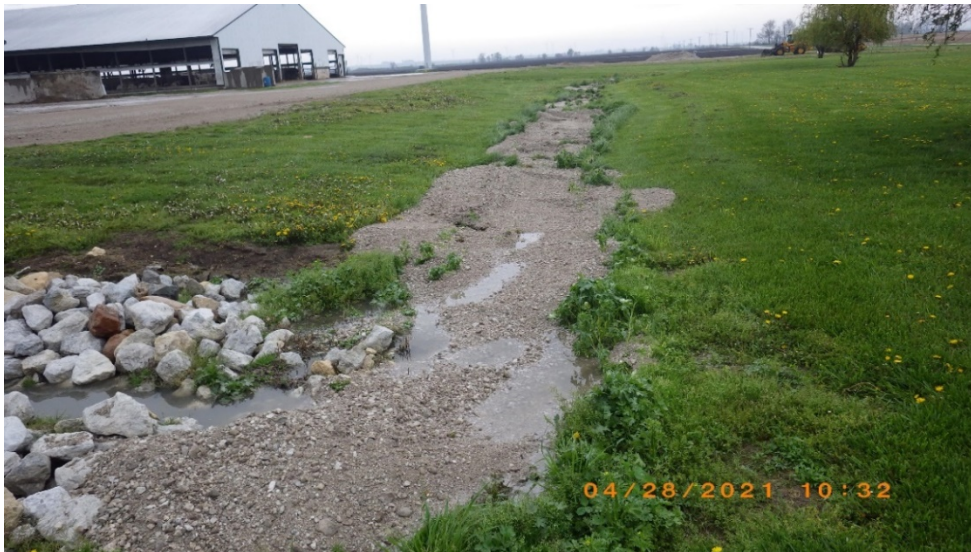
Photo Number: RIMG0077

Description: The drainage tile outlets into the East Drainage Channel.

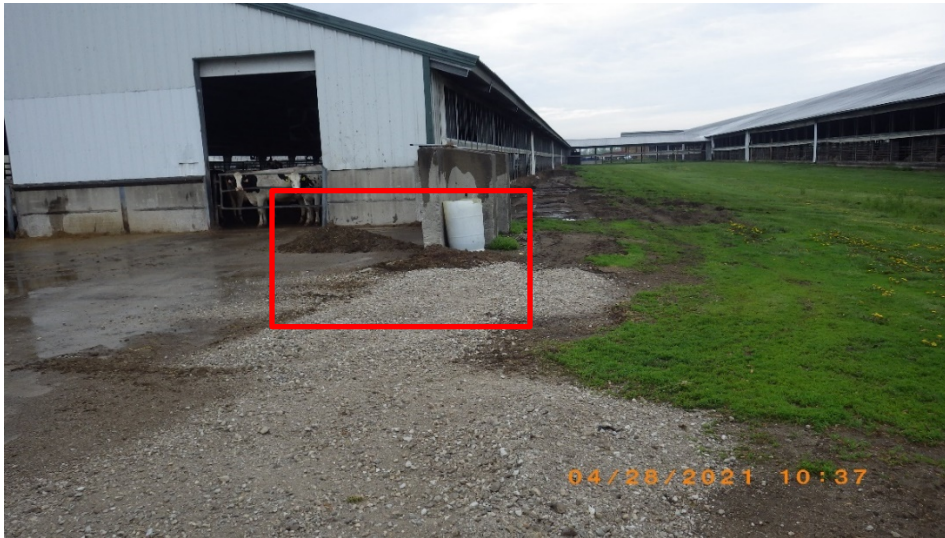
Photo Number: RIMG0078

Description: Used bedding that came out of Barn 2.

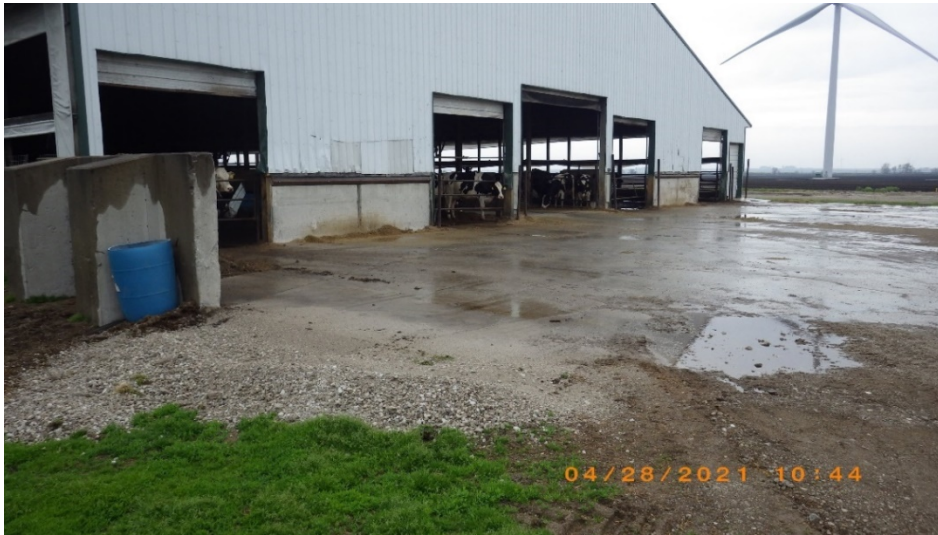
Photo Number: RIMG0082

Description: Used bedding pushed out of Barn 1 on the east side of Barn 1.

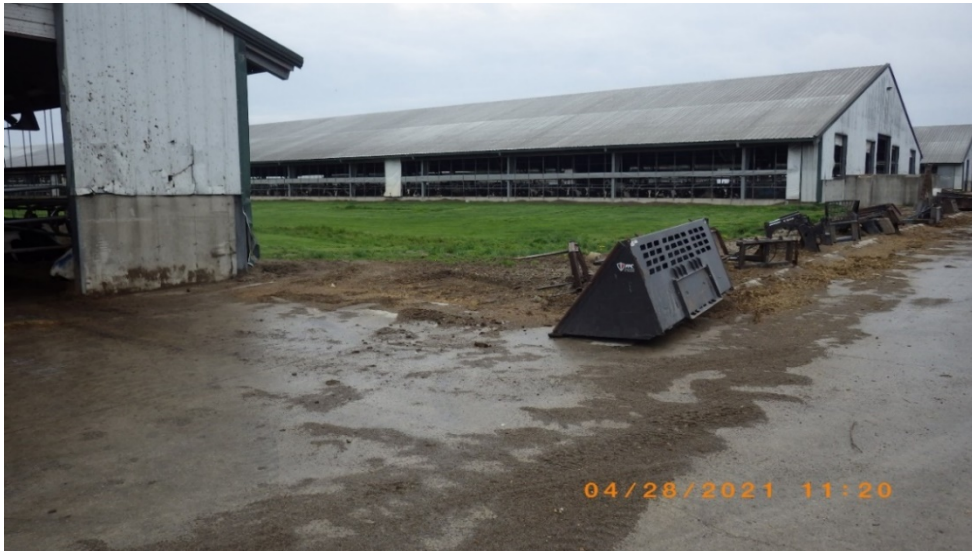
Photo Number: RIMG0102

Description: Used bedding and feed on the West Access Road between Barn 1 and Barn 2.

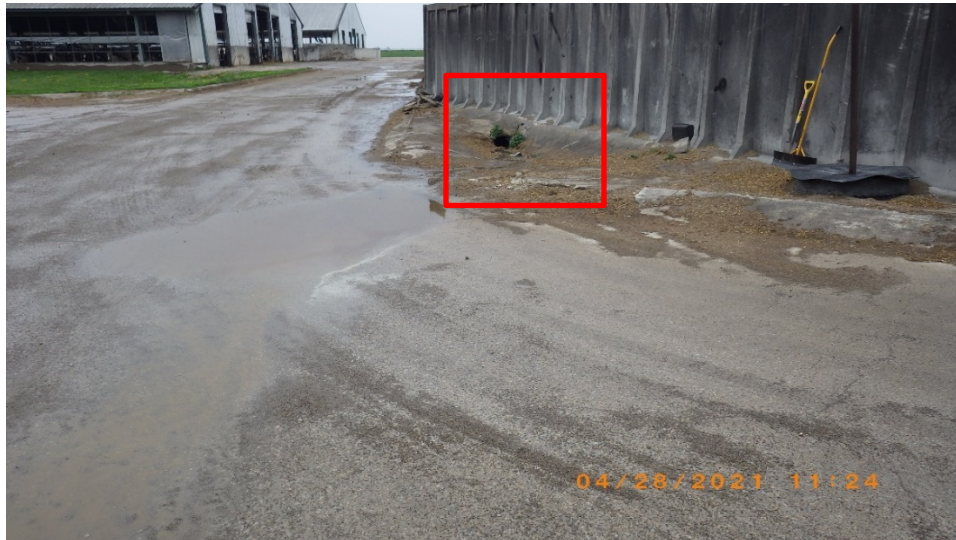
Photo Number: RIMG0106

Description: Stormwater mixed with used bedding and manure from Barns 1, 2, and 3 and feed on the West Access Road sloped to the southeast to drain into the tile inlet identified in the red outlined box.

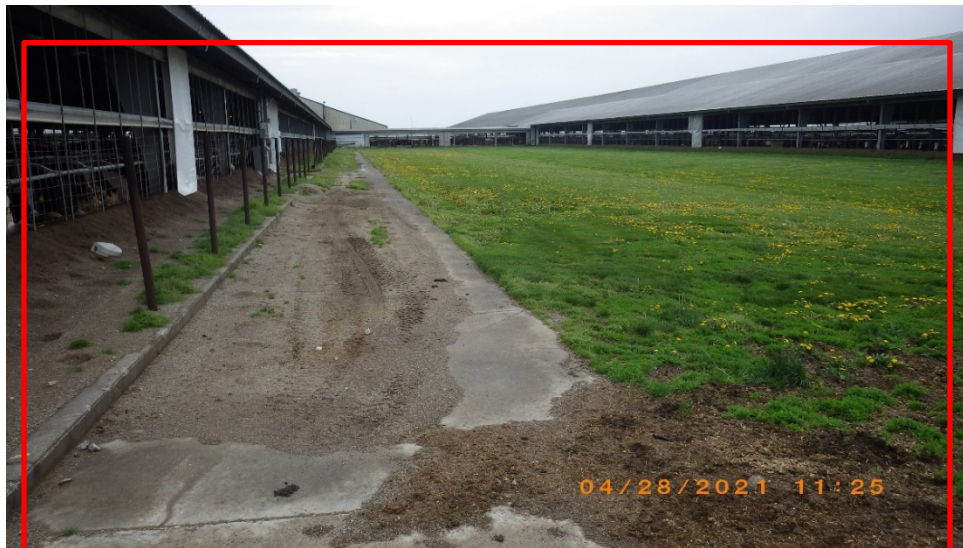
Photo Number: RIMG0108

Description: Looking between Barn 2 and Barn 3. Used bedding pushed out of the south side of Barn 3 shown in the red outlined box in the photo above.

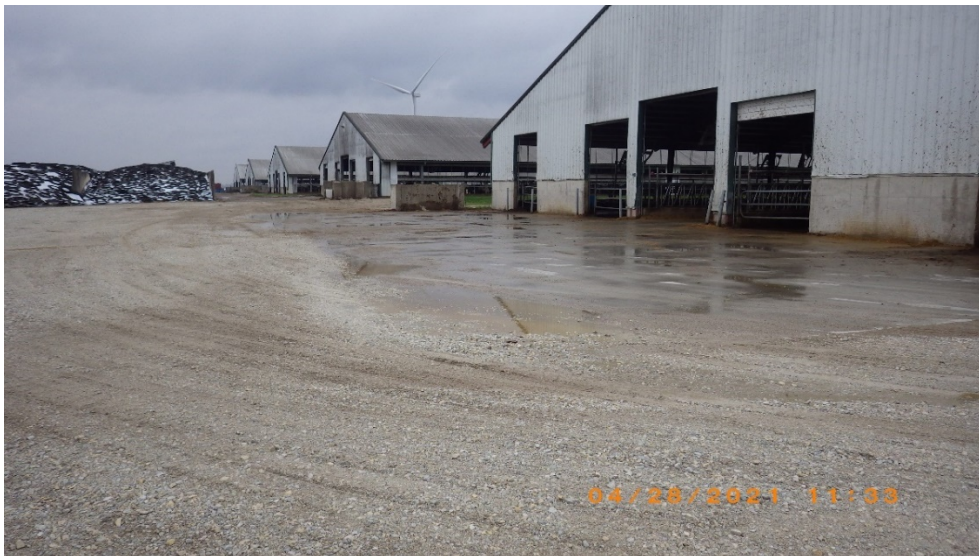
Photo Number: RIMG0117

We continued to the west side of the barns on the West Access Road (Attachment B). EPA observed the Hay Storage Barn on the west side of the facility and observed used bedding, feed, and manure on the West Access Road tracked out of Barn 1.(Photos RIMG0098 and RIMG0099). Mr. Boerman stated that any stormwater that comes into contact with solids tracked out of Barns 1, 2, or 3 flows either into the tile inlets between these barns or surface flows east along the West Access Road to the Solid and Sand Stacking Pad. Mr. Boerman stated that when stormwater comes into contact with solids on the West Access Road west of the Barn 4 and Barn 5, it surface flows to the South Drainage Ditch (Attachment B) and into the Stormwater Pond (Photos RIMG0115, RIMG0116, and RIMG0117).

Description: Observing the direction of flow on the west side of Barns 5 through 4, which is to the southwest.

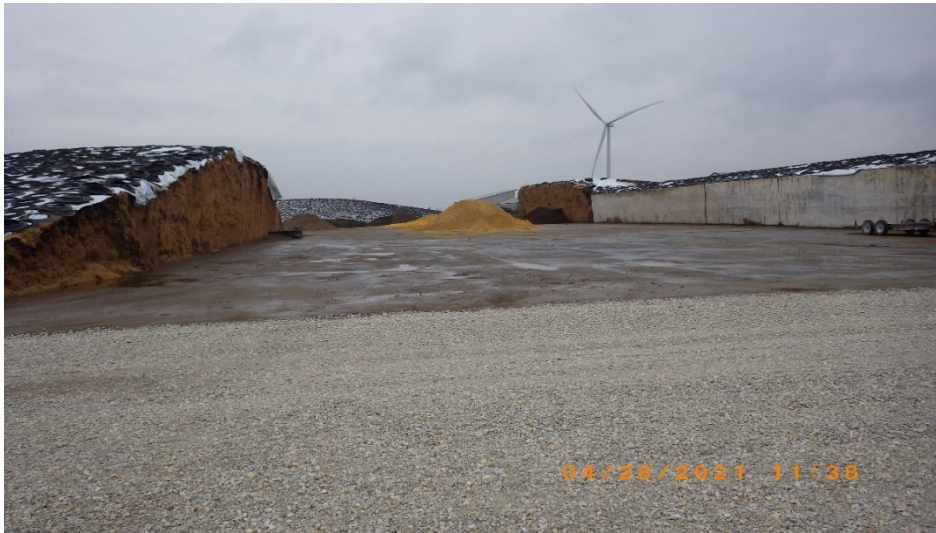
Photo Number: RIMG0120

We continued our walk-through to the south side of the Stormwater Pond and observed leachate from the silage stored in the silage bunkers. Any leachate, stormwater, and/or stormwater that comes into contact with the feed in the bunkers flows either into the South Drainage Ditch (Attachment B) or along the South Access Road (Attachment B) and into the Stormwater Pond (Photos RIMG0119 through RIMG0128).

Description: High grains stored in the concrete Feed storage Area that drain to the manholes that drain to the Silage Leachate Collection Pond.

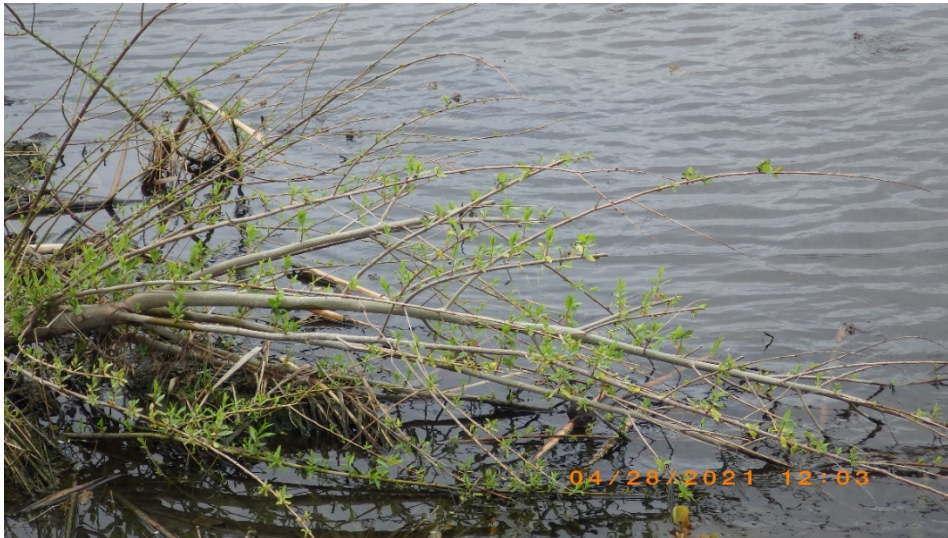
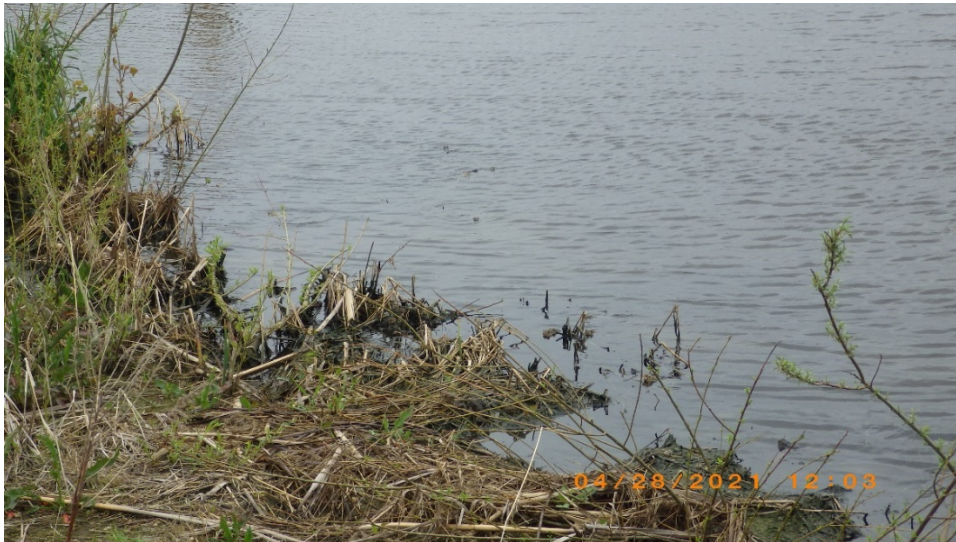
As we were walking on the south side of the Stormwater Pond, we observed approximately one hundred frogs/toads within the Stormwater Pond (Photos RIMG0129 through RIMG0132). We continued to the southwest side of the Stormwater Pond where we observed the tile outlet into the Stormwater Pond. Mr. Boerman explained that the

Description: Observed hundreds of frogs in the Stormwater Pond.

Description: There were hundreds of frogs within the Stormwater Pond.

Description: Trying to show the frogs within the Stormwater Pond.

Description: Again, frogs within the Stormwater Pond.

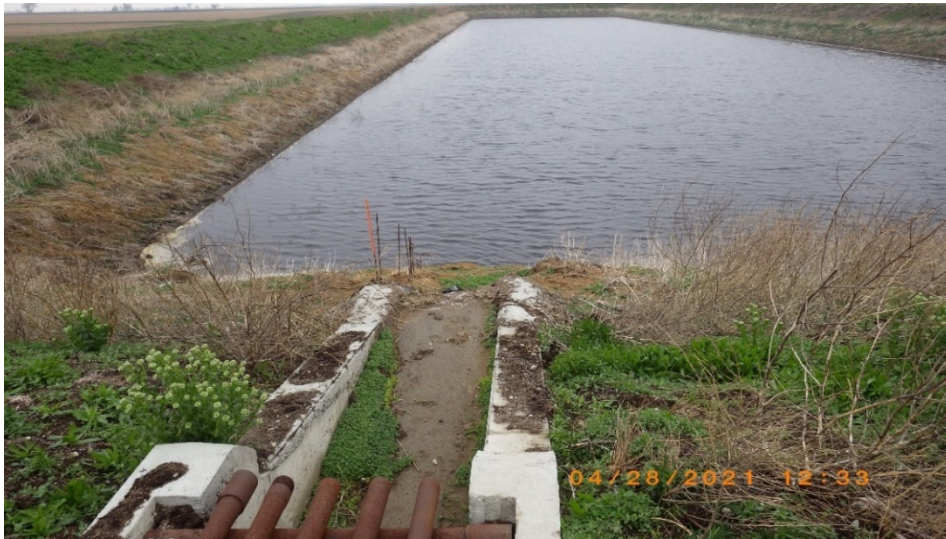
Photo Number: RIMG0143

We observed the concrete overflow between the 4<sup>th</sup> and 5<sup>th</sup> Stage Lagoon on the east side of the 5<sup>th</sup> Stage Lagoon (Photo RIMG0143). The concrete overflow works when the liquids reaches the height of the overflow, the liquids will gravity flow into the next stage lagoon, with less and less solids. We observed the depth marker within the 4<sup>th</sup> Stage Lagoon.

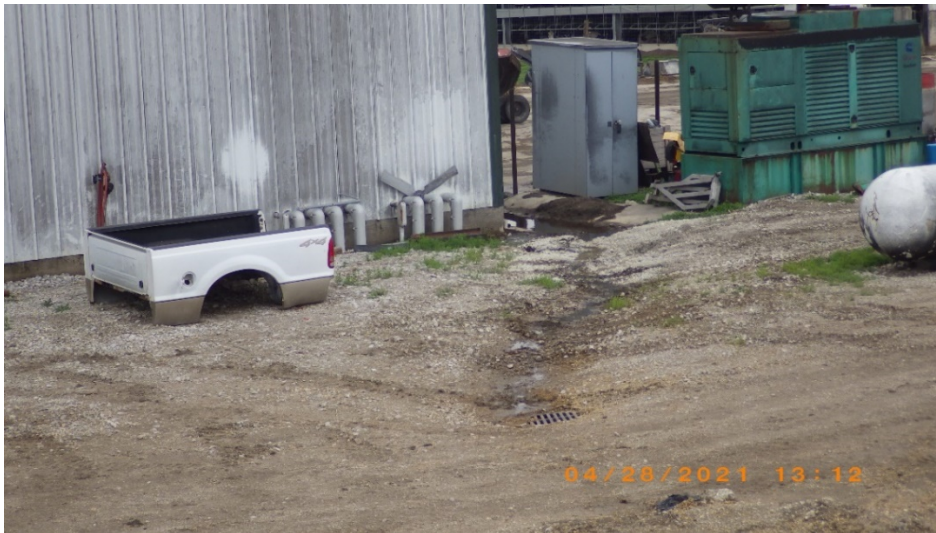
Photo Number: RIMG0176  
Description: The pump to the 1<sup>st</sup> Stage Lagoon from the Sand Separator and drains flow to the Stormwater Pond.  
Location: West of Feed Storage Area and south of commodity shed.  
40.486248, -87.497026  
Facing: Southeast.  
Date/Time: 4/28/2021 1:12 p.m.
