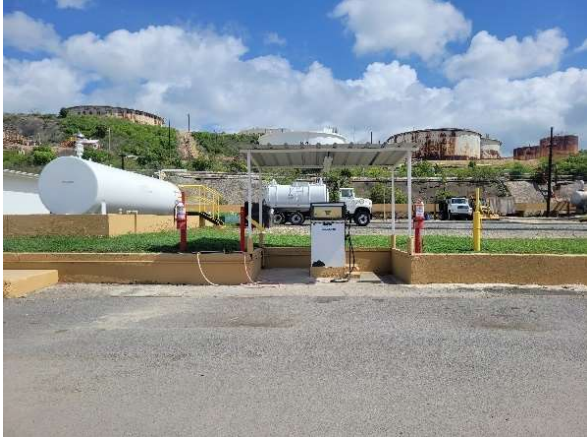
| | <p>Picture 1<br/>View of a gasoline pump station located under a roof.</p> |

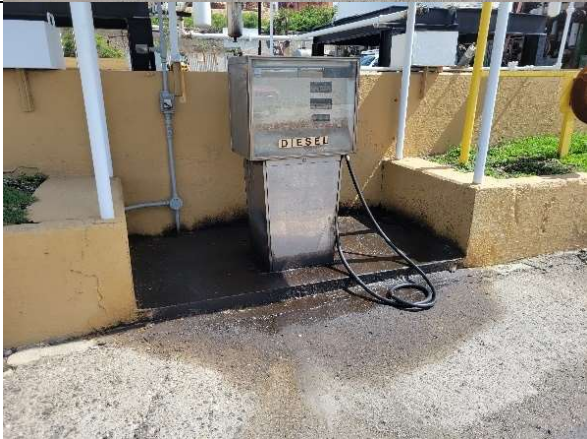
| | <p>Picture 2<br/>View of the diesel pump station located under a roof. Fuel stains were observed at the floor.</p> |

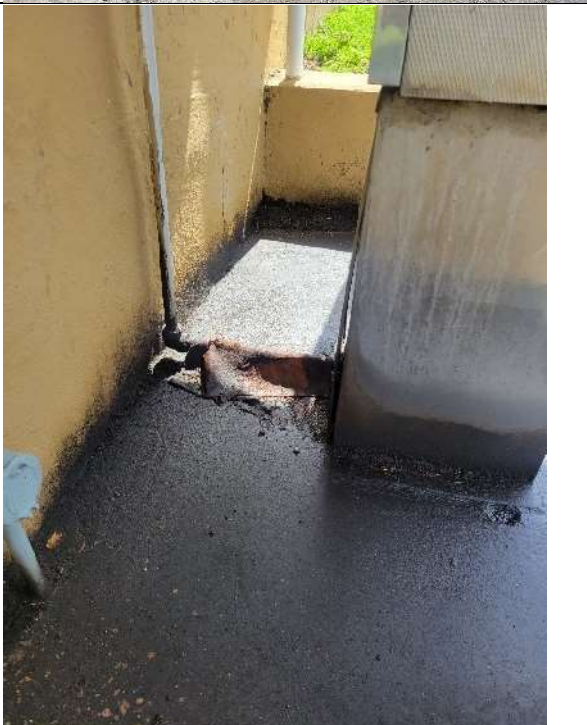
| | <p>Picture 3<br/>View of the back side of the diesel pump station. Fuel was observed over the floor and absorbing material was placed at the pipe that feeds the pump.</p> |

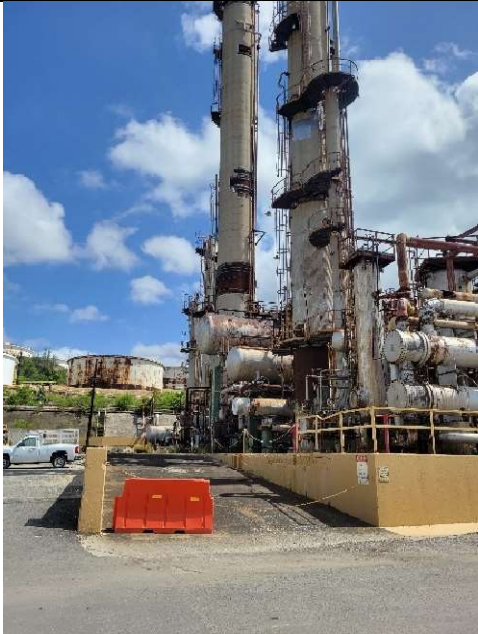
| A photograph showing a large, rusted industrial structure, likely a distillation column or reactor, with various pipes and ladders. The structure is situated in an open area with a paved ground in the foreground and some vegetation in the background. A white pickup truck is parked to the left. | <p>Picture 4</p> <p>View of the abandoned plant besides the fuel pump stations in Pictures 1 and 2. The structures were corroded and deteriorated.</p> |

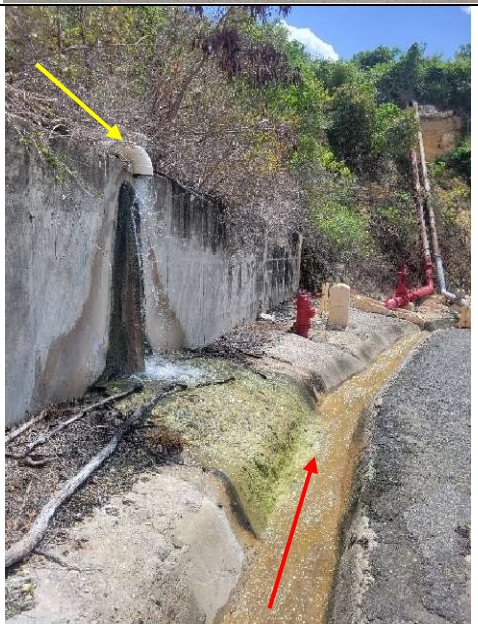
| A photograph of a concrete wall with a yellow arrow pointing to a small opening where water is dripping. A red arrow points to a larger discharge of water into a concrete channel. The ground is covered with green slime. | <p>Picture 5</p> <p>The red arrow depicts the water coming from the secondary containment of Tank 1014. The yellow arrow shows a groundwater discharge coming from underneath Tank 1021. A stain was observed in the concrete wall where the discharge occurs, and the ground was green like slime. Both discharges reach the stormwater concrete channel at the north side of the Facility and eventually discharge through Outfall 003.</p> |

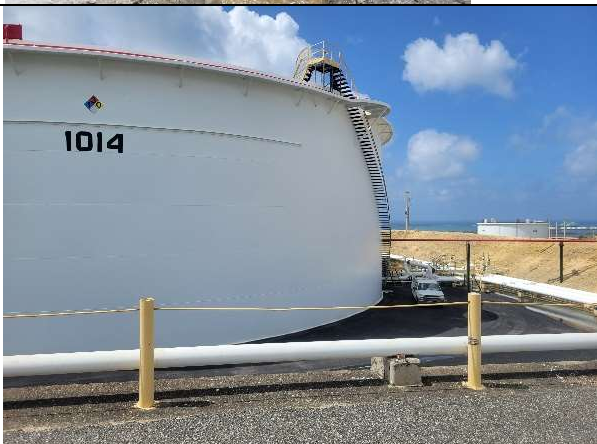
| A photograph of a large white storage tank with the number '1014' on its side. The tank is surrounded by a concrete wall and a gravel area. A white pickup truck is parked in the background. | <p>Picture 6</p> <p>View of tank 1014. The secondary containment had standing water and it was being discharged into the stormwater concrete channel at the north side of the Facility during the Inspection.</p> |

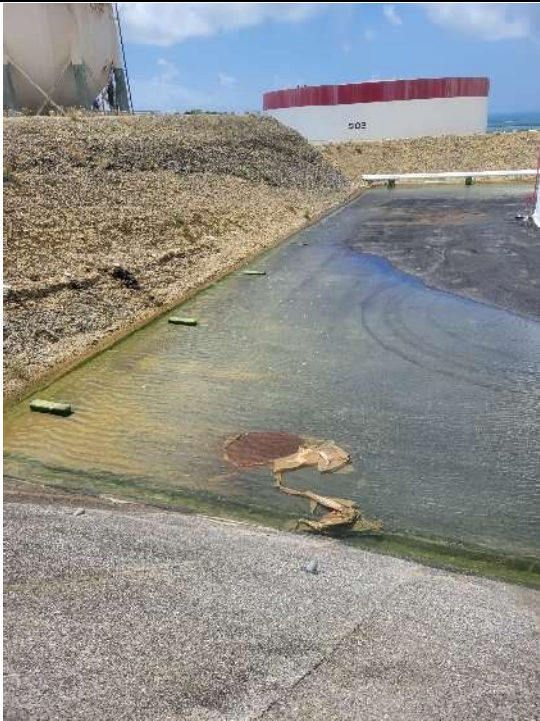
| | <p>Picture 7</p> <p>View of the water accumulated at the secondary containment of tank 1014. Brown sediments were observed at the bottom of the secondary containment, the water was clear, and no oil sheen was observed.</p> |

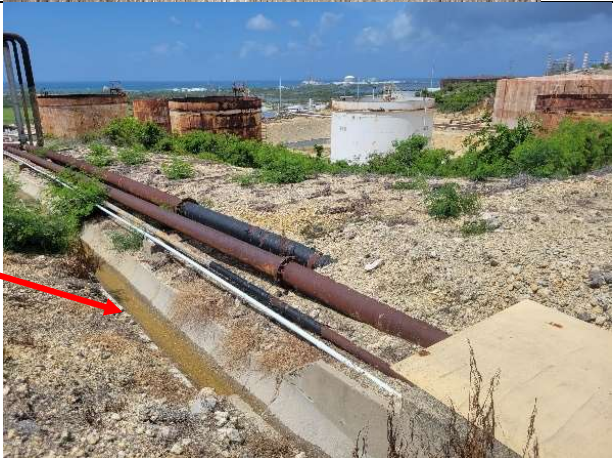
| | <p>Picture 8</p> <p>View of the Facility from the north side. Corroded tanks were observed. The arrow depicts the discharge coming from the secondary containment of tank 1014.</p> |

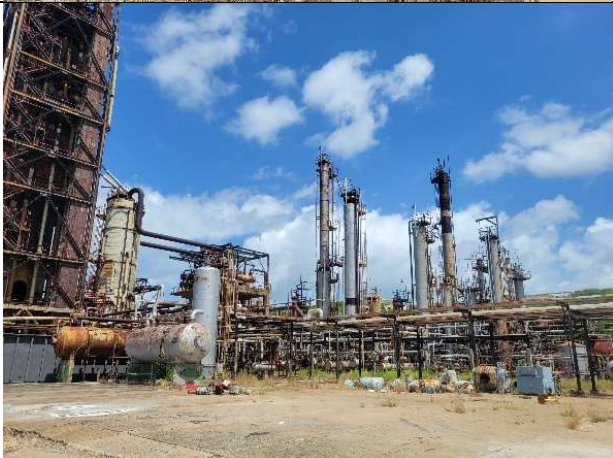
| | <p>Picture 9</p> <p>View of the abandoned plant at the north side of the Facility. The structures were corroded and deteriorated.</p> |

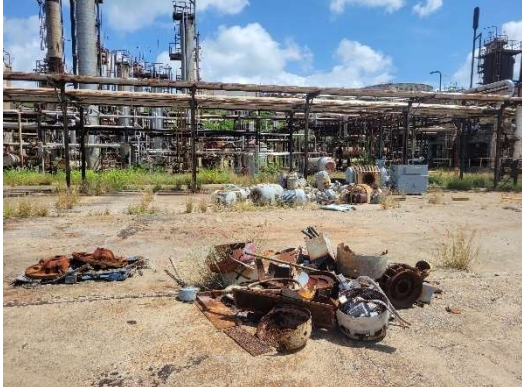
| | <p>Picture 10<br/>View of motors and mechanical equipment placed over the concrete floor exposed to stormwater. Equipment was corroded and deteriorated.</p> |

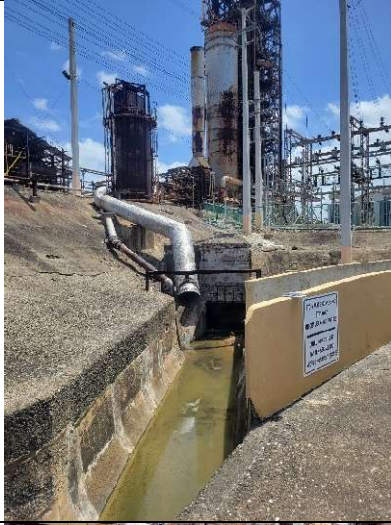
| | <p>Picture 11<br/>View of a concrete stormwater channel that conveys stormwater from the north side of the Facility into Outfall 003. This concrete stormwater channel is commonly referred to as "Tren Urbano". The water was turbid, had sediment and a brown/green color.</p> |

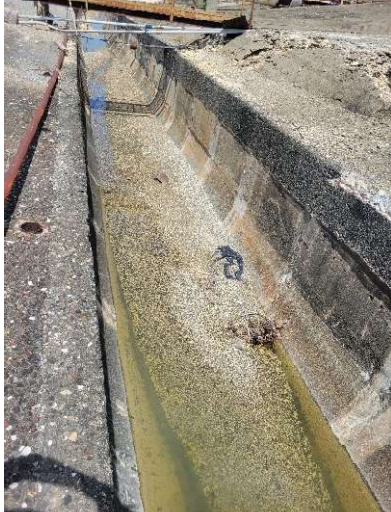
| | <p>Picture 12<br/>Another view of a stormwater conveyance concrete channel shown in the previous picture. Sediments were observed at the bottom of the channel and the water had a brown/green color.</p> |

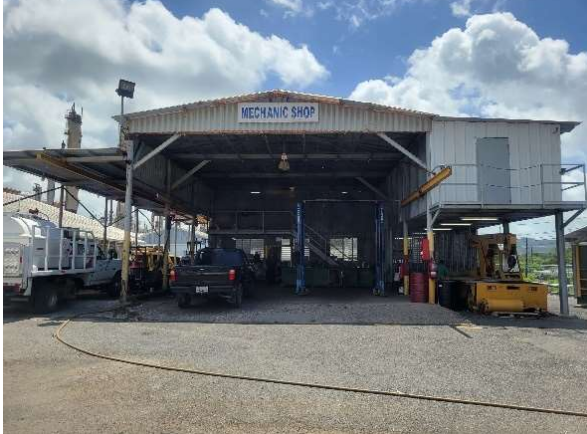
| | <p>Picture 13<br/>View of the mechanical shop. Operation is performed under the roof and not exposed to rain.</p> |

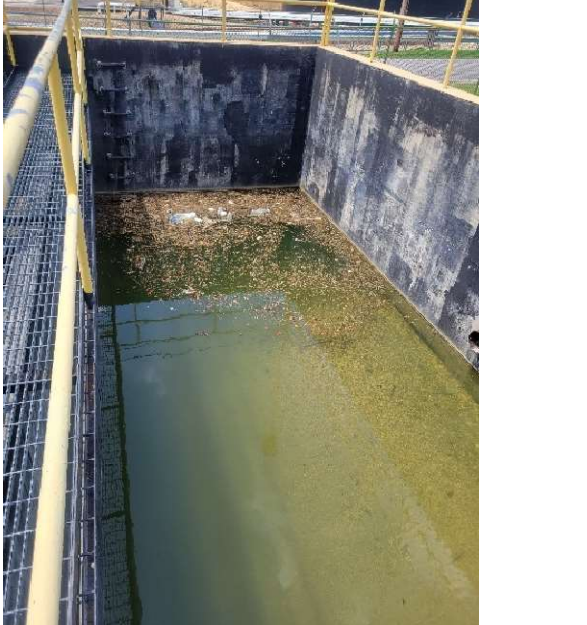
| | <p>Picture 14<br/>View of Oil Trap Box #1 located between tanks 903 and 950. Sediment was observed accumulated at the bottom of the tank and waste was observed floating at the water surface including plastic bottles, foam cups, and leaves.</p> |

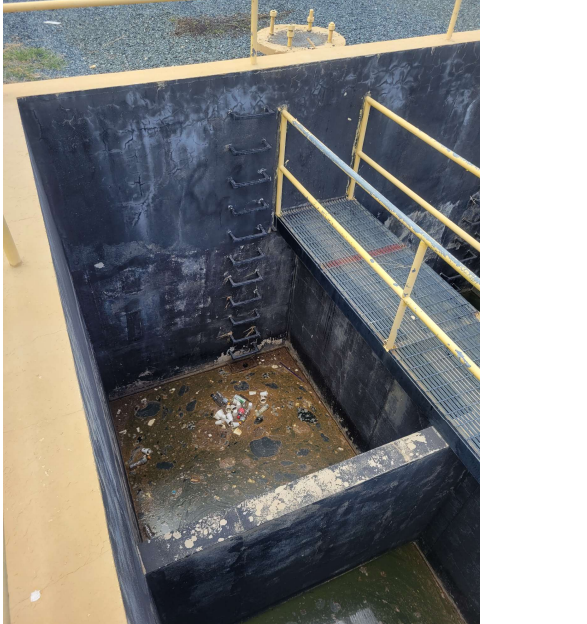
| | <p>Picture 15<br/>View of Oil Trap Box #2 near tank 902. Fuel residues, oil sheens and waste (like foam cups and water bottles) were observed floating at the water surface. Fuel odors were perceived.</p> |

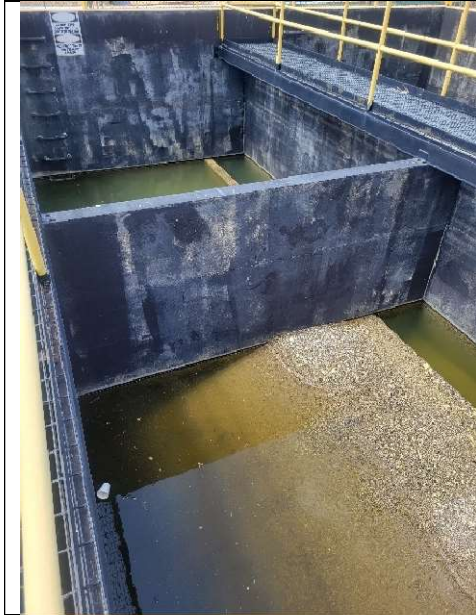
Picture 16  
View of Oil Trap Box #2. Sediment was observed accumulated at the bottom of the tank reaching above the water surface.

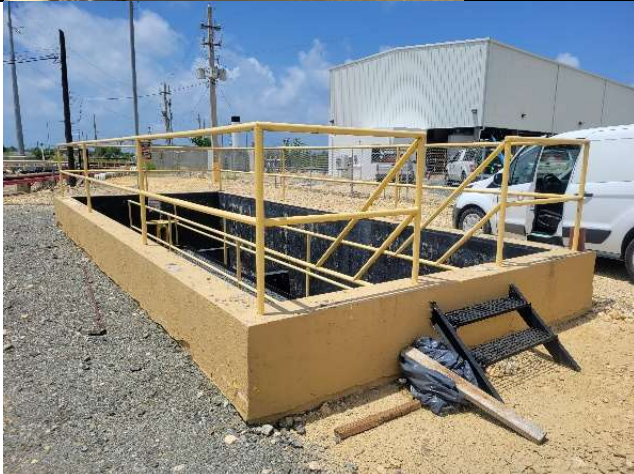
Picture 17  
View of the Oil Trap Box #3 located besides the WWTP.

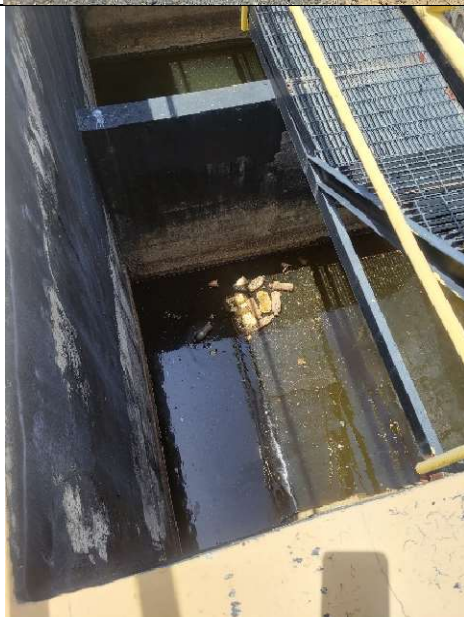
Picture 18  
View of Oil Trap Box #3. Oil sheens and waste (like water bottles, foam cups and plates) were observed floating at the water surface. The water had a dark green color.

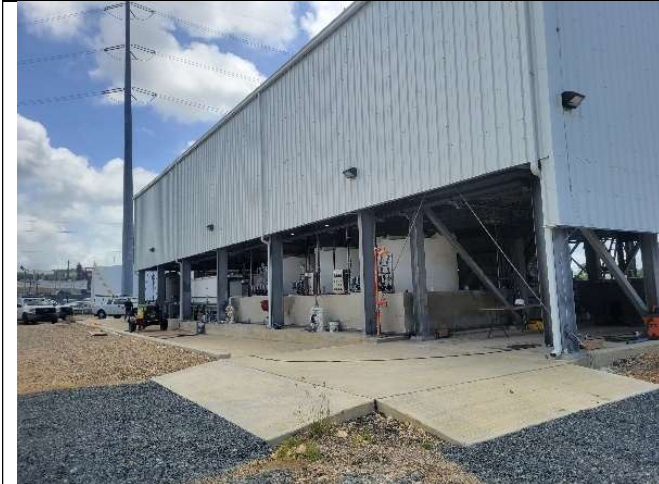
Picture 19  
View of the WWTP.

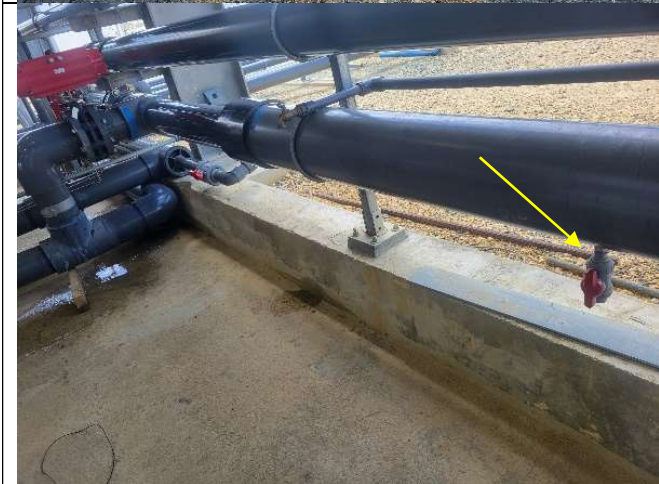
Picture 20  
The yellow arrow depicts the location where samples will be taken. The flow meter is located after the red box.

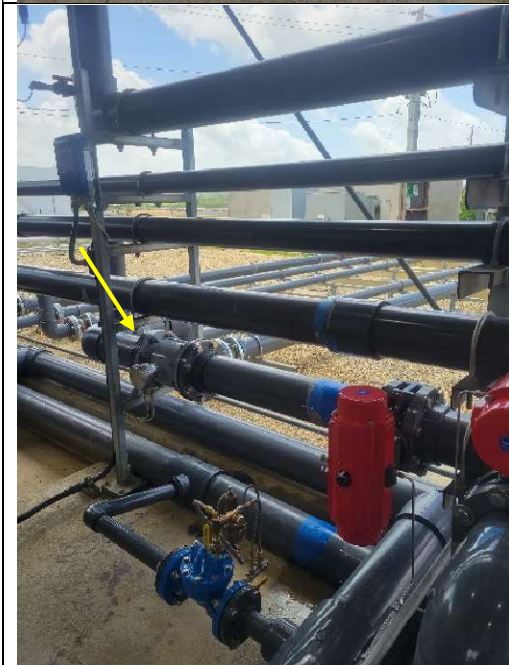
Picture 21  
The yellow arrow depicts the location where the flow meter is located, which is after the sampling point.

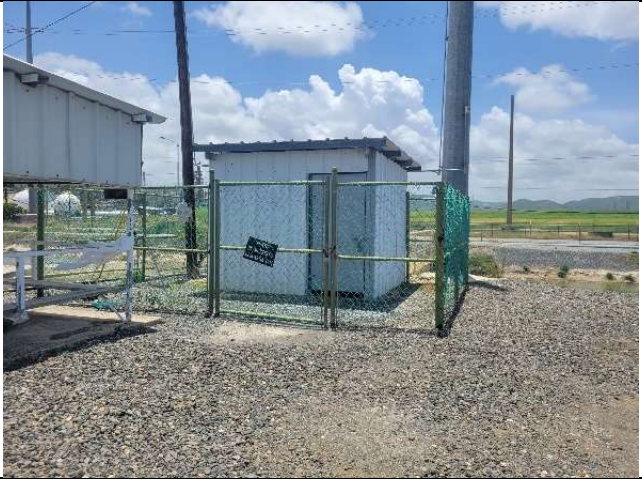
| | <p>Picture 22</p> <p>Depicts a view of the shed where the automatic sampler and the flowmeter for Outfall 003 are located. Also, a sign was place in front of the shed that reads “Punto de Muestreo Descarga 003”.</p> |

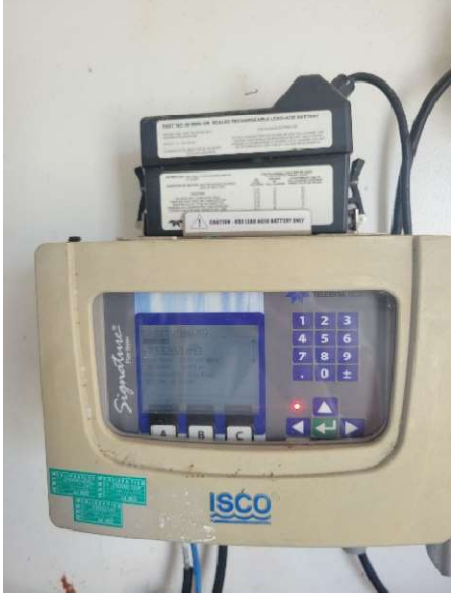
| | <p>Picture 23</p> <p>View of the flowmeter located in the shed. The reading shows a value of - 2353.49 gpm. Mr. Seda explained that the negative reading is because the direction of flow in the channel is towards the Facility, rather than into the water body. It shows a sticker with the calibration and the next schedule calibration is in July 2023.</p> |

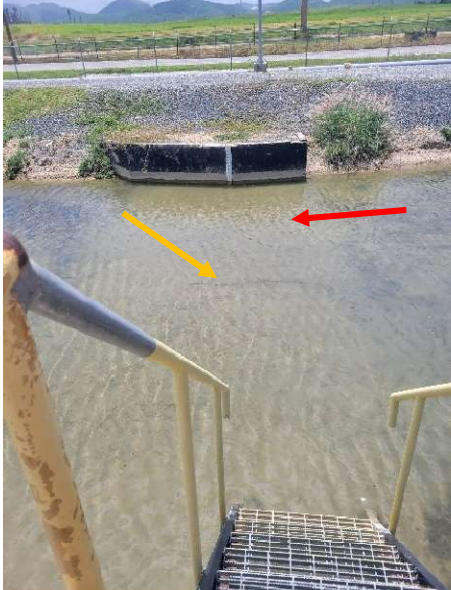
| | <p>Picture 24</p> <p>View of the sampling location for Outfall 003 at the Effluent Channel. The red arrow indicates the direction of the flow in the Effluent Channel. The yellow arrow depicts the location of the automatic sampler inlet tube and where the water sample for monitoring is taken. Outfall 003 was accessible and free of vegetation, debris, and trash.</p> |

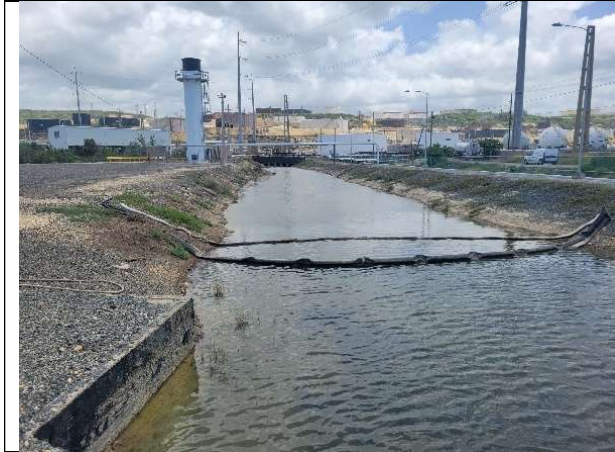
Picture 25  
View of the Effluent Channel that receive the discharges from Outfall 001 and 003. Absorbent booms were installed.

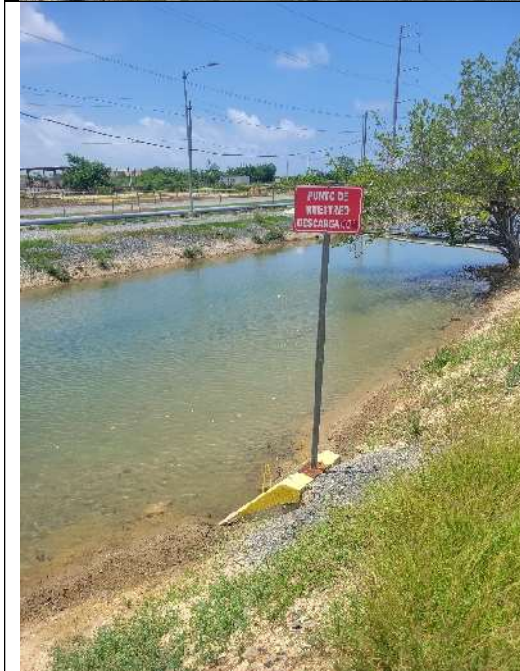
Picture 26  
View of Outfall 001 located after Outfall 003 at the Effluent Channel. A label was observed and reads “Punto de Muestreo Descarga 001”. Outfall 001 is accessible and free of vegetation, debris, and trash.

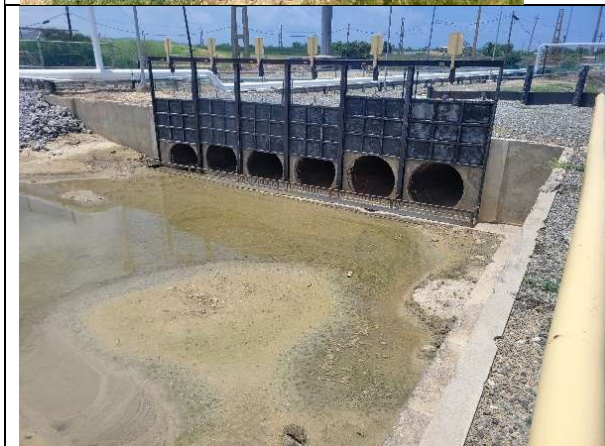
Picture 27  
View of the guillotine valves prior discharge into the effluent channel. During the Inspection, storm water was not being discharged through the guillotine valves.

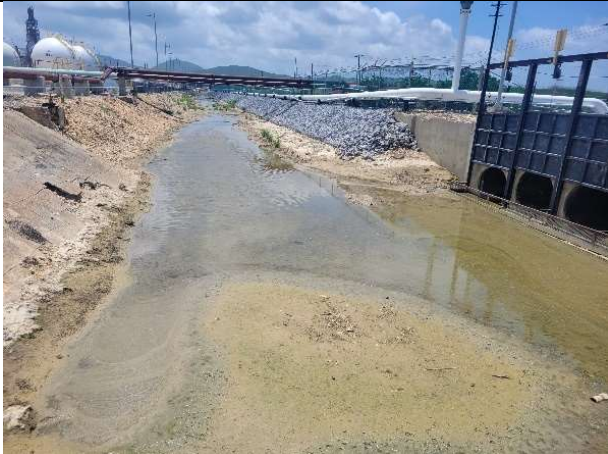
| A photograph showing a concrete channel filled with murky, brownish water. The water surface is covered with a layer of sediment. The channel is bordered by concrete walls, and in the background, industrial structures and a clear sky are visible. | <p>Picture 28<br/>View of the stormwater concrete channel that flows to Outfall 003, before the guillotine valves. Sediments were observed, and the concrete walls were deteriorated.</p> |

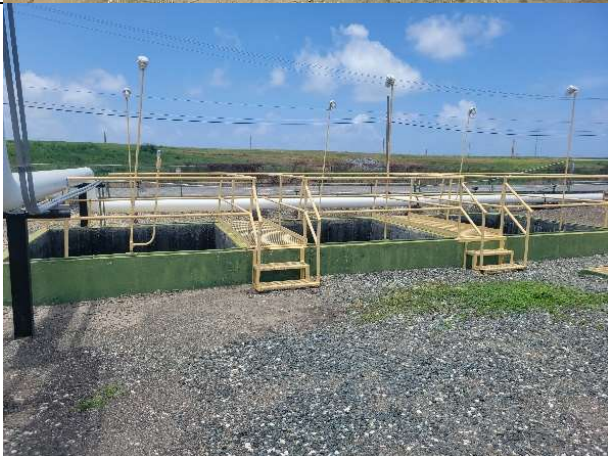
| A photograph of an industrial facility featuring a large rectangular concrete tank with a yellow metal walkway and stairs leading into it. The surrounding area is covered in gravel, and several tall light poles are visible in the background under a blue sky with scattered clouds. | <p>Picture 29<br/>View of Oil Trap Box #4 located in the North Side of the Facility.</p> |

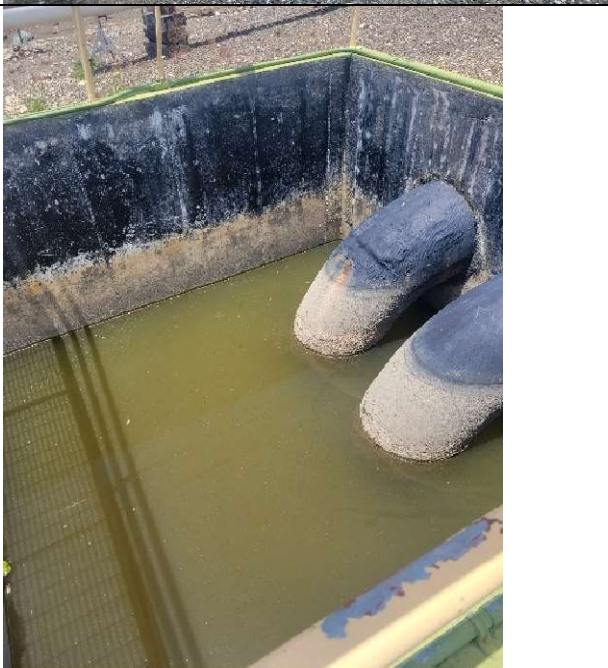
| A close-up photograph of the interior of a concrete tank. The water is a dark, opaque green color and appears very turbid. Two large, rounded concrete structures are partially submerged in the water. The concrete walls of the tank show signs of wear and discoloration. | <p>Picture 30<br/>View of the water in the Oil Trap Box #4, the water was turbid and had a dark green color and sediments were observed.</p> |

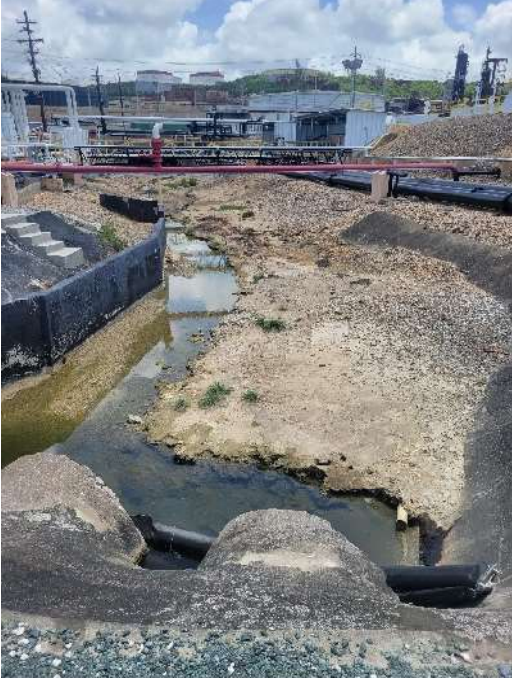
| | <p>Picture 31<br/>View of the channel that conveys stormwater from the Oil Trap Box #1 into the concrete stormwater channel at the north side of the Facility. The channel was filled with sediments, the concrete walls were deteriorated, the water in the channel was green, an oil sheen was observed, and fuel odors were perceived.</p> |

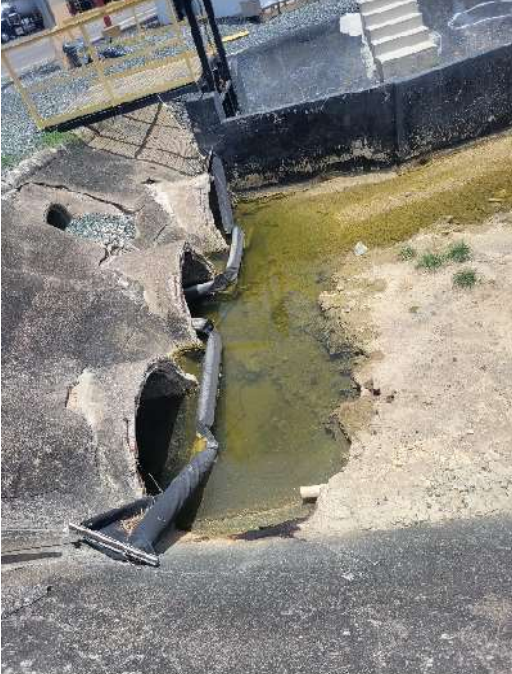
| | <p>Picture 32<br/>View of the same channel shown in the previous picture. The concrete headwall structure was broken and deteriorated, the channel was filled with sediments, and oil booms were installed at the entrance of each pipe.</p> |
