# **NPDES Compliance Inspection Report**

## **Tree Farm North Bend, Washington**

### **Washington State Department of Ecology Construction Stormwater General Permit Permit # WAR309272**

**Inspection Date: December 16, 2022**

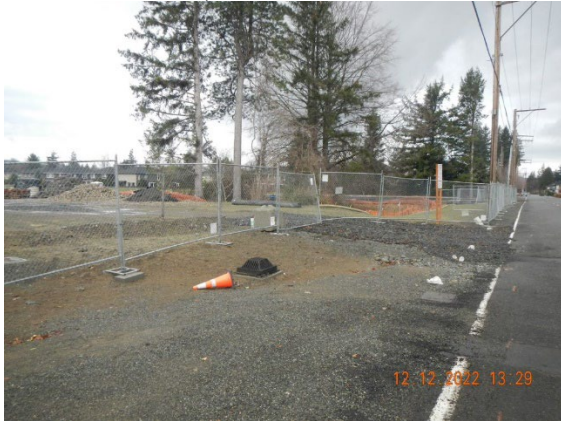
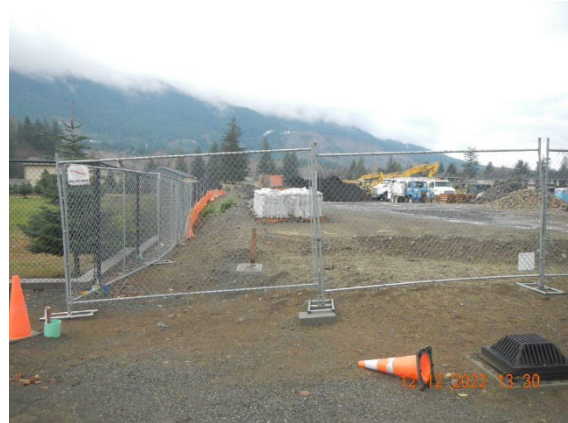
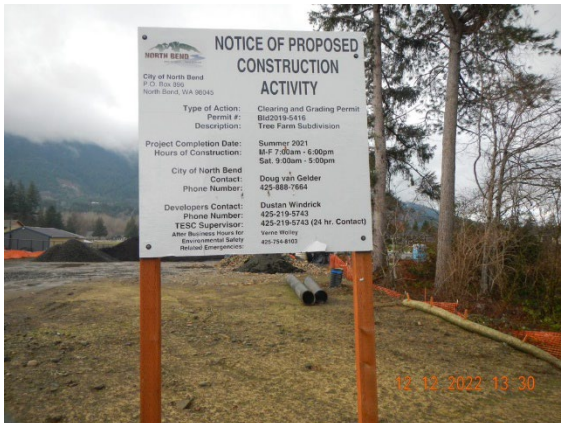
1. On both December 12 and 16 we observed approximately five unworked stockpiles lacking stabilization (**Photos 1-3, 25, 31-33**).

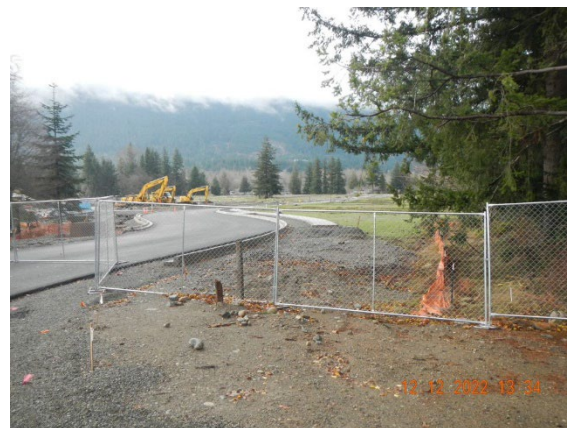
On December 12, 2022, along with Mr. Klemesrud and Mr. Hackel, I attempted to conduct an unannounced compliance evaluation inspection (CEI) of the Tree Farm site. We arrived at approximately 12:00 p.m. and found the site fenced-off with locked gates. We walked the streetwards (eastern) perimeter of the site and took photos of our observations (**Photos 1-6**). We observed approximately four uncovered soil stockpiles (**Photos 1-2**). We also saw some silt fence badly frayed and torn along the north perimeter (**Photo 6**).

1. During the inspection we observed a portion of silt fence in need of repair (**Photos 6, 9**). On-site BMP inspection reports noted the deficiency.
2. The temporary below-grade concrete washout area’s plastic liner lacked securing and failed to line the entire surface area of the washout (**Photo 31**).

| Photo Number | Digital Image Number | Description of Digital Image | Date and Time | |
|---|---|---|---|---|
| Photo 6 | DSCN2959.JPG | Facing west, photo of northern perimeter from Malone Grove SE | 12/12/2022 | 12:34 PM |

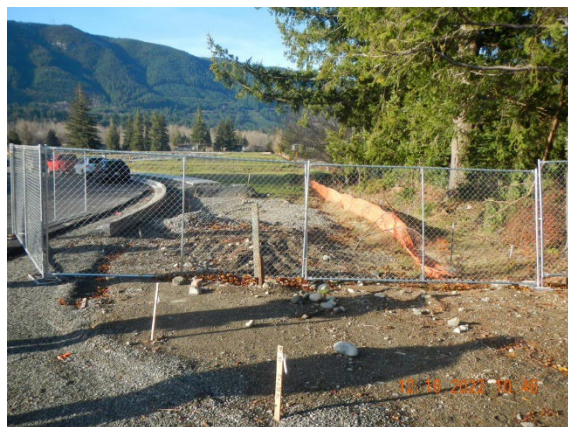
| Photo Number | Digital Image Number | Description of Digital Image | Date and Time | |
|---|---|---|---|---|
| Photo 9 | DSCN3068.JPG | Facing west, photo of northern perimeter from Malone Grove Ave SE | 12/16/2022 | 10:46 AM |

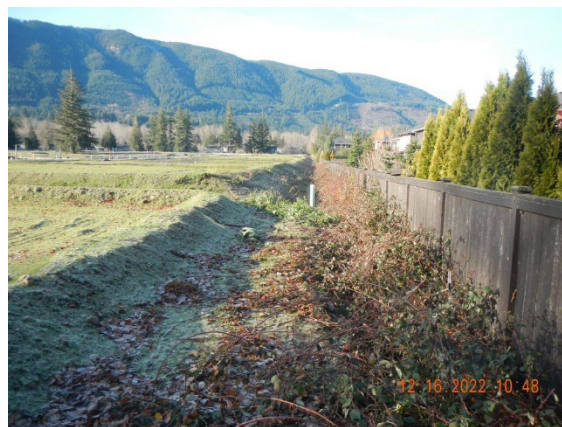
At the northwest corner, and main paved site entrance, we noticed the same silt fence in Photo 6; it still looked frayed, collapsed, and in need of repair (**Photo 10**). Continuing west along the perimeter we saw an installed bioswale and noted the berms outlining future housing lots, helping with stormwater control and infiltration (**Photos 11-12**). We also saw the operator draining stormwater from a lot on the central paved area and nearby bioswale, which drains into the northern bioswale and potential outfall, with check dams (**Photos 13-16**).

| Photo Number | Digital Image Number | Description of Digital Image | Date and Time | |
|---|---|---|---|---|
| Photo 10 | DSCN3069.JPG | Facing west, photo of northern perimeter west of Malone Grove Ave SE | 12/16/2022 | 10:48 AM |

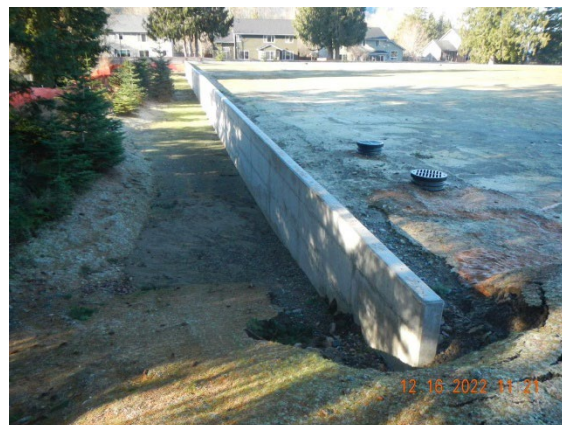
Turning back east, along the southern perimeter, we saw noticeable signs of erosion along a concrete wall, with flow apparently into the floodplain (**Photo 24**). Mr. Boles told us this appeared new. Continuing east we saw more lots temporarily holding stormwater, silt fencing along the perimeter, and we saw an unworked, uncovered soil stockpile (**Photos 25-26**). Further east we saw a temporary swale for inflow drainage, and the permanent bioswale along the middle-southern portion of the site containing check-dams that will aid in future infiltration at Tree Farm (**Photos 27-30**).

| Photo 24 | DSCN3083.JPG | Facing west, photo of southwest perimeter, minimal erosion observed along concrete wall | 12/16/2022 | 11:21 AM |

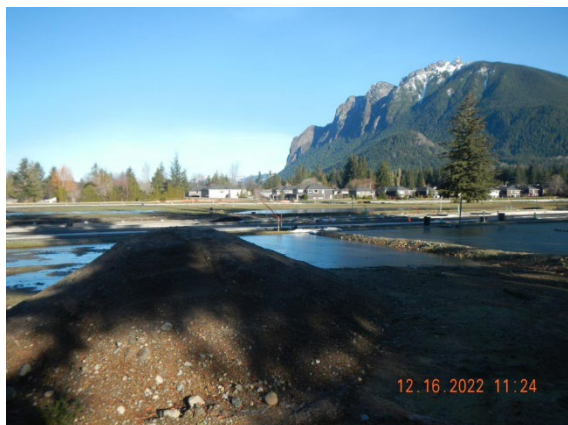
| Photo 25 | DSCN3084.JPG | Facing north/northeast, photo of stockpile near southern perimeter | 12/16/2022 | 11:24 AM |

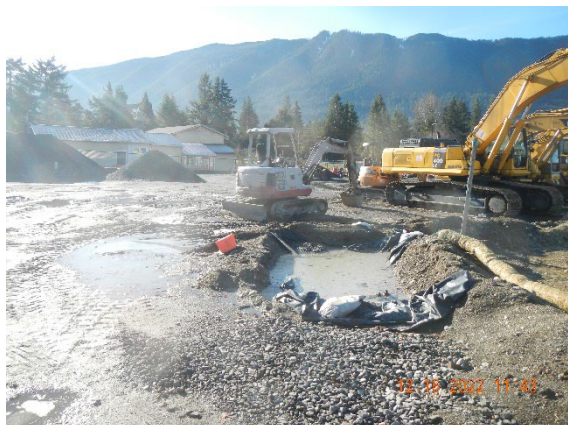
1. During the inspection we observed two pallets holding weathered chemical materials stored without cover, spill response equipment, or other controls (**Photos 35-37**). These materials included oil, paints, and bentonite and ready-mix concrete.
2. The portable on-site sanitation facility appeared unsecured (**Photo 34**).
3. The staging ground, or laydown area, where we saw a fuel truck and multiple heavy excavation machines lacked appropriate spill response measures, such as a dedicated oil and fuel spill kit (**Photos 31-34**).

| Photo 31 | DSCN3090.JPG | Facing southeast, photo of concrete washout area, stockpiles in the background. | 12/16/2022 | 11:43 AM |

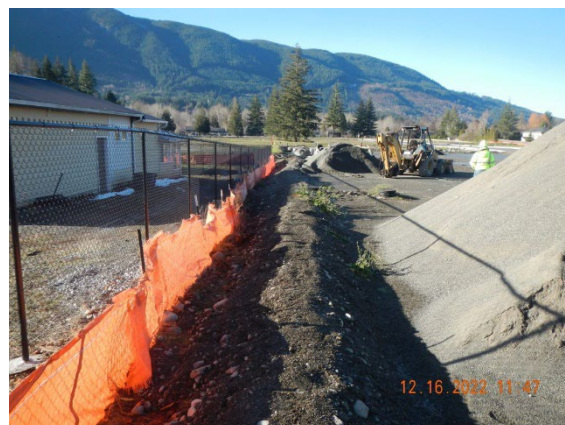
| Photo 32 | DSCN3091.JPG | Facing west, photo of southeast perimeter and sand stockpile | 12/16/2022 | 11:47 AM |

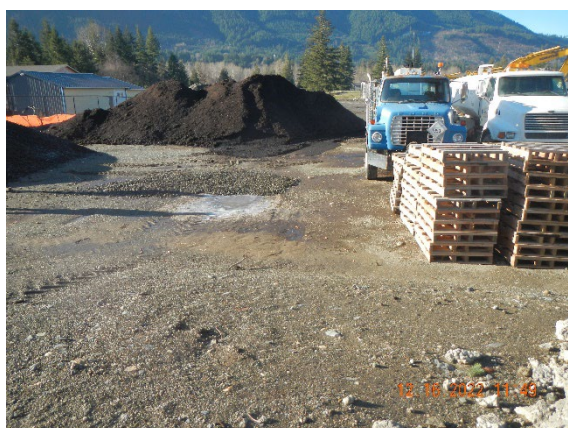
| Photo 33 | DSCN3092.JPG | Facing west, photo of stockpiles and material storage area | 12/16/2022 | 11:49 AM |

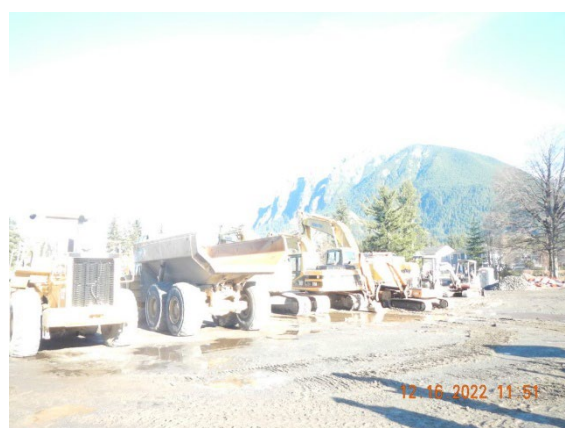
Photo 34

Next, at the southeast portion of Tree Farm, we inspected the staging ground, also referred to as the laydown area, portion of the site. We observed a small concrete washout area, with the perimeter partly reinforced with wattle and sandbags. We noted the same uncovered soil stockpiles from our December 12 site visit behind this area (**Photo 31-33**). We observed the on-site fuel truck, described above, water truck, approximately five excavators of various sizes, and a large dump truck staged in the area (**Photos 33-34**). We did not observe a spill kit near these trucks, though Mr. Boles told us they keep some spill response equipment, namely spill absorbent pads, inside the fuel truck. Closer to the concrete washout area, but showed in the foreground of **Photo 34**, we saw a portable sanitation facility. It appeared unsecured.

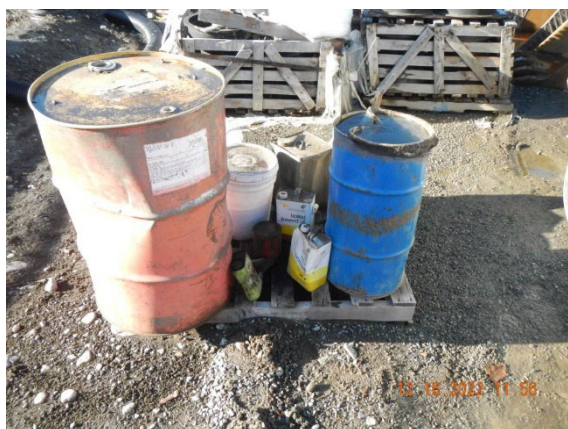
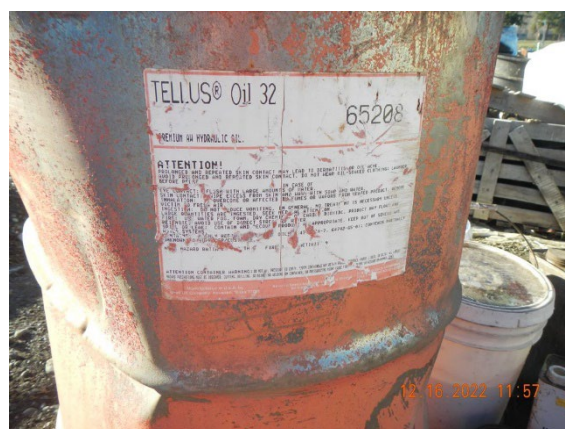
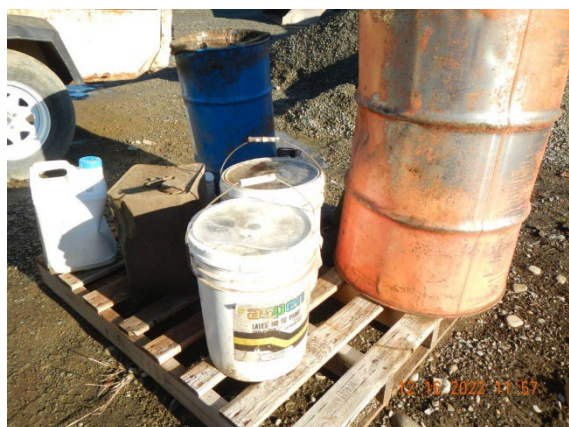
We also observed two pallets holding weathered chemical materials in this area. On one pallet we saw seven containers ranging in size from 55-gallon drum to 5-gallon pail, to one-pint can holding a variety of oils and paints (**Photos 35-37**). We did not see any spill response equipment, over head coverings, or other pollution control devices in this area. In the background of **Photo 35**, we also saw a second pallet holding many, approximately 40-pound, bags of bentonite and ready-mix concrete. The bags appeared sealed from the wholesaler/retailer, but also appeared weathered and lacking containment.
