## Experience With Main Breaks in Four Large Cities

### Panel Discussion

*A Panel Discussion presented on May 17, 1960, at the Annual Conference, Dal Harbour, Fla.*

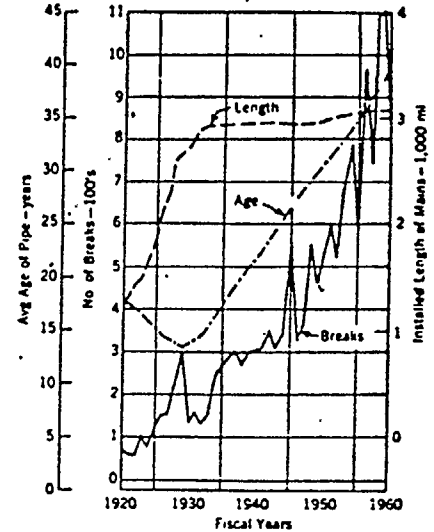
Fig. 1. Cast-Iron Main Breaks in Detroit, 1920-60

*Because of the increase in the number of breaks in cast-iron mains (the total miles of main remains relatively constant), Class 150 cast-iron pipe is no longer acceptable in Detroit.*

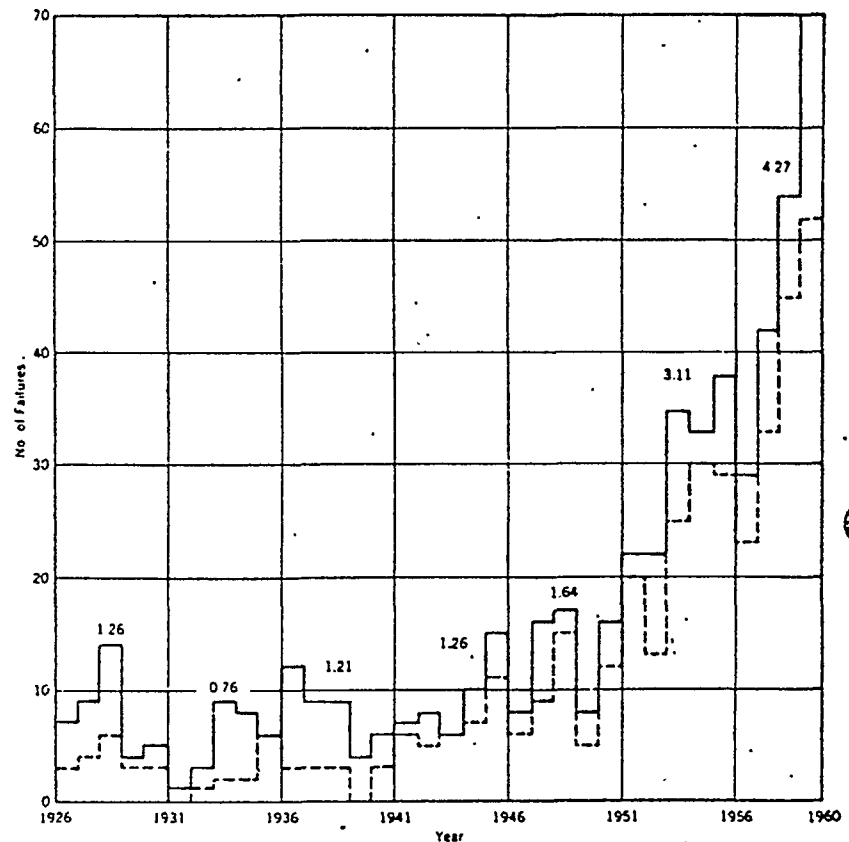
Fig. 2. Cast-Iron Main Failures Other Than Those Caused by Accidents or Freezing, 1926-59

The dashed curve represents that portion of the failures that was caused by circumferential breaks. Figures accompanying the curves represent averages per 100 mi of main per year.

The reader's attention is directed to the relatively small number of pipe breaks prior to 1941 (Fig. 2). In this early period of the record the incidence of pipe failures averaged only little more than one break per year per 100 mi of main—certainly a favor-

drant in place of the solid-barrel type has been one solution to this problem. There were no circumferential breaks in the years 1931 and 1939. The absence of any effect of severe winter temperatures on the incidence of breaks is to be particularly noted for the years 1936 and 1940. Since 1940, however, the incidence of pipe failures has steadily increased to a high of six failures per 100 mi of

main in 1959, or six times the average prior to 1941. This increase has been almost entirely due to circumferential breaks which have accounted for 78 per cent of all breaks in the last 10 years. Other kinds of pipe failures have held a rather consistent relationship with miles of mains, amounting to an average of only about one per year for each 200 mi. An increase in the latter types of failures did occur in 1959 because there were nine instances of hole development in pipe from corrosion. The corrosion was later found to be the result of electrolysis in the vicinity of rectifier stations installed by the telephone company for cathodic protection of their underground cables, which paralleled the water main.

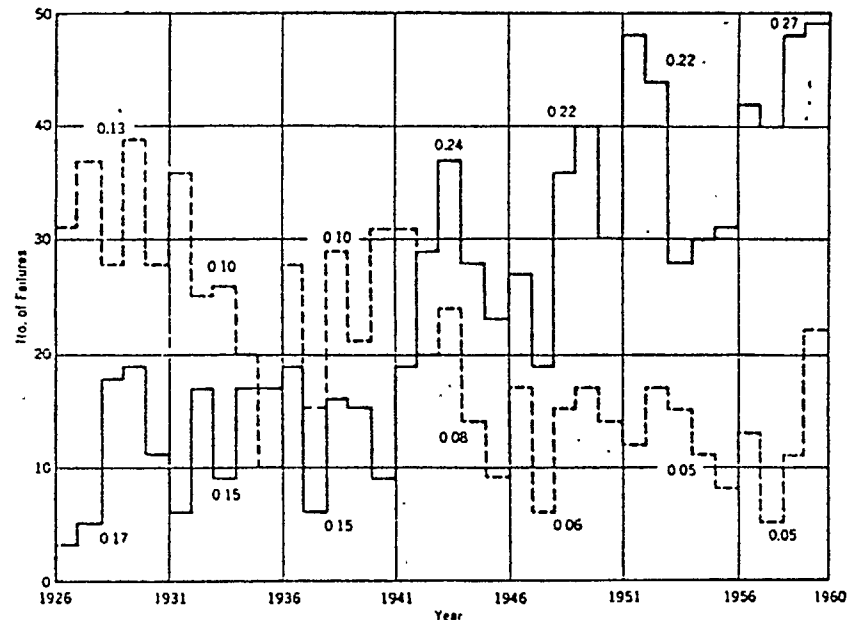
Fig. 3. Joint Failures, 1926-59

The solid and dashed curves represent failures of sulfur compound and lead joints, respectively. Figures accompanying the curves represent averages per 1,000 joints per year.

Figure 3 shows the performance of jointing material, for joint failures share equally with pipe breaks in the maintenance problems of distribution systems. It can also be shown that sulfur compound failures can be related to the temperature stresses imposed on pipelines by their restraint. No rubber gasket joint failures are recorded, as the trouble experienced with this type of joint has been very limited and has invariably resulted from improper tightening of the bolts in mechanical joints at time of installation. There has been no instance of mechanical-joint failure from corrosion of the bolts, although some of the bolts uncovered have shown evidence of galvanic action. Also excluded from the record are instances of rubber gasket joint failures on hydrants, bends, and other fittings if thrust blocking has shifted, permitting a joint to slip. There is a need for some simple and effective means to provide positive

Joint failures have outnumbered pipe breaks in Indianapolis two to one in the past 10 years. Sulfur compound has been responsible for 75 per cent of joint failures, although only 35 per cent of all joints are of this material. It is interesting to observe from Fig. 3 that lead joints, which have the greatest age, are showing a decreasing

incidence of failure, whereas sulfur compound failures have been increasing. The seasonal pattern of both sulfur compound failures and circumferential breaks indicates a relationship of failure to water temperature. By plotting such failures by month of repair and superimposing water temperature curves on the graph as shown in Fig. 4, one can see a rather fixed relationship. A similar plot of other types of pipe breaks failed to produce a similar relation. Lead joint failures so plotted did show a somewhat

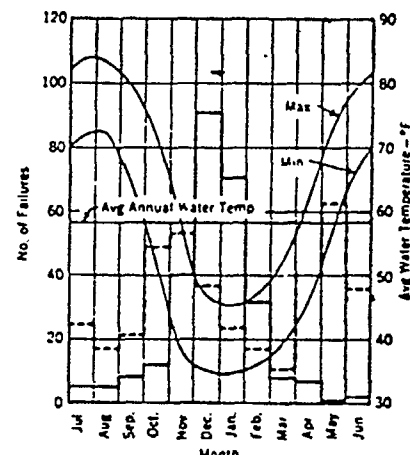
Fig. 4. Pipeline Failures by Month of Repair, 1950-59

The solid and dashed curves represent circumferential pipe breaks and failures in sulfur compound joints, respectively. As can be seen, circumferential breaks appear to occur during periods of low temperature, whereas joint failures occur during periods of rapid temperature change.

From Fig. 4, it can be seen that sulfur compound failures have two peak periods of occurrence, in spring and fall when the water temperature is approximately at the annual mean. Minimum frequency is first at the maximum water temperature and then again after the minimum level has been passed. The peaks and valleys of the
