## Region 6 - Enforcement & Compliance Assurance Division

### INSPECTION REPORT

| Inspection Date(s): | 04/10/2024 | |
| Company Name: | <b>Tap Rock Resources LLC</b> | |

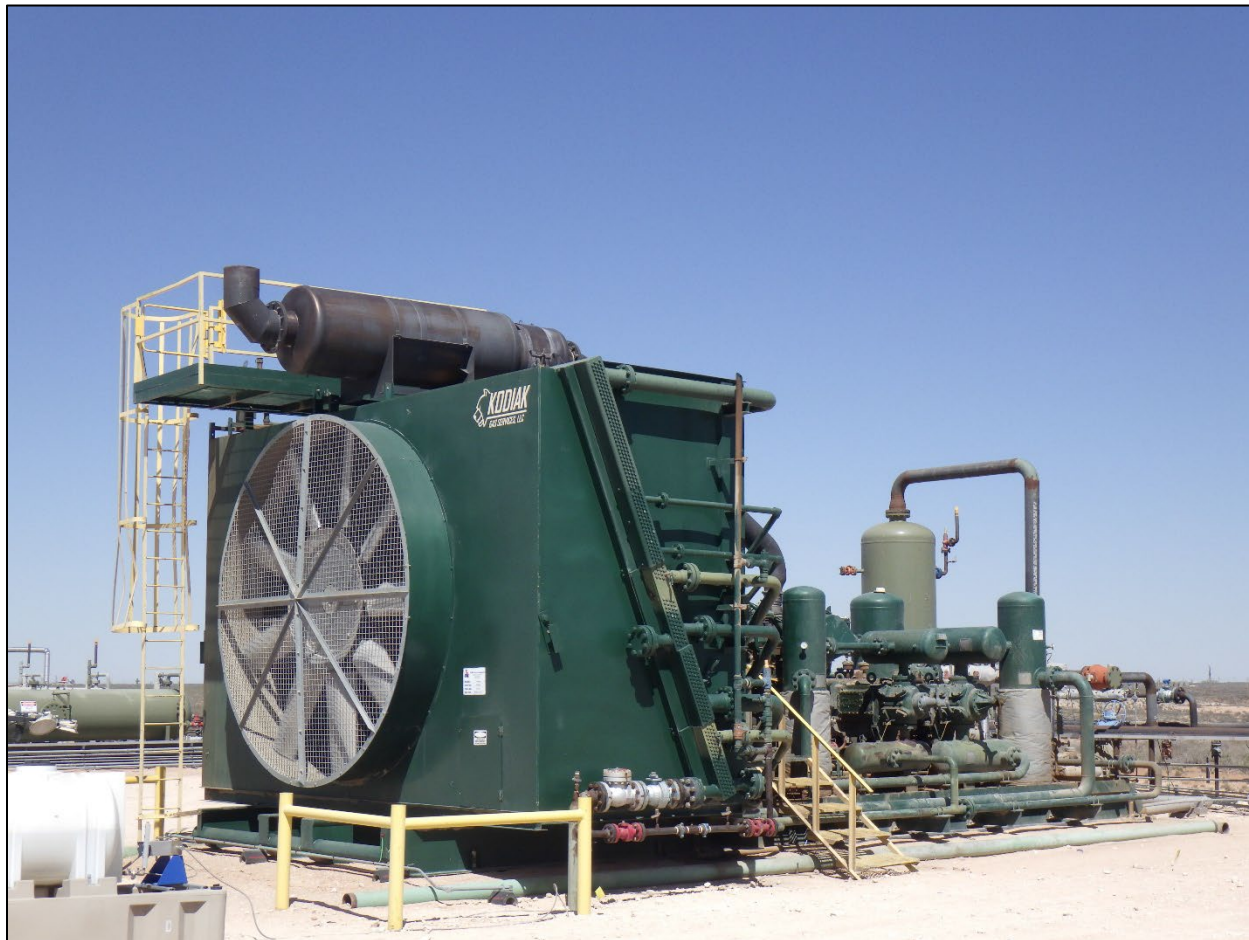
Description: Gas Lift Compressor Engine 1 hydrocarbon emissions observed trailing from exhaust stack using an optical gas imaging camera.

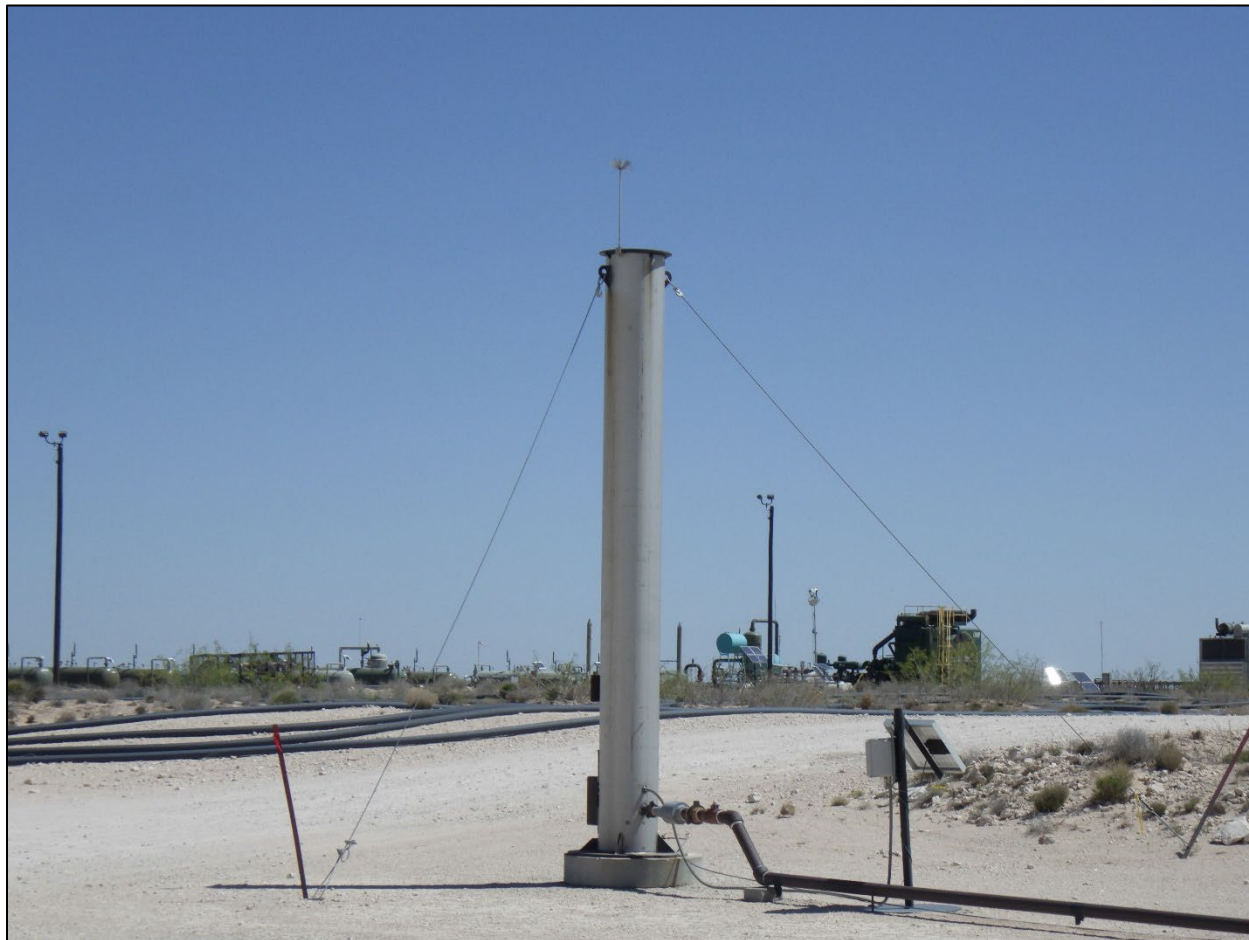
Description: Uncontrolled hydrocarbon emissions observed from the top of the Enclosed Combustor using an optical gas imaging camera.

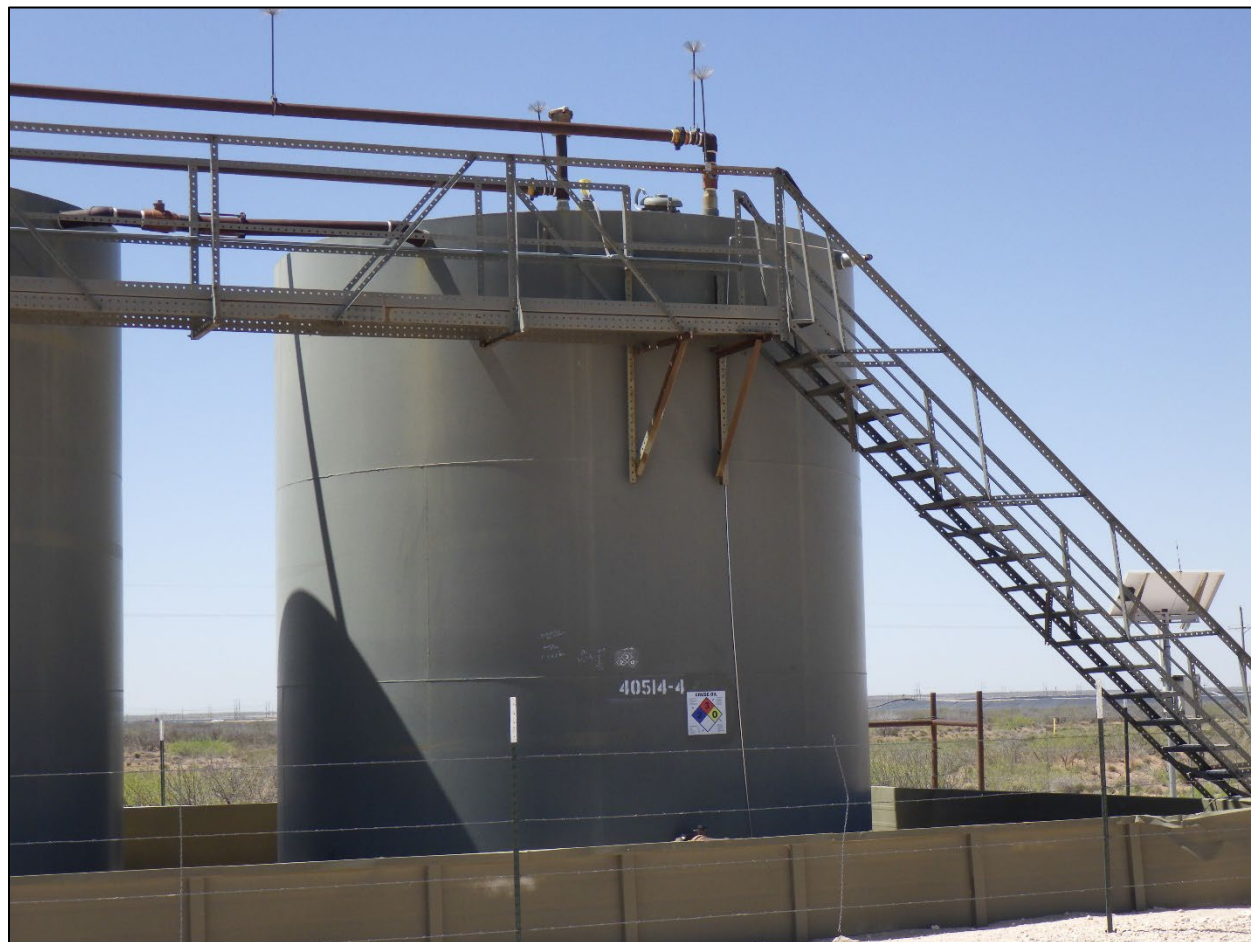
Description: Hydrocarbon emissions observed from pressure relief valve on the top of Oil Tank 4 (40414-4) using optical gas imaging camera.

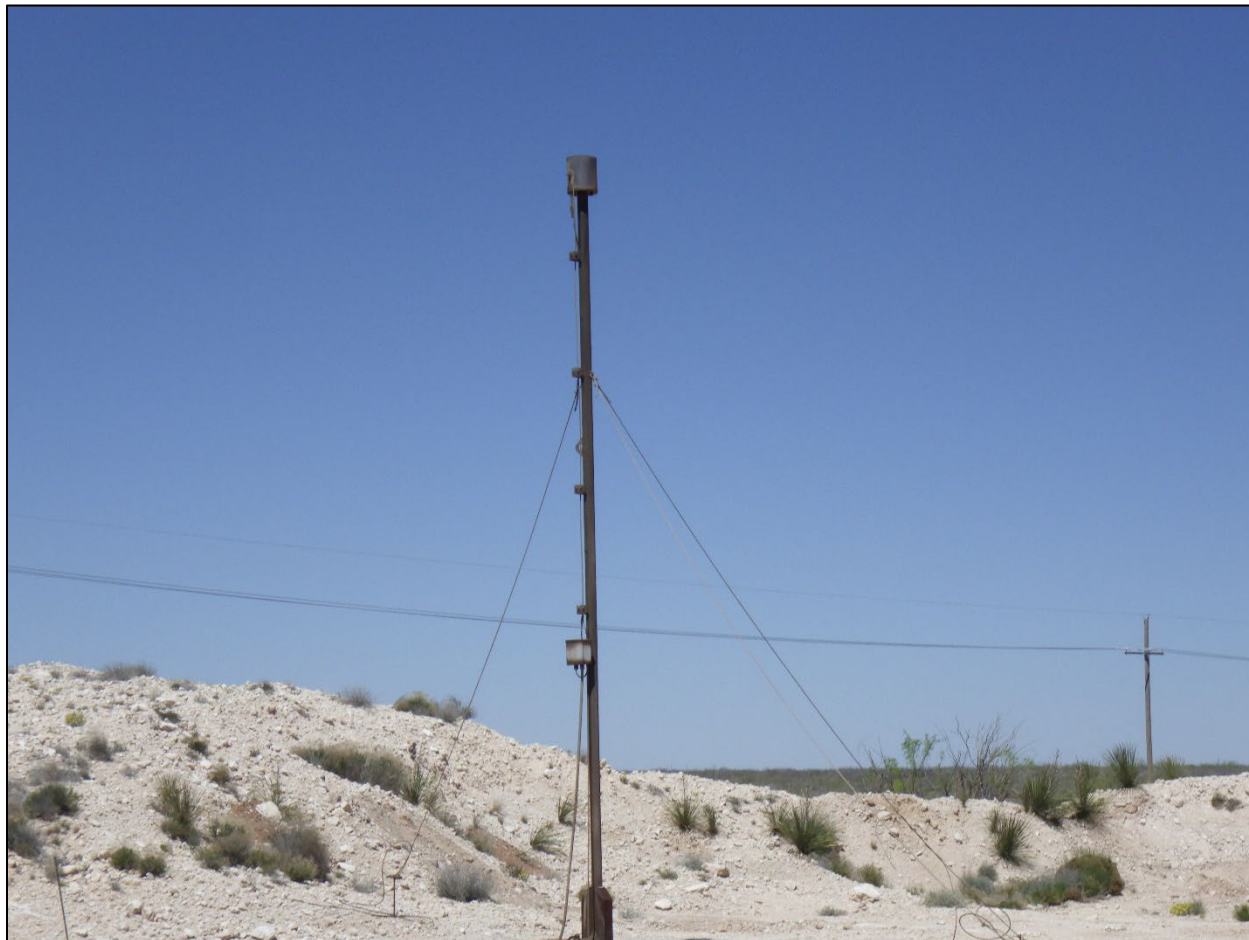
Description: Uncontrolled hydrocarbon emissions observed from the high-pressure flare using an optical gas imaging camera.

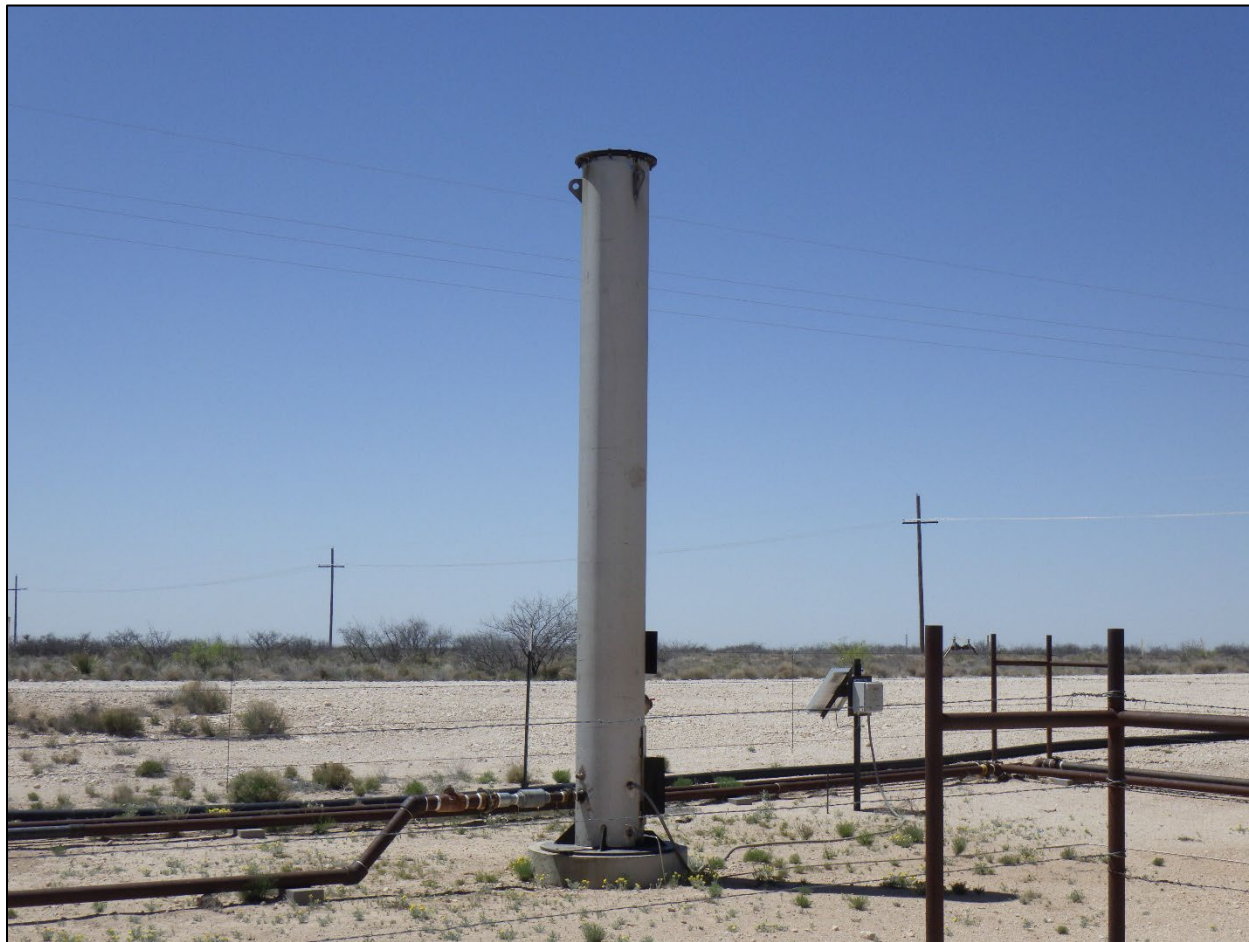
Description: Uncontrolled hydrocarbon emissions observed from the enclosed combustor using an optical gas imaging camera.

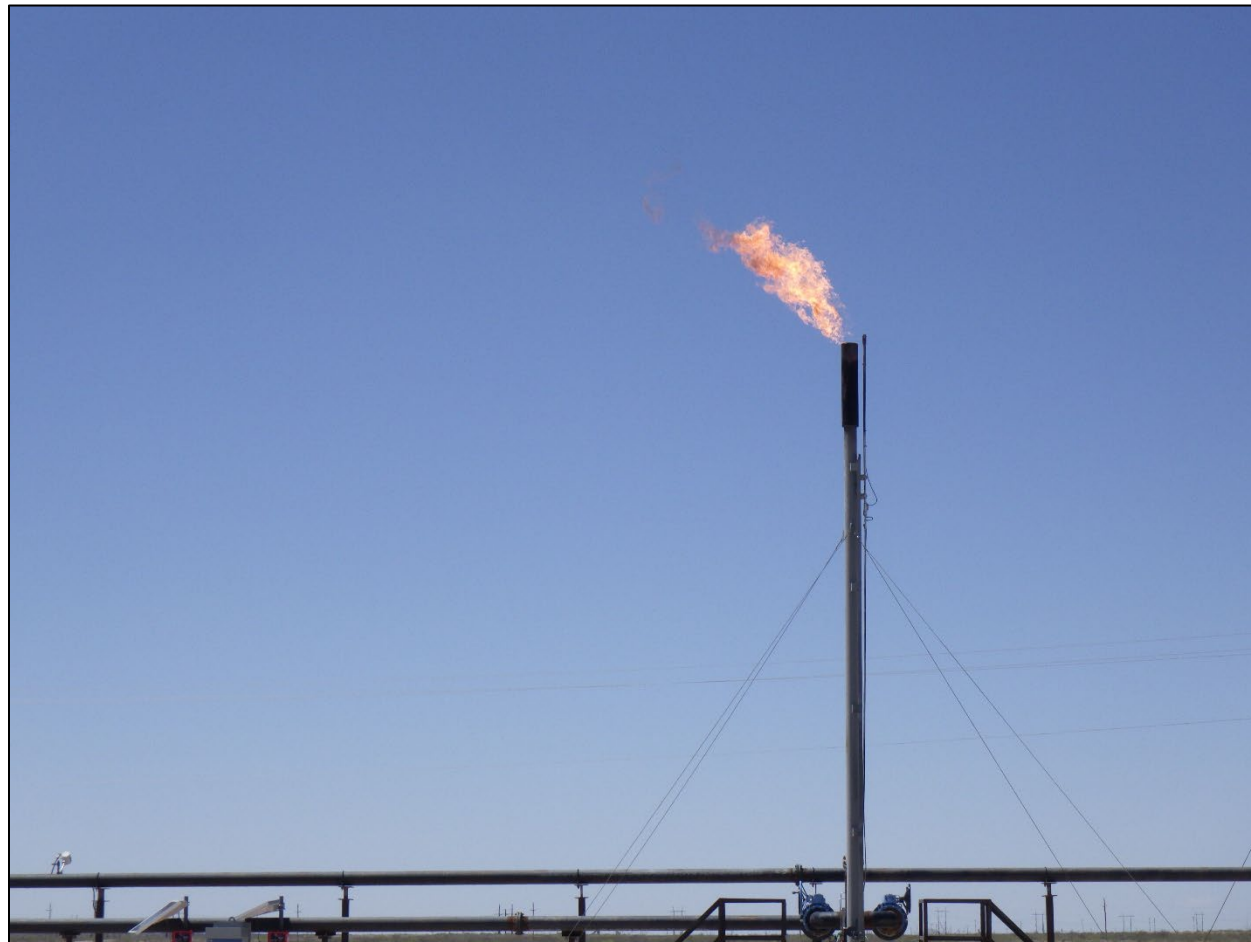
Description: Uncontrolled hydrocarbon emissions observed trailing from the low-pressure flare during flaring operations using an optical gas imaging camera.

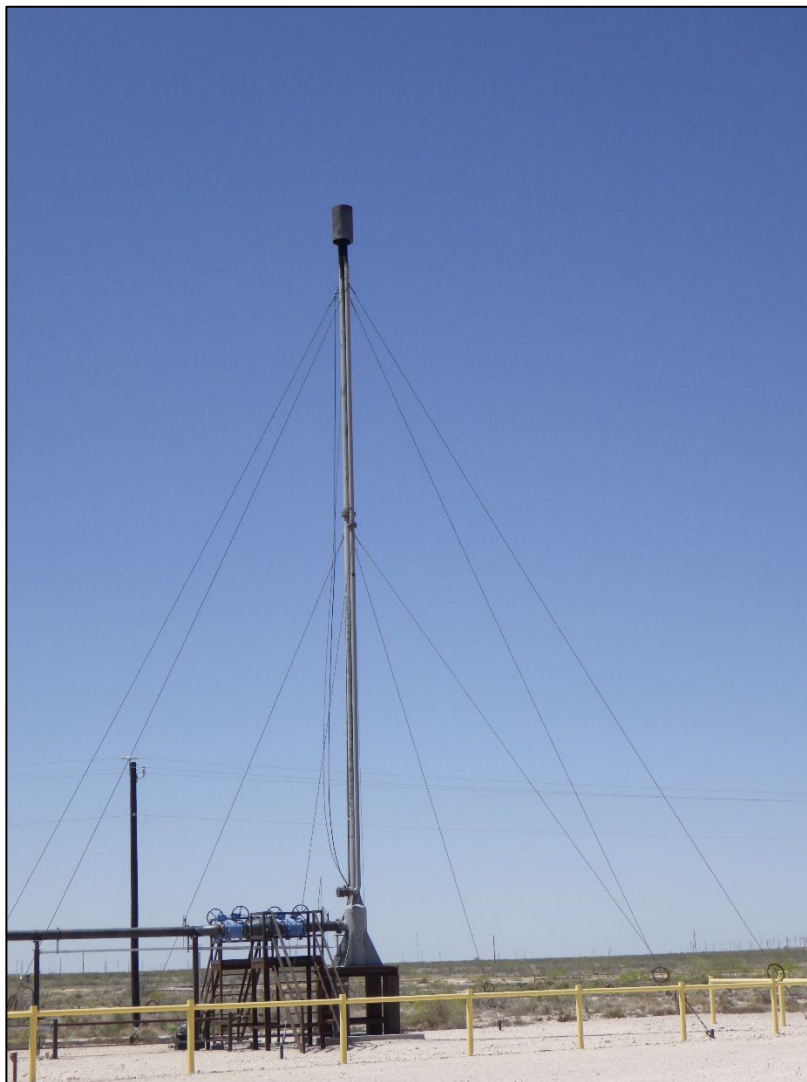
Description: Uncontrolled hydrocarbon emissions observed trailing from the high-pressure flare using an optical gas imaging camera.

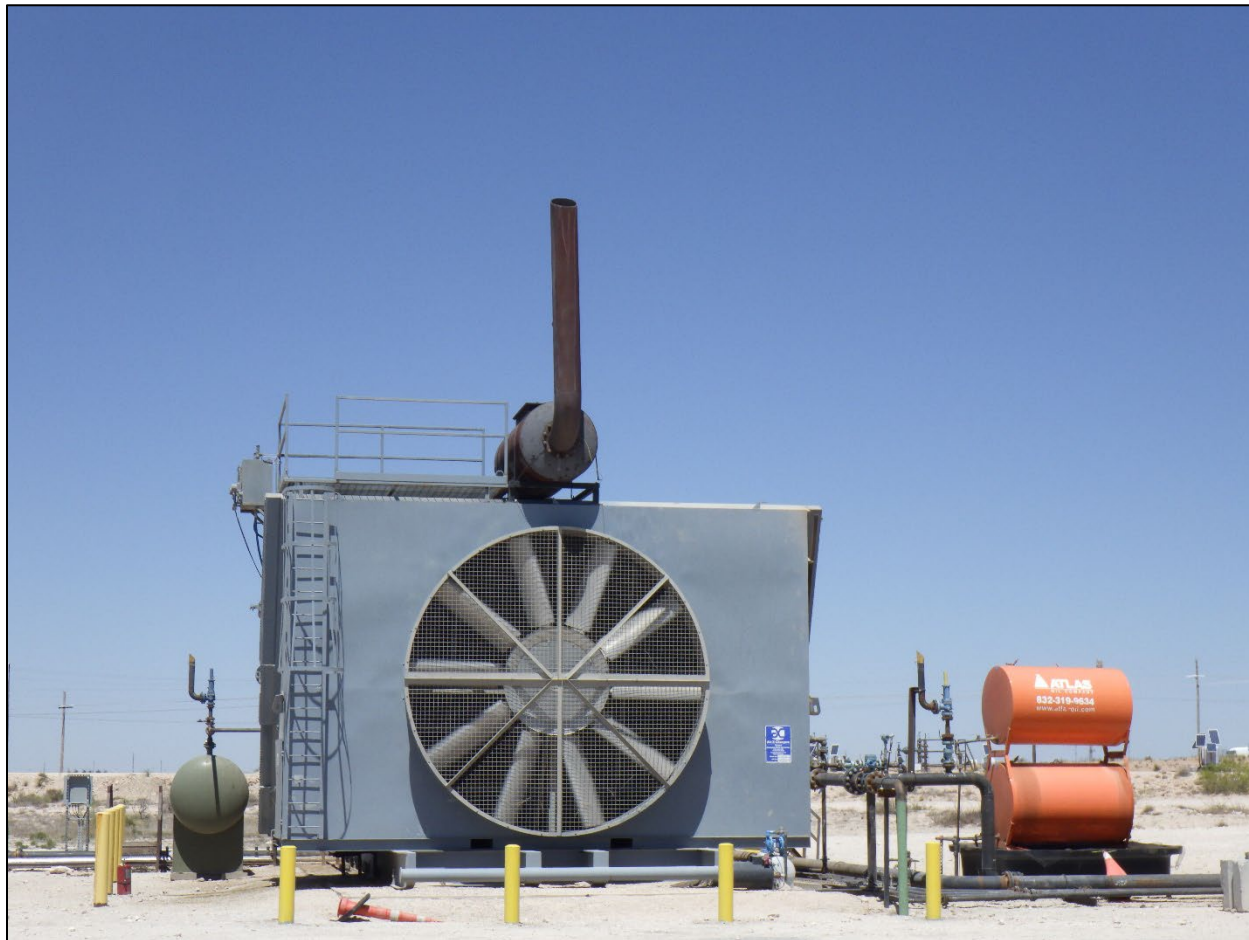
Description: Hydrocarbon emissions observed trailing from the exhaust stack of gas lift compressor Engine 1 using an optical gas imaging camera.

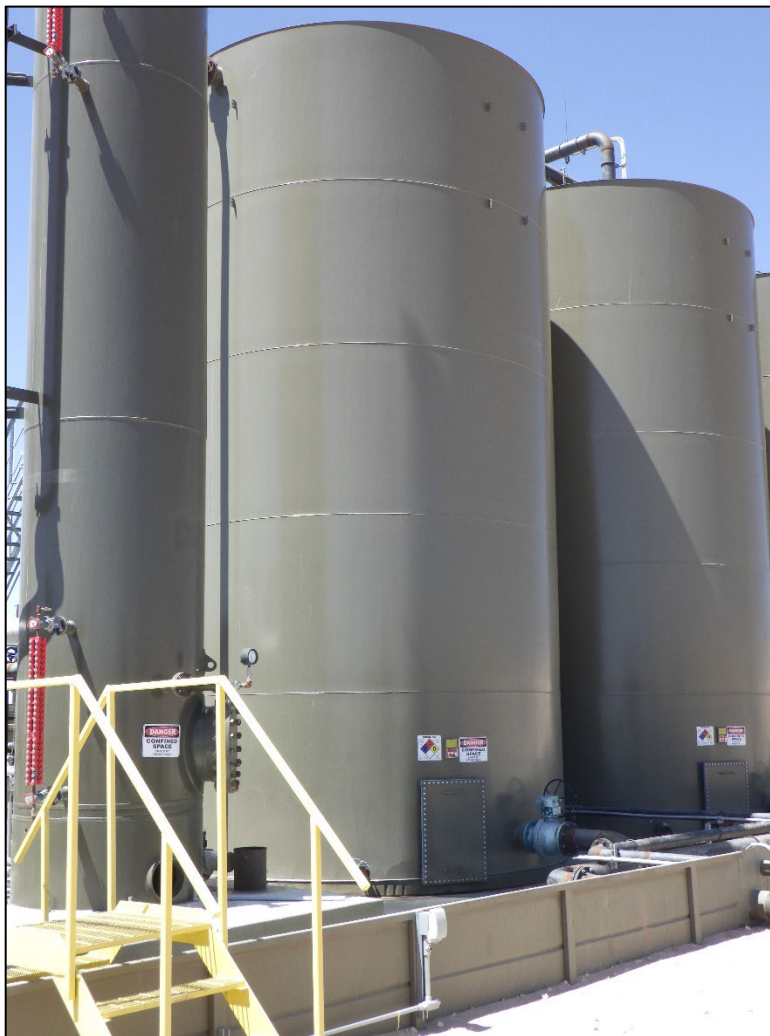
Description: Hydrocarbon emissions observed from a hatch on the top of Oil Tank 1 using an optical gas imaging camera.

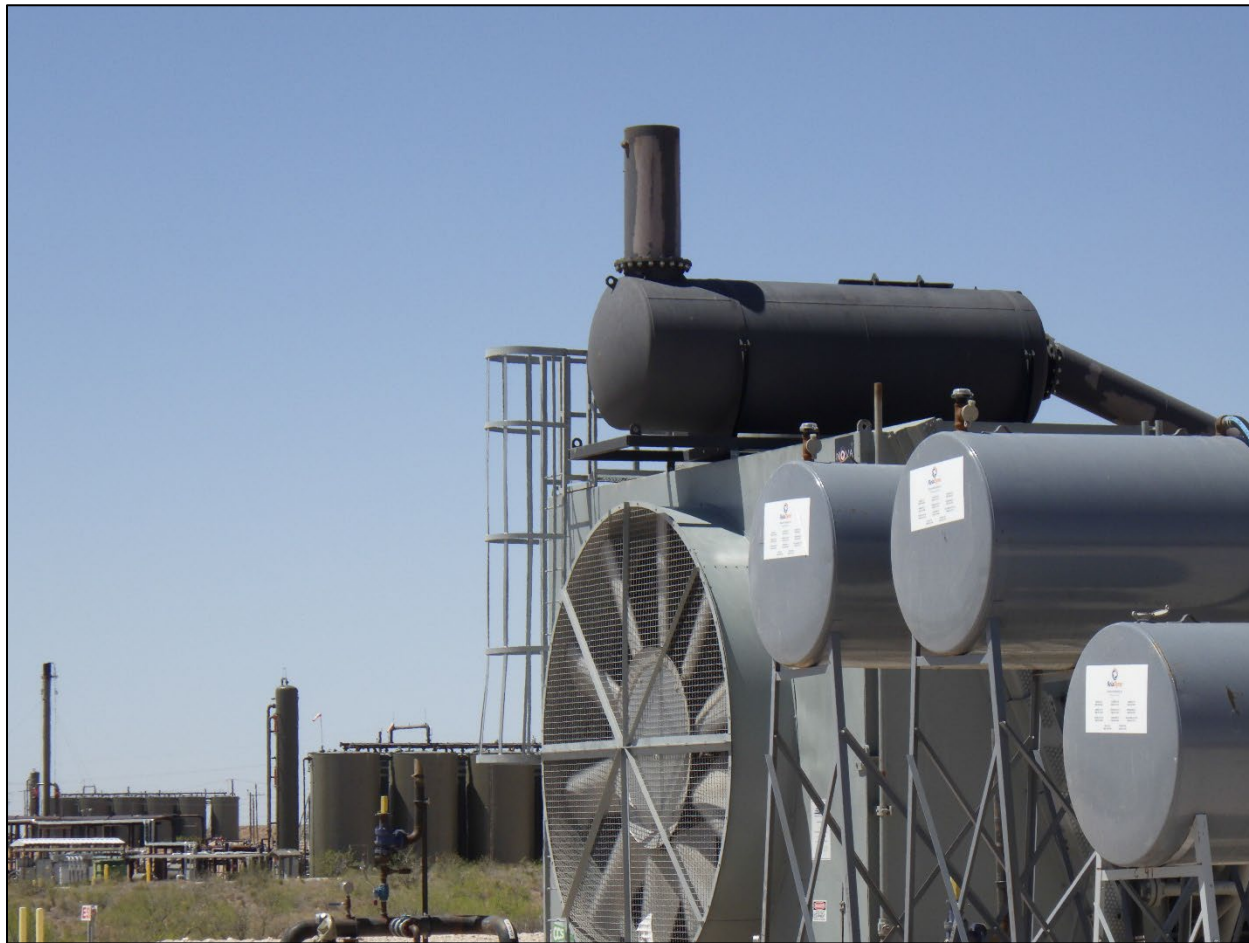
Description: Hydrocarbon emissions observed trailing from the exhaust stack of gas lift compressor Engine 1 using an optical gas imaging camera.

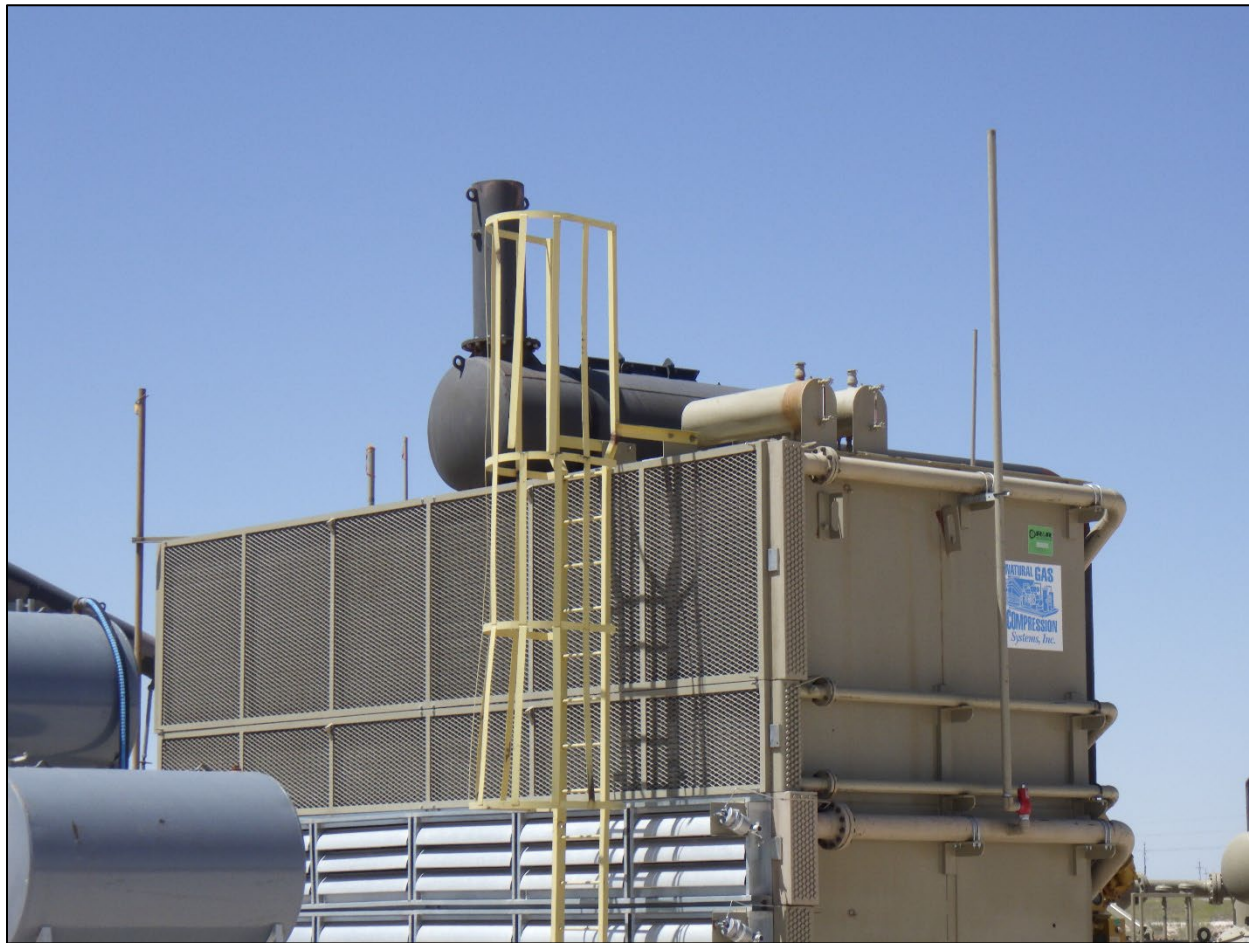
Description: Hydrocarbon emissions observed trailing from the exhaust stack of gas lift compressor Engine 2 using an optical gas imaging camera.

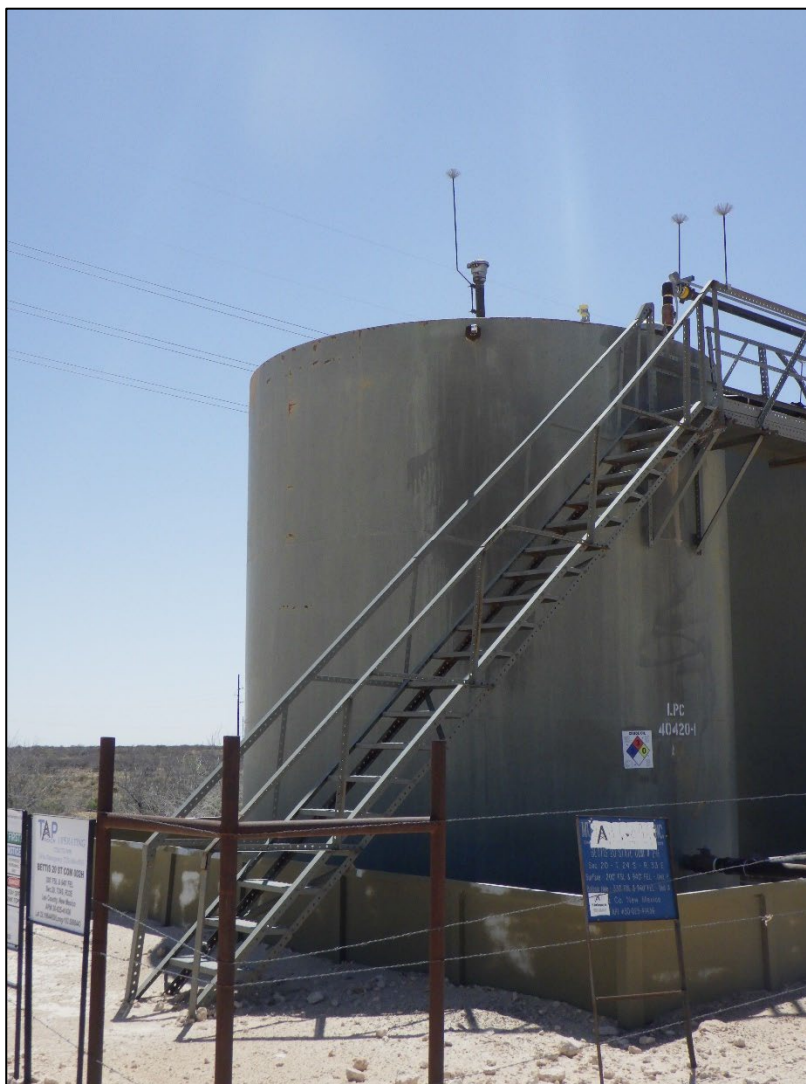
Description: Hydrocarbon emissions observed from the pressure relief valve on top of Oil Tank 1 (40420-1) using an optical gas imaging camera.

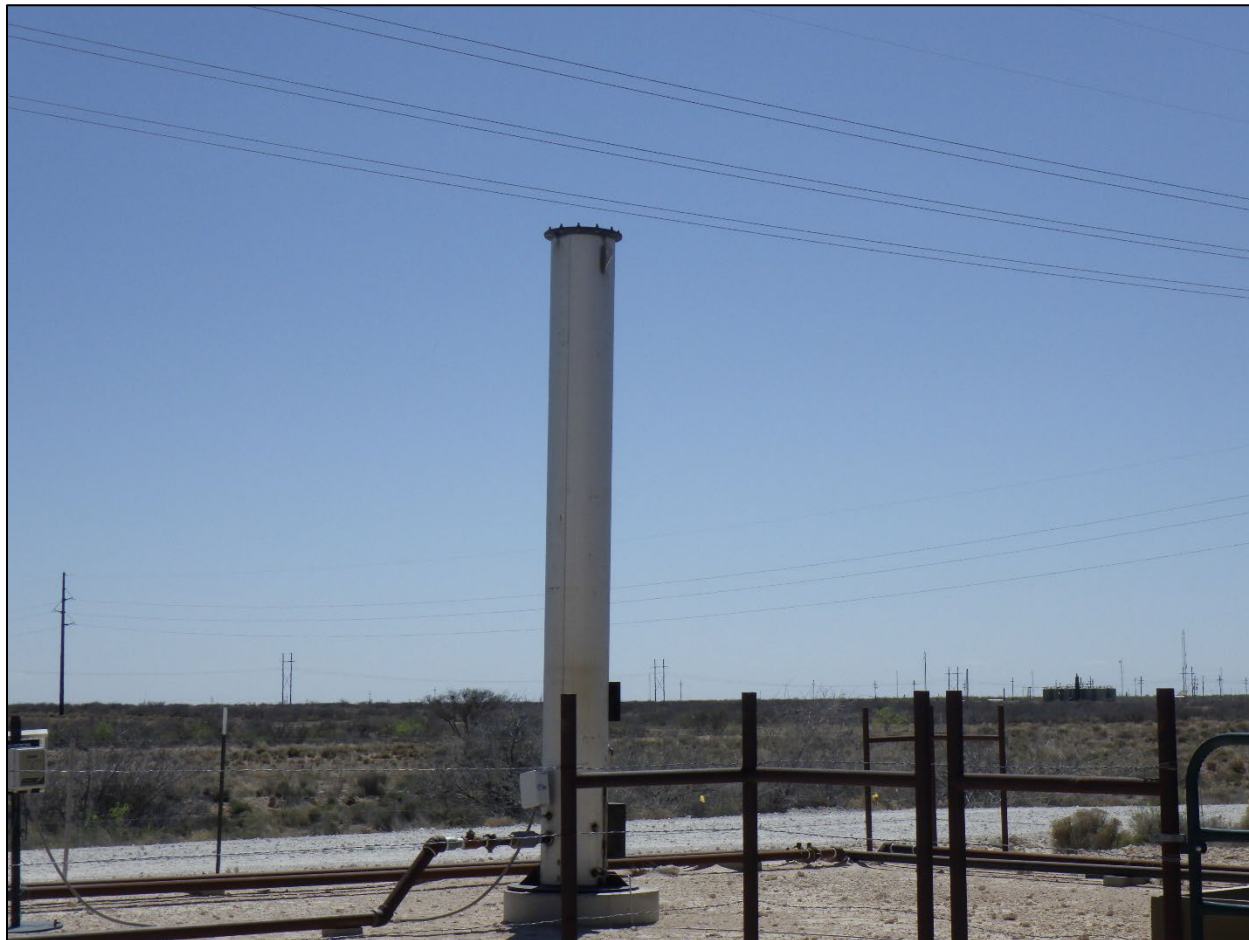
Description: Uncontrolled hydrocarbon emissions observed from the enclosed combustor using an optical gas imaging camera.

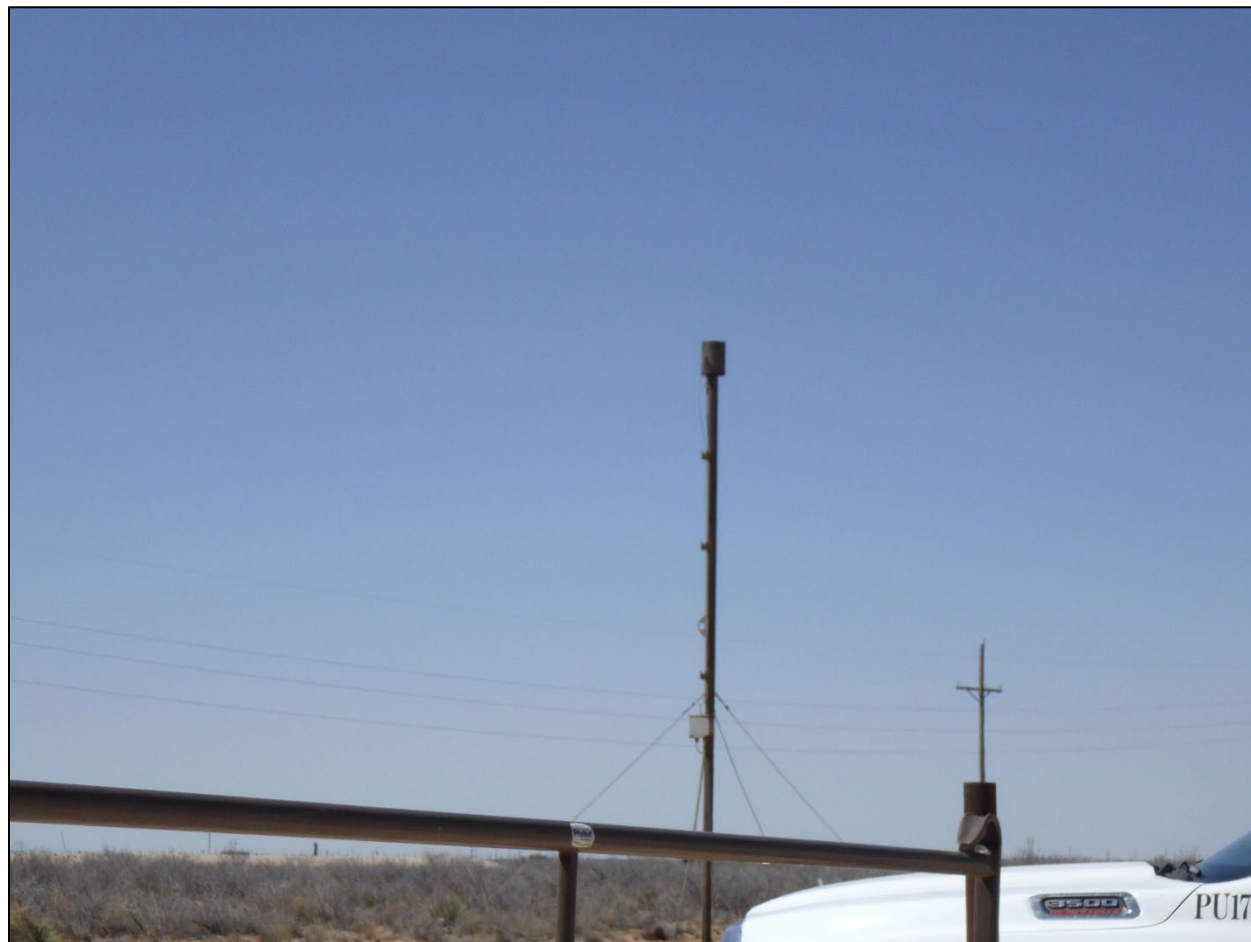
Description: Uncontrolled hydrocarbon emissions observed from the high-pressure flare using an optical gas imaging camera.

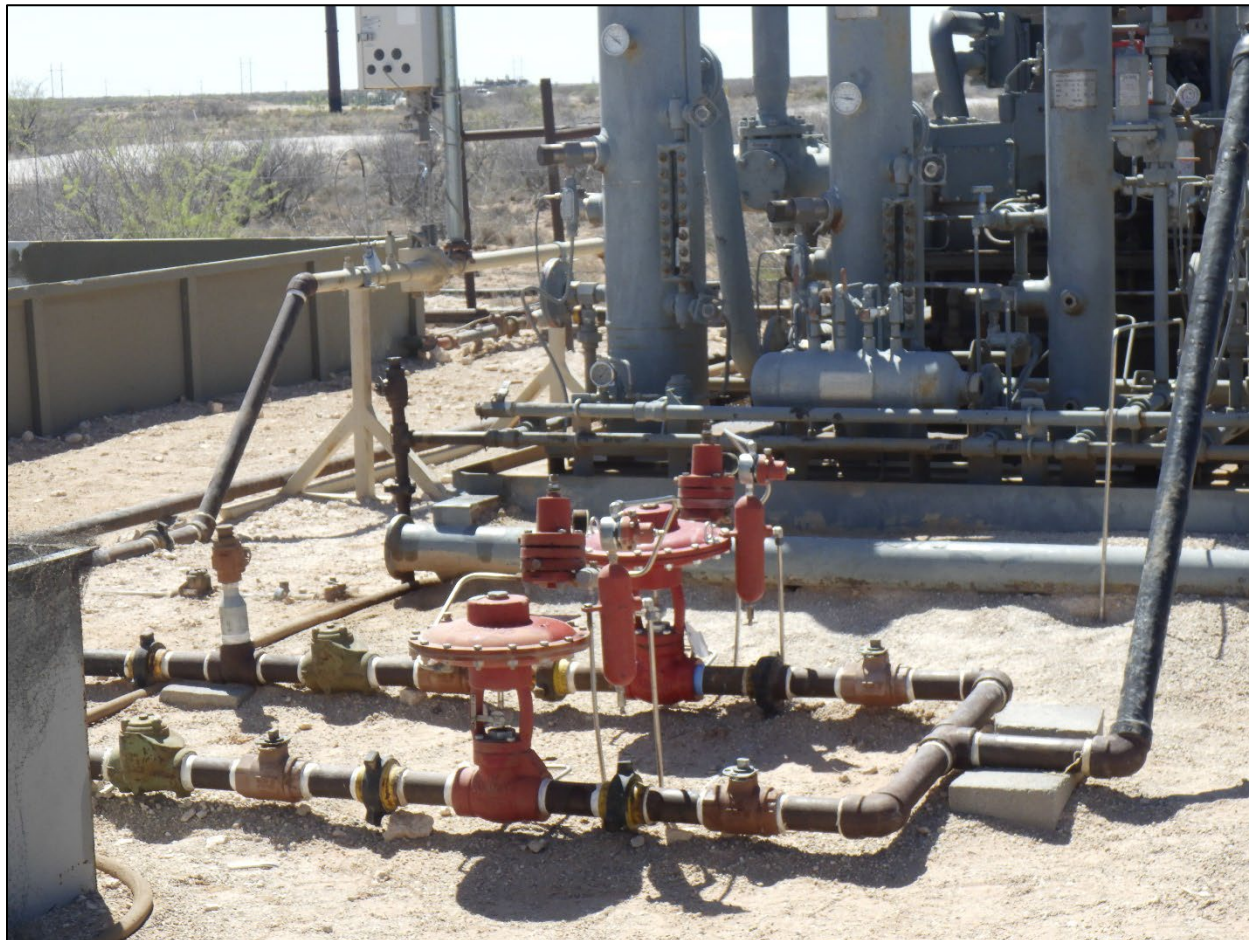
Description: Hydrocarbon emissions observed from the back pressure pilot valve to the back pressure pilot shut-off suction using an optical gas imaging camera.

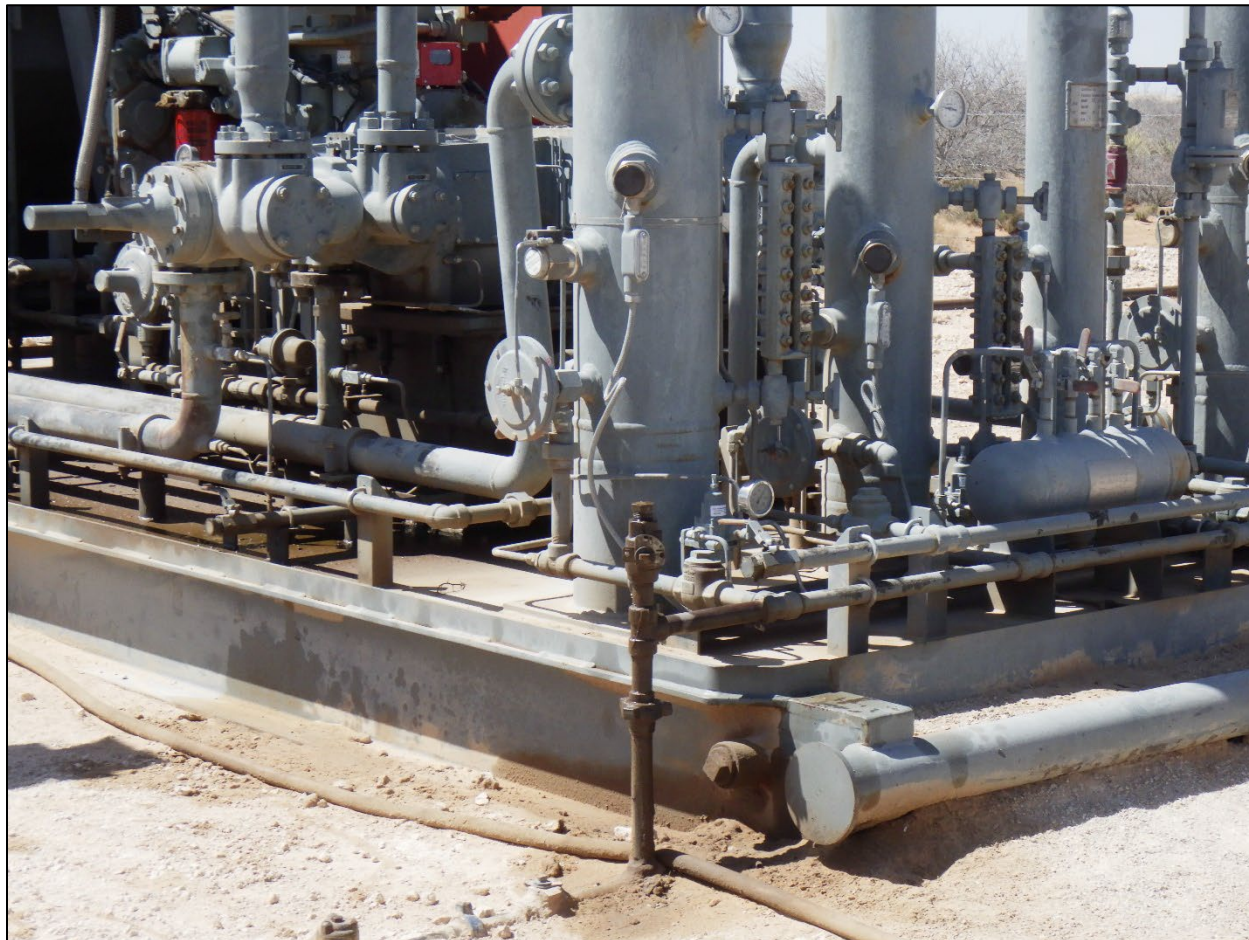
Description: Hydrocarbon emissions observed from the regulator on the sales compressor using an optical gas imaging camera.

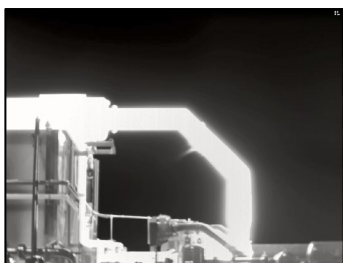
Video: 2  
 Video File Name: [FLIR0096.mp4](#)  
 Date of Video: 04/10/2024  
 Time of Video: 10:06 AM  
 Videographer: Daniel Heins  
 Description: Posiedon A Central Tank Battery - Compressor.  
 Visible hydrocarbon emissions observed trailing  
 from open ended line associated with compressor.

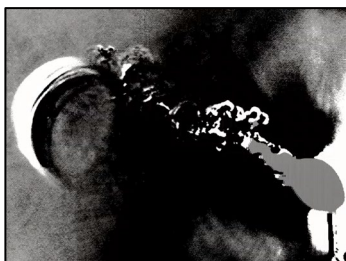
Video: 10  
 Video File Name: [FLIR0105.mp4](#)  
 Date of Video: 04/10/2024  
 Time of Video: 12:05 PM  
 Videographer: Daniel Heins  
 Description: Brininstool 4 State No. 4H – Enclosed Combustor. Visible uncombusted hydrocarbon emissions observed from enclosed combustor with no heat signature.

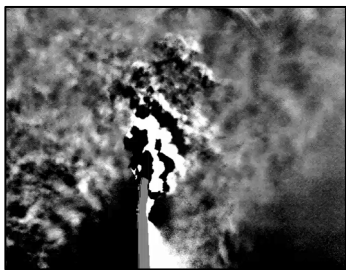
Video: 11  
 Video File Name: [FLIR0106.mp4](#)  
 Date of Video: 04/10/2024  
 Time of Video: 12:43 PM  
 Videographer: Bailey Brown  
 Description: Hyperion A CTB – Both Flares. Visible uncombusted hydrocarbon emissions observed trailing from the combustion zone of both flares.

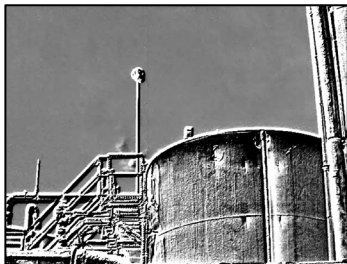
Video: 13  
 Video File Name: [FLIR0108.mp4](#)  
 Date of Video: 04/10/2024  
 Time of Video: 1:27 PM  
 Videographer: Daniel Heins  
 Description: Promethius C CTB – Tank Battery. Visible hydrocarbon emissions observed from hatch on Oil Tank No. 1.

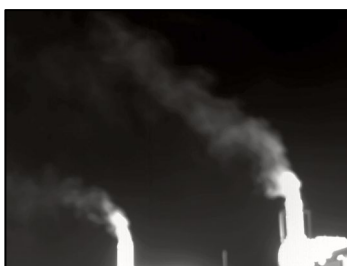
Video: 14  
 Video File Name: [FLIR0109.mp4](#)  
 Date of Video: 04/10/2024  
 Time of Video: 1:40 PM  
 Videographer: Daniel Heins  
 Description: Promethius C CTB – Compressors. Visible hydrocarbon emissions observed trailing from exhaust stacks of Compressors No. 1 and No. 2.

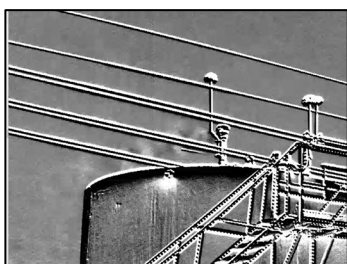
Video: 15  
 Video File Name: [FLIR0110.mp4](#)  
 Date of Video: 04/10/2024  
 Time of Video: 2:23 PM  
 Videographer: Daniel Heins  
 Description: Bettis 20 State Com No. 2H – Tank Battery. Visible hydrocarbon emissions observed trailing from pressure relief valve on Oil Tank No. 1.

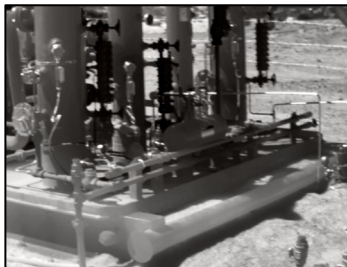
Video: 19  
 Video File Name: [FLIR0114.mp4](#)  
 Date of Video: 04/10/2024  
 Time of Video: 2:39 PM  
 Videographer: Daniel Heins  
 Description: Bettis 20 State Com No. 2H – Compressor. Visible hydrocarbon emissions observed from the compressor regulator.

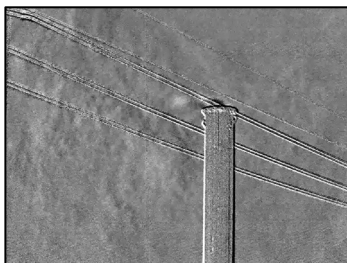
Video: 20  
 Video File Name: [FLIR0115.mp4](#)  
 Date of Video: 04/10/2024  
 Time of Video: 2:47 PM  
 Videographer: Daniel Heins  
 Description: Bettis 20 State Com No. 3H – Enclosed Combustor. Visible uncontrolled hydrocarbon emissions observed from enclosed combustor with no heat signature.

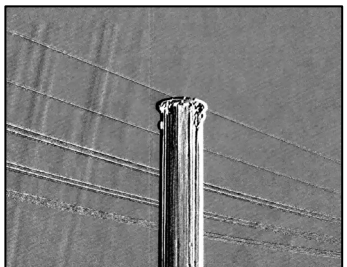
Video: 21  
 Video File Name: [FLIR0116.mp4](#)  
 Date of Video: 04/10/2024  
 Time of Video: 2:59 PM  
 Videographer: Daniel Heins  
 Description: Bettis 20 State Com No. 4H – Enclosed Combustor. Visible uncontrolled hydrocarbon emissions observed from enclosed combustor with no heat signature.
