**Clean Water Act (CWA) Inspection Report**

| Type of Inspection | CEI - Compliance Evaluation Inspection | | | |
| Facility Name | Idaho Forest Group LLC – Grangeville | | | |
| EPA Permit Tracking # | IDR053246 | | | |

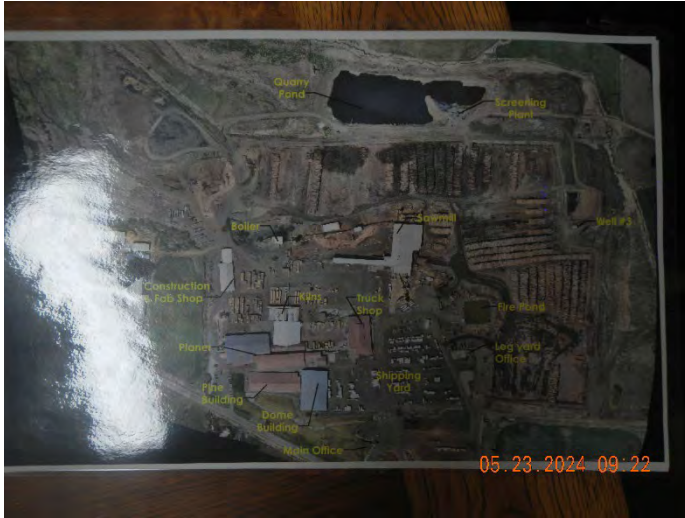
Photo #:01 (DSCN3770)

To assist in orienting me with the Facility's layout, Mr. E. Smith brought in a large Facility Map (**Photo 1**) to review/discuss. After a brief review, we began the walk-through just north of the main office and parking area. I was accompanied throughout the inspection/walk-through by Mr. E. Smith, Ms. Taylor, and Mr. F. Smith. Mr. Miller joined the inspection for the records review and closing conference.

Description: Photo of printed map used for Facility walk-through.

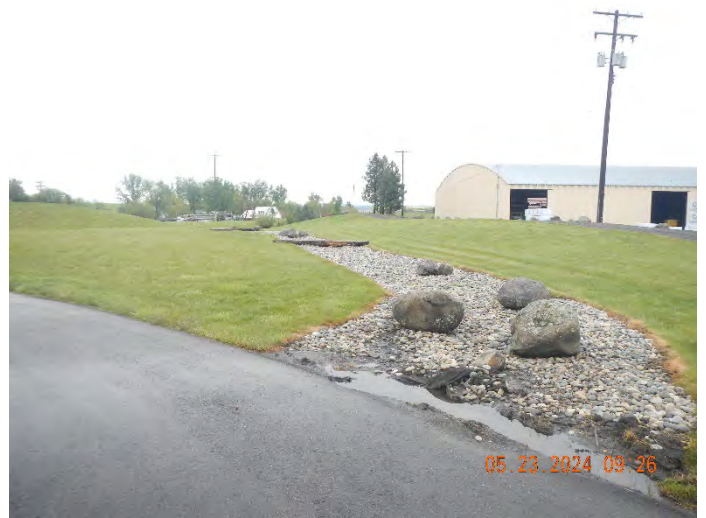
Photo #:02 (DSCN3771)

We first observed the paved parking and entrance area north of the main office. The paved areas are generally sloped to the west, routing stormwater to an engineered drainage channel that travels along the southwestern perimeter (**Photo 2**). The drainage channel then enters subsurface piping, routing stormwater to the stormwater pond and avoiding the industrial areas on the property. The large parking area as well as the areas east of the truck entrance appeared to be well maintained and free of debris (**Photo 3**). Northeast of the entrance/log scale, we observed a catch basin inlet within the entrance area routing stormwater to the stormwater pond via subsurface piping (**Photo 4**). The general area was well maintained and free of debris.

Description: Facing west, photo of drainage channel used for collecting/routing stormwater from the parking area to the stormwater collection pond.

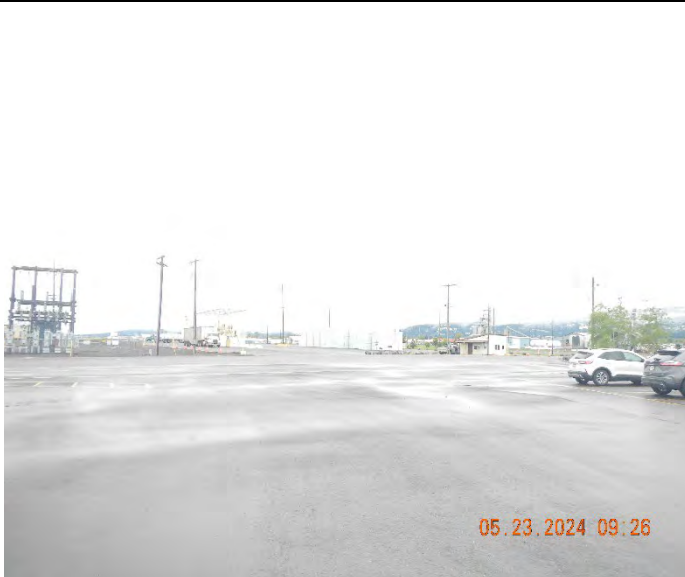
Photo #:03 (DSCN3772)

Description: Facing east, photo of parking area near the office building.

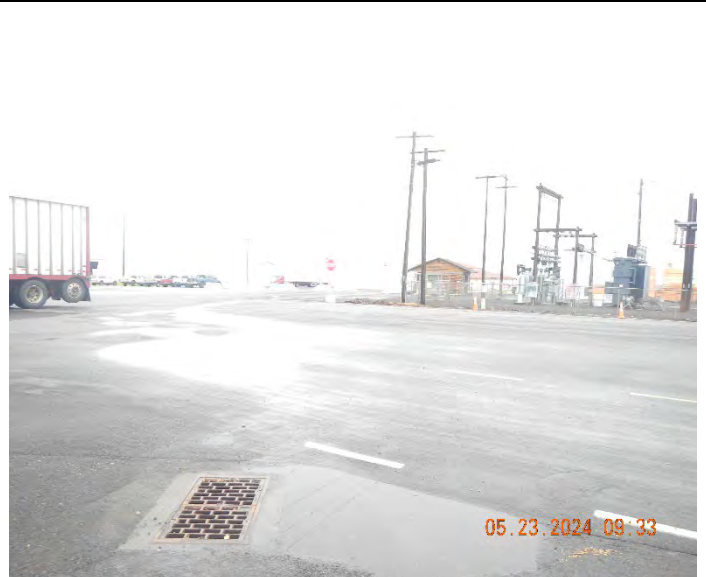
Photo #:04 (DSCN3773)

Description: Facing east, photo of a stormwater catch basin along northeast of the entry scale/entrance. Stormwater is routed to the subsurface collection system to the stormwater collection pond.

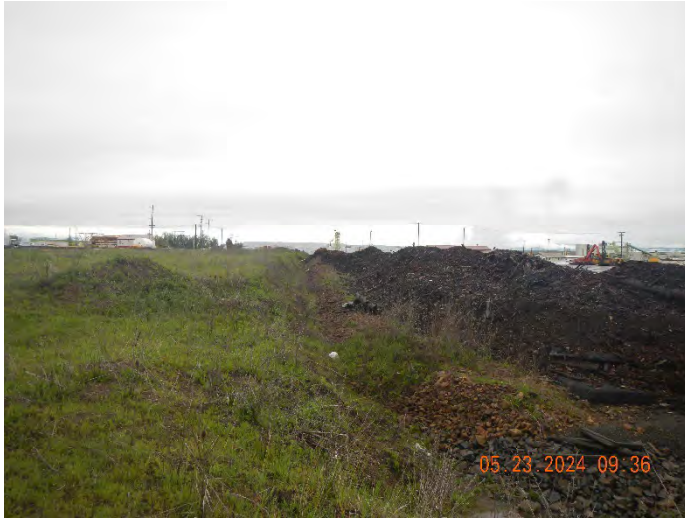
Photo #:05 (DSCN3774)

We continued east along the southern perimeter and observed the southern end of the log deck/storage area. A large earthen berm was constructed along the southern and eastern perimeter (**Photo 5, Photo 6**). In general, stormwater is designed to be contained within the log yard and either evaporated, infiltrated, or routed to the Facility's stormwater pond.

Description: Facing west, photo of southern perimeter of the log deck/storage area. Southern perimeter is bermed.

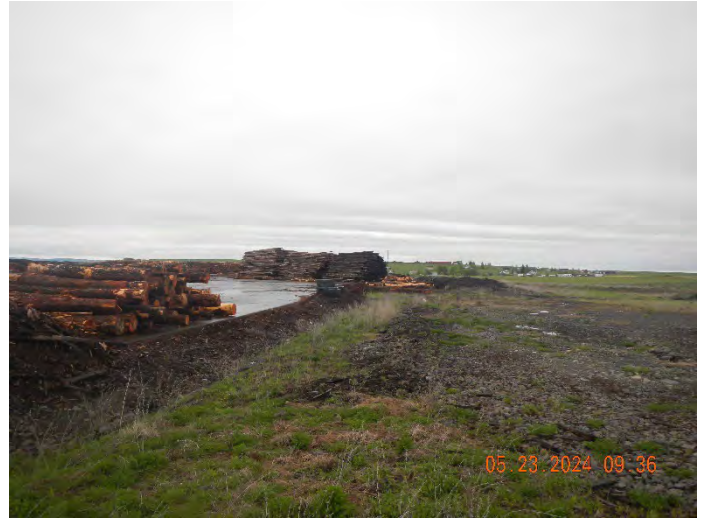
Photo #:06 (DSCN3775)

Description: Facing north, photo of east perimeter of the log deck storage area. Photo taken from southeast corner of the Facility. East perimeter is bermed.

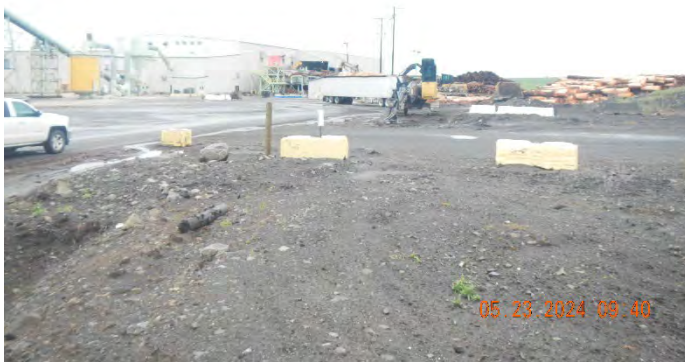
Photo #:07 (DSCN3776)

We continued north into the central areas of the Facility, west of log yard. We observed a central drainage channel located north of the Log Yard Office (**Photo 7**). The central drainage channel routes stormwater from the western perimeter of the log yard away from the fueling area and access road (**Photo 8**). Stormwater then flows back south, away from the mill area and into a central catch basin located north of the fueling area (**Photo 9**). It was discussed that all catch basins connect to the subsurface piping system and then into the Facility's stormwater pond.

Description: Facing north, photo of stormwater drainage channel along a primary access road. Photo was taken east of the fuel storage area and west of the shipping yard.

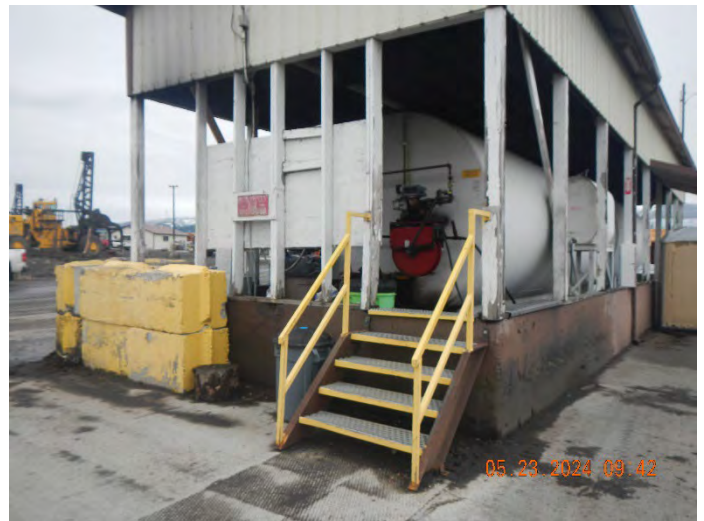
Photo #:08 (DSCN3777)

We observed the fueling area which consists of a covered 15,000-gallon fuel tank with secondary containment. The 15,000-gallon tank/fueling area provides on-site fueling of “off-road diesel.” There is also a smaller unleaded gas tank mounted within the containment area. The Facility maintains a spill kit within the areas as well as a Spill Prevention Control, and Countermeasure (SPCC) Plan.

Description: Facing south, photo of diesel fuel tank and unleaded fuel tank used for on-site fueling. A spill kit is maintained within the fueling area.

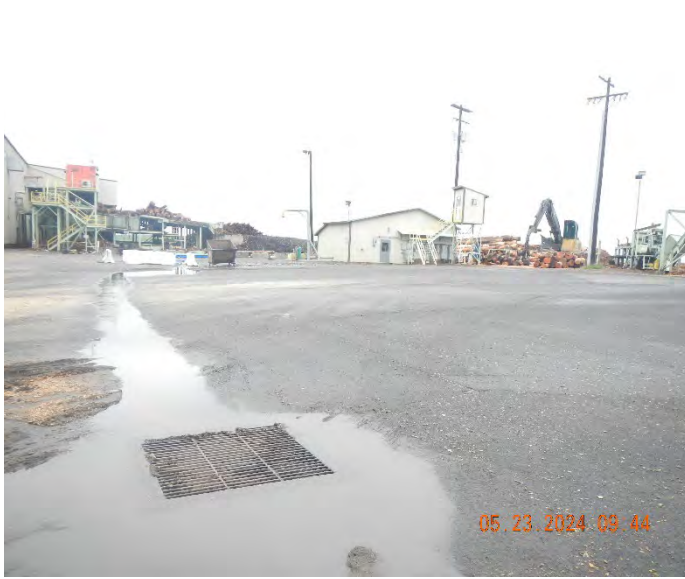
Photo #:09 (DSCN3778)

Description: Facing north, photo of primary catch basin capturing stormwater from central drainage area. Photo taken west of the log yard and south of the mill.

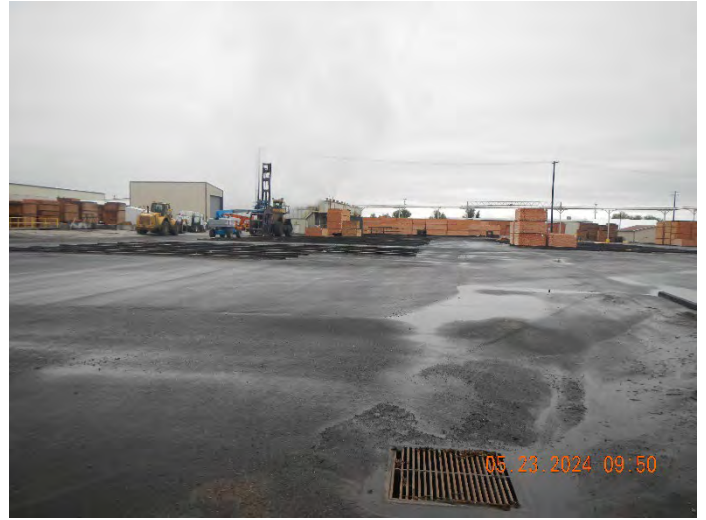
Photo #:10 (DSCN3779)

We then continued southeast of the mill to the southern areas of the “green yard.” We observed one catch basin within the area (**Photo 10**). Within the “green yard,” freshly cut “green lumber” from the mill is stored prior to entering the kilns (**Photo 11**).

Description: Facing east, photo of catch basin within the "green lumber" storage area. Lumber is stored in the location temporarily after being milled, and prior to being dried in the kilns.

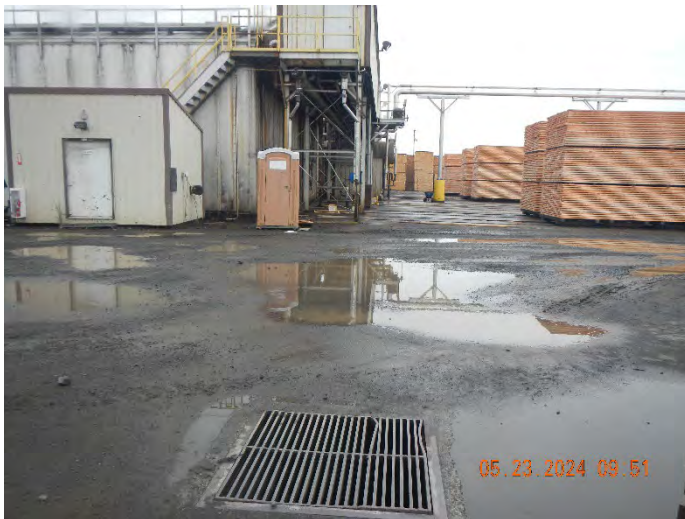
Photo #:11 (DSCN3780)

Description: Facing west, photo of catch basin east of the kilns.

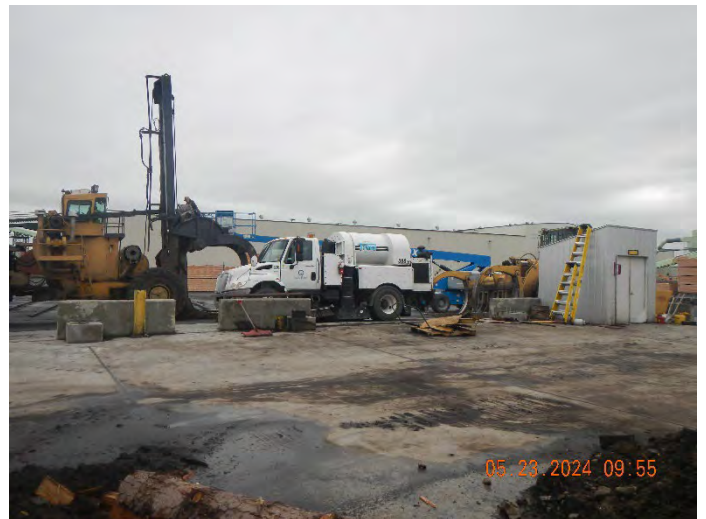
Photo #:12 (DSCN3781)

We observed designated wash bay and associated drying bed. It was discussed that the wash bay routes wash water to sanitary sewer. North of the wash bay, we observed the Facility’s Tymco vacuum sweeper truck (**Photo 12**), it was discussed that the Facility maintains a clean-up crew for the property, generally operating weekly or as needed.

Description: Facing north, photo of the Facility's vacuum sweeper truck.

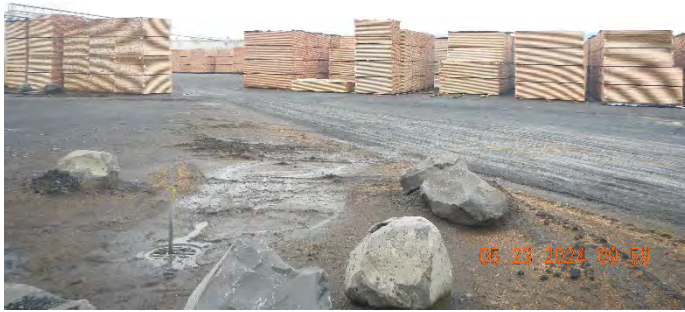
Photo #:13 (DSCN3782)

Description: Facing south, photo of catch basin south of the boiler building, north of the green lumber storage area.

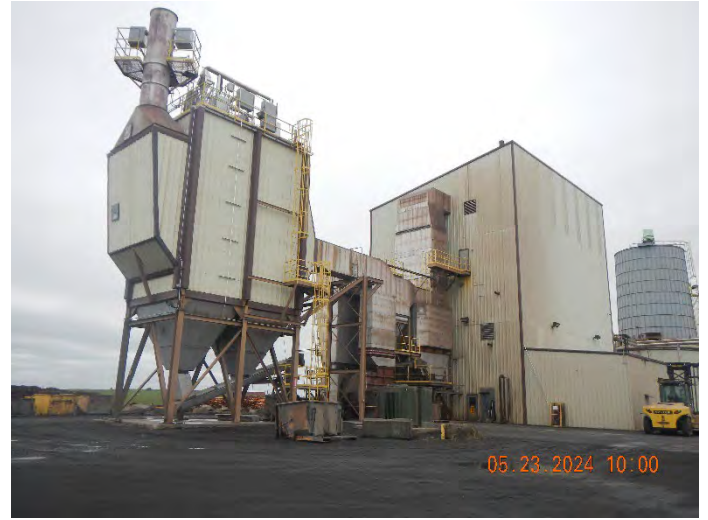
Photo #:14 (DSCN3783)

Description: Facing north, photo of the Facility's boiler building.

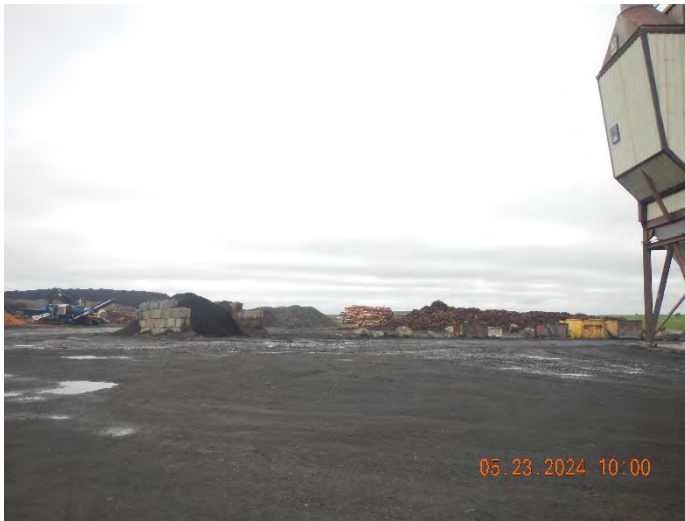
Photo #:15 (DSCN3784)

Following our time near the lumber storage area and maintenance area, we headed toward the boiler building. This north end of the property transitions to an unpaved surface. We observed a central catch basin between the lumber storage area and boiler building (**Photo 13, Photo 14**). It was discussed that the boiler was currently in a scheduled shut down for maintenance. The boiler utilizes a reverse osmosis (RO) system. West of the boiler, we observed a small containment area utilized for boiler ash cooling (**Photo 15**).

Description: Facing north, photo of area west of the boiler building. Temporary boiler ash storage area.

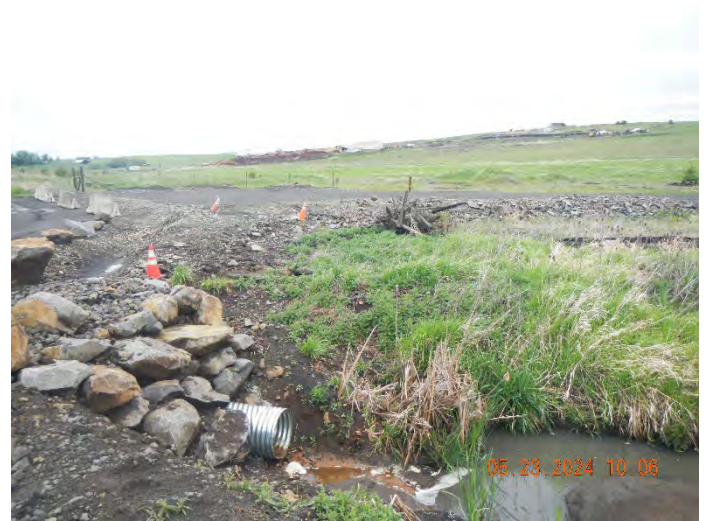
Photo #:16 (DSCN3785)

We then continued to the northwest corner of the property; we observed a stormwater collection area discharging to an initial stormwater channel prior to discharging to the stormwater pond (**Photo 16 – Photo 18**). We traveled east along the northwest log deck storage area (**Photo 19**); it was discussed that the log deck has several catch basins as well as channels that route stormwater downslope to the north. Stormwater is ultimately collected in a northern drainage channel (**Photo 20**), discharging to the stormwater pond via culverts. Stormwater from the northwest log yard is first routed to an initial settling pond prior to entering the larger/primary collection pond (**Photo 21 - Photo 23**).

Description: Photo of stormwater collection area from northwest corner of the Facility. Culvert discharges to an initial stormwater channel prior to being discharged to stormwater collection pond.

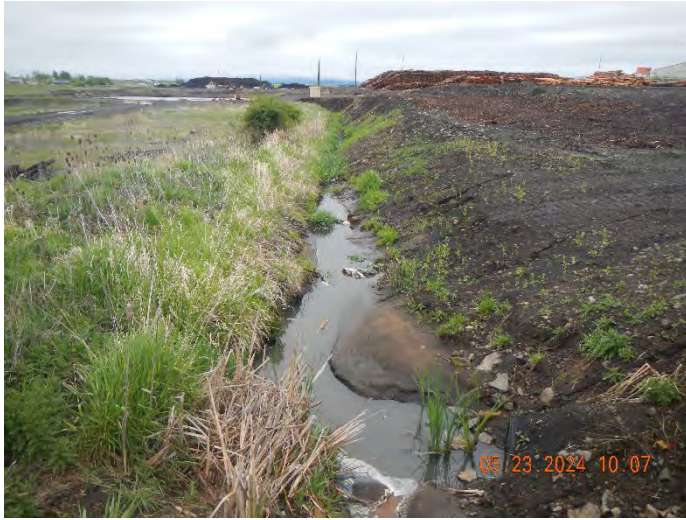
Photo #:17 (DSCN3786)

Description: Facing east, photo of stormwater channel along the northwest area of the Facility.

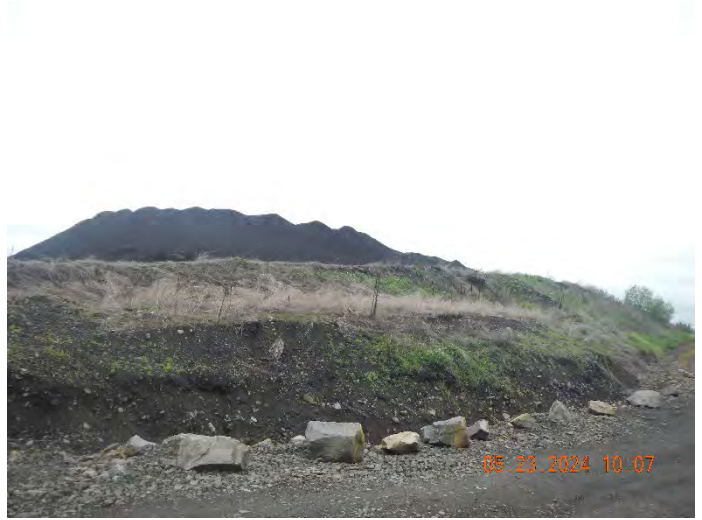
Photo #:18 (DSCN3787)

Description: Facing northwest, photo of northwest corner stormwater collection channel.

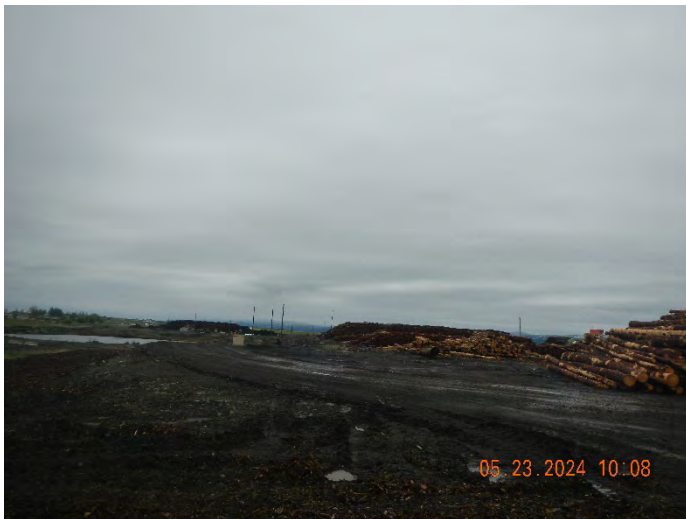
Photo #:19 (DSCN3788)

Description: Facing east, photo of northwest log deck storage area and access road to the stormwater collection pond.

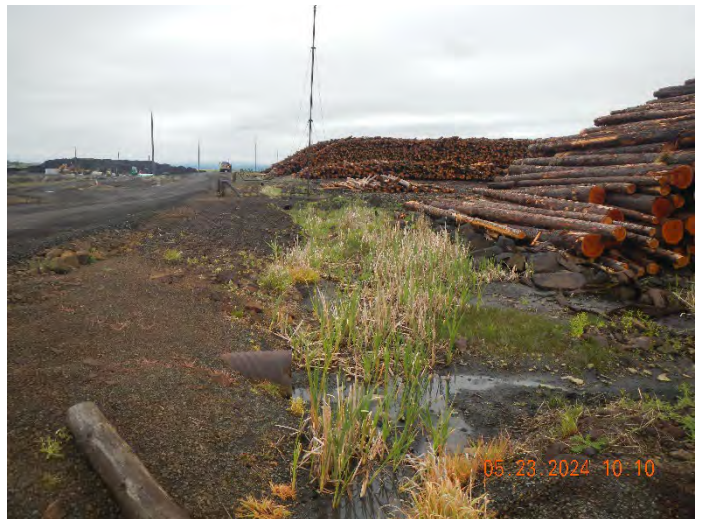
Photo #:20 (DSCN3789)

Description: Facing east, photo of the drainage channel near the northwest log deck storage area.

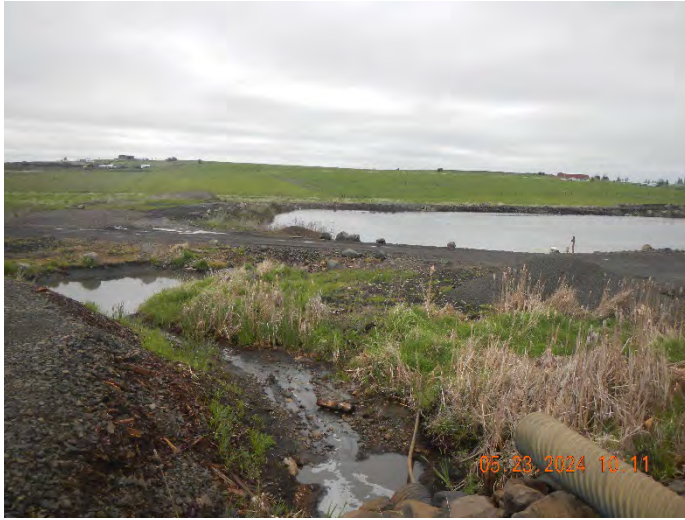
Photo #:21 (DSCN3790)

Description: Facing north, photo of the northwest discharge to an initial settling pond. Discharge is prior entering the larger stormwater collection pond.

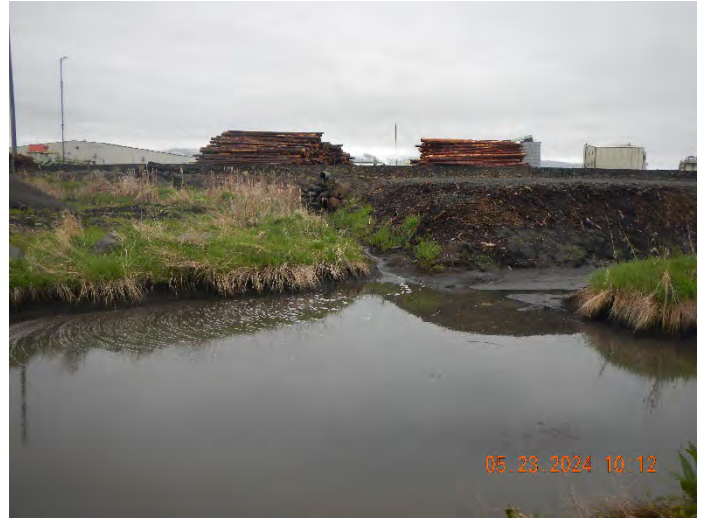
Photo #:22 (DSCN3791)

Description: Facing south, photo of the northwest discharge to an initial settling pond. Discharge is prior entering the larger stormwater collection pond.

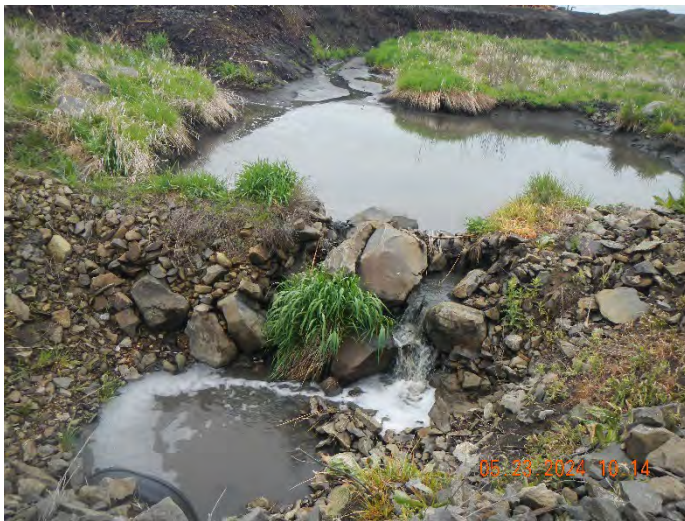
Photo #:23 (DSCN3792)

Description: Facing southwest, photo of stormwater drainage channel prior to discharge to stormwater collection pond.

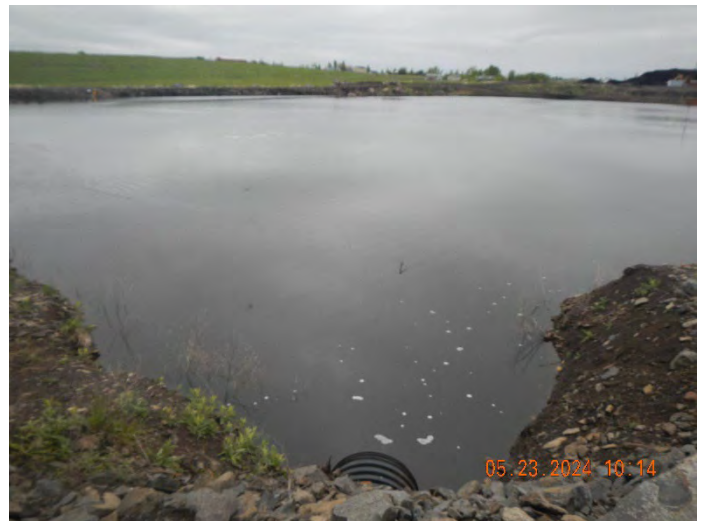
Photo #:24 (DSCN3793)

We arrived at the Facility’s primary stormwater collection pond (**Photo 24**) and discussed/observed the eight aerators that were operating. It was discussed that the aeration system recently installed within the pond approximately one month prior. We continued to the northwest corner where we observed the pond’s discharge to a vegetative area west of the pond (**Photo 25**) via culvert. The discharge point is considered the Facility’s Outfall 001 and was discharging at the time of inspection. The discharge was slightly turbid with no floating debris. It was discussed that the ponds discharge/culvert is the monitoring point for permit compliance. The discharge then meanders within the vegetative area before entering the receiving water (Long Haul Creek) approximately 300-400 yards to the northwest. Mr. E. Smith discussed that the vegetative area was on private property owned by an adjacent landowner and that the Facility was exploring purchasing the lot.

Description: Facing northeast, photo of stormwater discharge to stormwater collection pond.

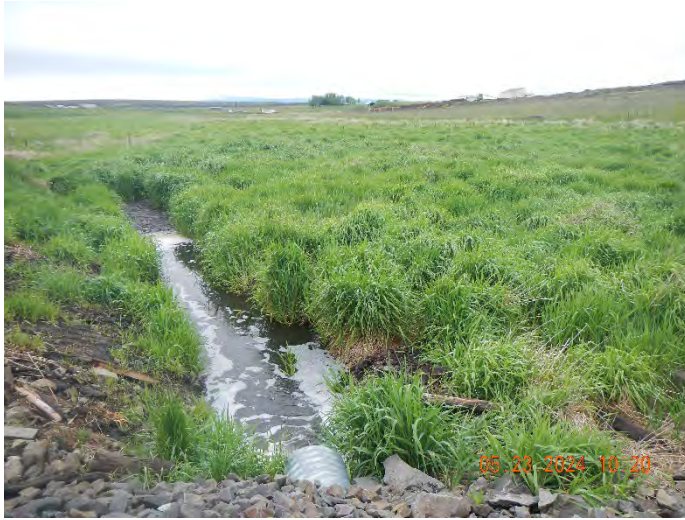
Photo #:25 (DSCN3794)

Description: Facing northwest, photo of stormwater collection pond discharge to vegetative area west of the pond. According to the Facility, discharge enters the receiving water (Long Haul Creek) approximately 400 yards to the northwest.

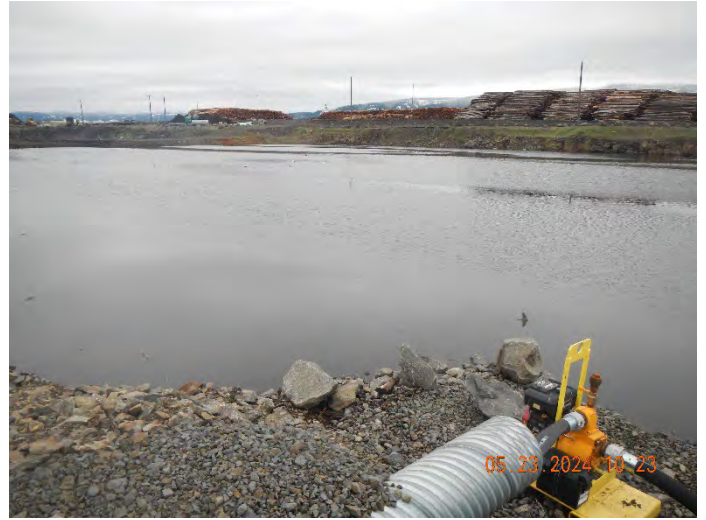
Photo #:26 (DSCN3795)

We then travelled to the north side of the pond and observed the newly installed pump station (**Photo 26**). The pump station was installed to provide the option for land application to a vegetative field north of the Long Haul Creek (**Photo 27**).

Description: Facing southeast, photo of pump station installed along the north end of the pond. Pump station to be used to route pond water to land application field north of Long Haul Creek.

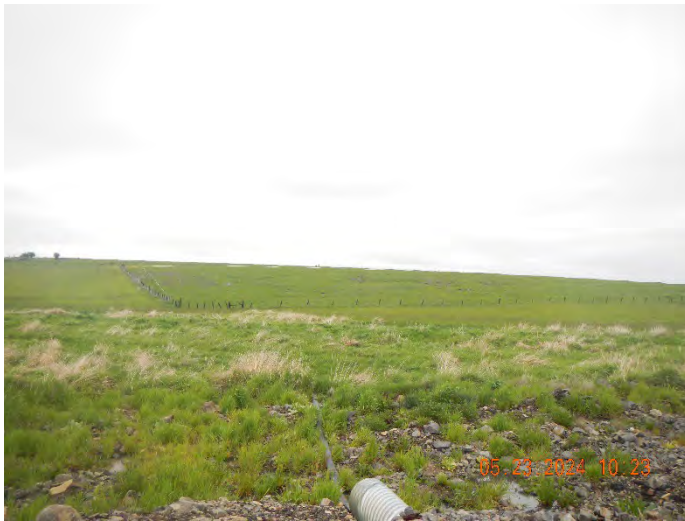
Photo #:27 (DSCN3796)

Description: Facing north, photo of land application field north of the stormwater collection pond.

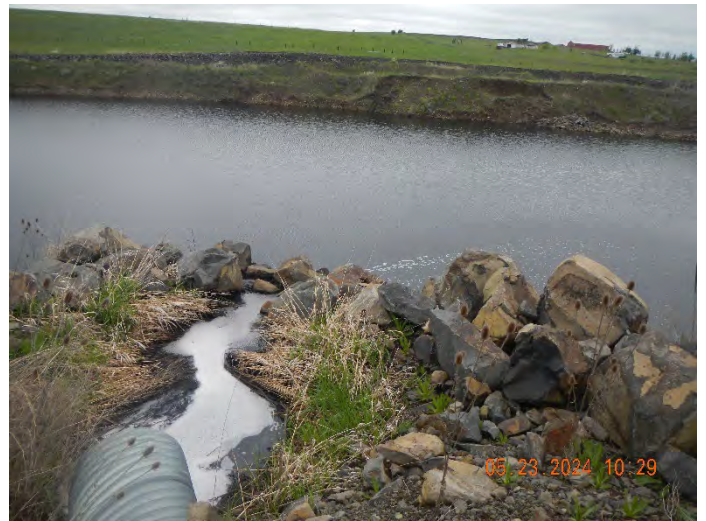
Photo #:28 (DSCN3797)

We continued to the east end of the pond and observed additional influent sources from the log deck collection system (**Photo 28**). We also observed the constructed forebay berm within the pond (**Photo 29**).

Description: Facing north, photo of log deck storage collection system discharge to stormwater collection pond.

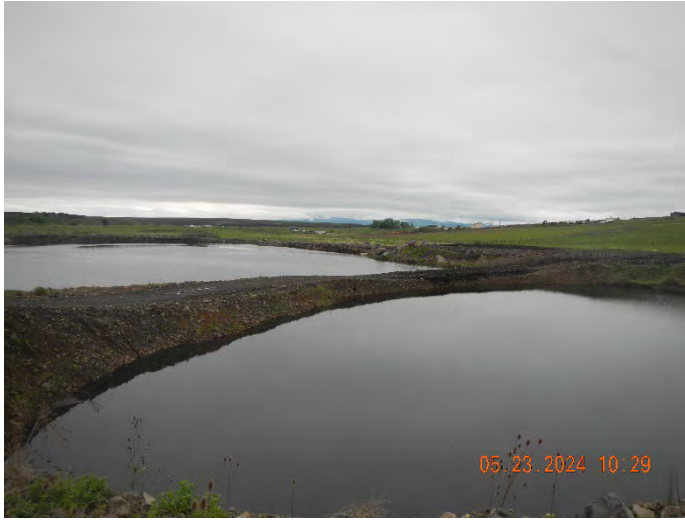
Photo #:29 (DSCN3798)

Description: Facing northwest, photo of stormwater collection pond.

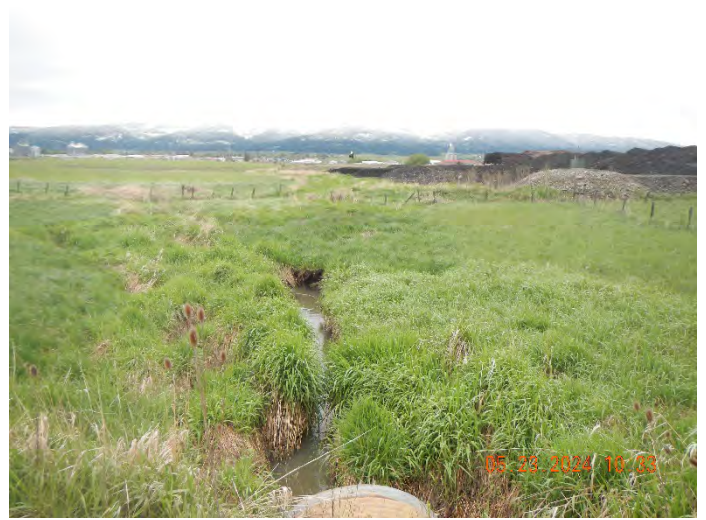
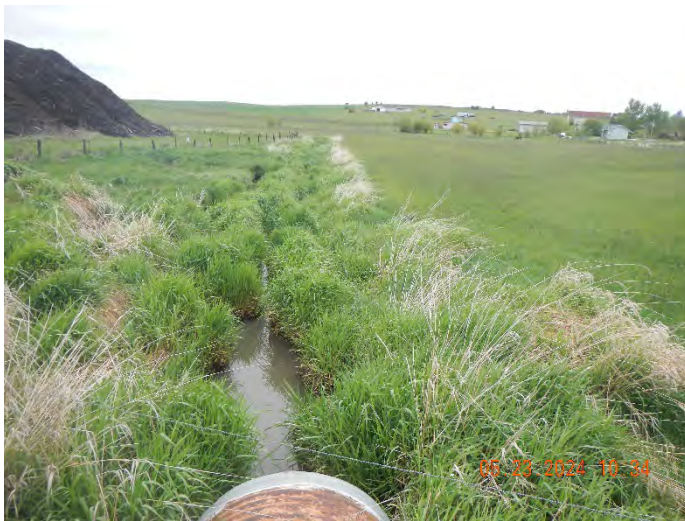
Photo #:30 (DSCN3799)

We then travelled to the northeast corner of the site and observed Long Haul Creek, flowing north along the property boundary near the Facility's screening/sorting pile (**Photo 30, Photo 31**). A slight berm is located between the property and Long Haul Creek along the eastern perimeter. No stormwater was observed entering Long Haul Creek. Due to the short distance between the Facility's screening/sorting pile and Long Haul Creek, I suggested the Facility consider some additional BMPs at this location to ensure no direct discharge from the area.

Description: Facing south, photo of Long Haul creek, east of the Facility.

Description: Facing north, photo of Long Haul Creek, easter of the Facility.

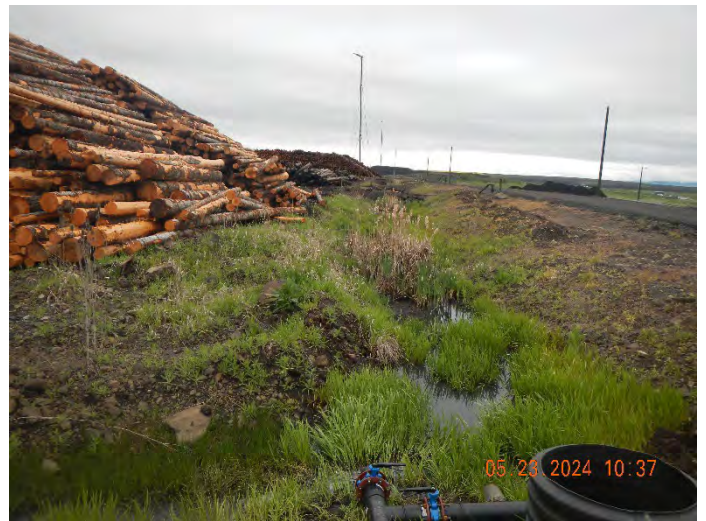
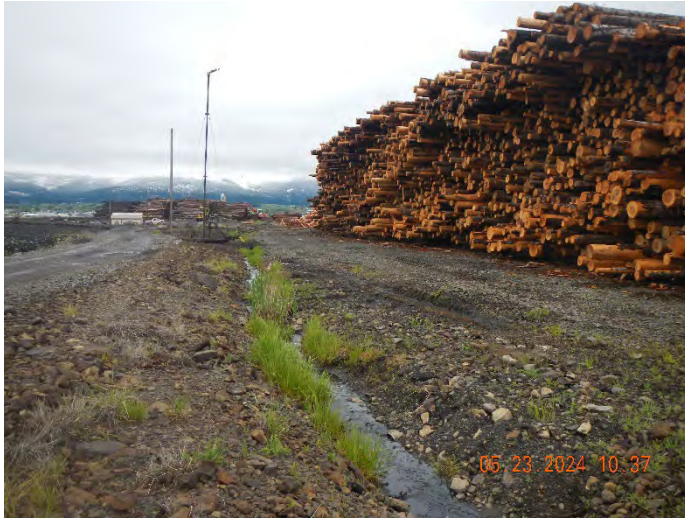
Photo #:32 (DSCN3801)

We then continued back to the log yard and observed a stormwater collection channel within the northeastern corner (**Photo 32, Photo 33**). The channel directs stormwater from the log yard to the primary collection pond.

Description: Facing west, photo of stormwater collection channel located in the northeast corner of the log deck storage area.

Description: Facing south, photo of stormwater collection channel located east of the log deck storage area.

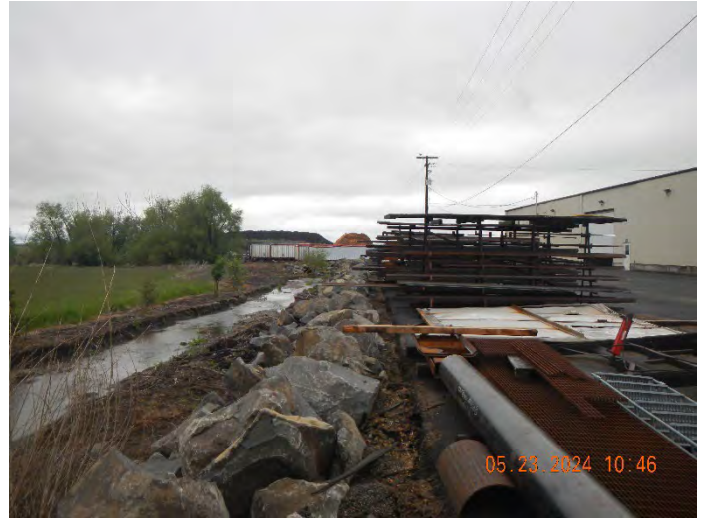
Photo #:34 (DSCN3803)

We continued from the eastern perimeter back to the western perimeter near the fabrication building to observe West Fork of Long Haul Creek which runs adjacent to the Facility (**Photo 34**). Berming extends along the western perimeter as well as a vegetative area that is maintained with irrigation (**Photo 35**). We continued south and observed the planer mill area and associated sawdust/shaving/chip bins (**Photo 36**). We then observed where the parking lot drainage channel observed earlier in the inspection enters the below ground stormwater collection system (**Photo 37**). The walk-through concluded after viewing the MSPG permit coverage signage (**Photo 38**) located along the Highway, southwest of the pine building. We then returned to the Facility's conference room to begin the records review.

Description: Facing north, photo of western perimeter. West Fork of Long Haul Creek travel's adjacent to the Facility.

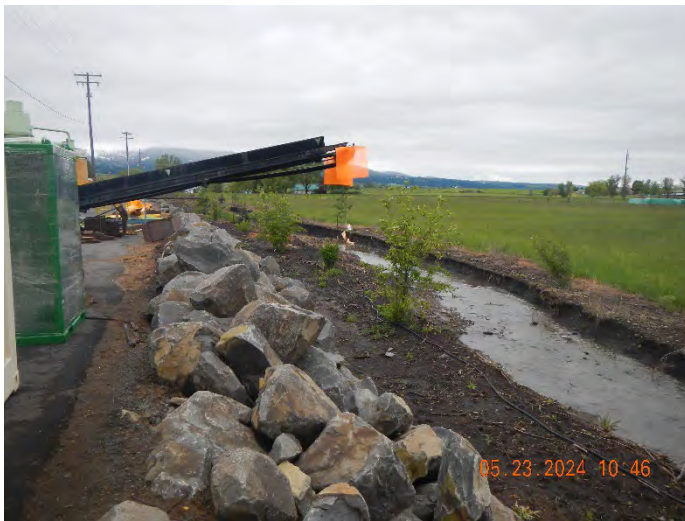
Photo #:35 (DSCN3804)

Description: Facing south, photo of western perimeter. West Fork of Long Haul Creek travels adjacent to the Facility.

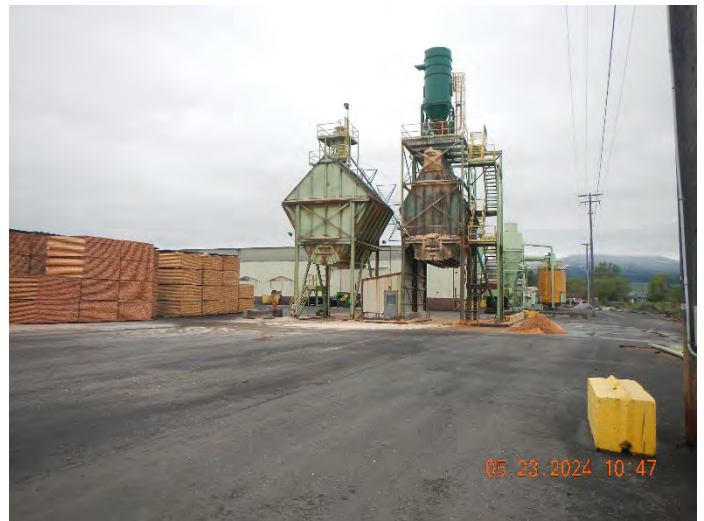
Photo #:36 (DSCN3805)

Description: Facing south, photo of sawdust and chip bins from the planer building.

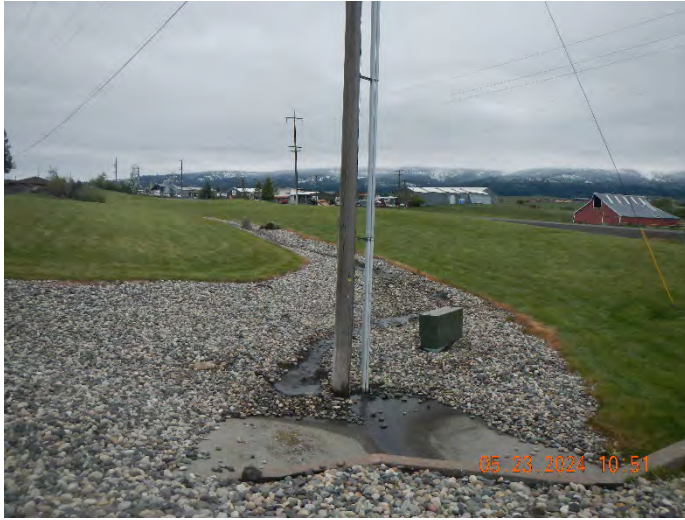
Photo #:37 (DSCN3806)

Description: Facing southeast, photo of drainage channel along southwest perimeter.

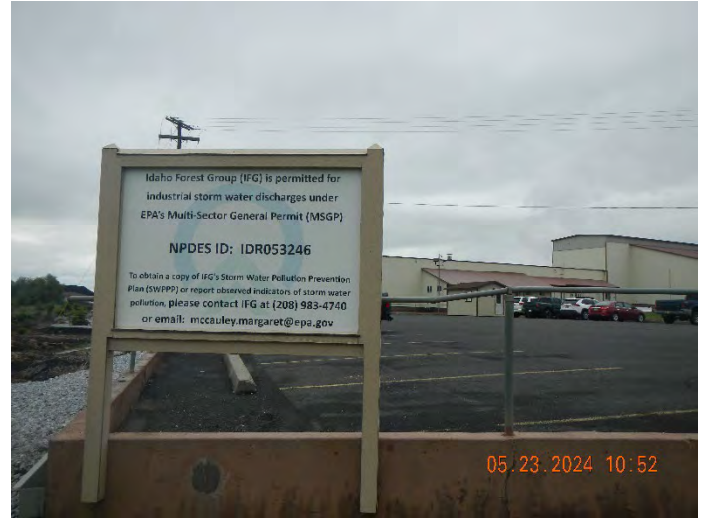
Photo #:38 (DSCN3807)

Description: Photo of MSGP permit signage posted southwest of the Pine Building along the highway.
