# **NPDES Compliance Inspection Report**

## **Palmer Municipal WWTF**

**Permit # AK-002249-7**

**Inspection Date: September 27, 2021**

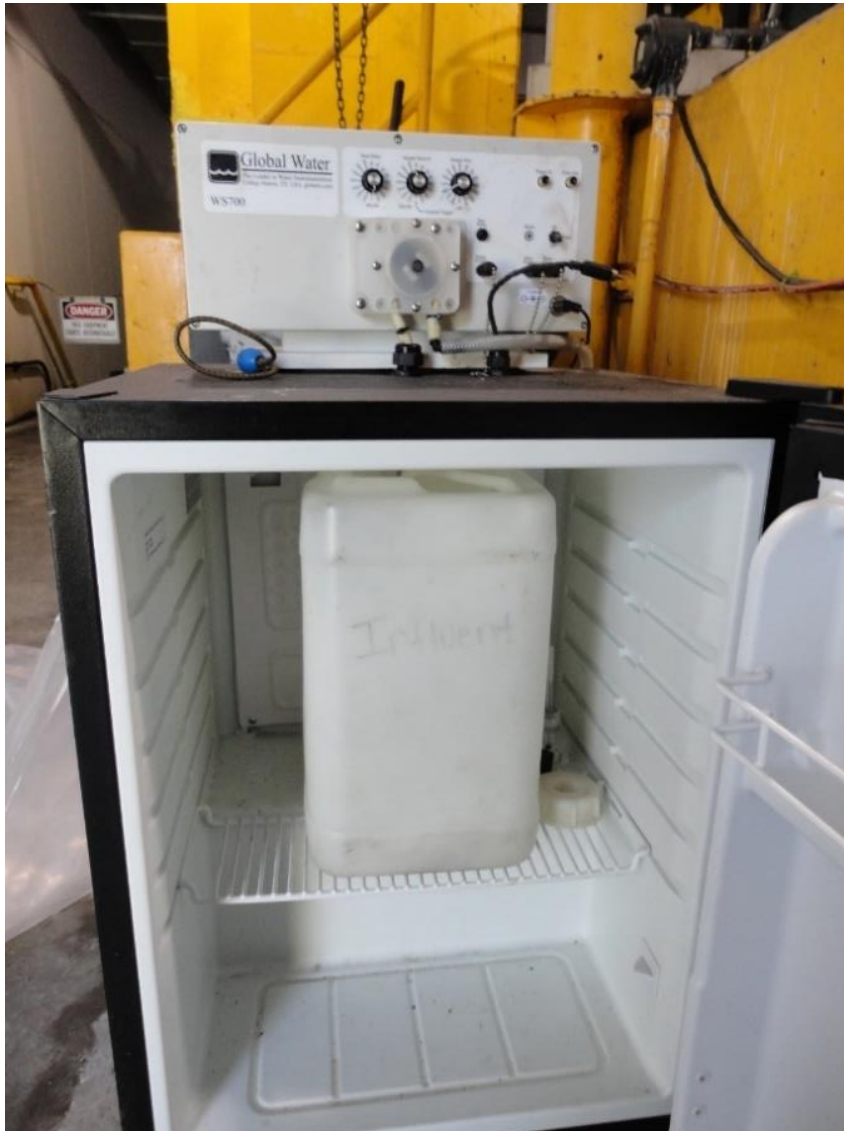
**Photo 1**

We began the site tour at the facility's headworks, where I inspected the municipal intake, the influent flow meter, the autosampler and storage fridge (**Photo 1**), and the facility's screening, auger and grinder, as water flowed through the headworks building. Alycia noted the influent flow meter is not regularly calibrated but the effluent flow meter is. At the time of the inspection, the autosampler was not hooked up in its usual place since Mr. Howard had moved it to conduct weekly sampling.

Description: Refrigerator where the sampled water is stored during composite sampling inside the headworks building.

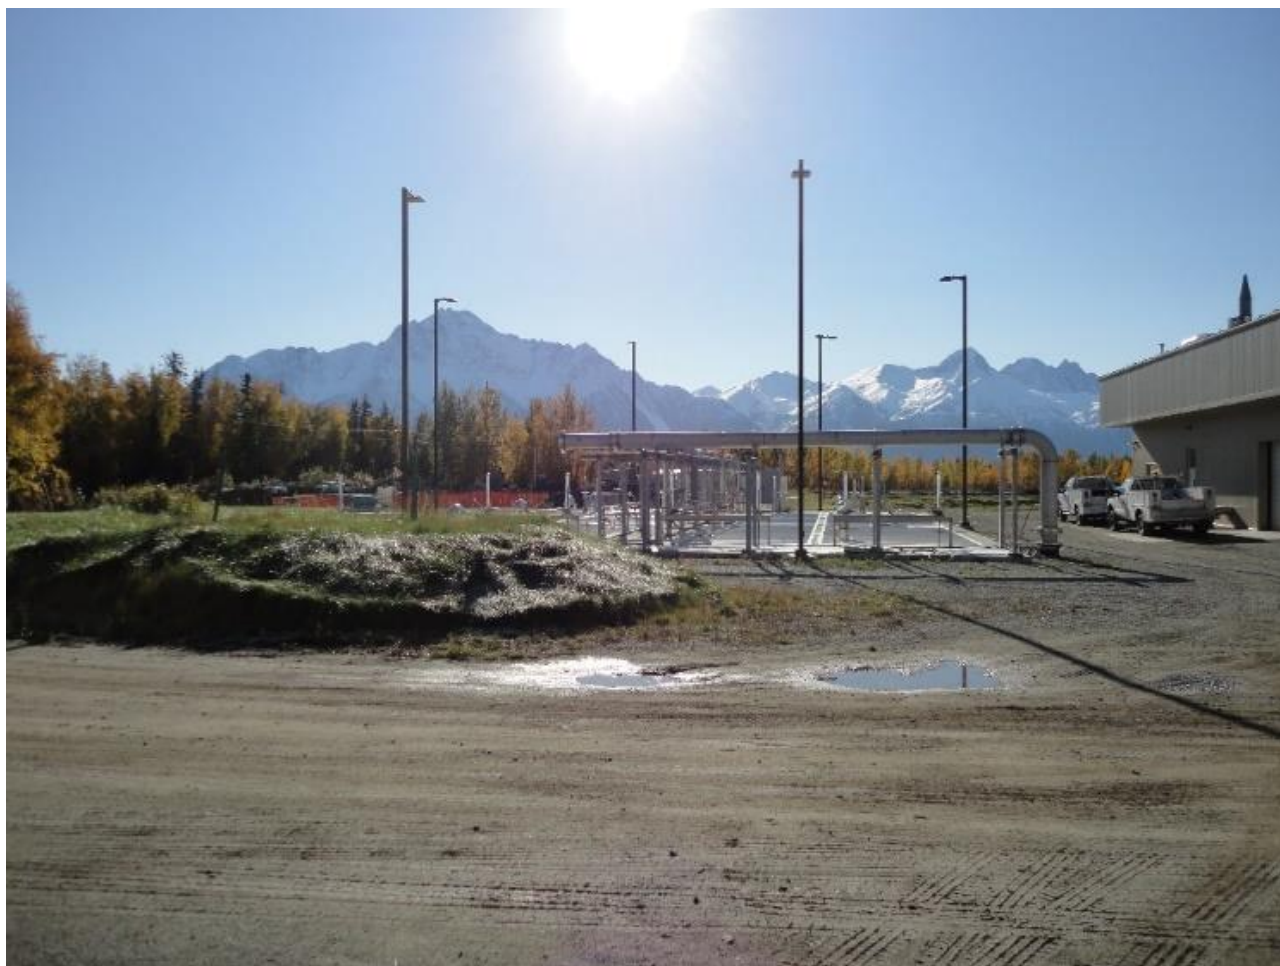
**Photo 2**

Description: Above-ground view of the new MBBR system. The new laboratory building can be seen on the right.

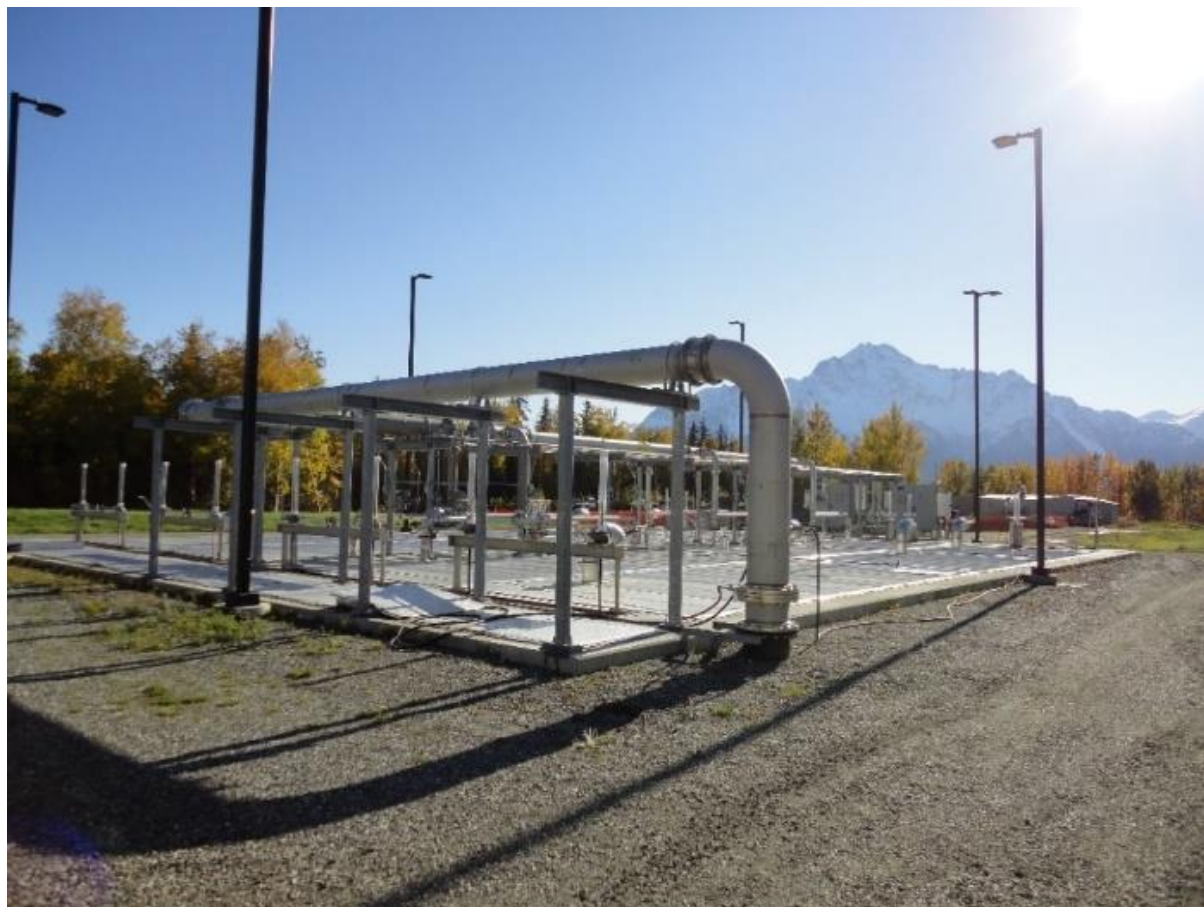
**Photo 3**

Description: Corner view of the MBBR.

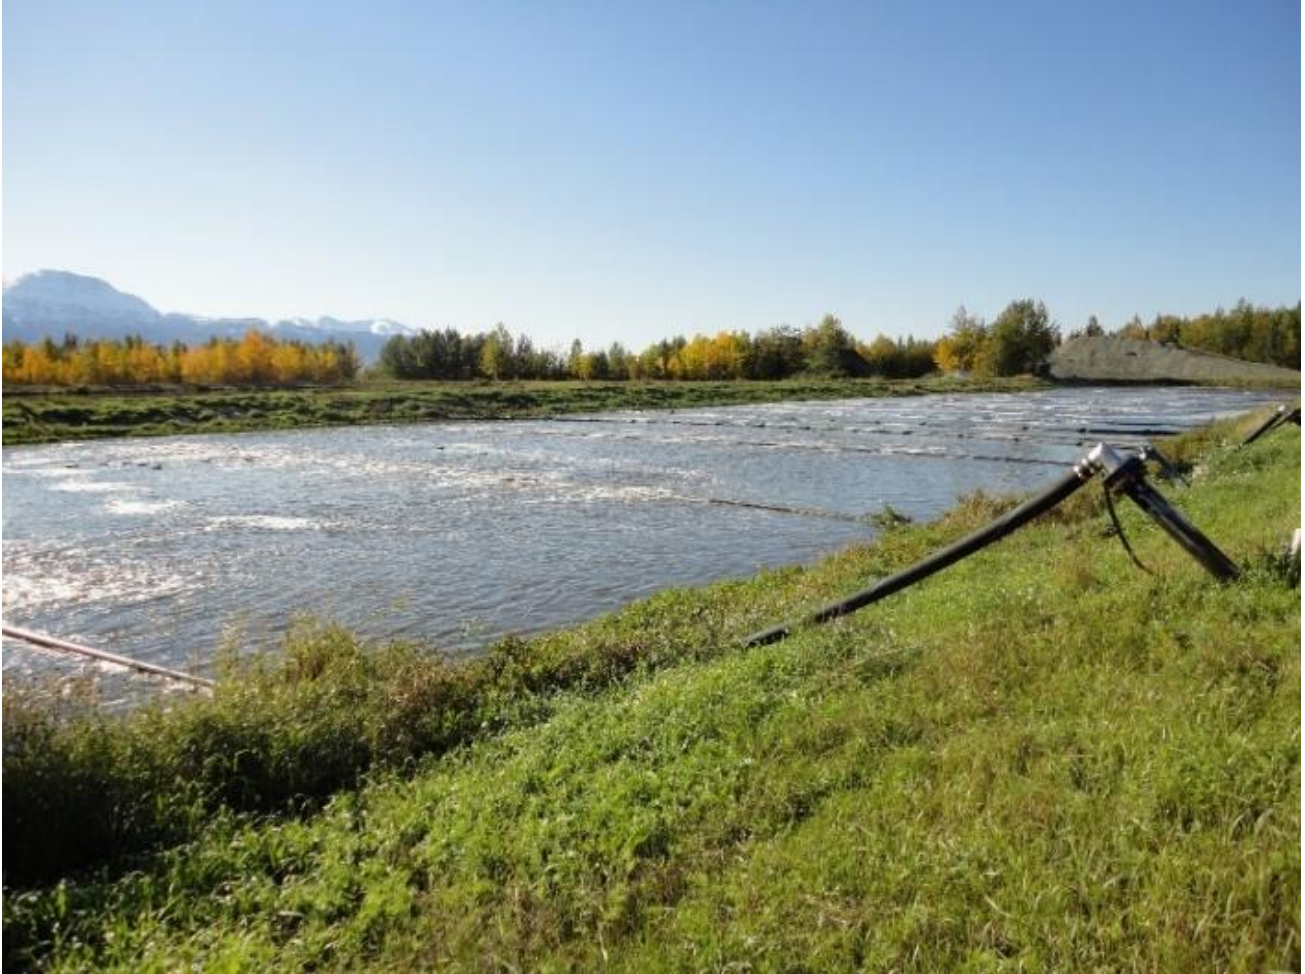
**Photo 4**

I then inspected Lagoon 2 and Lagoon 3. Both Lagoon 2 and 3 are Biolac aerated lagoons roughly 8 feet deep. In 2020, the submerged diffusers in Lagoon 2 became stuck in sludge as it accumulated and rendered the diffusers ineffective. That summer the facility replaced the cracked diffusers and raised the diffusers' elevation. The fine-bubble diffusers now hang three feet from the main manifold and are evenly spaced (**Photo 4**).

Description: After water is brought from the headworks intake through the MBBR, it is released into Lagoon 2. View of Lagoon 2 with fine-bubble diffusers. Facing SW.

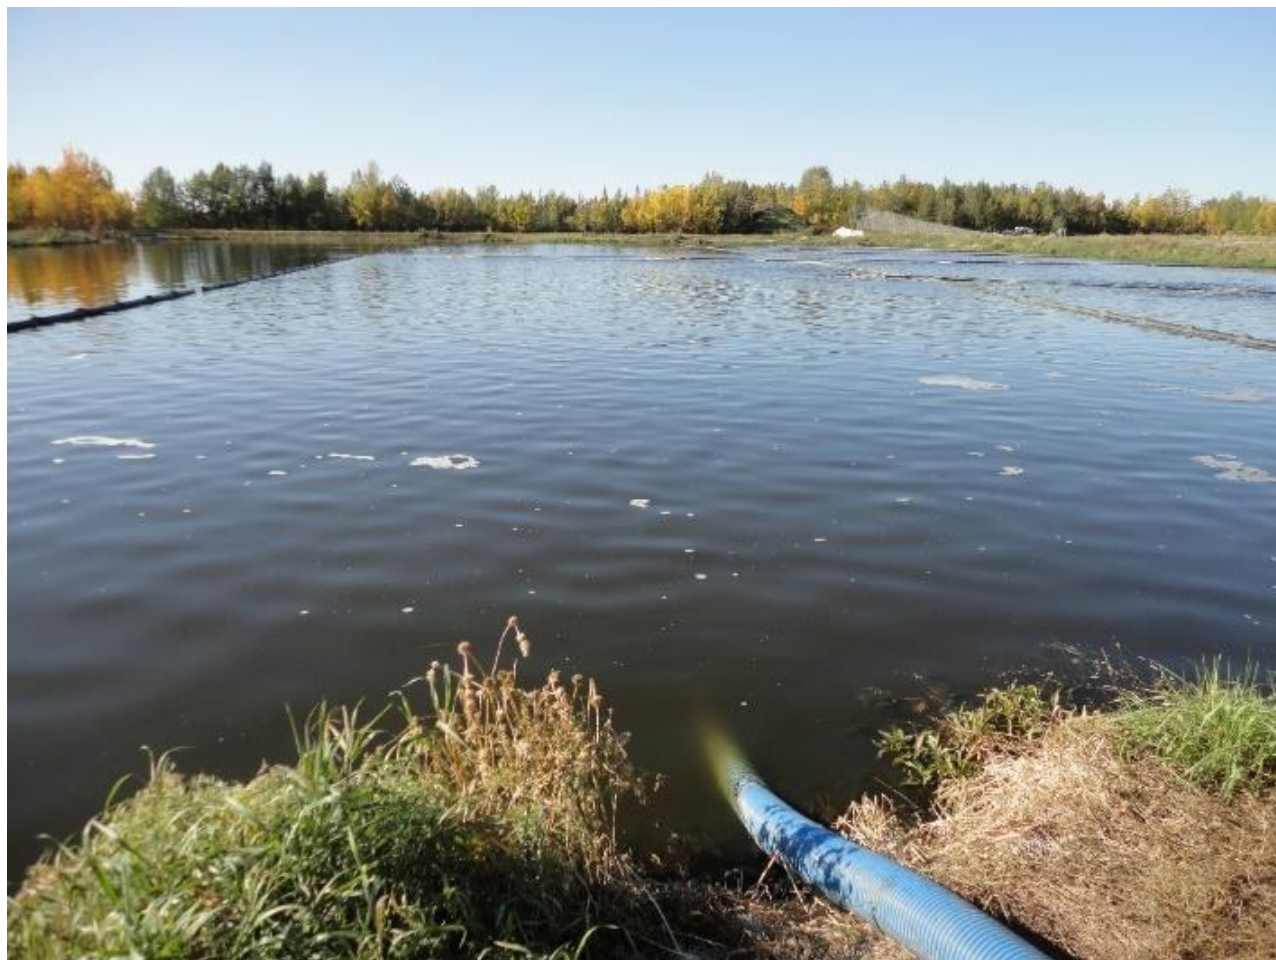
**Photo 5**

Lagoon 3 is situated south of Lagoon 2 and adjacent to the UV Disinfection Building. Some foam was present on the surface of Lagoon 3, in its eastern cell (**Photo 5**). Ms. Anderson said the facility experienced algal buildup in Lagoon 3 this past August.

Description: Closer view of water in Lagoon 3. Foam present in a cell on the eastern side of Lagoon 3.

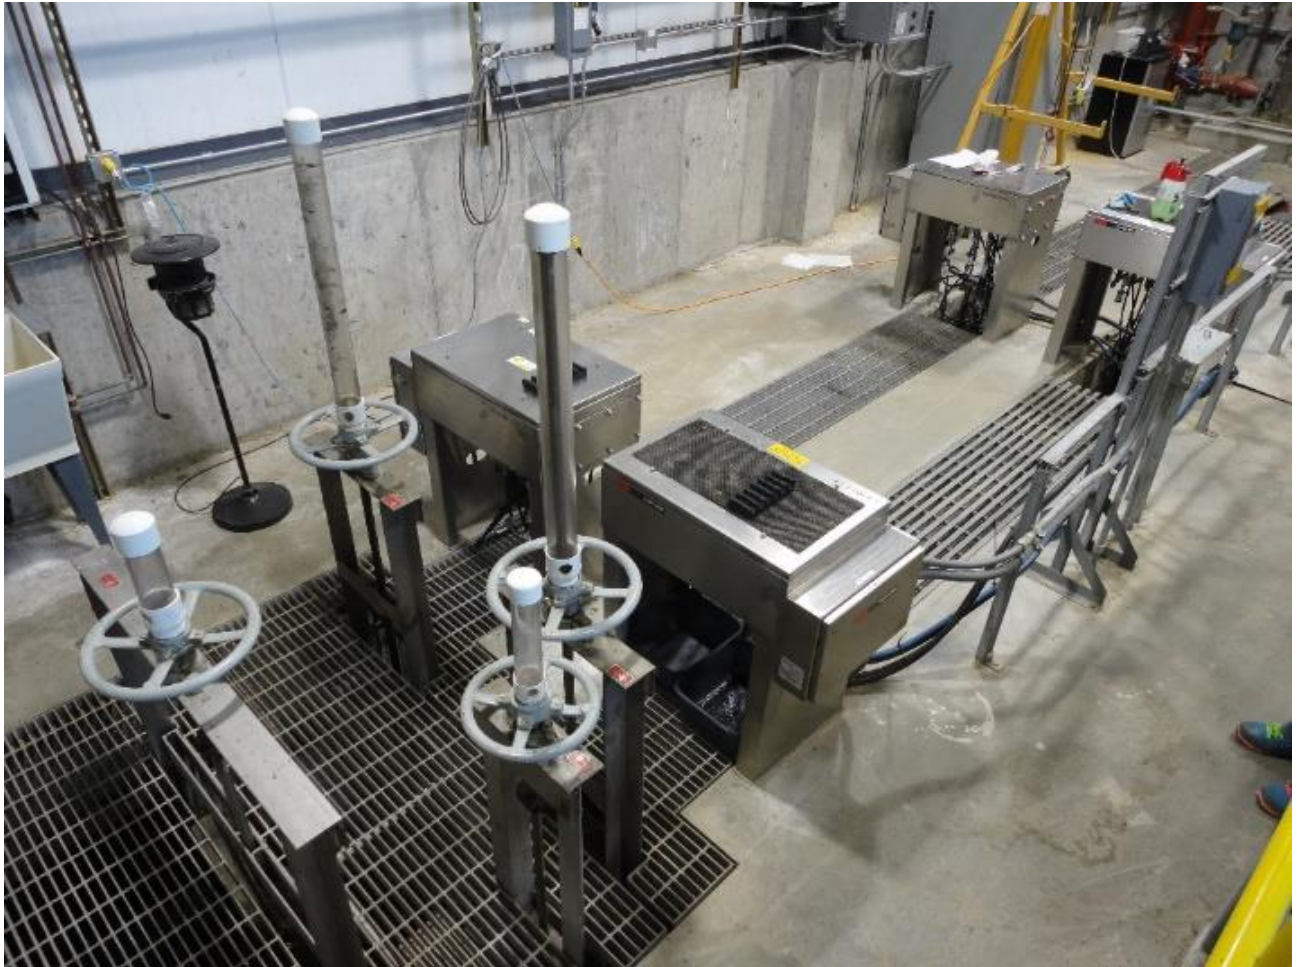
**Photo 6**

In the UV Building (**Photo 6**), I inspected the UV bulb replacements, the four UV units, the effluent flow meter, autosampler, sampler tubing, sample location, and sample storage fridge inside the building. Ms. Anderson and Mr. Howard demonstrated their sampling protocol. A recirculation pump collected water post-UV treatment to spray the upstream pump filters.

Description: Inside the UV building, looking down at the enclosed, UV lamp process streams. Show here are the four UV units, each with five ballasts, each of which contain eight UV bulbs.

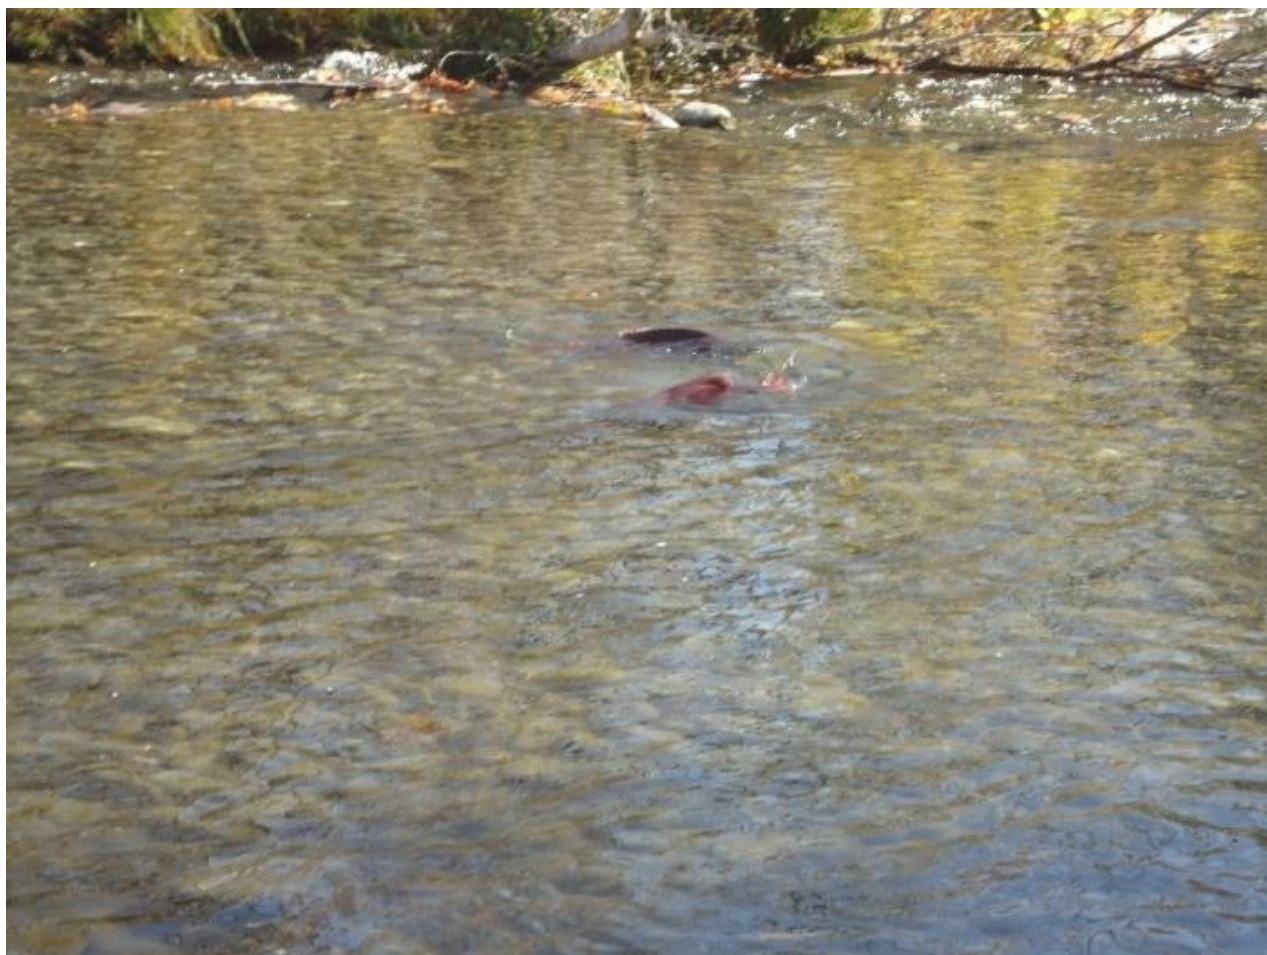
**Photo 8**

Description: Salmon spotted in the receiving waters of the Matanuska River.

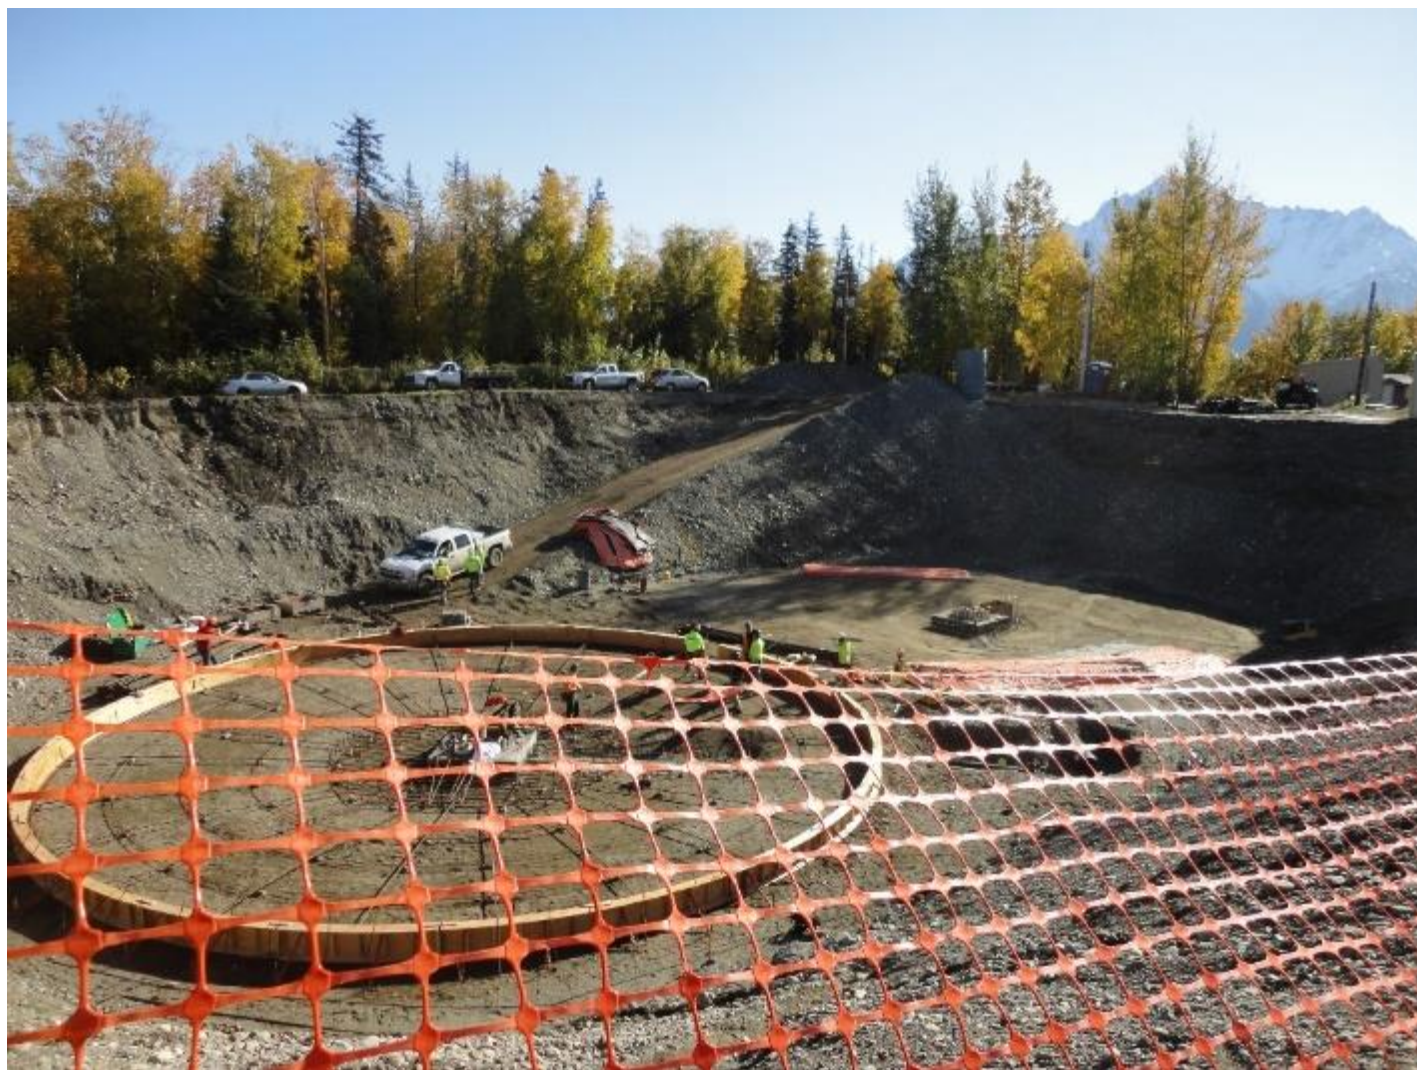
**Photo 11**

Ammonia effluent limits as permitted are significantly lower for the months of July and August than they are for the rest of the year. Ms. Anderson immediately identified the ammonia - nitrogen parameter the most difficult for her facility to achieve, and she said the lagoon system, as it currently stands, and the challenge of sludge removal are why the facility frequently fails this parameter, especially during the summer months. Ms. Anderson expressed her belief that the secondary clarifier (construction shown in

**Photo 11)** will significantly upgrade the Palmer Municipal WWTF and improve its treatment efficiency.

Description: Construction progress of the facility's secondary clarifier.
